Expertise

Protocol number: 39572090  
Order No. / Reference: 24722598  
Inspection date: 30 Apr 2025

Manufacturer: Volkswagen

Model: T-Roc 2.0 TDI SCR DSG Style

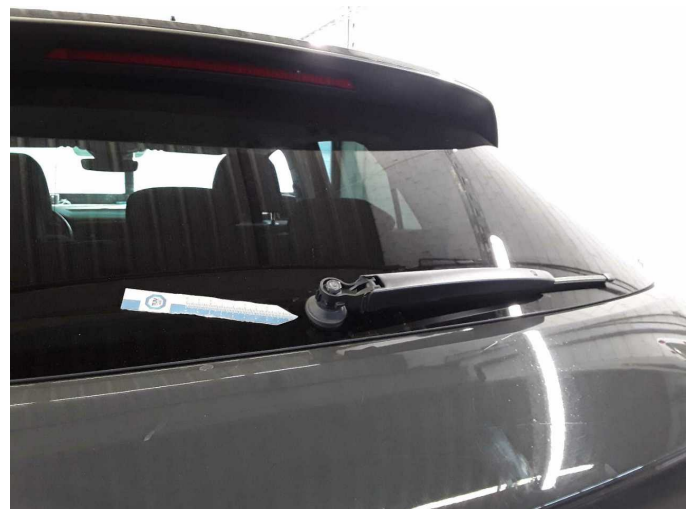
**Damage 1:** Screen cleaning: Wiper arm - rear (Abdeckung) - Missing - Replace

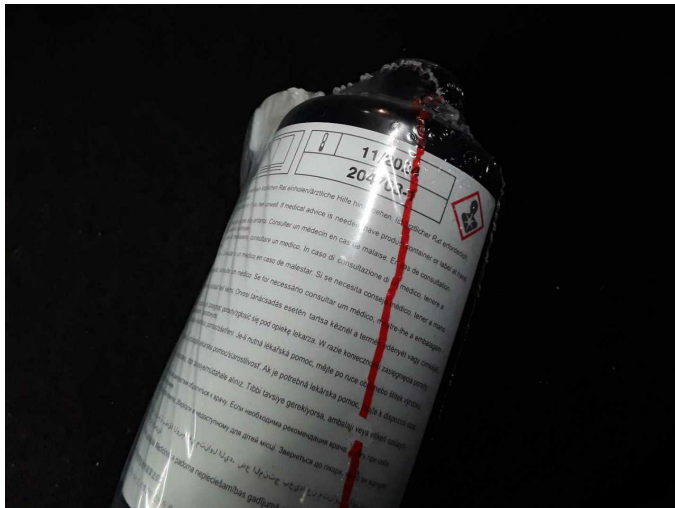
**Damage 2:** Equipment: Tirefit filler - Expired - Replace

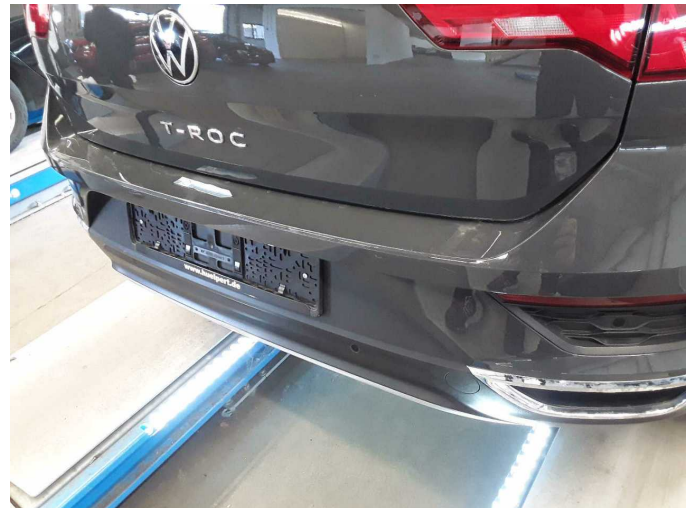
**Damage 3:** Rear bumper: Rear bumper - Scratch(es) - Paint

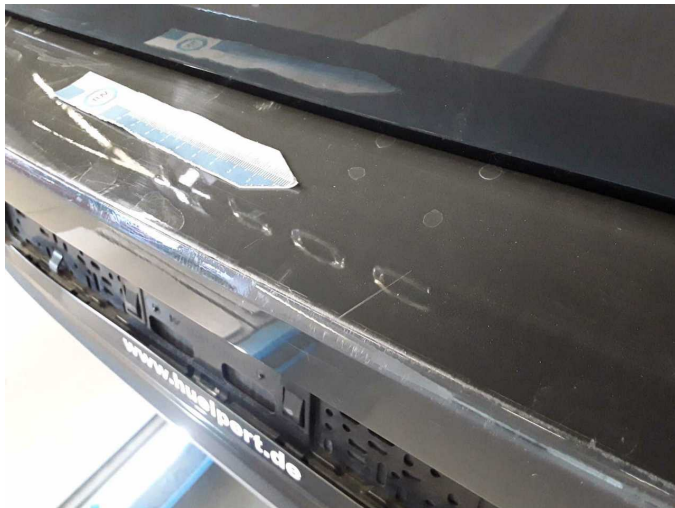
**Damage 3:** Rear bumper: Rear bumper - Scratch(es) - Paint

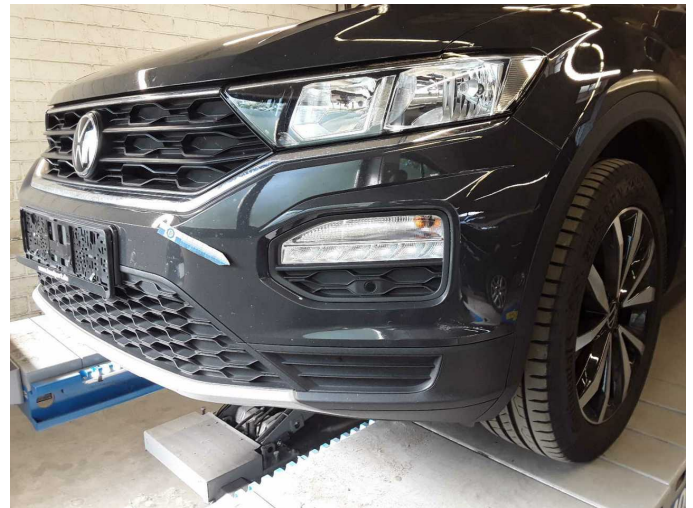
**Damage 4:** Front bumper: Front bumper - Stone chips - Paint

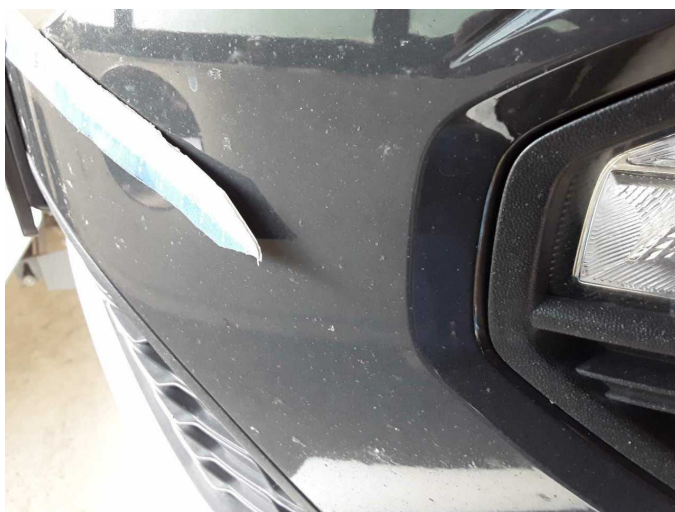
**Damage 4:** Front bumper: Front bumper - Stone chips - Paint

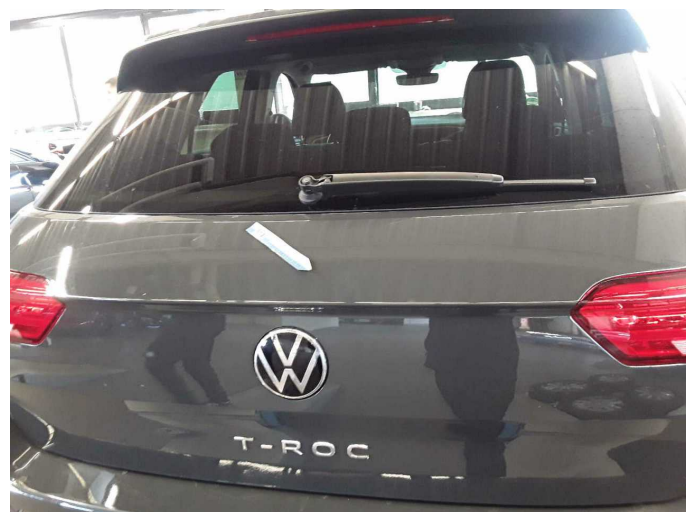
Boot lid / rear door 174  $\mu\text{m}$  |

**Damage 5:** Boot lid / rear door: Boot lid (Schleifriefen) - Unprofessionally repaired - Repair and paint

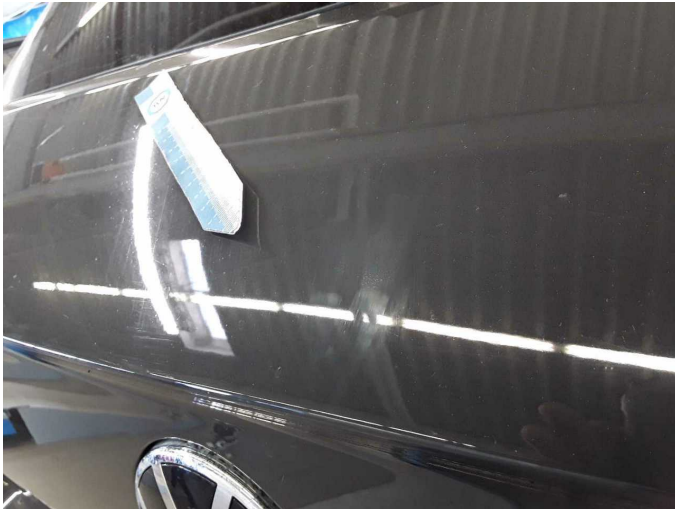
**Damage 5:** Boot lid / rear door: Boot lid (Schleifriefen) - Unprofessionally repaired - Repair and paint

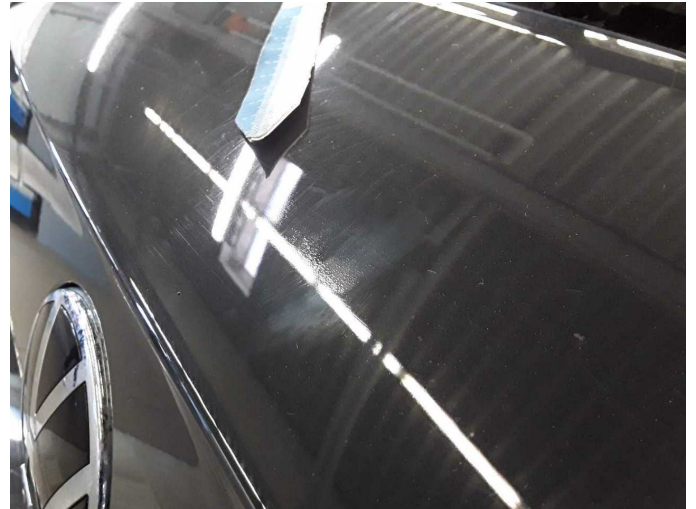
**Damage 5:** Boot lid / rear door: Boot lid (Schleifriefen) - Unprofessionally repaired - Repair and paint

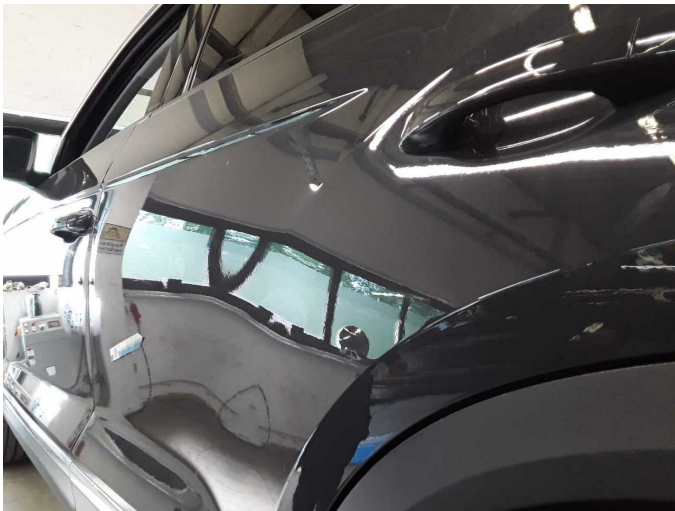
**Damage 6:** Door - rear left side: Door - Scratch(es) - Paint

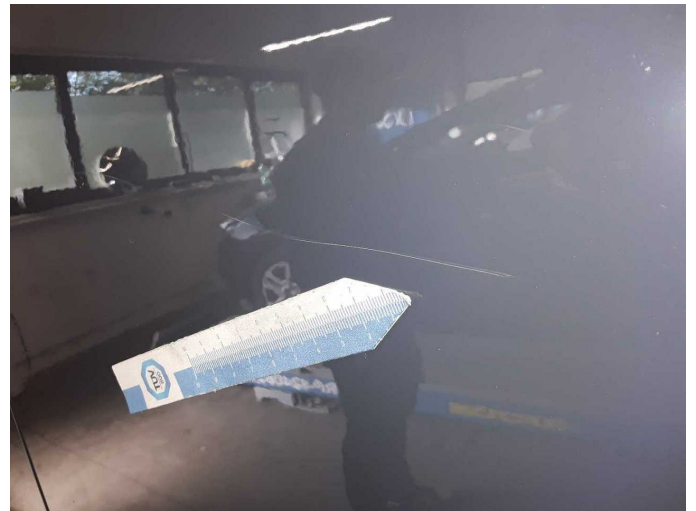
**Damage 6:** Door - rear left side: Door - Scratch(es) - Paint

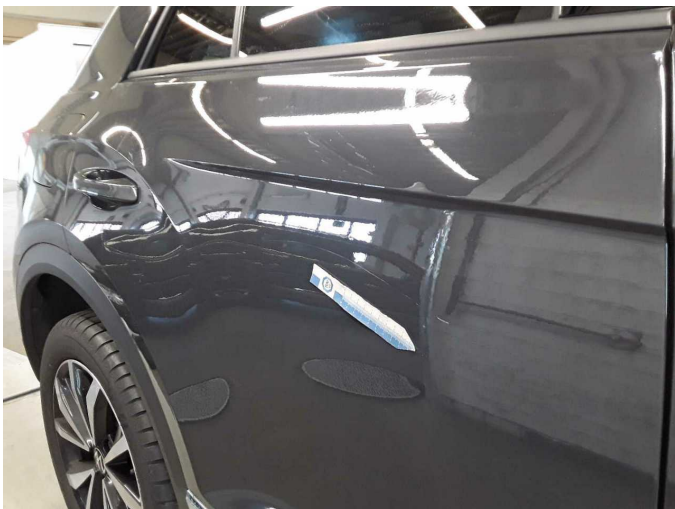
**Damage 7:** Door - rear right side: Door - Scratch(es) - Paint

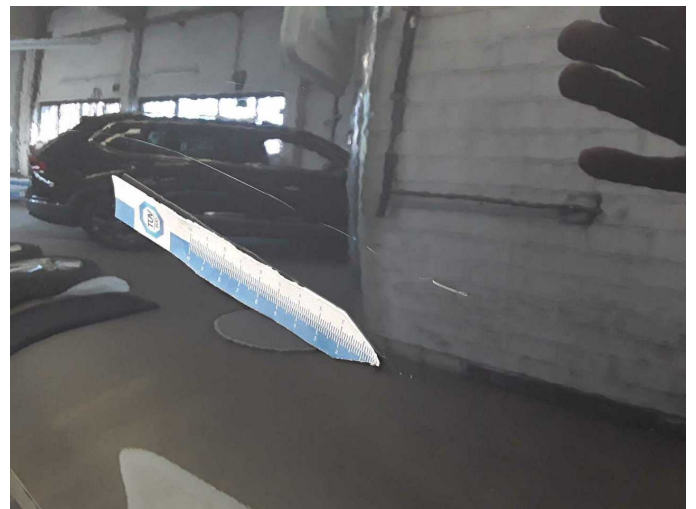
**Damage 7:** Door - rear right side: Door - Scratch(es) - Paint

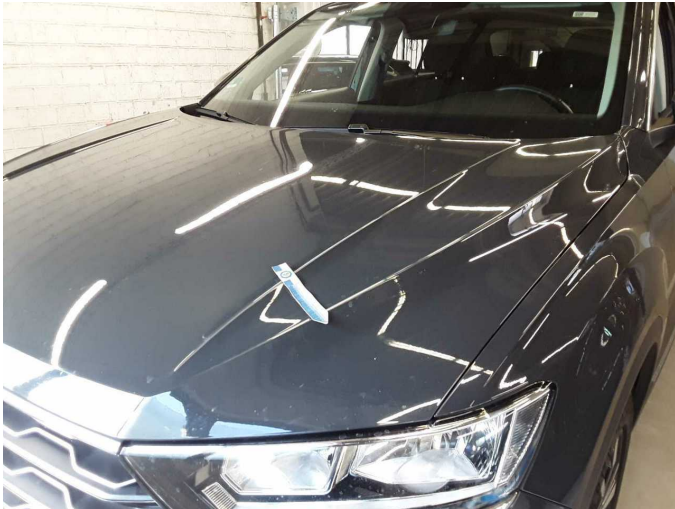
**Damage 8:** Bonnet: Bonnet (Vermehrte Steinschläge) - Stone chips - Paint

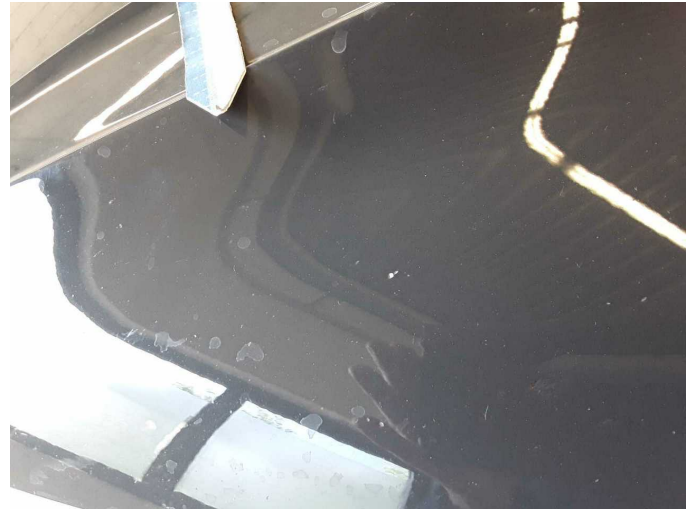
**Damage 8:** Bonnet: Bonnet (Vermehrte Steinschläge) - Stone chips - Paint

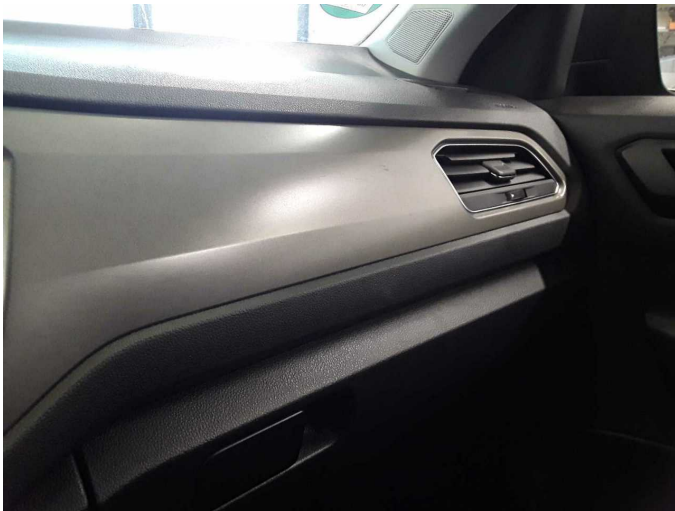
**Wear and tear 1:** Interior: Interior - Scratch(es) - No deduction

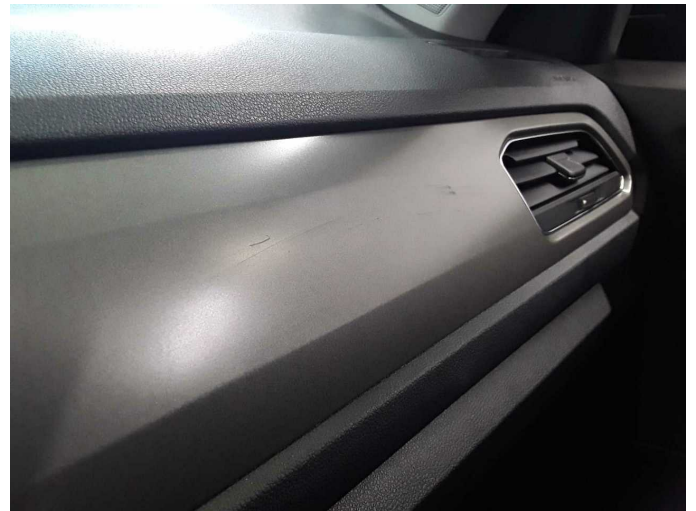
**Wear and tear 1:** Interior: Interior - Scratch(es) - No deduction

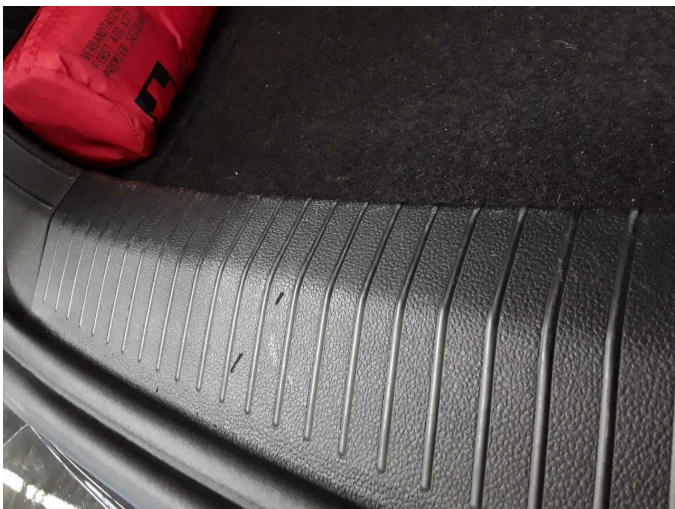
**Wear and tear 1:** Interior: Interior - Scratch(es) - No deduction

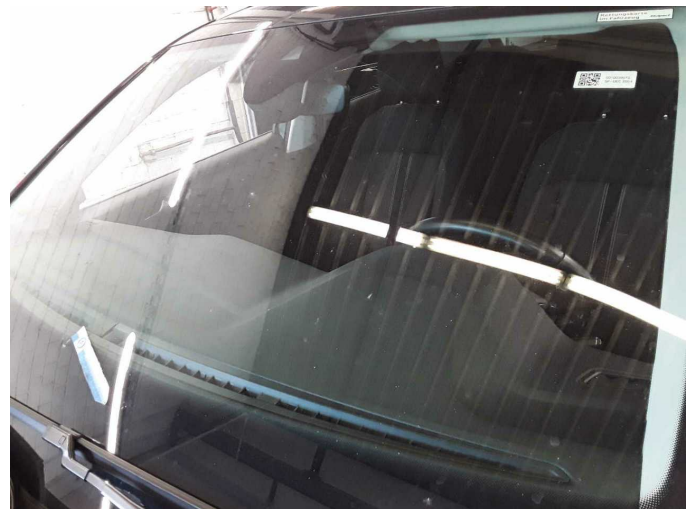
**Wear and tear 2:** Vehicle glazing: Windscreen - Stone chips - No deduction

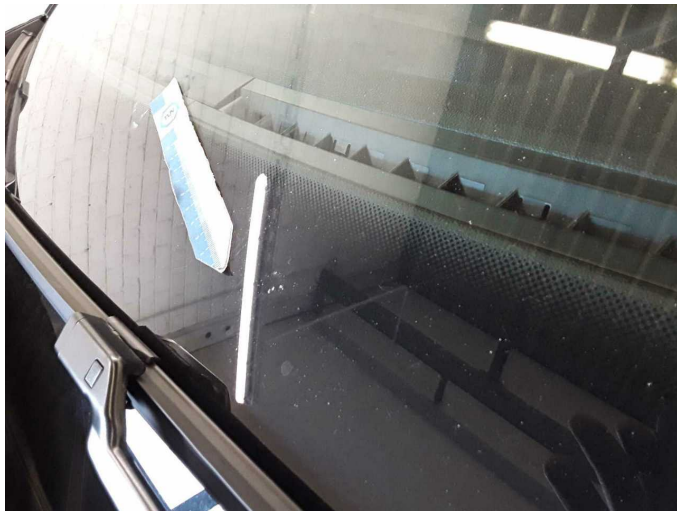
**Wear and tear 2:** Vehicle glazing: Windscreen - Stone chips - No deduction

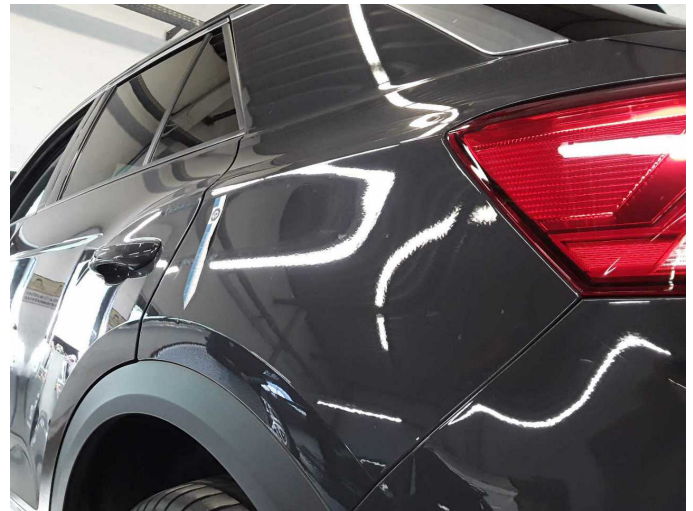
**Wear and tear 3:** Side panel - rear left side: Side panel - Dent / paintcoat damage - No deduction

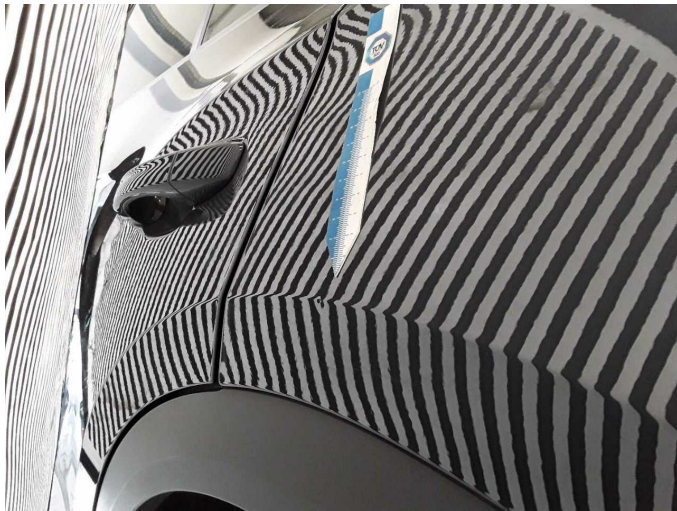
**Wear and tear 3:** Side panel - rear left side: Side panel - Dent / paintcoat damage - No deduction

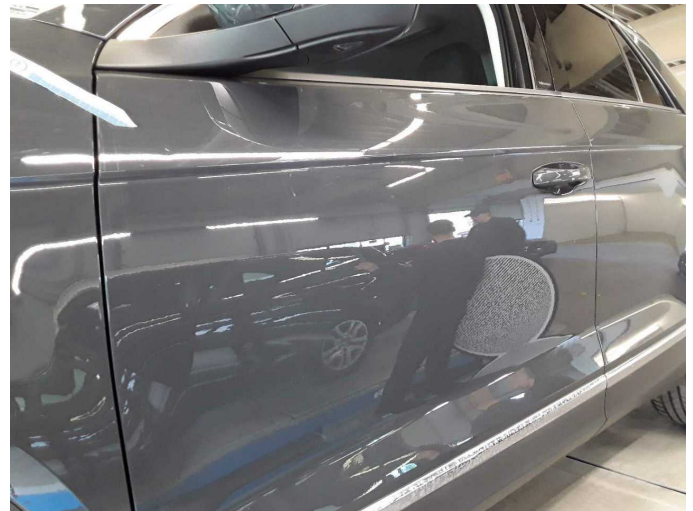
**Wear and tear 4:** Door - front right side: Door - Dent / paintcoat damage - Smart repair

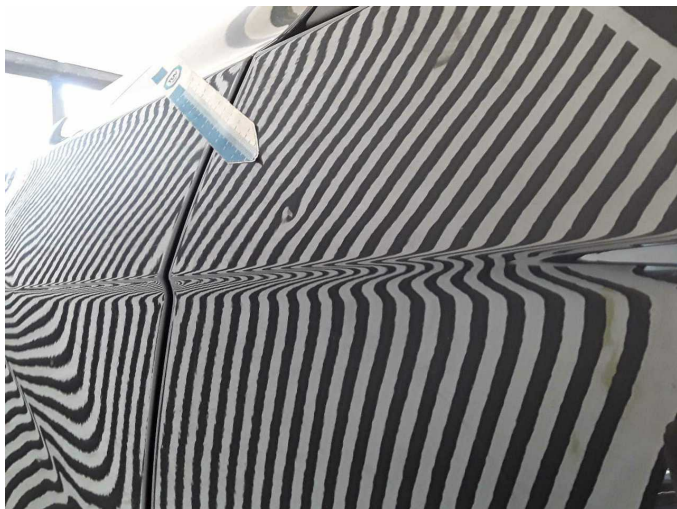
**Wear and tear 4:** Door - front right side: Door - Dent / paintcoat damage - Smart repair

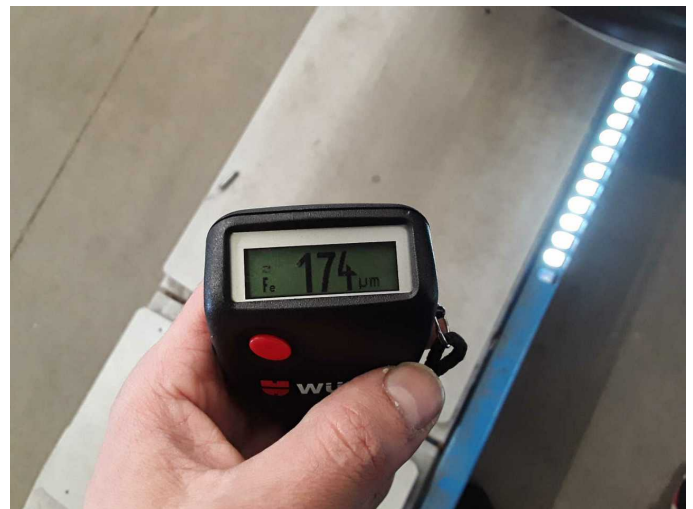
- 1 Boot lid / rear door, Unprofessionally carried out, Invoice of repair done Non-existent

**Repainting 1:** Boot lid / rear door

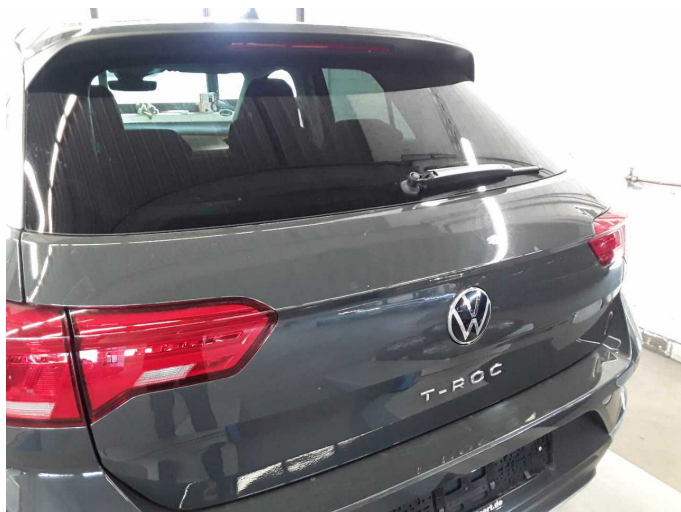
**Repainting 1:** Boot lid / rear door
