VEHICLE INSPECTION REPORT

1001843970

WVGZZZE2ZMP022371

ID.4 Pro First Edition electric 150kW 1-speed 1-speed automatic

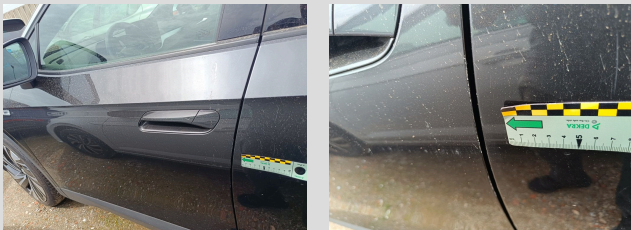
8

Component

Front door

Side

Left

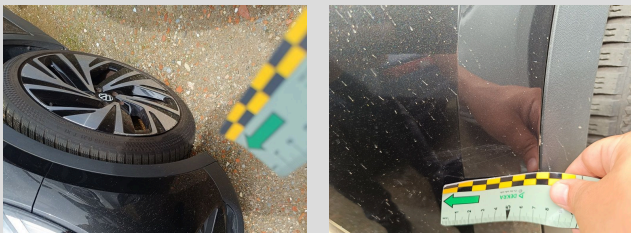
9

Component

Front bumper primer

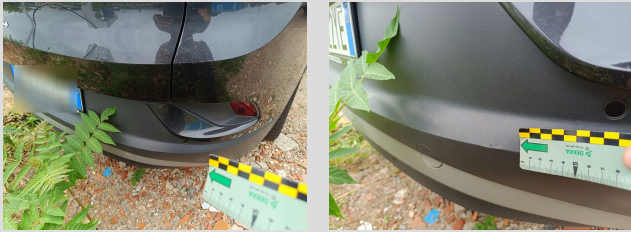
11

Component

Centre rear bumper
