VOLKSWAGEN Golf V

Golf 1.6

Inspection Report Summary

Customer	BCA Online	Report Number	P20250917105224
Inspection Date / Place	2025-09-17 / ARS Altmann AG Riedstadt	Cosmetic Grade	5

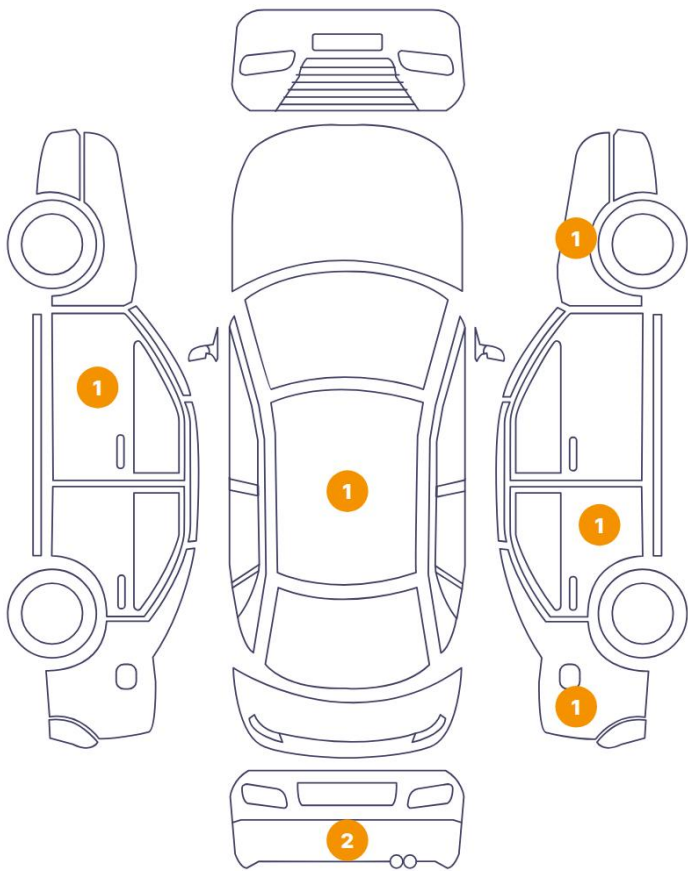
7 Schäden

Component	Damage	Comments
1 Roof	Bodywork / Dent	
2 Door / Front Left	Paint / Scratch / Scuff	
3 Interior door handle Front left	Interior / Scratched	
4 Bumper / Back	Bodywork / Dent / Deformation	
5 Bumper / Back	Paint / Scratch / Scuff	
6 Side Panel / Back Right	Bodywork / Dent / Deformation	
7 Door / Back Right	Bodywork / Dent / Deformation	
8 Center Console	Interior / Broken	
9 Fender / Front Right	Bodywork / Dent / Dent

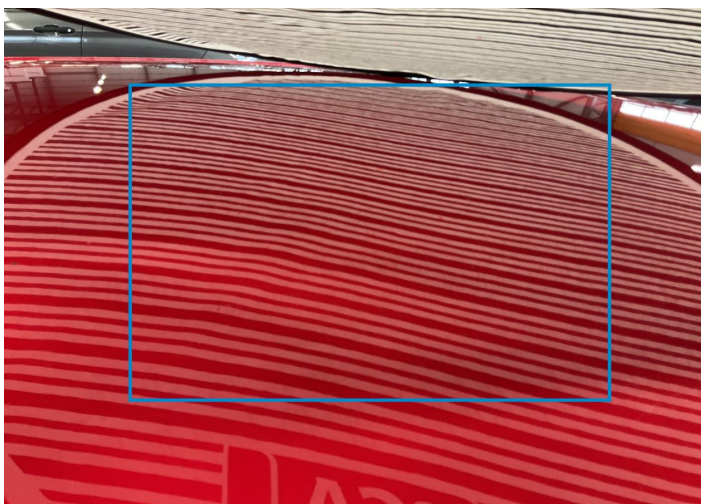
1. Roof
Bodywork / Dent -

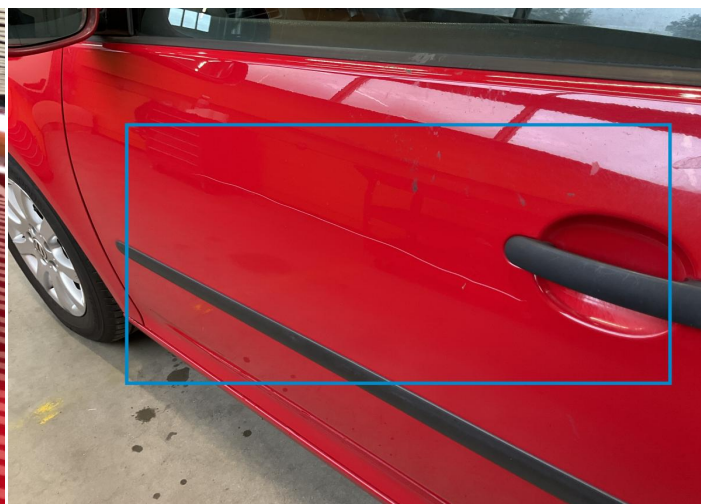
2. Door / Front Left
Paint / Scratch / Scuff -

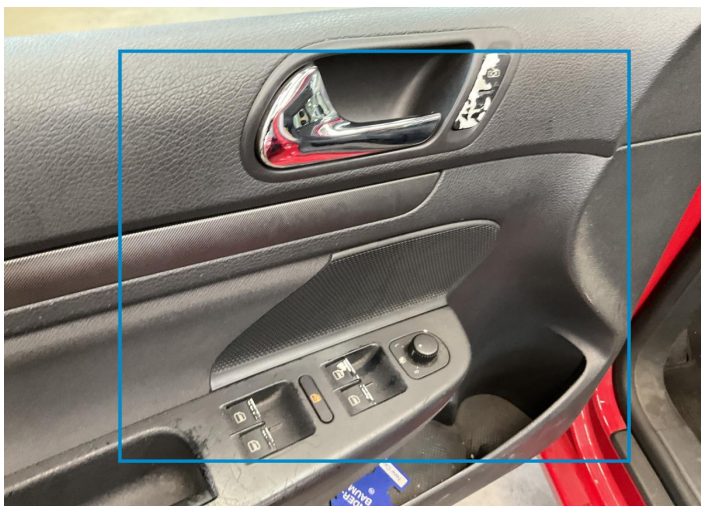
3. Interior door handle Front left
Interior / Scratched -

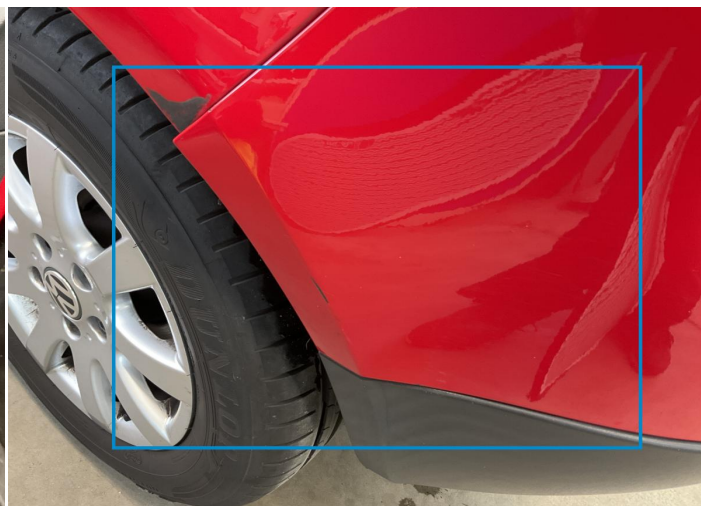
4. Bumper / Back
Bodywork / Dent / Deformation -

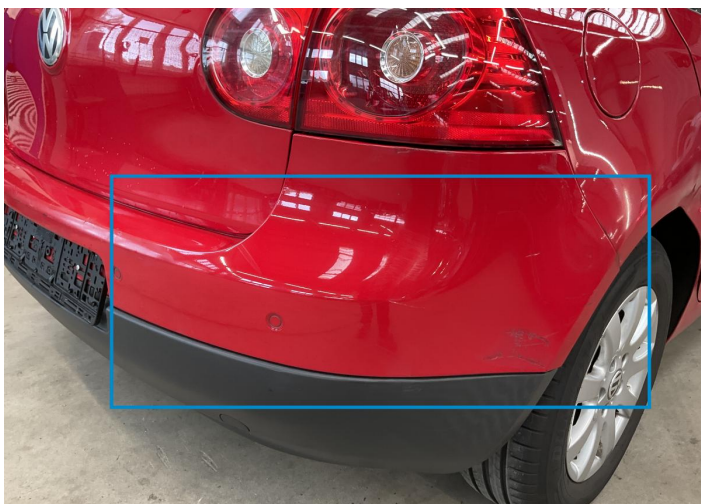
5. Bumper / Back
Paint / Scratch / Scuff -

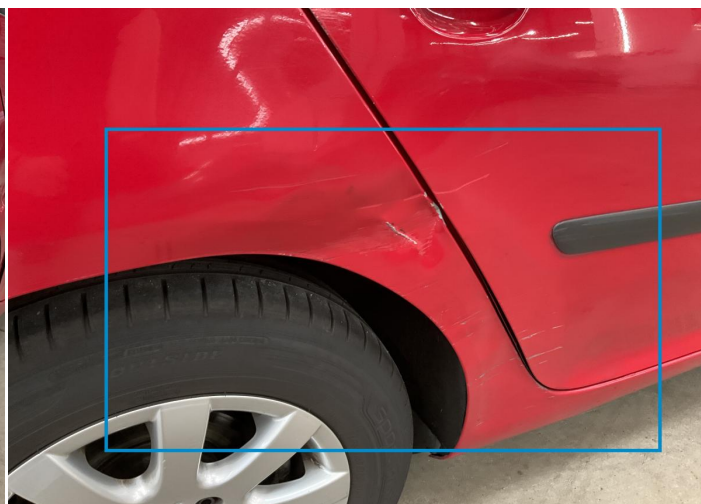
6. Side Panel / Back Right
Bodywork / Dent / Deformation -

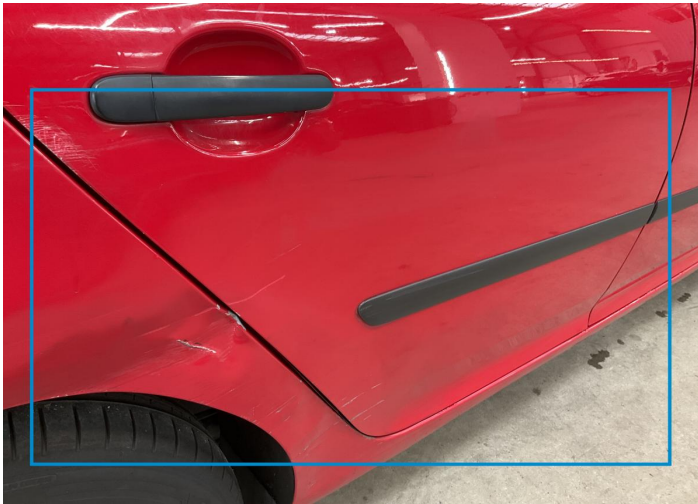
7. Door / Back Right
Bodywork / Dent / Deformation -

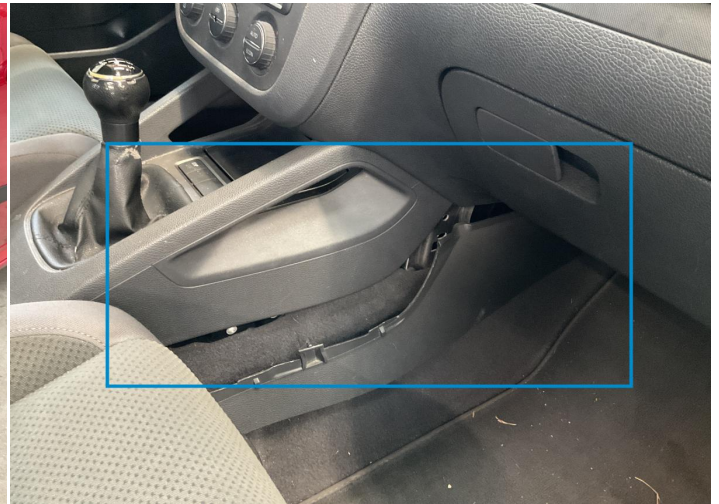
8. Center Console
Interior / Broken -

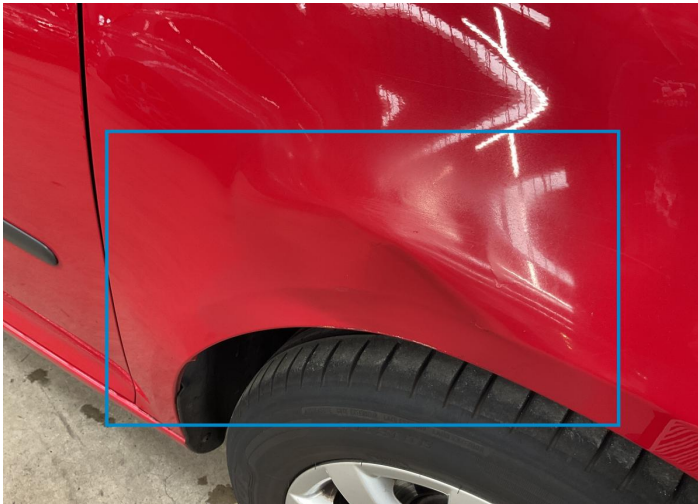
9. Fender / Front Right
Bodywork / Dent / Dent -
