VOLKSWAGEN Golf V

Golf 1.6

Inspection Report Summary

Customer	BCA Online	Report Number	P20250930094842
Inspection Date / Place	2025-09-30 / BCA Neuss	Cosmetic Grade	3

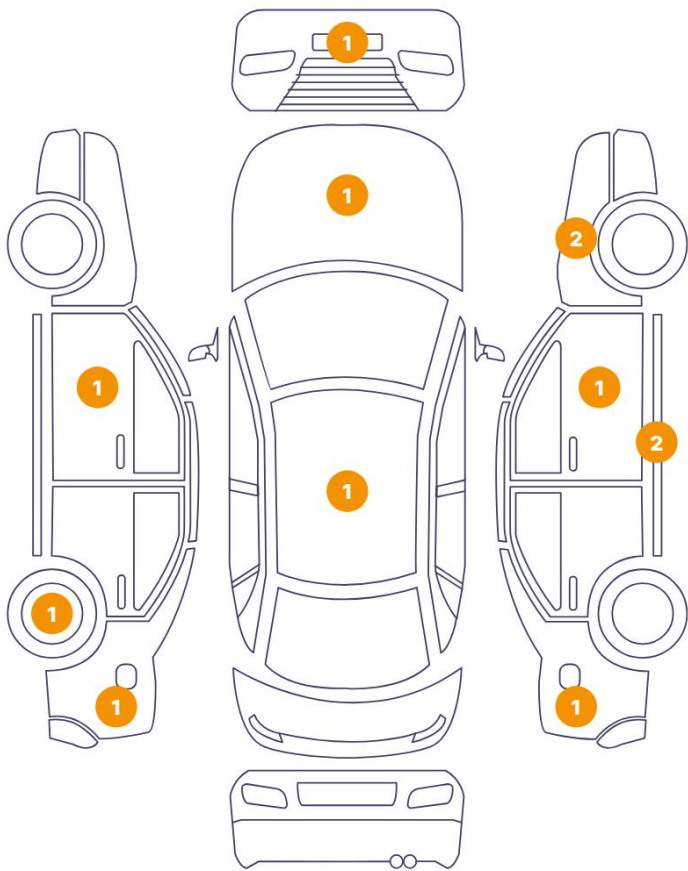
12 Schäden

Component		Damage	Comments
1	Roof	Bodywork / Dent / Dent	
2	Fender / Back Left	Bodywork / Dent / Dent	
3	Door / Front Left	Bodywork / Dent / Dent	
4	Hood	Bodywork / Dent / Dent	
5	Corner Bumper / Front Right	Paint / Scratch / Scuff	
6	Fender / Front Right	Bodywork / Dent / Dent	
7	Fender / Front Right	Paint / Scratch / Scuff	
8	Rocker Panel / Center Right	Bodywork / Dent / Dent	
9	Fender / Back Right	Bodywork / Dent / Dent	
10	Rocker Panel / Center Right	Bodywork / Dent / Dent	
11	Door / Front Right	Paint / Scratch / Scuff	
12	Rim / Back Left	Paint / Corrosion

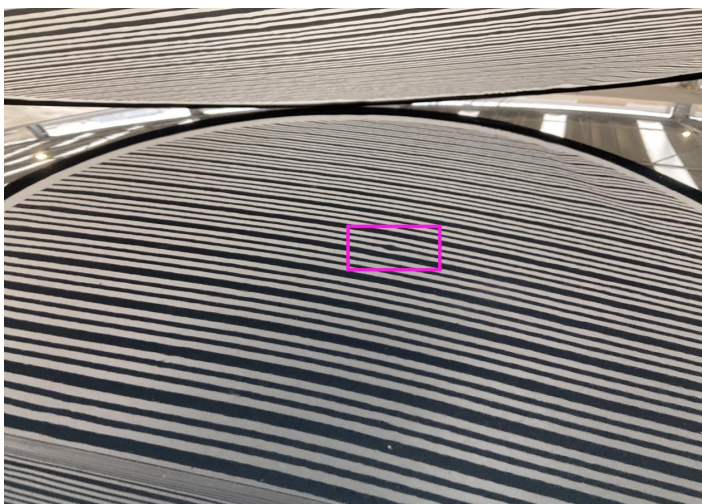
1. Roof
Bodywork / Dent / Dent -

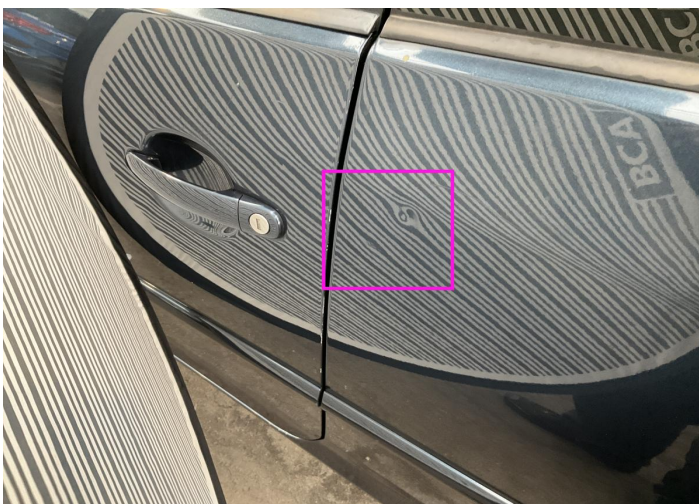
2. Fender / Back Left
Bodywork / Dent / Dent -

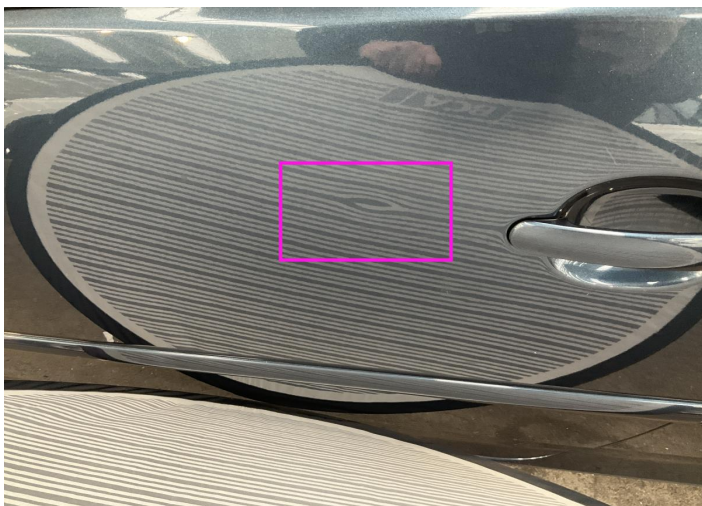
3. Door / Front Left
Bodywork / Dent / Dent -

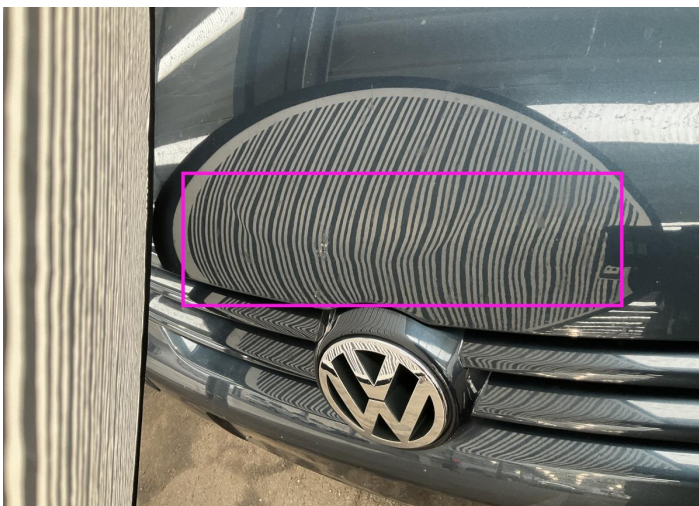
4. Hood
Bodywork / Dent / Dent -

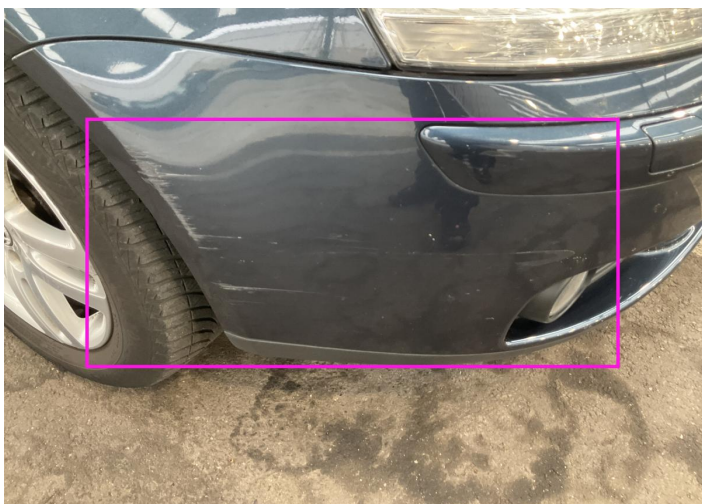
5. Corner Bumper / Front Right
Paint / Scratch / Scuff -

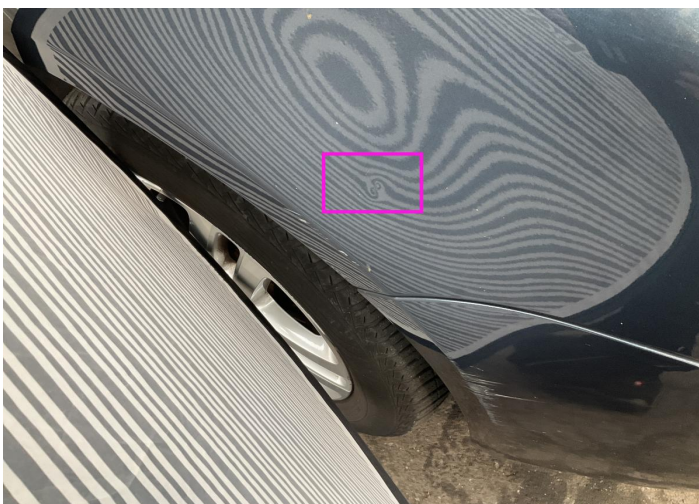
6. Fender / Front Right
Bodywork / Dent / Dent -

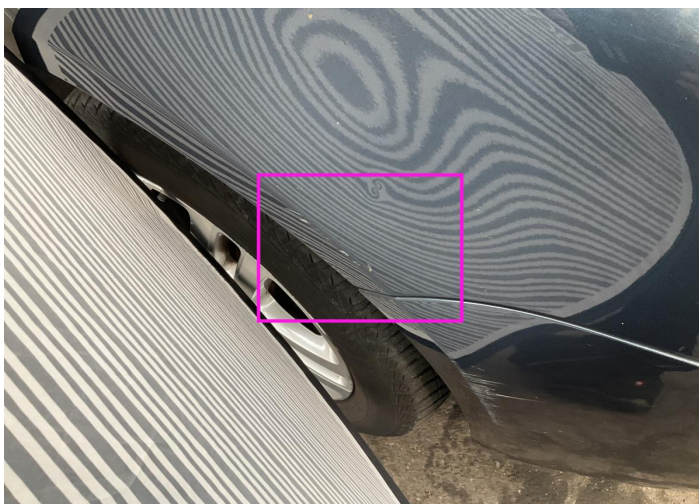
7. Fender / Front Right
Paint / Scratch / Scuff -

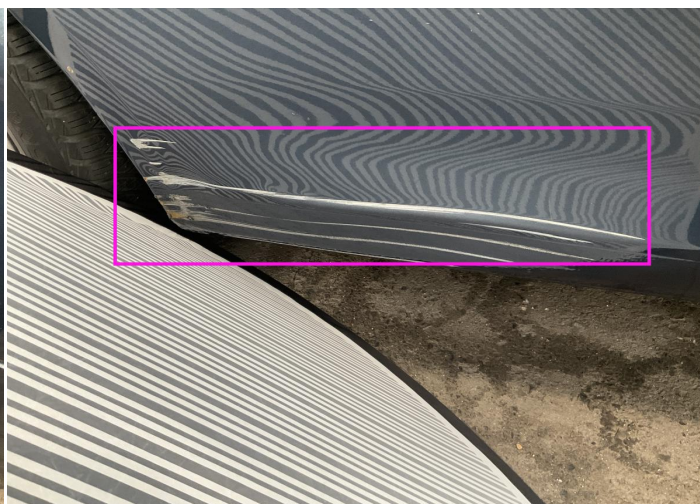
8. Rocker Panel / Center Right
Bodywork / Dent / Dent -

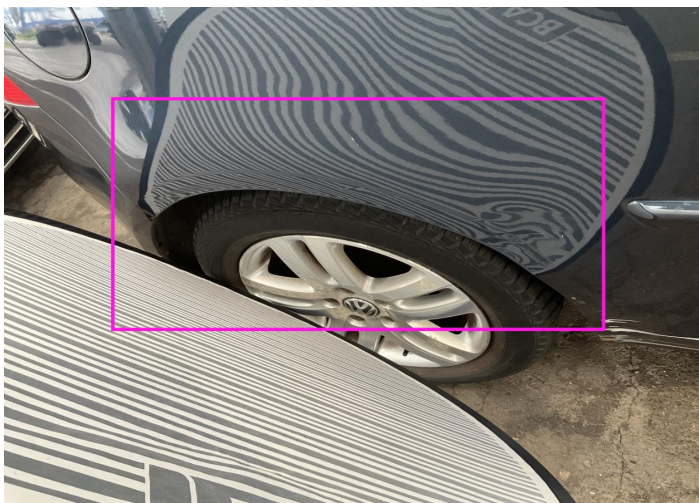
9. Fender / Back Right
Bodywork / Dent / Dent -

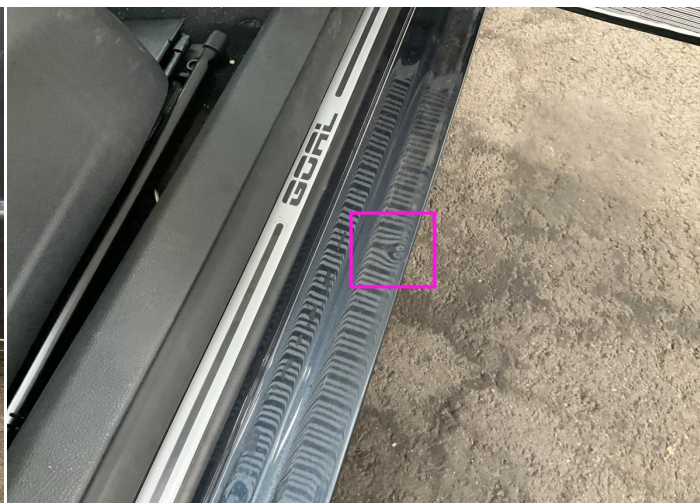
10. Rocker Panel / Center Right
Bodywork / Dent / Dent -

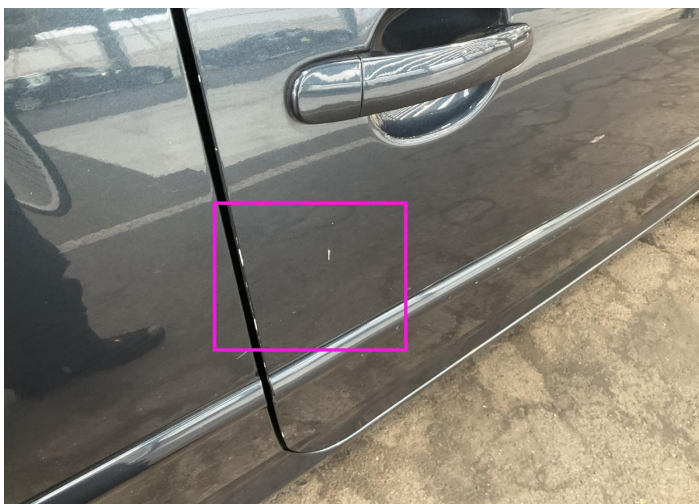
11. Door / Front Right
Paint / Scratch / Scuff -

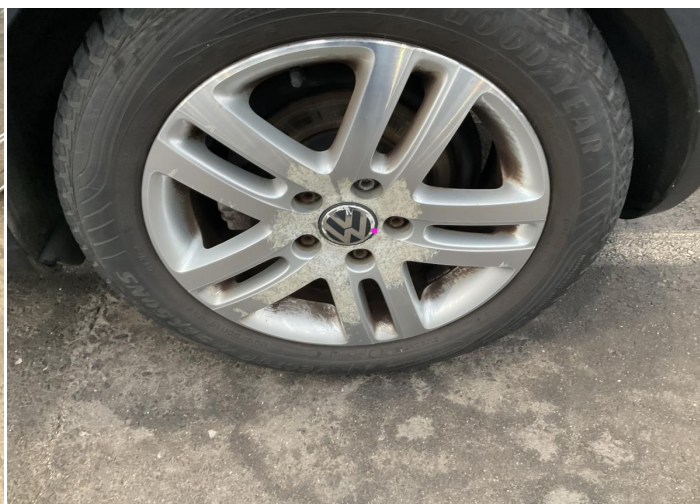
12. Rim / Back Left
Paint / Corrosion -
