VOLKSWAGEN Golf V 2003 Diesel  
golf 1.9 tdi Comfortline 5p 5m

VIN NO WVWZZZ1KZ8W028651  
Registration Number DN397TW

Inspection Report Summary

| Customer | BCA Lodi | Report Number | P20251010115908 |

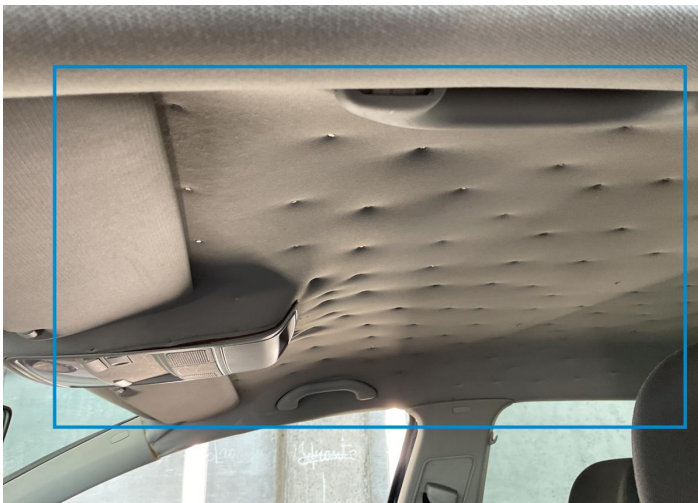
| Component | | Damage | Comments |
|---|---|---|---|
| 1 | Roof Upholstery | Interior / Broken | |

1. Roof Upholstery  
Interior / Broken -

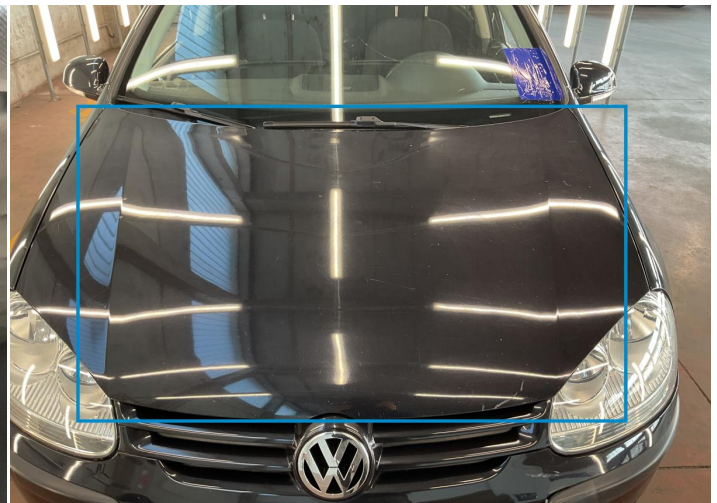
| Component | | Damage | Comments |
|---|---|---|---|
| 2 | Hood | Paint / Scratch / Line | |

2. Hood  
Paint / Scratch / Line -

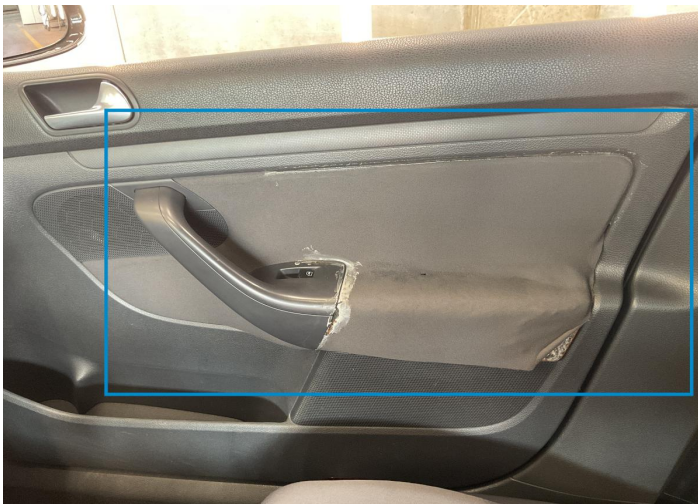
| Component | | Damage | Comments |
|---|---|---|---|
| 3 | Panel Filling / Front Right | Interior / Broken | |

3. Panel Filling / Front Right  
Interior / Broken -

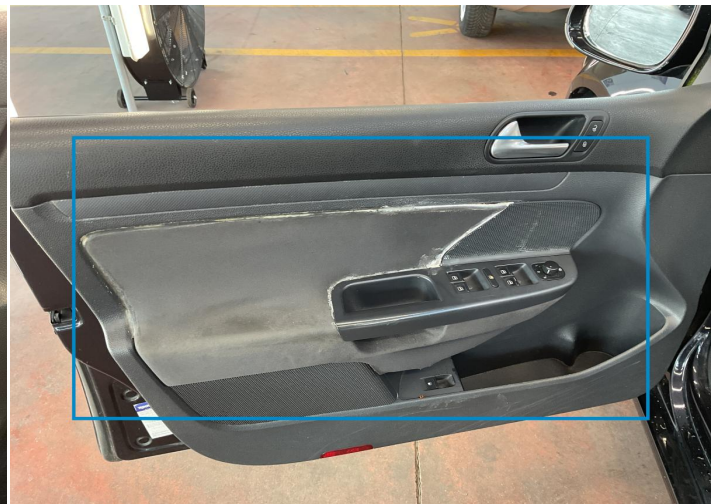
| Component | | Damage | Comments |
|---|---|---|---|
| 4 | Panel Filling / Front Left | Interior / Broken | |

4. Panel Filling / Front Left  
Interior / Broken -

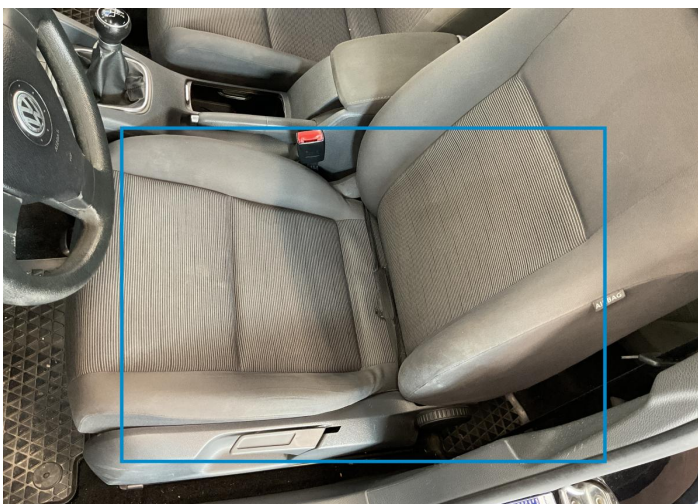
| Component | | Damage | Comments |
|---|---|---|---|
| 5 | Seat / Front Left | Interior / Worn - out | |

5. Seat / Front Left  
Interior / Worn - out -

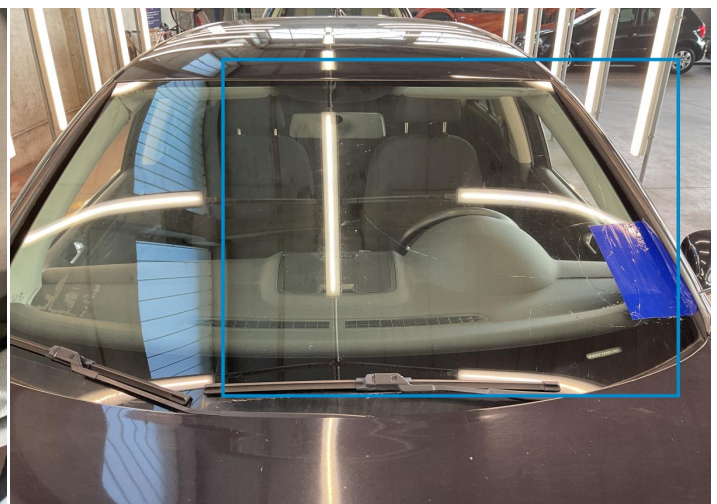
| Component | | Damage | Comments |
|---|---|---|---|
| 6 | Windshield / Front | Glass Break | |

6. Windshield / Front  
Glass Break -

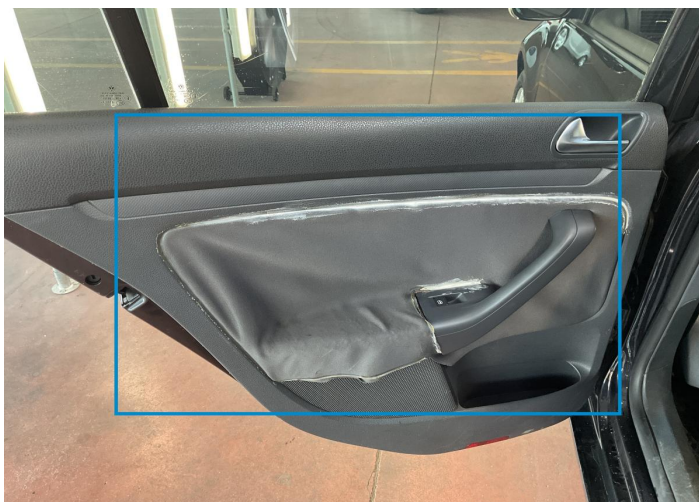
| Component | | Damage | Comments |
|---|---|---|---|
| 7 | Panel Filling / Back Left | Interior / Broken | |

7. Panel Filling / Back Left  
Interior / Broken -

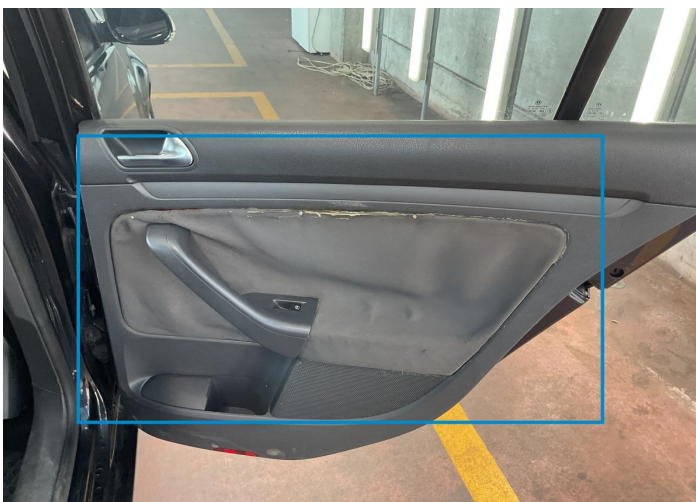
| Component | | Damage | Comments |
|---|---|---|---|
| 8 | Panel Filling / Back Right | Interior / Broken | |

8. Panel Filling / Back Right  
Interior / Broken -

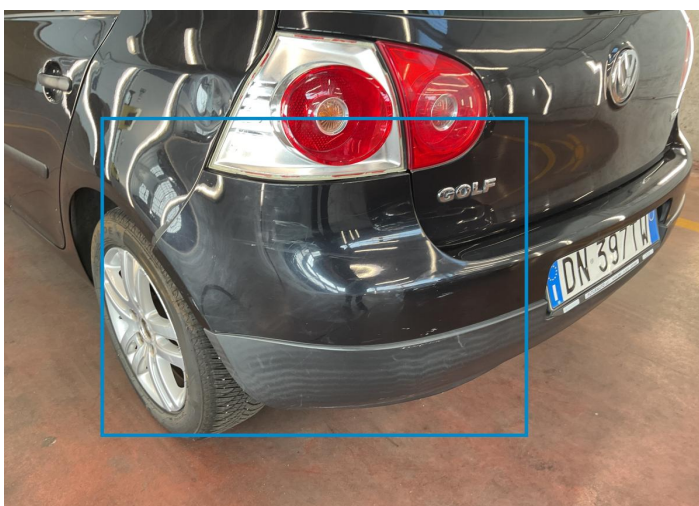
| Component | | Damage | Comments |
|---|---|---|---|
| 9 | Bumper / Back | Bodywork / Breakage | |

9. Bumper / Back  
Bodywork / Breakage -

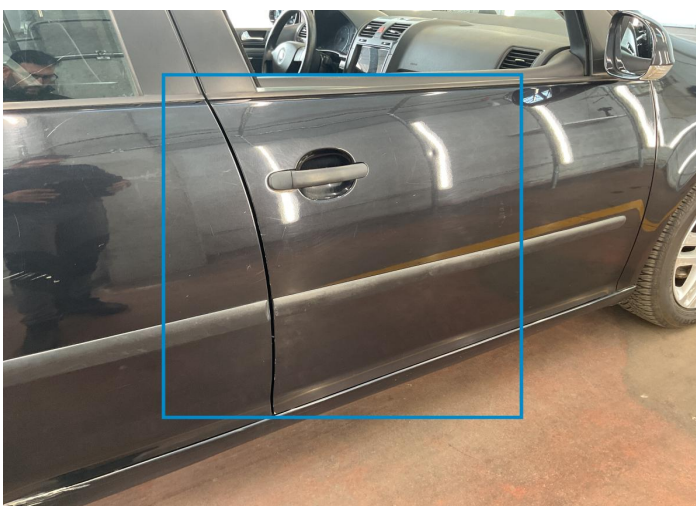
| Component | | Damage | Comments |
|---|---|---|---|
| 10 | Door / Front Right | Bodywork / Dent | |

10. Door / Front Right  
Bodywork / Dent -

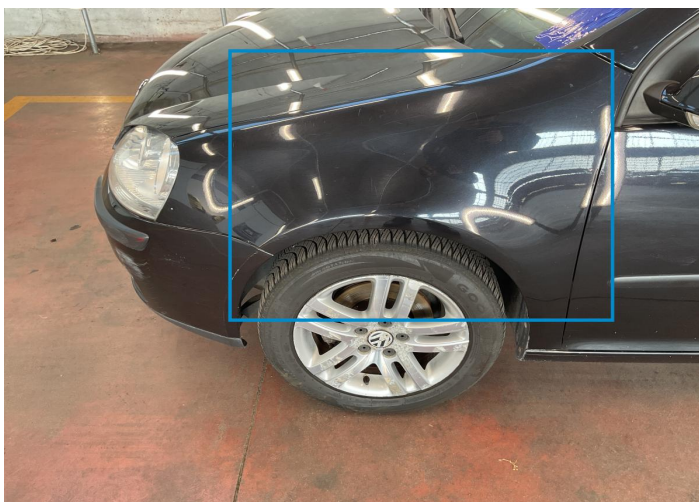
| Component | | Damage | Comments |
|---|---|---|---|
| 11 | Fender / Front Left | Paint / Scratch / Line | |

11. Fender / Front Left  
Paint / Scratch / Line -

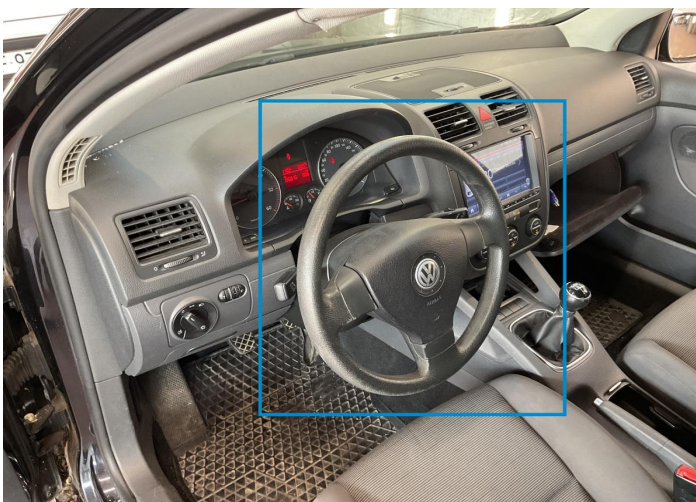
| Component | | Damage | Comments |
|---|---|---|---|
| 12 | Steering Wheel / Front | Interior / Worn - out | |

12. Steering Wheel / Front  
Interior / Worn - out -

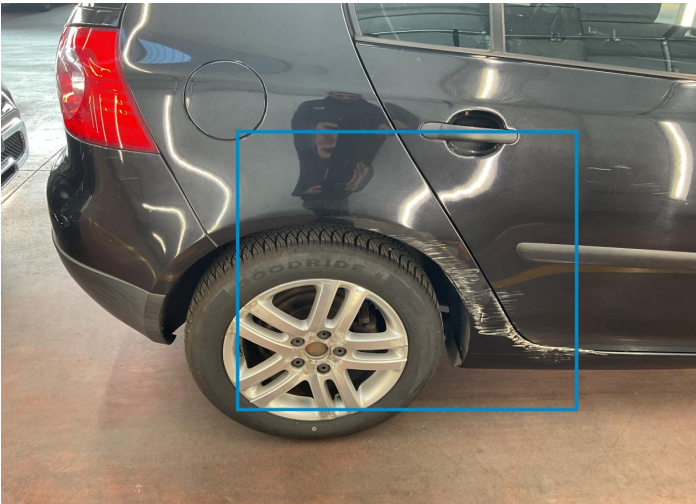
| 13 | Fender / Back Right | Bodywork / Dent |

13. Fender / Back Right  
Bodywork / Dent -

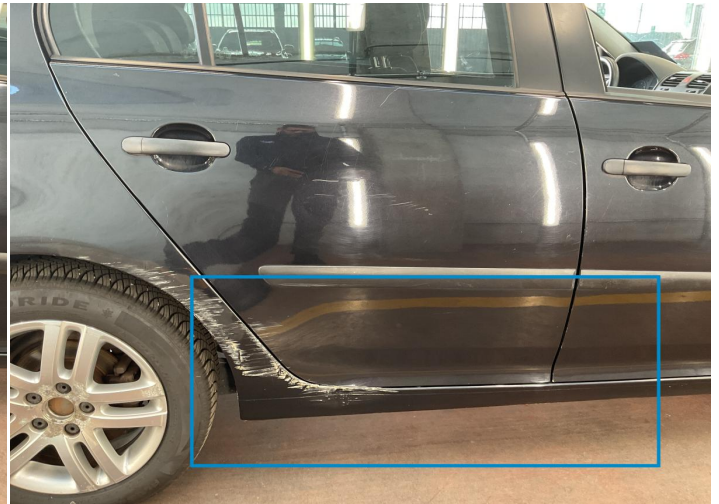
| 14 | Rocker Panel / Center Right | Bodywork / Dent |

14. Rocker Panel / Center Right  
Bodywork / Dent -

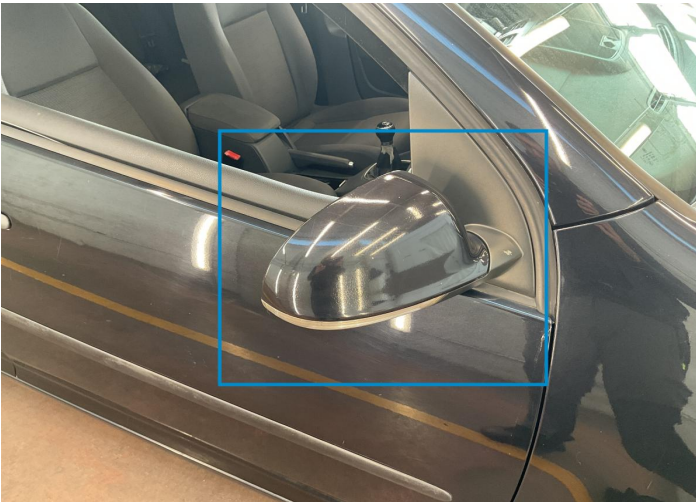
| 15 | Mirror Shell / Front Right | Bodywork / Poor Previous Repair |

15. Mirror Shell / Front Right  
Bodywork / Poor Previous Repair -

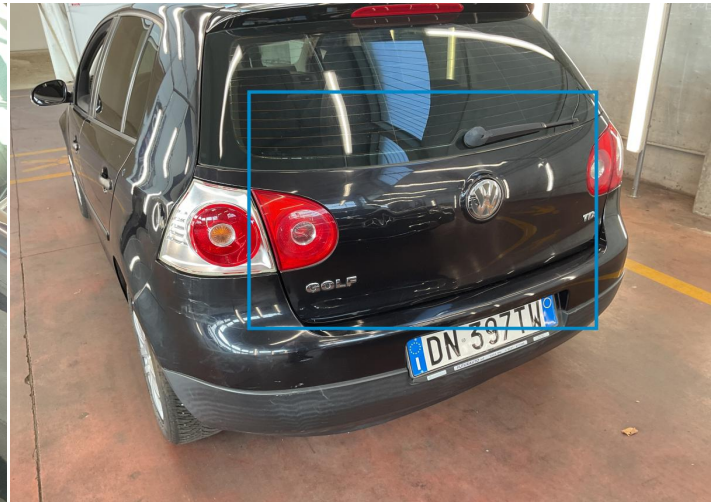
| 16 | Tailgate | Bodywork / Dent / Hail Area |

16. Tailgate  
Bodywork / Dent / Hail Area -

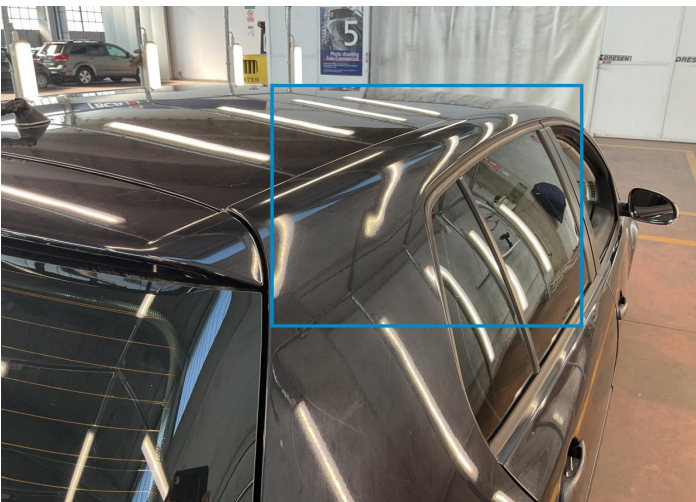
| 17 | Pillar / Front Right | Bodywork / Dent |

17. Pillar / Front Right  
Bodywork / Dent -

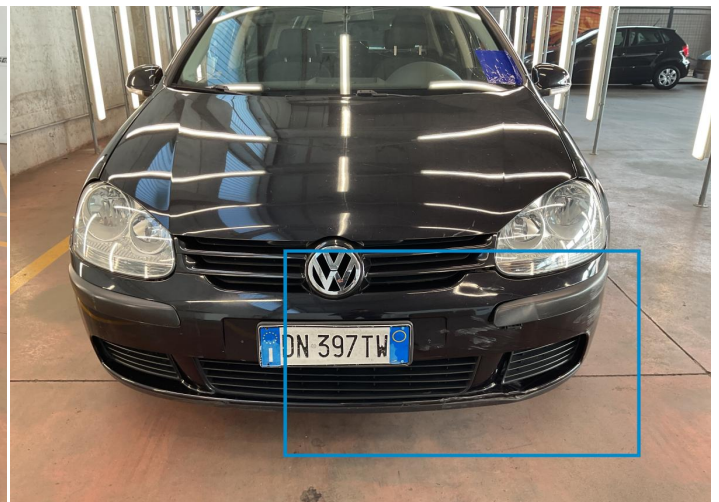
| 18 | Bumper / Front | Bodywork / Breakage |

18. Bumper / Front  
Bodywork / Breakage -

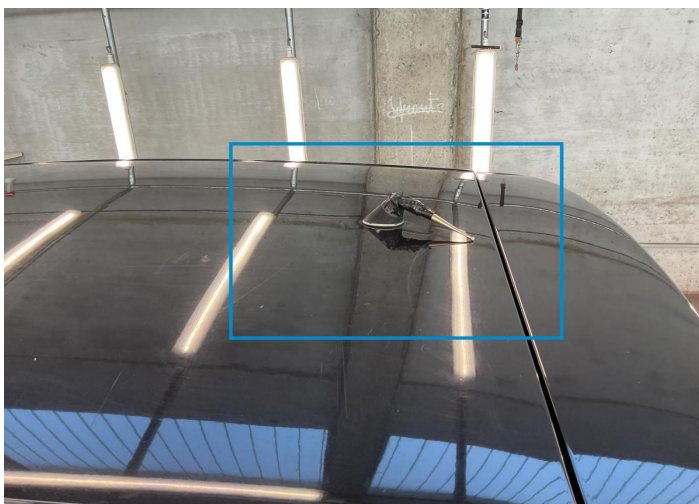
| 19 | Roof | Bodywork / Dent |

19. Roof  
Bodywork / Dent -

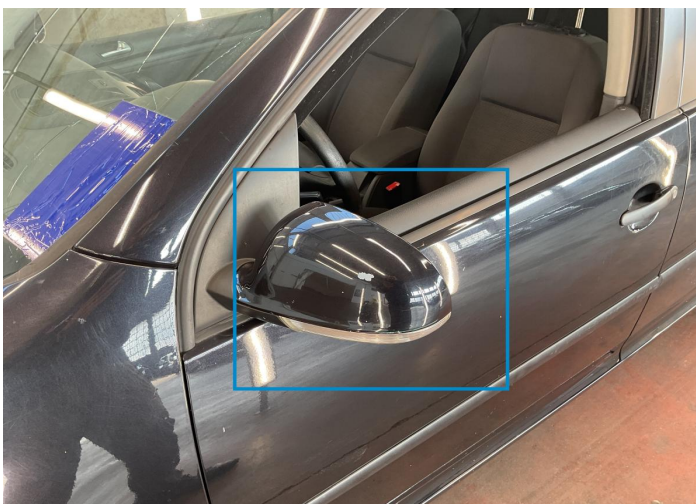
| 20 | Mirror Shell / Front Left | Bodywork / Poor Previous Repair |

20. Mirror Shell / Front Left  
Bodywork / Poor Previous Repair -

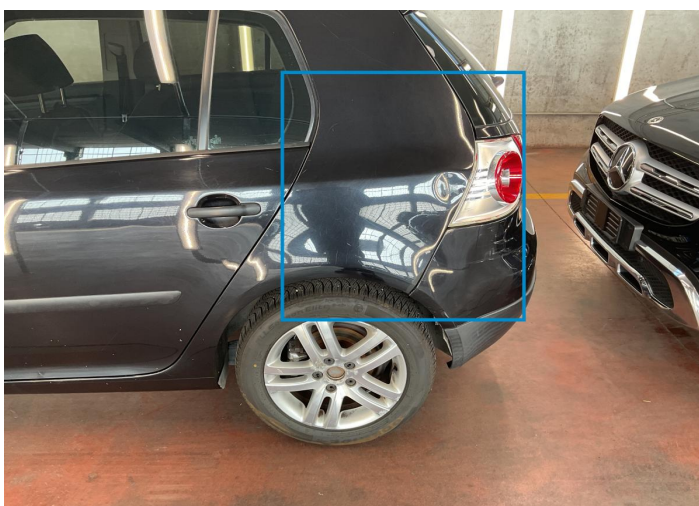
| 21 | Fender / Back Left | Bodywork / Dent |

21. Fender / Back Left  
Bodywork / Dent -

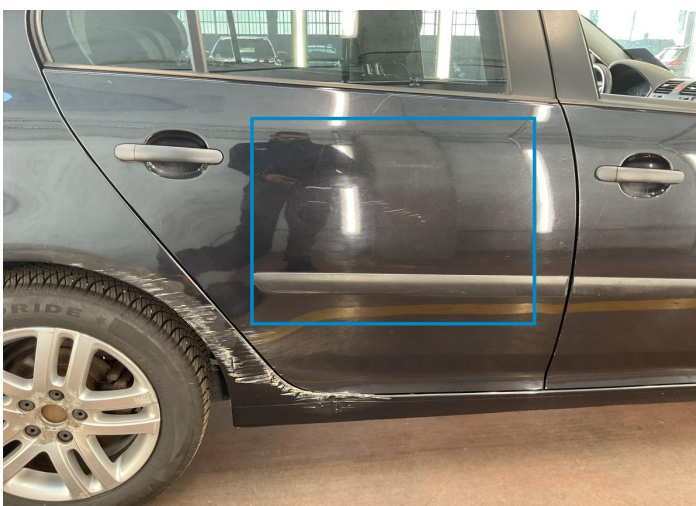
| 22 | Door / Back Right | Bodywork / Dent |

22. Door / Back Right  
Bodywork / Dent -

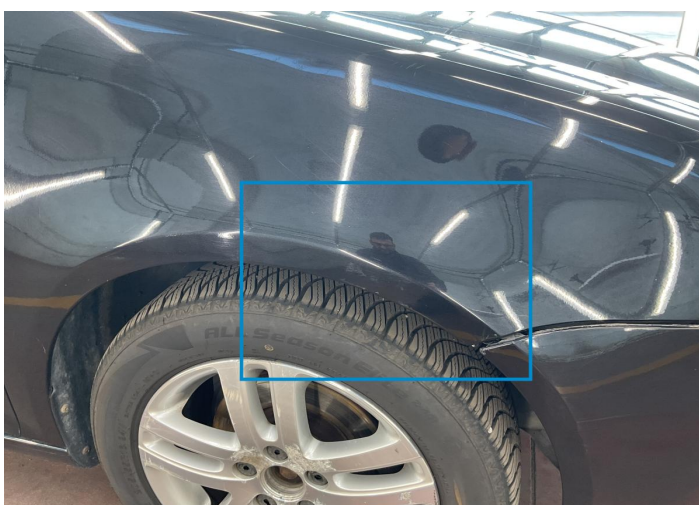
| 23 | Fender / Front Right | Paint / Scratch / Line |

23. Fender / Front Right  
Paint / Scratch / Line -

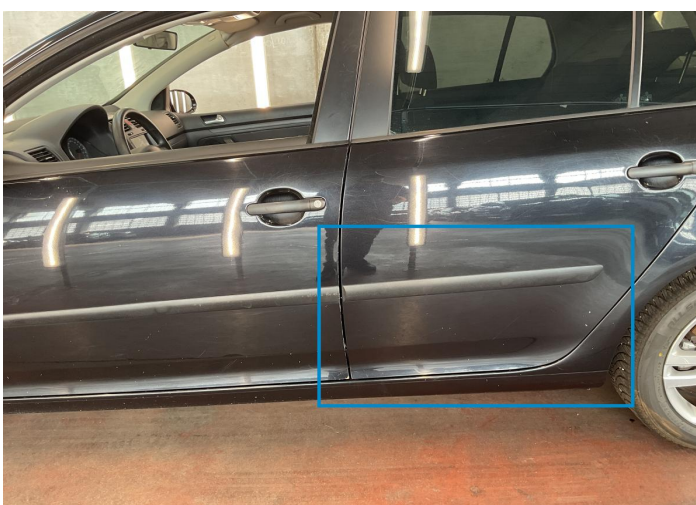
| 24 | Door / Back Left | Paint / Scratch / Line |

24. Door / Back Left  
Paint / Scratch / Line -

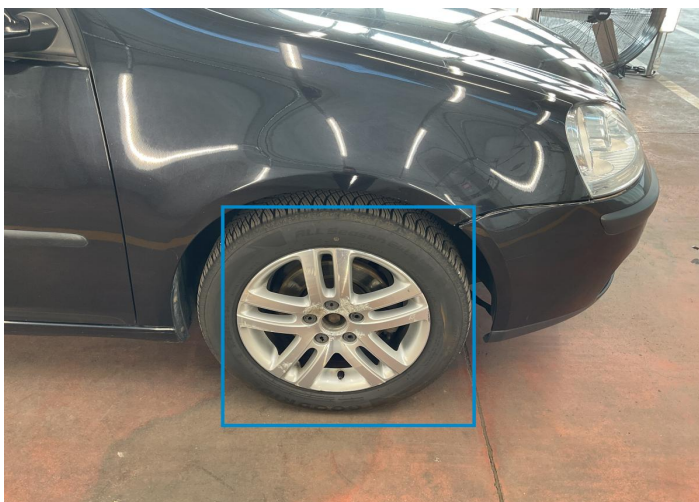
| 25 | Rim / Front Right | Out of Bodywork / Scratch |

25. Rim / Front Right  
Out of Bodywork / Scratch -

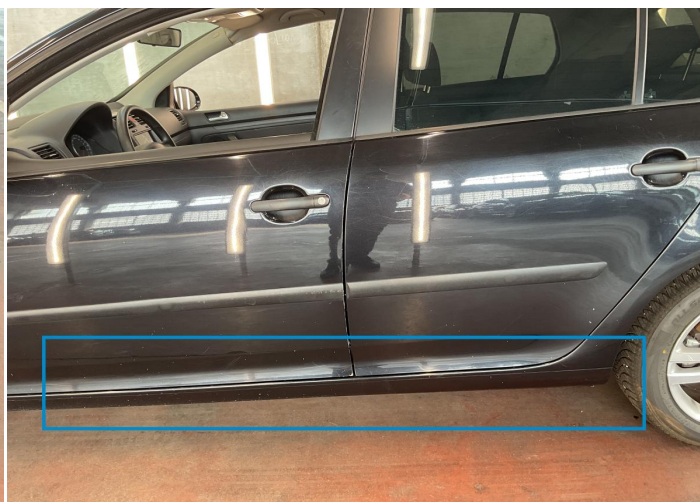
| 26 | Rocker Panel / Center Left | Paint / Chipping |

26. Rocker Panel / Center Left  
Paint / Chipping -

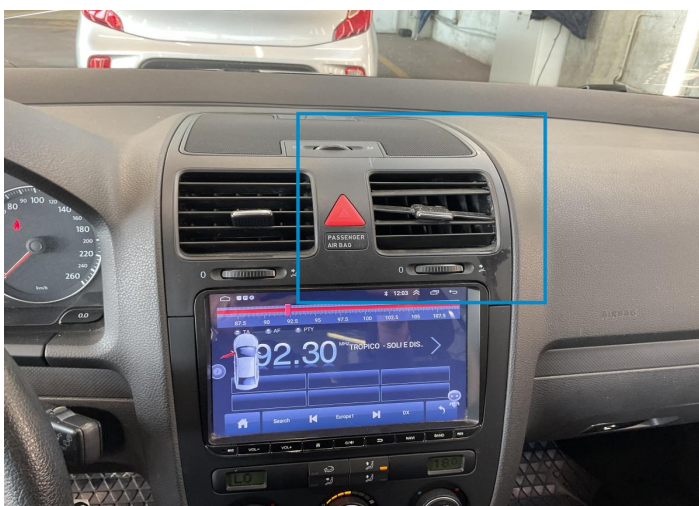
| 27 | Aeration Grid / Front Center | Interior / Broken |

27. Aeration Grid / Front Center  
Interior / Broken -

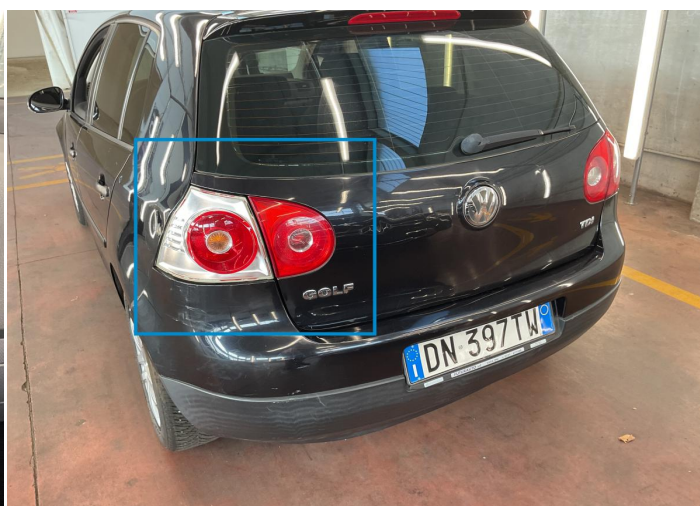
| 28 | Back Light / Left | Glass Break |

28. Back Light / Left  
Glass Break -

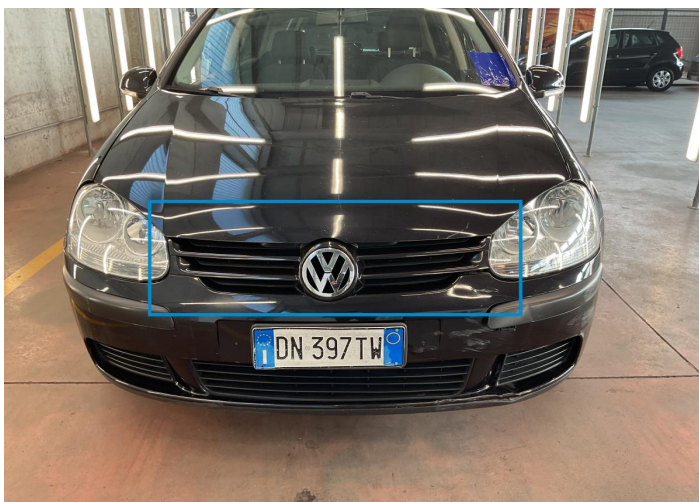
| 29 | Grille / Front | Bodywork / Breakage |

29. Grille / Front  
Bodywork / Breakage -

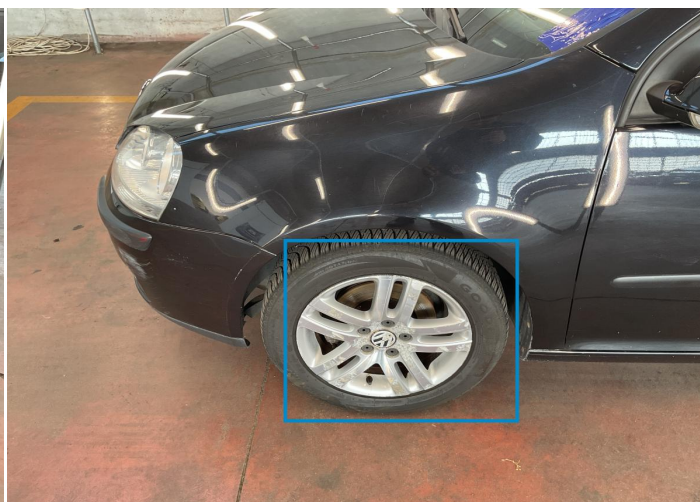
| 30 | Rim / Front Left | Out of Bodywork / Scratch |

30. Rim / Front Left  
Out of Bodywork / Scratch -

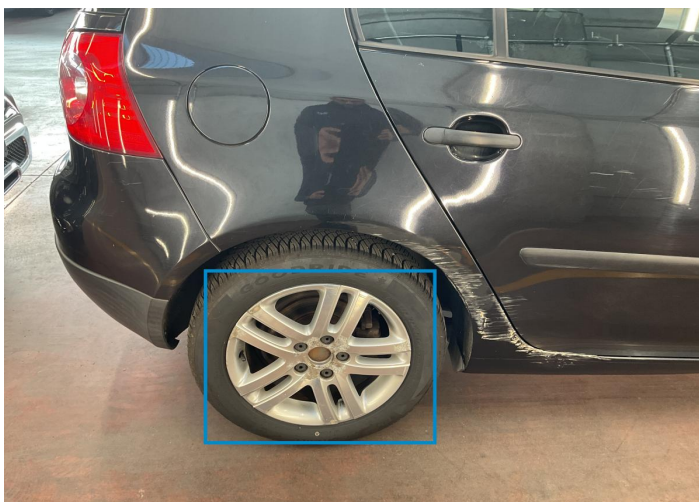
| 31 | Rim / Back Right | Out of Bodywork / Scratch |

31. Rim / Back Right  
Out of Bodywork / Scratch -

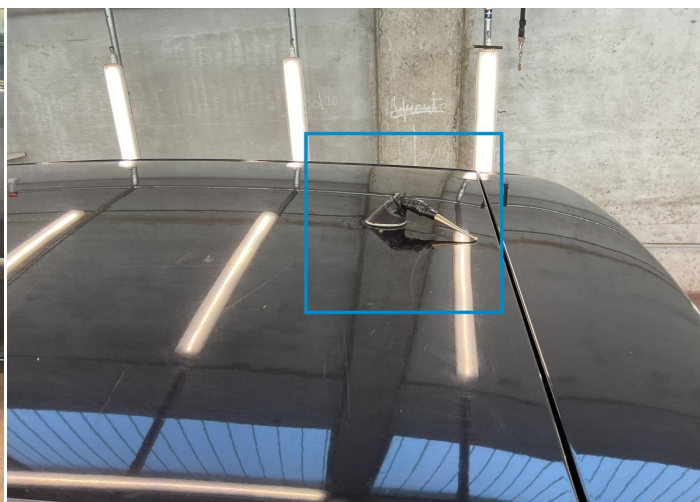
| 32 | Antenna Rod | Out of Bodywork / Breakage |

32. Antenna Rod  
Out of Bodywork / Breakage -

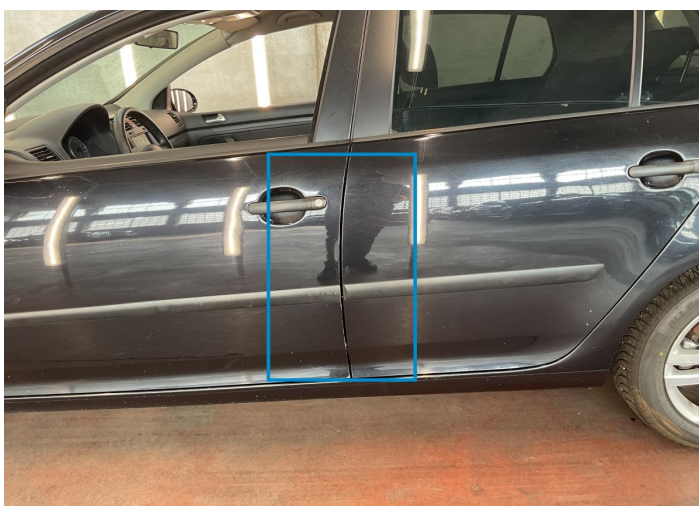
| 33 | Door / Front Left | Bodywork / Dent |

33. Door / Front Left  
Bodywork / Dent -

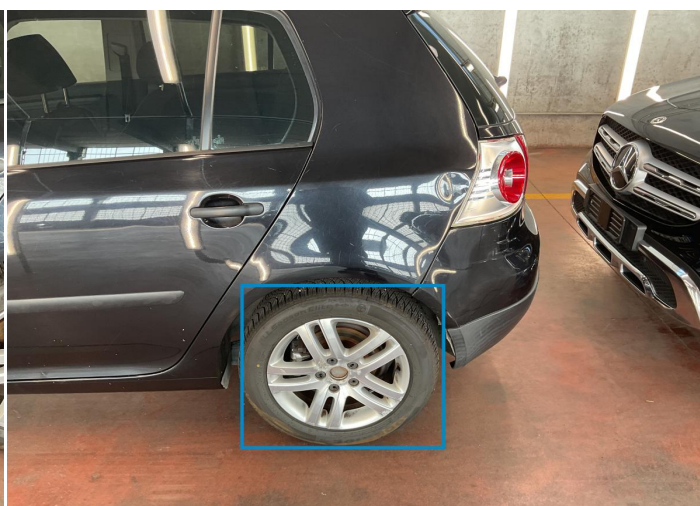
| 34 | Rim / Back Left | Out of Bodywork / Scratch |

34. Rim / Back Left  
Out of Bodywork / Scratch -

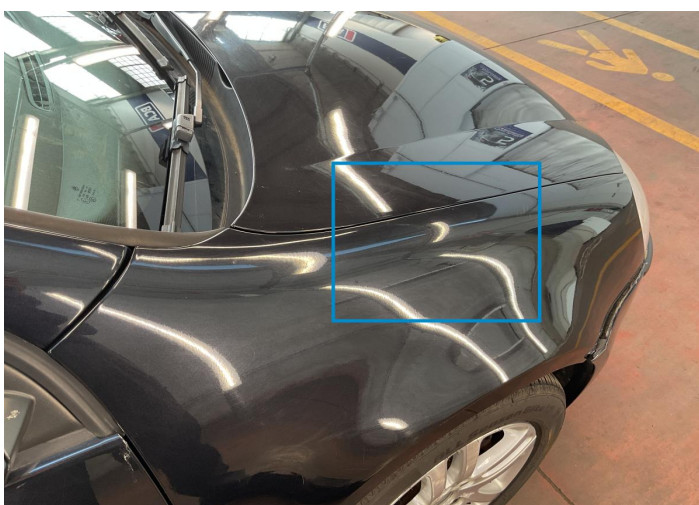
| 35 | Fender / Front Right | Bodywork / Dent |

35. Fender / Front Right  
Bodywork / Dent -

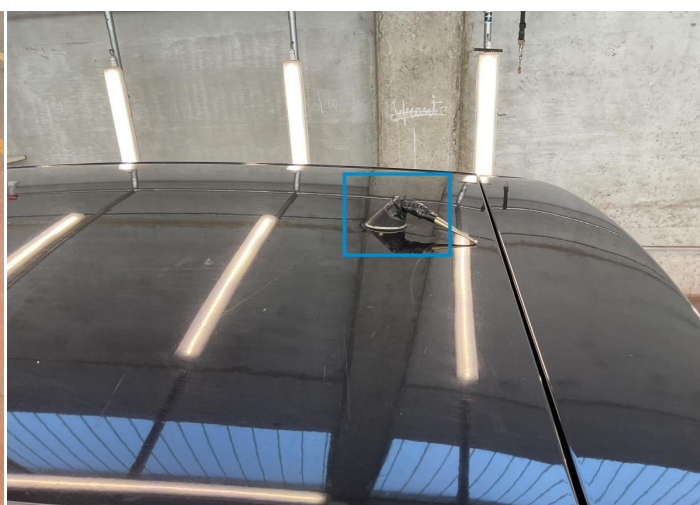
| 36 | Antenna Base | Bodywork / Breakage |

36. Antenna Base  
Bodywork / Breakage -

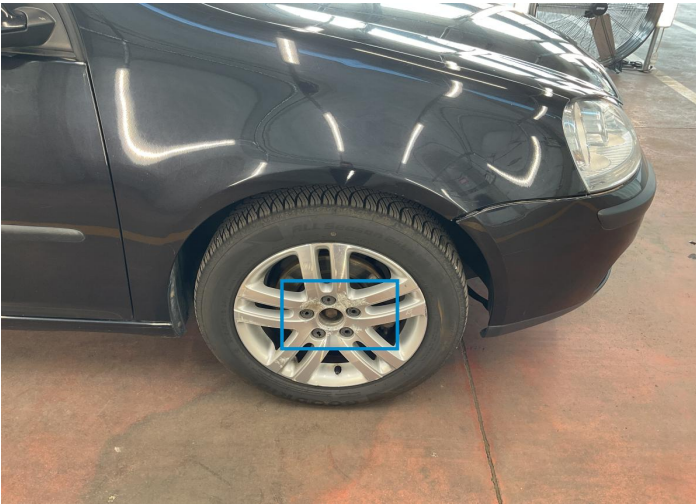
| 37 | Rim Brand Logo / Front Right | Missing Part |

37. Rim Brand Logo / Front Right  
Missing Part -

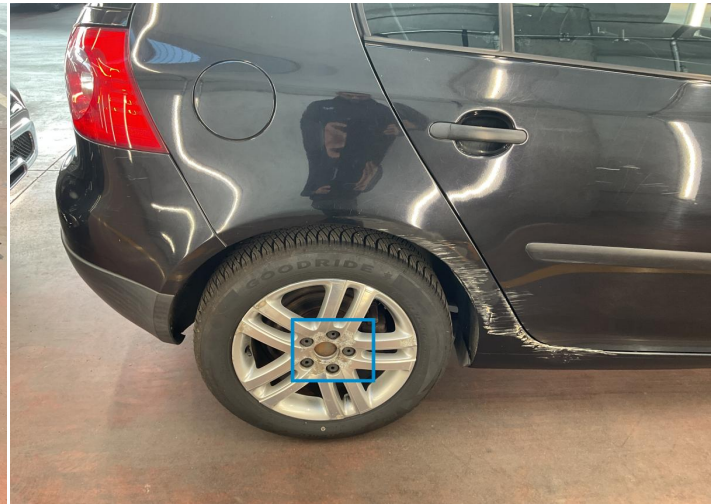
| 38 | Rim Brand Logo / Back Right | Missing Part |

38. Rim Brand Logo / Back Right  
Missing Part -

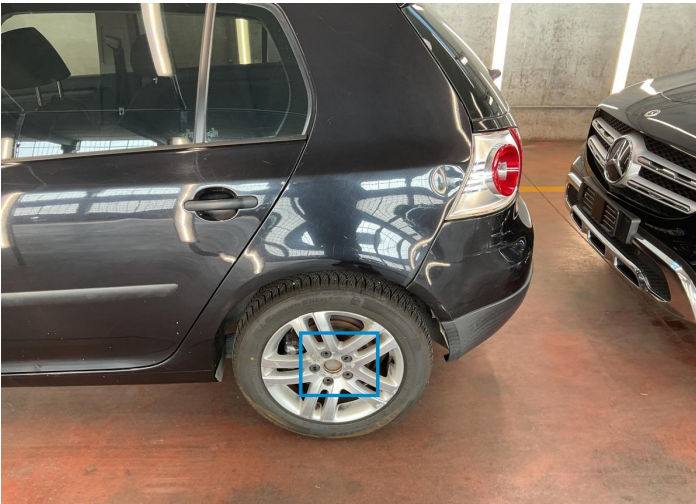
| 39 | Rim Brand Logo / Back Left | Missing Part |

39. Rim Brand Logo / Back Left  
Missing Part -
