# VOLKSWAGEN Golf V

## Golf 1.6

VIN NO WVWZZZ1KZ9P013850  
Registration Number KZ9P013850

### Inspection Report Summary

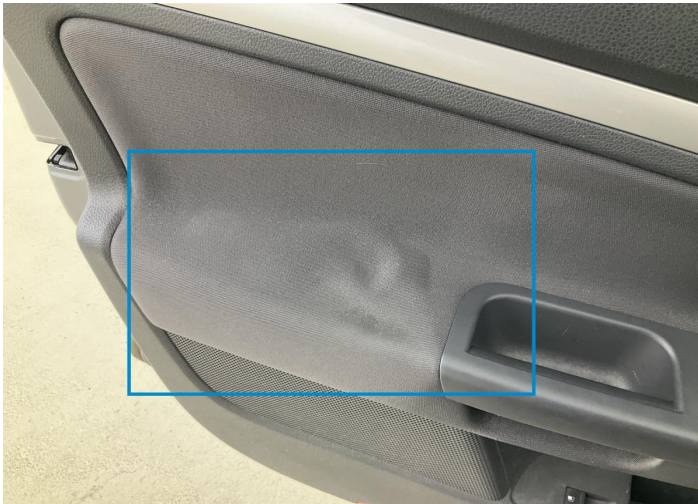
| Component | | Damage | Comments |
|---|---|---|---|
| 1 | Panel Filling / Front Left | Interior / Loose | |

1. Panel Filling / Front Left  
Interior / Loose -

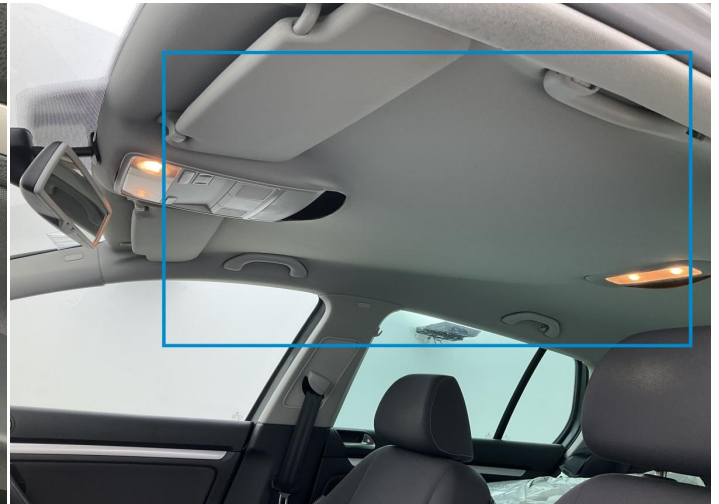
| Component | | Damage | Comments |
|---|---|---|---|
| 2 | Roof Upholstery | Interior / Loose | |

2. Roof Upholstery  
Interior / Loose -

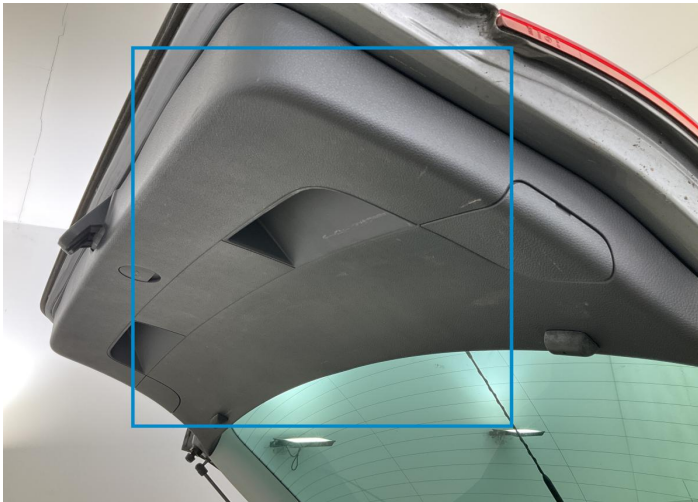
| Component | | Damage | Comments |
|---|---|---|---|
| 3 | Trunk Upholstery / Back | Interior / Scratched | |

3. Trunk Upholstery / Back  
Interior / Scratched -

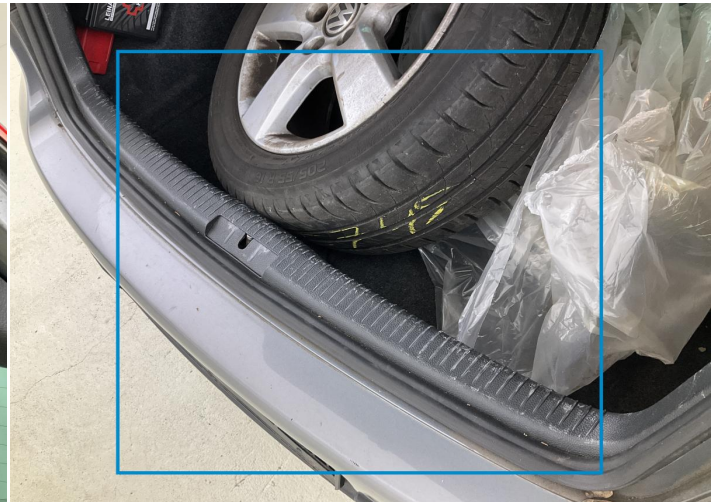
| Component | | Damage | Comments |
|---|---|---|---|
| 4 | Ply Lining (LCV) | Interior / Scratched | |

4. Ply Lining (LCV)  
Interior / Scratched -

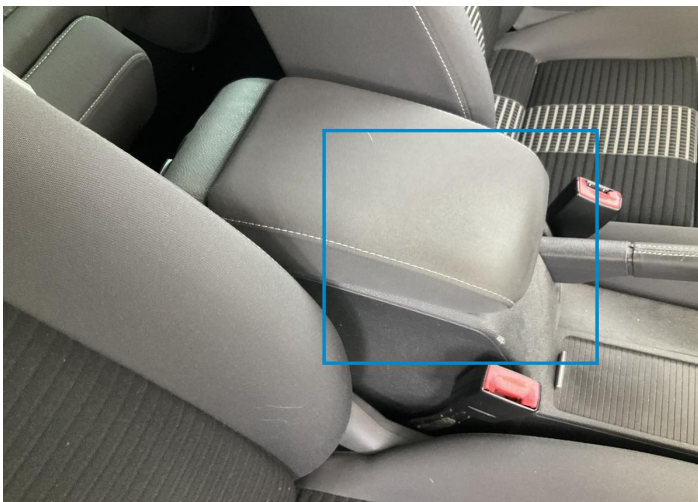
| Component | | Damage | Comments |
|---|---|---|---|
| 5 | Center Console | Interior / Worn - out | |

5. Center Console  
Interior / Worn - out -

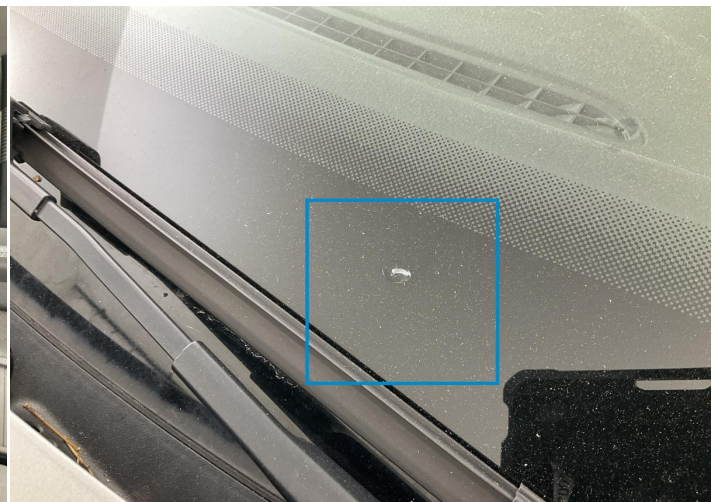
| Component | | Damage | Comments |
|---|---|---|---|
| 6 | Windshield / Front | Glass Break / Impact | |

6. Windshield / Front  
Glass Break / Impact -

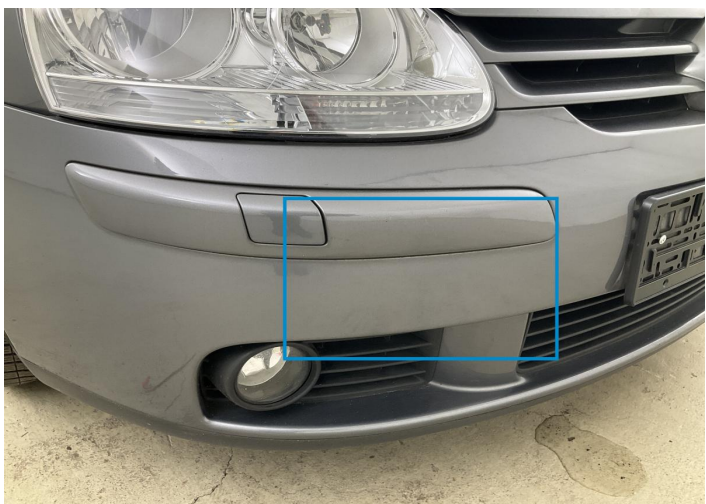
| Component | | Damage | Comments |
|---|---|---|---|
| 7 | Corner Bumper / Front Right | Paint / Scratch / Scuff | |

7. Corner Bumper / Front Right  
Paint / Scratch / Scuff -

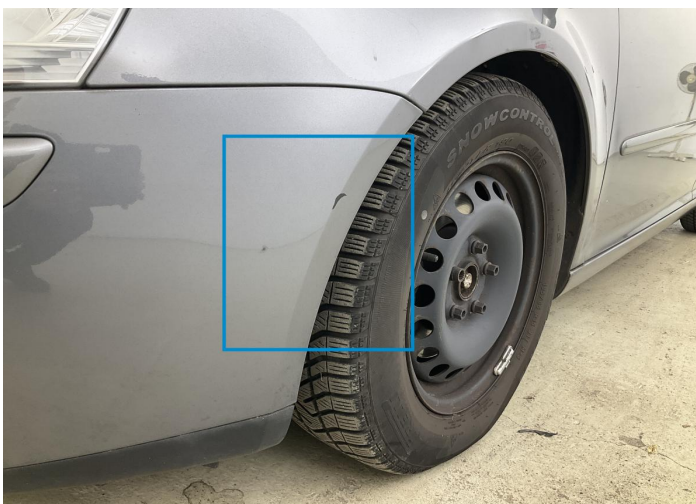
| Component | | Damage | Comments |
|---|---|---|---|
| 8 | Corner Bumper / Front Left | Paint / Scratch / Scuff | |

8. Corner Bumper / Front Left  
Paint / Scratch / Scuff -

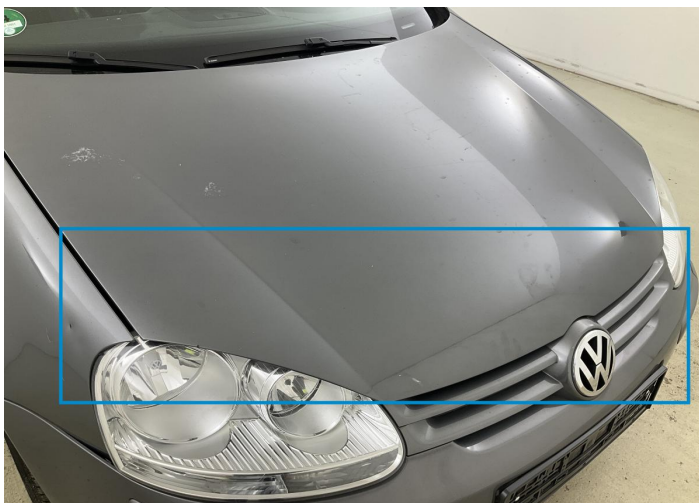
| Component | | Damage | Comments |
|---|---|---|---|
| 9 | Hood | Paint / Stone Chip | |

9. Hood  
Paint / Stone Chip -

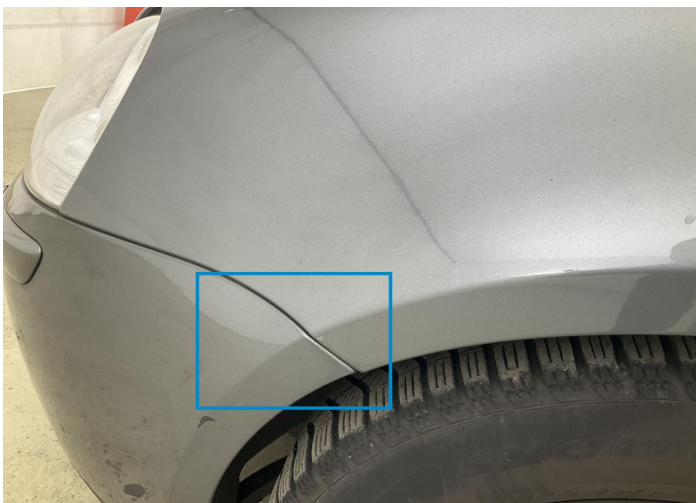
| Component | | Damage | Comments |
|---|---|---|---|
| 10 | Wing Expander / Front Left | Paint / Scratch / Scuff | |

10. Wing Expander / Front Left  
Paint / Scratch / Scuff -

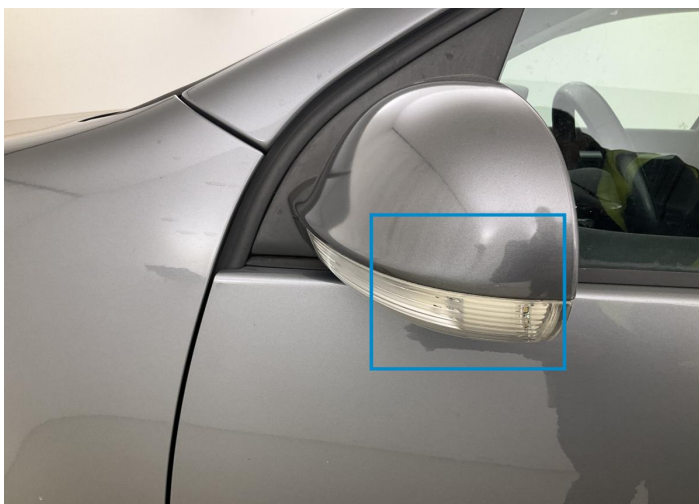
| Component | | Damage | Comments |
|---|---|---|---|
| 11 | Mirror / Front Left | Paint / Scratch / Scuff | |

11. Mirror / Front Left  
Paint / Scratch / Scuff -

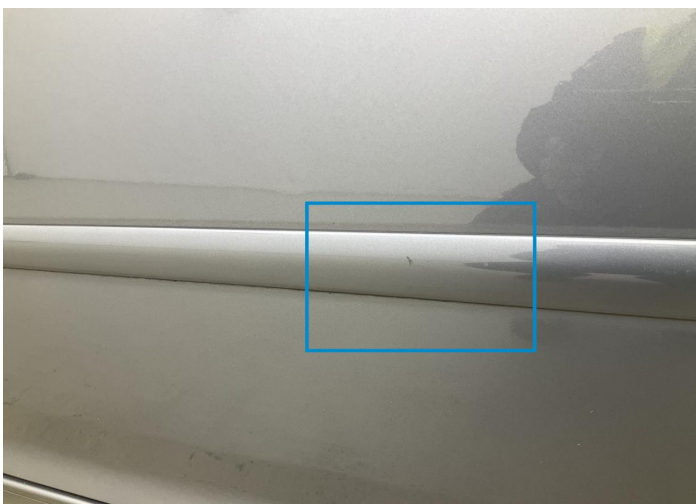
| Component | | Damage | Comments |
|---|---|---|---|
| 12 | Door / Front Left | Paint / Scratch / Scuff | |

12. Door / Front Left  
Paint / Scratch / Scuff -

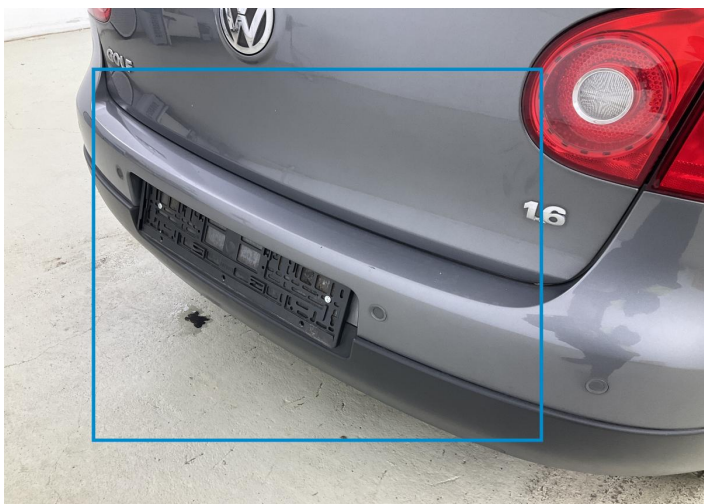
| 13 | Bumper / Back | Paint / Scratch / Scuff |

13. Bumper / Back  
Paint / Scratch / Scuff -

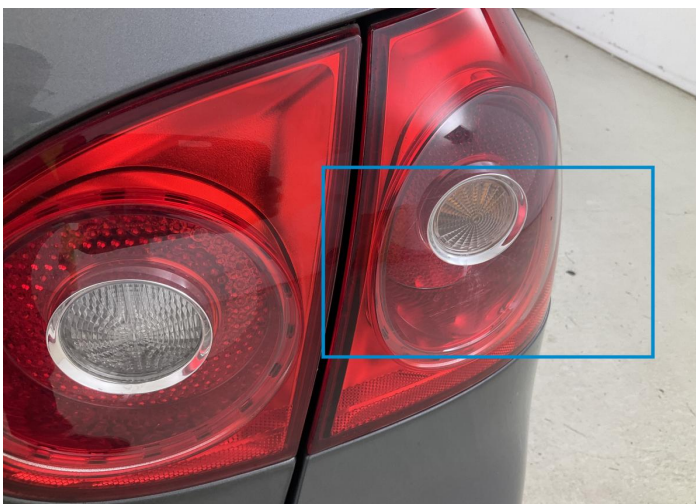
| 14 | Back Light / Right | Glass Break |

14. Back Light / Right  
Glass Break -

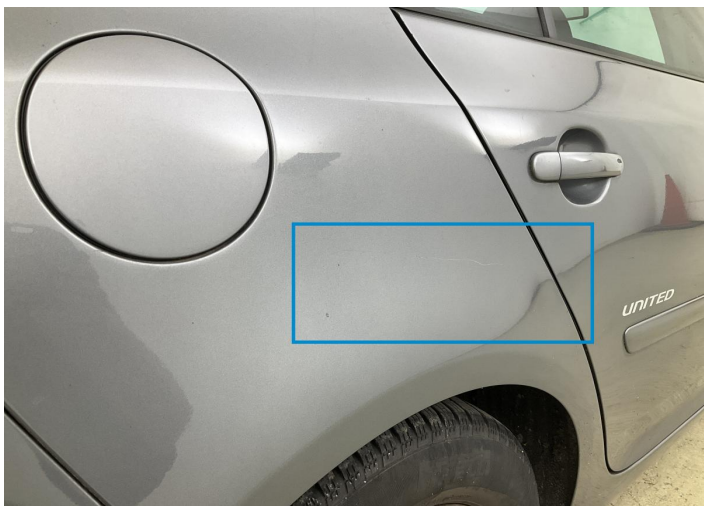
| 15 | Side Panel / Back Right | Paint / Scratch / Scuff |

15. Side Panel / Back Right  
Paint / Scratch / Scuff -

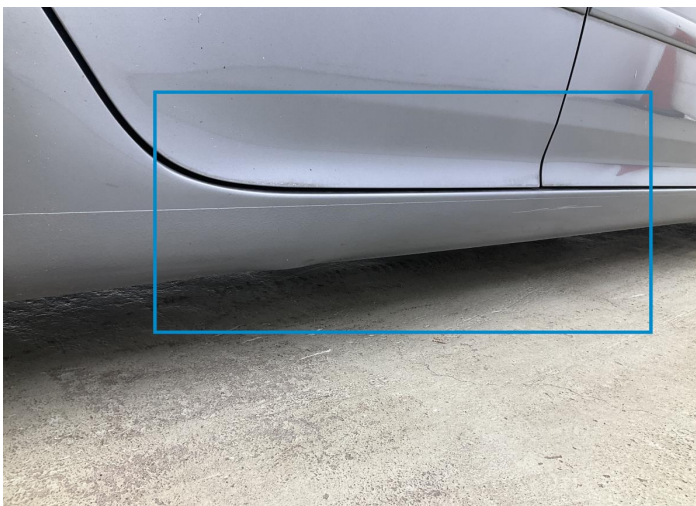
| 16 | Rocker Panel / Center Right | Bodywork / Dent / Dent |

16. Rocker Panel / Center Right  
Bodywork / Dent / Dent -

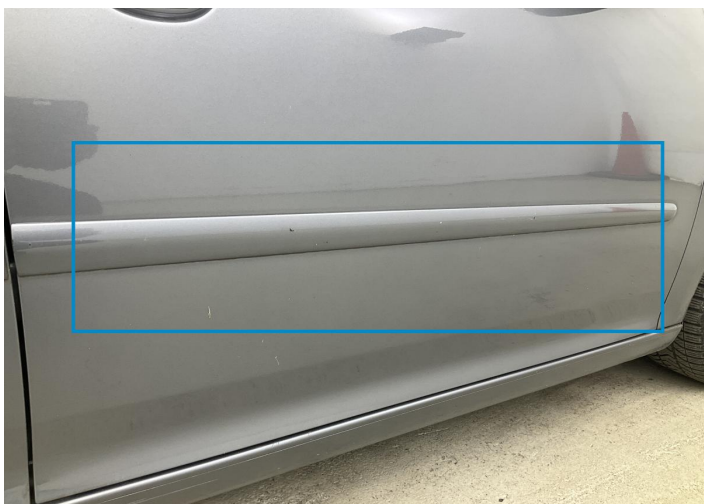
| 17 | Door / Front Right | Paint / Scratch / Scuff |

17. Door / Front Right  
Paint / Scratch / Scuff -

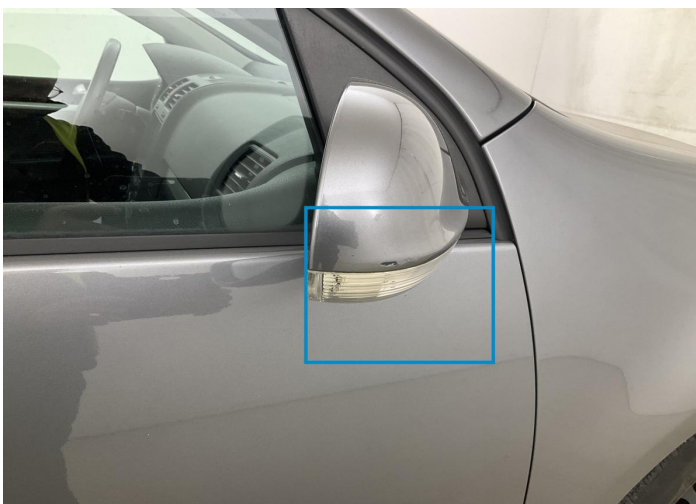
| 18 | Mirror / Front Right | Paint / Scratch / Scuff |

18. Mirror / Front Right  
Paint / Scratch / Scuff -

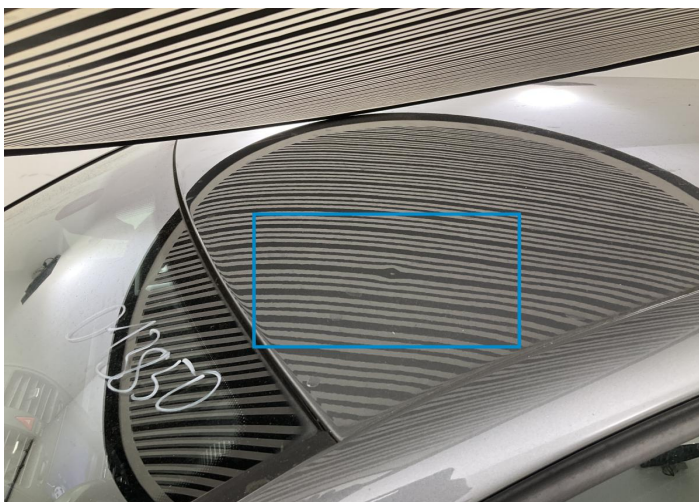
| 19 | Roof | Bodywork / Dent / Dent |

19. Roof  
Bodywork / Dent / Dent -

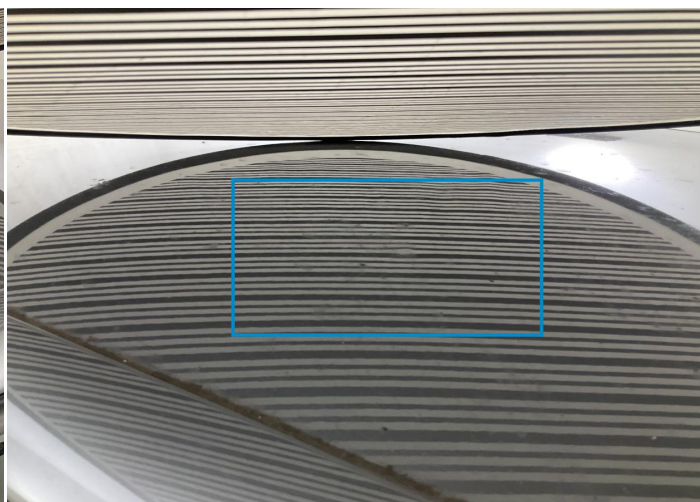
| 20 | Roof | Bodywork / Dent / Dent |

20. Roof  
Bodywork / Dent / Dent -

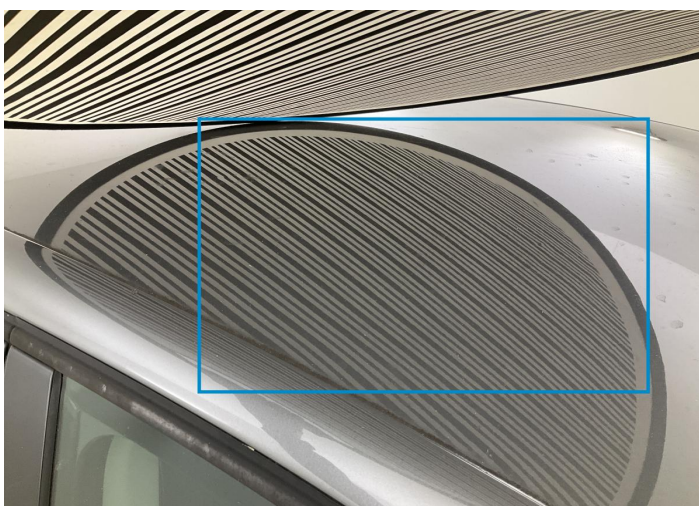
| 21 | Roof | Bodywork / Dent / Dent |

21. Roof  
Bodywork / Dent / Dent -

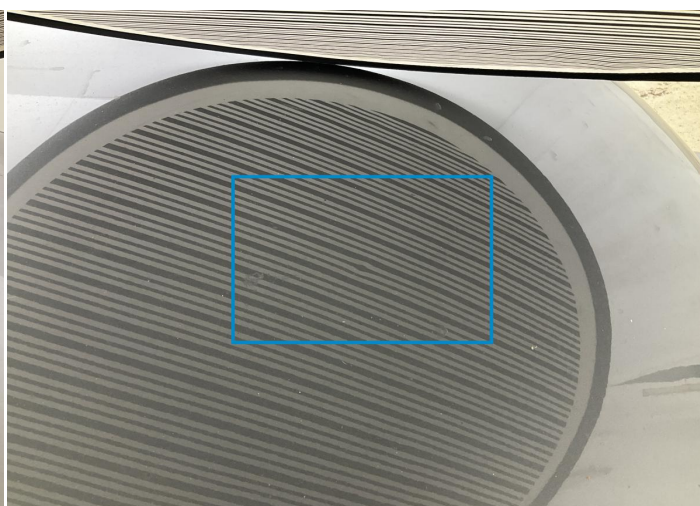
| 22 | Hood | Bodywork / Dent / Dent |

22. Hood  
Bodywork / Dent / Dent -

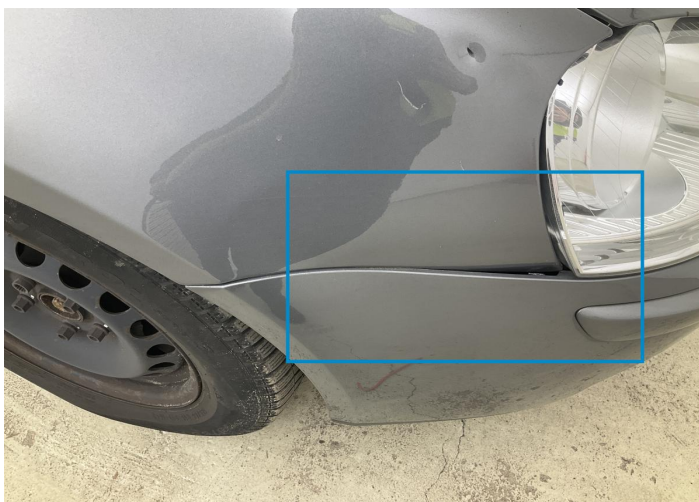
| 23 | Fender / Front Right | Bodywork / Poor Previous Repair |

23. Fender / Front Right  
Bodywork / Poor Previous Repair -

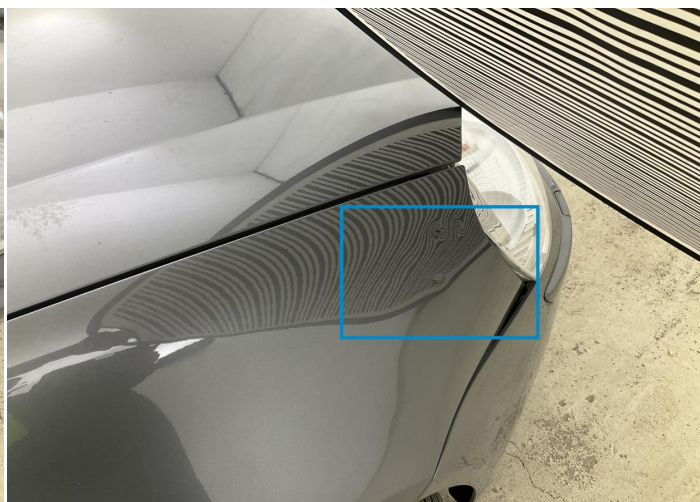
| 24 | Fender / Front Right | Bodywork / Dent / Dent |

24. Fender / Front Right  
Bodywork / Dent / Dent -

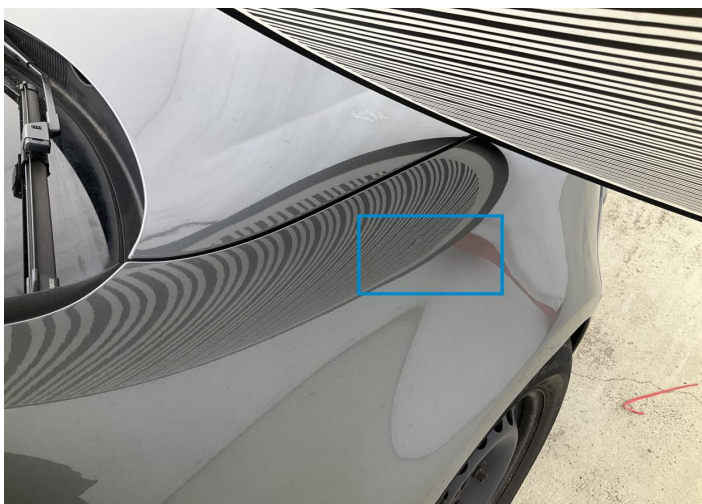
| 25 | Fender / Front Right | Bodywork / Dent / Dent |

25. Fender / Front Right  
Bodywork / Dent / Dent -

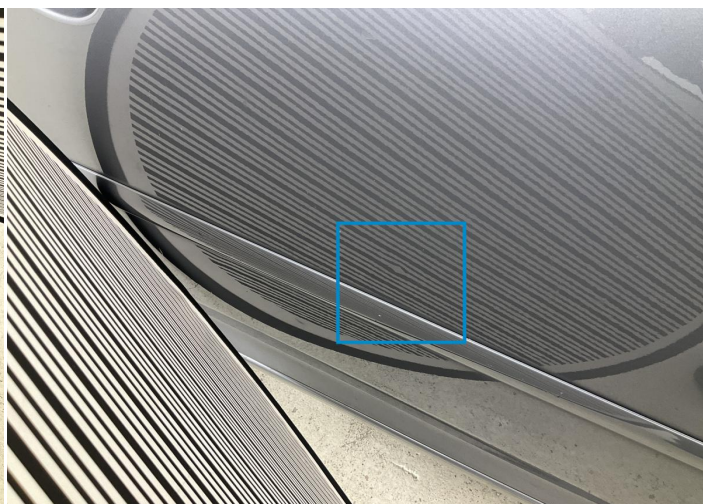
| 26 | Door / Front Right | Bodywork / Dent / Dent |

26. Door / Front Right  
Bodywork / Dent / Dent -

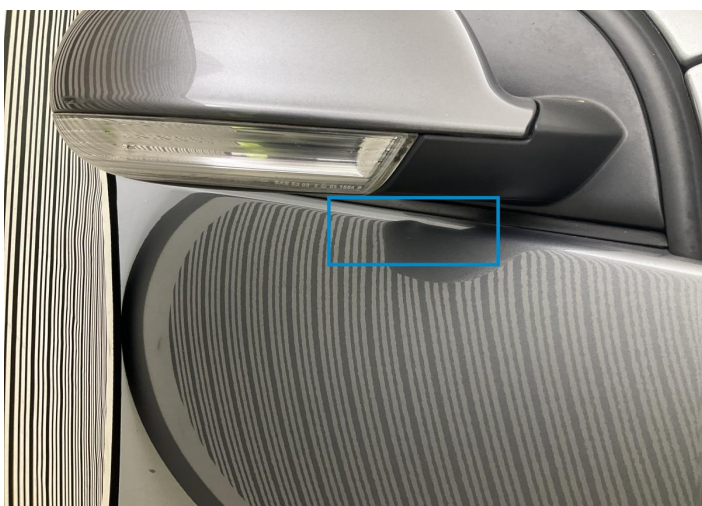
| 27 | Door / Front Right | Bodywork / Dent / Dent |

27. Door / Front Right  
Bodywork / Dent / Dent -

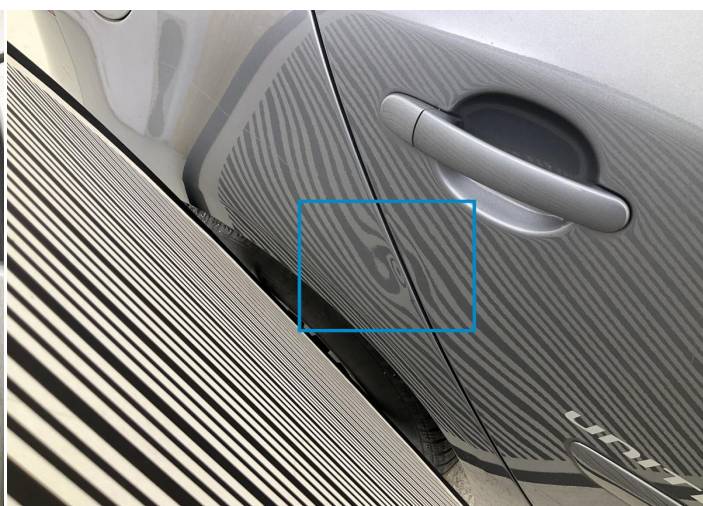
| 28 | Side Panel / Back Right | Bodywork / Dent / Dent |

28. Side Panel / Back Right  
Bodywork / Dent / Dent -

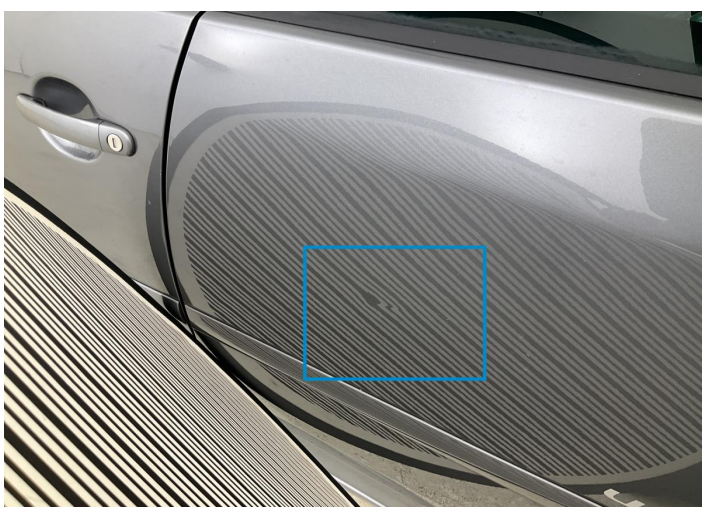
| 29 | Door / Back Left | Bodywork / Dent / Dent |

29. Door / Back Left  
Bodywork / Dent / Dent -

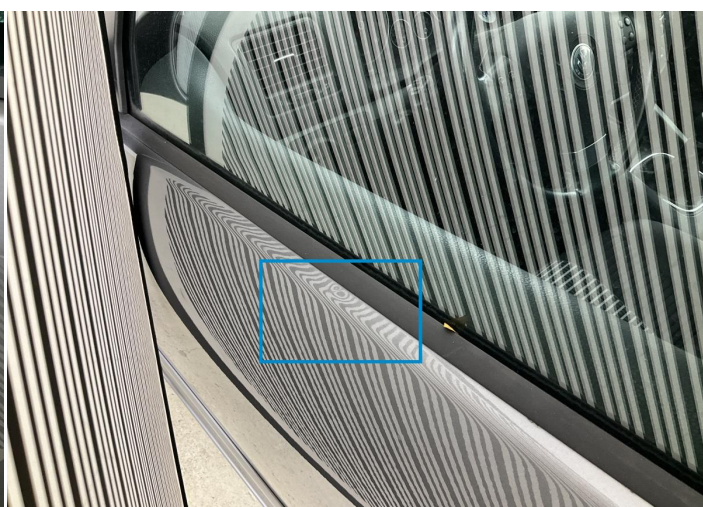
| 30 | Door / Front Left | Bodywork / Dent / Dent |

30. Door / Front Left  
Bodywork / Dent / Dent -

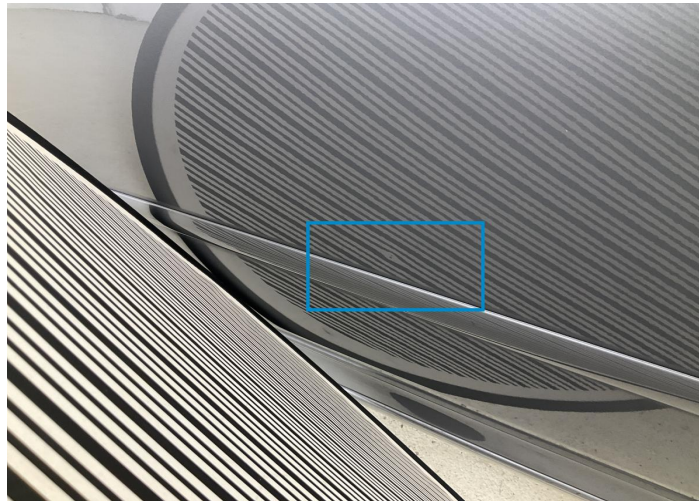
| 31 | Door / Front Left | Bodywork / Dent / Dent |

31. Door / Front Left  
Bodywork / Dent / Dent -
