## status report

#### Volkswagen Golf V Lim. United

| Vehicle identification number | <b>VWVZZZ1KZ9W009150</b> | mileage read: | <b>146654 km</b> |

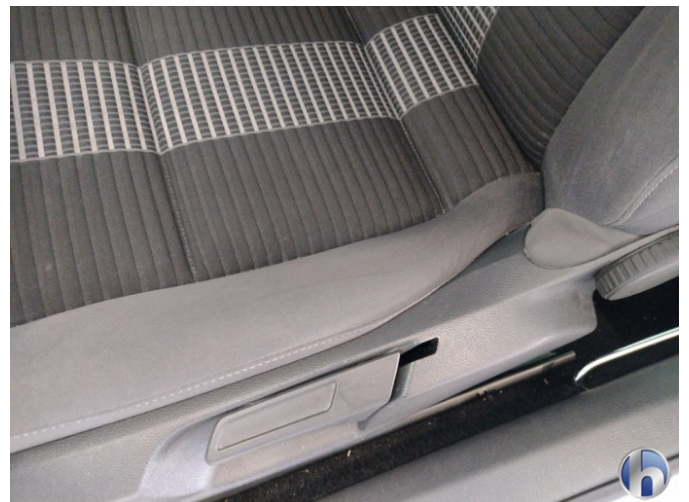
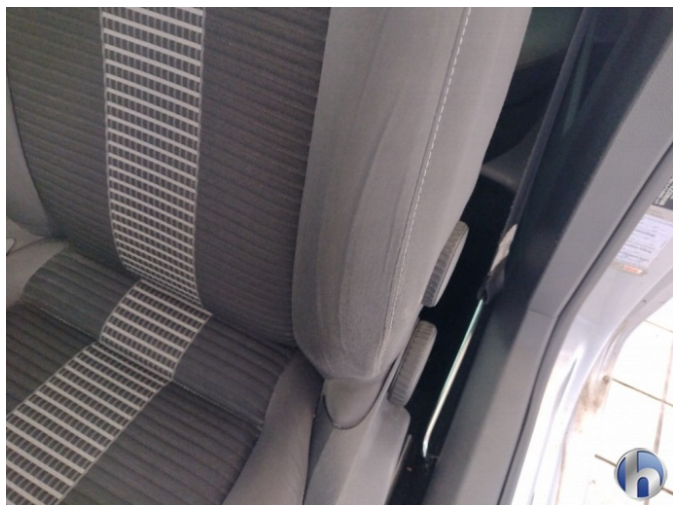
| component | Damage | Rep kind |
|---|---|---|
| 1. Sitz Vorne Links | Wear and tear | acceptable |

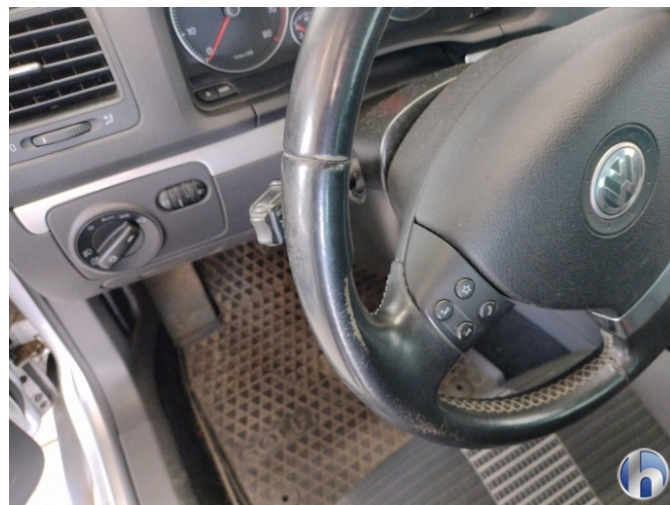
| component | Damage | Rep kind |
|---|---|---|
| 2. steering wheel | Damaged | Smart repair |

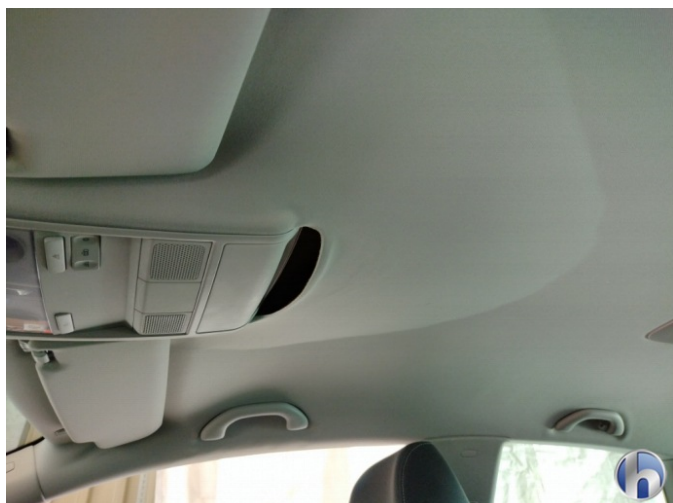
| component | Damage | Rep kind |
|---|---|---|
| 3. headlining | Damaged | Replace |

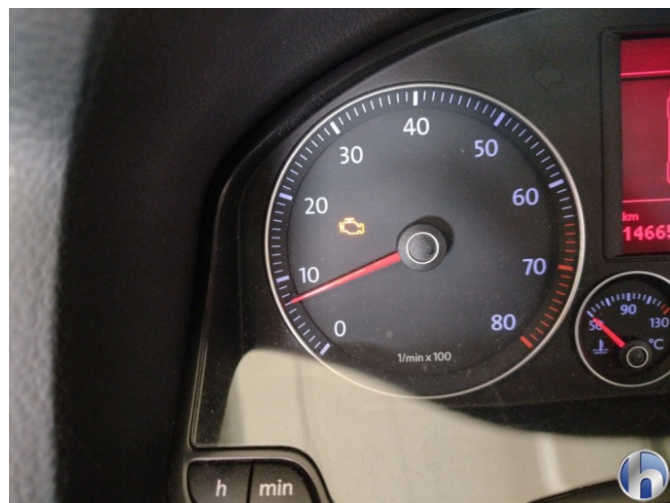
| Performed testing technology | |
|---|---|
| <b>engine running:</b> | A field test of the engine had to acoustic or visual defects for visiting time .<br>**Engine warning light. |

| component | Damage | Rep kind |
|---|---|---|
| 5. Motorkontrollleuchte | Error message | Carry out a fault diagnosis |

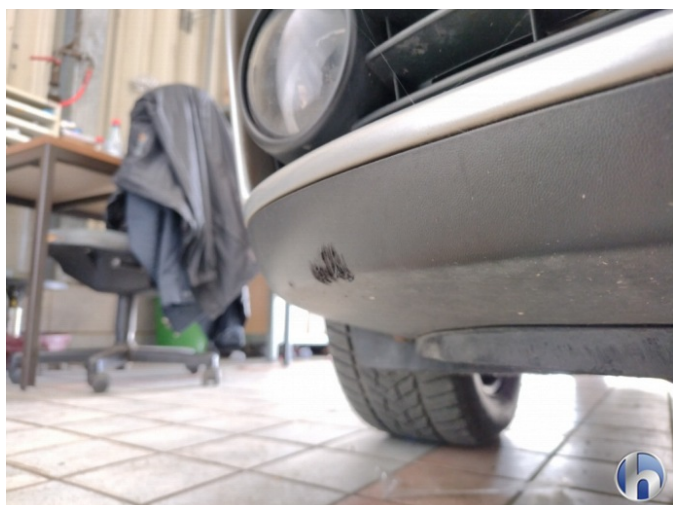
| component | Damage | Rep kind |
|---|---|---|
| 6. spoiler | Scrape | Replace |

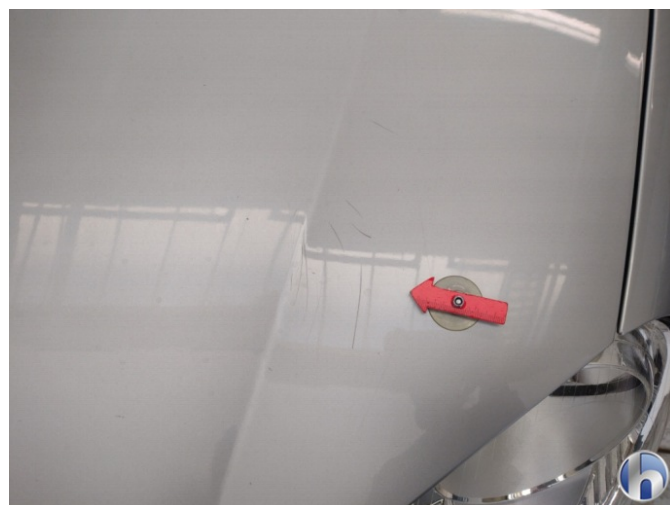
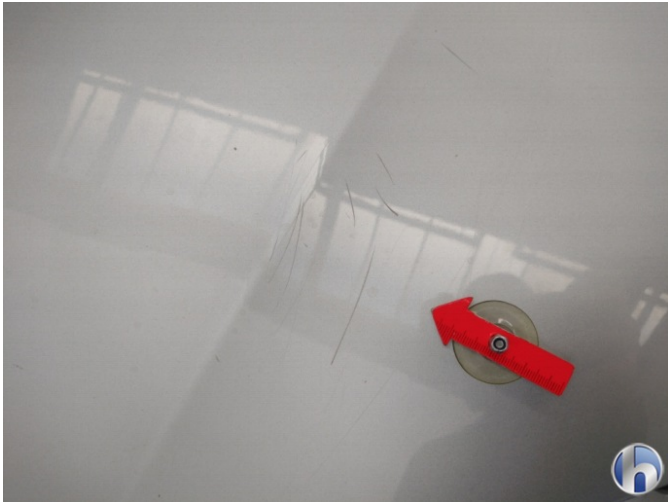
| component | Damage | Rep kind |
|---|---|---|
| 7. hood | Scratch(es) | Paint |

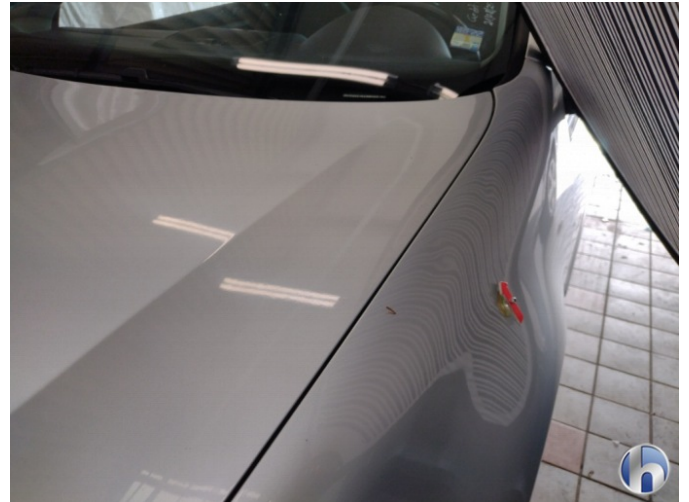
| component | Damage | Rep kind |
|---|---|---|
| 8. Front fender - left | Deformed | Refurbish and paint |

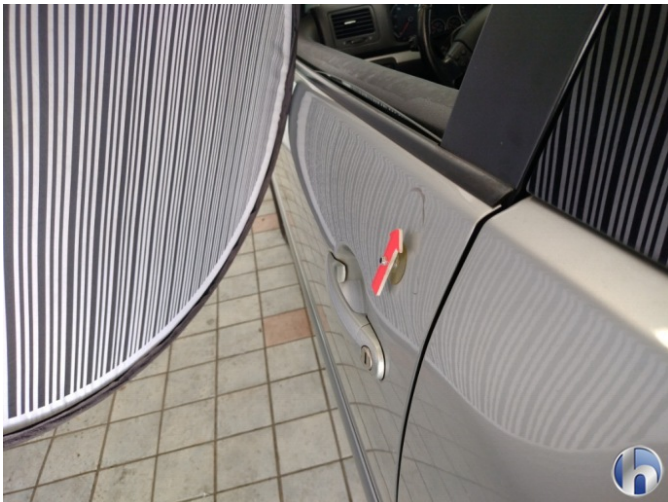
| component | Damage | Rep kind |
|---|---|---|
| 9. Front door - left | Deformed | Refurbish and paint |

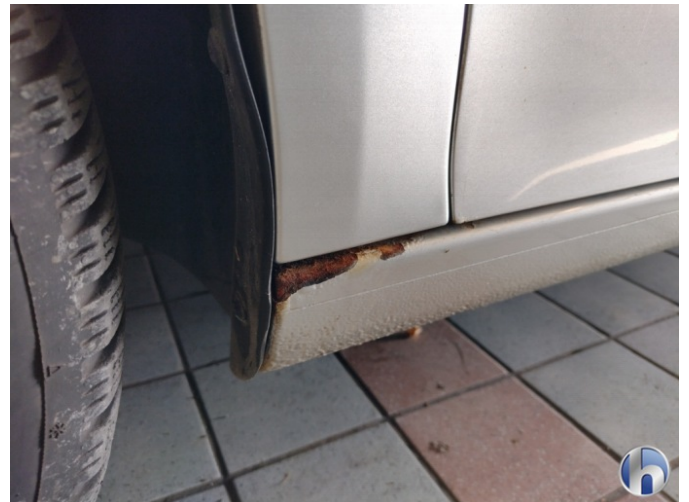
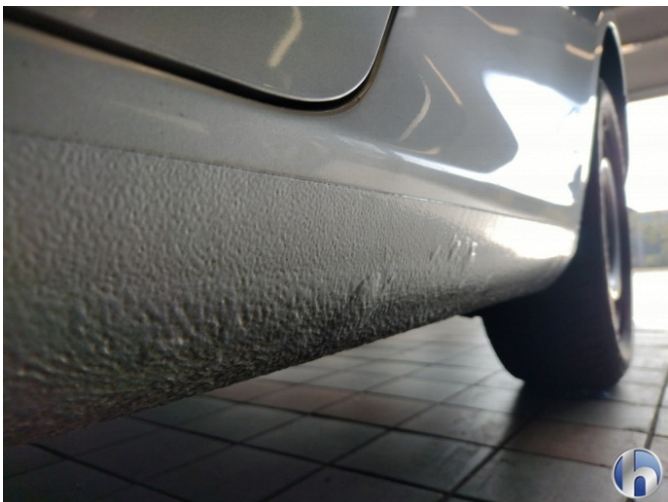
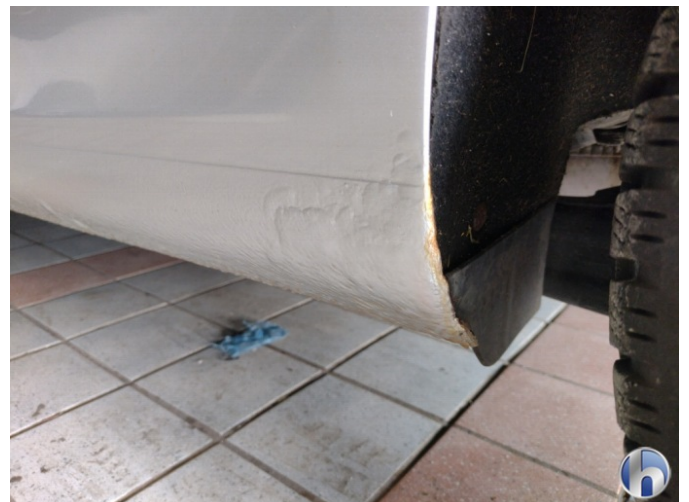
| component | Damage | Rep kind |
|---|---|---|
| 10. side skirt - left | Rust | Replace |

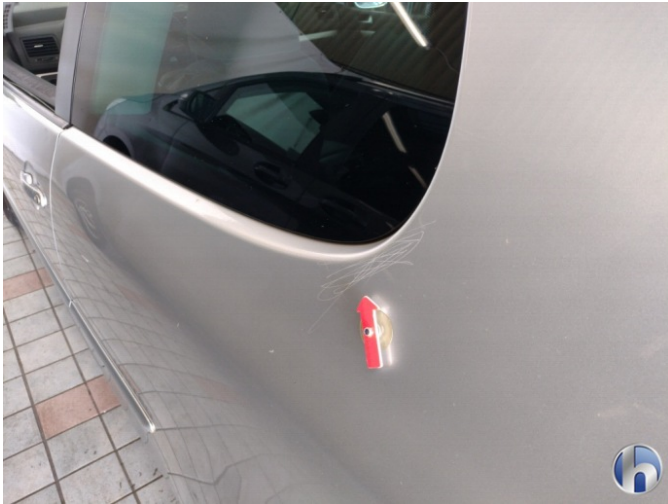
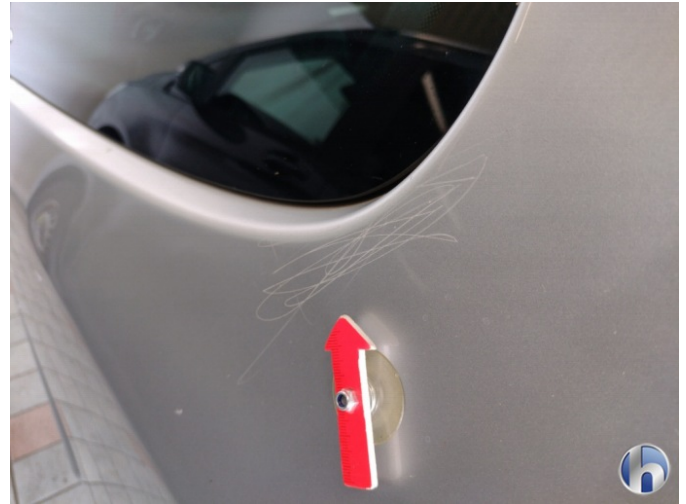
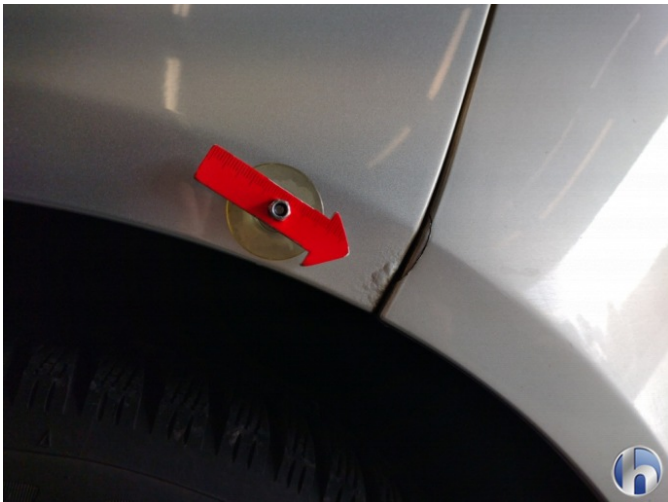
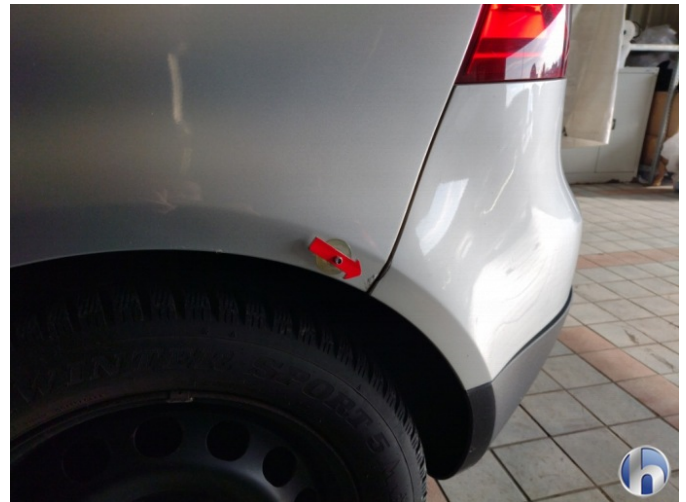
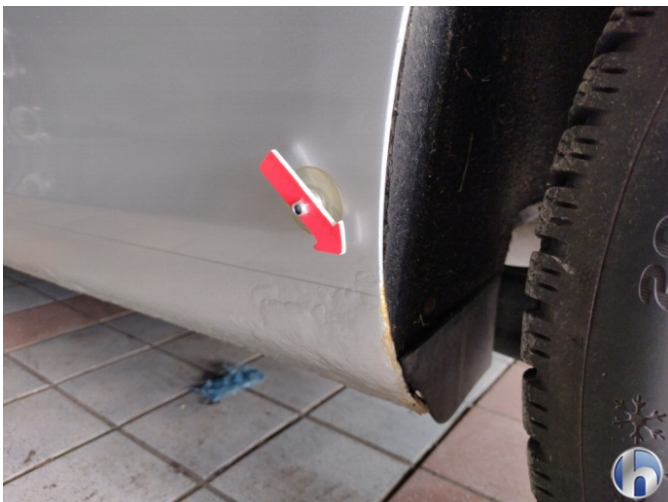
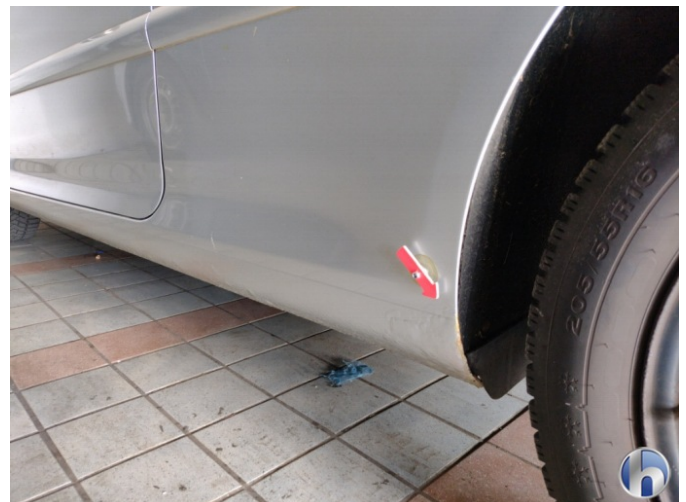
| component | Damage | Rep kind |
|---|---|---|
| 11. Sidewall - Rear - Left | Rust | Replace |

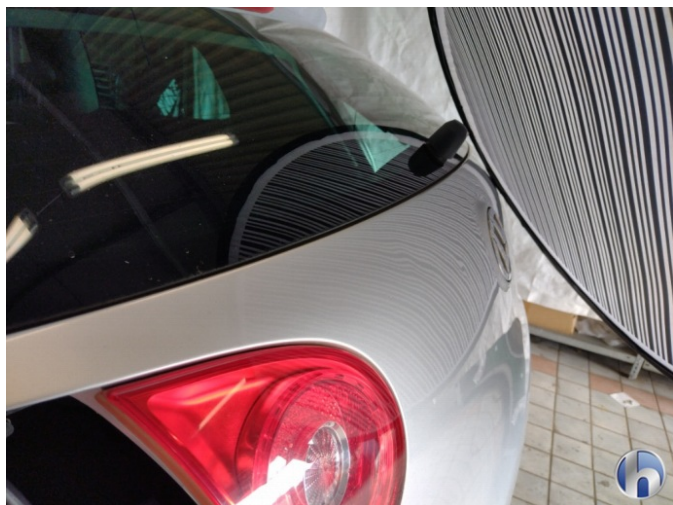
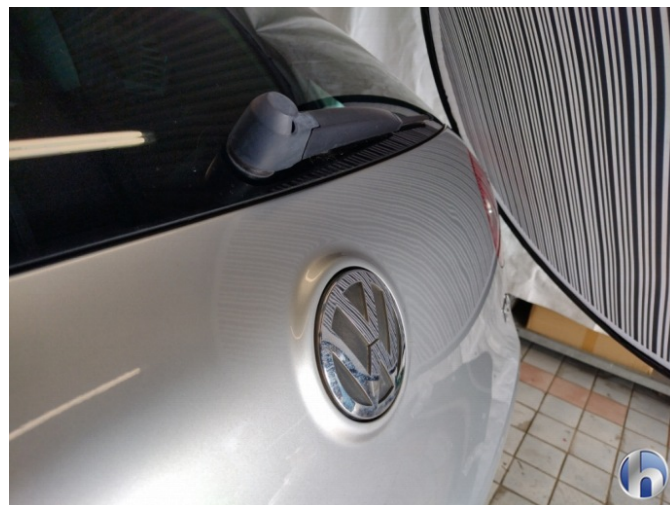
| component | Damage | Rep kind |
|---|---|---|
| 12. tailgate | Deformed | Refurbish and paint |

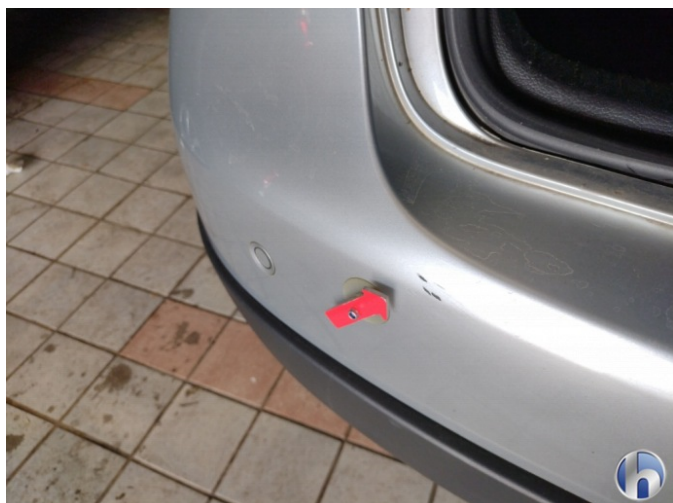
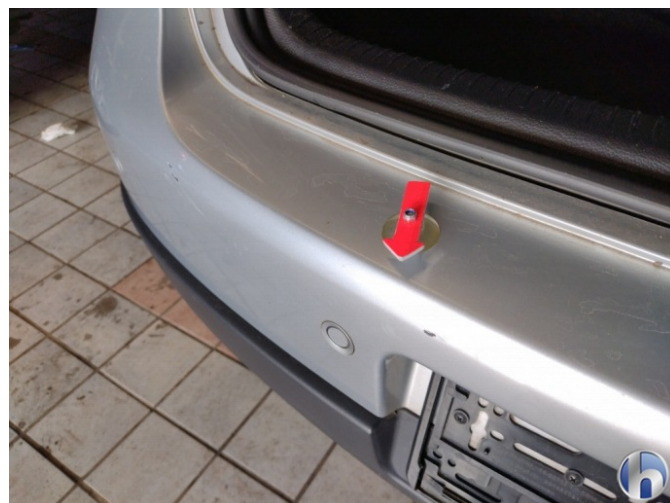
| component | Damage | Rep kind |
|---|---|---|
| 13. Rear bumper | Scratch(es) | Paint |

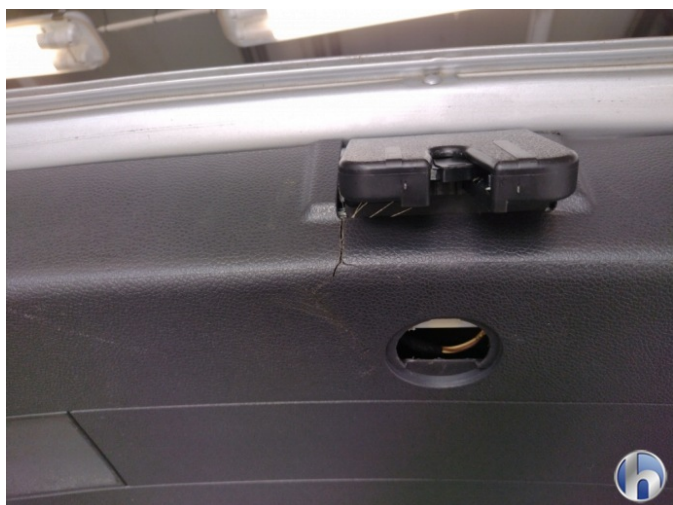
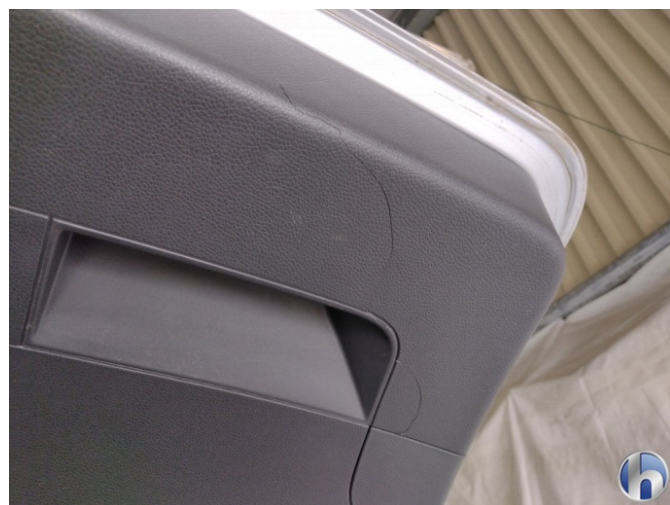
| component | Damage | Rep kind |
|---|---|---|
| 14. tailgate trim | Breakage | Replace |

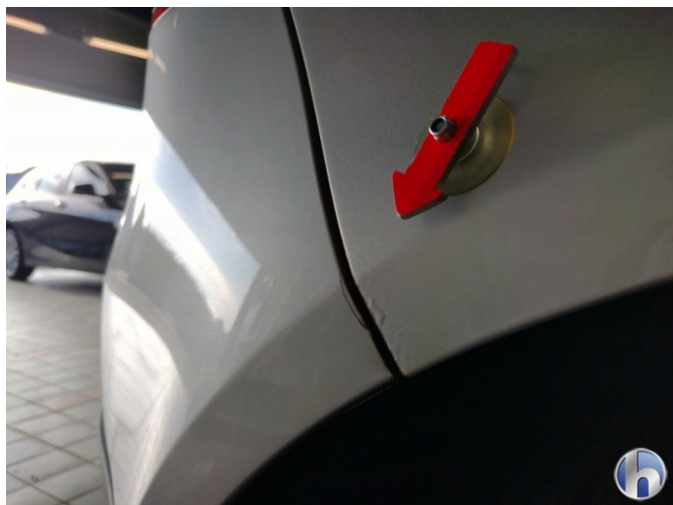
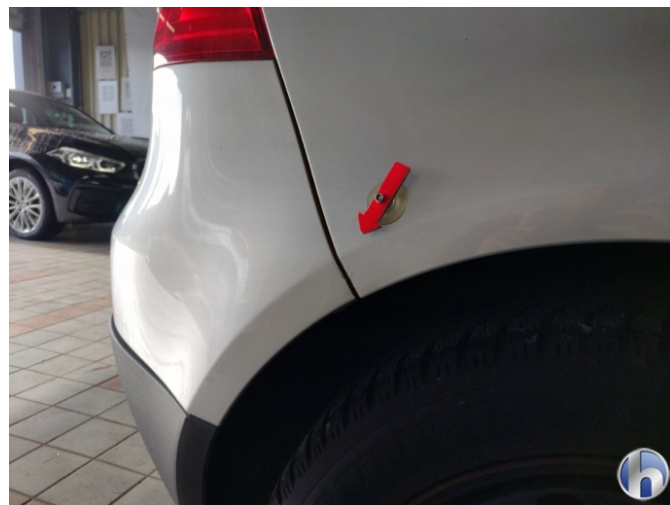
| component | Damage | Rep kind |
|---|---|---|
| 15. Sidewall - Rear - right | Rust | Replace |

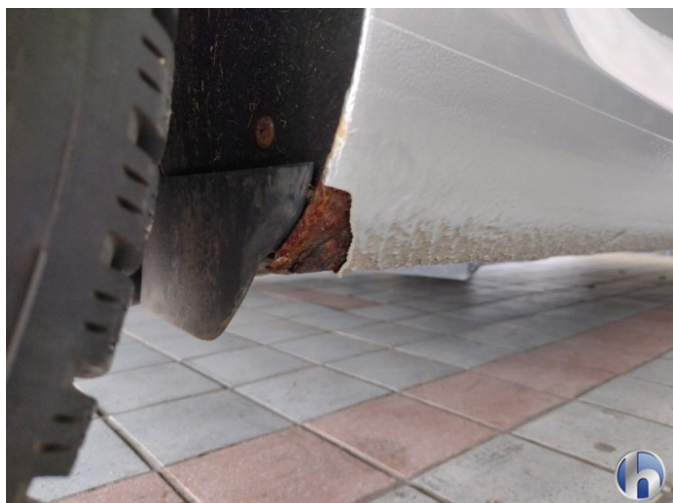
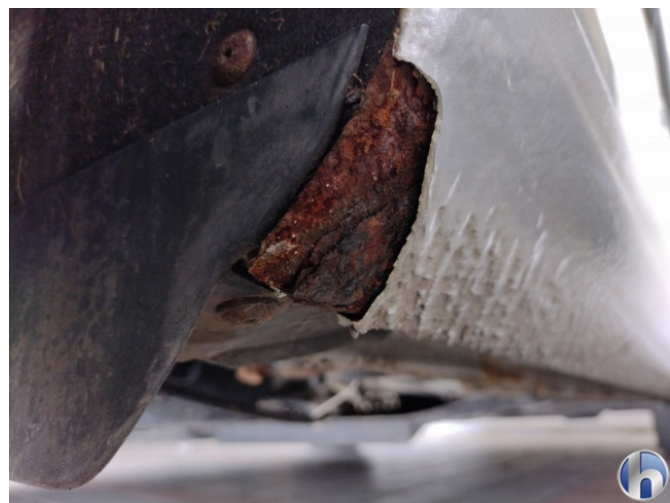
| component | Damage | Rep kind |
|---|---|---|
| 16. side skirt - right | Rust | Replace |

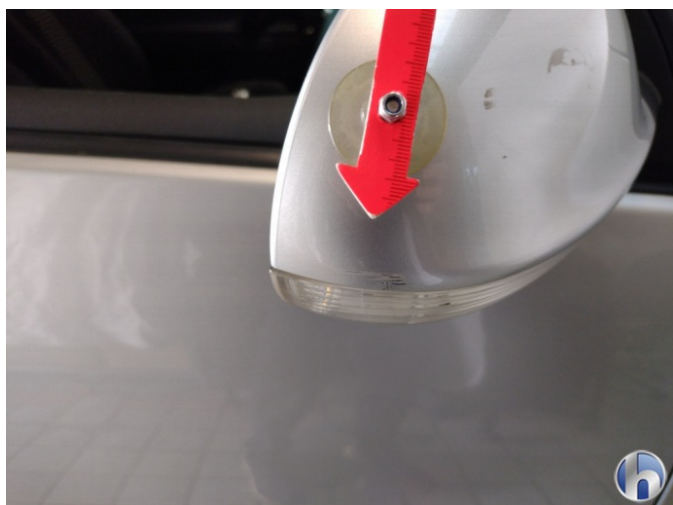
| component | Damage | Rep kind |
|---|---|---|
| 17. | Scratch(es) | Paint |

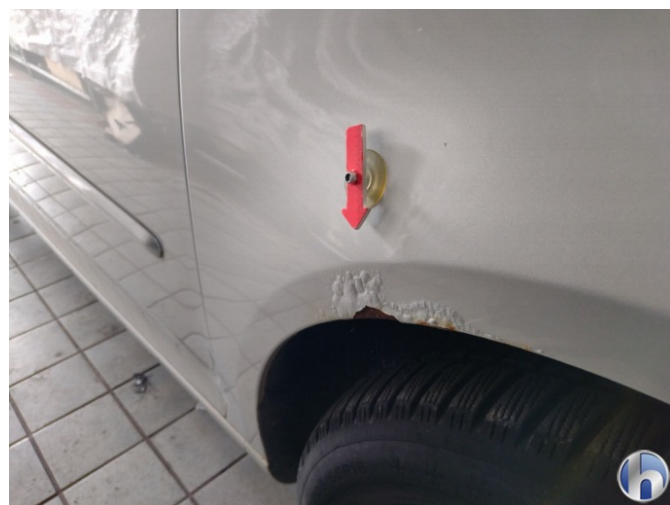
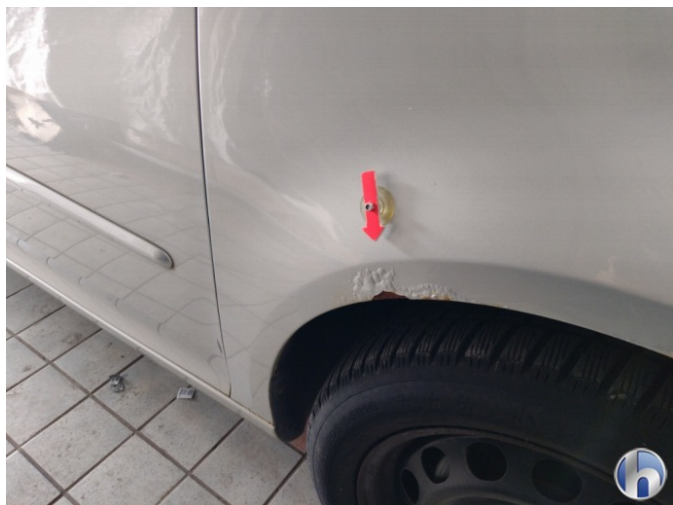
| component | Damage | Rep kind |
|---|---|---|
| 18. Front fender - right | Rust | Refurbish and paint |

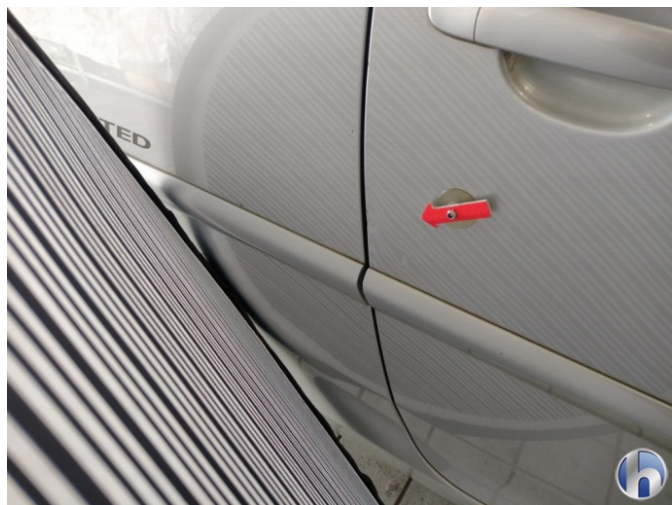
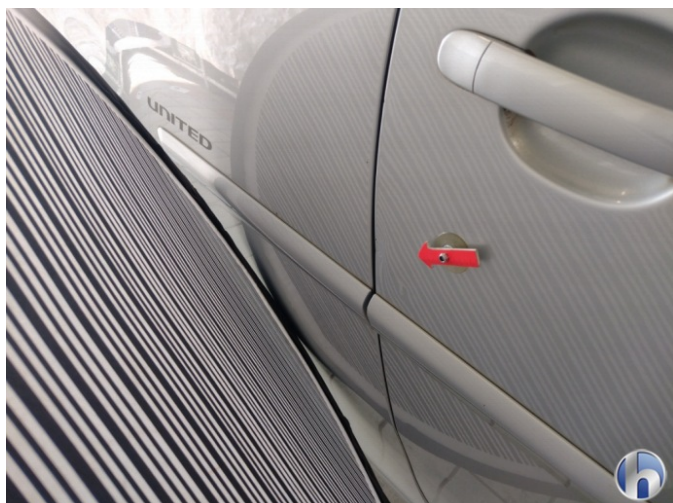
| component | Damage | Rep kind |
|---|---|---|
| 19. Front door - right | Deformed | Refurbish and paint |
