VOLKSWAGEN Golf VI

Golf Variant 2.0 TDI DPF

VIN NO WVWZZZ1KZDM665939
Registration Number KZDM665939

Inspection Report Summary

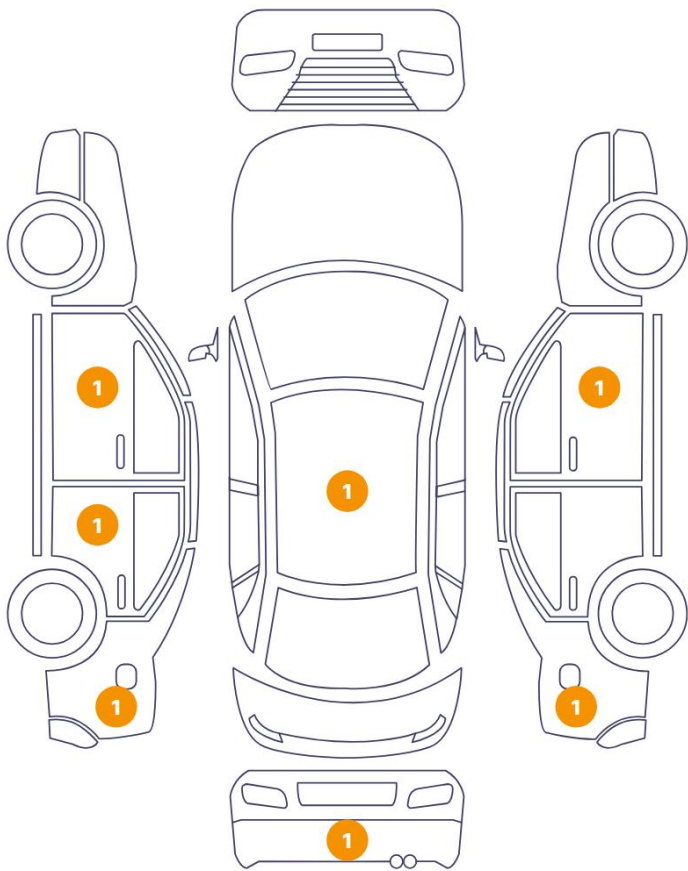
7 Schäden

Component		Damage	Comments
1	Roof	Bodywork / Dent / Dent	
2	Door / Front Left	Paint / Scratch / Scuff	
3	Door / Back Left	Bodywork / Dent / Dent	
4	Fender / Back Left	Paint / Scratch / Scuff	
5	Bumper / Back	Paint / Scratch / Scuff	
6	Fender / Back Right	Paint / Scratch / Scuff	
7	Door / Front Right	Paint / Scratch / Scuff

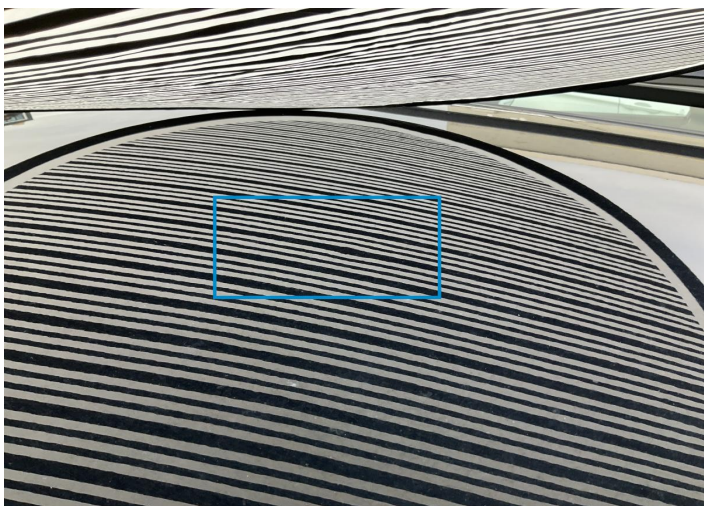
1. Roof
Bodywork / Dent / Dent -

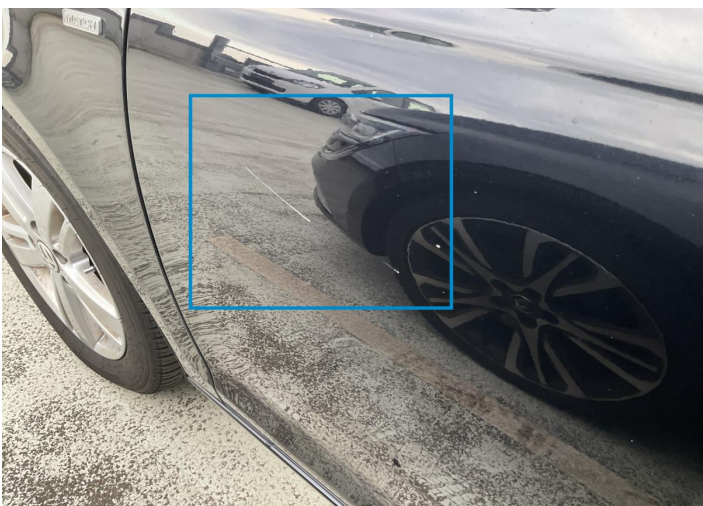
2. Door / Front Left
Paint / Scratch / Scuff -

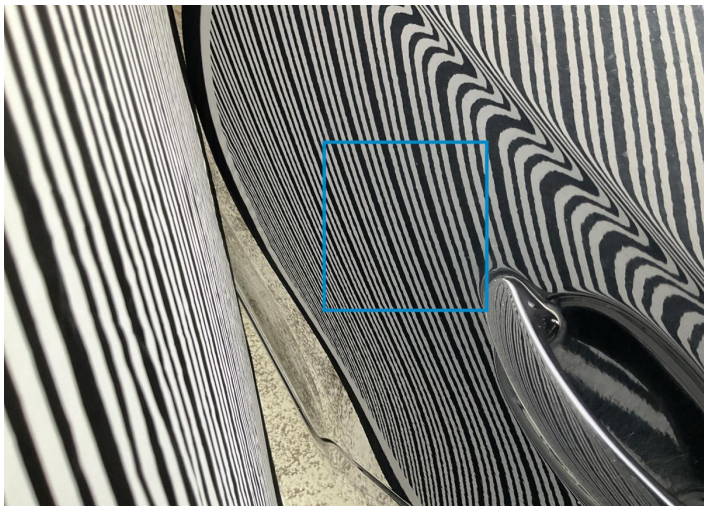
3. Door / Back Left
Bodywork / Dent / Dent -

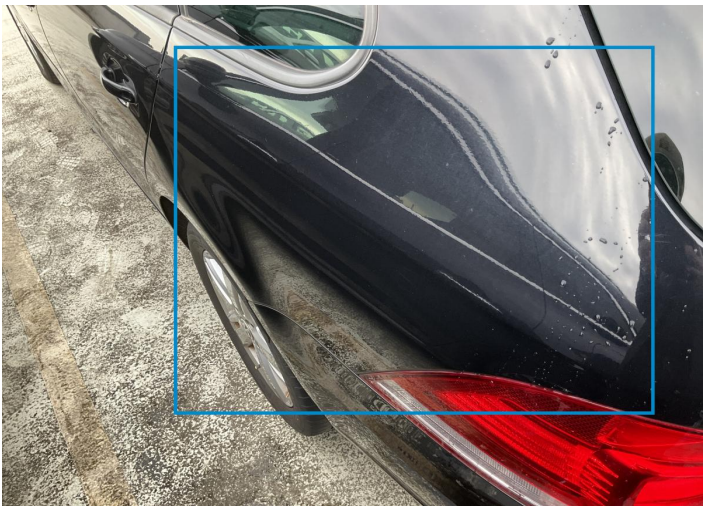
4. Fender / Back Left
Paint / Scratch / Scuff -

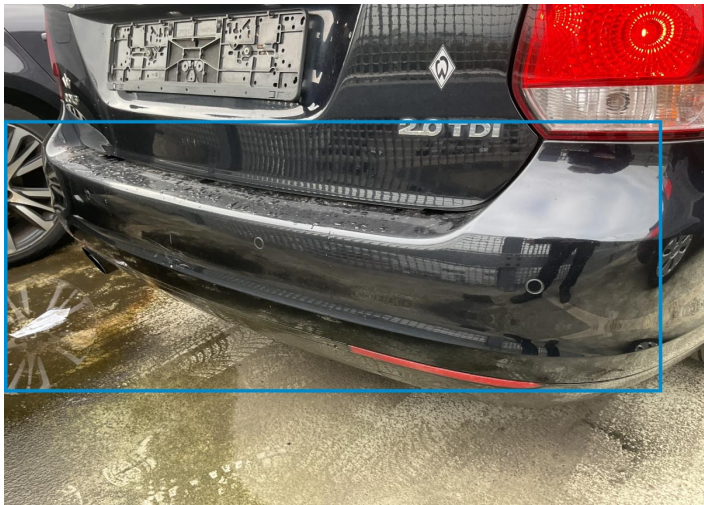
5. Bumper / Back
Paint / Scratch / Scuff -

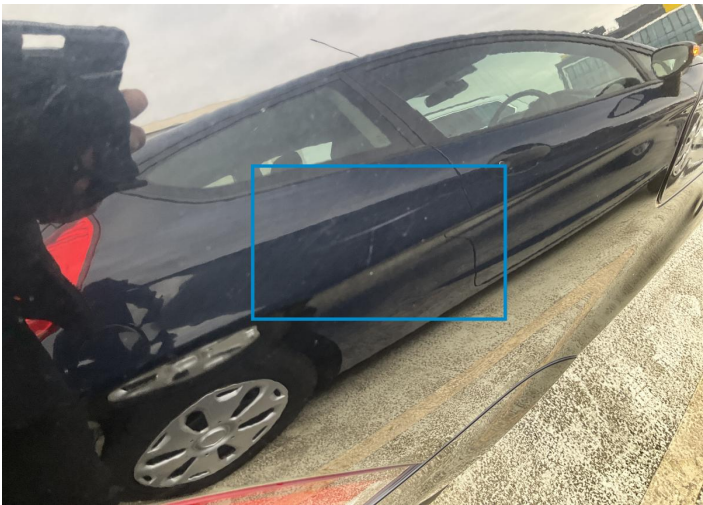
6. Fender / Back Right
Paint / Scratch / Scuff -

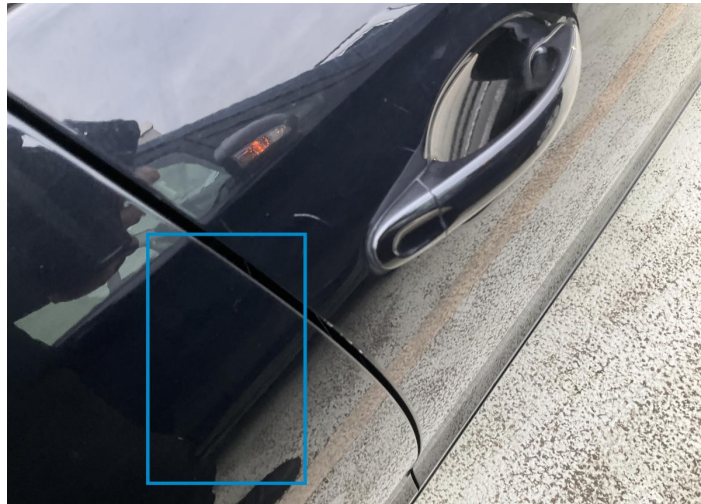
7. Door / Front Right
Paint / Scratch / Scuff -
