## VOLKSWAGEN Golf VI Golf 1.2 TSI

VIN NO WVWZZZ1KZDW007769 Registration Number KZDW007769

#### **Inspection Report Summary**

Customer	BCA Online	Report Number	P20250918141458
Inspection Date / Place	2025-09-19 / Extern	Cosmetic Grade	1

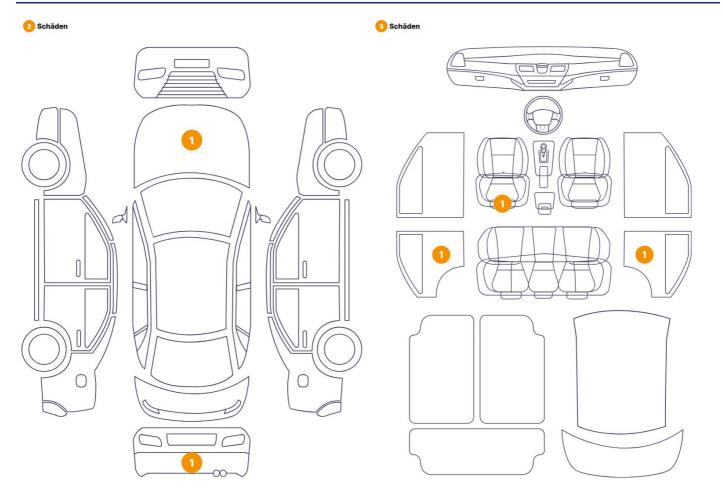
Component	Damage	Comments
1	Panel Filling / Back Left	Interior / Scratched	
2	Bumper / Back	Paint / Scratch / Scuff	
3	Panel Filling / Back Right	Interior / Scratched	
4	Hood	Paint / Stone Chip	
5	Seat / Front Left	Interior / Holed

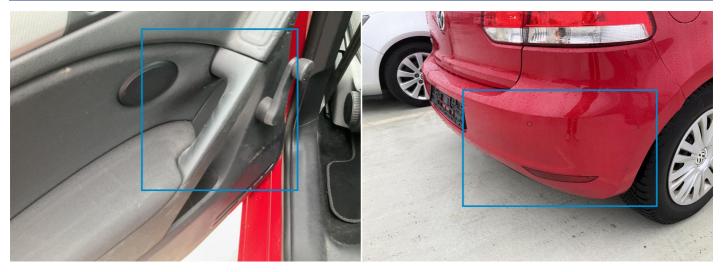
1. Panel Filling / Back Left Interior / Scratched -

2. Bumper / Back Paint / Scratch / Scuff -

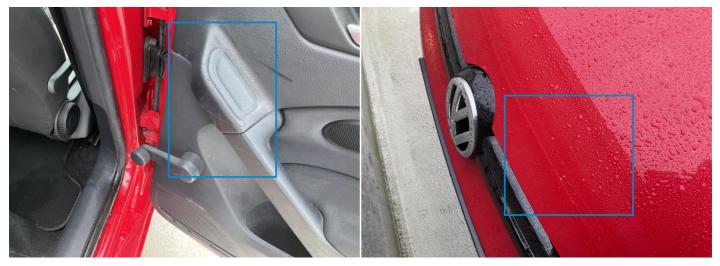
3. Panel Filling / Back Right Interior / Scratched -

4. Hood Paint / Stone Chip -

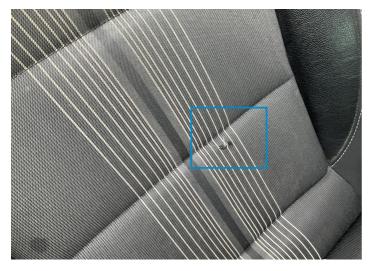
5. Seat / Front Left Interior / Holed -
