# VOLKSWAGEN Golf VI Golf Plus 1.2 TSI

VIN NO WVWZZZ1KZDW540484  
Registration Number KZDW540484

## Inspection Report Summary

| Customer | BCA Online | Report Number | P20250825095956 |

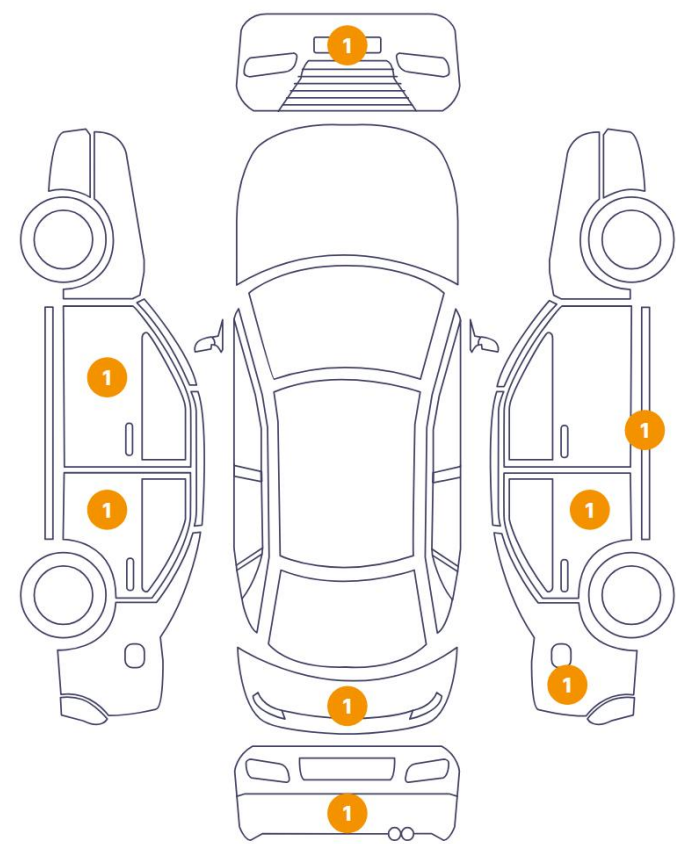
8 Schäden

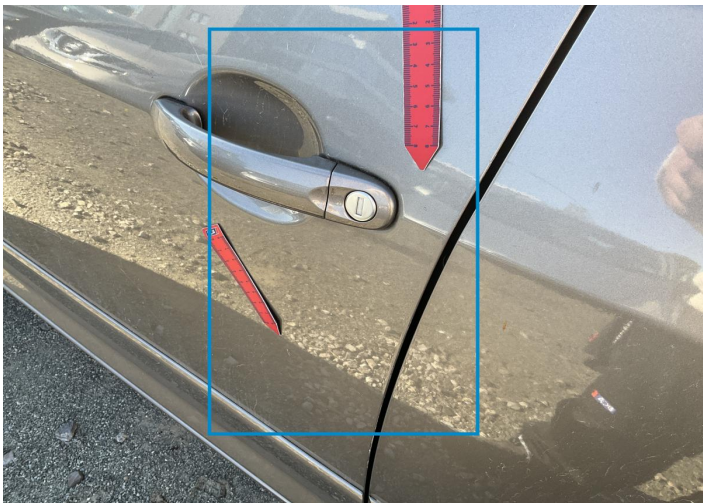
| Component | | Damage | Comments |
|---|---|---|---|
| 1 | Door / Front Left | Paint / Scratch / Scuff | |

1. Door / Front Left  
Paint / Scratch / Scuff -

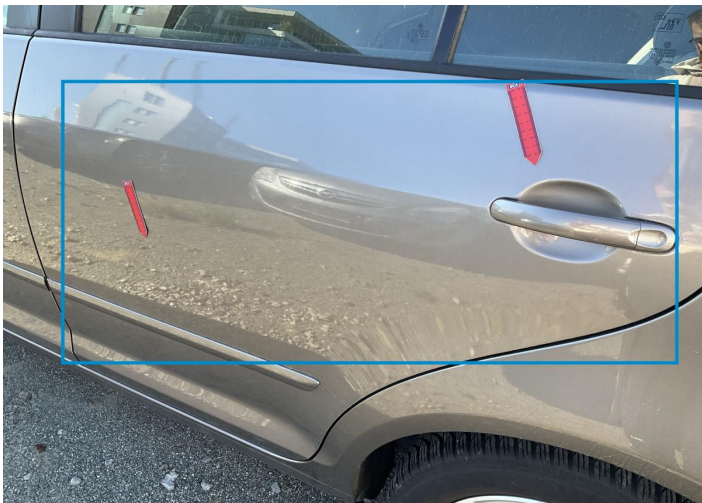
| Component | | Damage | Comments |
|---|---|---|---|
| 2 | Door / Back Left | Paint / Scratch / Scuff | |

2. Door / Back Left  
Paint / Scratch / Scuff -

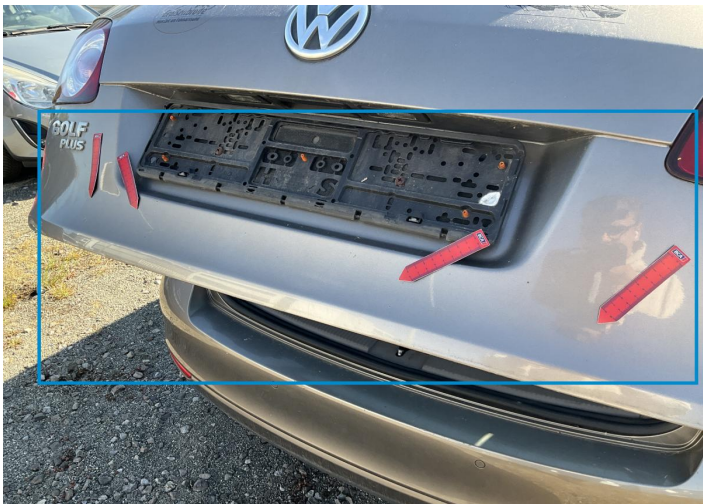
| Component | | Damage | Comments |
|---|---|---|---|
| 3 | Tailgate | Paint / Scratch / Scuff | |

3. Tailgate  
Paint / Scratch / Scuff -

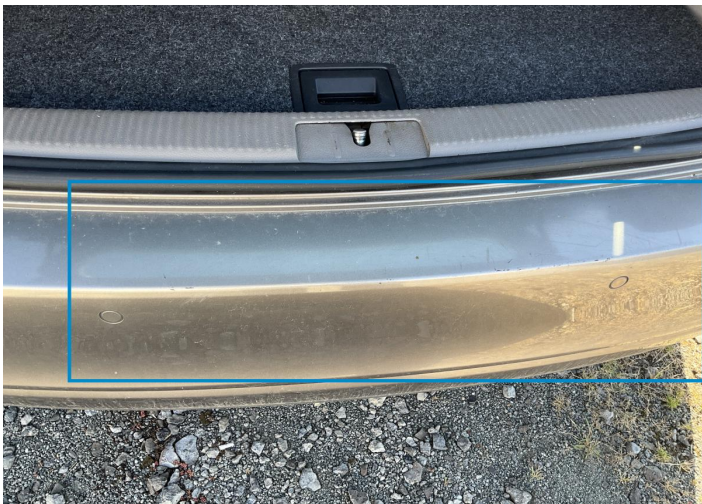
| Component | | Damage | Comments |
|---|---|---|---|
| 4 | Bumper / Back | Paint / Scratch / Scuff | |

4. Bumper / Back  
Paint / Scratch / Scuff -

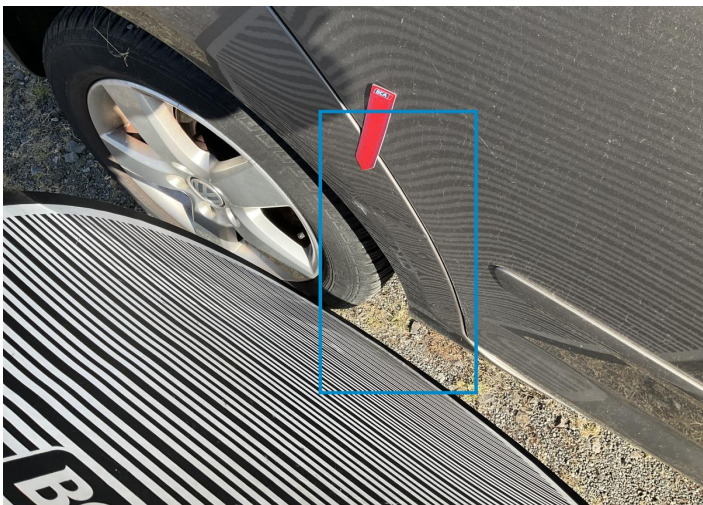
| Component | | Damage | Comments |
|---|---|---|---|
| 5 | Side Panel / Back Right | Bodywork / Dent / Dent | |

5. Side Panel / Back Right  
Bodywork / Dent / Dent -

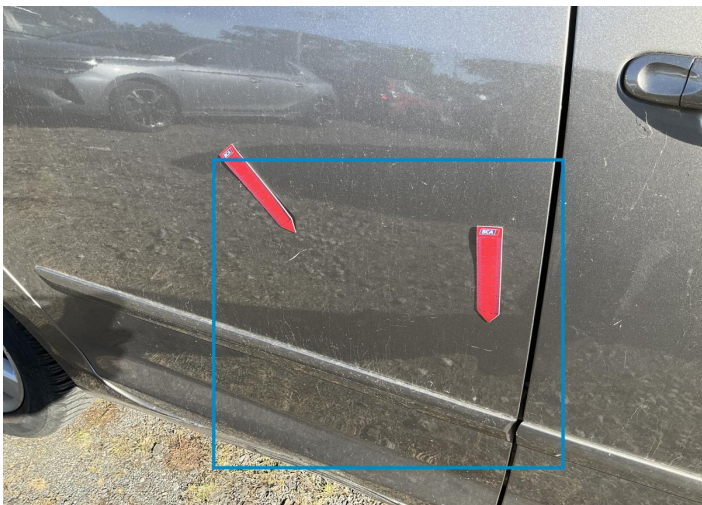
| Component | | Damage | Comments |
|---|---|---|---|
| 6 | Door / Back Right | Paint / Scratch / Scuff | |

6. Door / Back Right  
Paint / Scratch / Scuff -

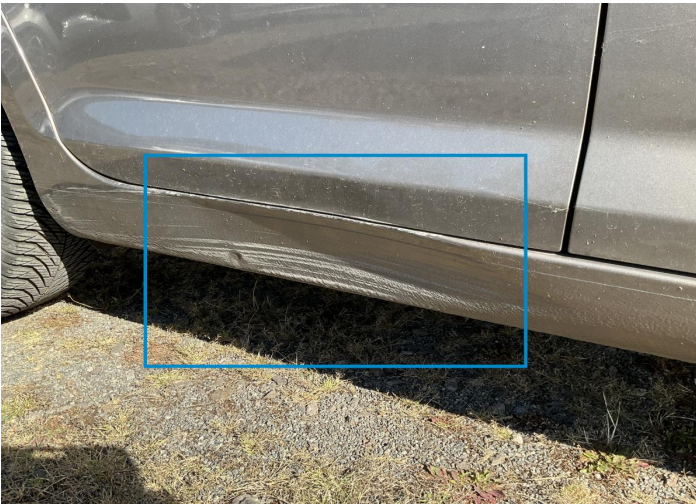
| Component | | Damage | Comments |
|---|---|---|---|
| 7 | Rocker Panel / Center Right | Bodywork / Dent / Dent | |

7. Rocker Panel / Center Right  
Bodywork / Dent / Dent -

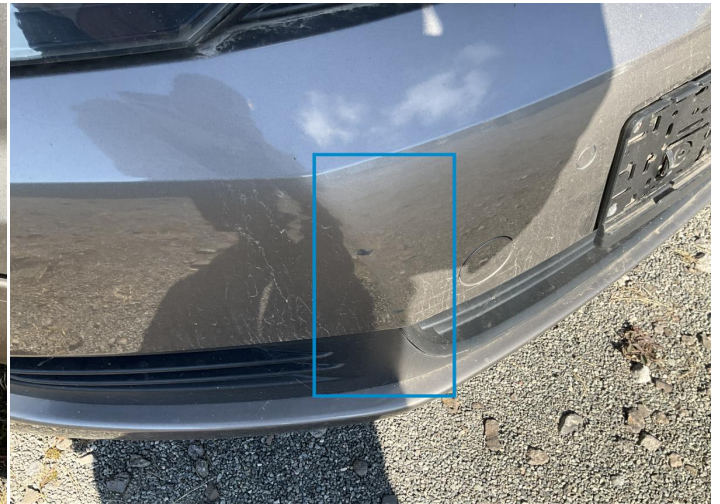
| Component | | Damage | Comments |
|---|---|---|---|
| 8 | Bumper / Front | Paint / Scratch / Scuff | |

8. Bumper / Front  
Paint / Scratch / Scuff -
