VOLKSWAGEN Passat

Passat Variant 1.6

VIN NO WVWZZZ3BZ3E464067
Registration Number BZ3E464067

Inspection Report Summary

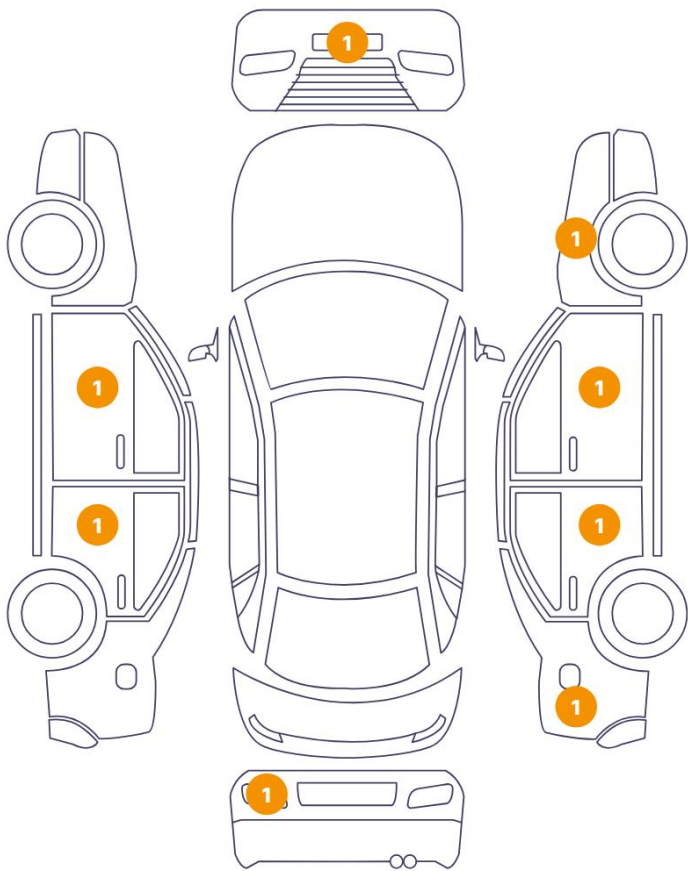
8 Schäden

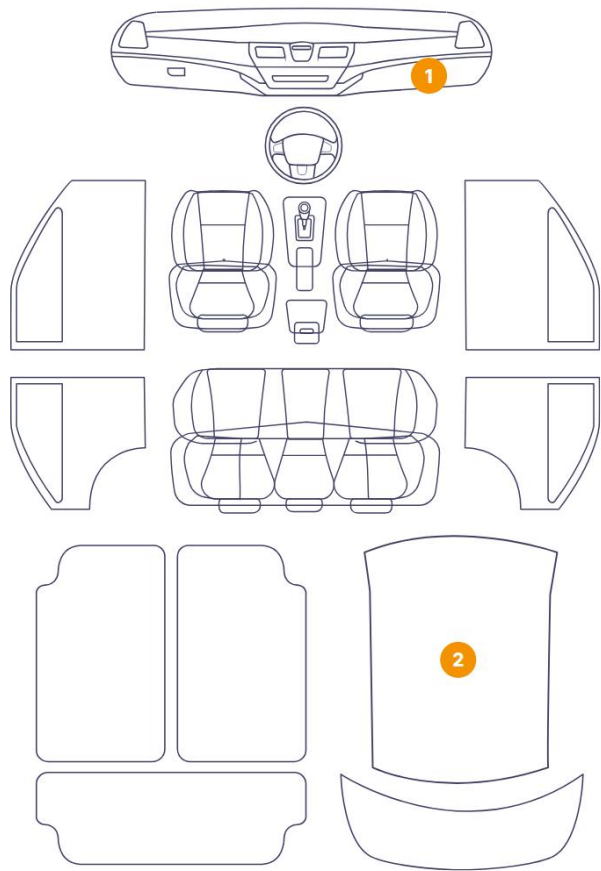
3 Schäden

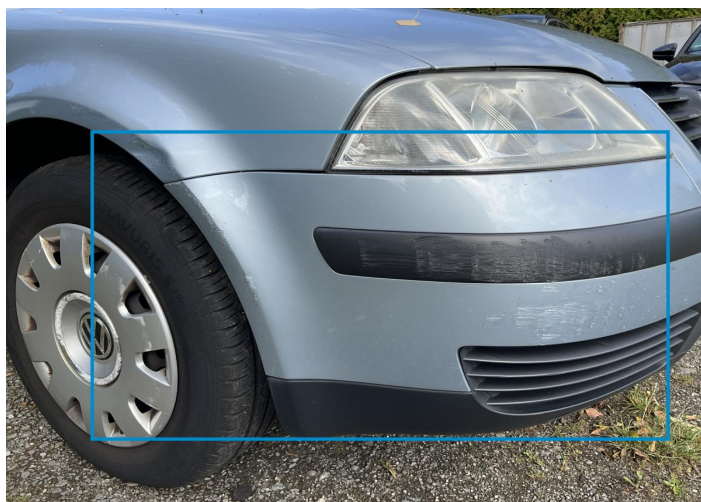
1. Bumper / Front
Bodywork / Dent / Dent -

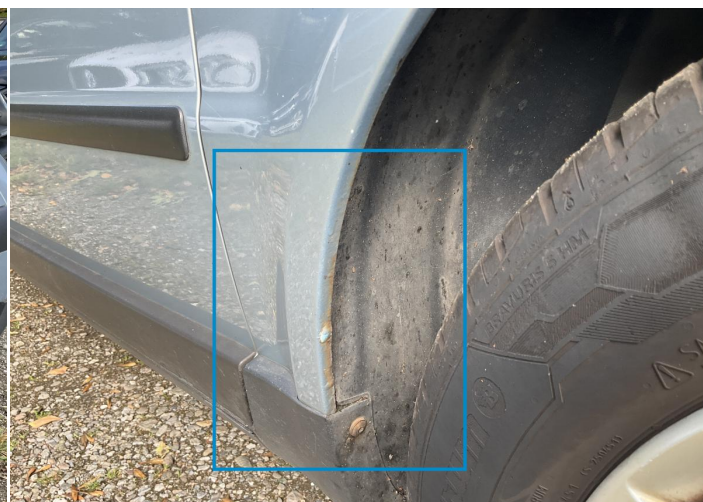
2. Fender / Front Right
Paint / Corrosion -

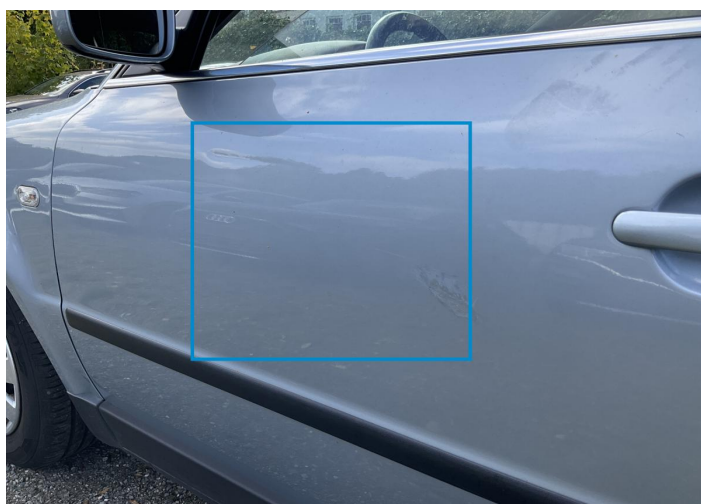
3. Door / Front Left
Bodywork / Dent / Dent -

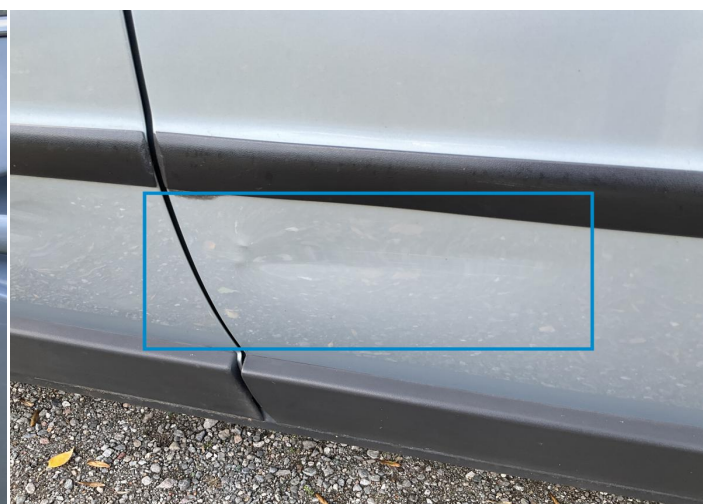
4. Door / Back Left
Bodywork / Dent / Dent -

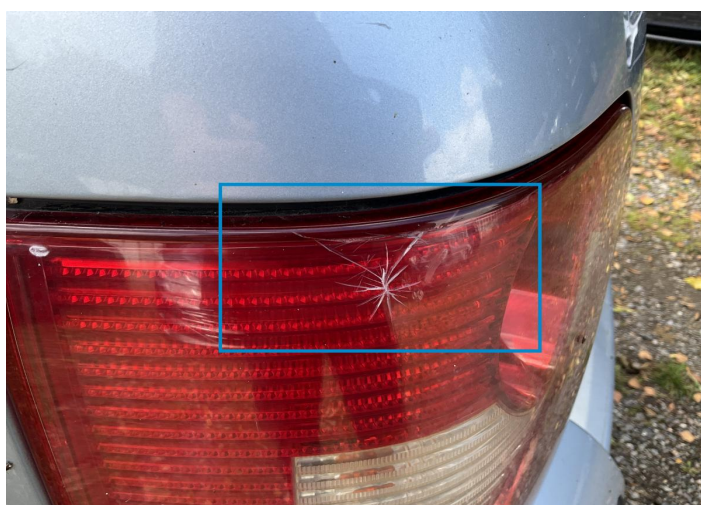
5. Back Light / Left
Glass Break -

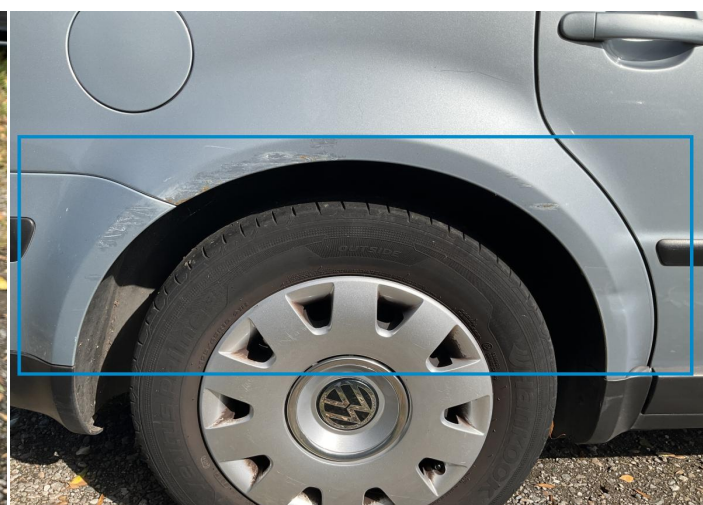
6. Fender / Back Right
Bodywork / Dent / Dent -

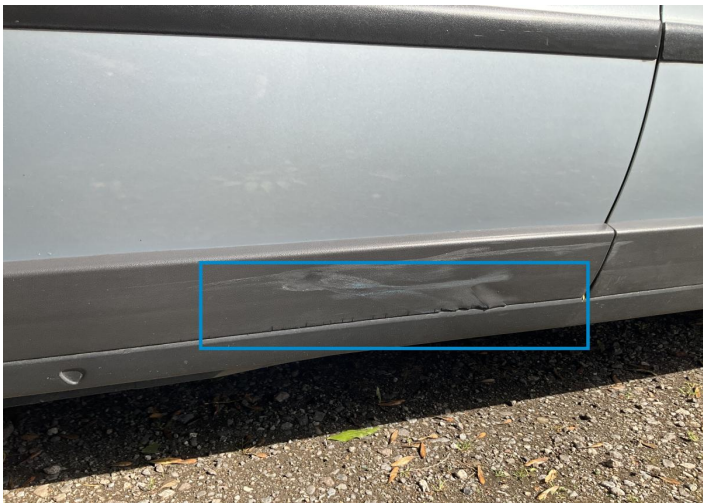
7. Door / Back Right
Bodywork / Breakage -

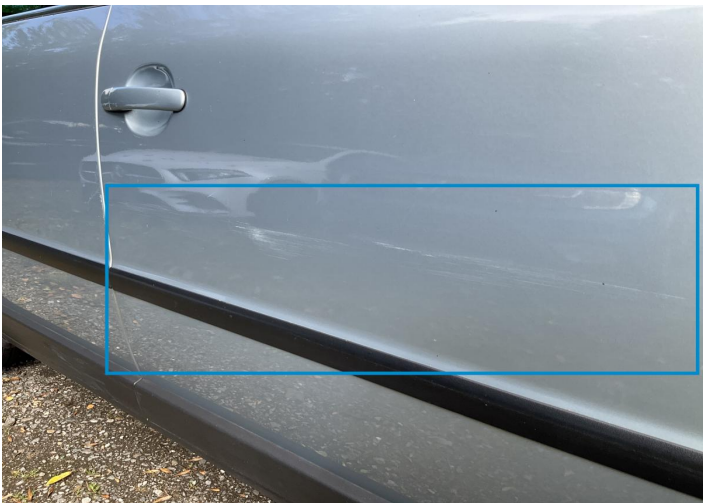
8. Door / Front Right
Paint / Scratch / Scuff -

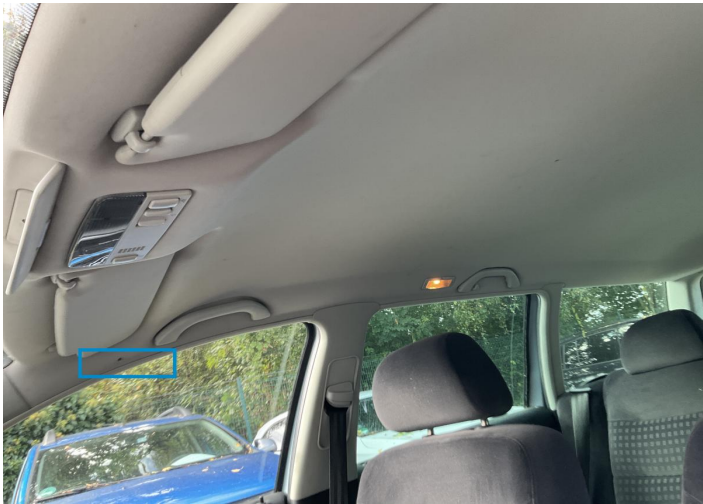
9. Roof Upholstery
Interior / Holed -

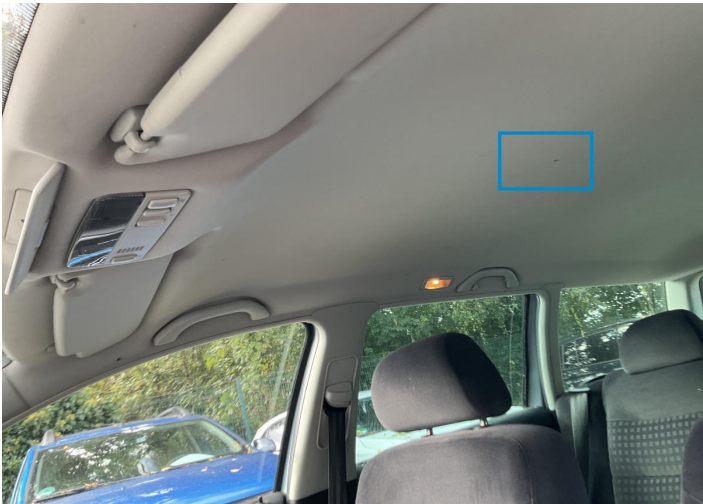
10. Roof Upholstery
Interior / Holed -

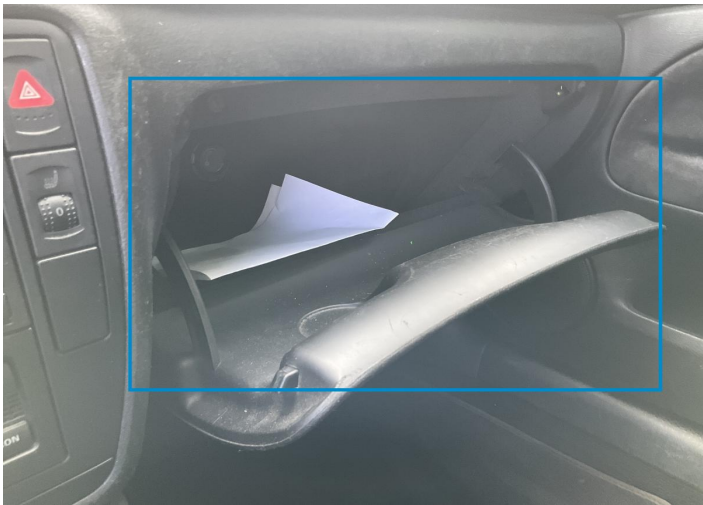
11. Glovebox
Interior / Broken -
