## VOLKSWAGEN Passat Passat Variant 1.6

VIN NO WVWZZZ3BZ3E464067 Registration Number BZ3E464067

### **Inspection Report Summary**

Customer	BCA Online	Report Number	P20250919121452
Inspection Date / Place	2025-09-19 / Extern	Cosmetic Grade	5

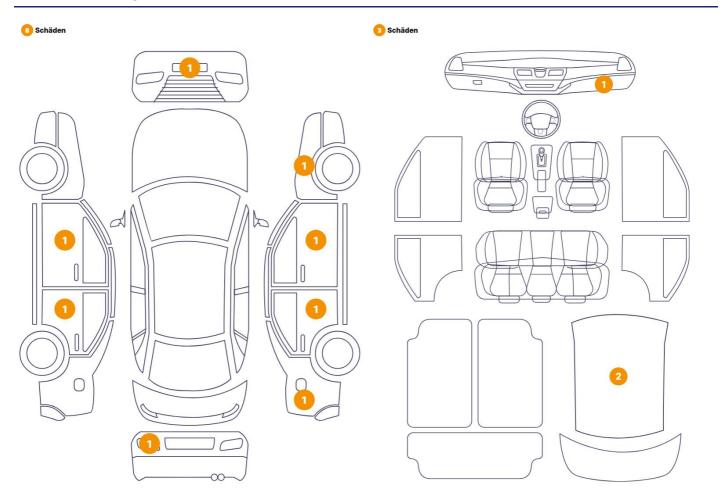
Component	Damage	Comments
1	Bumper / Front	Bodywork / Dent / Dent	
2	Fender / Front Right	Paint / Corrosion	
3	Door / Front Left	Bodywork / Dent / Dent	
4	Door / Back Left	Bodywork / Dent / Dent	
5	Back Light / Left	Glass Break	
6	Fender / Back Right	Bodywork / Dent / Dent	
7	Door / Back Right	Bodywork / Breakage	
8	Door / Front Right	Paint / Scratch / Scuff	
9	Roof Upholstery	Interior / Holed	
10	Roof Upholstery	Interior / Holed	
11	Glovebox	Interior / Broken

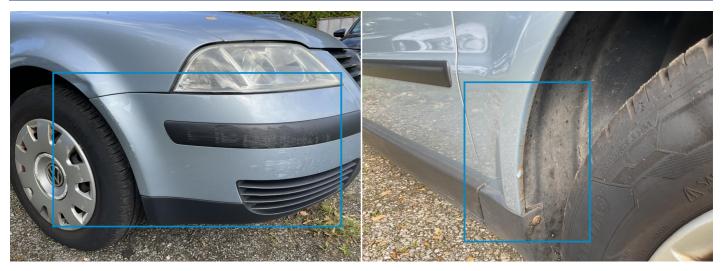
1. Bumper / Front Bodywork / Dent / Dent -

2. Fender / Front Right Paint / Corrosion -

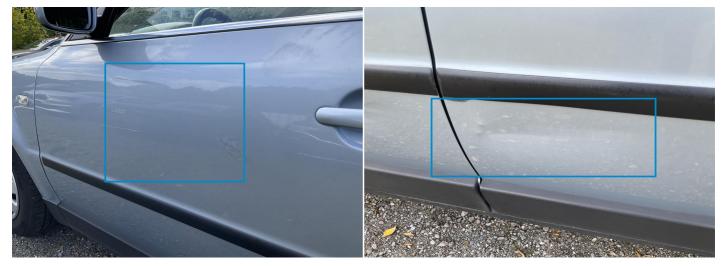
3. Door / Front Left Bodywork / Dent / Dent -

4. Door / Back Left Bodywork / Dent / Dent -

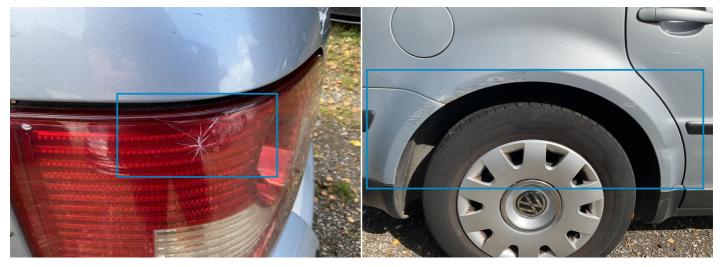
5. Back Light / Left Glass Break -

6. Fender / Back Right Bodywork / Dent / Dent -

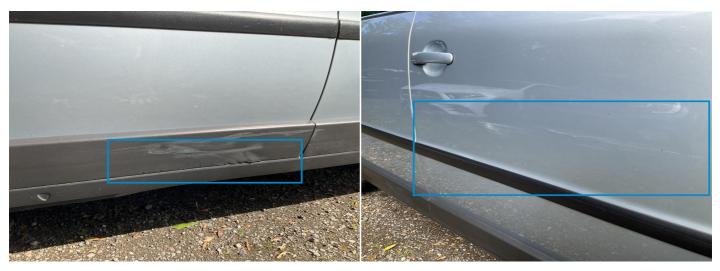
7. Door / Back Right Bodywork / Breakage -

8. Door / Front Right Paint / Scratch / Scuff -

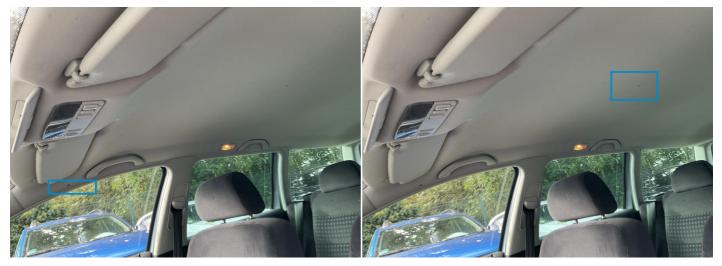
9. Roof Upholstery Interior / Holed -

10. Roof Upholstery Interior / Holed -

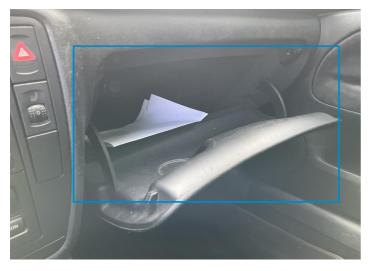
11. Glovebox Interior / Broken -
