# **Expertise**

Protocol number: 41819090
Order number / reference: 25282554
Inspection date: 2 Oct 2025

Manufacturer: Volkswagen

Model: Passat Variant 2.0 TDI SCR DSG Conceptline

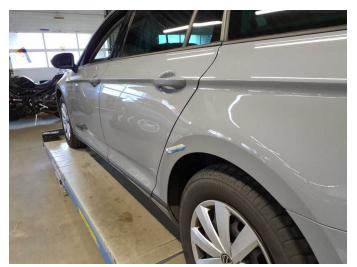
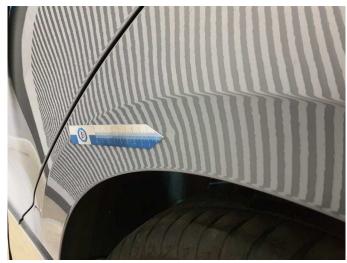
No.	Component group	Description
1	Side panel - rear left side	Side panel - dent(s) - Smooth repair work
2	Roof	Roof (Verätzung durch Vogelkot, Mehrkosten möglich) - Paint defect - Conditioning
3	Bonnet	Bonnet - Stone chips - Paint
4	Rear bumper	Rear bumper (+Delle) - Scratched - Repair and paint
5	Door - rear right side	Door - Dent / paintcoat damage - Repair and paint
6	Door - front right side	Door - Dent / paintcoat damage - Repair and paint
7	Vehicle glazing	Windscreen (Sandstrahleffekt) - Stone chips - repair according to calculation

**Damage 1:** Side panel - rear left side: Side panel - dent(s) - Smooth repair work

$\label{eq:def:Def} \textbf{Damage 1:} \ \mbox{Side panel - rear left side: Side panel - dent(s) - Smooth} \\ \ \ \mbox{repair work}$

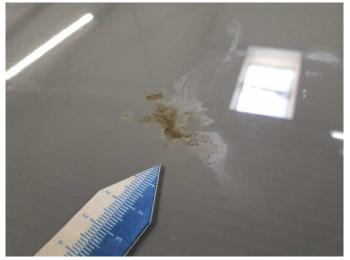
**Damage 2:** Roof: Roof (Verätzung durch Vogelkot, Mehrkosten möglich) - Paint defect - Conditioning

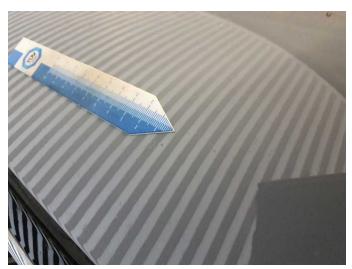
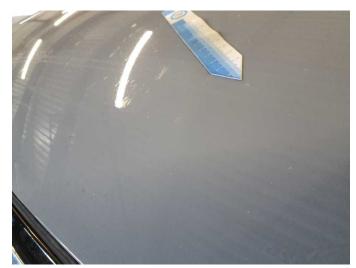
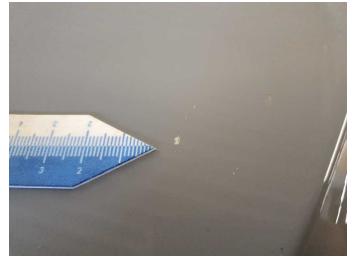
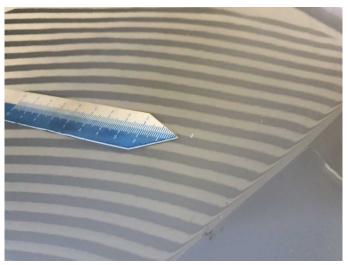
Damage 3: Bonnet: Bonnet - Stone chips - Paint

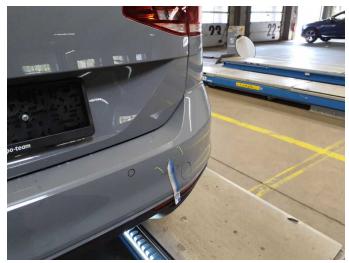
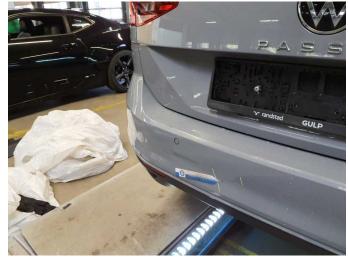
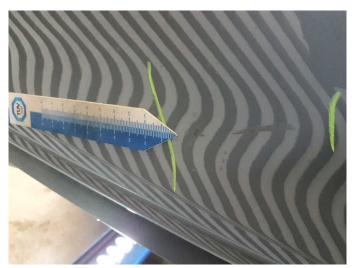
Damage 4: Rear bumper: Rear bumper (+Delle) - Scratched - Repair and Damage 4: Rear bumper: Rear bumper (+Delle) - Scratched - Repair and paint

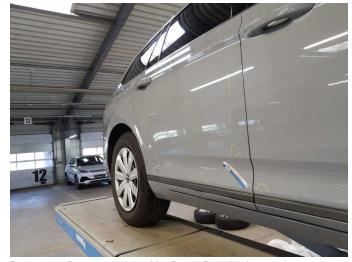
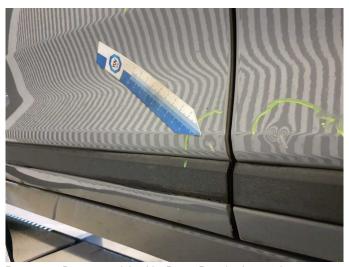
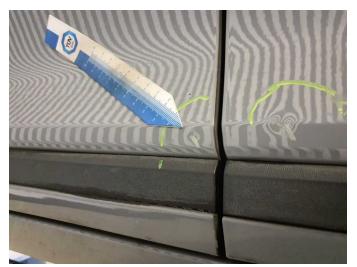
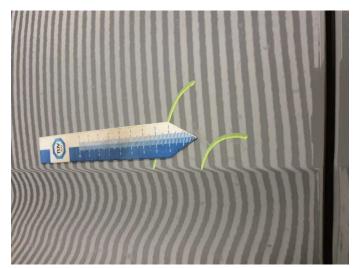
**Damage 5:** Door - rear right side: Door - Dent / paintcoat damage - Repair and paint

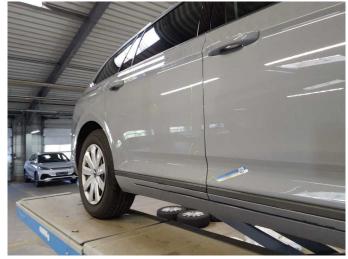
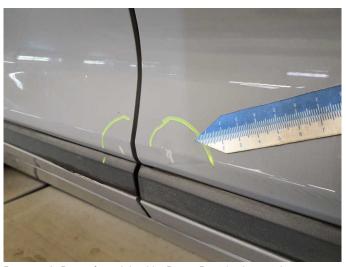
**Damage 6:** Door - front right side: Door - Dent / paintcoat damage - Repair and paint

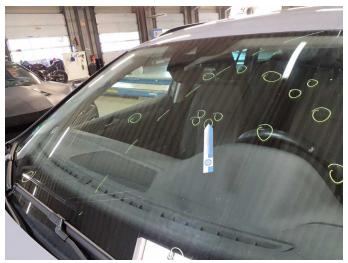
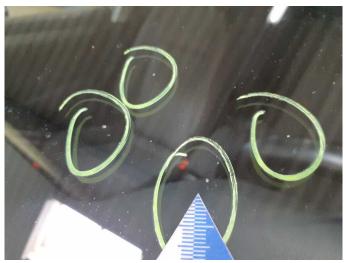
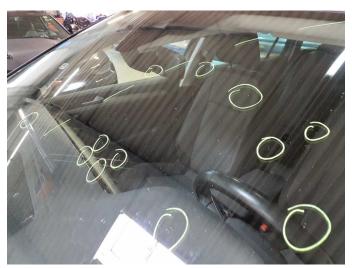
Damage 7: Vehicle glazing: Windscreen (Sandstrahleffekt) - Stone chips - repair according to calculation

**Damage 7:** Vehicle glazing: Windscreen (Sandstrahleffekt) - Stone chips - repair according to calculation

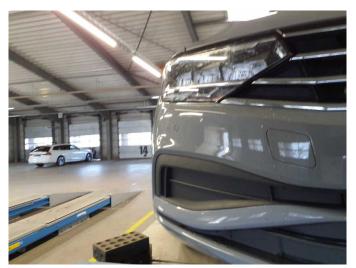
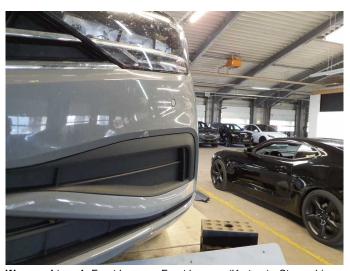
Wear and tear 1: Front bumper: Front bumper (Kratzer) - Stone chips - No deduction

**Wear and tear 1:** Front bumper: Front bumper (Kratzer) - Stone chips - No deduction

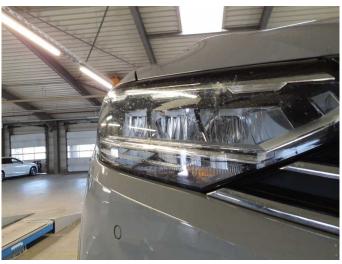
Wear and tear 2: Headlight: Headlight - right side - Stone chips - No deduction

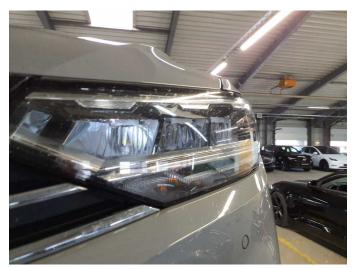
Wear and tear 3: Headlight: Headlight - left side - Stone chips - No deduction
