VOLKSWAGEN Passat Passat Variant 2.0 TDI DPF

Inspection Report Summary

| Customer | BCA Online | Report Number | P20250523093014 |
| Inspection Date / Place | 2025-05-23 / BCA Heidenheim | Cosmetic Grade | 4 |

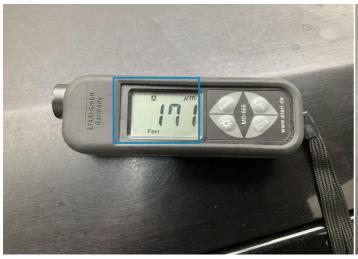
1. Fender / Front Left Paint / Poor Previous Repair -

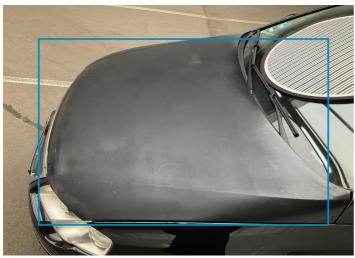
2. Hood Paint / Poor Previous Repair -

3. Hood Paint / Poor Previous Repair -

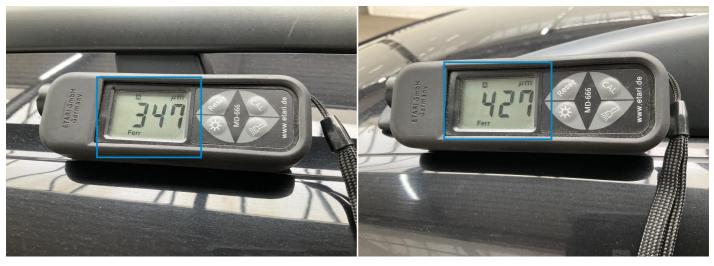
7. Door / Back Left Paint / Poor Previous Repair -

8. Door / Front Left Paint / Poor Previous Repair -

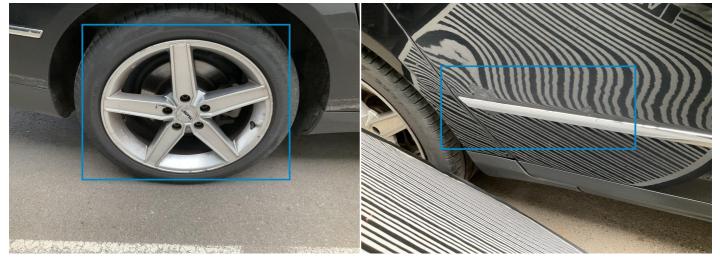
9. Rim / Back Right Out of Bodywork / Scratch -

10. Door / Back Right Paint / Corrosion -

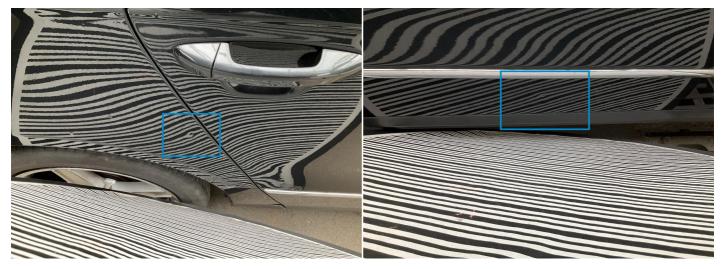
11. Side Panel / Back Right Bodywork / Dent / Dent -

12. Door / Front Right Bodywork / Dent / Dent -

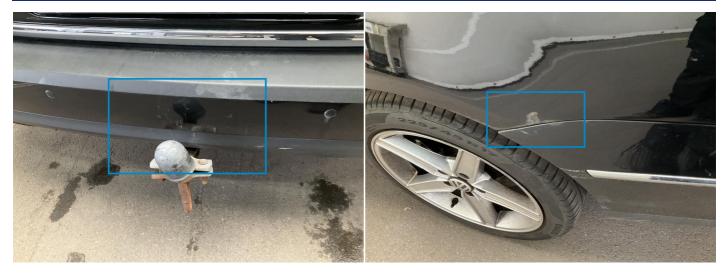
| 14 | Side Panel / Back Left | Paint / Corrosion |

13. Bumper / Back Paint / Scratch / Scuff -

14. Side Panel / Back Left Paint / Corrosion -

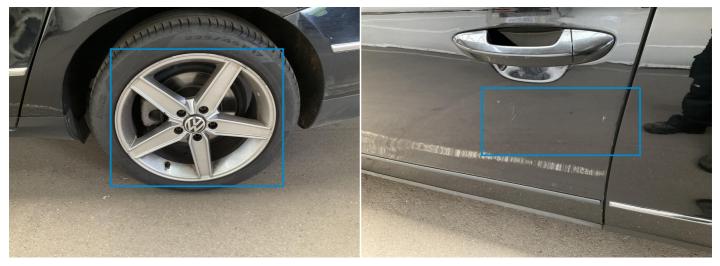
| 14 | Side Panel / Back Left | Paint / Corrosion |
|---|---|---|
| 15 | Rim / Back Left | Out of Bodywork / Scratch |
| 16 | Door / Front Left | Paint / Scratch / Scuff |

15. Rim / Back Left Out of Bodywork / Scratch -

16. Door / Front Left Paint / Scratch / Scuff -

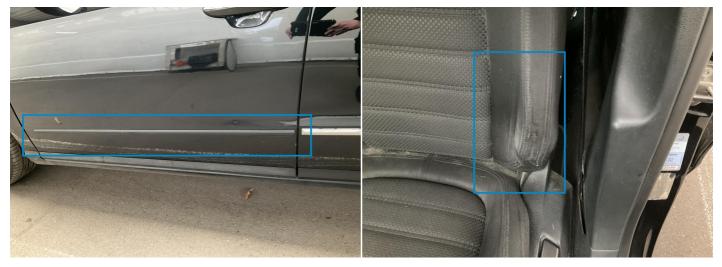
| 14 | Side Panel / Back Left | Paint / Corrosion |
|---|---|---|
| 17 | Door Side Molding / Front Left | Bodywork / Poor Previous Repair |
| 18 | Seat / Front Left | Interior / Holed |

17. Door Side Molding / Front Left Bodywork / Poor Previous Repair -

18. Seat / Front Left Interior / Holed -

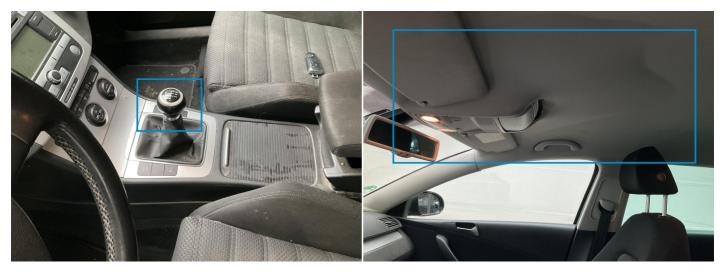
| 14 | Side Panel / Back Left | Paint / Corrosion |
|---|---|---|
| 19 | Gear Knob | Interior / Scratched |
| 20 | Roof Upholstery | Interior / Distorted |

19. Gear Knob Interior / Scratched -

20. Roof Upholstery Interior / Distorted -

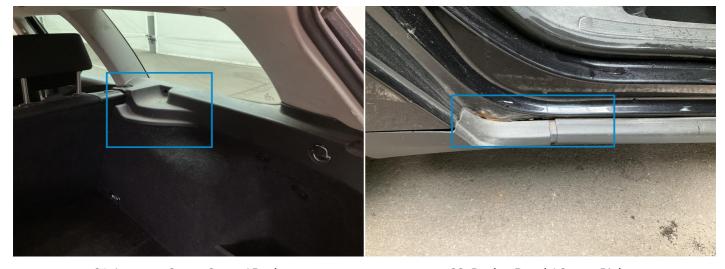
| 14 | Side Panel / Back Left | Paint / Corrosion |
|---|---|---|
| 21 | Luggage Space Cover / Back | Interior / Missing |
| 22 | Rocker Panel / Center Right | Paint / Corrosion |

21. Luggage Space Cover / Back Interior / Missing -

22. Rocker Panel / Center Right Paint / Corrosion -
