Hüsges Gruppe®  
Die Gutachter

## status report

#### Volkswagen Passat Variant Highline BMT/Start-Stopp 4Motion

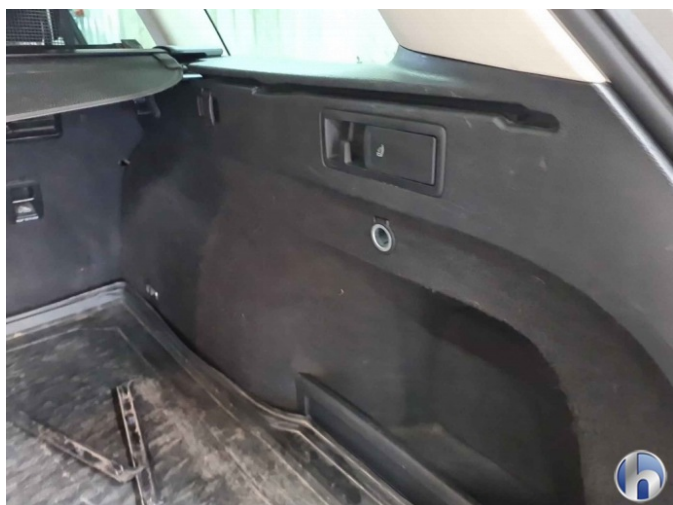
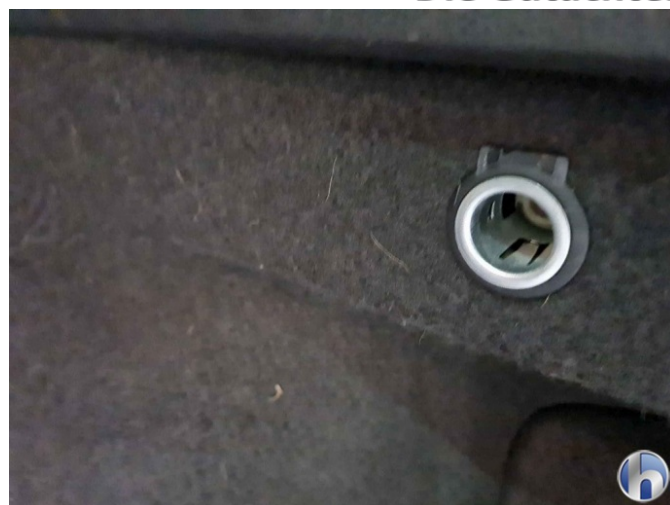
| component | Damage | Rep kind |
|---|---|---|
| 1. Zigarettenanzünder (Kofferraum): Klappe | Missing | Replace |

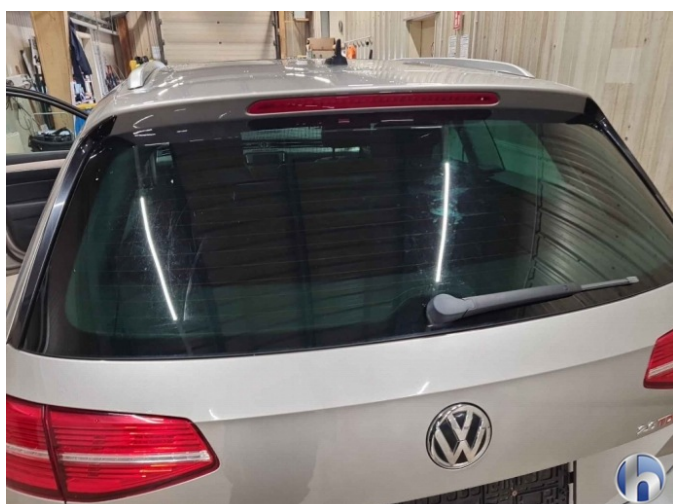
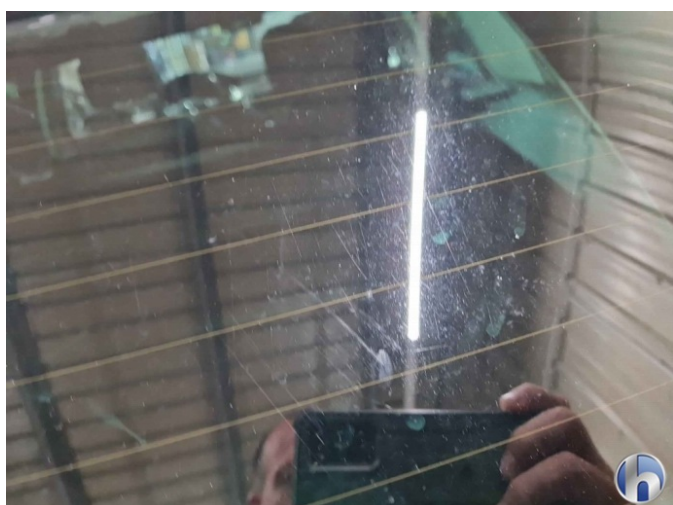
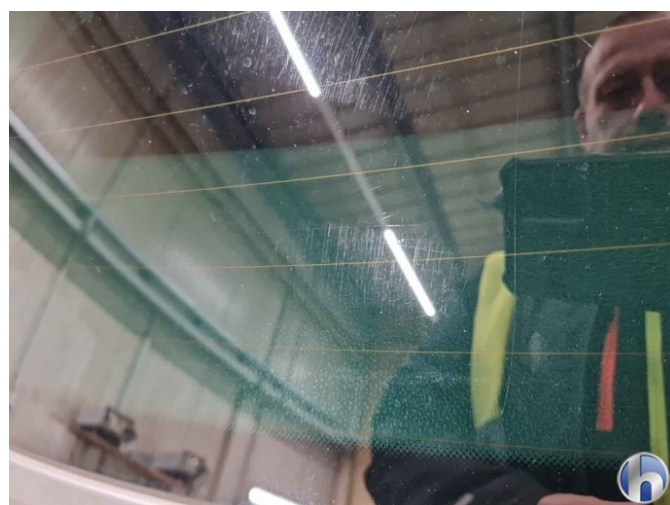
| component | Damage | Rep kind |
|---|---|---|
| 2. rear window | Scratch(es) | Replace |

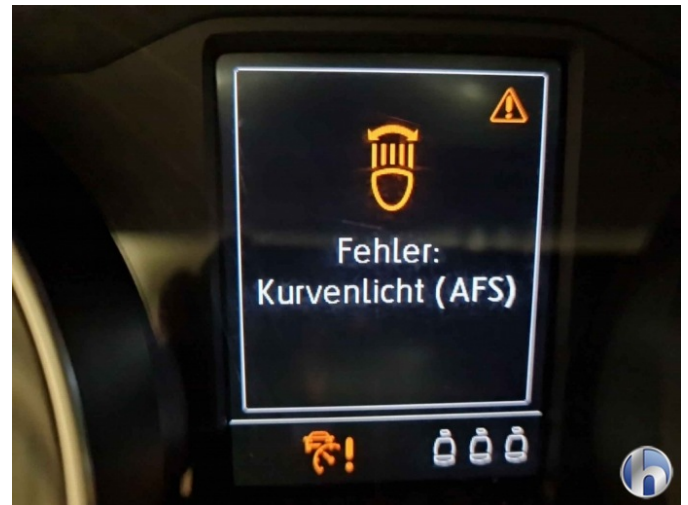
| component | Damage | Rep kind |
|---|---|---|
| 4. Kurvenlicht | Error message | Carry out a fault diagnosis |

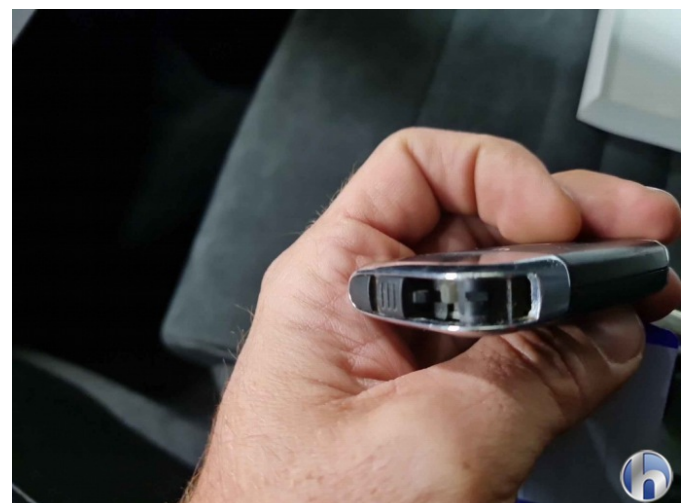
| component | Damage | Rep kind |
|---|---|---|
| 7. 1× Notschlüssel | Missing | Replace |

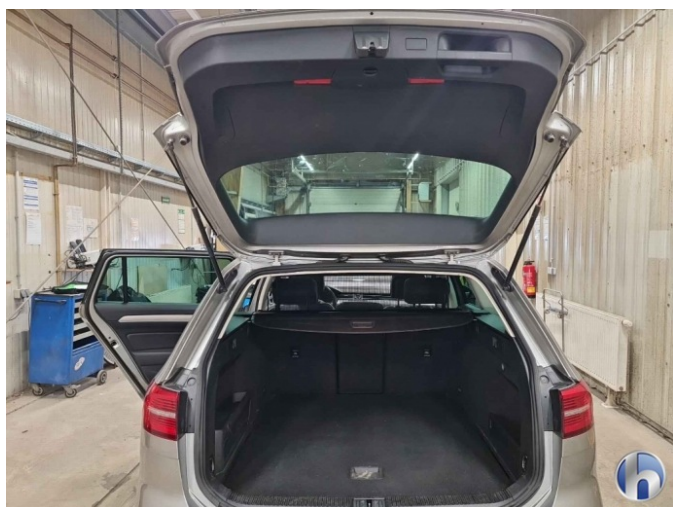
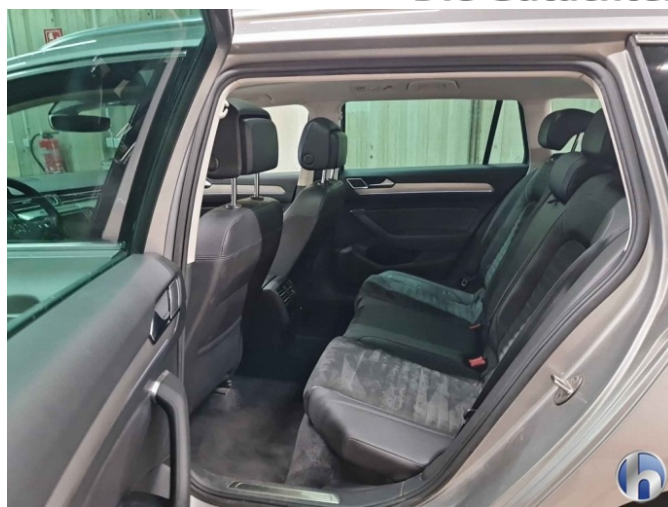
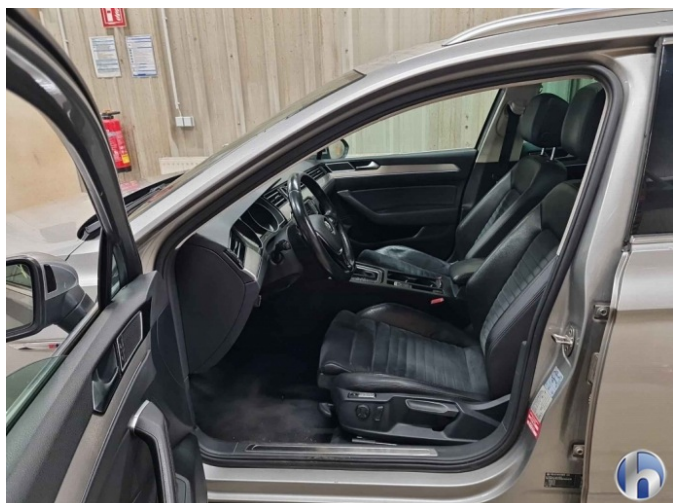
| component | Damage | Rep kind |
|---|---|---|
| 8. Kofferraum und Innenraum | Wear and tear | acceptable |

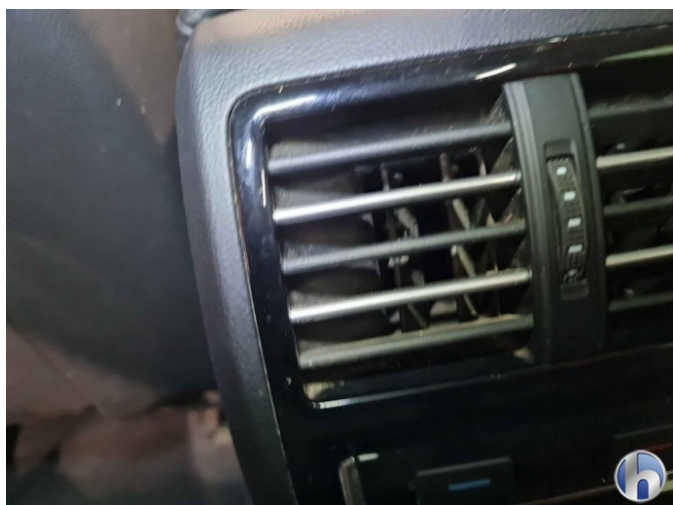
| component | Damage | Rep kind |
|---|---|---|
| 9. Luftausströmer hinten | Damaged | Replace |

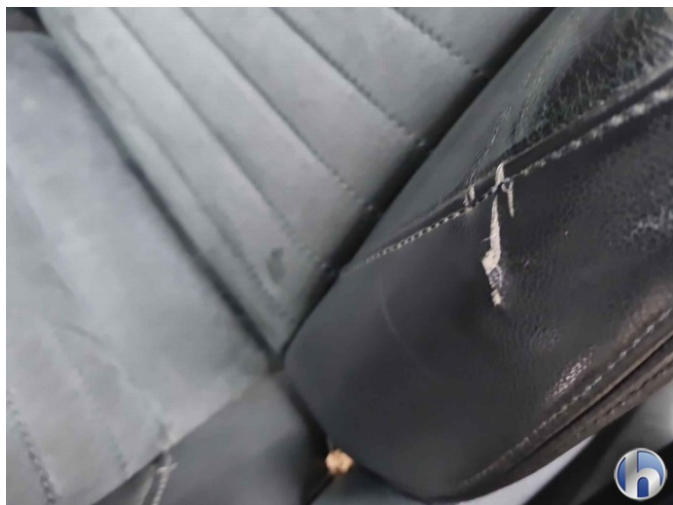
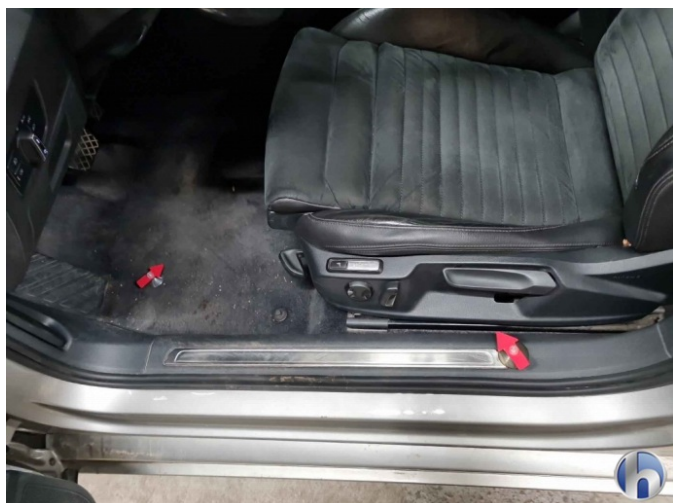
| component | Damage | Rep kind |
|---|---|---|
| 11. Sitz - Vorne - Links | Damaged | Replace |

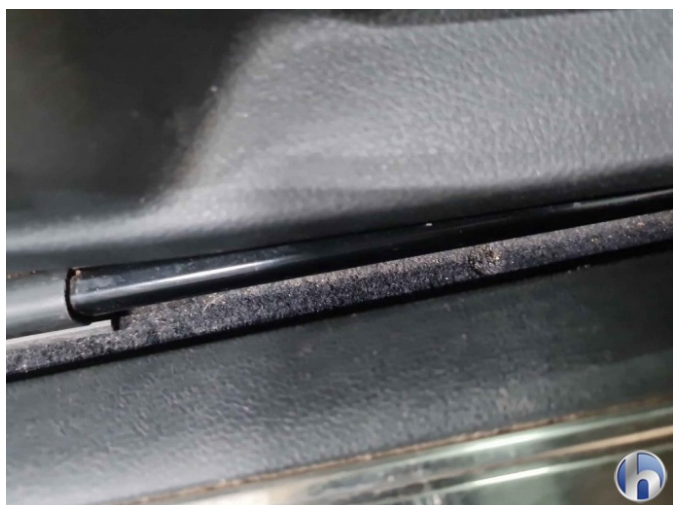
| component | Damage | Rep kind |
|---|---|---|
| 12. flooring | Burn hole | Smart repair |

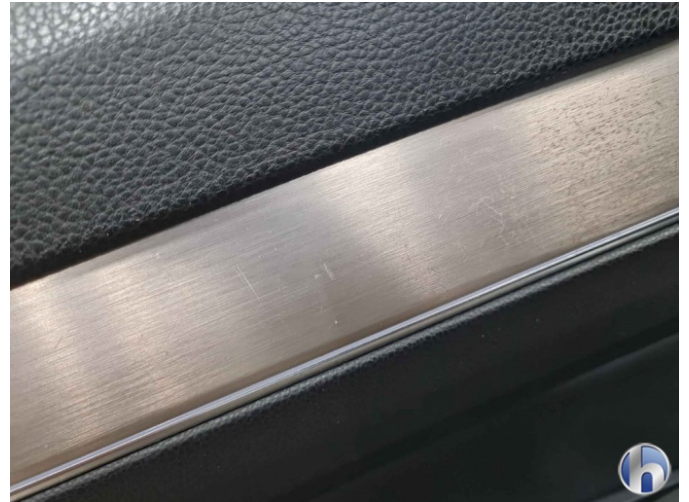
| component | Damage | Rep kind |
|---|---|---|
| 13. Türverkleidung Vorne - Links: Zierleiste | Scratch(es) | Replace |

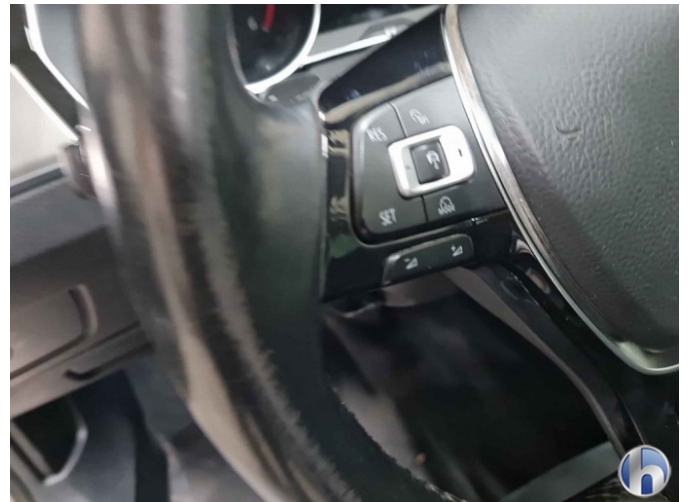
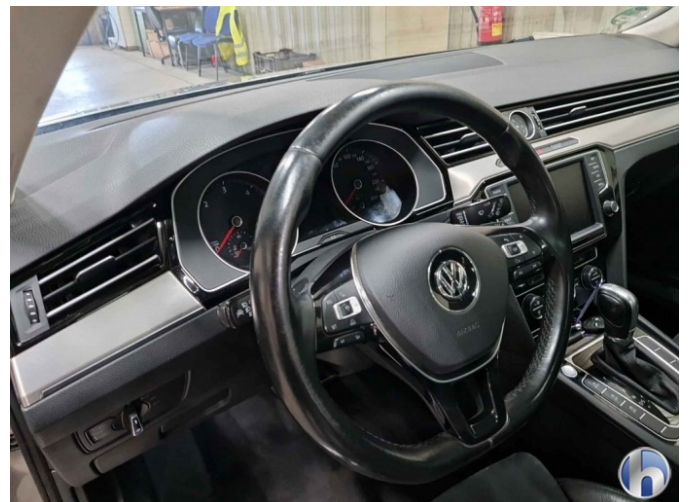
| component | Damage | Rep kind |
|---|---|---|
| 14. Lenkradtasten | No functionality | Carry out a fault diagnosis |

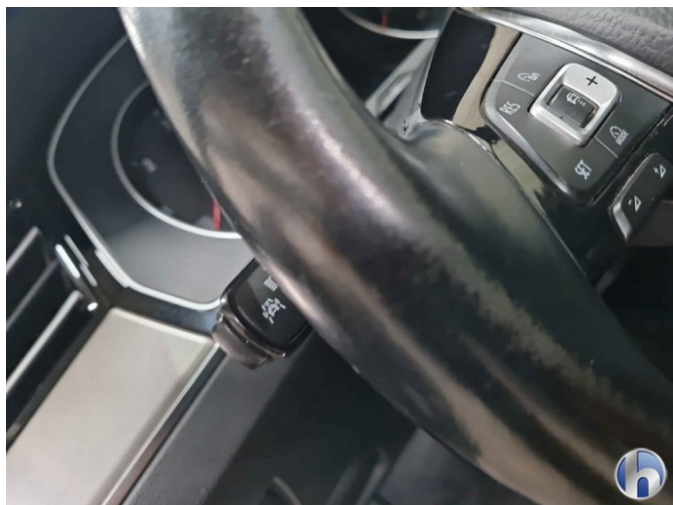
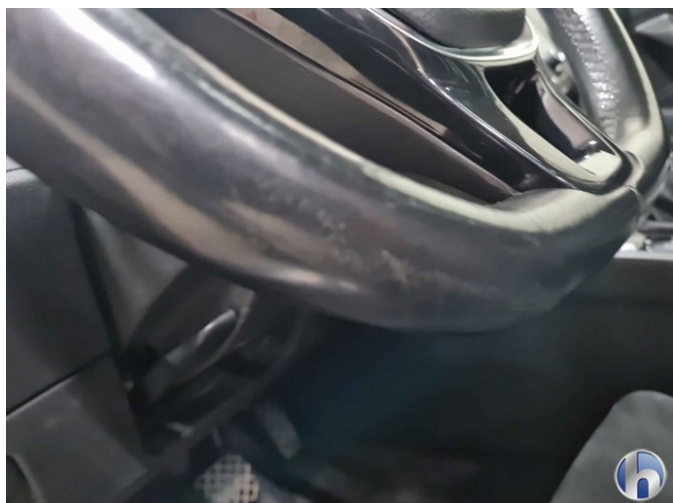
| component | Damage | Rep kind |
|---|---|---|
| 15. Lenkrad | Material wear | Replace |

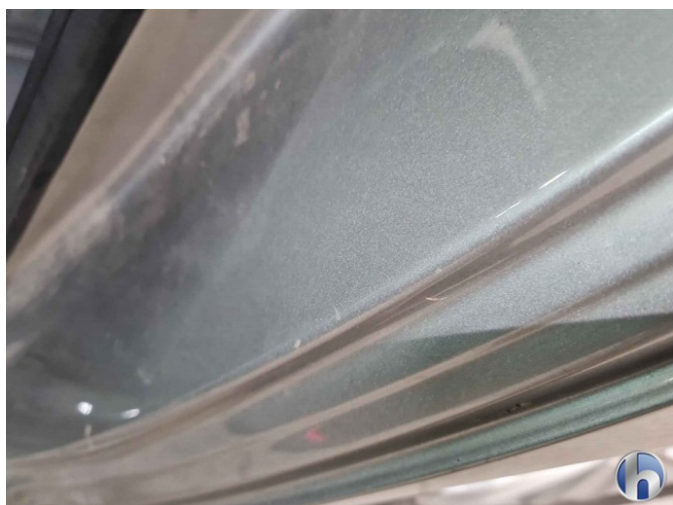
| component | Damage | Rep kind |
|---|---|---|
| 16. Türeinstieg Hinten - Links | Scrape | Smart repair |

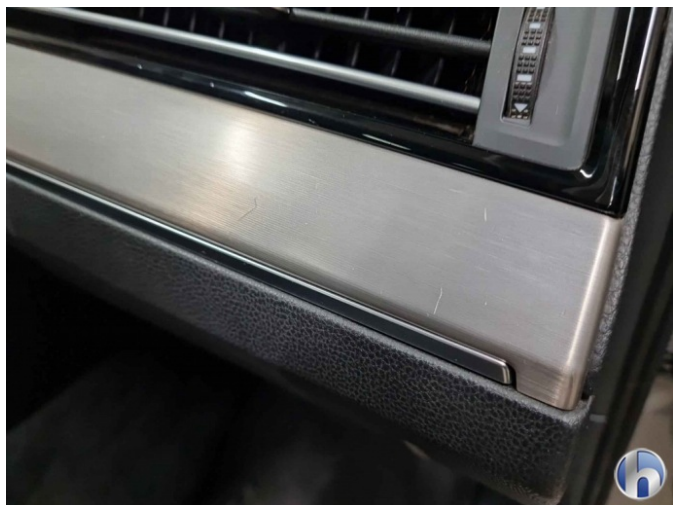
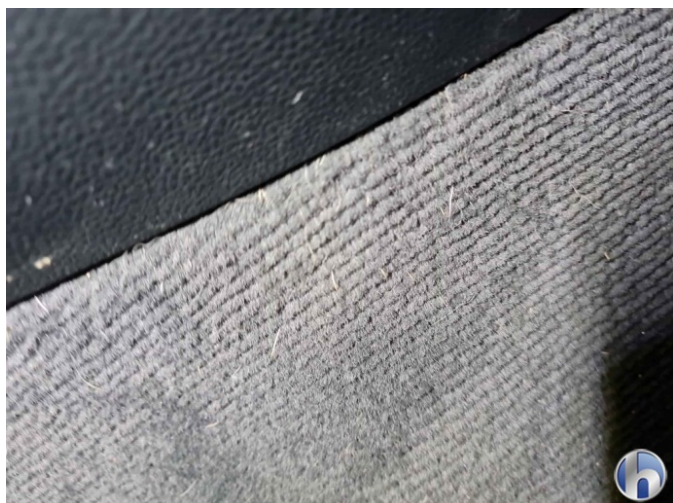
17. Armaturenbrett:Zierleiste

| component | Damage | Rep kind |
|---|---|---|
| 17. Armaturen Brett: Zierleiste | Scratch(es) | Replace |

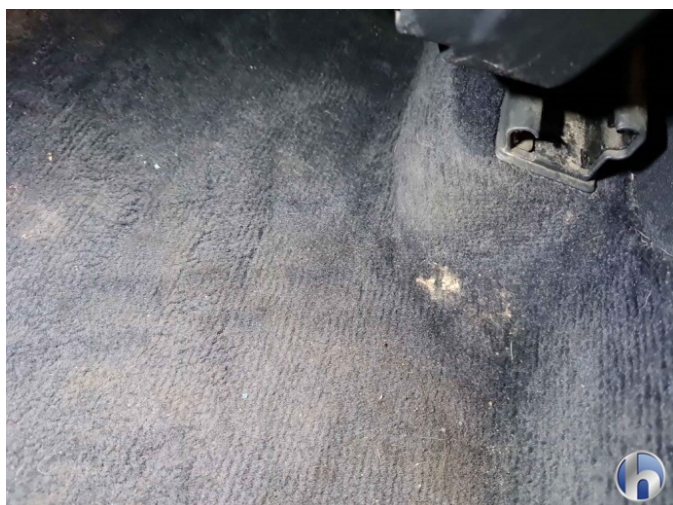
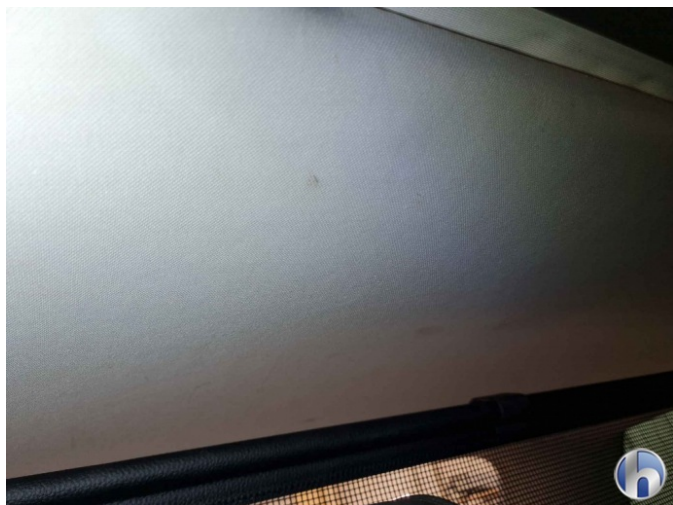
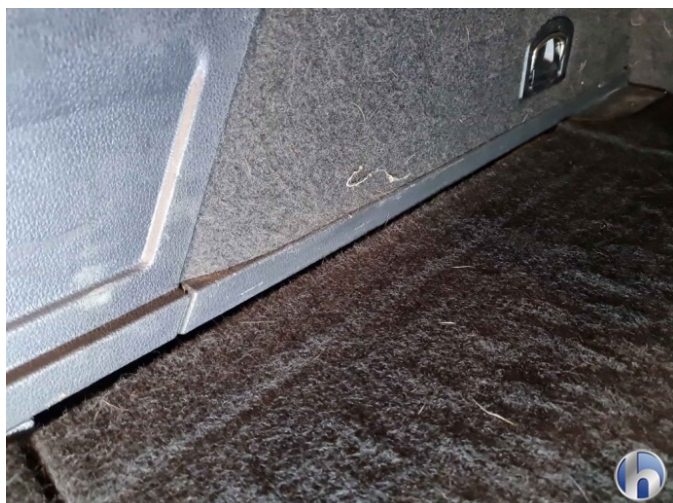
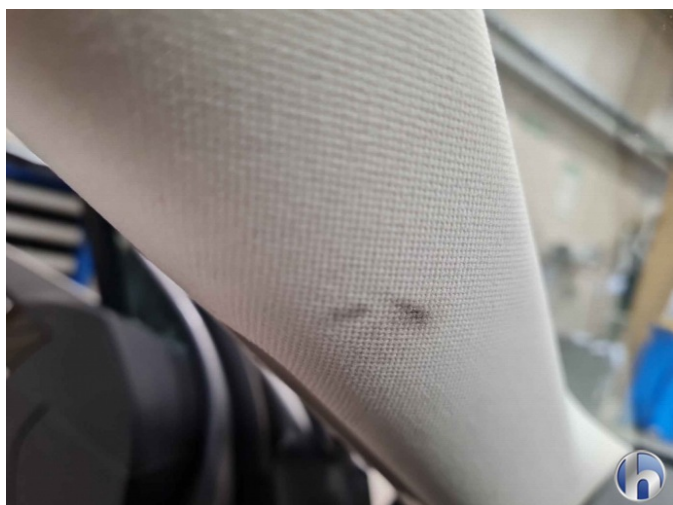
| component | Damage | Rep kind |
|---|---|---|
| 18. | Dirty (animal hair) | |

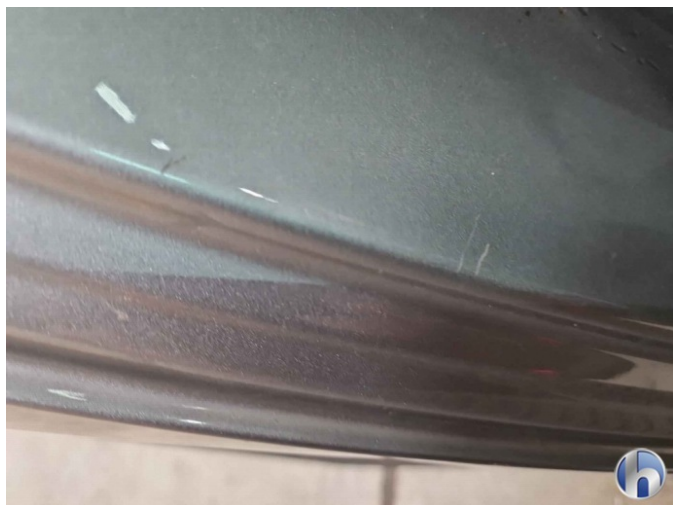
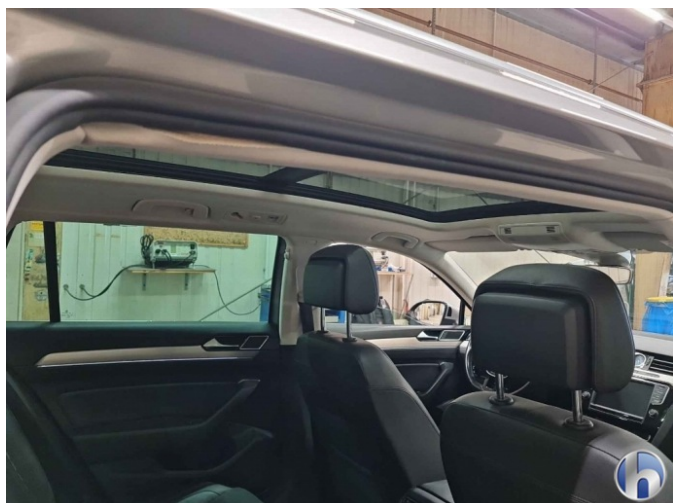
| component | Damage | Rep kind |
|---|---|---|
| 19. Türeinstieg Hinten - Rechts | Scratch(es) | Paint |

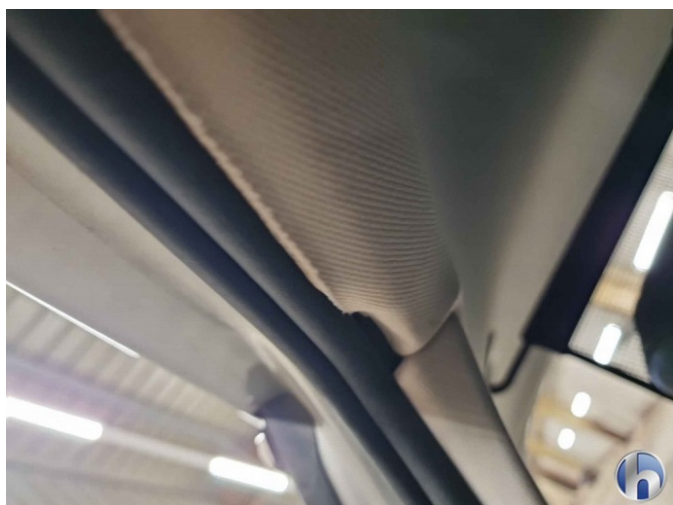
| component | Damage | Rep kind |
|---|---|---|
| 20. Dachhimmel | Clearance not exact | Uninstall/install |

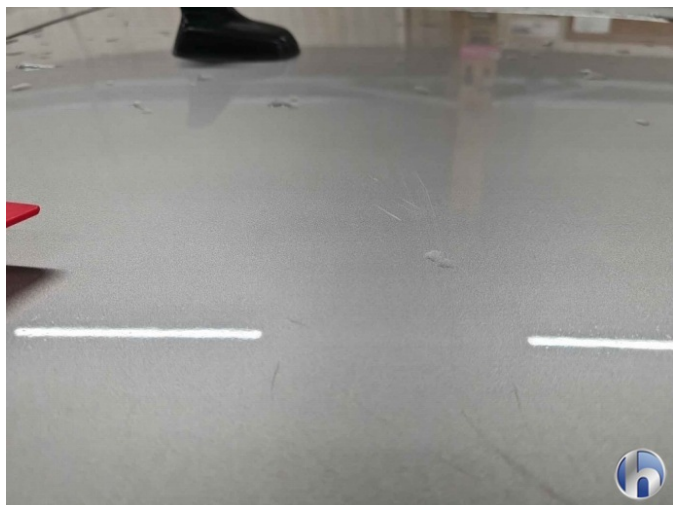
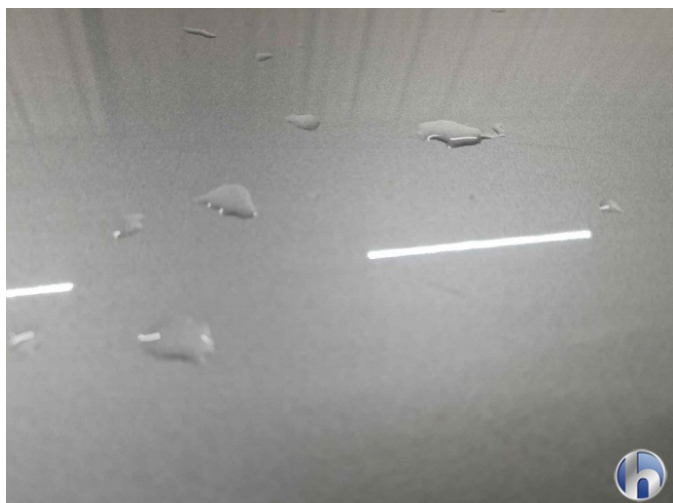
| component | Damage | Rep kind |
|---|---|---|
| 21. roof | Scratch(es) | Paint |

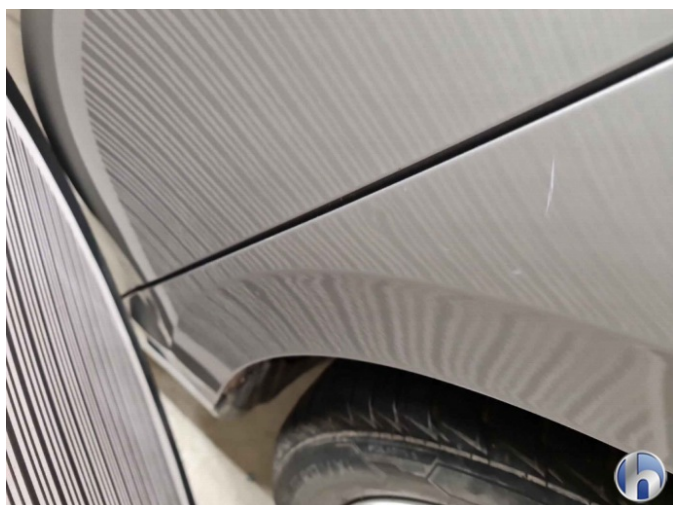
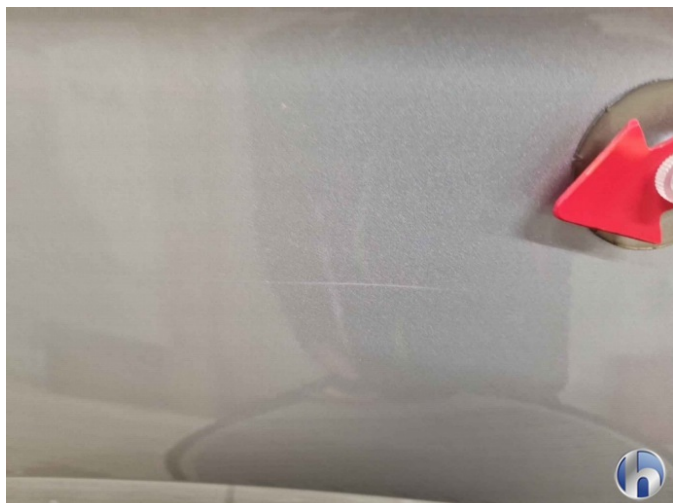
| component | Damage | Rep kind |
|---|---|---|
| 22. Sidewall - Rear - Left | Damaged | Refurbish and paint |

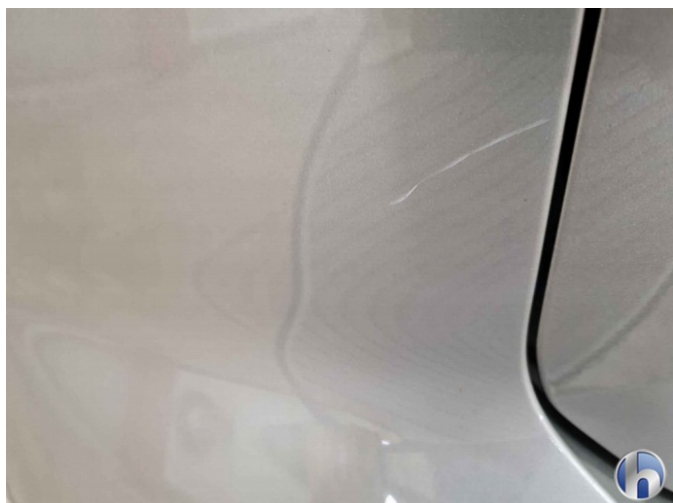
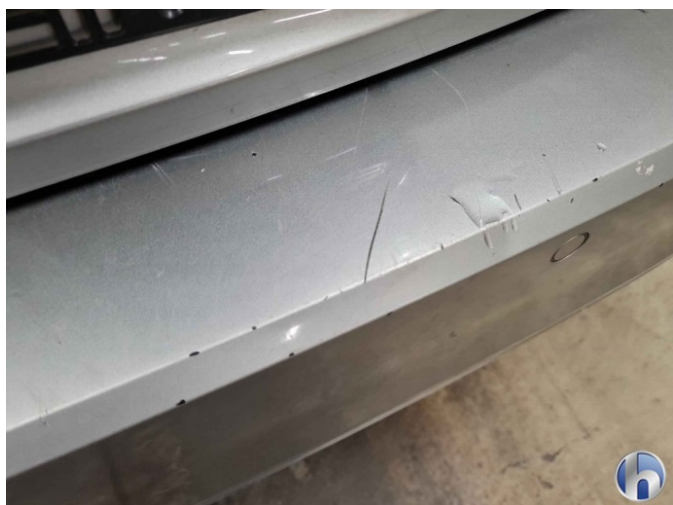
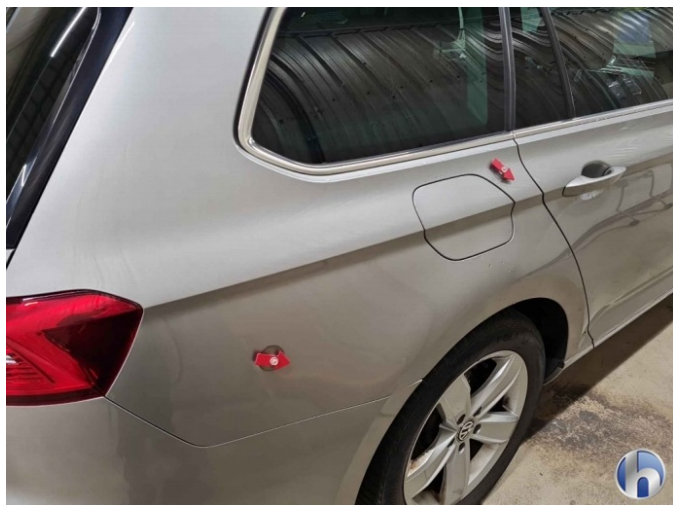
| component | Damage | Rep kind |
|---|---|---|
| 23. Rear bumper | Scrape | Paint |

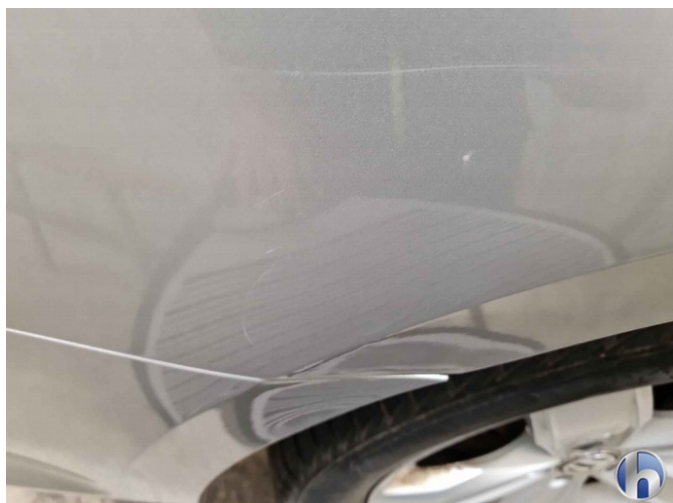
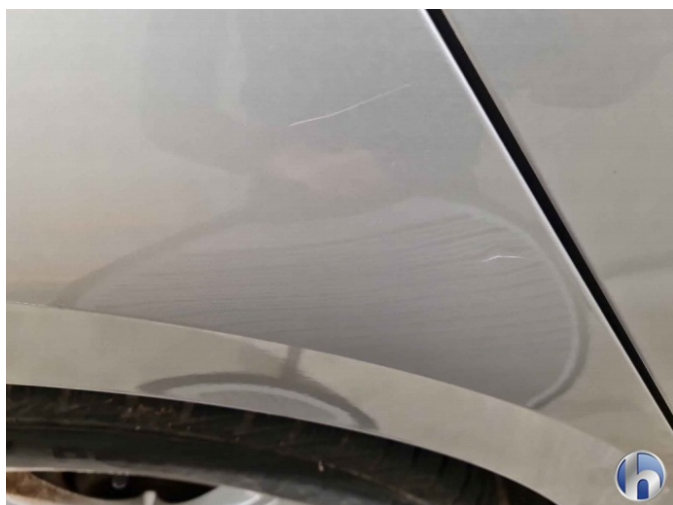
| component | Damage | Rep kind |
|---|---|---|
| 24. Sidewall - Rear - right | Damaged | Refurbish and paint |

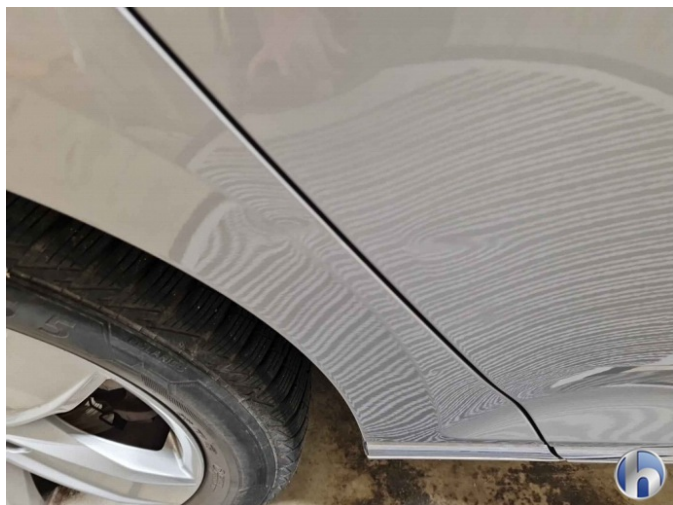
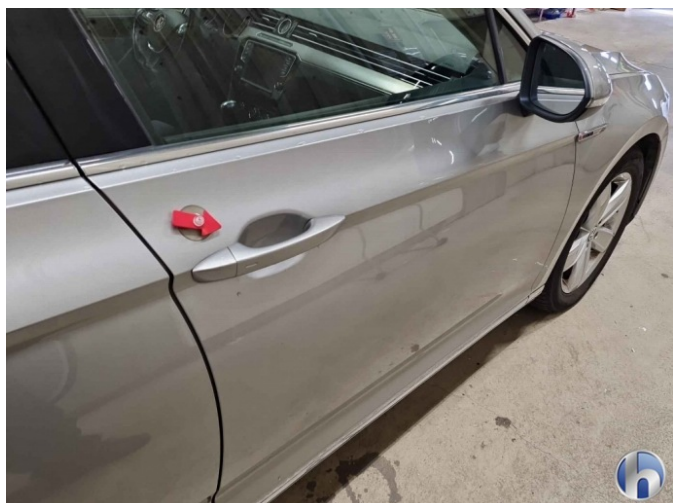
| component | Damage | Rep kind |
|---|---|---|
| 25. Door Rear - right | Damaged | Refurbish and paint |

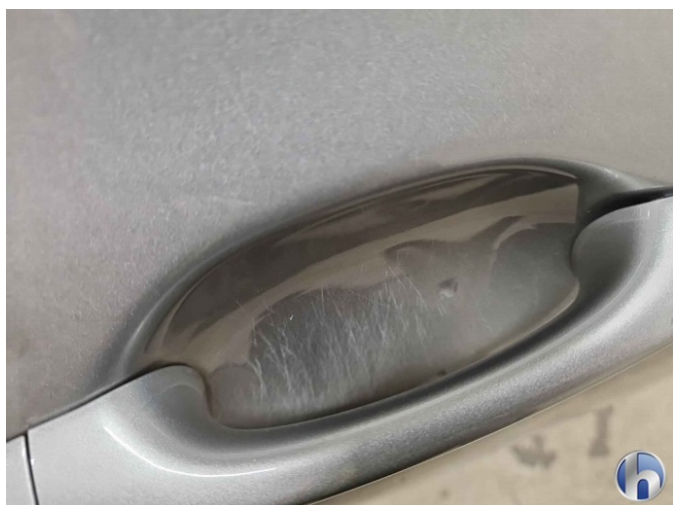
| component | Damage | Rep kind |
|---|---|---|
| 26. Front door - right | Scratch(es) | Smart repair |

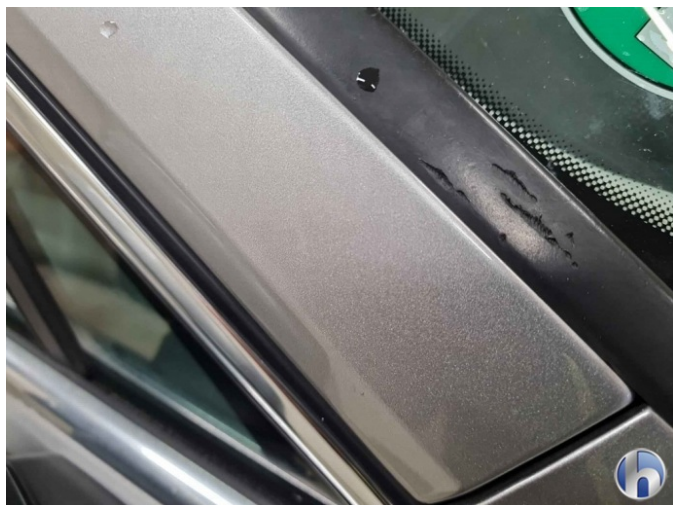
| component | Damage | Rep kind |
|---|---|---|
| 27. Frontscheibenleiste rechts | Damaged | Replace |

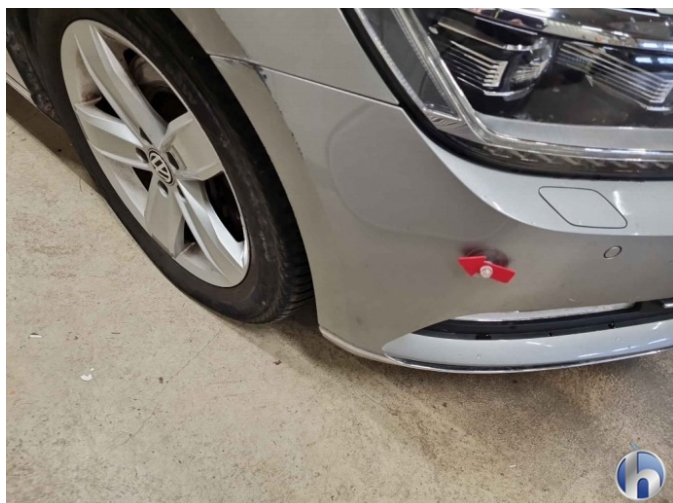
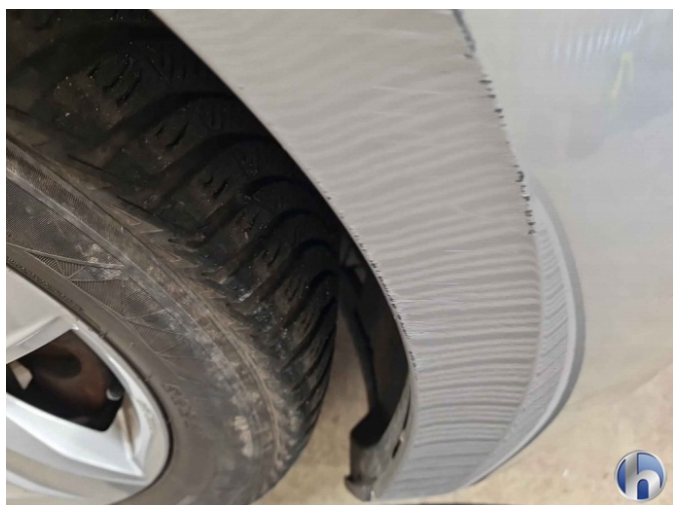
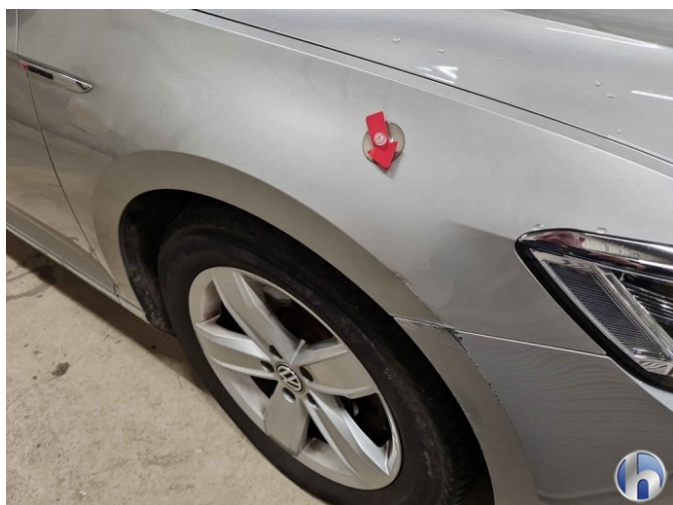
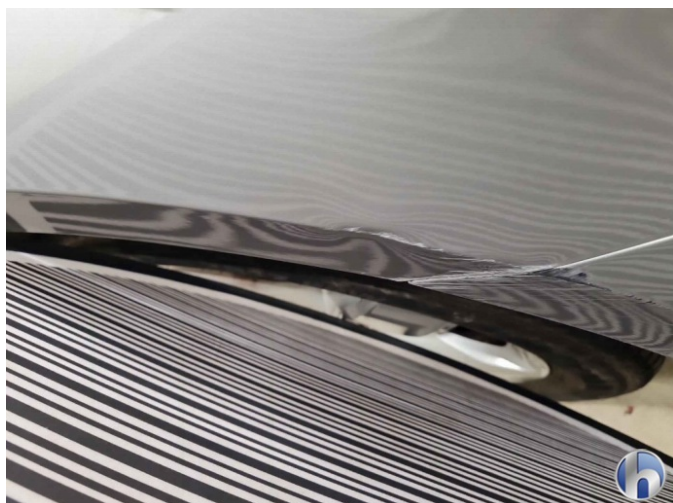
| Accident injury assessment | |
|---|---|
| <b>Existing collision damage:</b> | <p><b>found</b></p> <p>At the unrepaired vehicle accident damage were observed on visual examination on the body skin .</p> |
| <b>reference:</b> | <p>Die Lackschichtdicke ist ringsum erhöht. Fahrzeug mit bestehenden Unfallschaden, zur Schadensermittlung wurden keine Demontagearbeiten durchgeführt, verborgen gebliebene Schäden können nicht ausgeschlossen werden. Unfallschaden Kosten wurden überschlägig Kalkuliert, Kostenerweiterung möglich.</p> |

| component | Damage | Rep kind |
|---|---|---|
| 28. Fahrzeug vorn | Accident damage | Refurbish and paint |

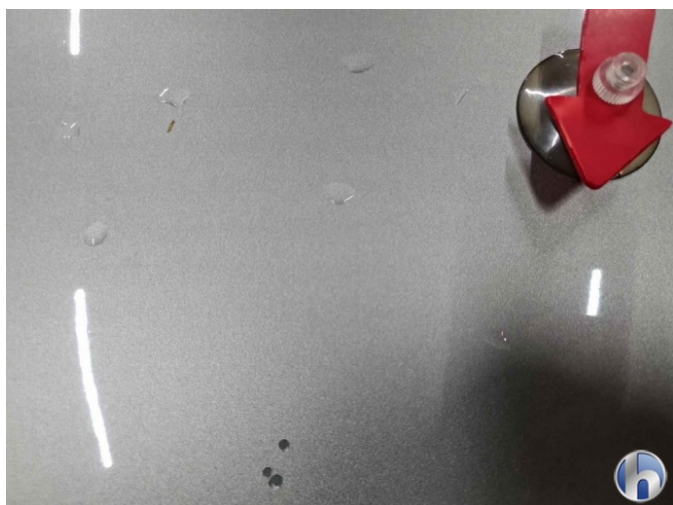
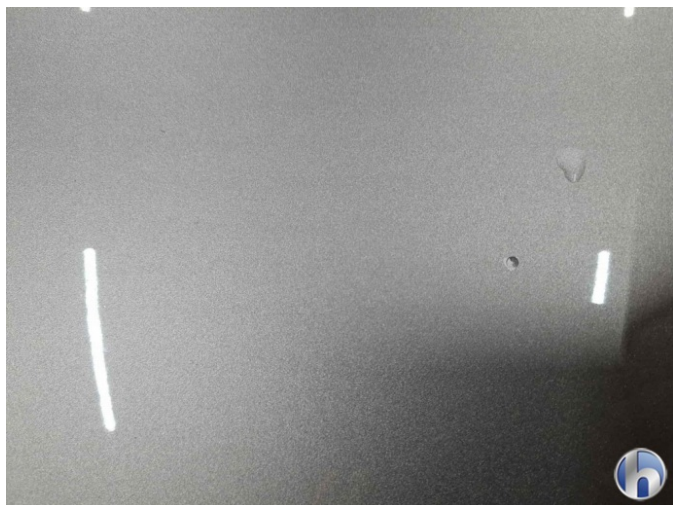
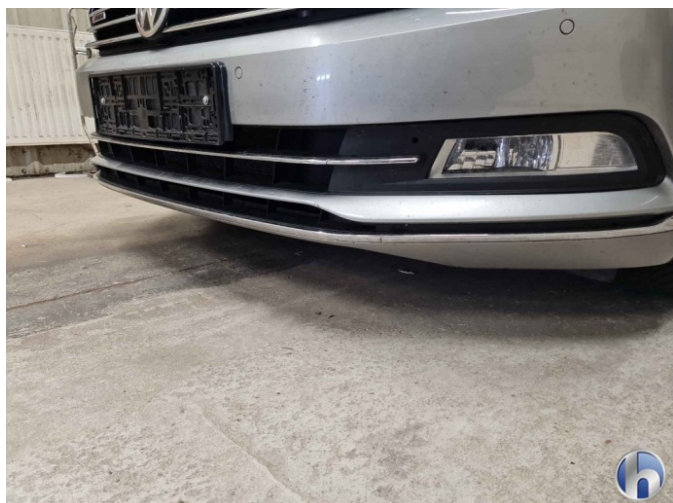
| component | Damage | Rep kind |
|---|---|---|
| 29. hood | Scratch(es) | Paint |

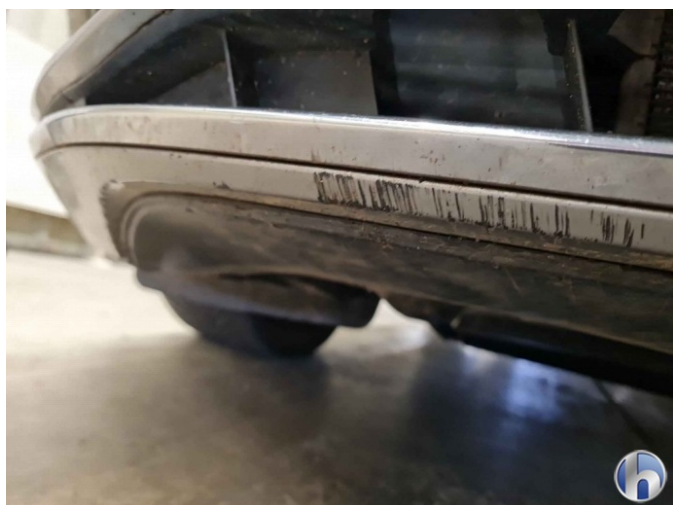
| component | Damage | Rep kind |
|---|---|---|
| 30. Frontspoiler | Scrape | Replace |

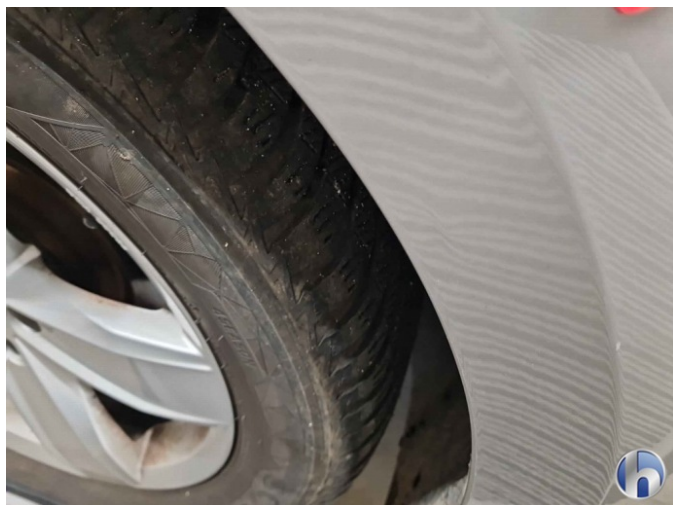
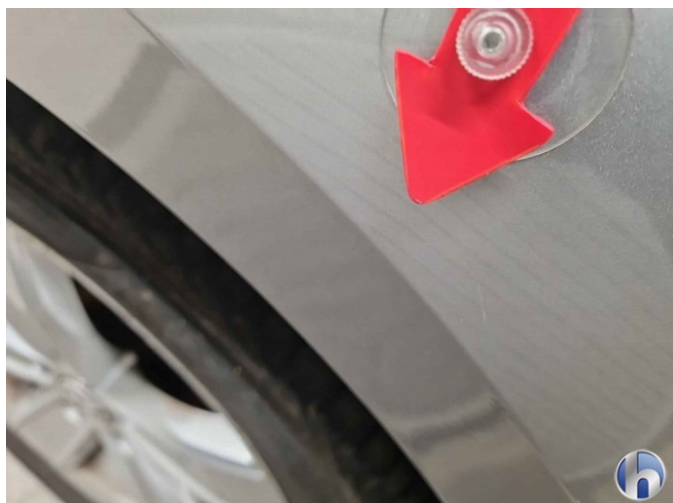
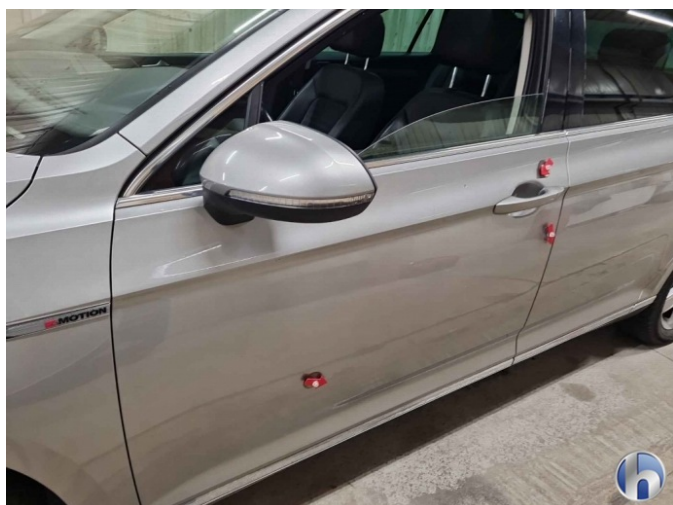
| component | Damage | Rep kind |
|---|---|---|
| 31. Front fender - left | Damaged | Refurbish and paint |

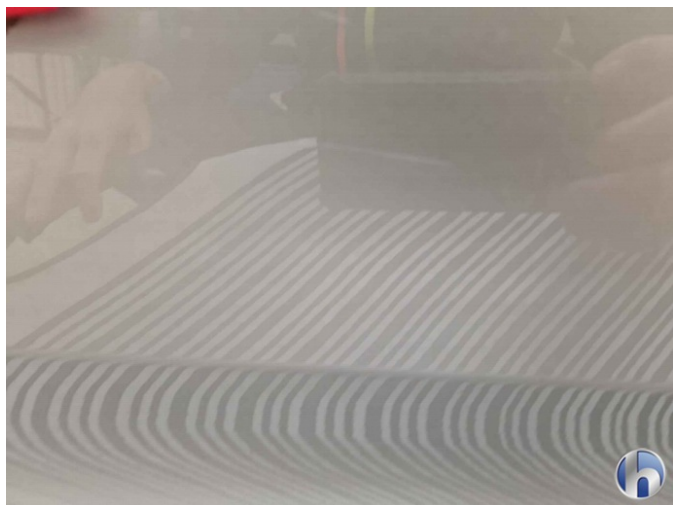
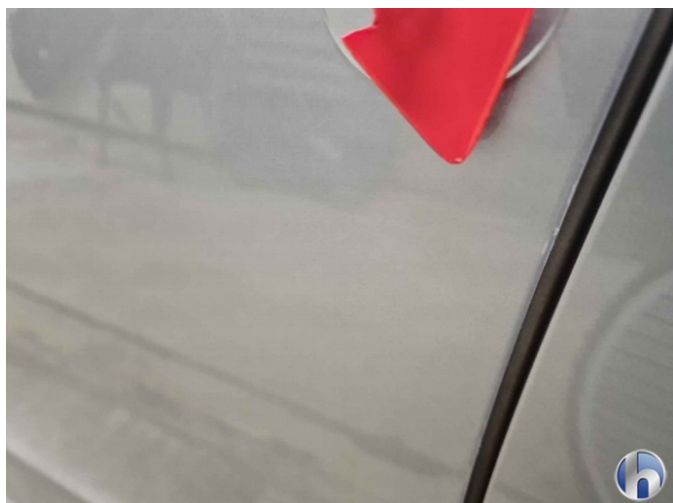
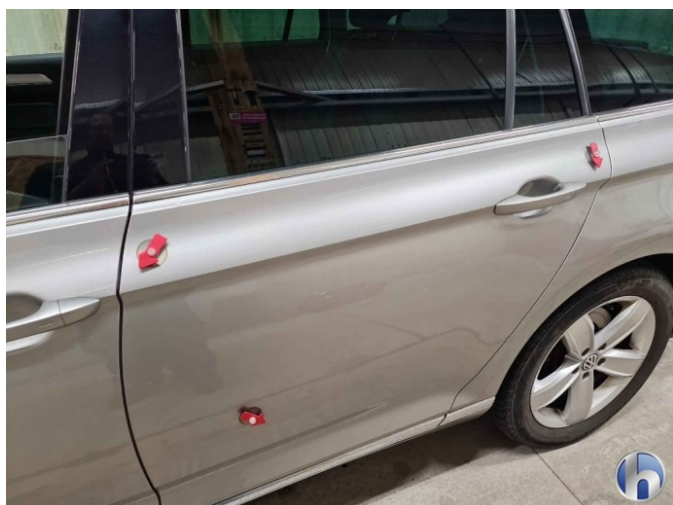
| component | Damage | Rep kind |
|---|---|---|
| 32. Front door - left | Scratch(es) | Paint |

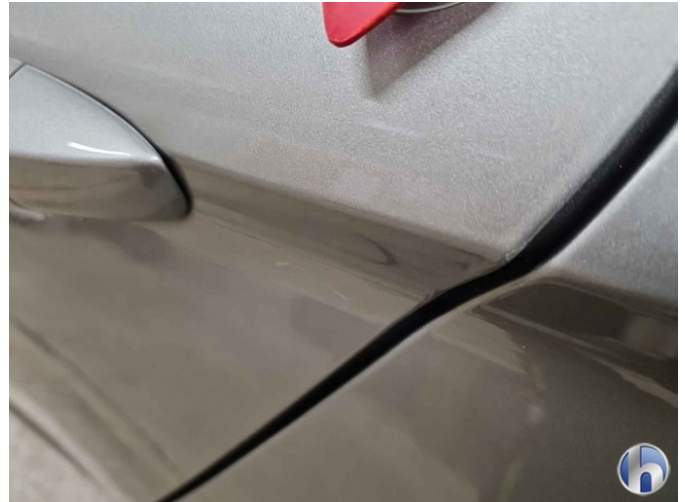
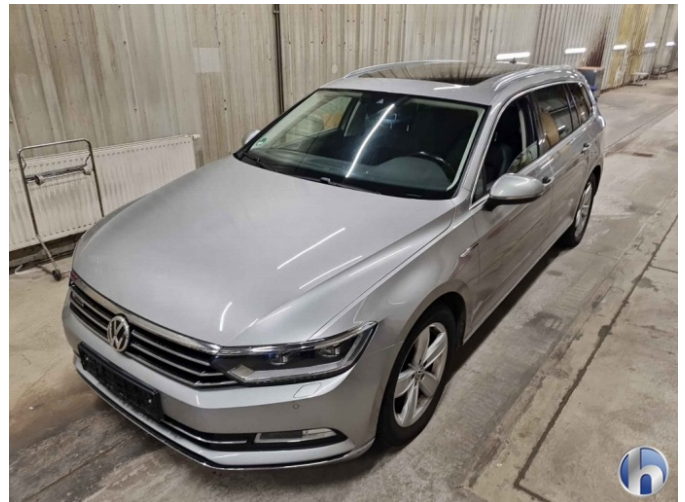
| component | Damage | Rep kind |
|---|---|---|
| 33. Rear door - left | Scratch(es) | Paint |
