# VOLKSWAGEN Passat

## Passat Variant 2.0 TDI SCR DSG (BlueM. Tech)

### Inspection Report Summary

Customer	BCA Online	Report Number	P20250930114520
Inspection Date / Place	2025-09-30 / BCA Neuss	Cosmetic Grade	2

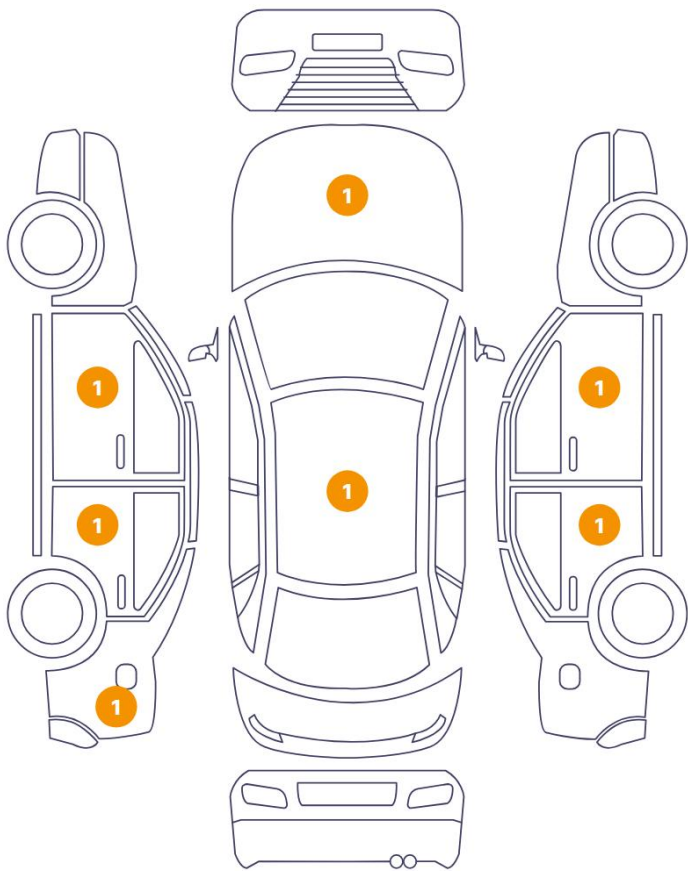
7 Schäden

Component		Damage	Comments
1	Fender / Back Left	Paint / Poor Previous Repair	
2	Door / Back Left	Paint / Poor Previous Repair	
3	Door / Front Left	Paint / Poor Previous Repair	
4	Roof	Bodywork / Dent / Dent	
5	Hood	Bodywork / Dent / Dent	
6	Door / Front Right	Bodywork / Dent / Dent	
7	Door / Back Right	Bodywork / Dent / Dent

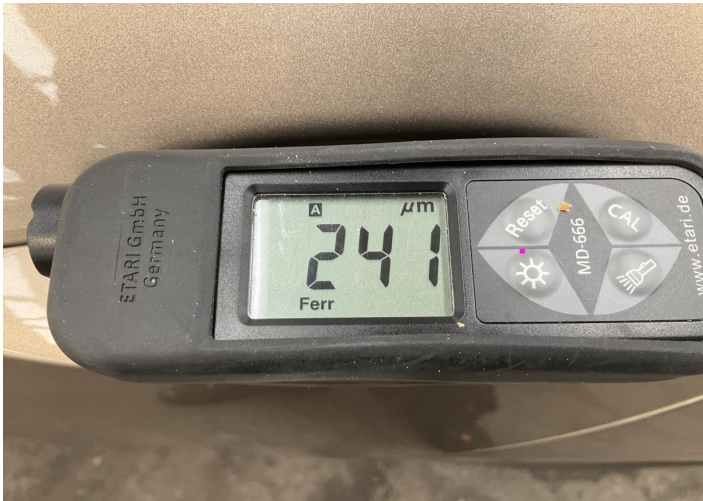
1. Fender / Back Left  
Paint / Poor Previous Repair -

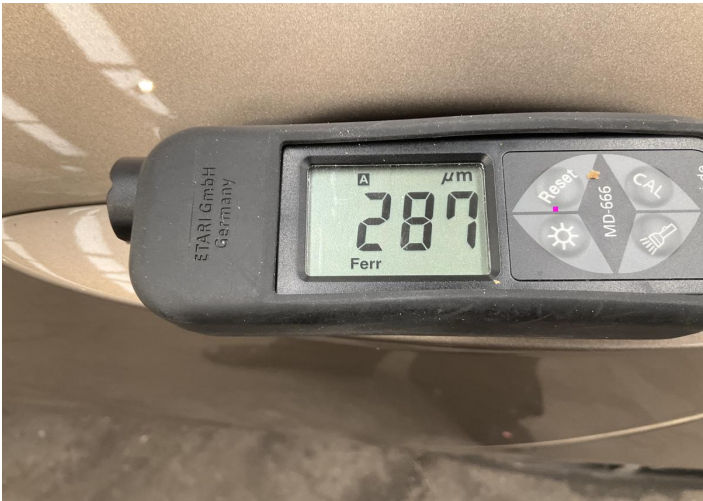
2. Door / Back Left  
Paint / Poor Previous Repair -

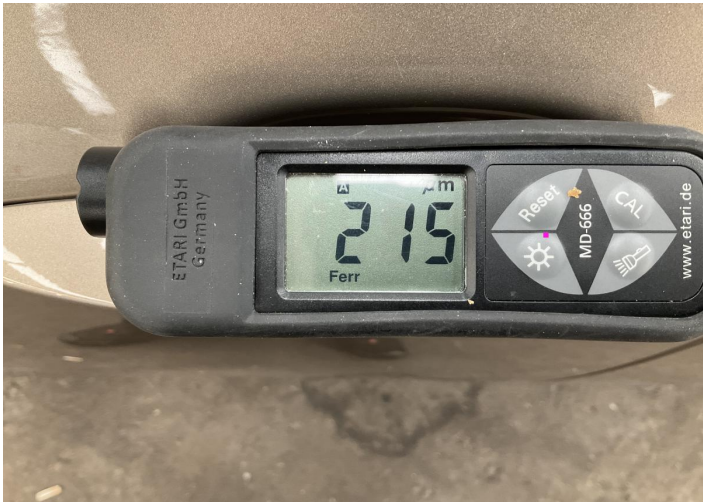
3. Door / Front Left  
Paint / Poor Previous Repair -

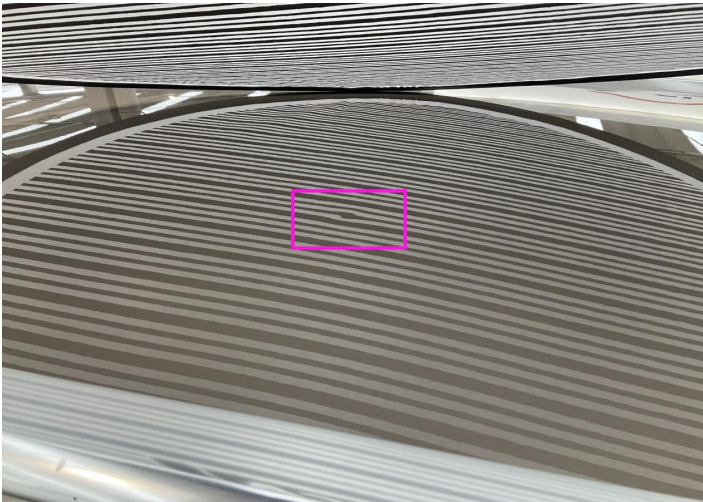
4. Roof  
Bodywork / Dent / Dent -

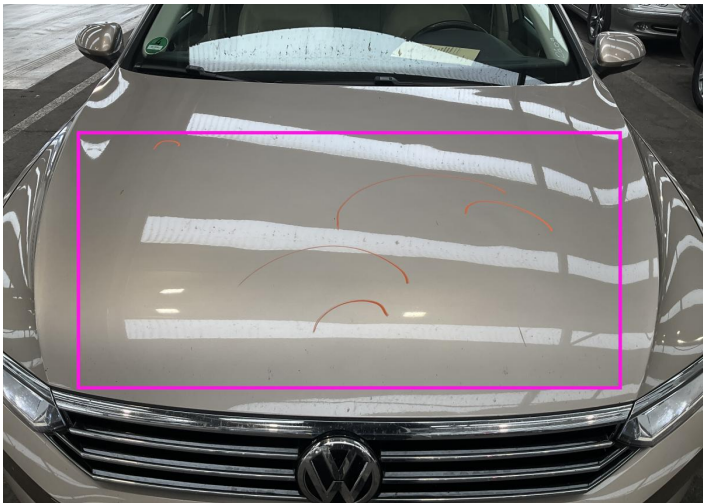
5. Hood  
Bodywork / Dent / Dent -

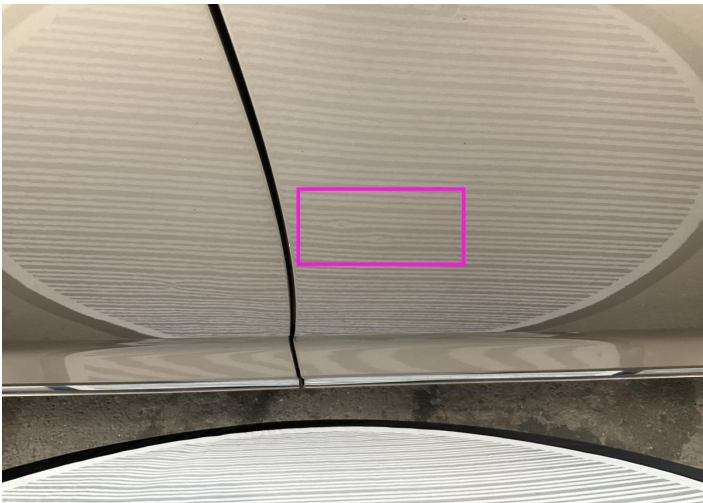
6. Door / Front Right  
Bodywork / Dent / Dent -

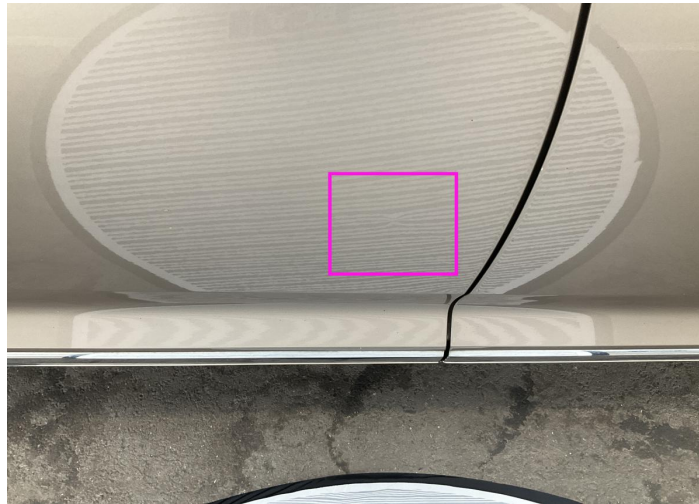
7. Door / Back Right  
Bodywork / Dent / Dent -
