Expertise

Protocol number: 41795377  
Order number / reference: 25226219  
Inspection date: 25 Sept 2025

Manufacturer: Volkswagen

Model: Passat Variant 1.4 TSI Plug-In-Hybrid DSG GTE

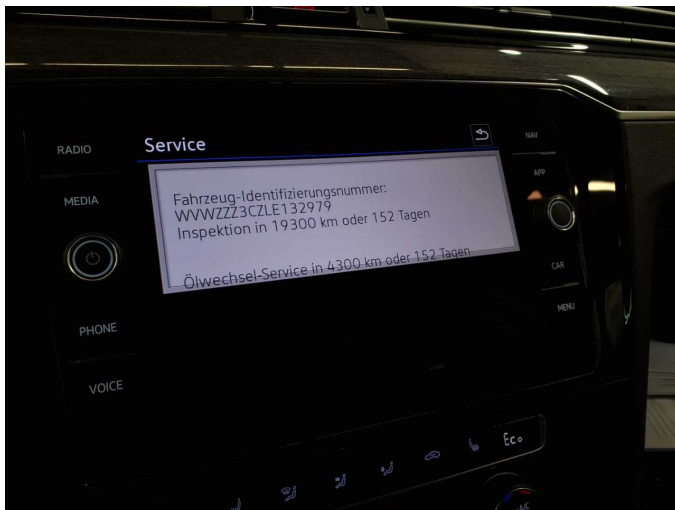
| No. | Component group | Description |
|---|---|---|
| 1 | Misc. | Misc. (halber Bildschirm) - No deduction |

**Damage 1:** Misc.: Misc. (halber Bildschirm) - No deduction

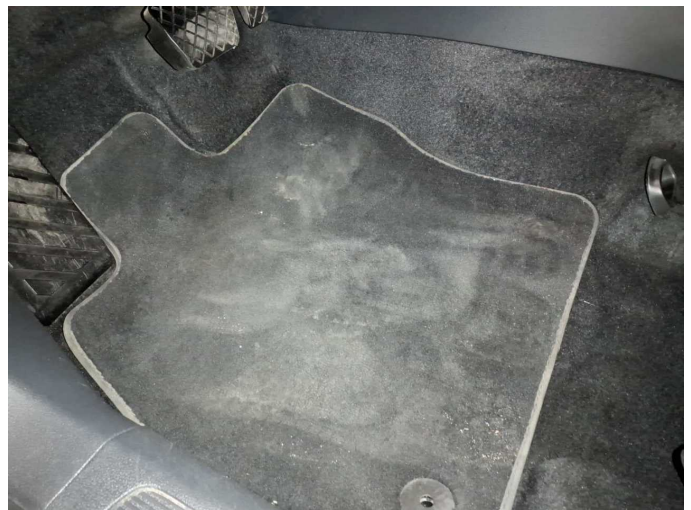
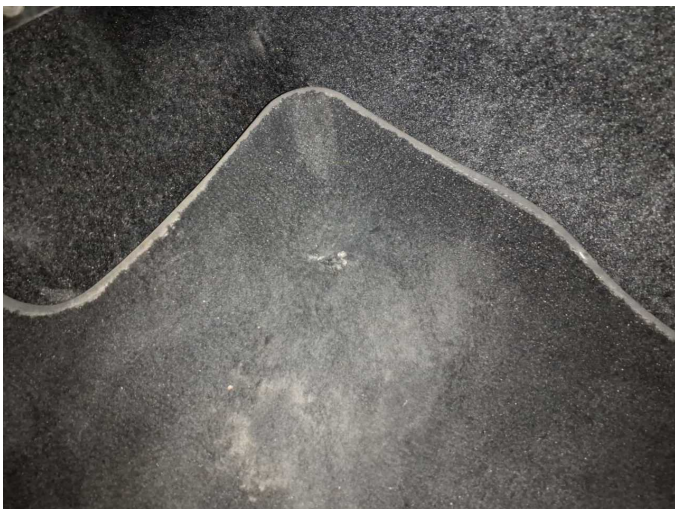
| No. | Component group | Description |
|---|---|---|
| 2 | Trim / covers | Floor mats - Holes - Replace |

**Damage 2:** Trim / covers: Floor mats - Holes - Replace

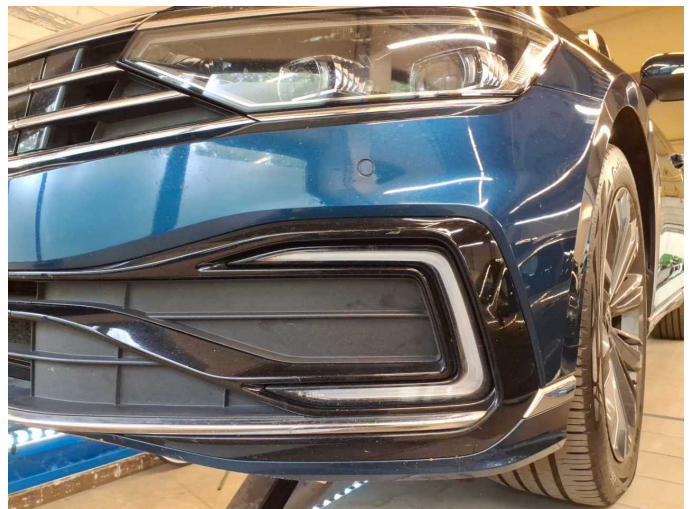
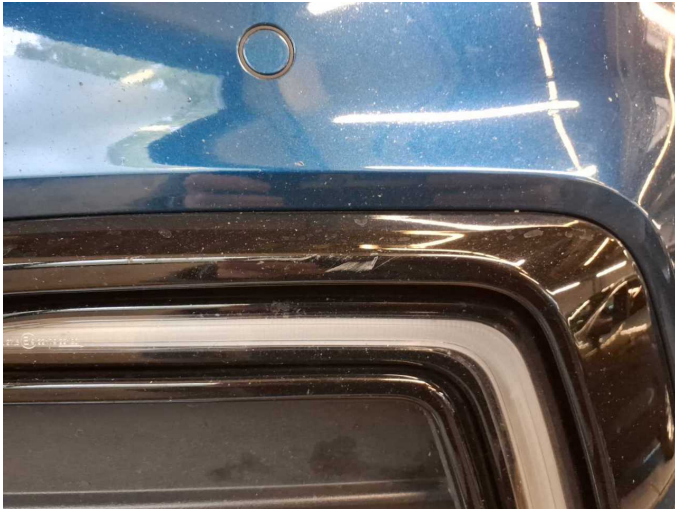
| No. | Component group | Description |
|---|---|---|
| 3 | Trim / covers | Trim / covers - Scratch(es) - Loss in value |

**Damage 3:** Trim / covers: Trim / covers - Scratch(es) - Loss in value

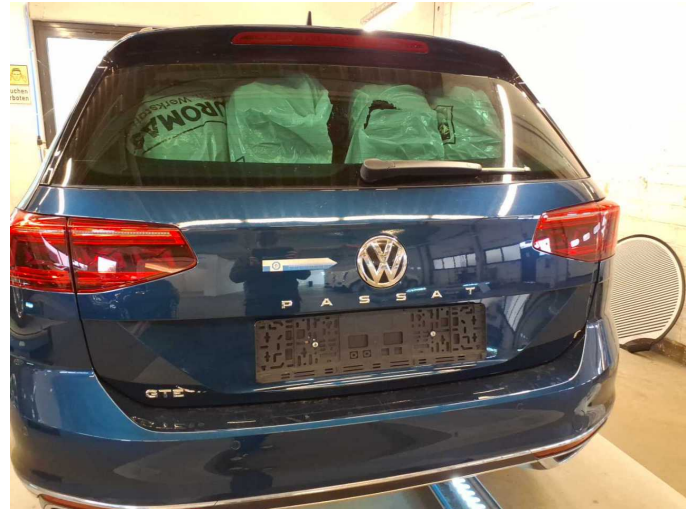
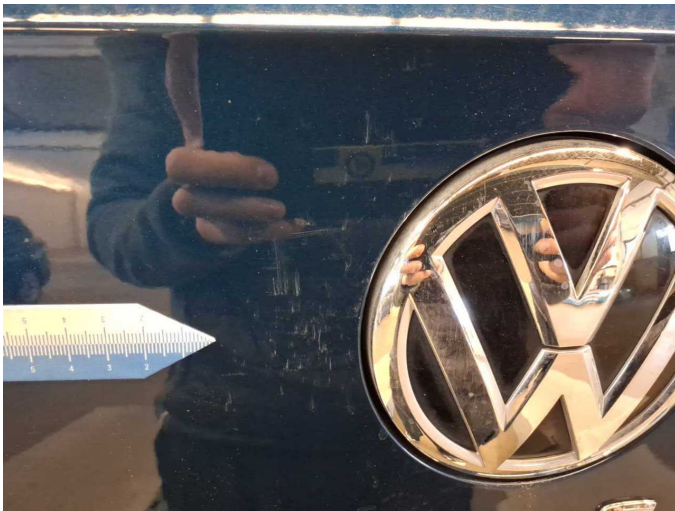
| No. | Component group | Description |
|---|---|---|
| 4 | Boot lid / rear door | Boot lid - Scratch(es) - Smart repair |

**Damage 4:** Boot lid / rear door: Boot lid - Scratch(es) - Smart repair

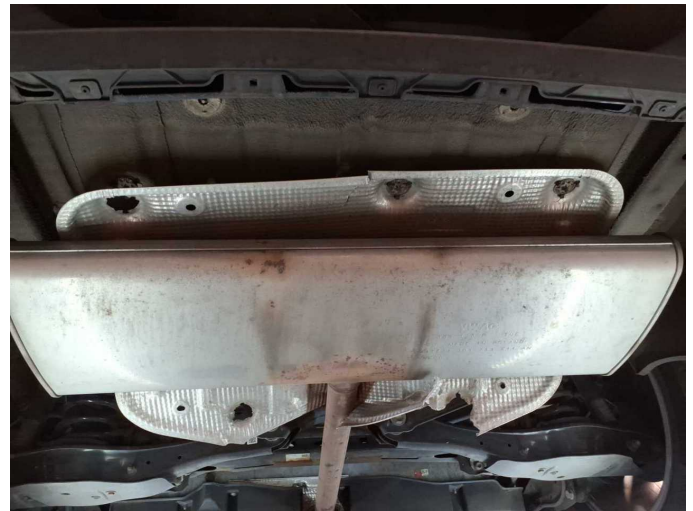
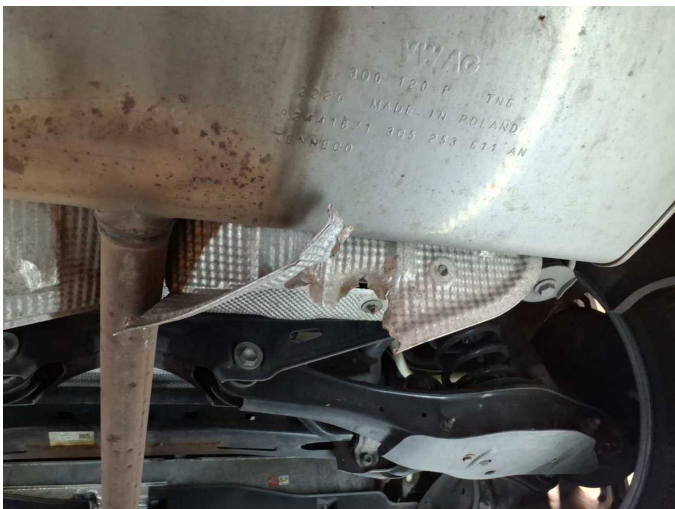
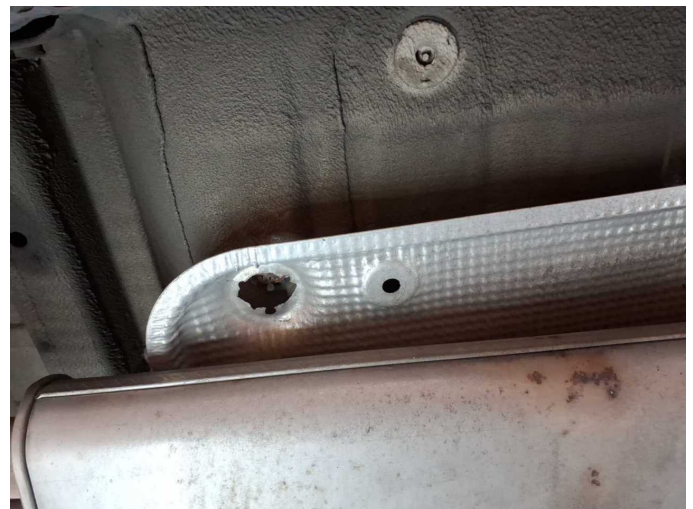
| No. | Component group | Description |
|---|---|---|
| 5 | Exhaust system | Heat shield - Broken / torn - Replace |

**Damage 5:** Exhaust system: Heat shield - Broken / torn - Replace

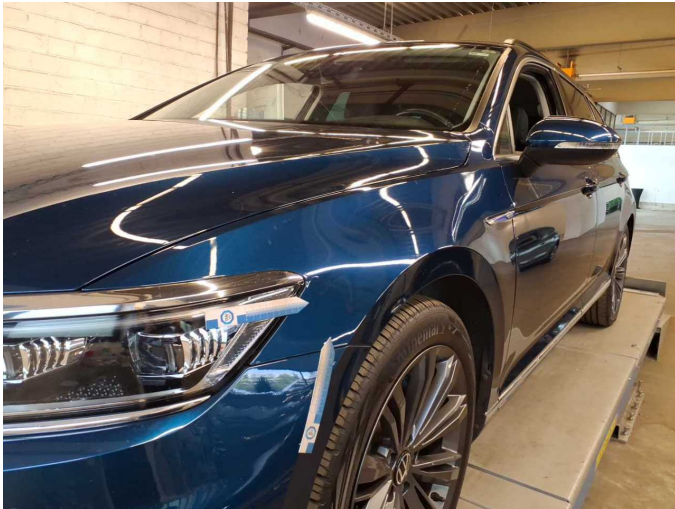
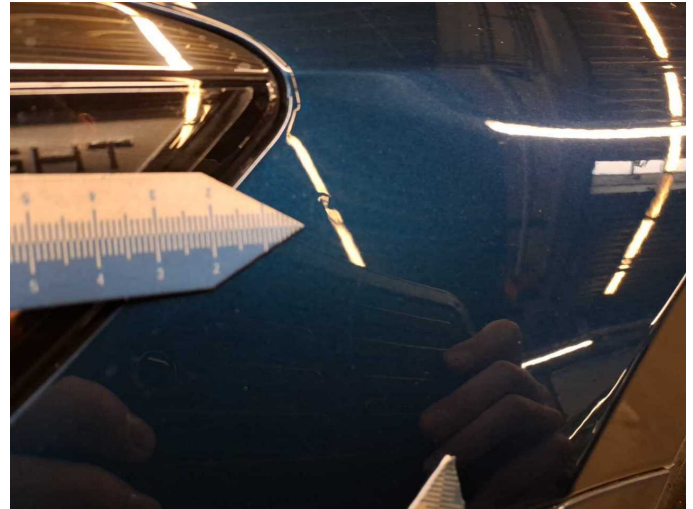
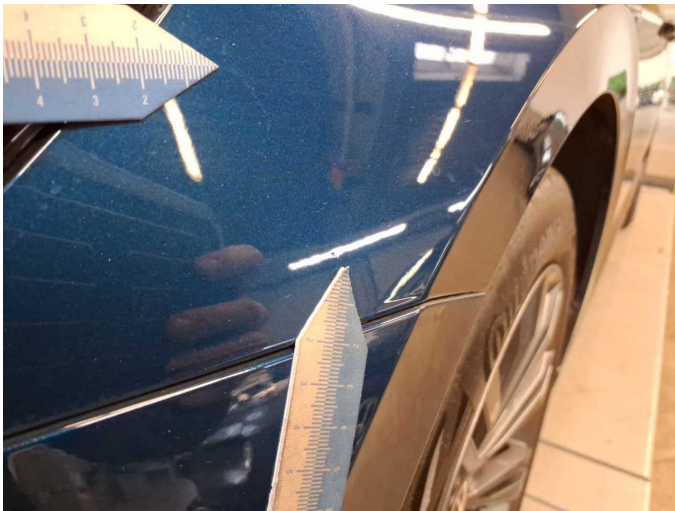
| No. | Component group | Description |
|---|---|---|
| 7 | Mudguard - left side | Mudguard - left side (Lackpickel) - Unprofessionally repaired - Conditioning |

| No. | Repainting |
|---|---|
| 3 | Mudguard - left side, Unprofessionally carried out, Invoice of repair done Non-existent |

**Damage 7:** Mudguard - left side: Mudguard - left side (Lackpickel) - Unprofessionally repaired - Conditioning

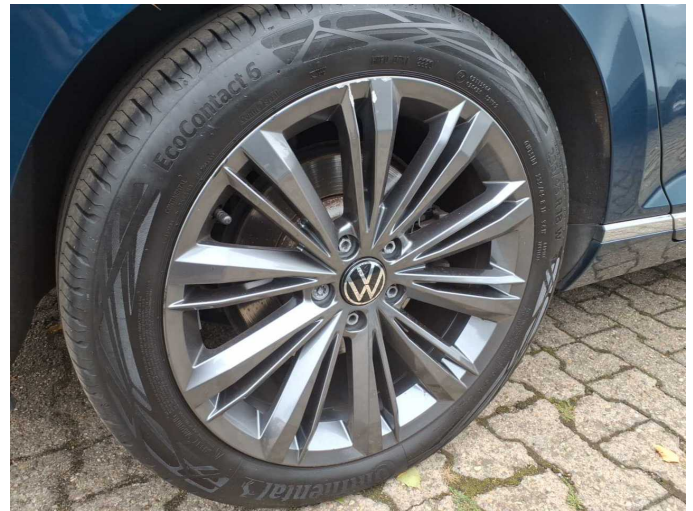
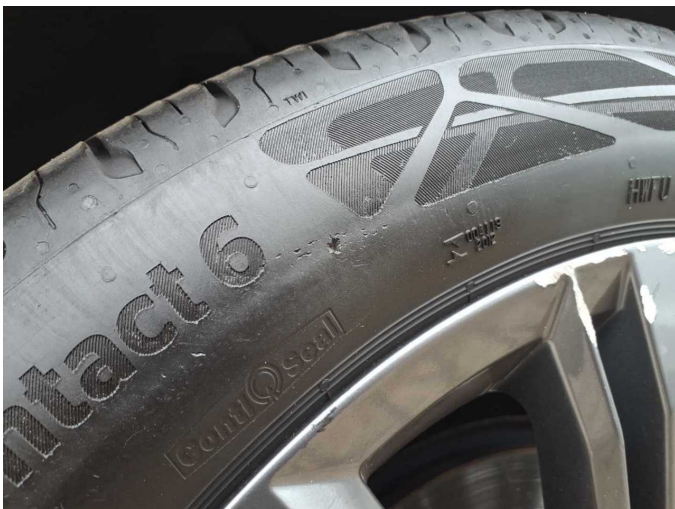
| No. | Component group | Description |
|---|---|---|
| 8 | Wheel / tyres | Tyre - rear right side (nicht fahrbereit) - Damaged - Replace |

**Damage 8:** Wheel / tyres: Tyre - rear right side (nicht fahrbereit) - Damaged - Replace

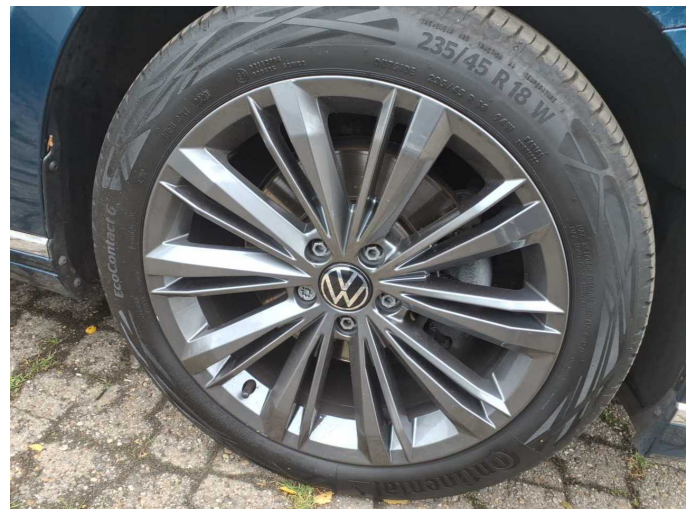
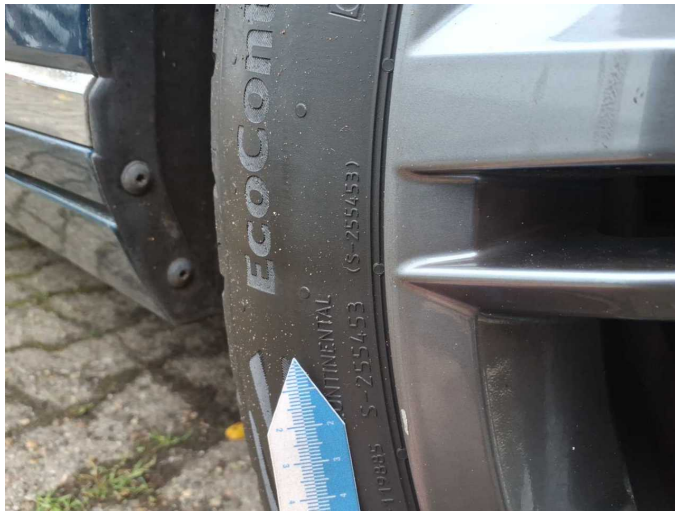
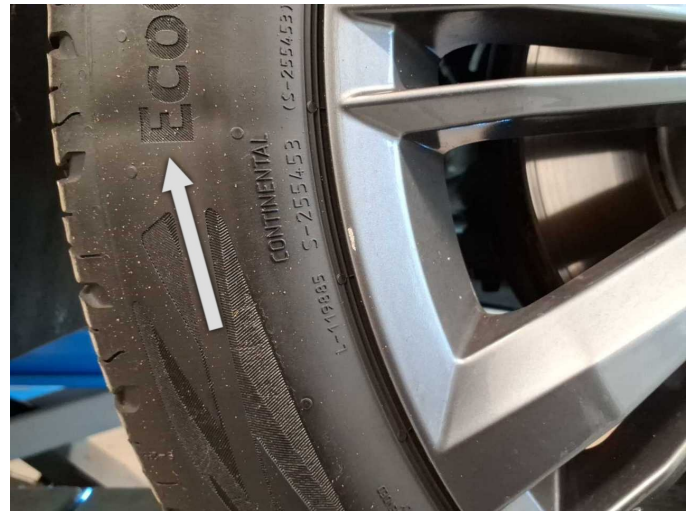
| No. | Component group | Description |
|---|---|---|
| 9 | Wheel / tyres | Tyre - front right side (nicht fahrbereit) - Deformed - Replace |

**Damage 9:** Wheel / tyres: Tyre - front right side (nicht fahrbereit) - Deformed - Replace

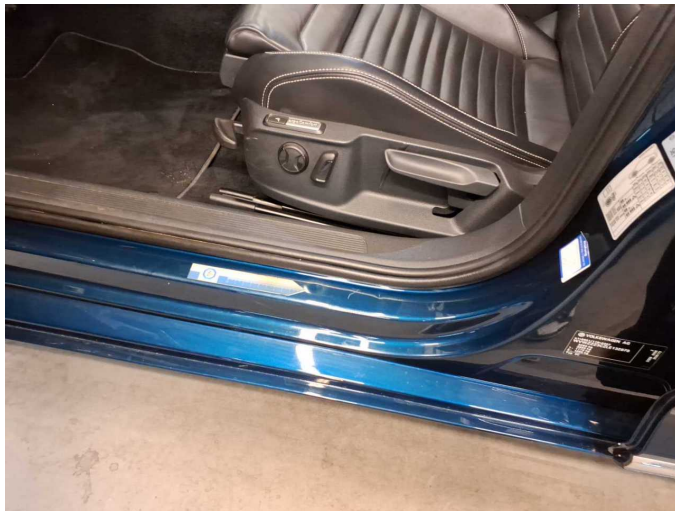
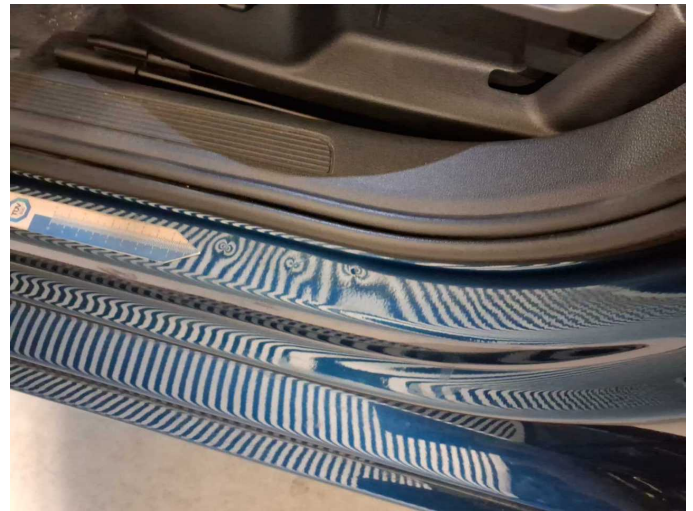
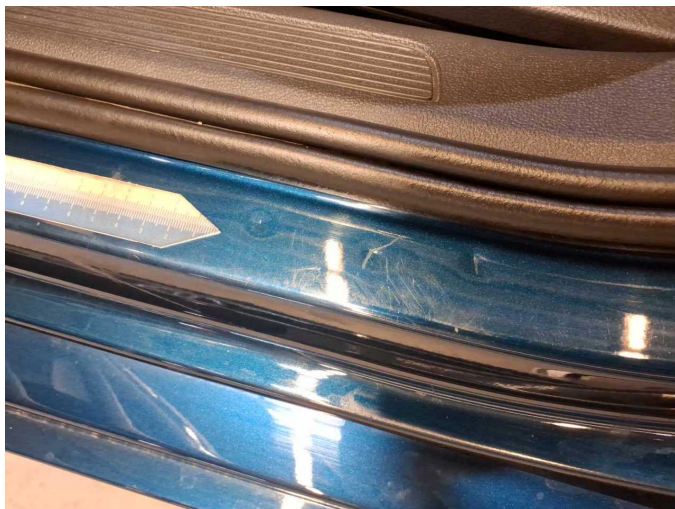
| No. | Component group | Description |
|---|---|---|
| 10 | Sill - left side | Sill - Dent / paintcoat damage - Smart repair |

**Damage 10:** Sill - left side: Sill - Dent / paintcoat damage - Smart repair

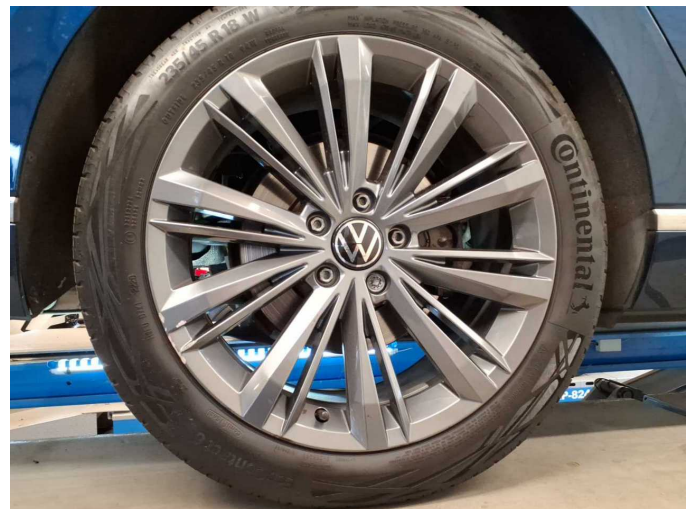
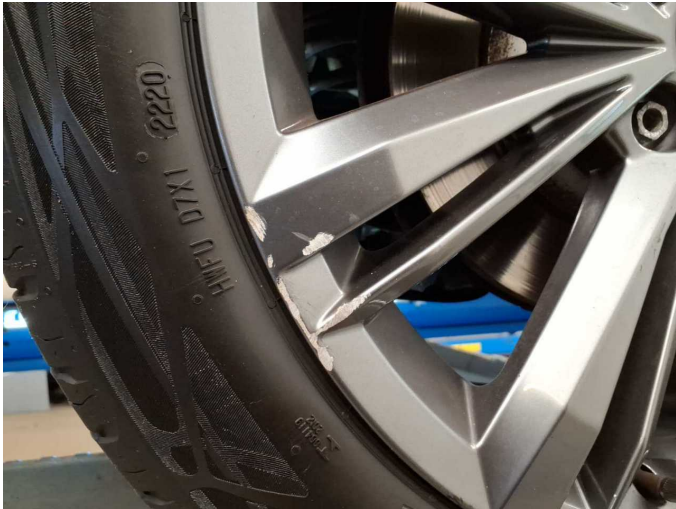
| No. | Component group | Description |
|---|---|---|
| 11 | Wheel / tyres | Alloy rim - rear right side - Scratch(es) - Loss in value |

**Damage 11:** Wheel / tyres: Alloy rim - rear right side - Scratch(es) - Loss in value

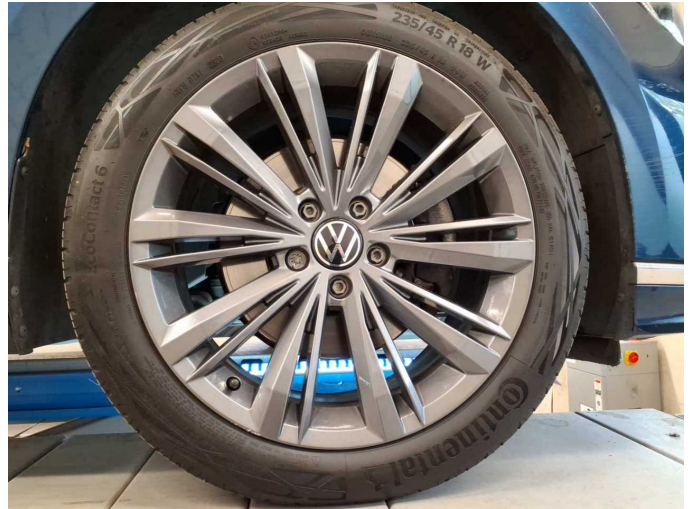
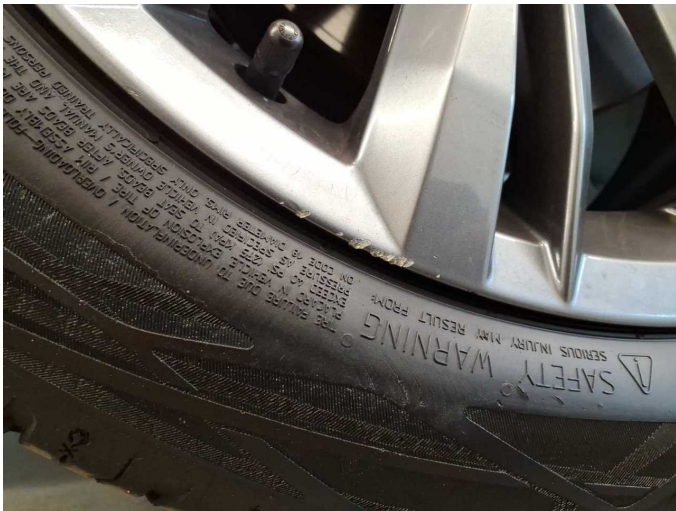
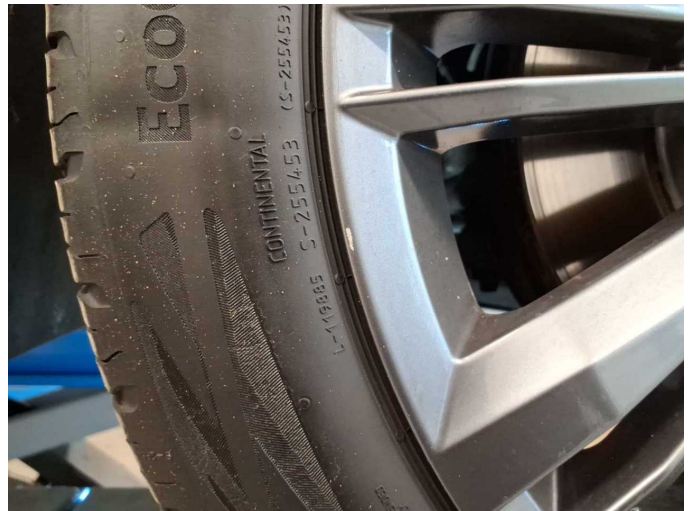
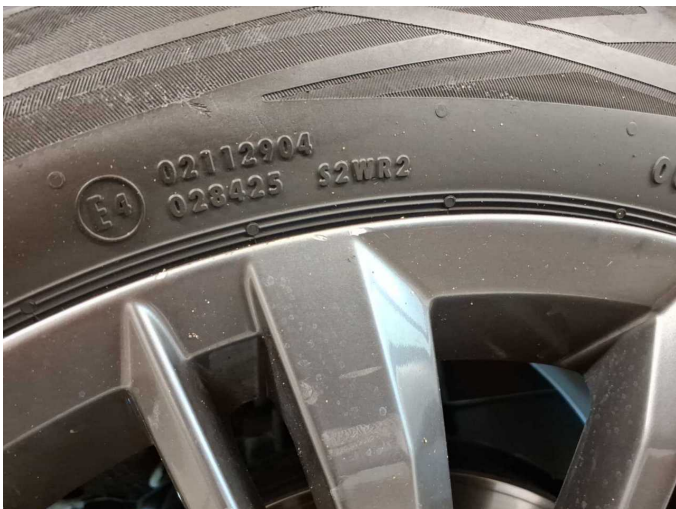
| No. | Component group | Description |
|---|---|---|
| 12 | Wheel / tyres | Alloy rim - front right side - Scratch(es) - Loss in value |

**Damage 12:** Wheel / tyres: Alloy rim - front right side - Scratch(es) - Loss in value

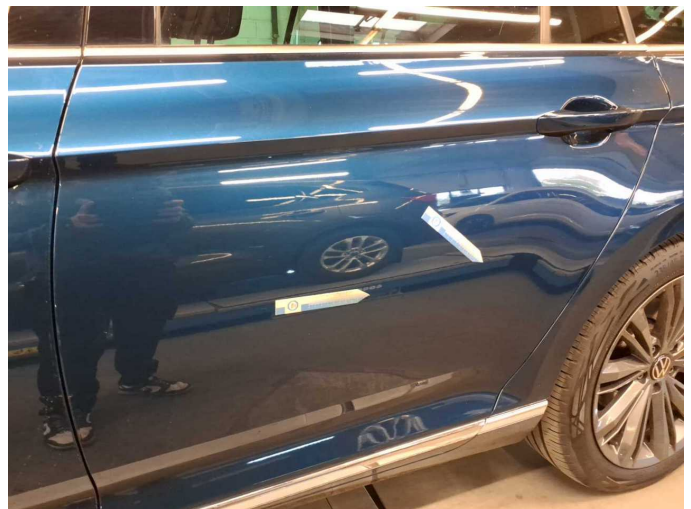
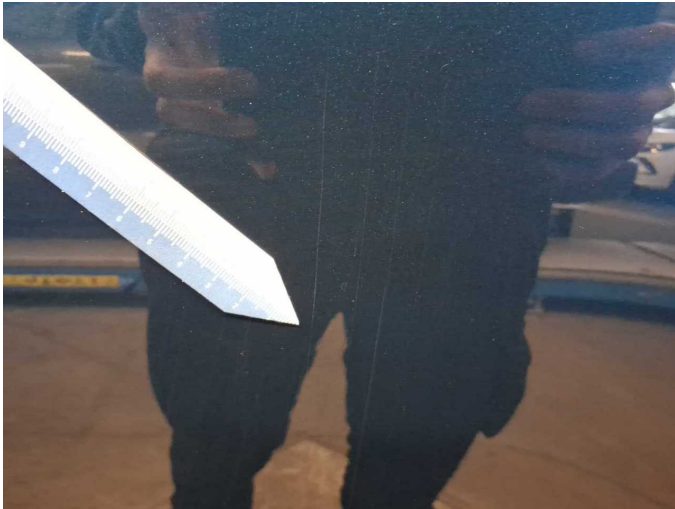
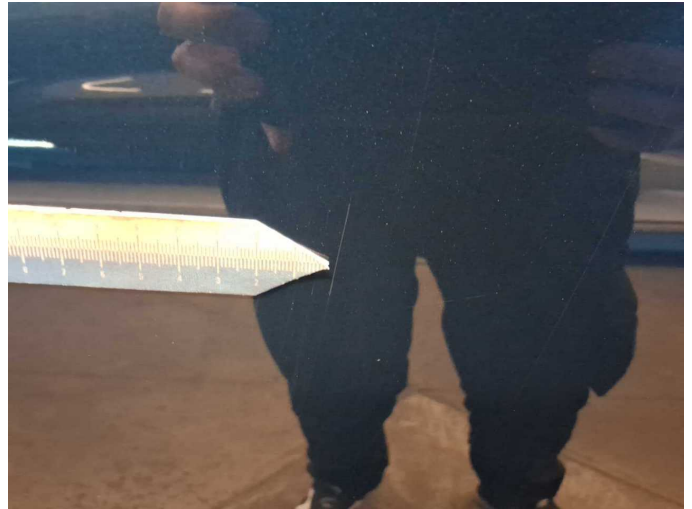
| No. | Component group | Description |
|---|---|---|
| 13 | Door - rear left side | Door - Scratch(es) - Paint |

**Damage 13:** Door - rear left side: Door - Scratch(es) - Paint

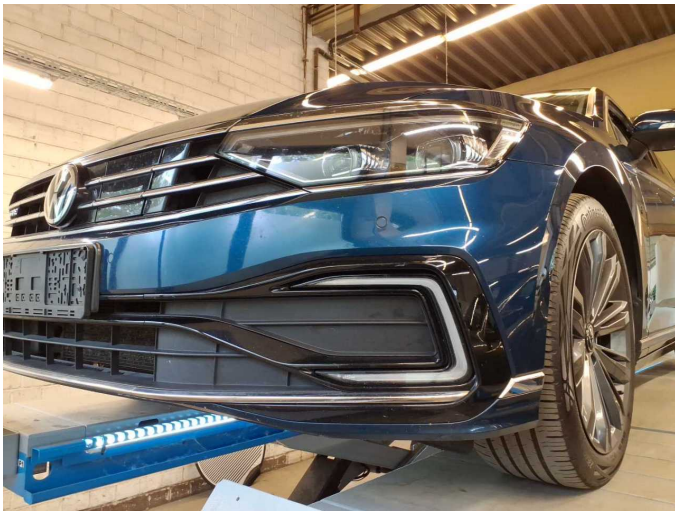
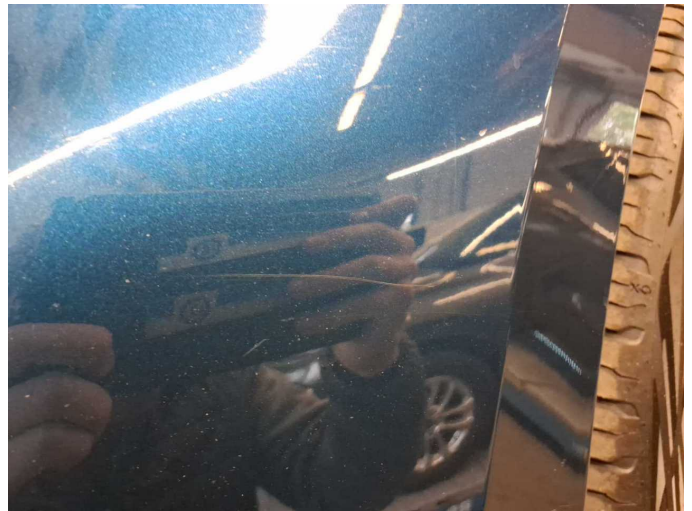
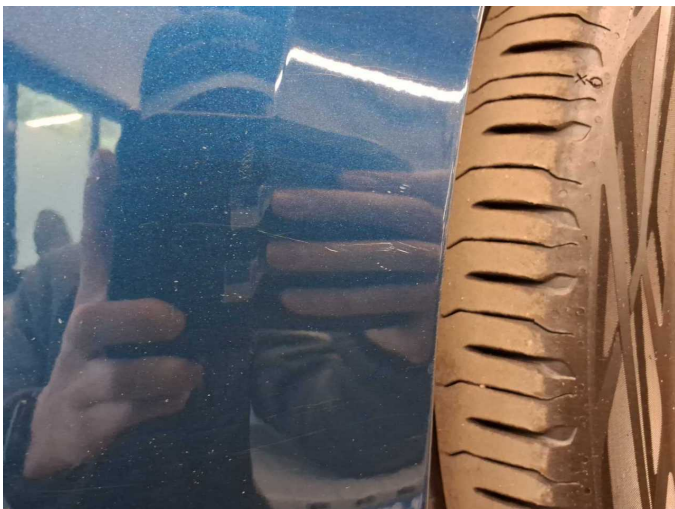
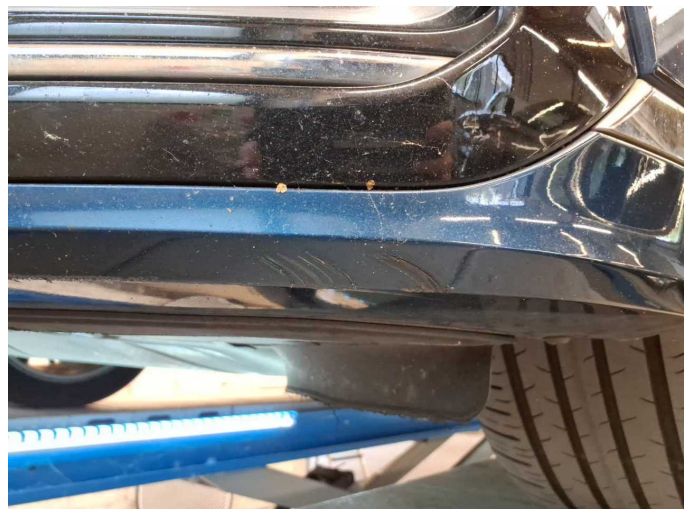
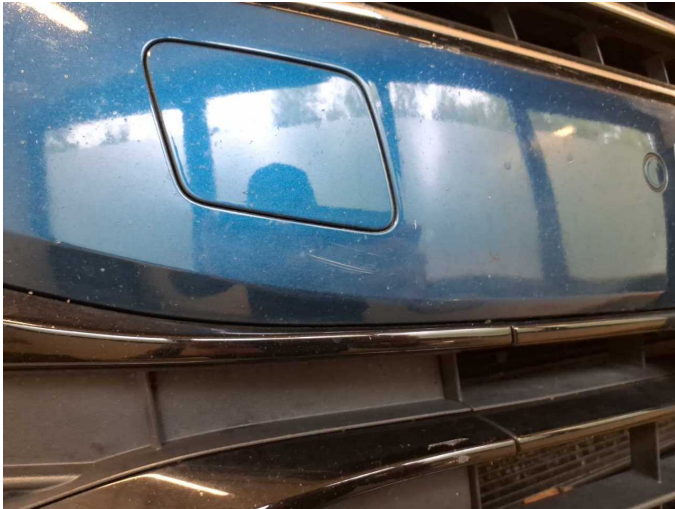
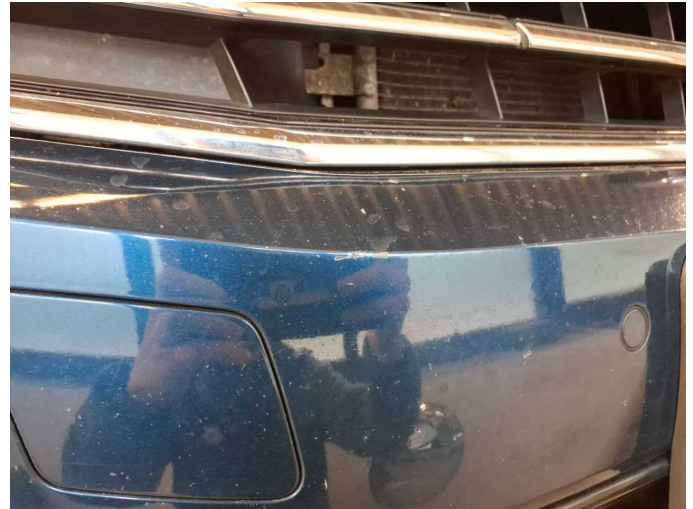
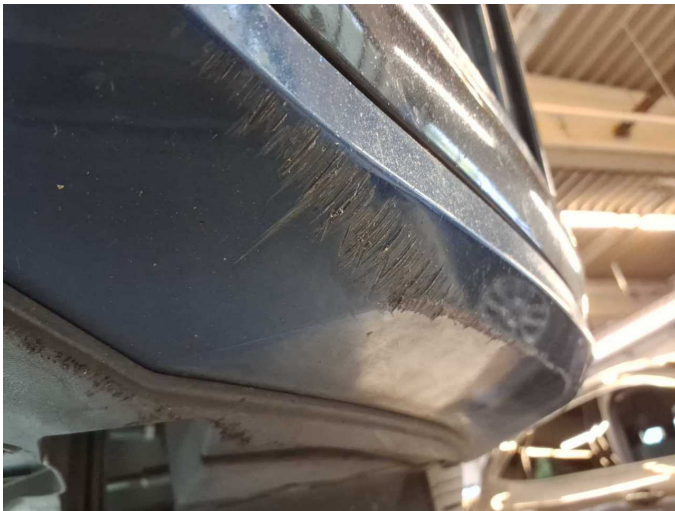
| No. | Component group | Description |
|---|---|---|
| 14 | Front bumper | Front bumper - Scratch(es) - Paint |

**Damage 14:** Front bumper: Front bumper - Scratch(es) - Paint

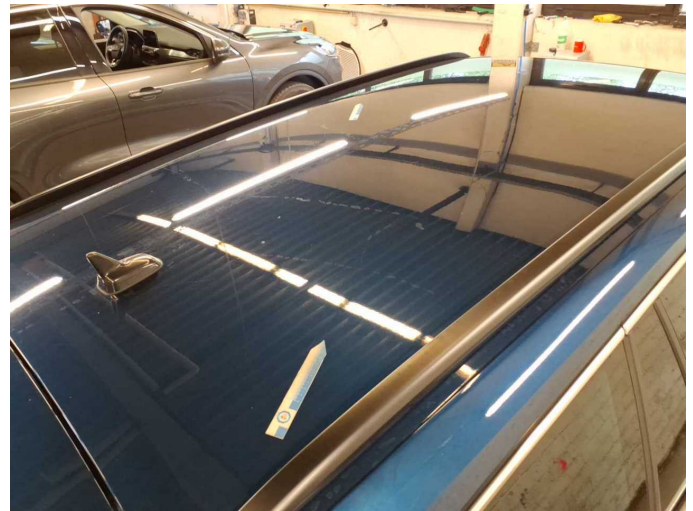
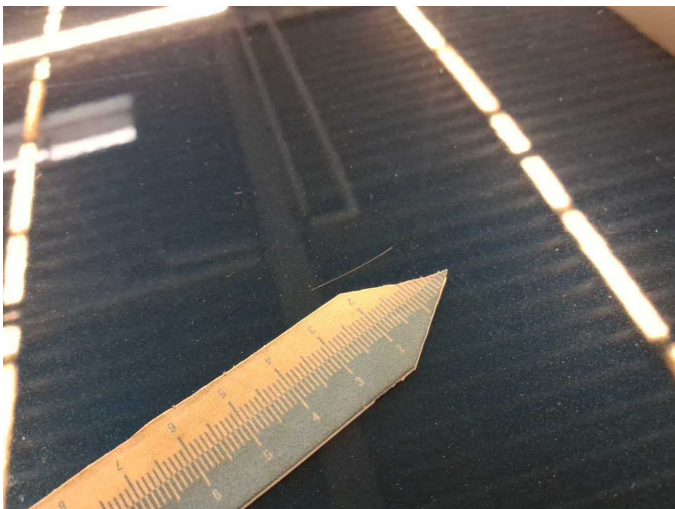
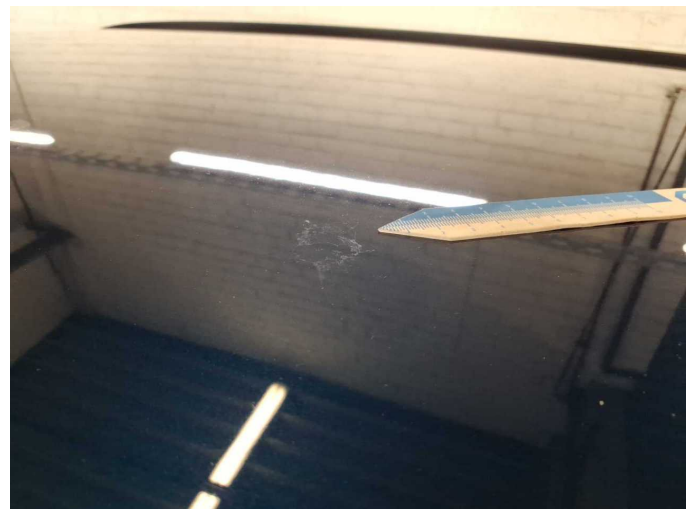
| No. | Component group | Description |
|---|---|---|
| 15 | Roof | Roof (Vogelkotverätzung + Kratzer) - Paint defect - Paint |

**Damage 15:** Roof: Roof (Vogelkotverätzung + Kratzer) - Paint defect - Paint

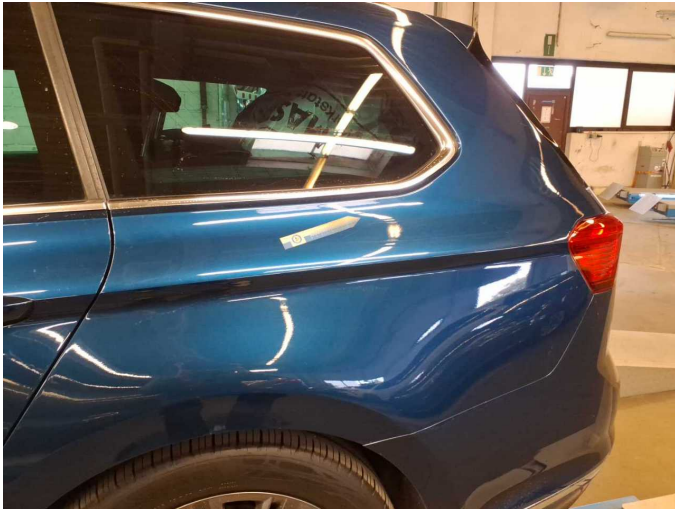
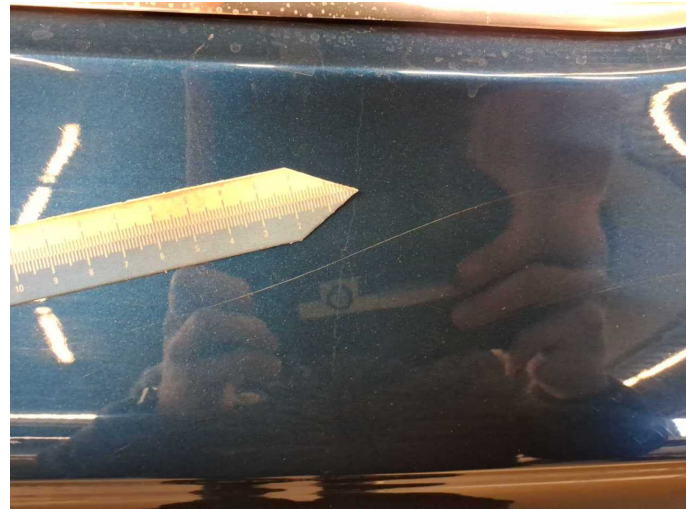
| No. | Component group | Description |
|---|---|---|
| 16 | Side panel - rear left side | Side panel - Scratch(es) - Paint |

**Damage 16:** Side panel - rear left side: Side panel - Scratch(es) - Paint

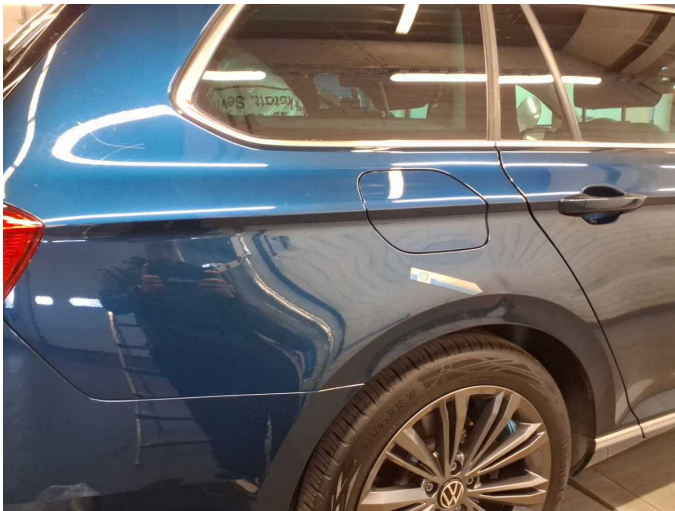
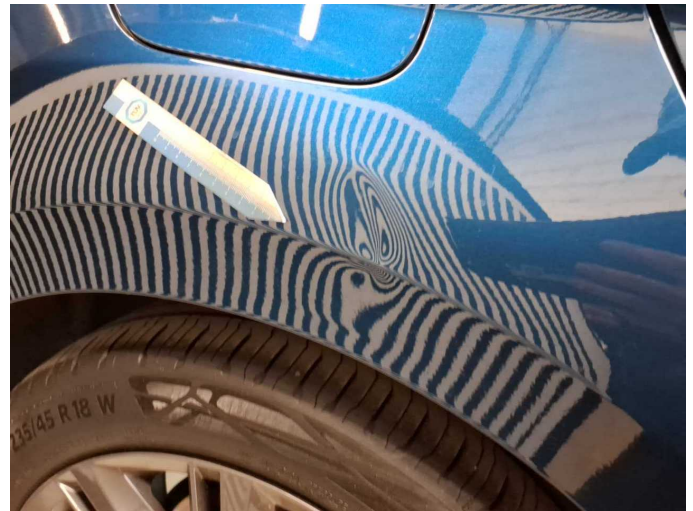
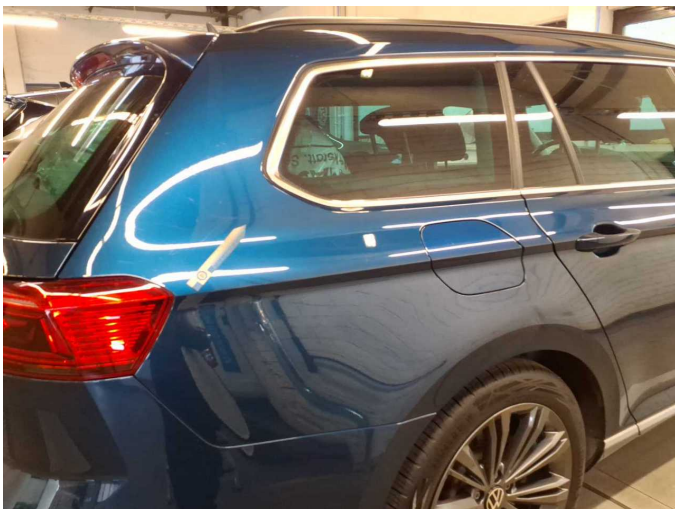
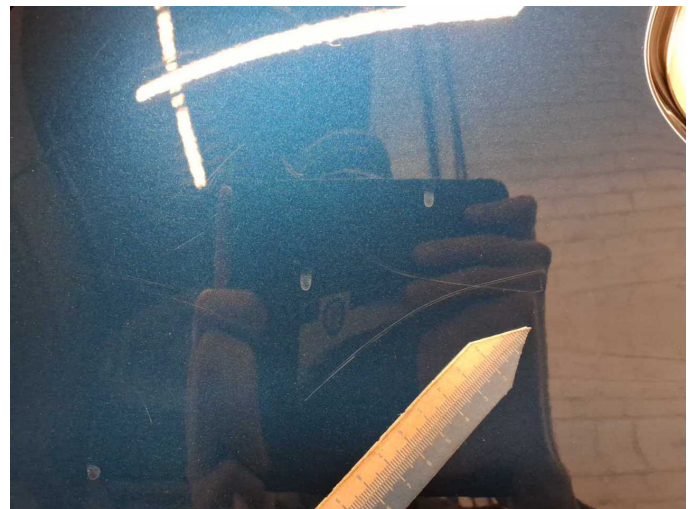
| No. | Component group | Description |
|---|---|---|
| 17 | Side panel - rear right side | Side panel - Deformed - Repair and paint |

**Damage 17:** Side panel - rear right side: Side panel - Deformed - Repair and paint

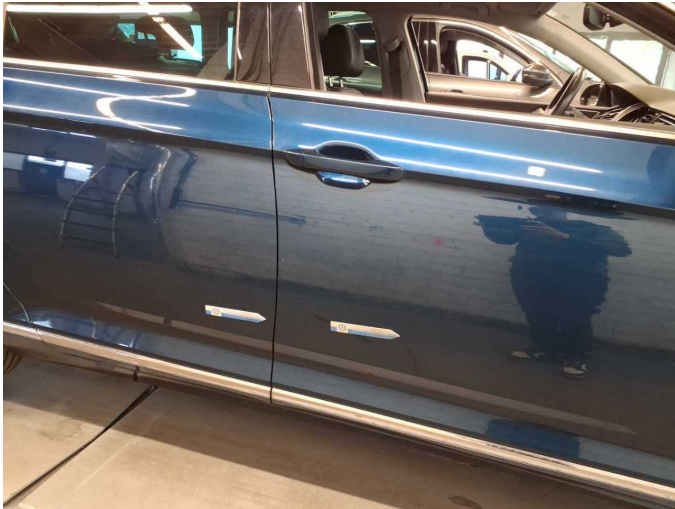
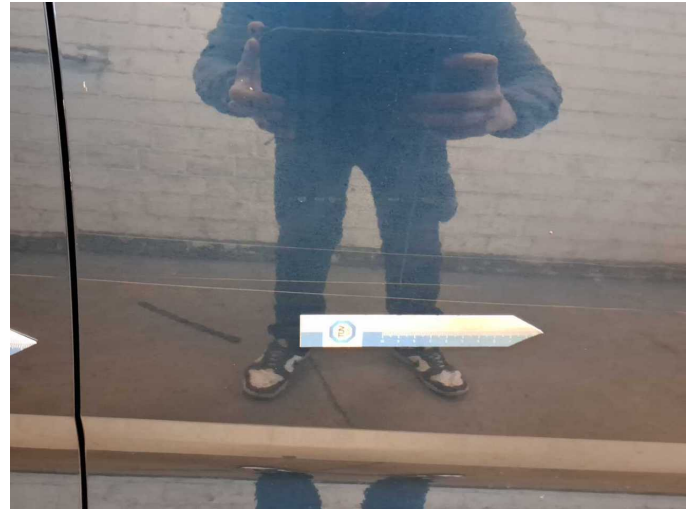
| No. | Accident |
|---|---|
| 1 | Side right |

**Accident 1: Side right**

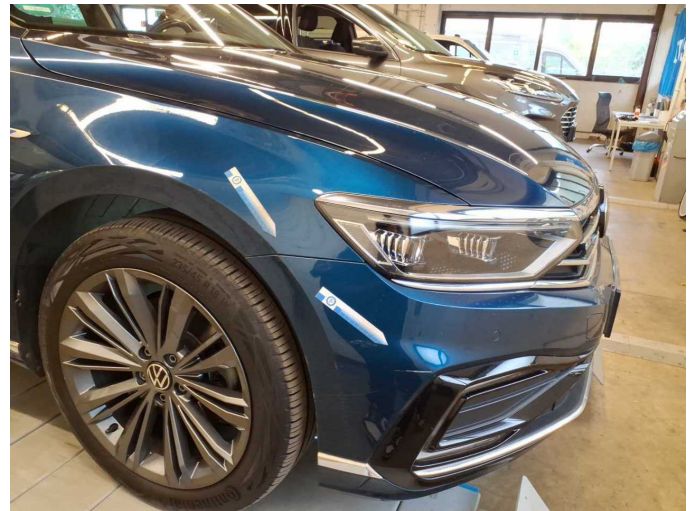
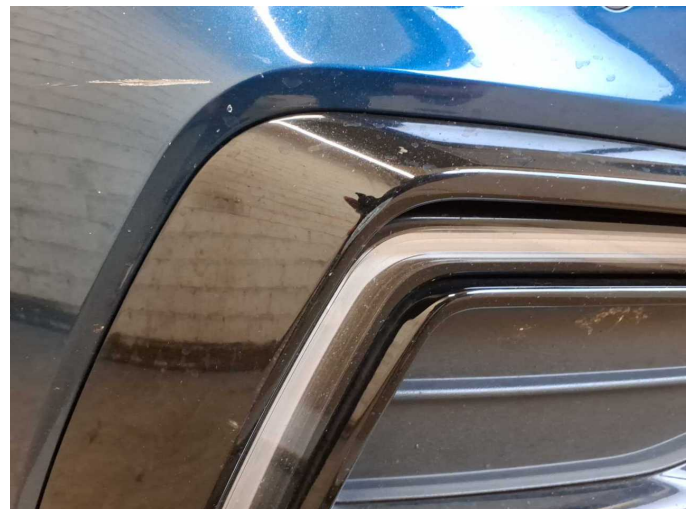
| No. | Accident |
|---|---|
| 2 | Front, Side right |

**Accident 2: Front, Side right**

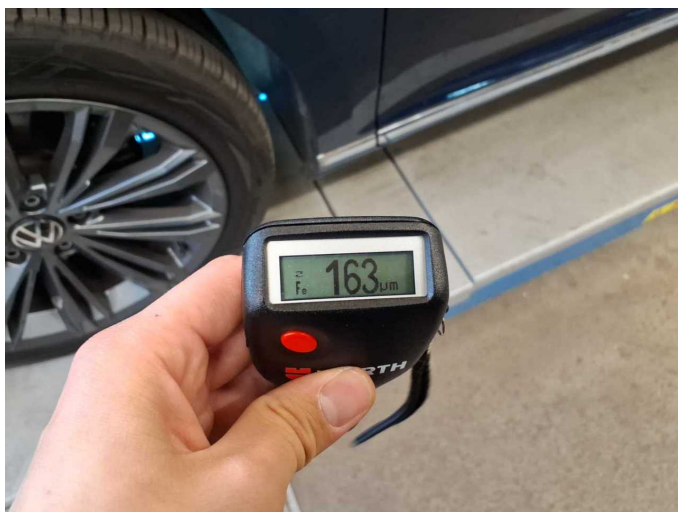
| No. | Repainting |
|---|---|
| 1 | Roof rail - left side, Professionally carried out, Invoice of repair done Non-existent |

**Repainting 1:** Roof rail - left side

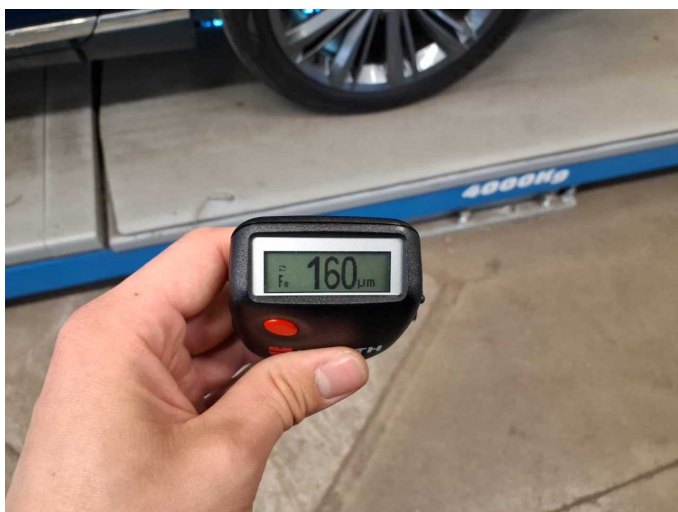
| No. | Repainting |
|---|---|
| 2 | Side panel - rear left side, Professionally carried out, Invoice of repair done Non-existent |

**Repainting 2:** Side panel - rear left side
