Expertise

Protocol number: 41662710
Order No. / Reference: 25185031
Inspection date: 19 Sept 2025

Manufacturer: Volkswagen

Model: Passat Variant 1.4 TSI Plug-In-Hybrid DSG GTE

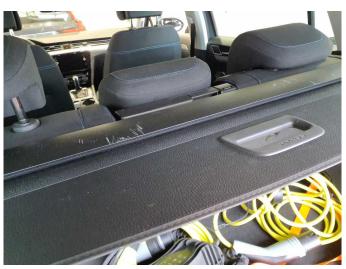
Damage 2: Interior: Boot cover / roller cover - Scratched - Loss in value

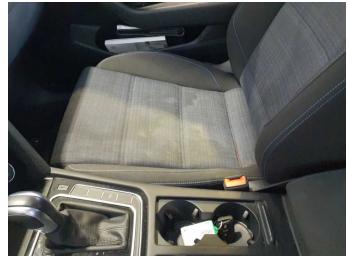
Damage 3: Interior: Interior - Soiled - Clean

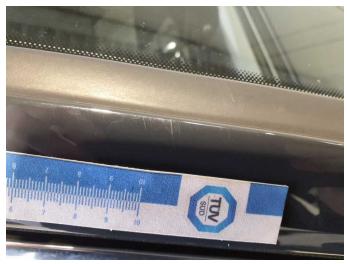
Damage 5: Roof: Roof rail - right side - Scratched - Smart repair

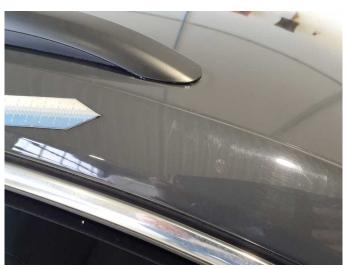
Damage 5: Roof: Roof rail - right side - Scratched - Smart repair

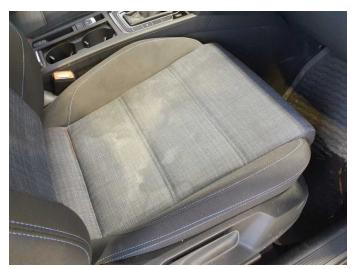
Damage 7: Interior: Interior - Leaking - Perform diagnosis

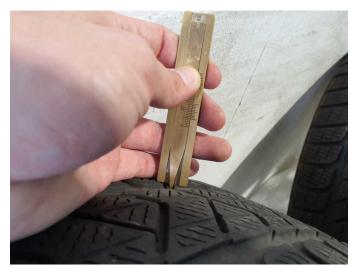
Damage 8: 2nd wheel set: 2 tyres - Does not meet the leasing specifications - Replace

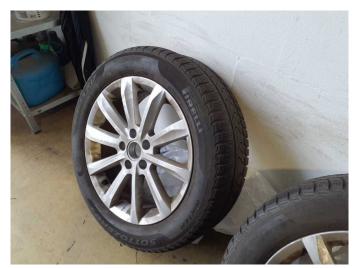
Damage 8: 2nd wheel set: 2 tyres - Does not meet the leasing specifications - Replace

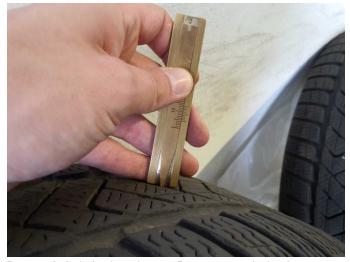
Damage 8: 2nd wheel set: 2 tyres - Does not meet the leasing specifications - Replace

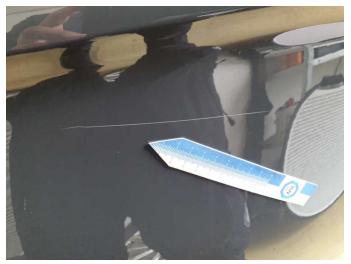
Damage 9: Side panel - rear left side: Side panel - Scratch(es) - Paint

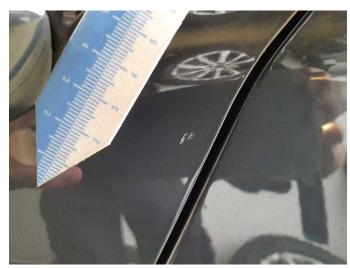
Damage 10: Door - rear left side: Door - Scratch(es) - Paint

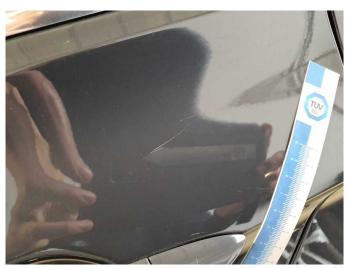
Damage 10: Door - rear left side: Door - Scratch(es) - Paint

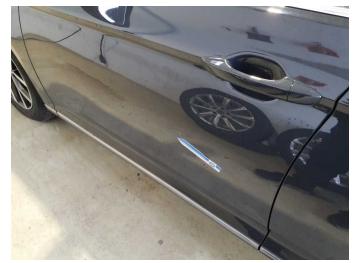
Damage 10: Door - rear left side: Door - Scratch(es) - Paint

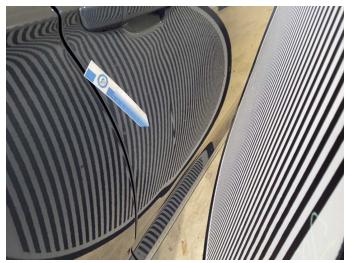
Damage 14: Door - front right side: Door - Dent / paintcoat damage - Repair and paint

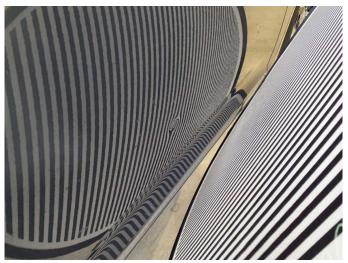
Damage 14: Door - front right side: Door - Dent / paintcoat damage - Repair and paint

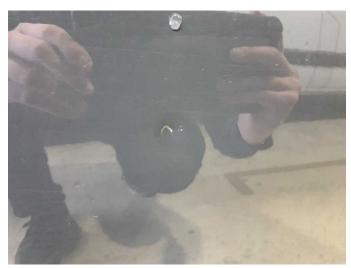
Damage 14: Door - front right side: Door - Dent / paintcoat damage - Repair and paint

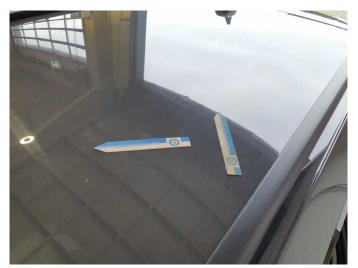
Damage 14: Door - front right side: Door - Dent / paintcoat damage - Repair and paint

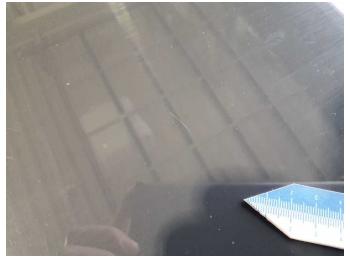
Damage 15: Roof: Roof - Scratched - Paint

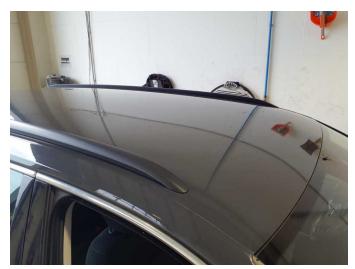
Damage 15: Roof: Roof - Scratched - Paint

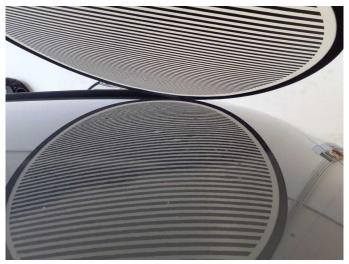
Damage 16: Body: Body - Damage by hail - repair according to calculation

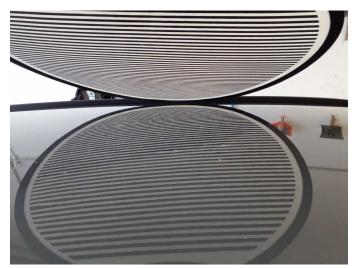
Damage 16: Body: Body - Damage by hail - repair according to calculation

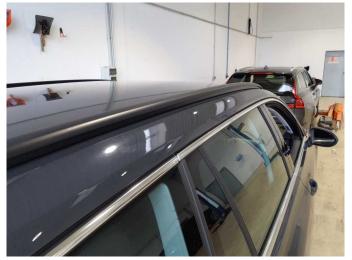
Damage 16: Body: Body - Damage by hail - repair according to calculation

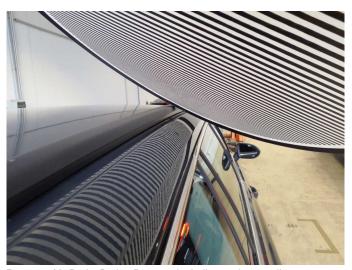
Damage 16: Body: Body - Damage by hail - repair according to

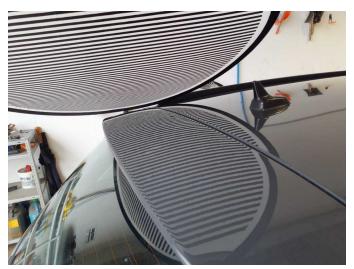
Damage 16: Body: Body - Damage by hail - repair according to calculation

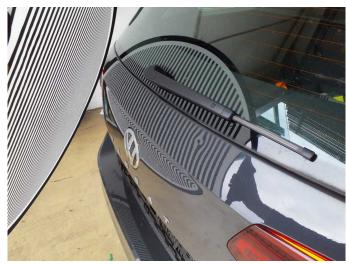
Damage 16: Body: Body - Damage by hail - repair according to calculation

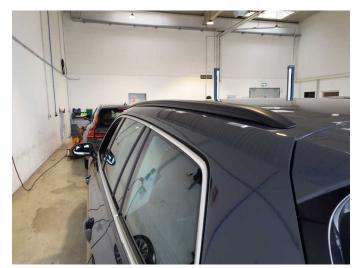
Damage 16: Body: Body - Damage by hail - repair according to calculation

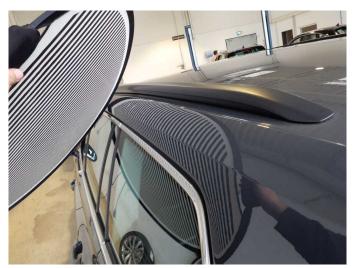
Damage 16: Body: Body - Damage by hail - repair according to calculation

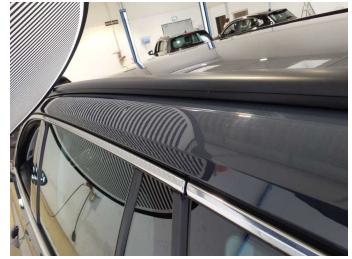
Damage 16: Body: Body - Damage by hail - repair according to calculation

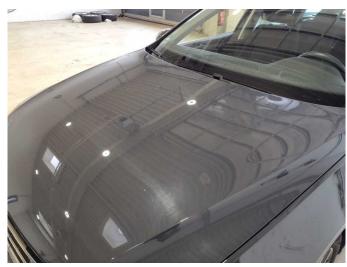
Damage 16: Body: Body - Damage by hail - repair according to calculation

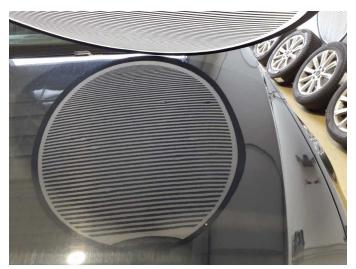
Damage 16: Body: Body - Damage by hail - repair according to calculation

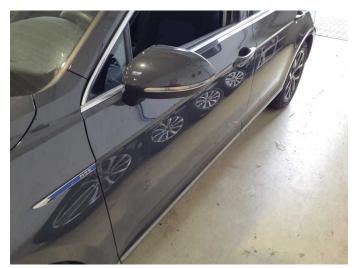
Damage 16: Body: Body - Damage by hail - repair according to calculation

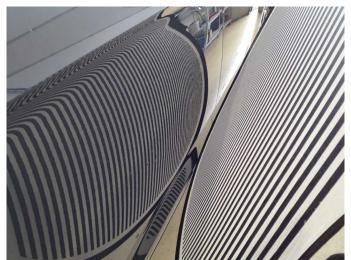
Damage 16: Body: Body - Damage by hail - repair according to calculation

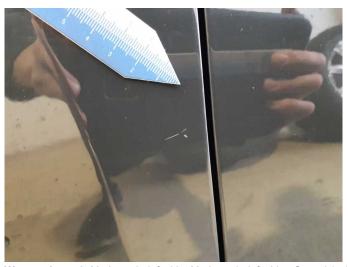
Wear and tear 1: Mudguard - left side: Mudguard - left side - Scratch(es) - No deduction

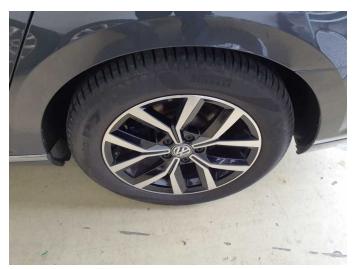
Wear and tear 1: Mudguard - left side: Mudguard - left side - Scratch(es) - No deduction

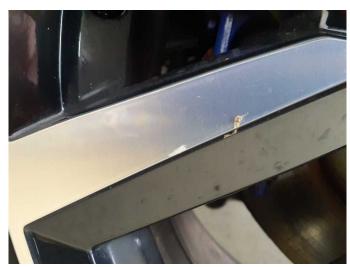
Wear and tear 2: Wheel / tyres: Alloy rim - rear left side - Scratch(es) - No deduction

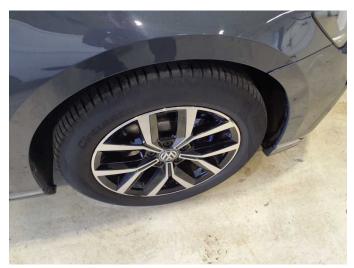
Wear and tear 2: Wheel / tyres: Alloy rim - rear left side - Scratch(es) - No deduction

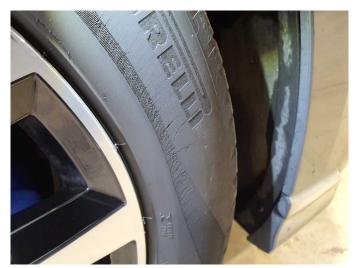
Wear and tear 3: Wheel / tyres: Tyre - front right side - Abrasion - No deduction
