Expertise

Protocol number: 41468356  
Order No. / Reference: 25144539  
Inspection date: 8 Sept 2025

Manufacturer: Volkswagen

Model: Passat Variant 1.4 TSI Plug-In-Hybrid DSG GTE

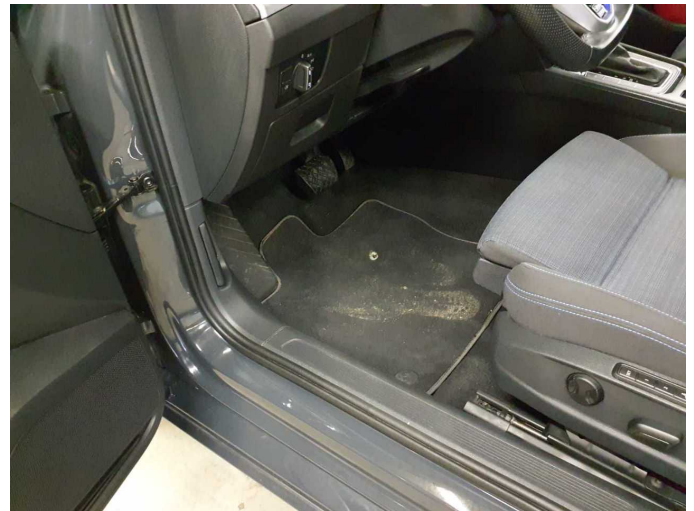
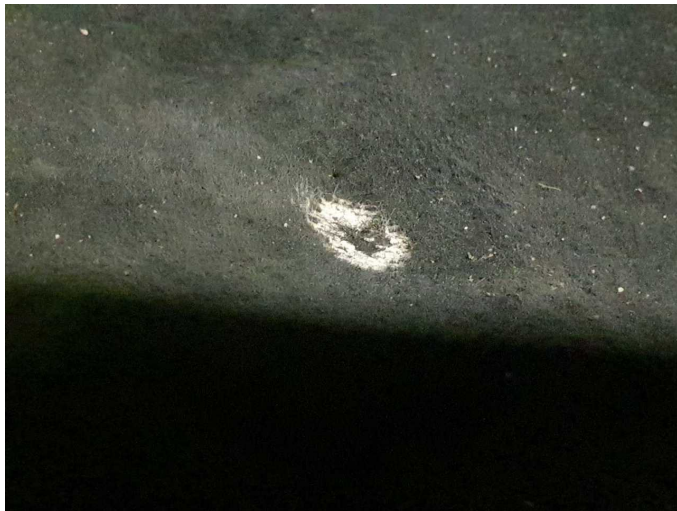
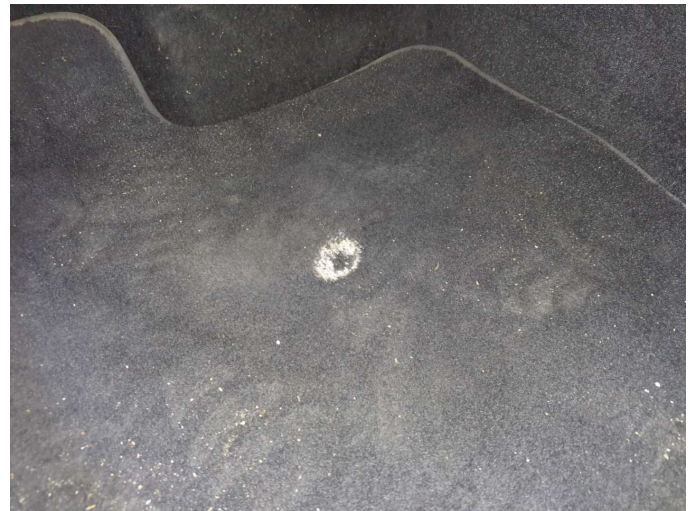
| No. | Component group | Description |
|---|---|---|
| 1 | Trim / covers | Floor mats - Holes - Replace |

**Damage 1:** Trim / covers: Floor mats - Holes - Replace

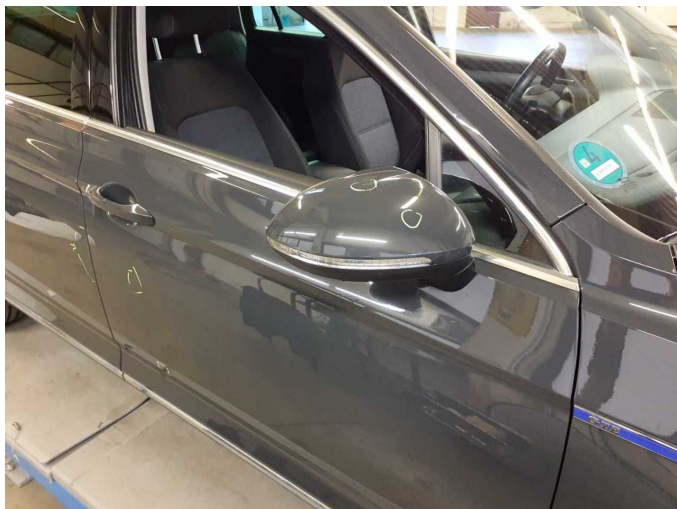
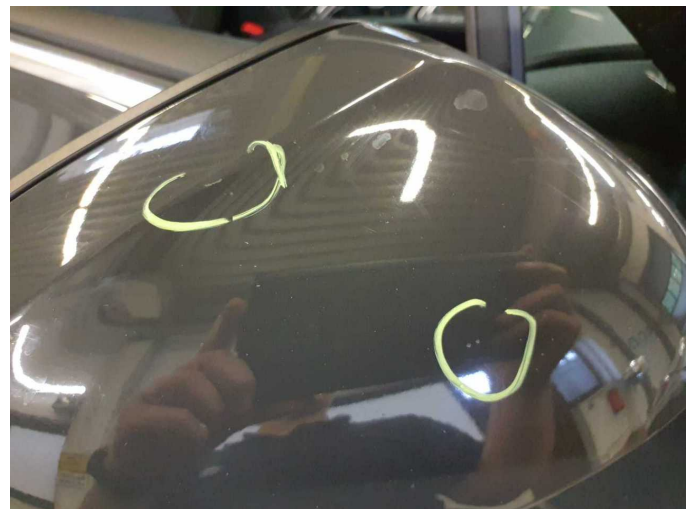
| No. | Component group | Description |
|---|---|---|
| 2 | Wing mirror - right side | Cap - Scratched - Smart repair |

**Damage 2:** Wing mirror - right side: Cap - Scratched - Smart repair

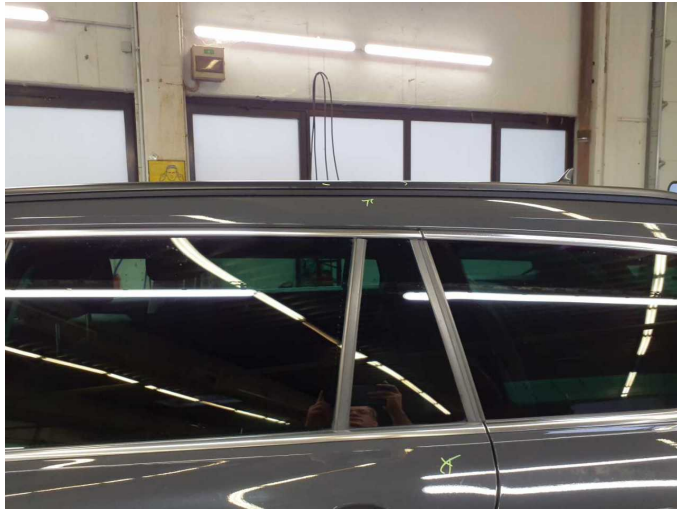
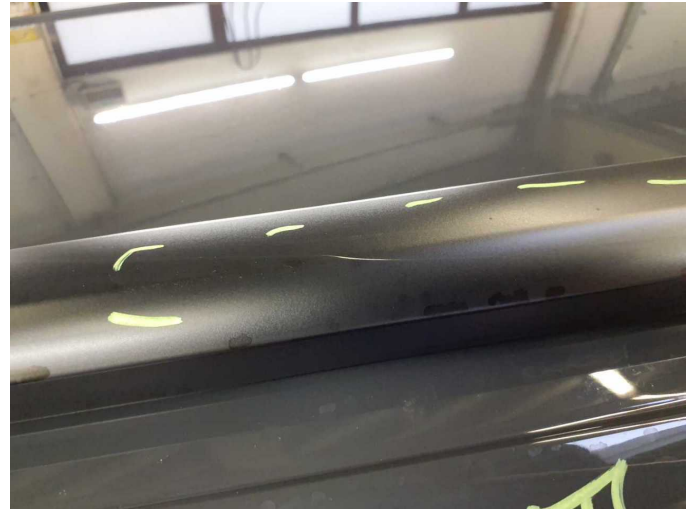
| No. | Component group | Description |
|---|---|---|
| 3 | Roof | Roof rail - left side - Scratched - Smart repair |

**Damage 3:** Roof: Roof rail - left side - Scratched - Smart repair

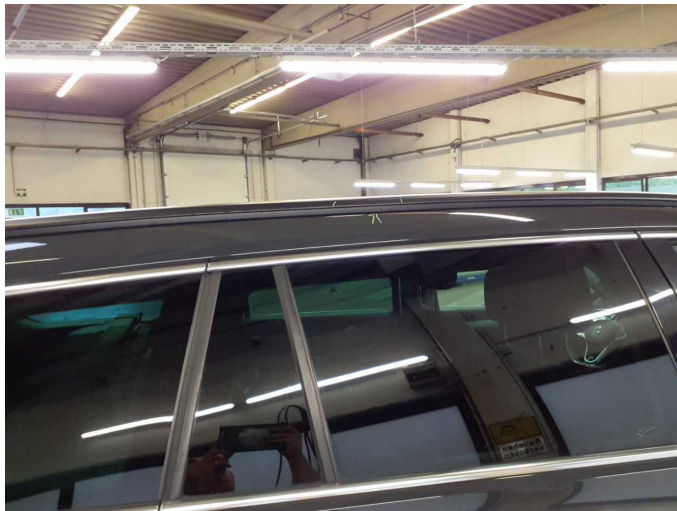
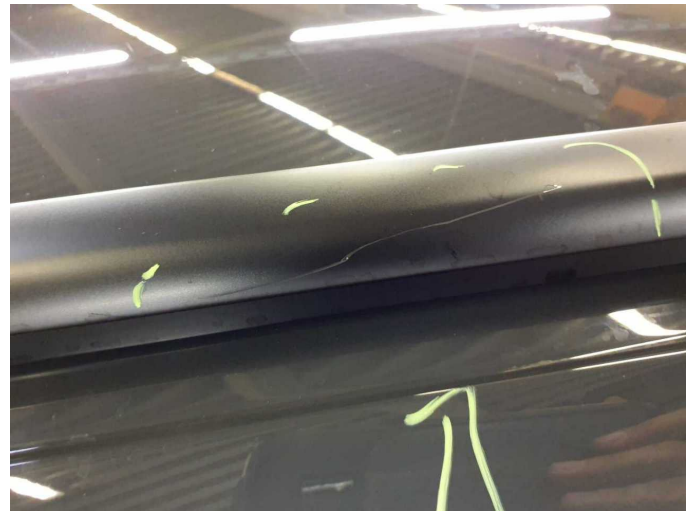
| No. | Component group | Description |
|---|---|---|
| 4 | Roof | Roof rail - right side - Scratched - Smart repair |

**Damage 4:** Roof: Roof rail - right side - Scratched - Smart repair

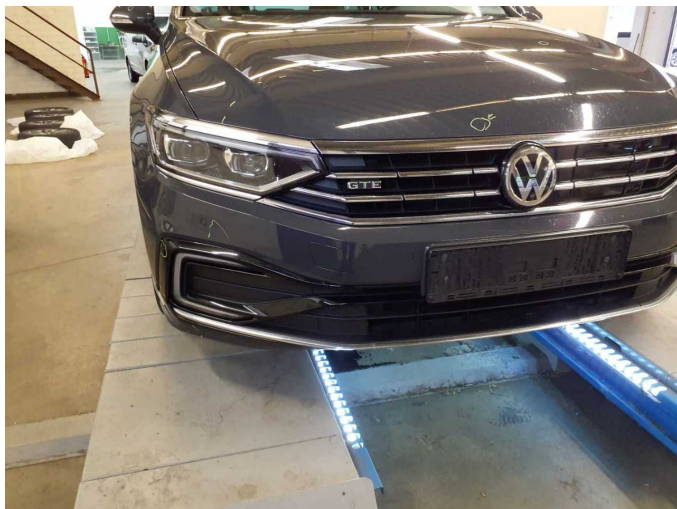
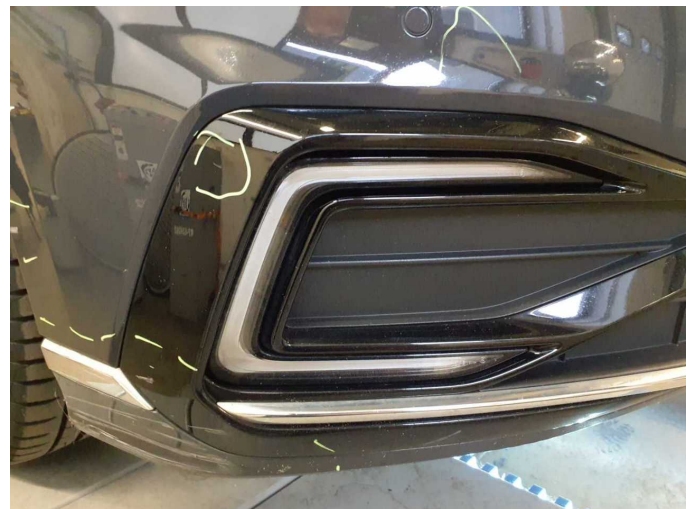
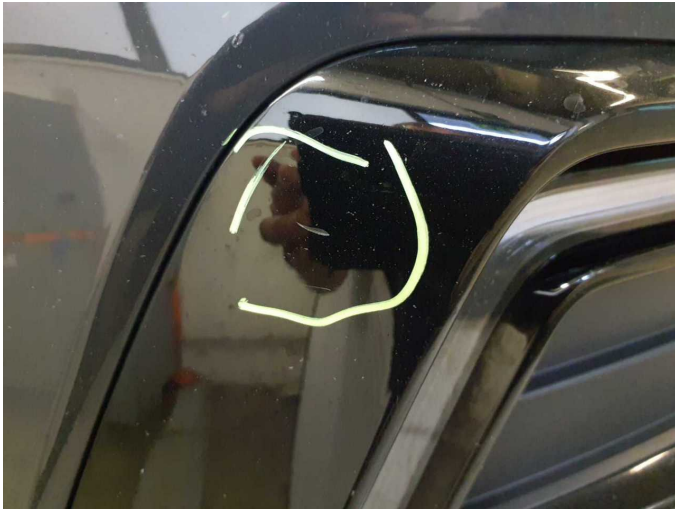
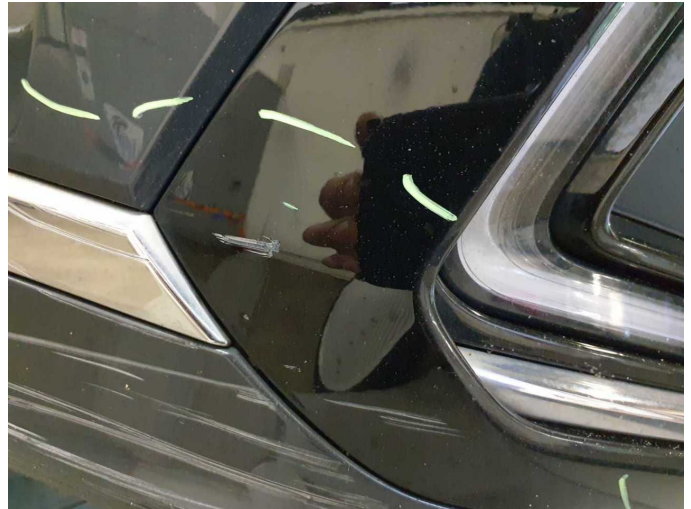
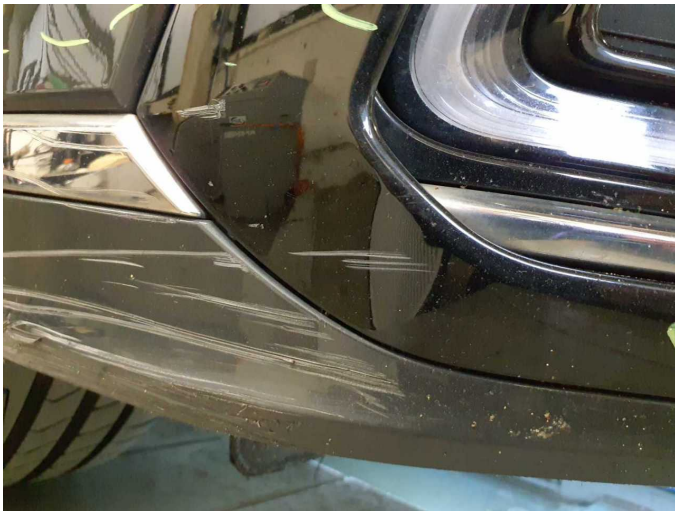
| No. | Component group | Description |
|---|---|---|
| 5 | Front bumper | Cover bumper - front (Materialabtrag) - Scratched - Replace |

**Damage 5:** Front bumper: Cover bumper - front (Materialabtrag) - Scratched - Replace

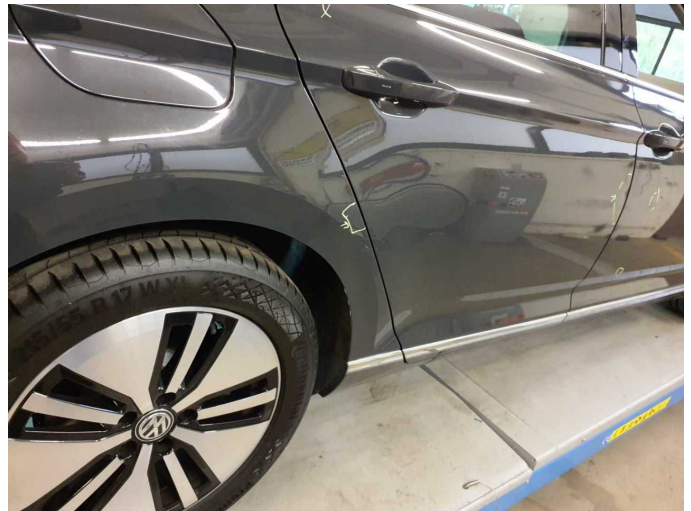
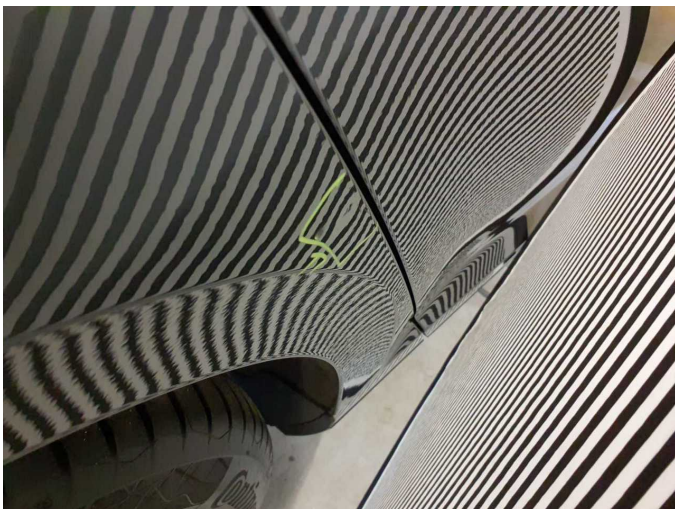
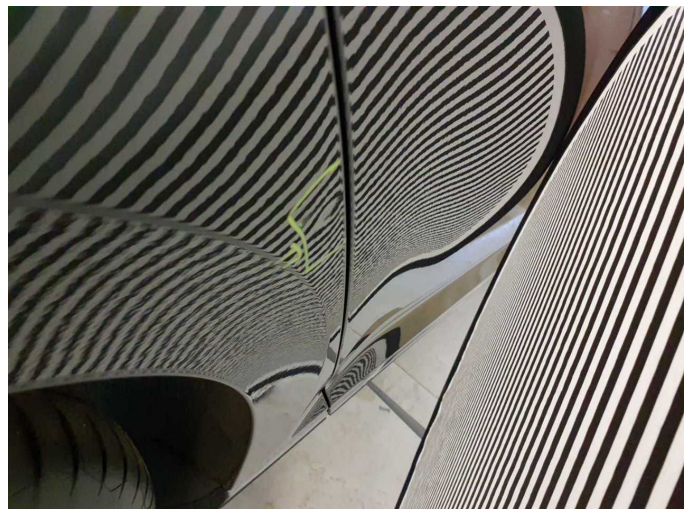
| No. | Component group | Description |
|---|---|---|
| 6 | Side panel - rear right side | Side panel - dent(s) - Smooth repair work |

**Damage 6:** Side panel - rear right side: Side panel - dent(s) - Smooth repair work

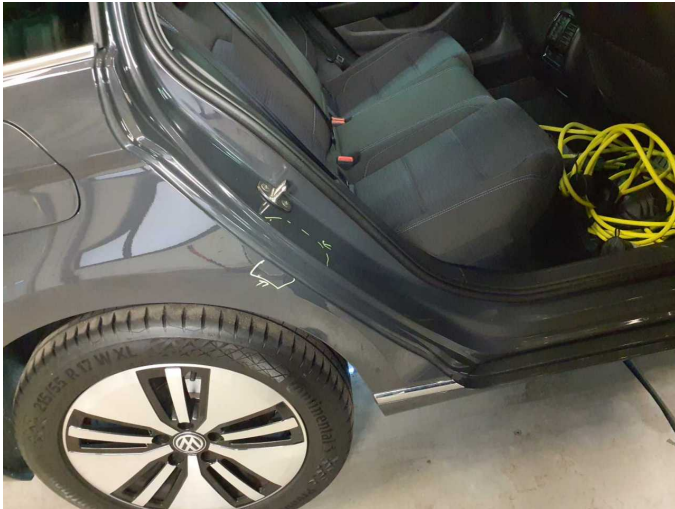
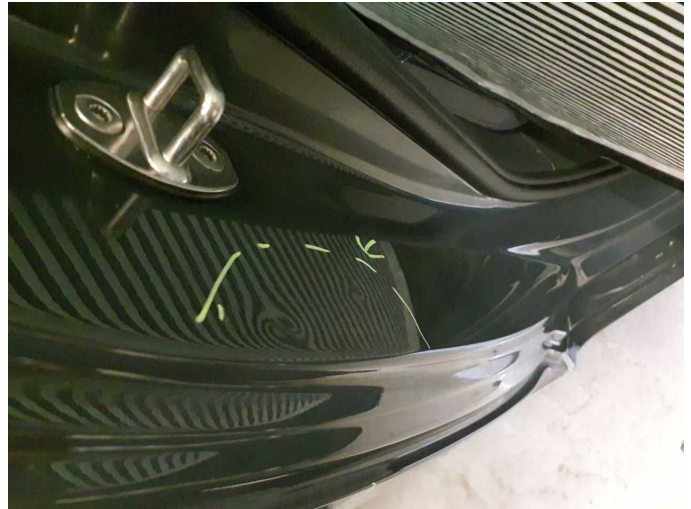
| No. | Component group | Description |
|---|---|---|
| 7 | Side panel - rear right side | Sill - dent(s) - Smooth repair work |

**Damage 7:** Side panel - rear right side: Sill - dent(s) - Smooth repair work

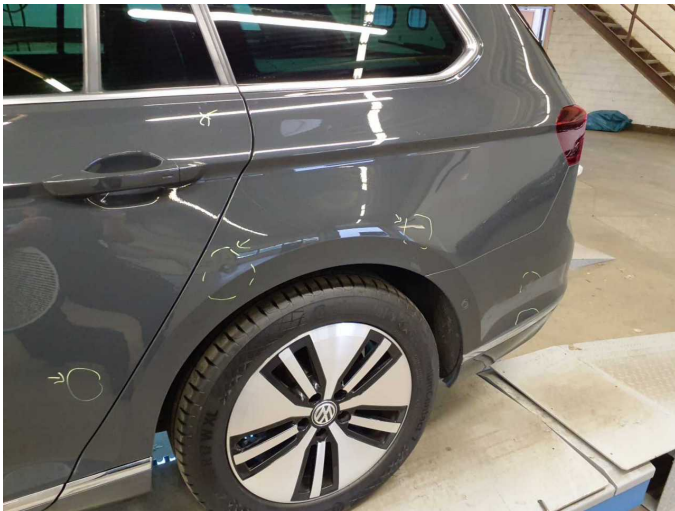
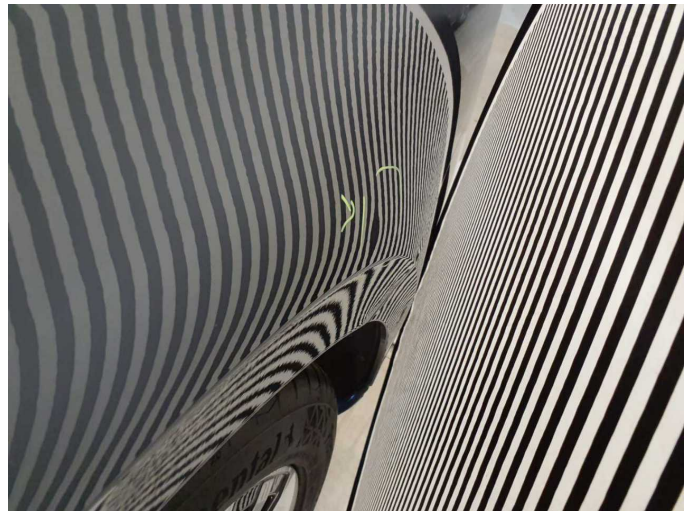
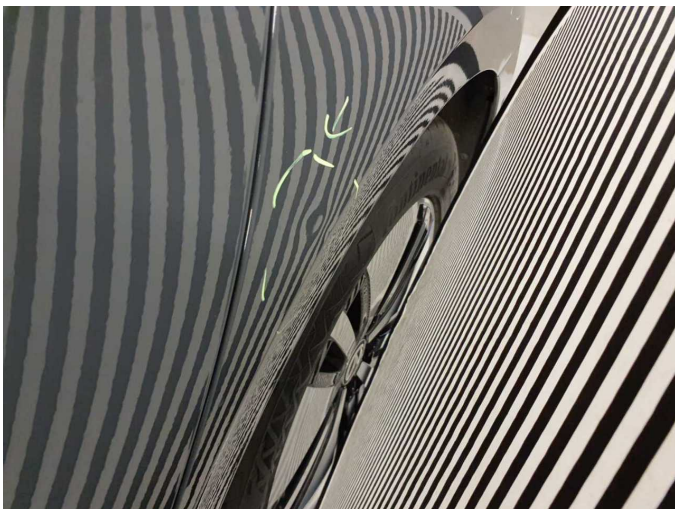
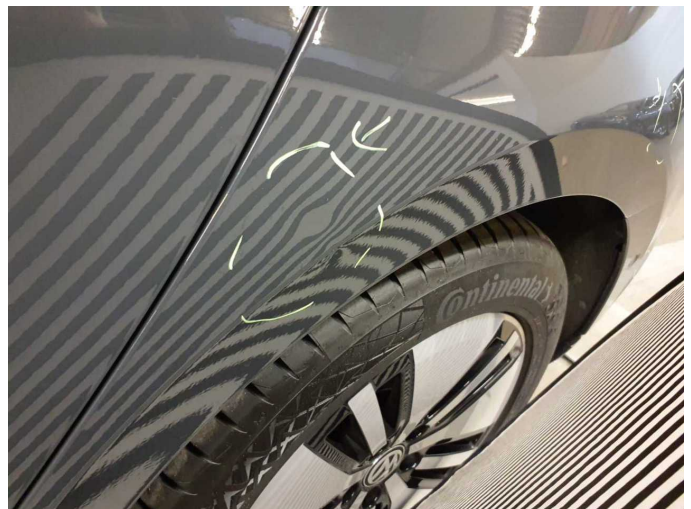
| No. | Component group | Description |
|---|---|---|
| 8 | Side panel - rear left side | Side panel - dent(s) - Smooth repair work |

**Damage 8:** Side panel - rear left side: Side panel - dent(s) - Smooth repair work

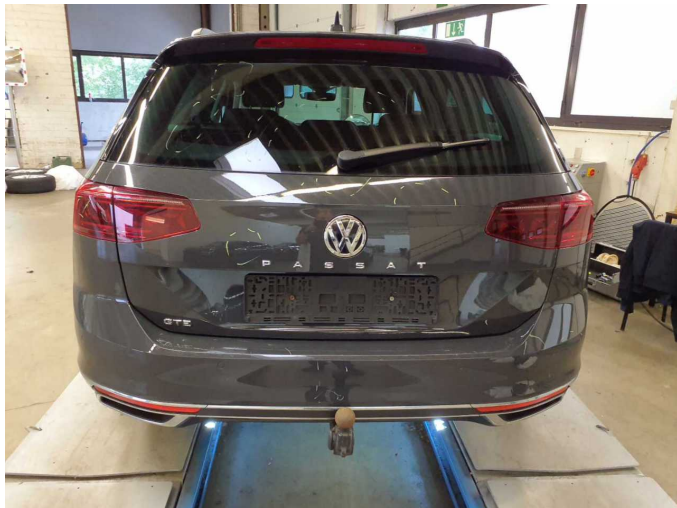
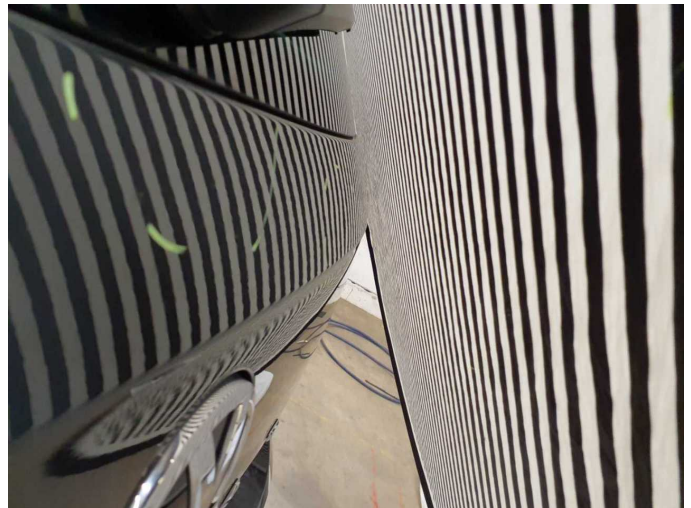
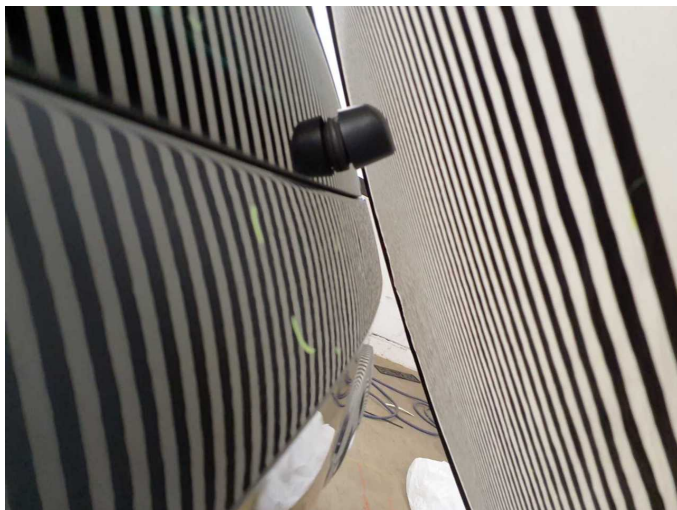
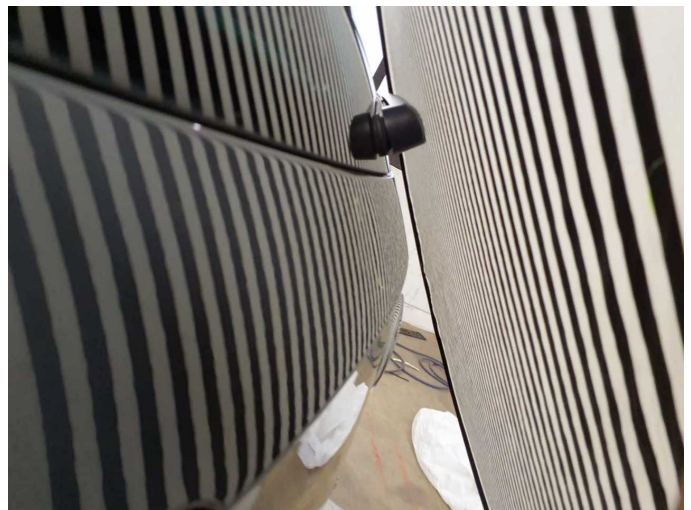
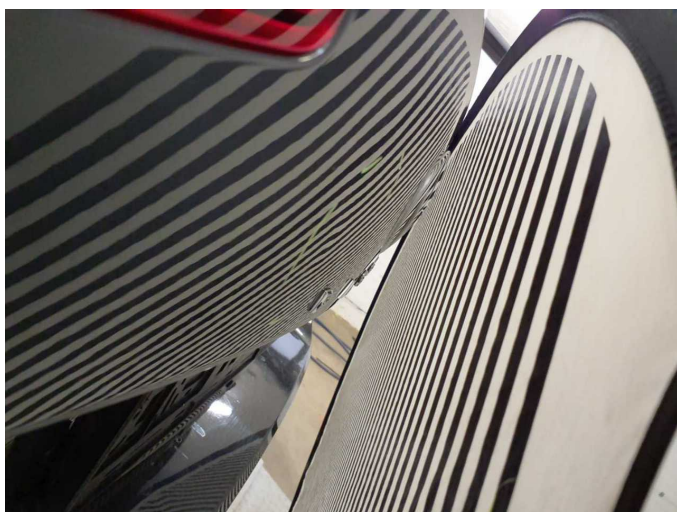
| No. | Component group | Description |
|---|---|---|
| 9 | Boot lid / rear door | Boot lid - dent(s) - Smooth repair work |

**Damage 9:** Boot lid / rear door: Boot lid - dent(s) - Smooth repair work

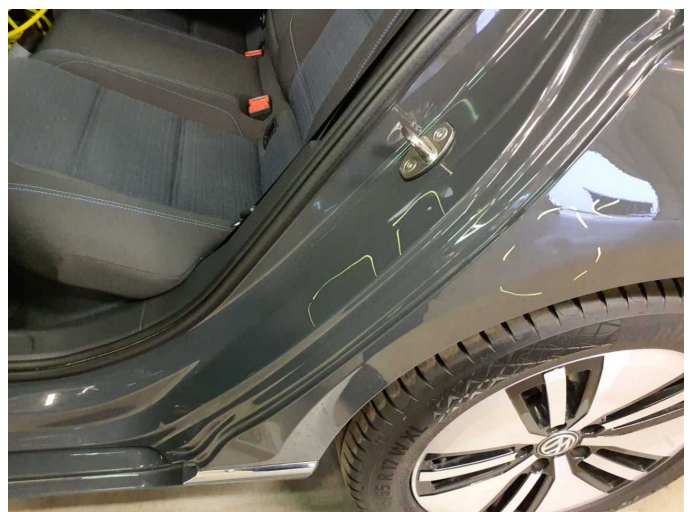
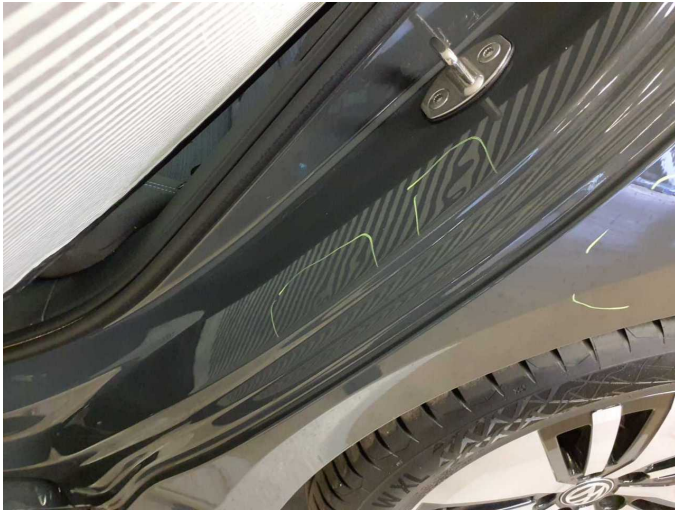
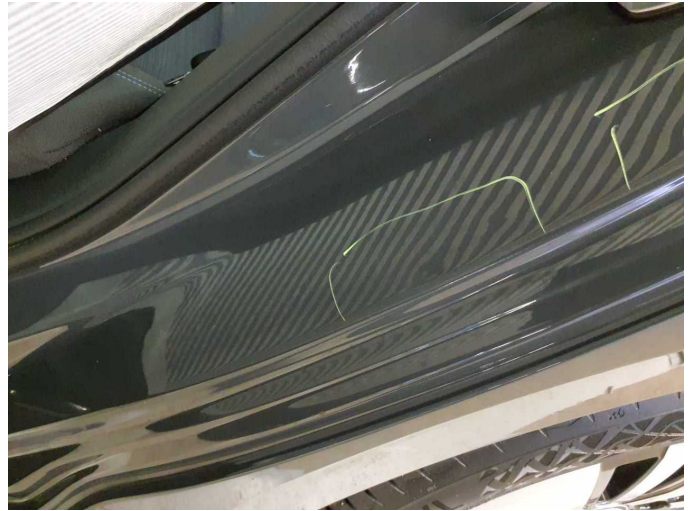
| No. | Component group | Description |
|---|---|---|
| 10 | Side panel - rear left side | Sill - dent(s) - Smooth repair work |

**Damage 10:** Side panel - rear left side: Sill - dent(s) - Smooth repair work

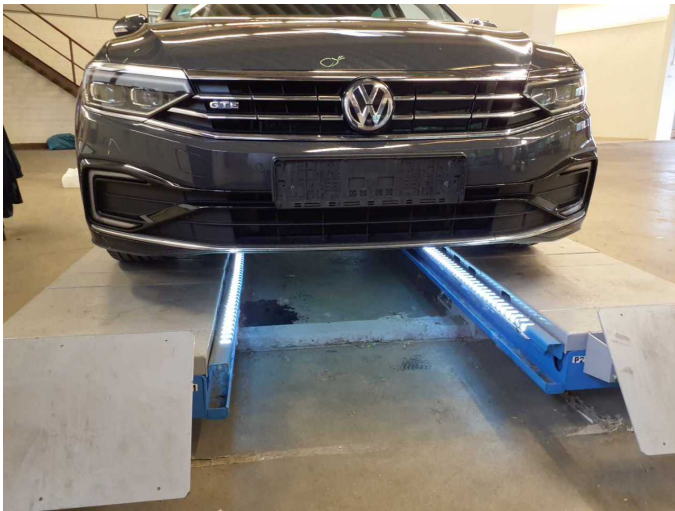
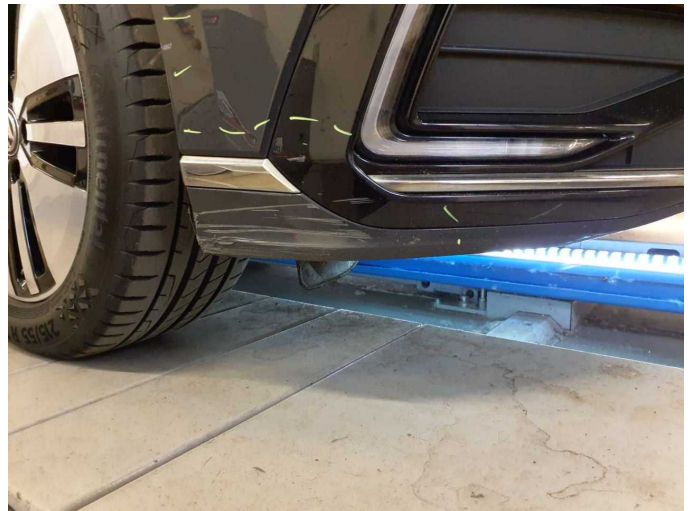
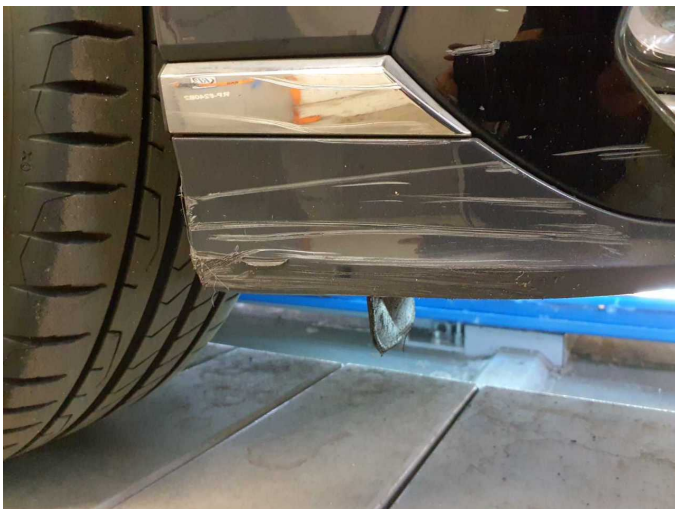
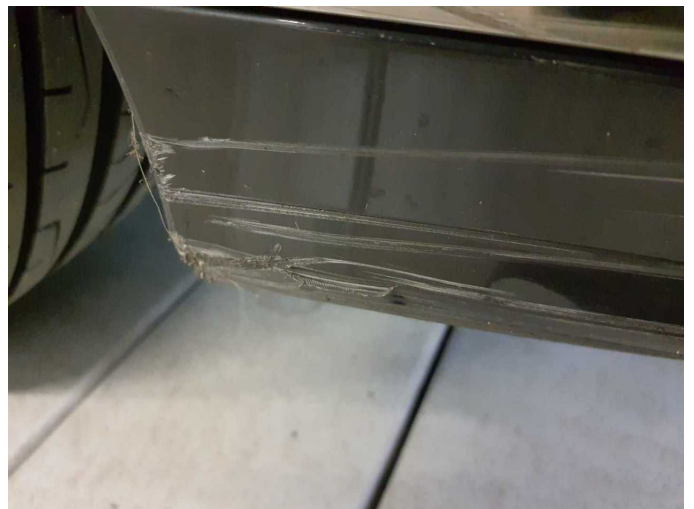
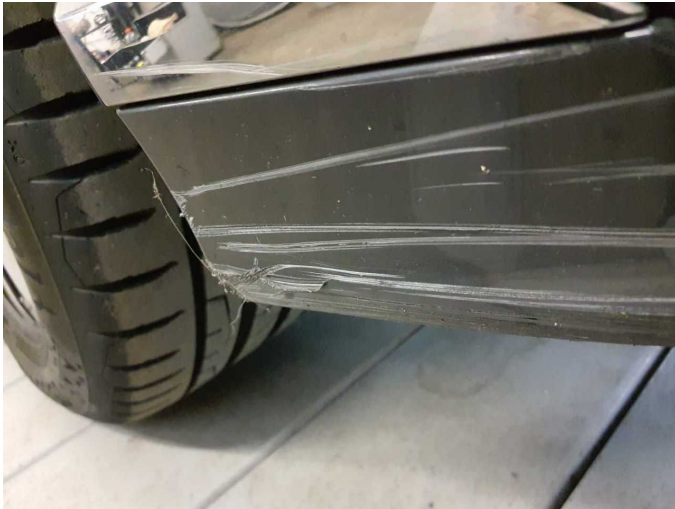
| No. | Component group | Description |
|---|---|---|
| 11 | Front bumper | Spoiler (Materialabtrag) - Scratched - Replace |

**Damage 11:** Front bumper: Spoiler (Materialabtrag) - Scratched - Replace

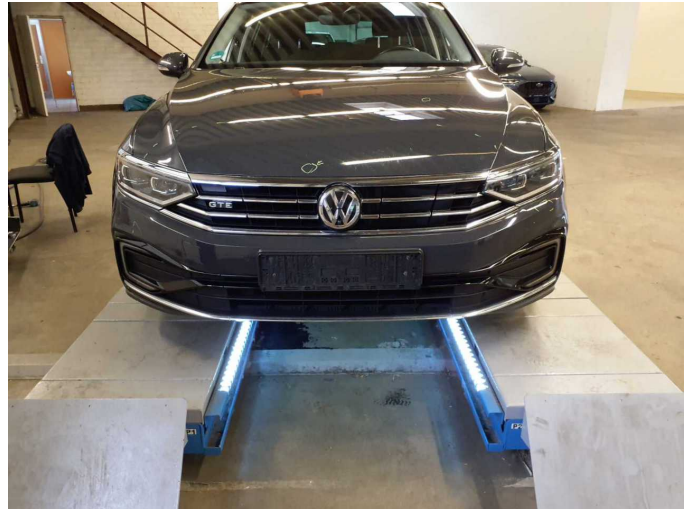
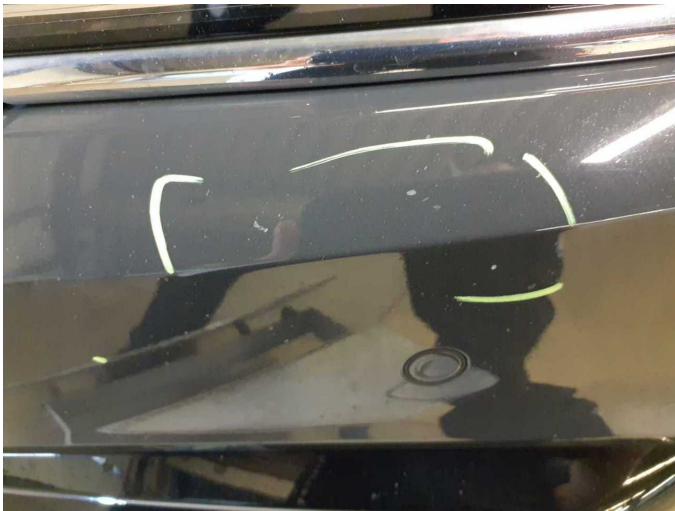
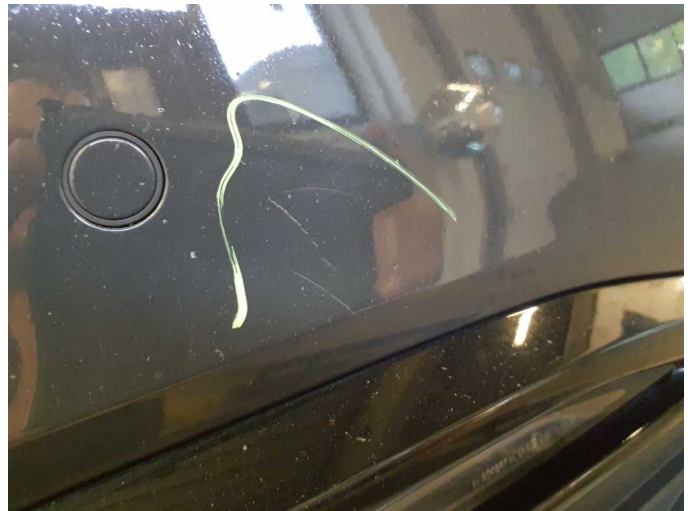
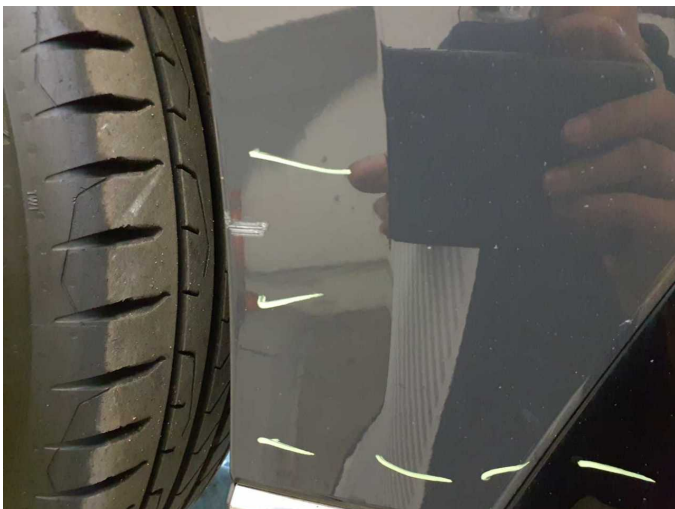
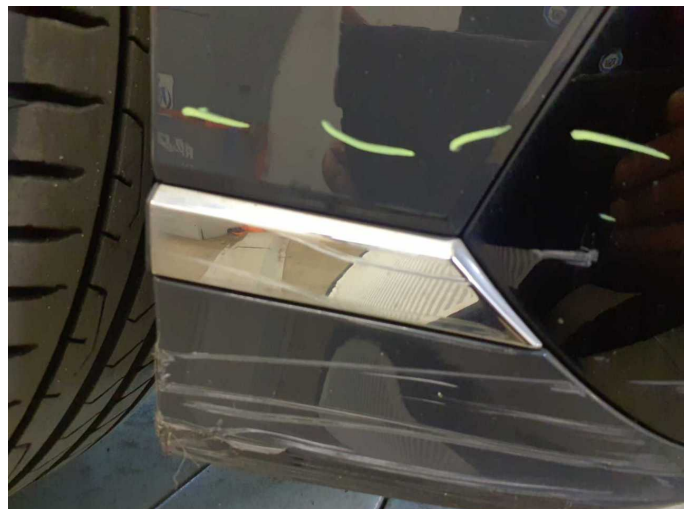
| No. | Component group | Description |
|---|---|---|
| 12 | Front bumper | Front bumper - Scratched - Paint |

**Damage 12:** Front bumper: Front bumper - Scratched - Paint

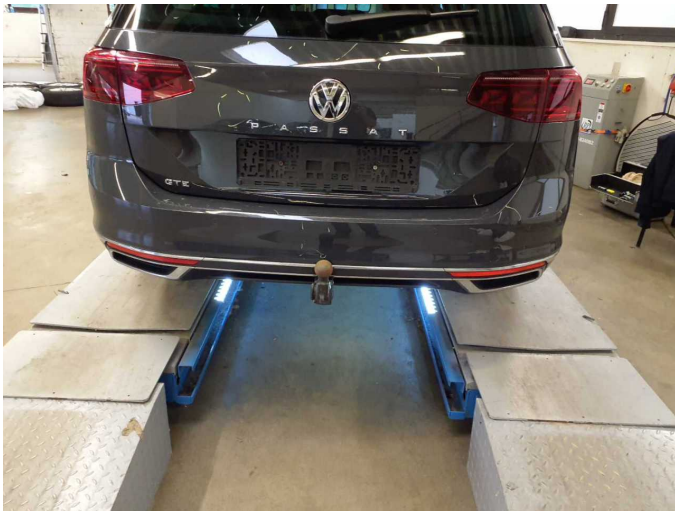
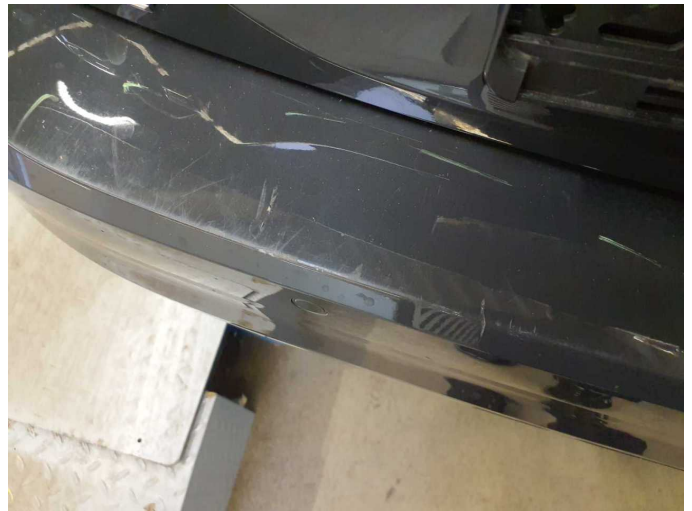
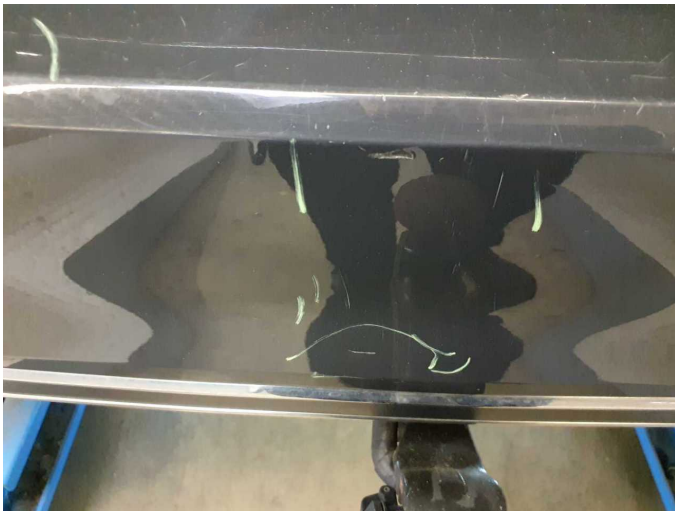
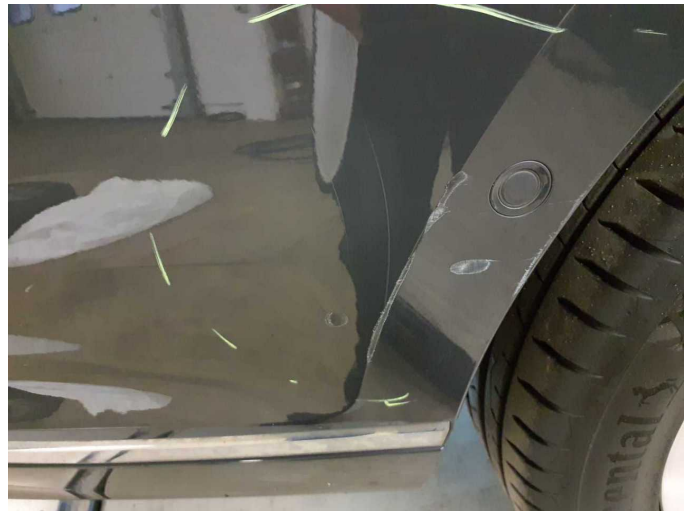
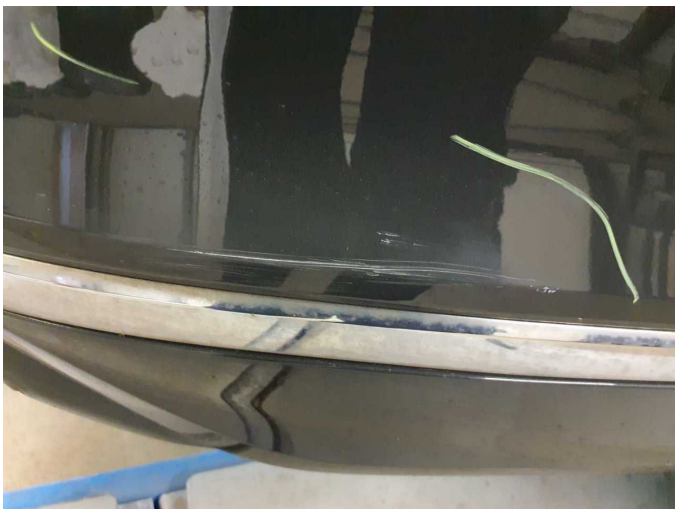
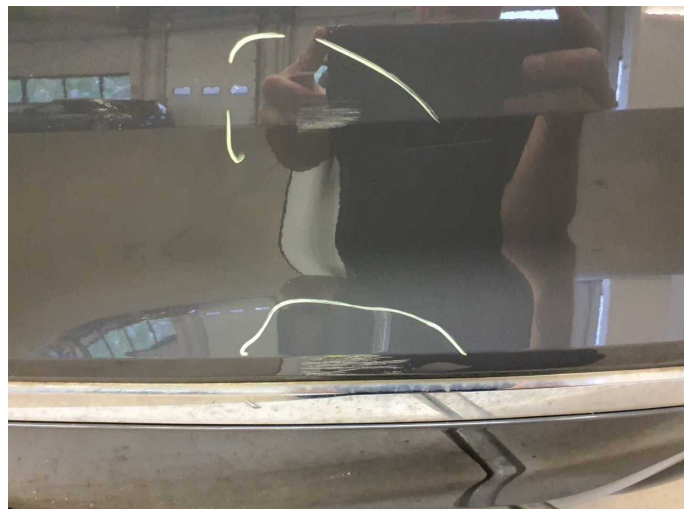
| No. | Component group | Description |
|---|---|---|
| 13 | Rear bumper | Rear bumper - Scratched - Paint |

**Damage 13:** Rear bumper: Rear bumper - Scratched - Paint

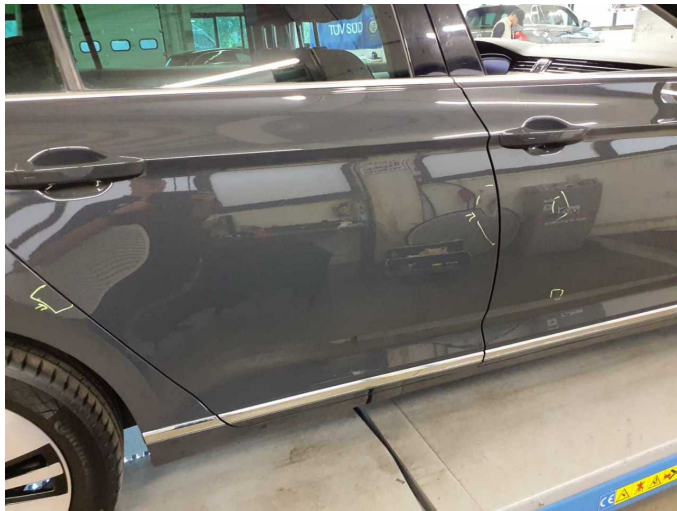
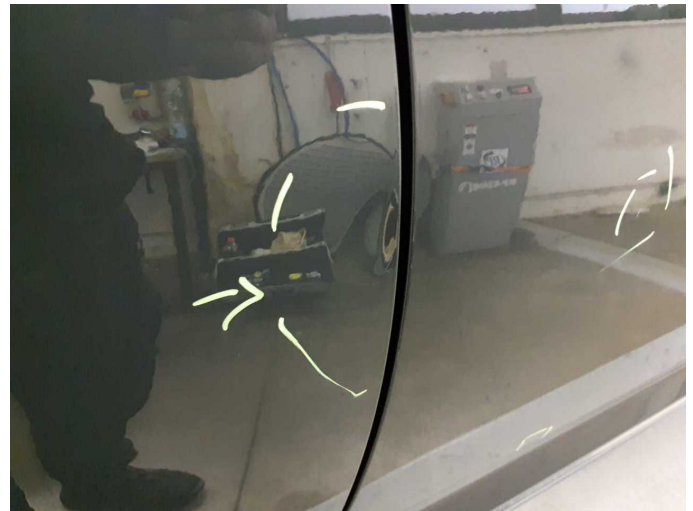
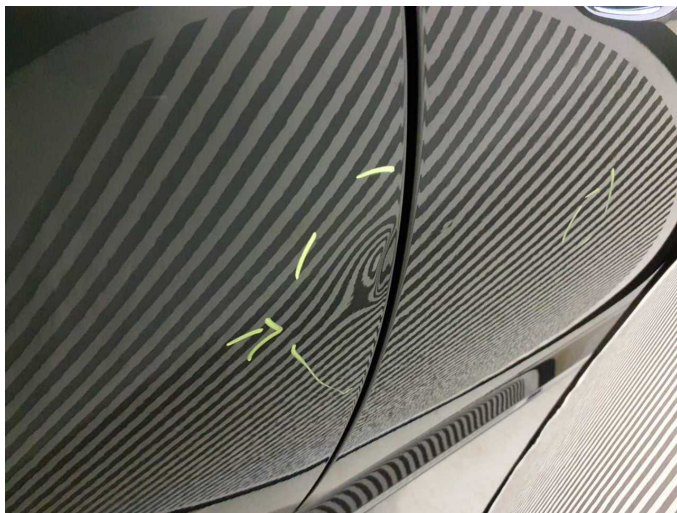
| No. | Component group | Description |
|---|---|---|
| 14 | Door - rear right side | Door - dent(s) - Repair and paint |

**Damage 14:** Door - rear right side: Door - dent(s) - Repair and paint

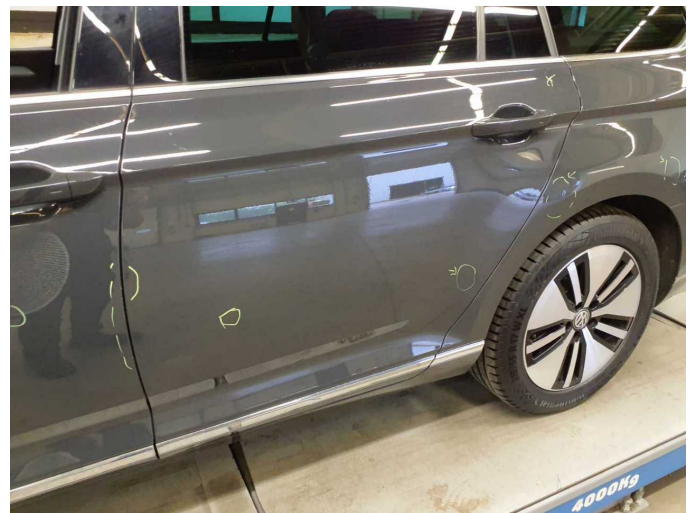
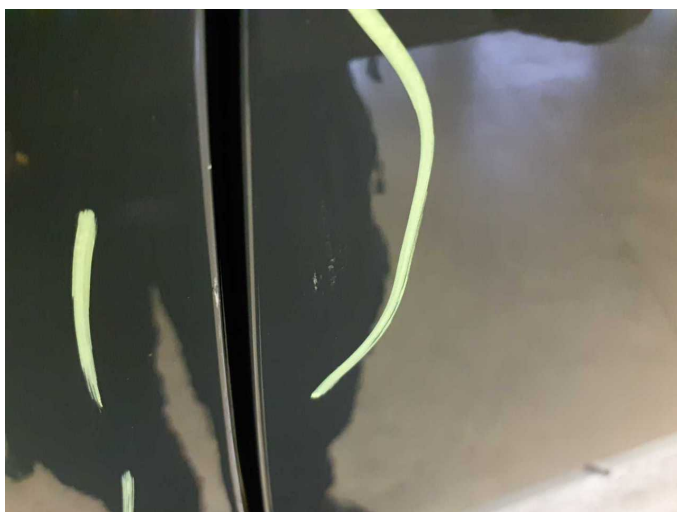
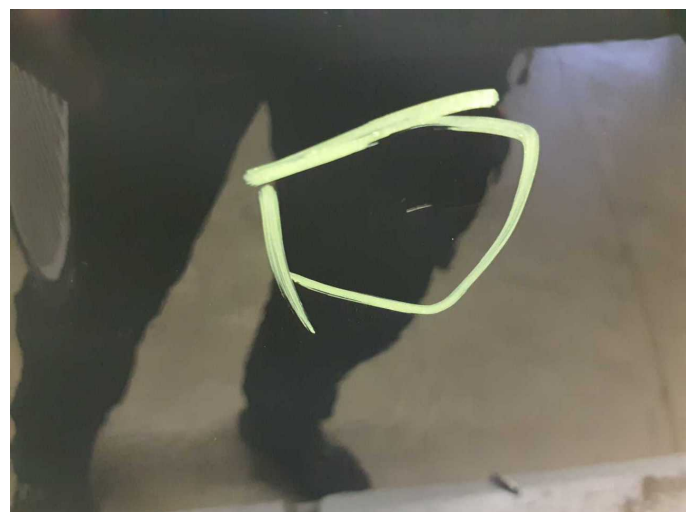
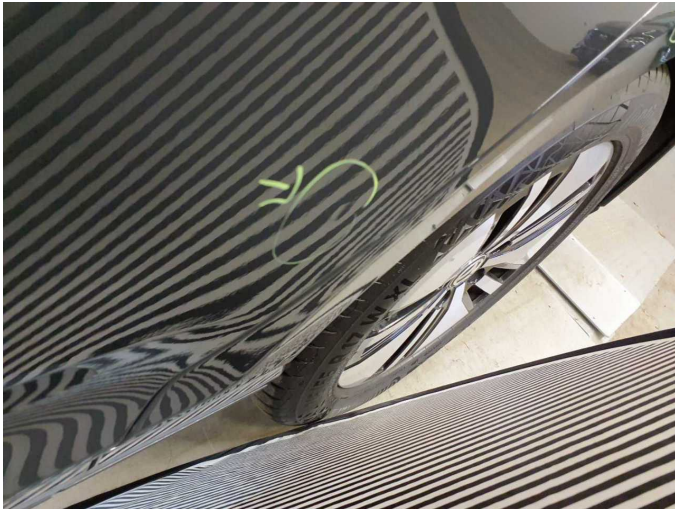
| No. | Component group | Description |
|---|---|---|
| 15 | Door - rear left side | Door - Dent / paintcoat damage - Repair and paint |

**Damage 15:** Door - rear left side: Door - Dent / paintcoat damage - Repair and paint

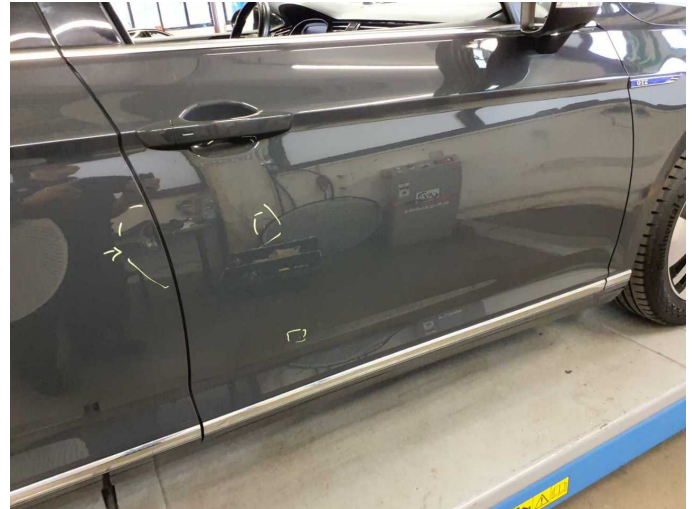
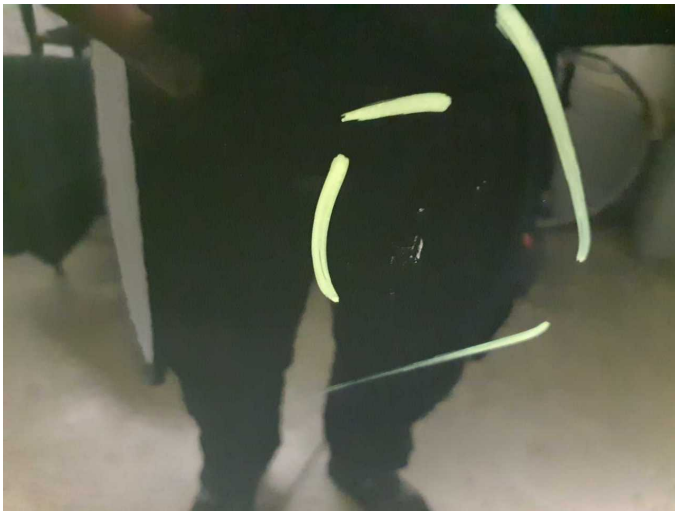
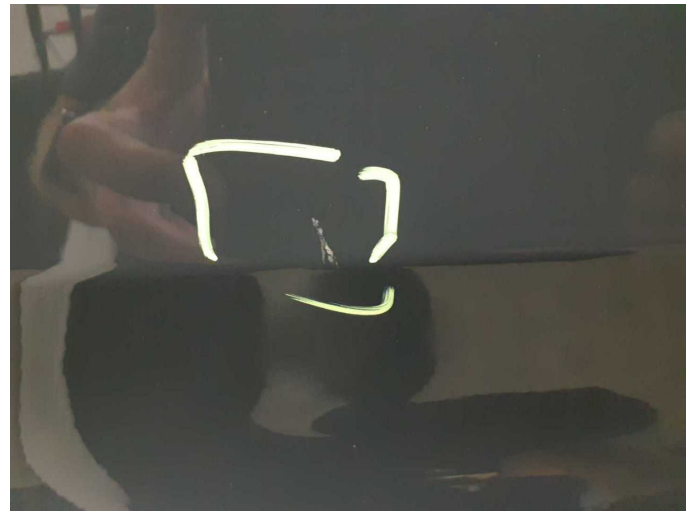
| No. | Component group | Description |
|---|---|---|
| 16 | Door - front right side | Door - Scratched - Paint |

**Damage 16:** Door - front right side: Door - Scratched - Paint

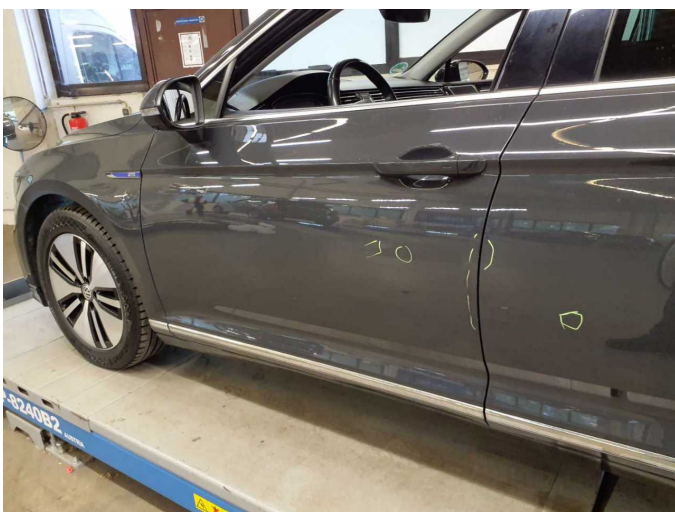
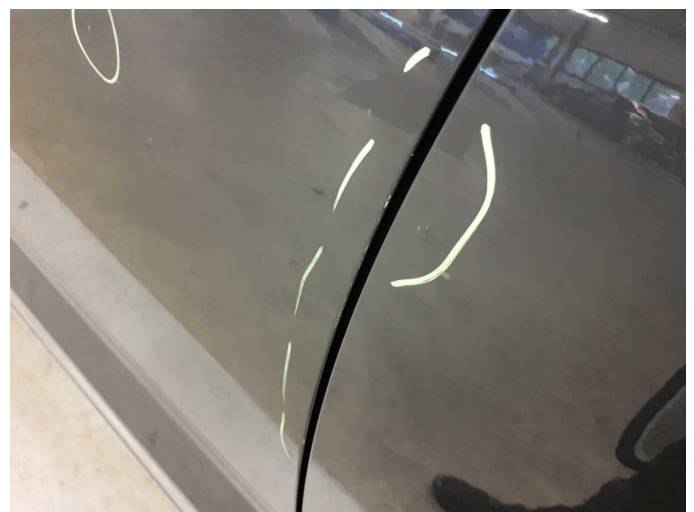
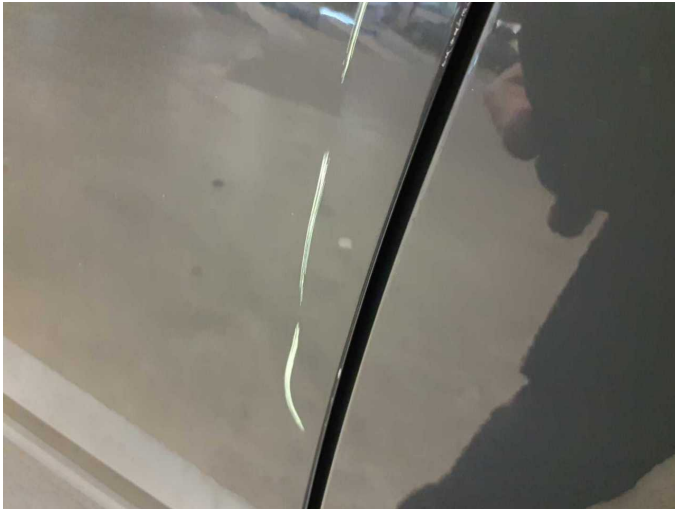
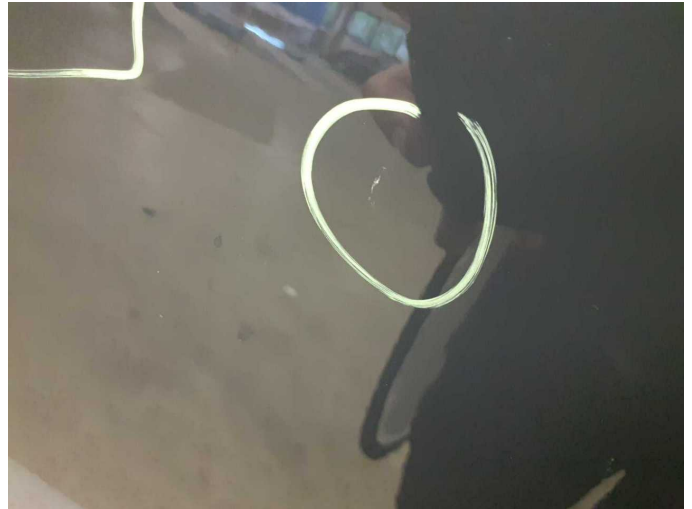
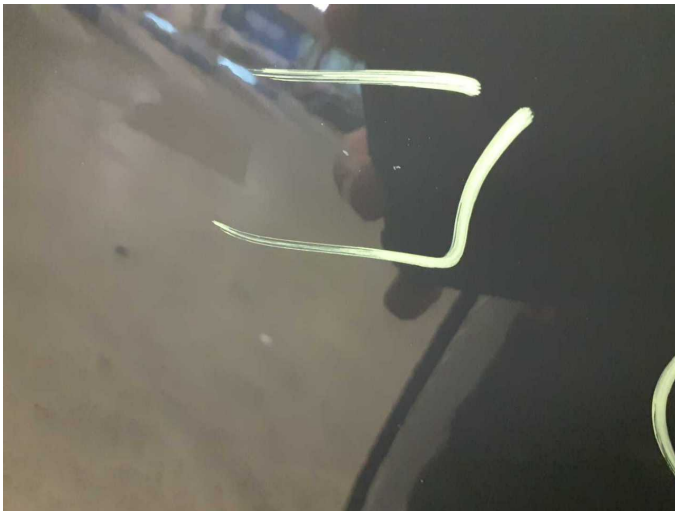
| No. | Component group | Description |
|---|---|---|
| 17 | Door - front left side | Door - Scratched - Paint |

**Damage 17:** Door - front left side: Door - Scratched - Paint
