Expertise

Protocol number: 41468356  
Order No. / Reference: 25144539  
Inspection date: 8 Sept 2025

Manufacturer: Volkswagen

Model: Passat Variant 1.4 TSI Plug-In-Hybrid DSG GTE

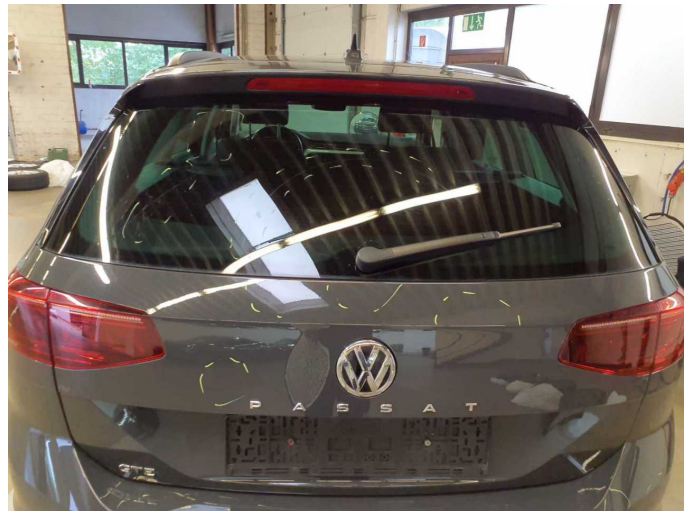
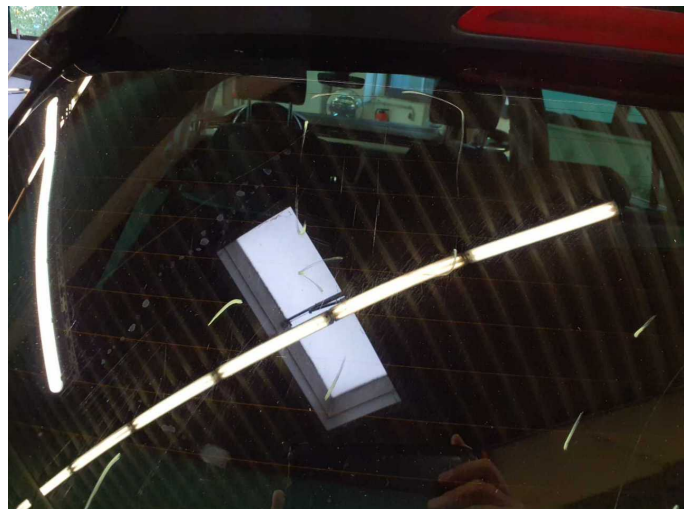
| No. | Component group | Description |
|---|---|---|
| 18 | Vehicle glazing | Rear window - Scratched - Replace |

**Damage 18:** Vehicle glazing: Rear window - Scratched - Replace

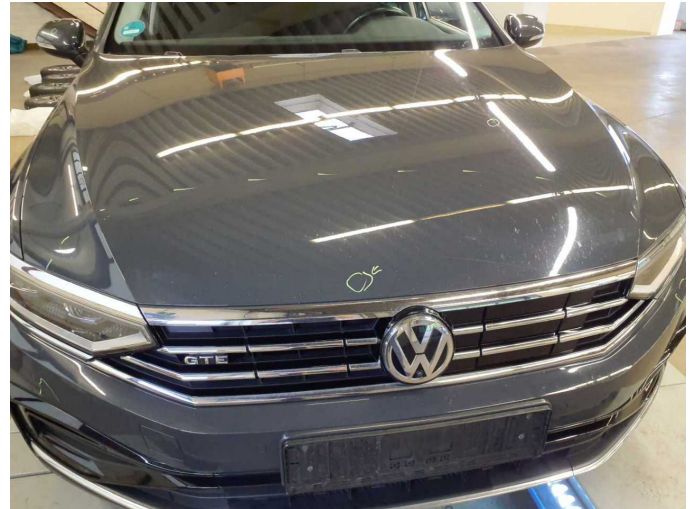
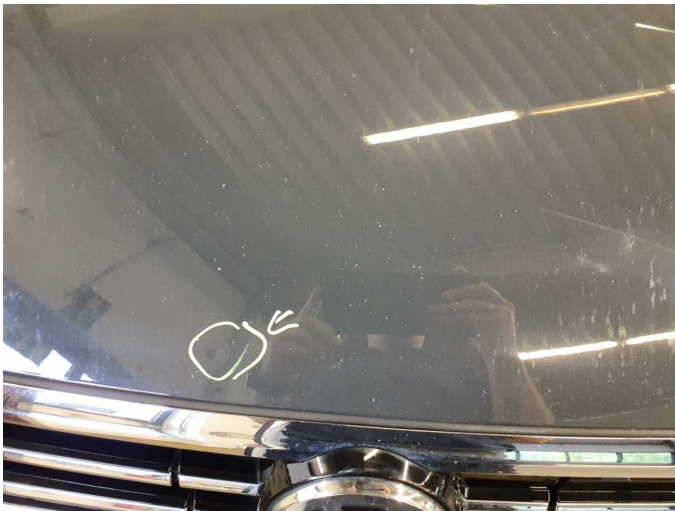
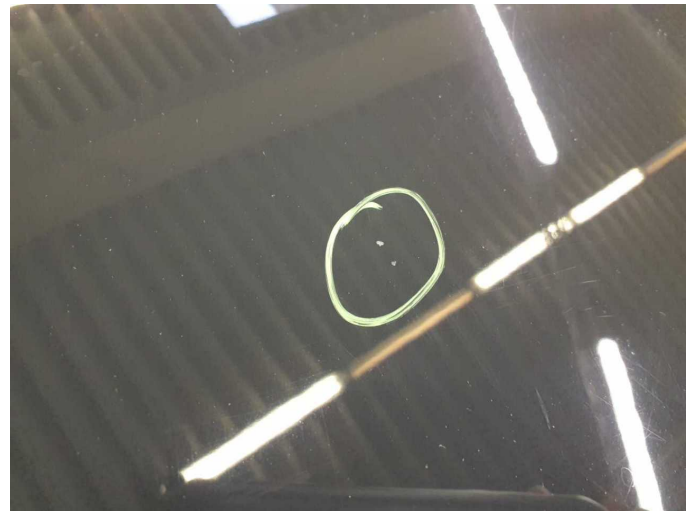
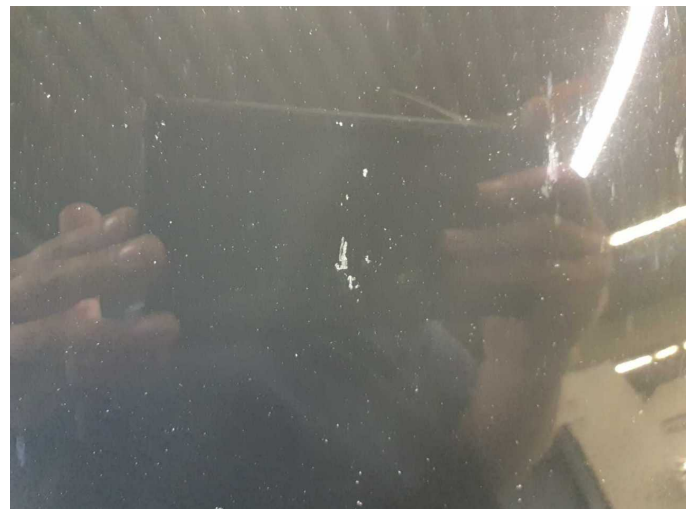
| No. | Component group | Description |
|---|---|---|
| 19 | Bonnet | Bonnet - Dent / paintcoat damage - Repair and paint |

**Damage 19:** Bonnet: Bonnet - Dent / paintcoat damage - Repair and paint

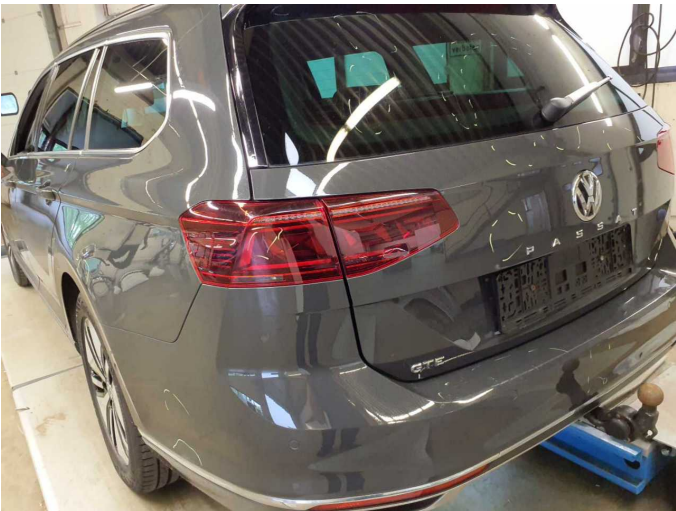
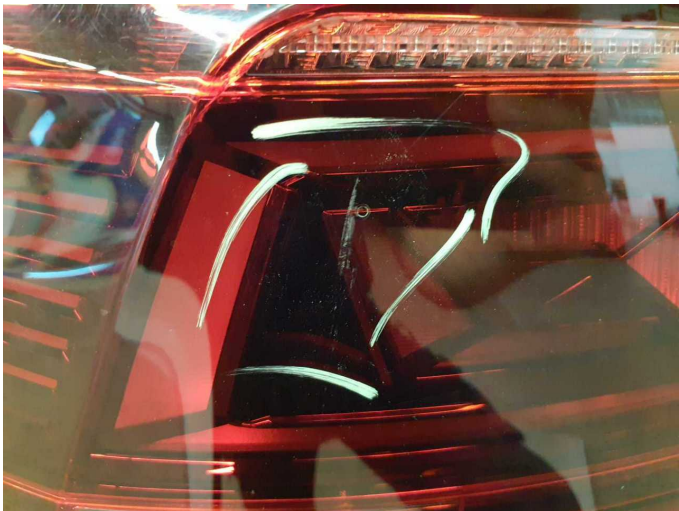
| No. | Component group | Description |
|---|---|---|
| 3 | Tail light | Tail lamp - left side - Scratched - No deduction |

**Wear and tear 3:** Tail light: Tail lamp - left side - Scratched - No deduction
