Expertise

Protocol number: 39852294  
Order No. / Reference: 24717176  
Inspection date: 22 May 2025

Manufacturer: Volkswagen

Model: Passat Variant 2.0 TDI SCR Business

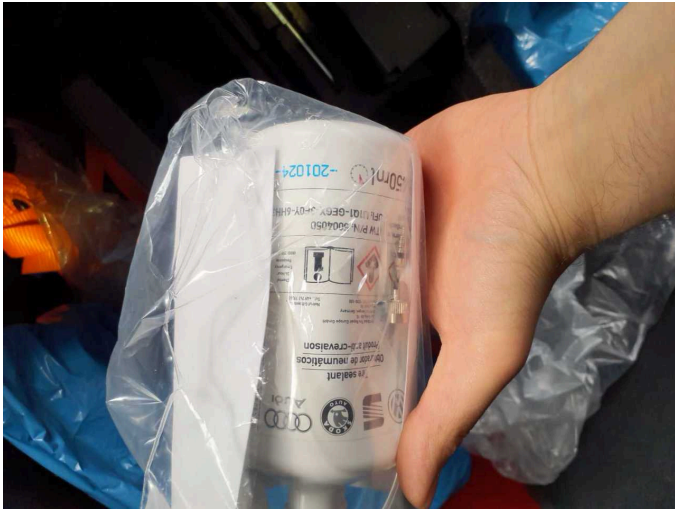
| No. | Component group | Description |
|---|---|--|
| 1 | Equipment | Tirefit filler - Expired - Replace |

**Damage 1:** Equipment: Tirefit filler - Expired - Replace

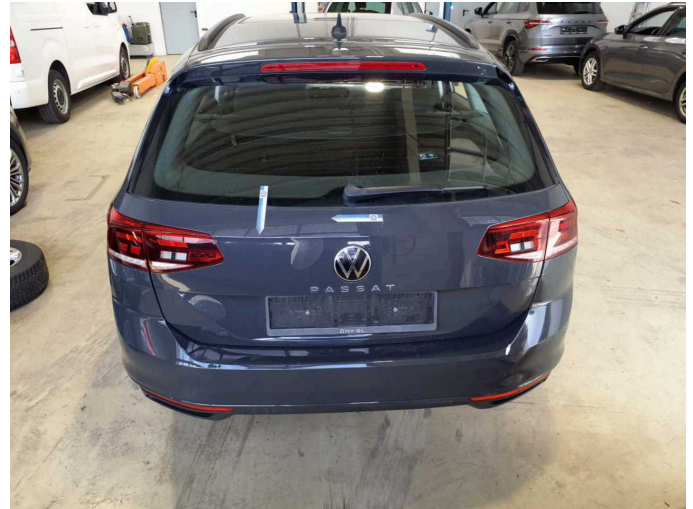
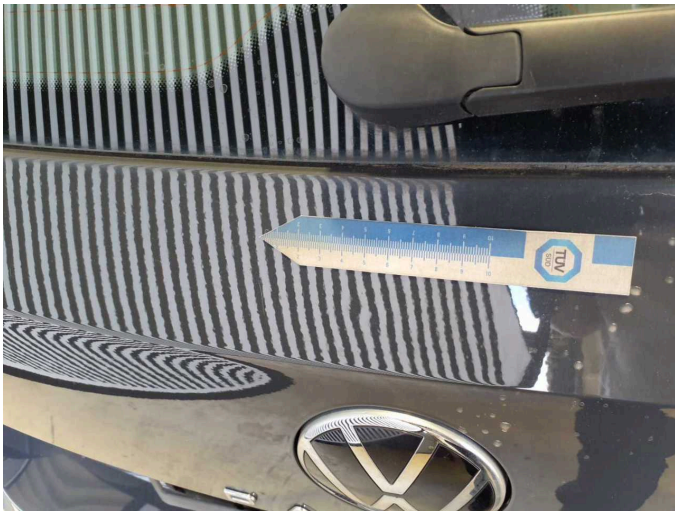
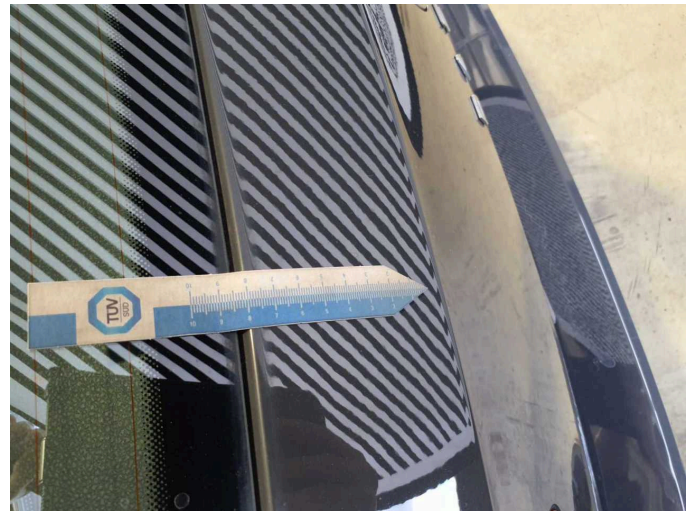
| No. | Component group | Description |
|---|---|--|
| 2 | Boot lid / rear door | Boot lid - dent(s) - Smooth repair work |

**Damage 2:** Boot lid / rear door: Boot lid - dent(s) - Smooth repair work

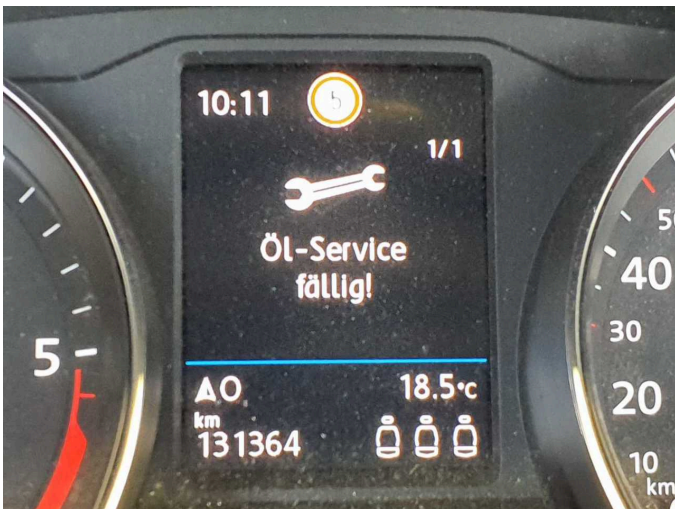
| No. | Component group | Description |
|---|---|--|
| 3 | Misc. | Inspection / maintenance - Due - Perform |

**Damage 3:** Misc.: Inspection / maintenance - Due - Perform

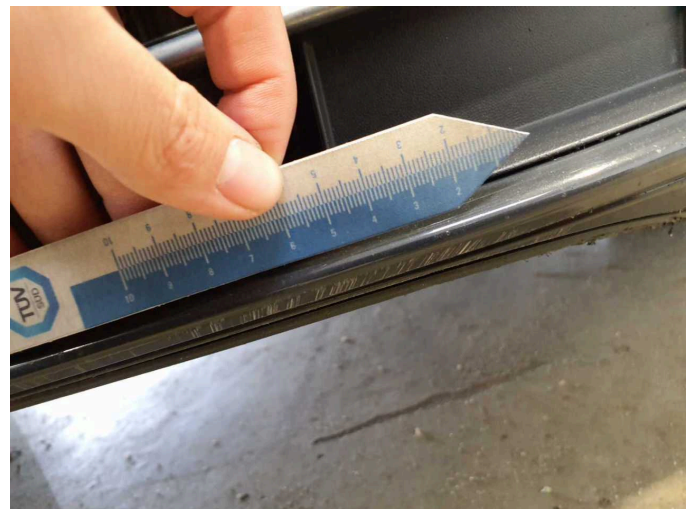
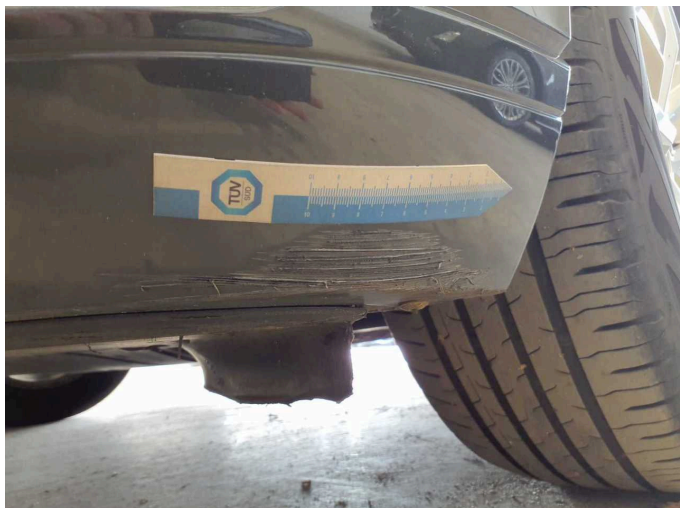
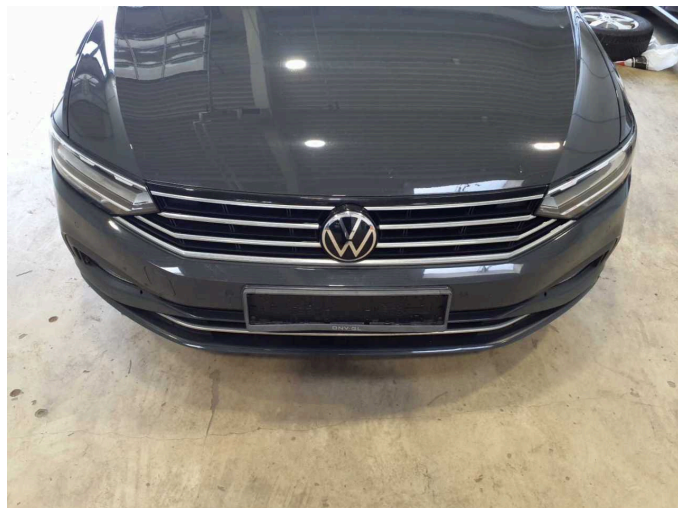
| No. | Component group | Description |
|---|---|--|
| 4 | Front bumper | Front bumper - Scratch(es) - Paint |

**Damage 4:** Front bumper: Front bumper - Scratch(es) - Paint

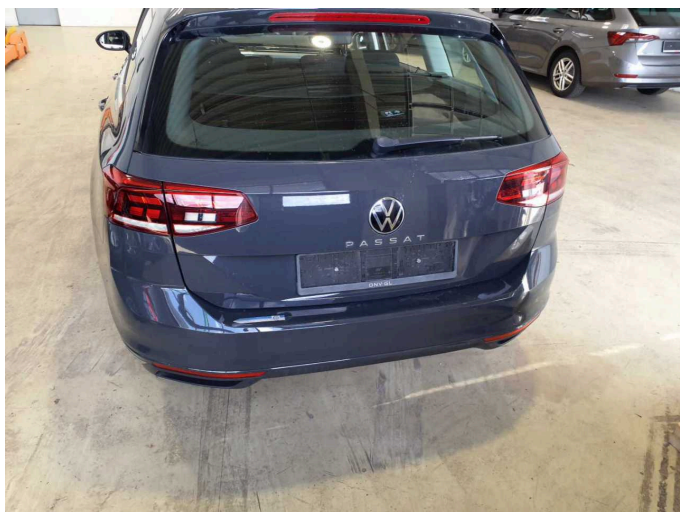
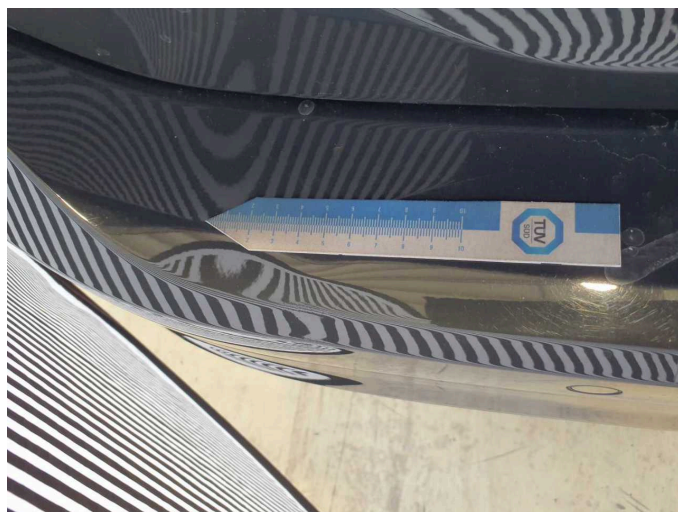
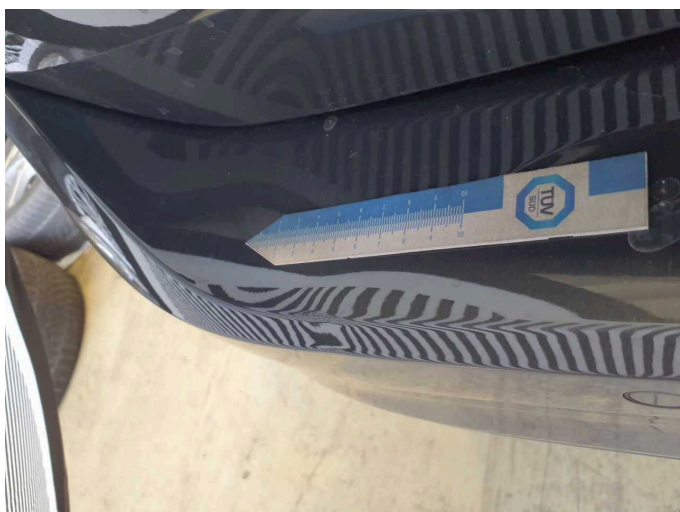
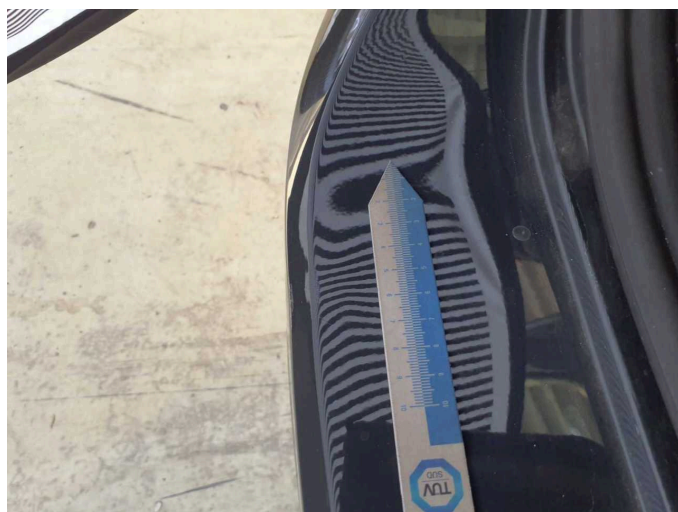
| No. | Component group | Description |
|---|---|--|
| 5 | Rear bumper | Rear bumper - Deformed - Repair and paint |

**Damage 5:** Rear bumper: Rear bumper - Deformed - Repair and paint

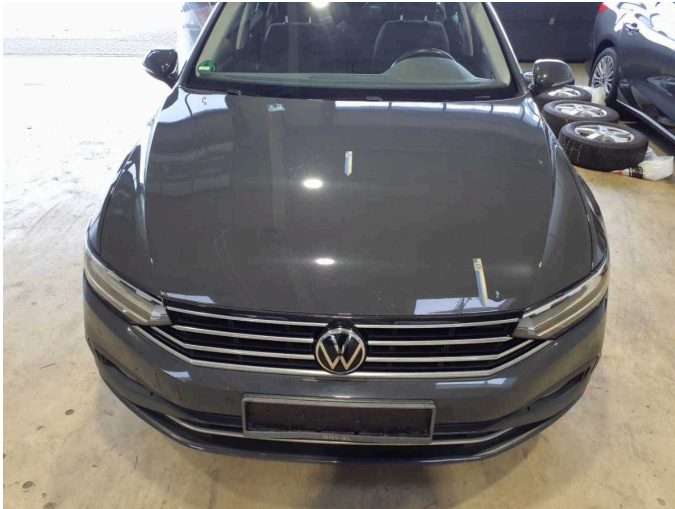
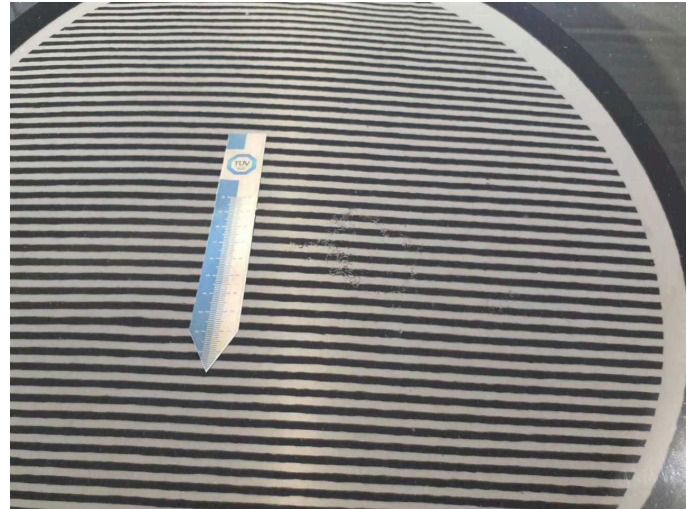
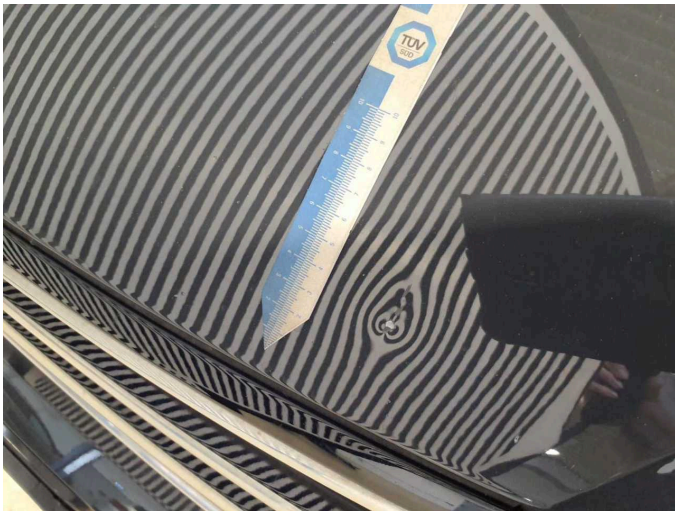
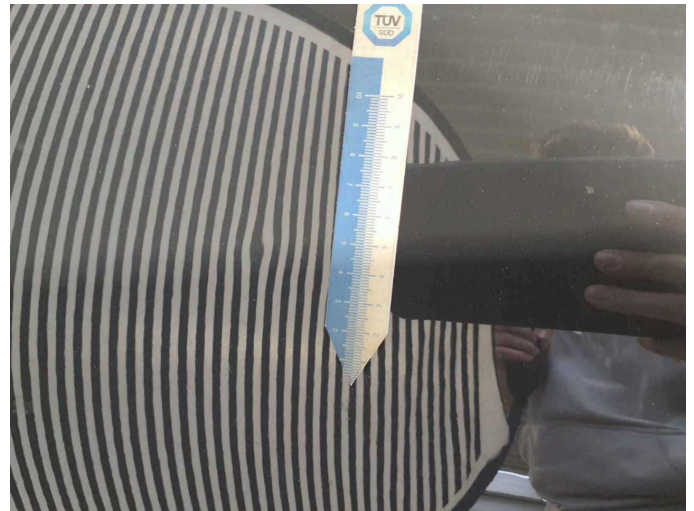
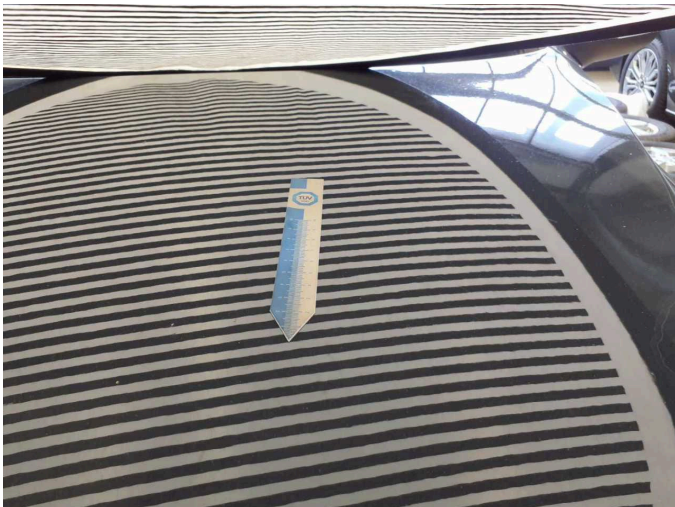
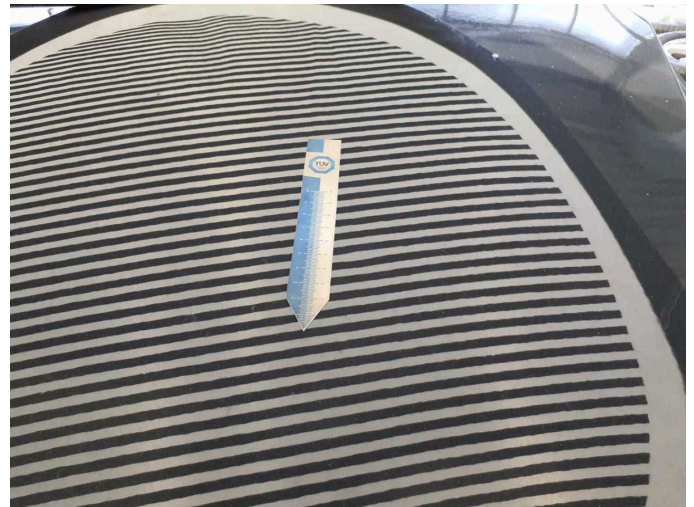
| No. | Component group | Description |
|---|---|--|
| 6 | Bonnet | Bonnet (Anätzung und 9 Dellen) - Paint defect - Repair and paint |

**Damage 6:** Bonnet: Bonnet (Anätzung und 9 Dellen) - Paint defect - Repair and paint

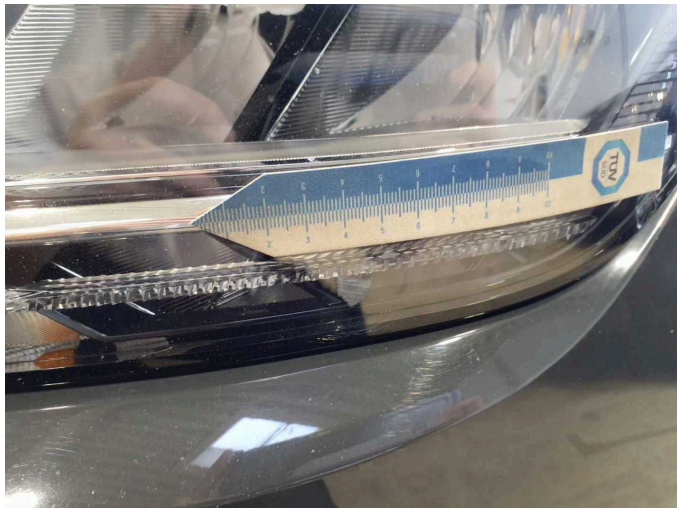
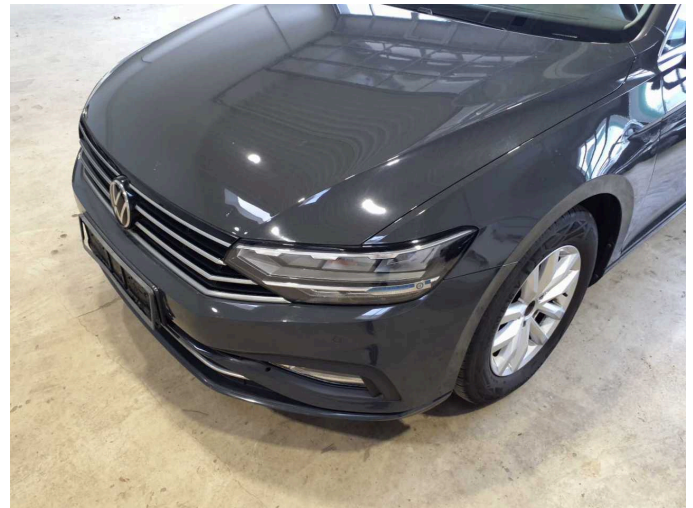
| No. | Component group | Description |
|---|---|--|
| 7 | Headlight | Headlight - left side - Scratch(es) - Replace |

**Damage 7:** Headlight: Headlight - left side - Scratch(es) - Replace

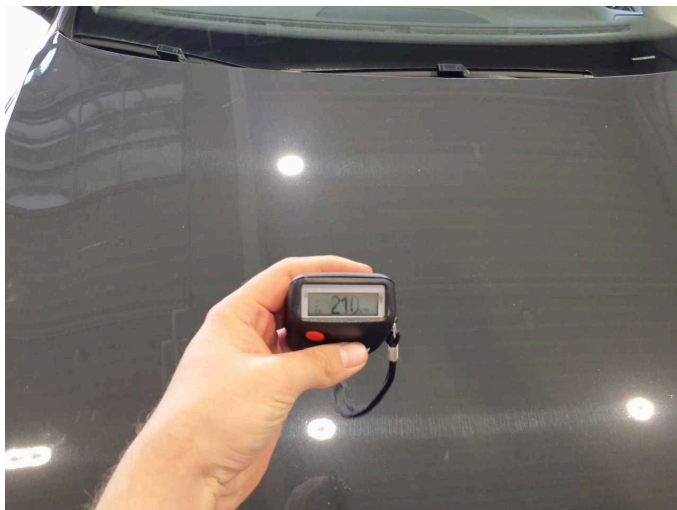
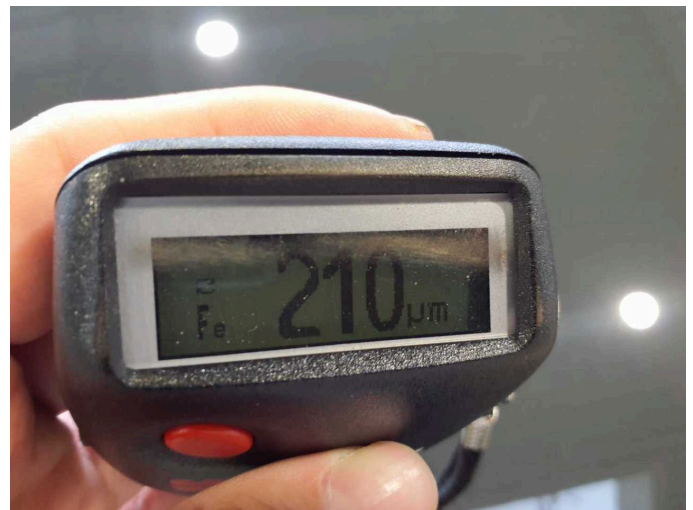
210 µm

**Repainting 1:** Bonnet
