Expertise

Protocol number: 41502581
Order No. / Reference: 25174242
Inspection date: 11 Sept 2025

Manufacturer: Volkswagen

Model: Passat Variant 1.4 TSI Plug-In-Hybrid DSG GTE

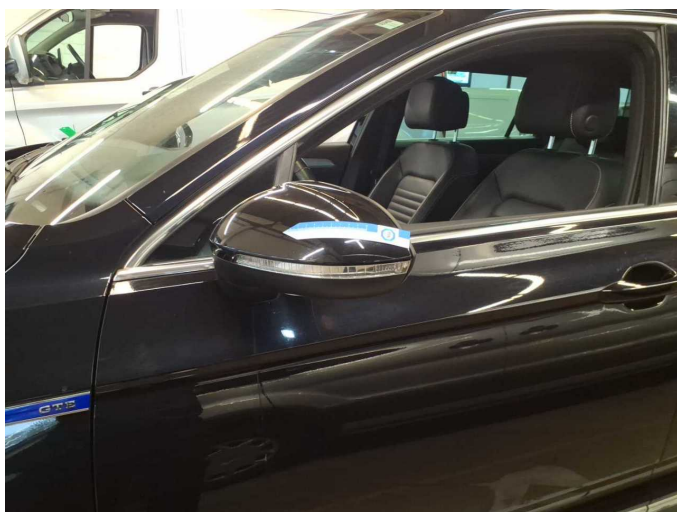
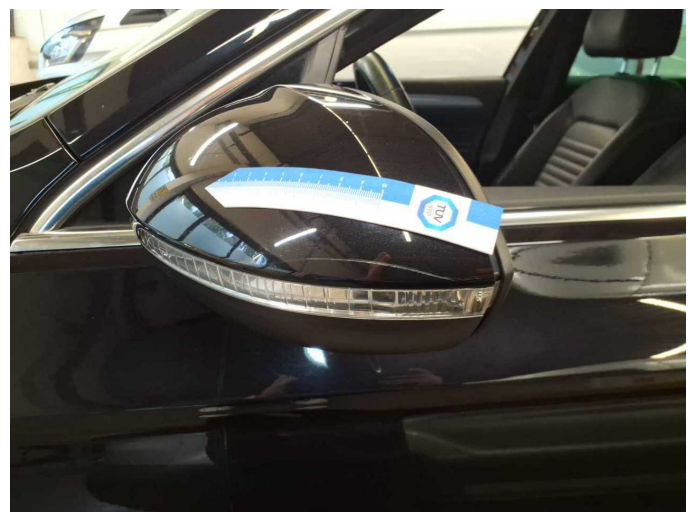
Damage 4: Wing mirror - left side: Cap - Scratch(es) - Smart repair

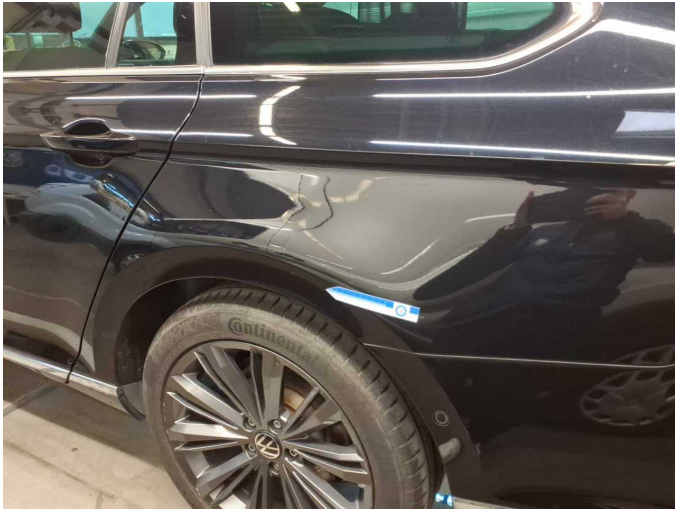
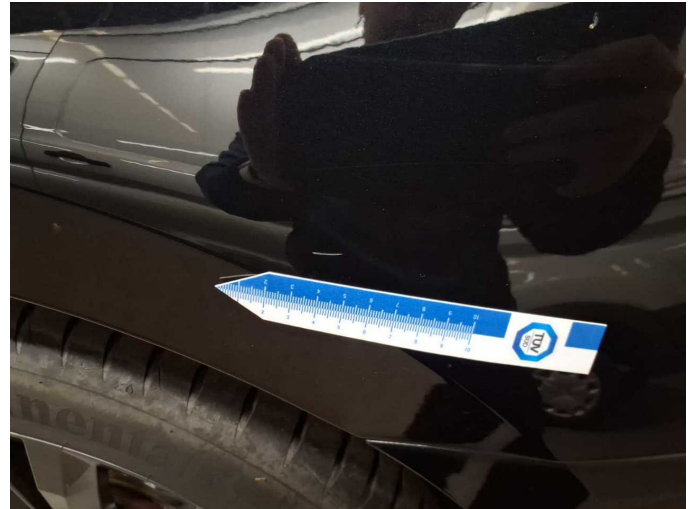
Damage 5: Side panel - rear left side: Side panel - Scratch(es) - Smart repair

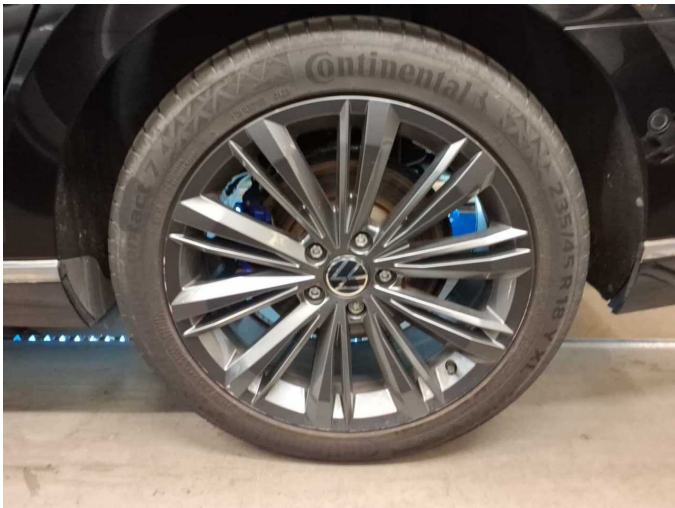
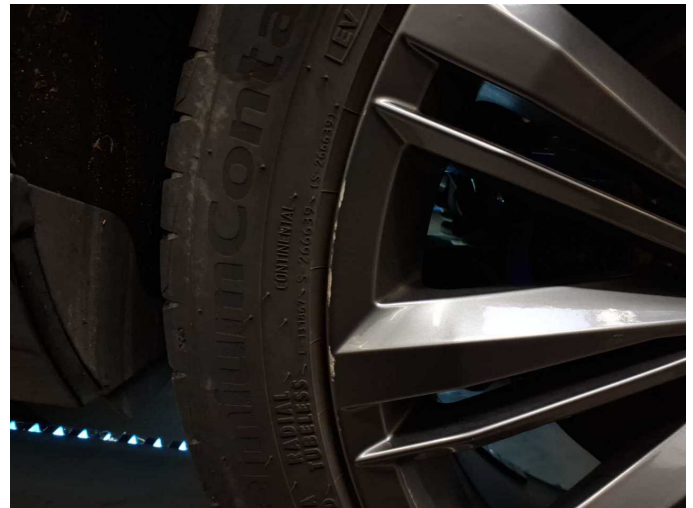
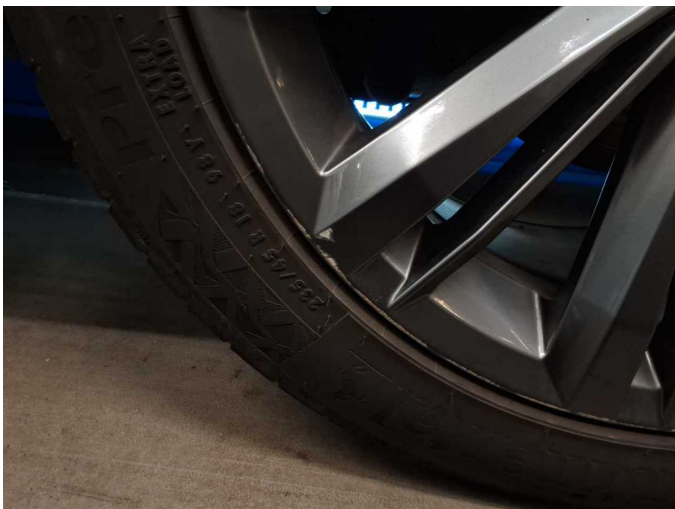
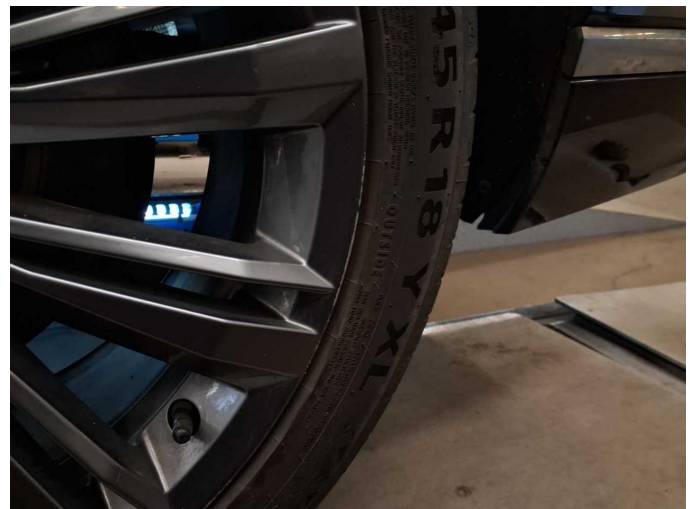
Damage 6: Wheel / tyres: Alloy rim - rear left side - Scratch(es) - Smart repair

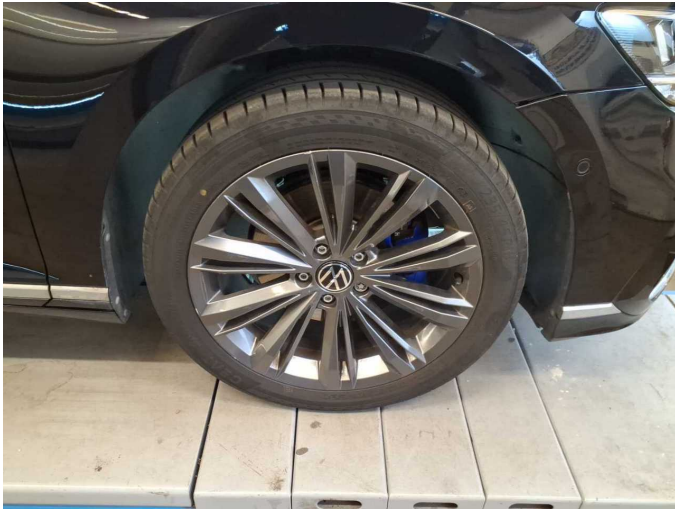
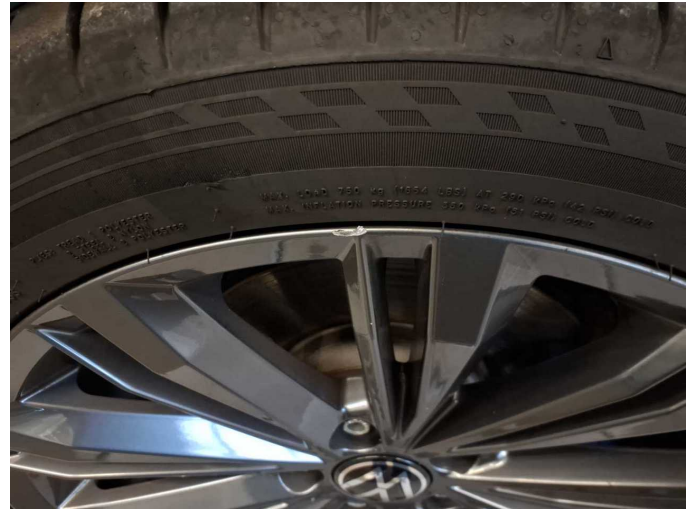
Damage 7: Wheel / tyres: Alloy rim - front right side - Scratch(es) - Loss in value

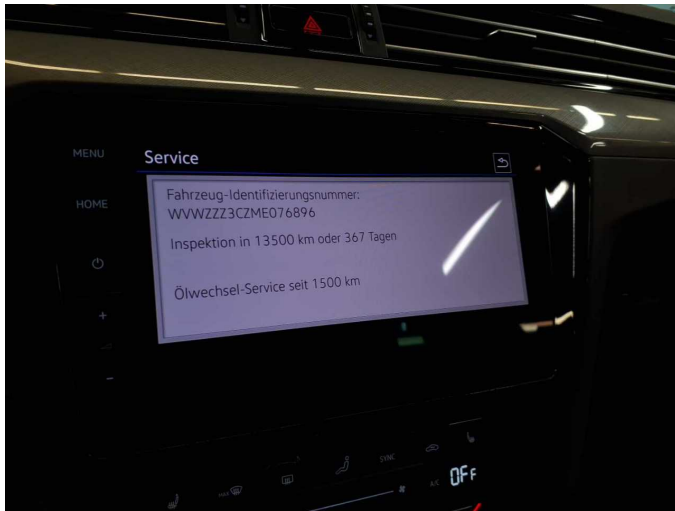
Damage 8: Misc.: Inspection / maintenance - Due - Perform

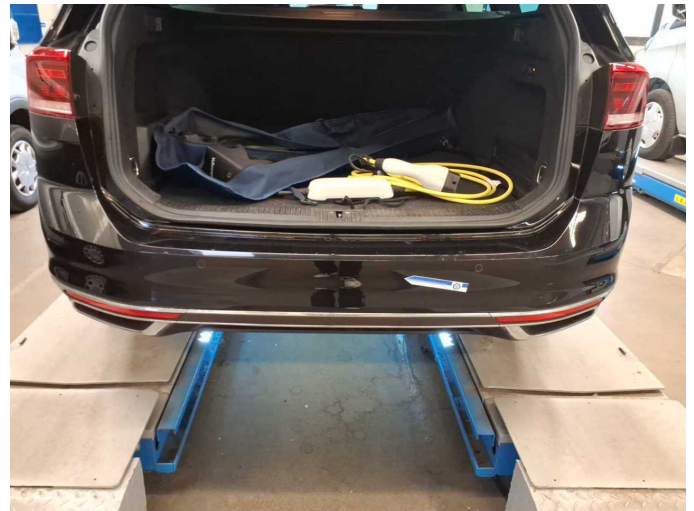
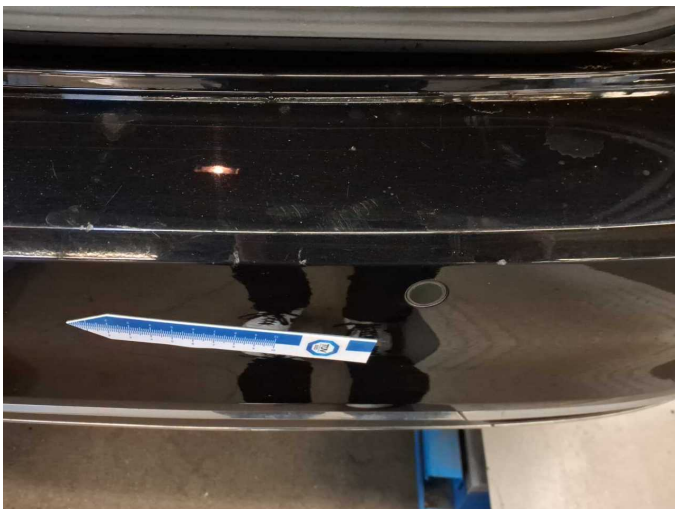
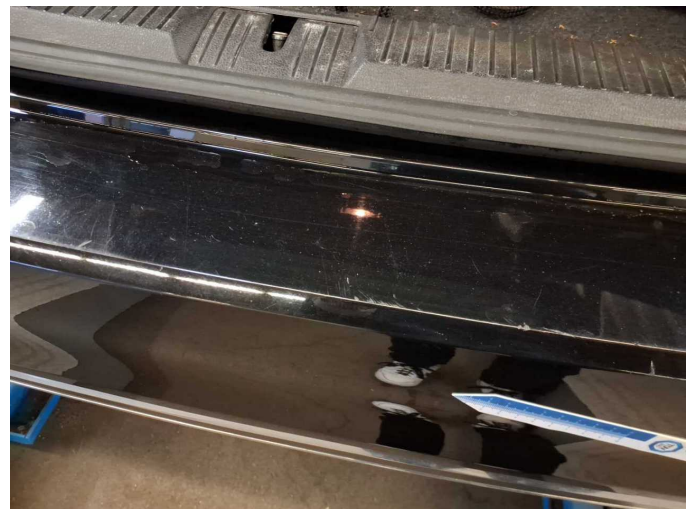
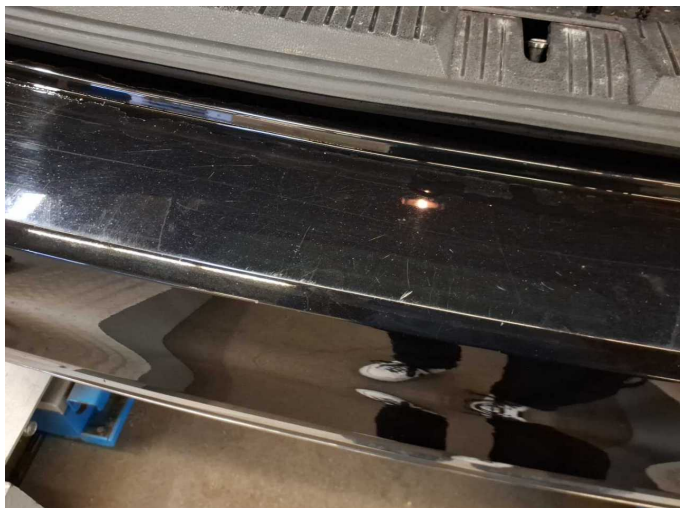
Damage 9: Rear bumper: Rear bumper - Scratch(es) - Paint

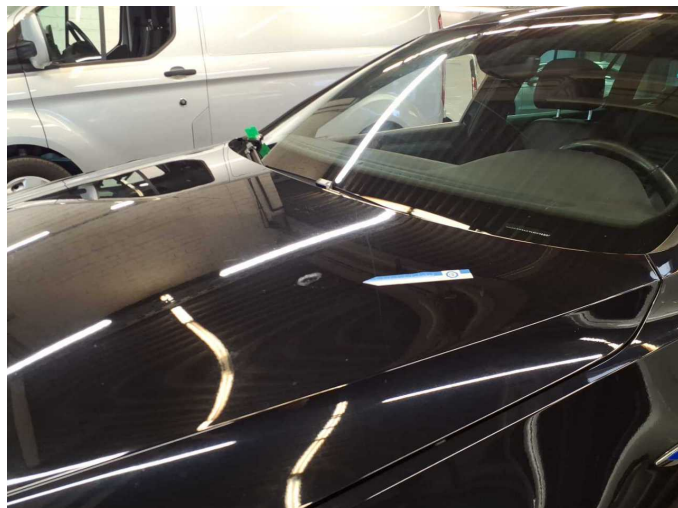
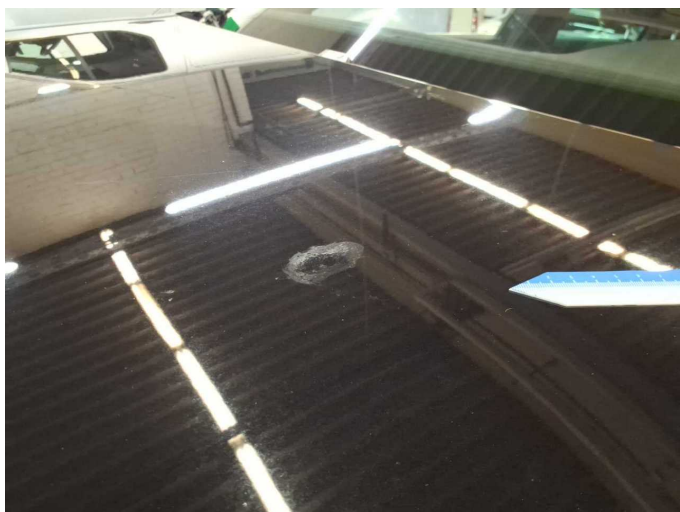
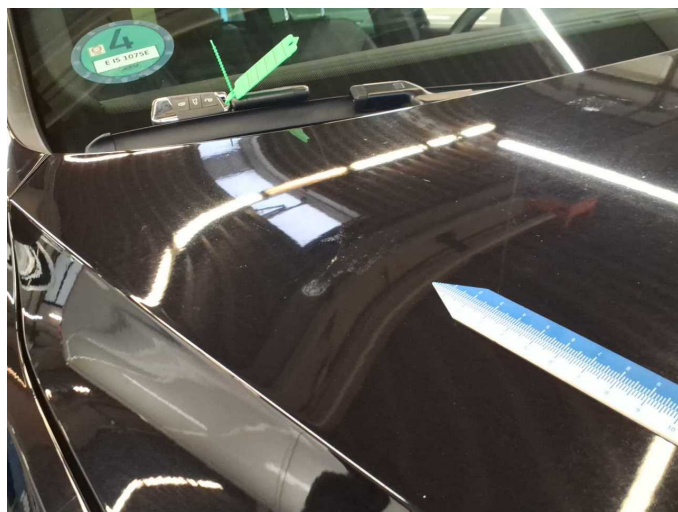
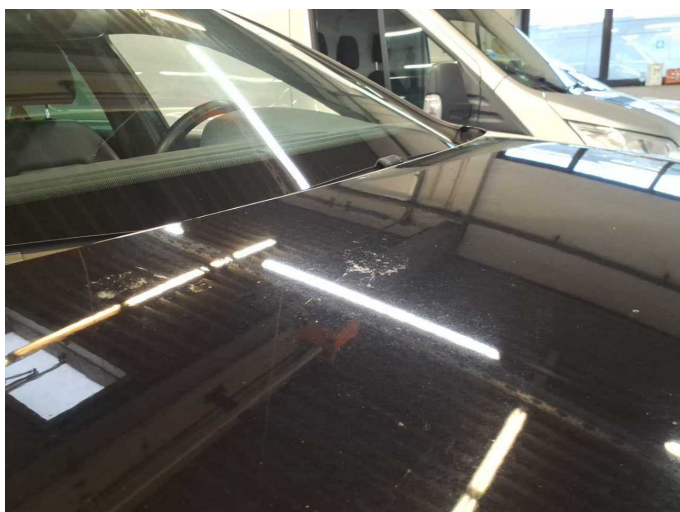
Damage 10: Bonnet: Bonnet (Vogelkotverätzung) - Paint defect - Paint

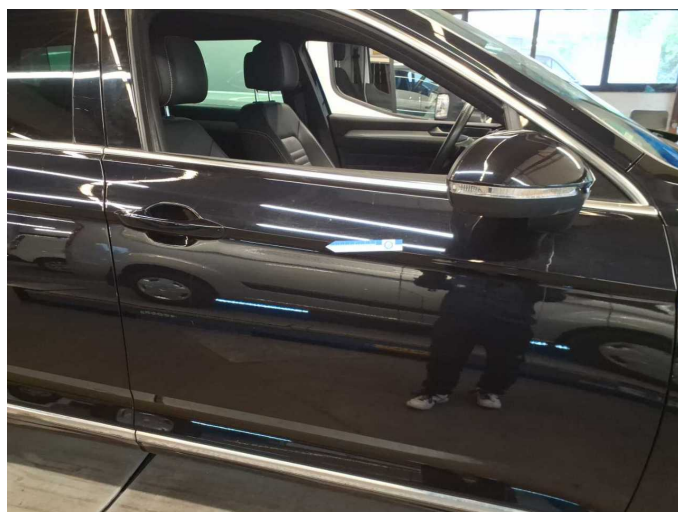
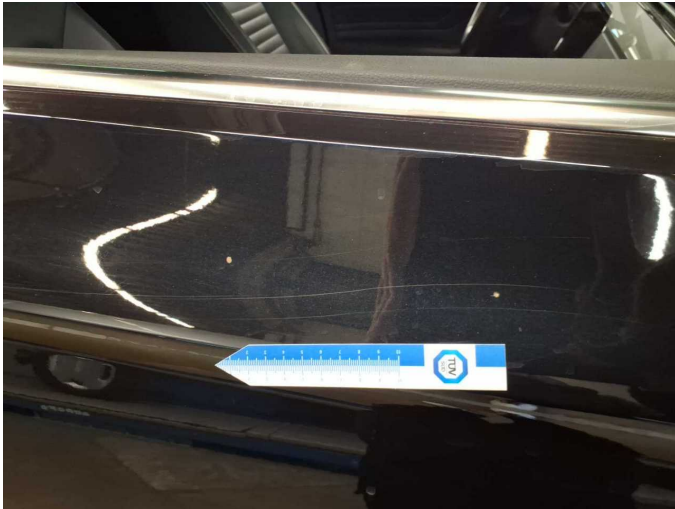
Damage 11: Door - front right side: Door - Scratch(es) - Paint

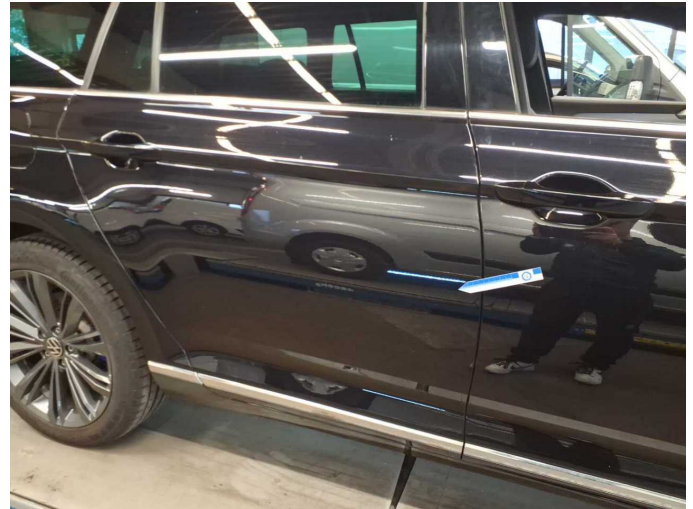
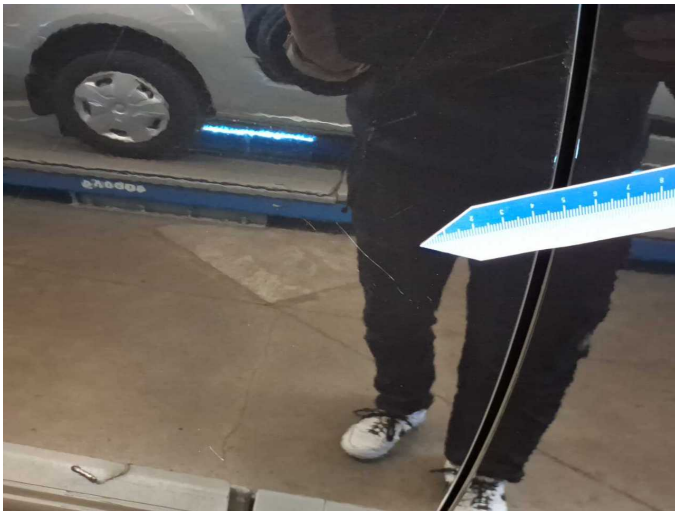
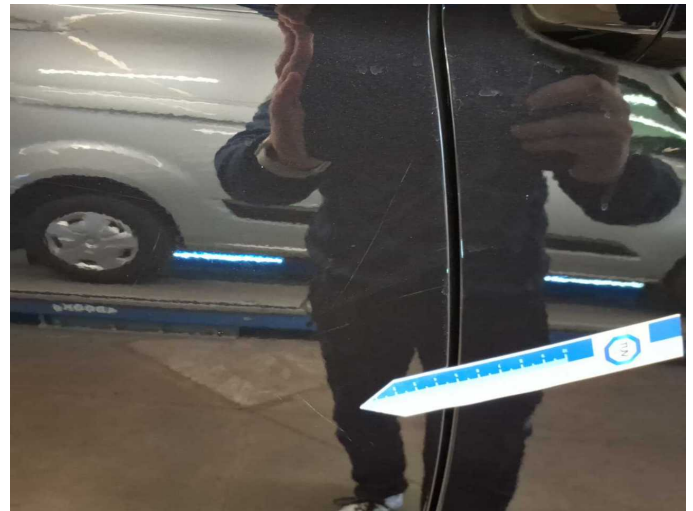
Damage 12: Door - rear right side: Door - Scratch(es) - Paint

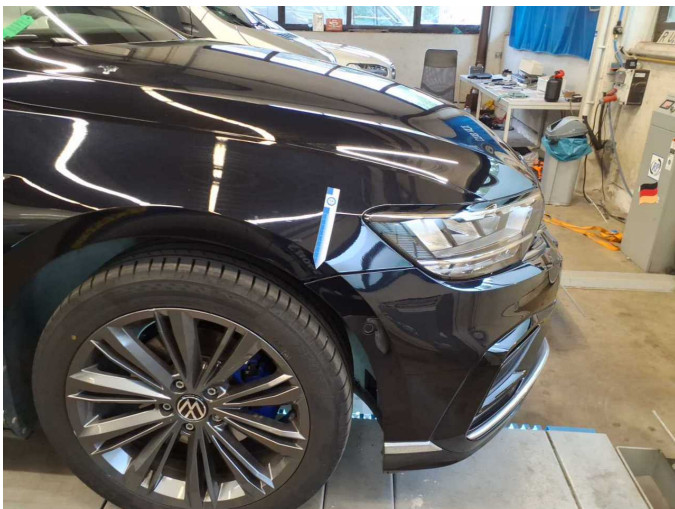
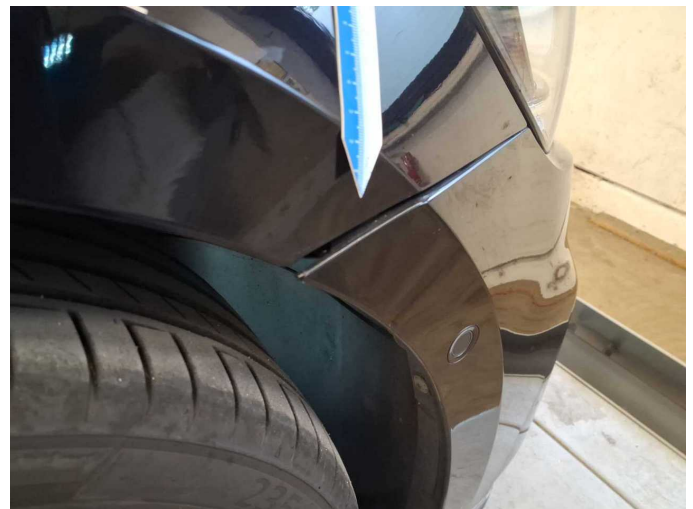
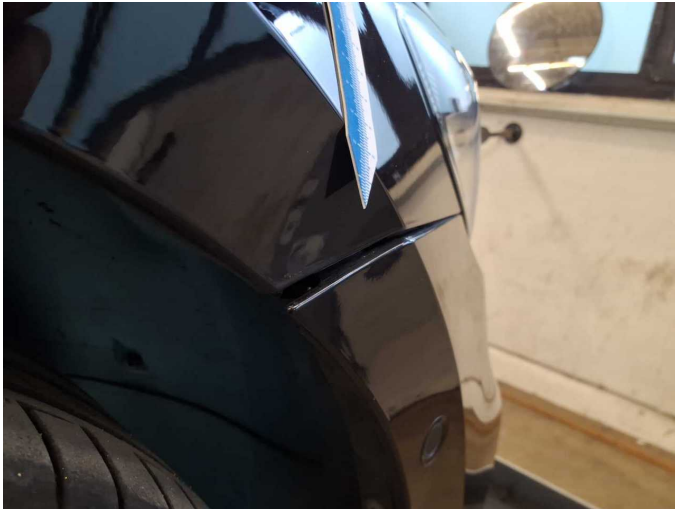
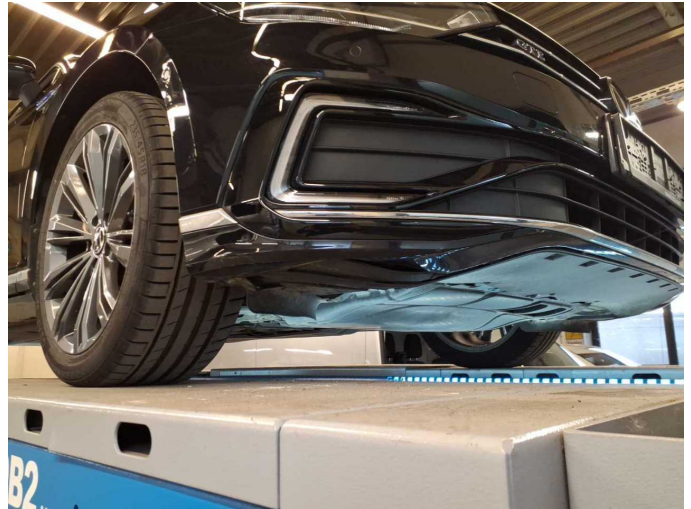
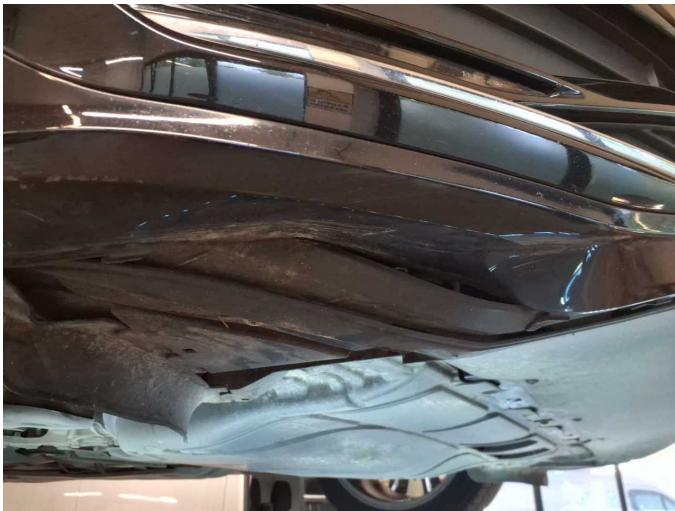
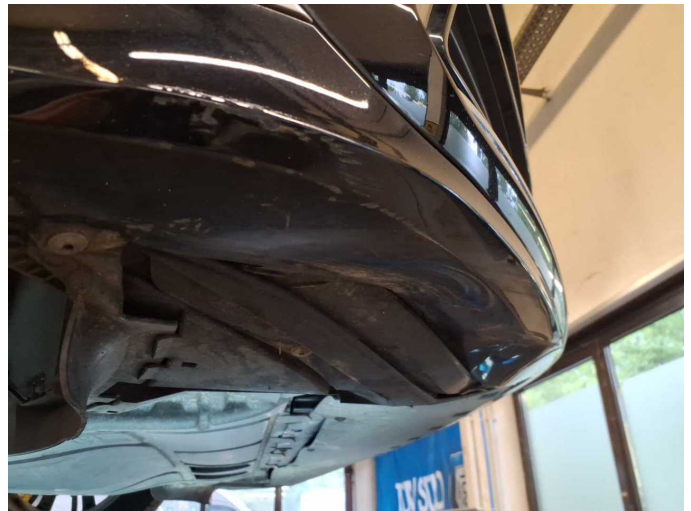
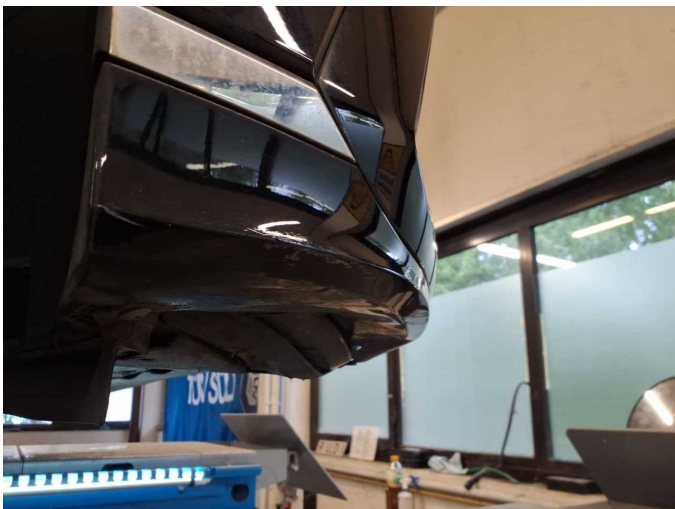
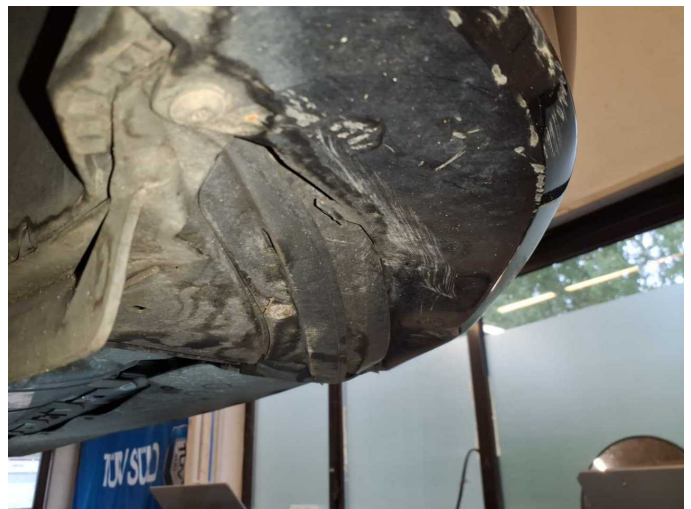
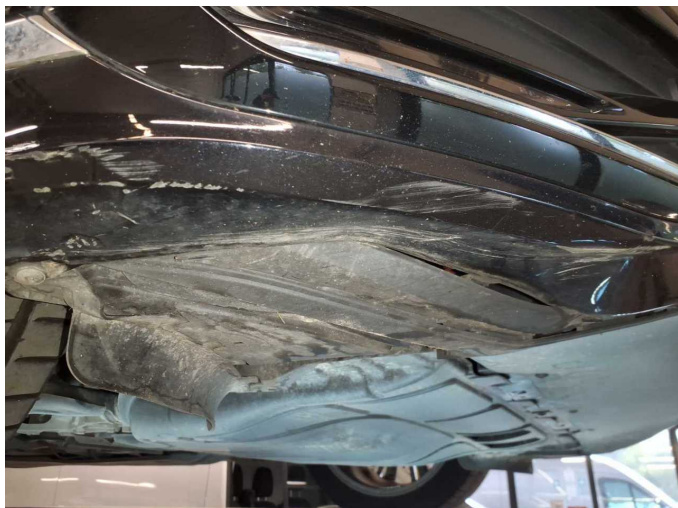
Die beigefügte Reparaturkostenkalkulation wurde nach bestem Wissen und Gewissen unter eingeschränkten Besichtigungsbedingung im demontagefreien Zustand erstellt. Es können aufgrund verdeckter Beschädigung, Mehrkosten und somit Abweichung der für die Stoßstange ausgewiesenen Reparaturkosten nicht ausgeschlossen werden.

Damage 13: Front bumper: Front bumper (inkl. Spoiler, Radhausabd. unten vorne) - Deformed - repair according to calculation
