Expertise

Protocol number: 41378512
Order No. / Reference: 25161509
Inspection date: 4 Sept 2025

Manufacturer: Volkswagen

Model: Passat Variant 1.4 TSI Plug-In-Hybrid DSG GTE

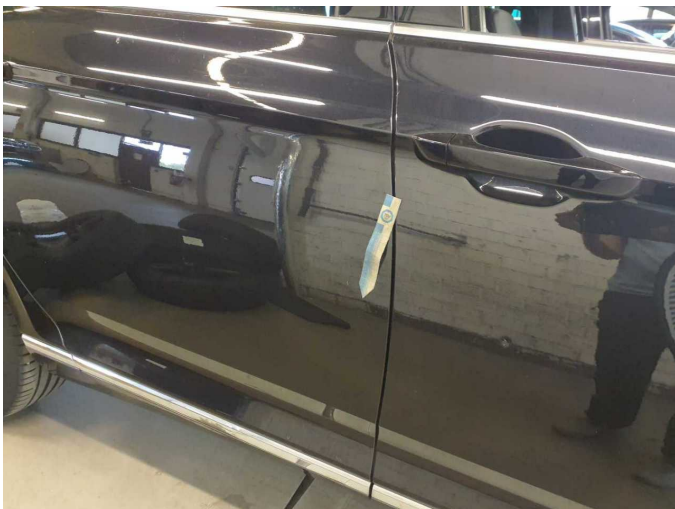
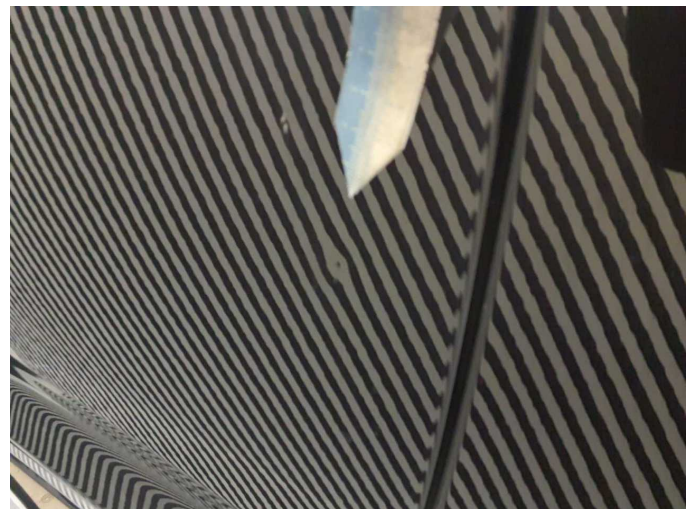
Damage 1: Door - rear right side: Door (+kratzer/gebrauchsspuren) - dent(s) - Smart repair

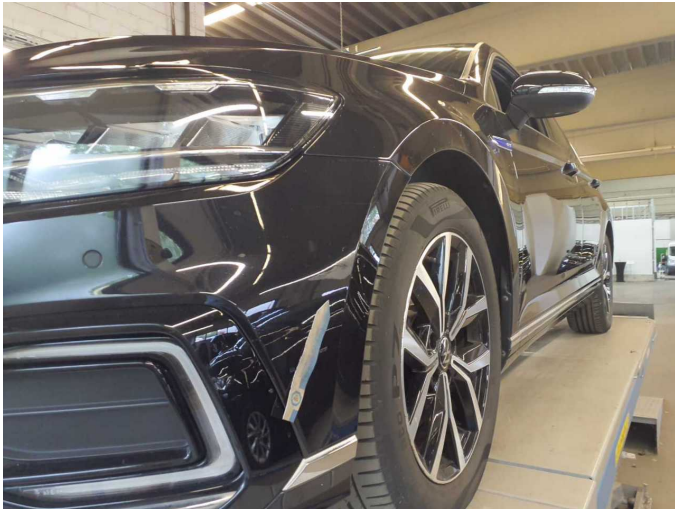
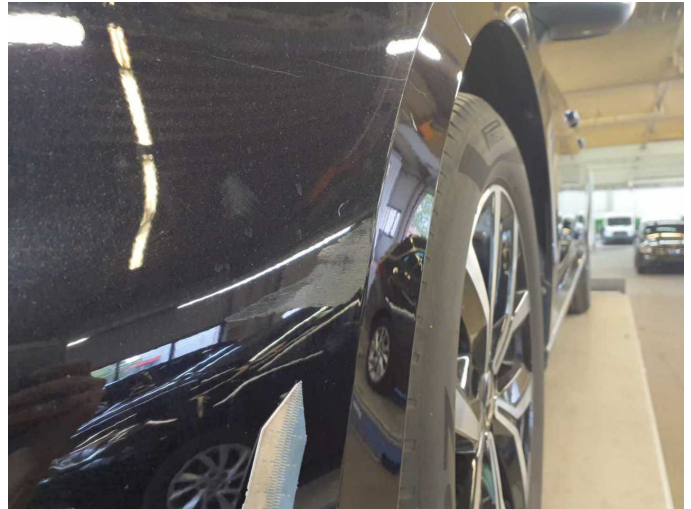
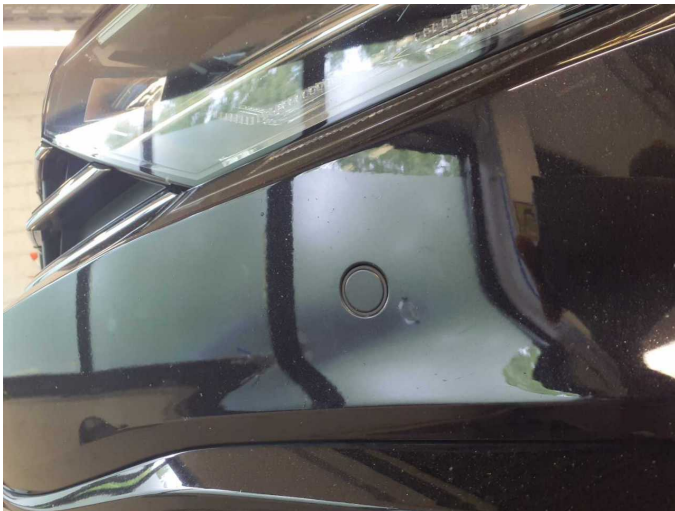
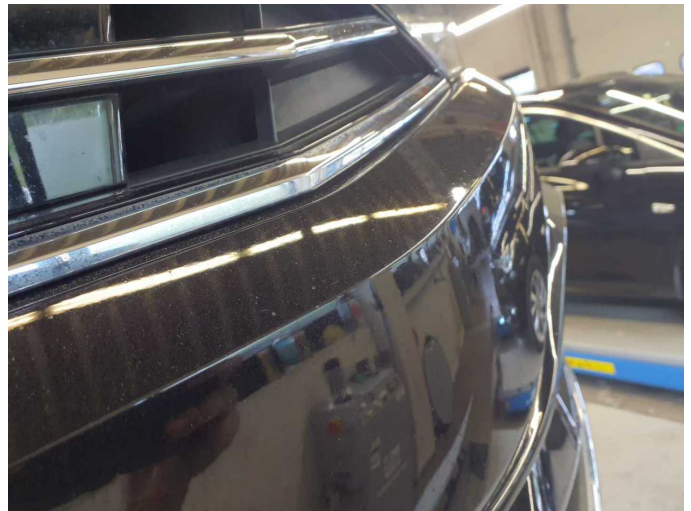
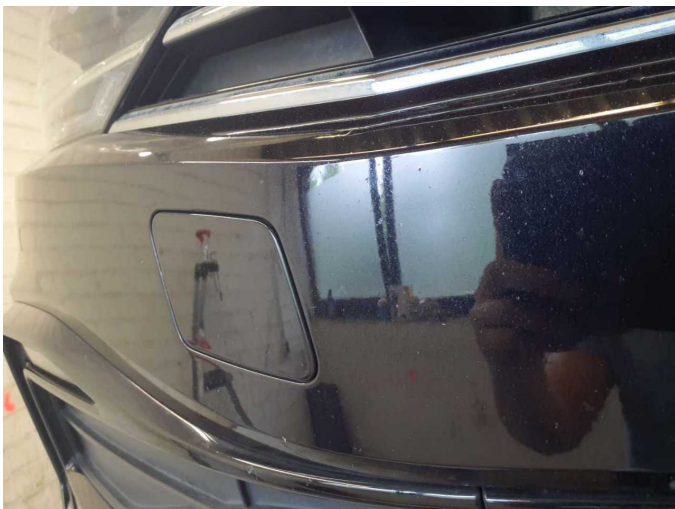
Damage 2: Front bumper: Front bumper (+sandstrahleffekt) - Scratch(es) - Paint

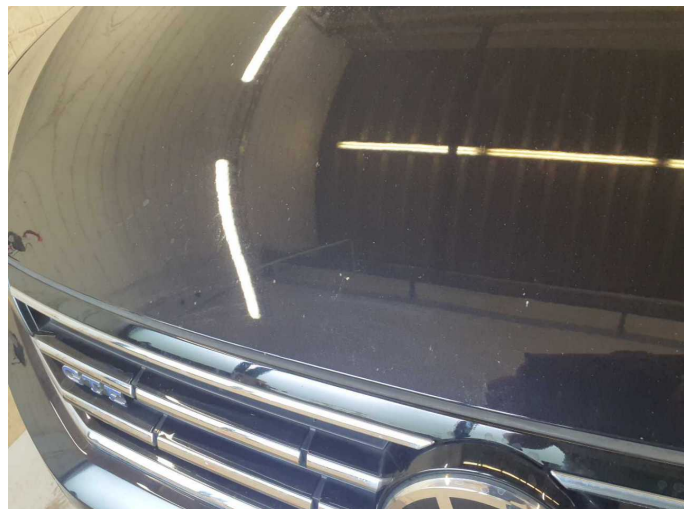
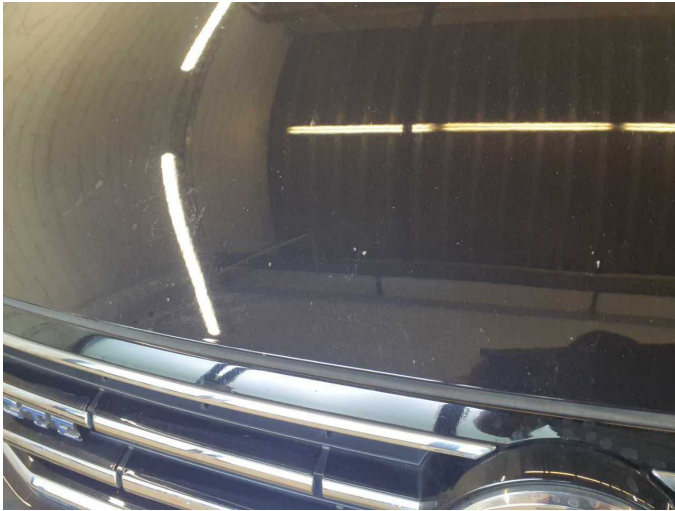
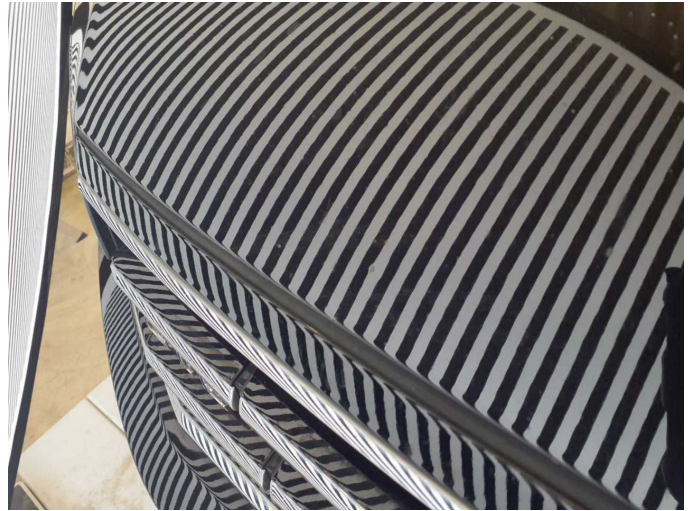
Damage 3: Bonnet: Bonnet - Dent / paintcoat damage - Repair and paint

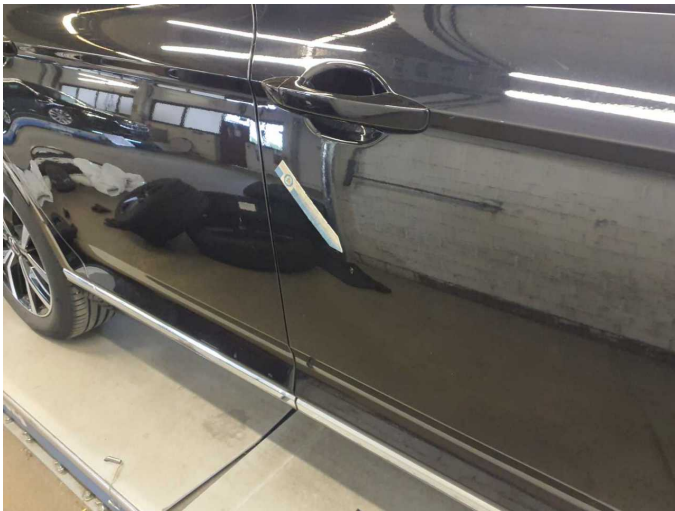
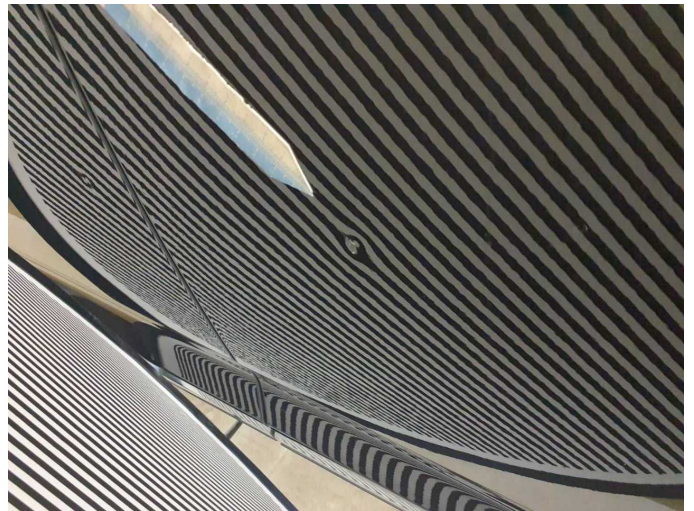
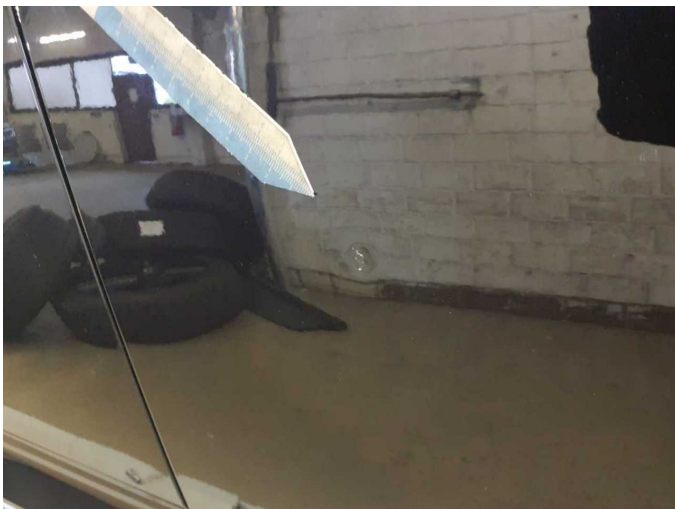
Damage 4: Door - front right side: Door - Dent / paintcoat damage - Repair and paint

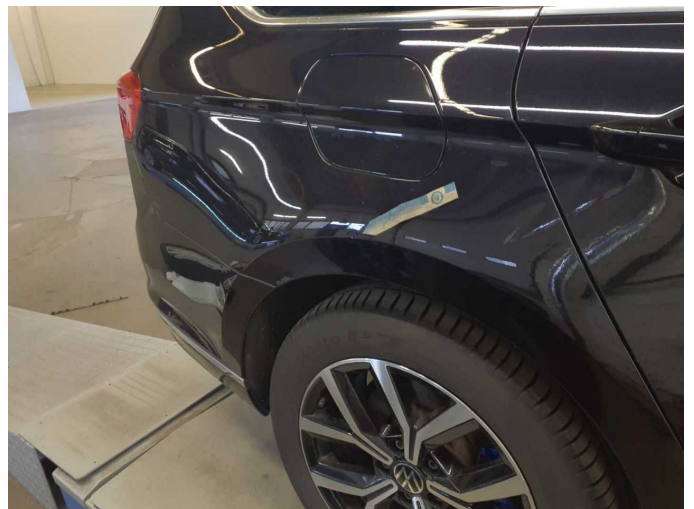
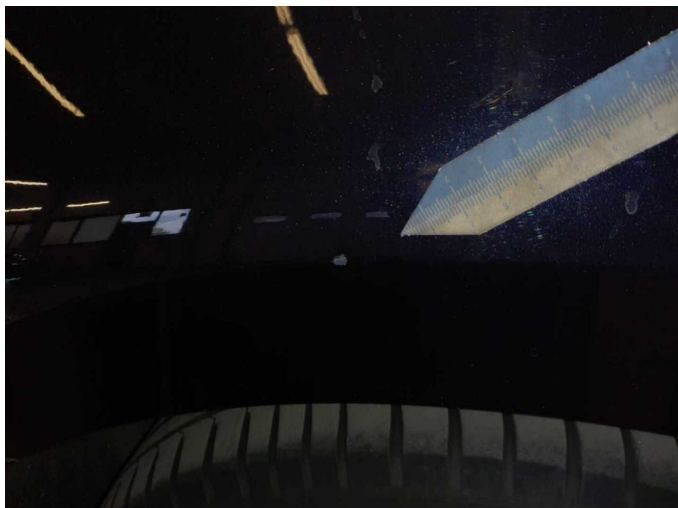
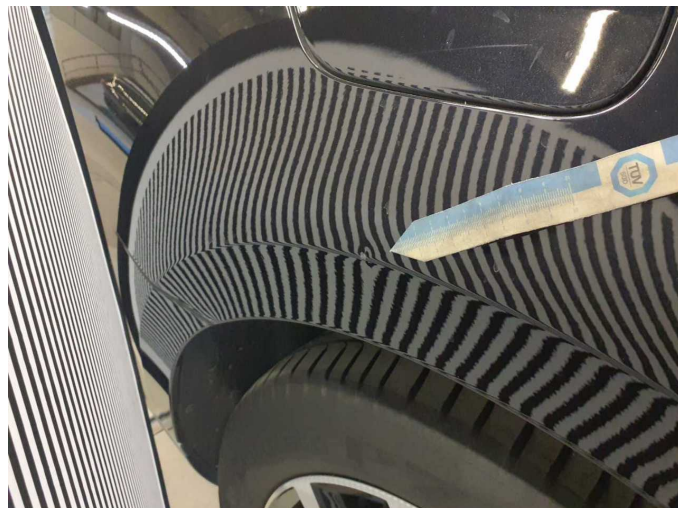
Damage 5: Side panel - rear right side: Side panel - Dent / paintcoat damage - Repair and paint

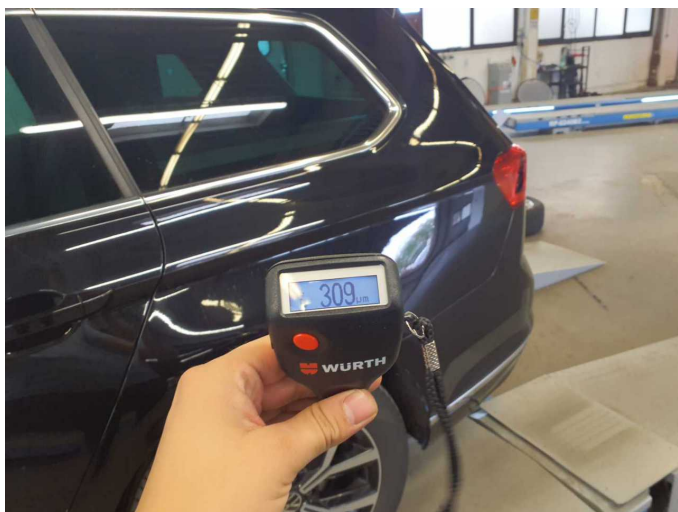
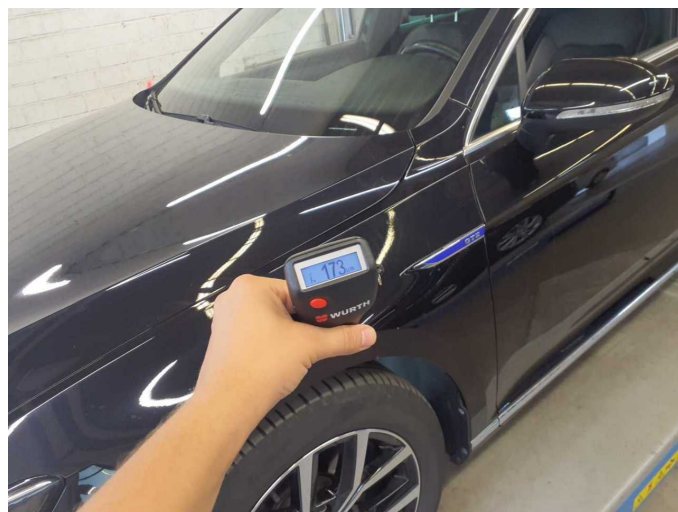
Mudguard - left side	173 µm	Side panel - rear left side	309 µm
----------------------	--------	-----------------------------	--------

Repainting 1: Mudguard - left side, Side panel - rear left side
