Expertise

Protocol number: 40936078 Order No. / Reference: 25039579 Inspection date: 6 Aug 2025

Manufacturer: Volkswagen

Model: Passat Variant 2.0 TDI SCR DSG Business

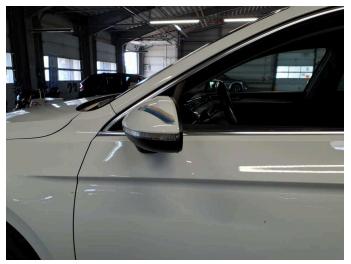
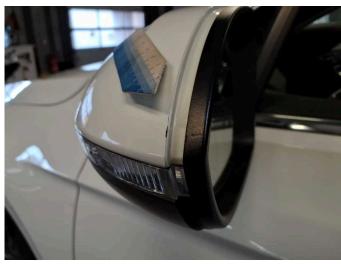
Damage 2: Wing mirror - left side: Cap - Scratch(es) - Smart repair

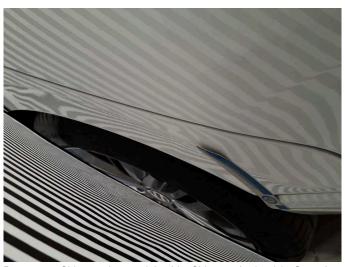
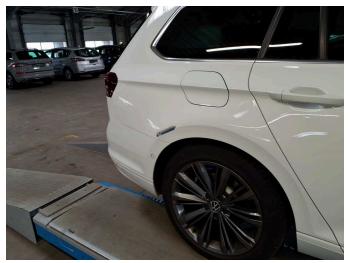
Damage 4: Side panel - rear right side: Side panel - dent(s) - Smooth repair work

$\label{eq:definition} \textbf{Damage 4:} \ \mbox{Side panel - rear right side: Side panel - dent(s) - Smooth repair work}$

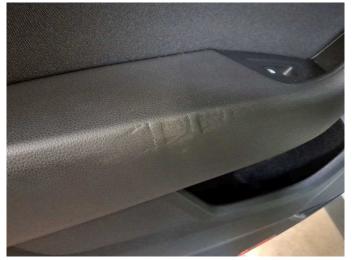
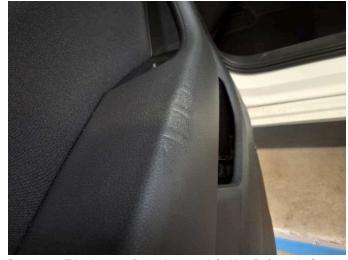
$\textbf{Damage 5:} \ \mathsf{Trim} \ / \ \mathsf{covers:} \ \mathsf{Door} \ \mathsf{trim} \ \mathsf{-} \ \mathsf{rear} \ \mathsf{left} \ \mathsf{side} \ \mathsf{-} \ \mathsf{Deformed} \ \mathsf{-} \ \mathsf{Smart} \ \mathsf{repair}$

Damage 5: Trim / covers: Door trim - rear left side - Deformed - Smart repair

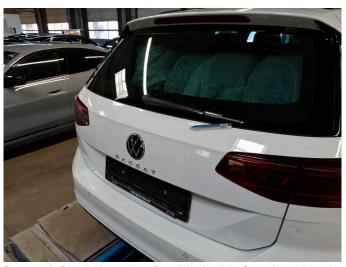
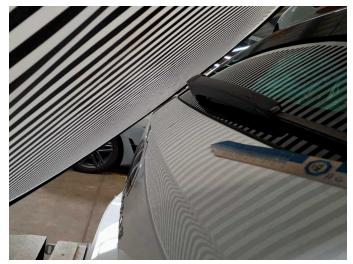
Damage 6: Boot lid / rear door: Boot lid - dent(s) - Smooth repair work

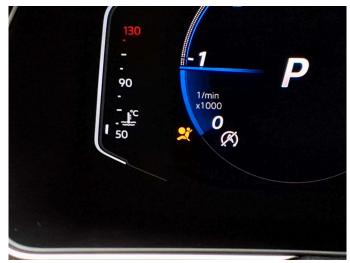
Damage 7: Airbag systems: Airbag system (Airbag Lampe an) - Functional / admissibility - Perform diagnosis

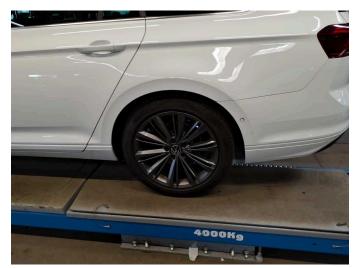
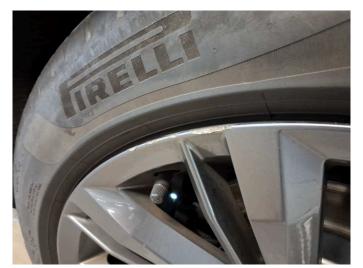
Damage 8: Wheel / tyres: Alloy rim - rear left side (Materialabtrag) - Scratched - Replace

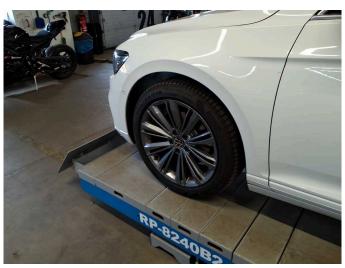
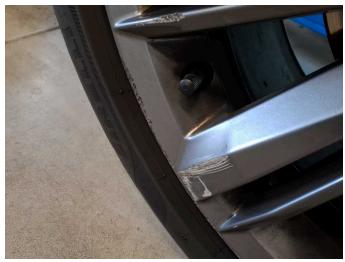
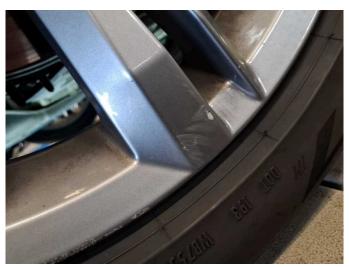
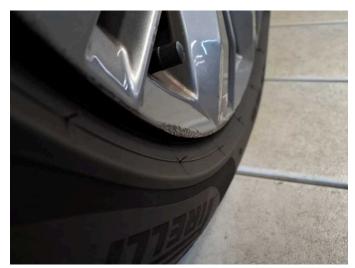
Damage 9: Wheel / tyres: Alloy rim - front left side (Materialabtrag) - Scratched - Replace

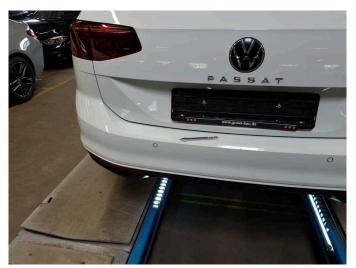
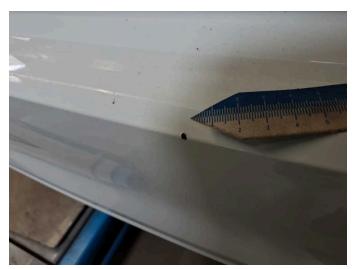
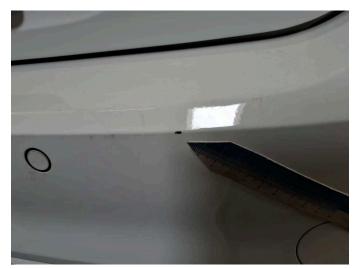
Damage 10: Rear bumper: Rear bumper - Scratch(es) - Paint

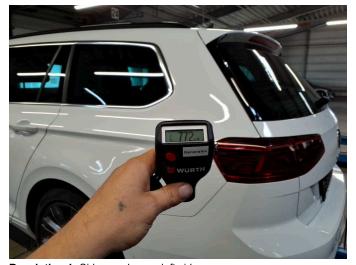
Repainting 1: Side panel - rear left side

- 1 Side panel rear left side, Professionally carried out, Invoice of repair done Non-existent
- 2 Door front left side, Professionally carried out, Invoice of repair done Non-existent

Side panel - rear left side 772 μm Door - front left side 186 μm
