Expertise

Protocol number: 41328682  
Order No. / Reference: 25110183  
Inspection date: 1 Sept 2025

Manufacturer: Volkswagen	Model: Passat Variant 2.0 TDI SCR DSG Business
VIN: WVGZZZ3CZNE045808

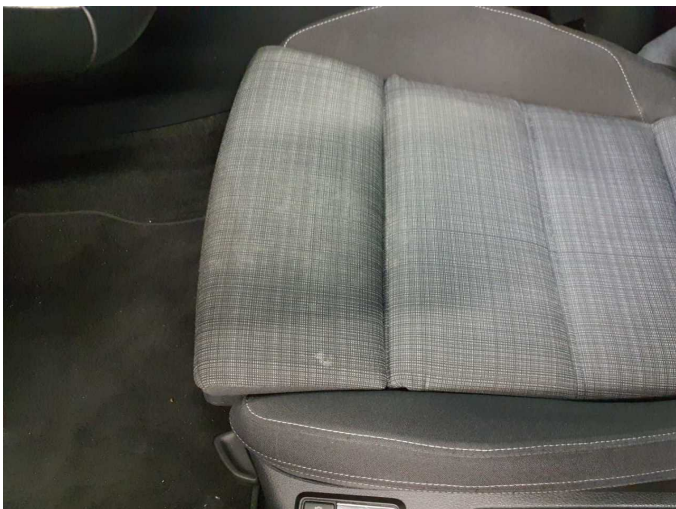
Damage 2: Seat - front: Seat cover - left side - Soiled - Clean

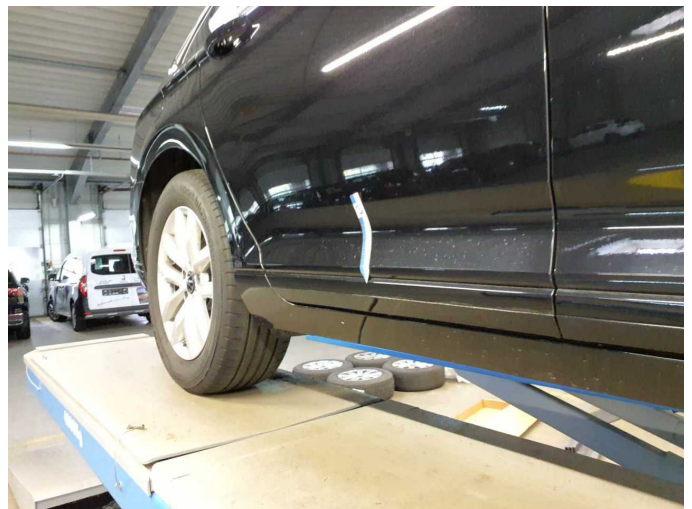
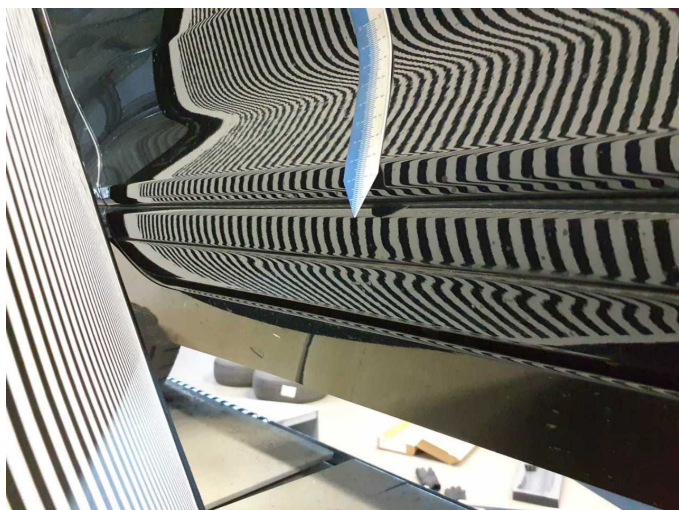
Damage 3: Door - rear right side: Door (Zierleiste) - dent(s) - Smart repair

**Damage 3:** Door - rear right side: Door (Zierleiste) - dent(s) - Smart repair

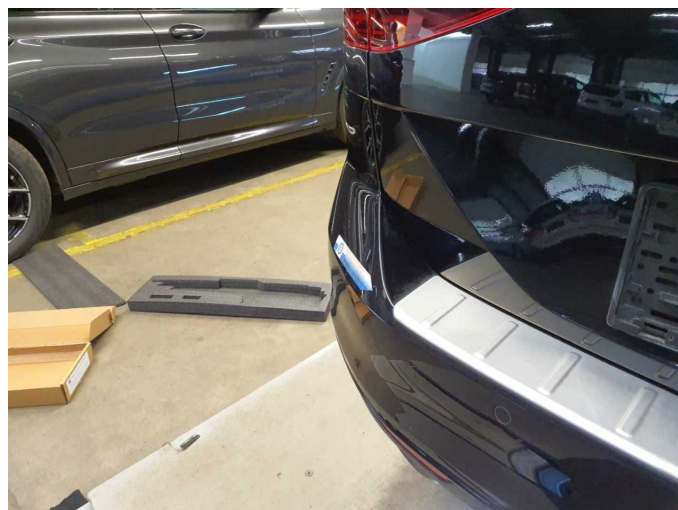
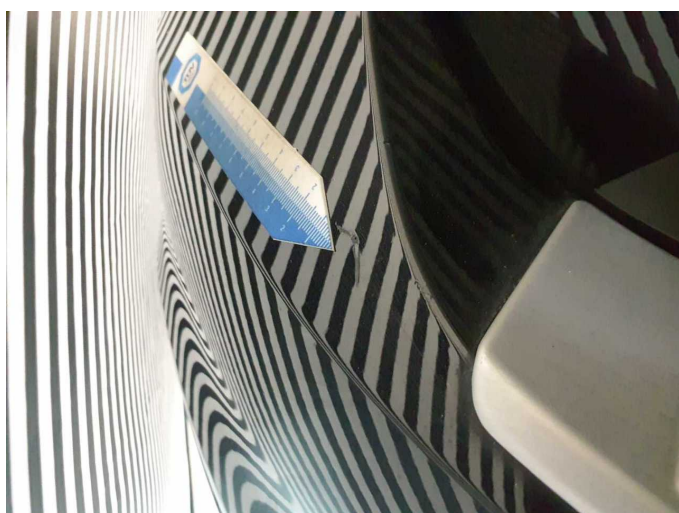
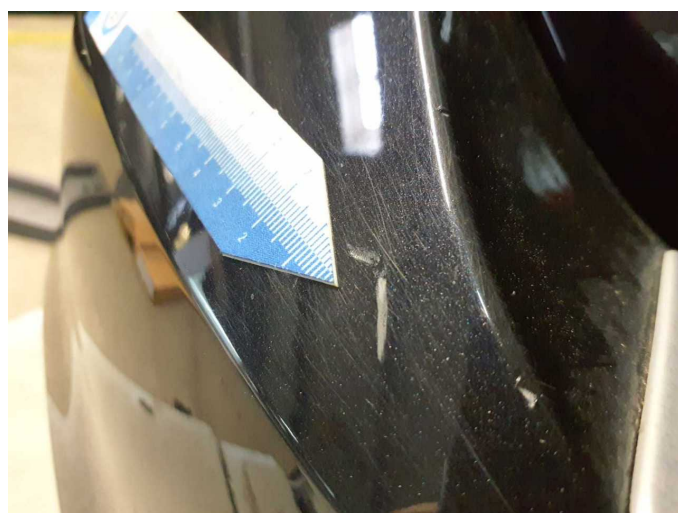
**Damage 4:** Rear bumper: Rear bumper - Scratched - Smart repair

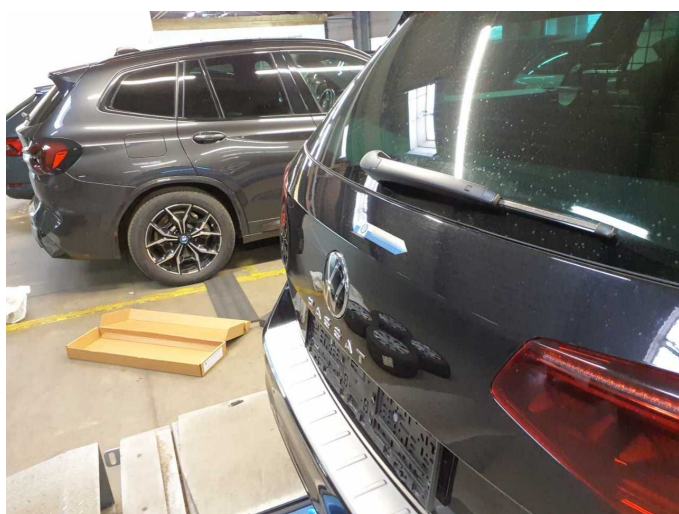
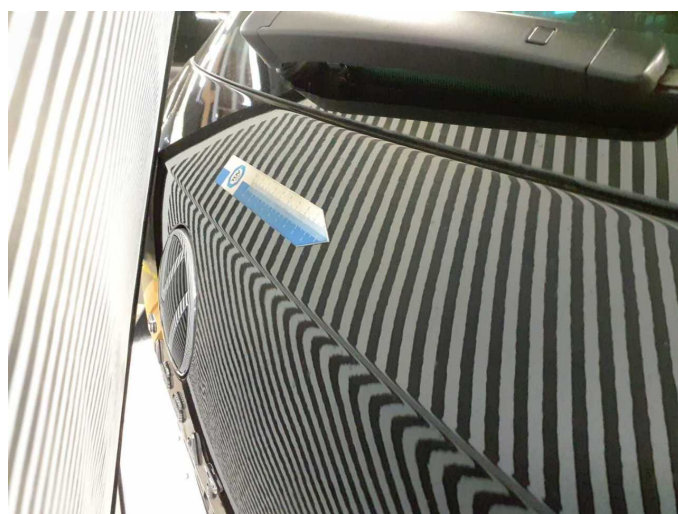
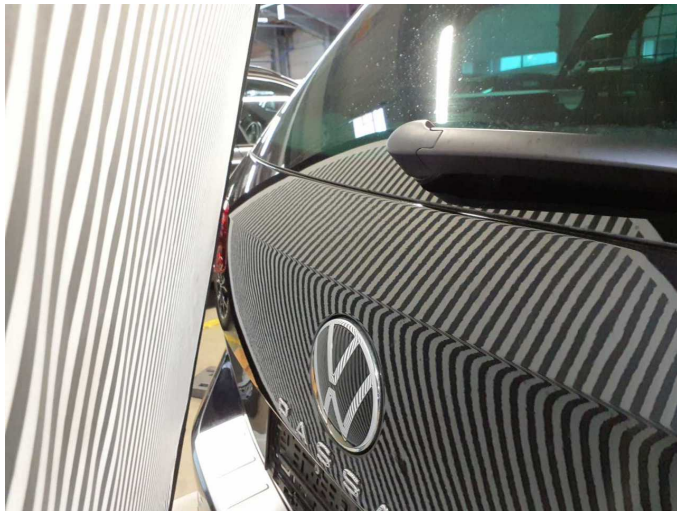
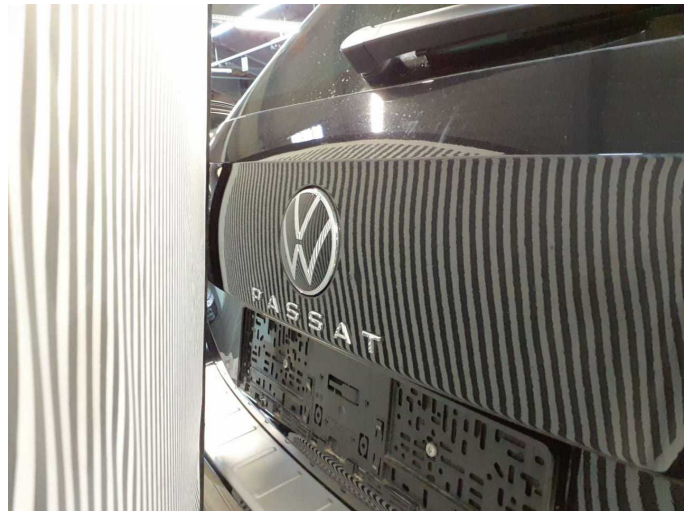
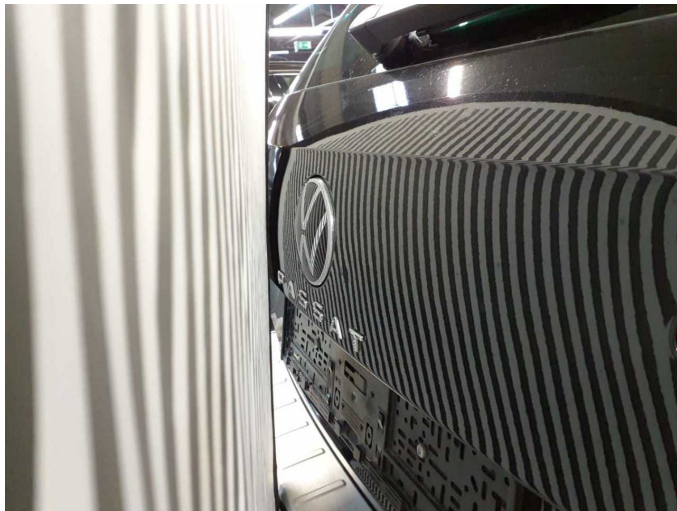
**Damage 5:** Boot lid / rear door: Boot lid - dent(s) - Smooth repair work

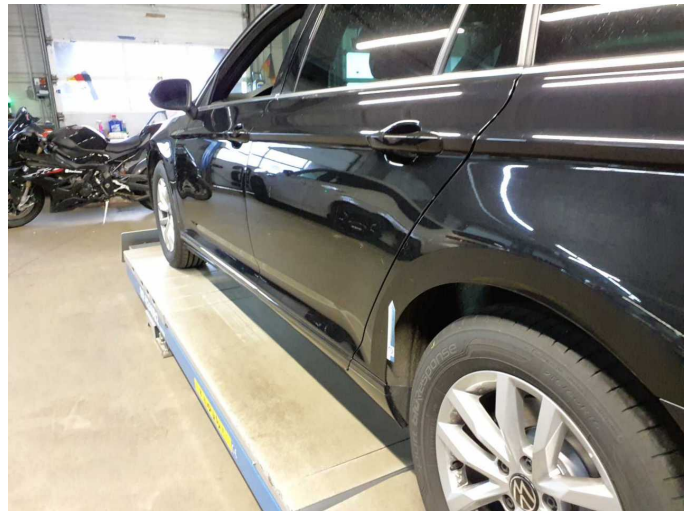
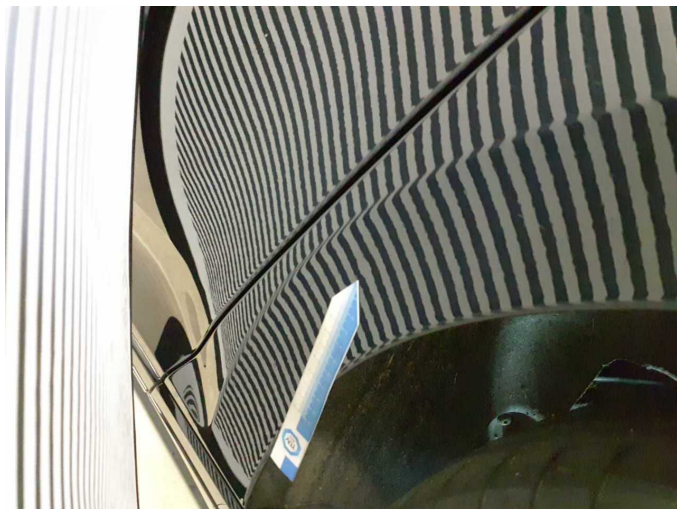
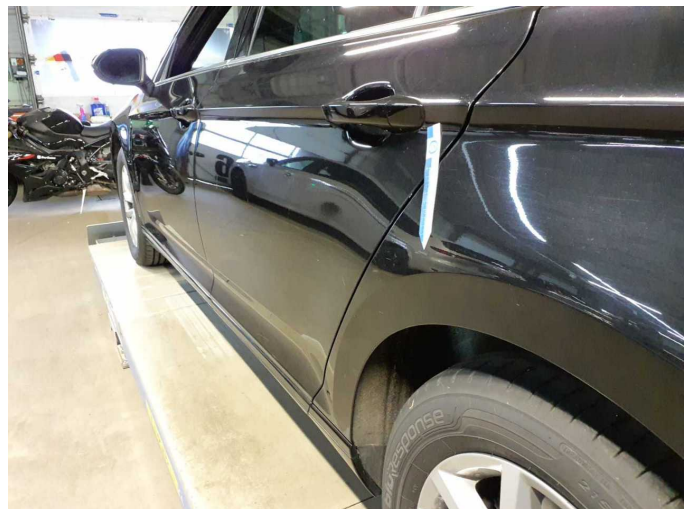
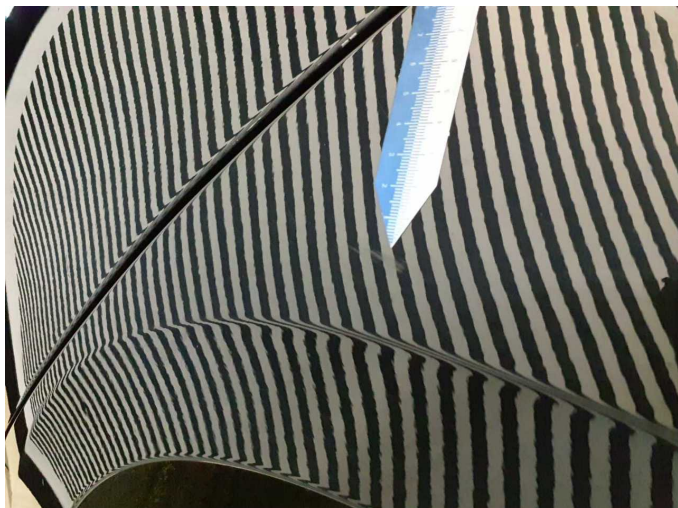
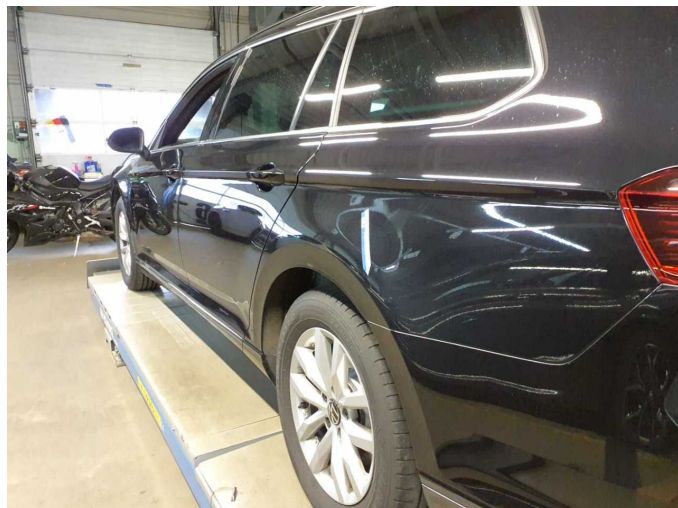
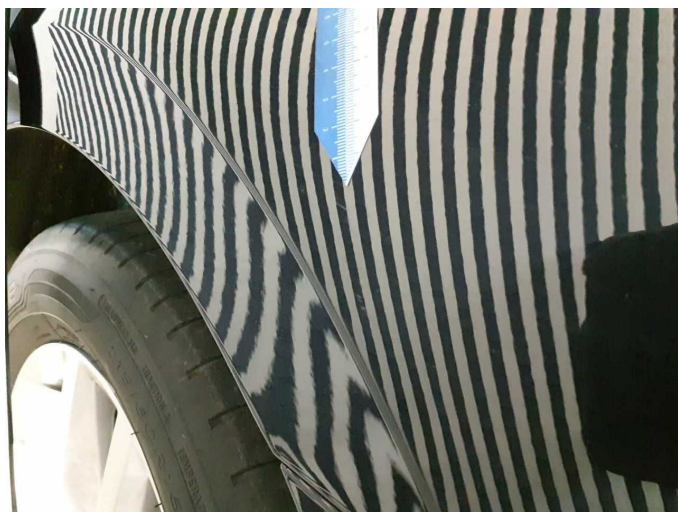
**Damage 6:** Side panel - rear left side: Side panel (Kratzer) - dent(s) - Smart repair

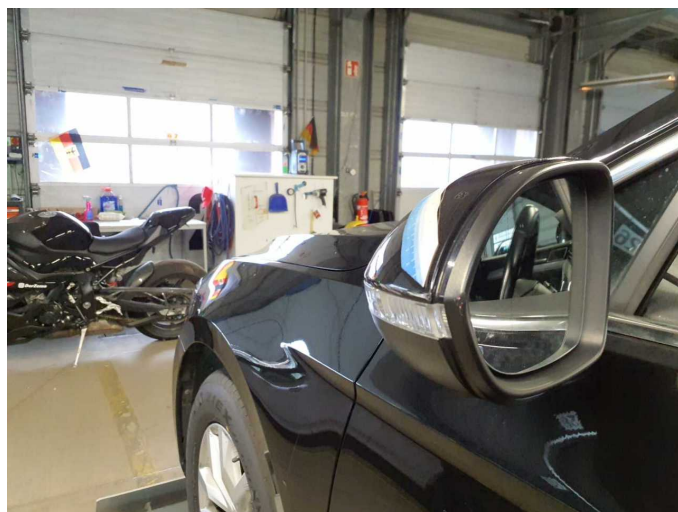
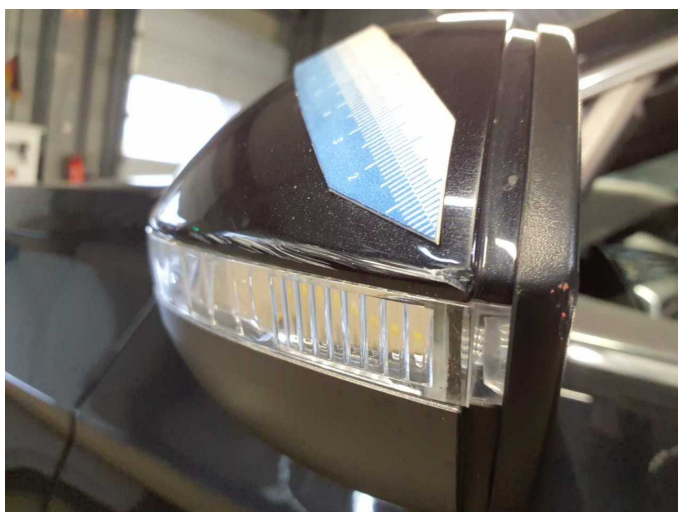
**Damage 7:** Wing mirror - left side: Cap - Broken / torn - Replace

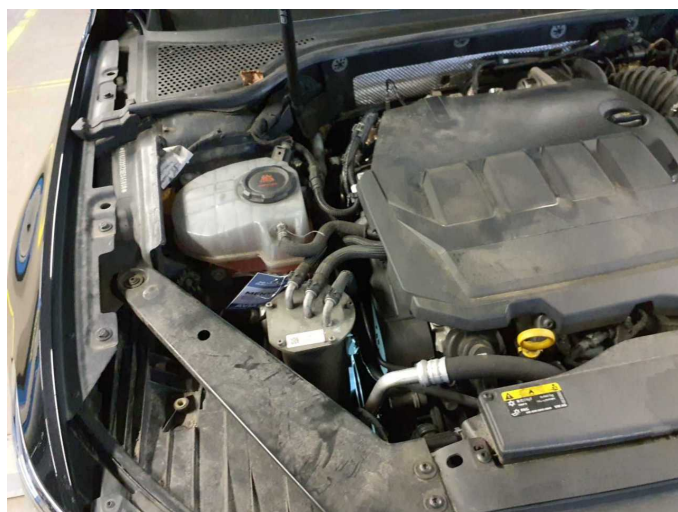
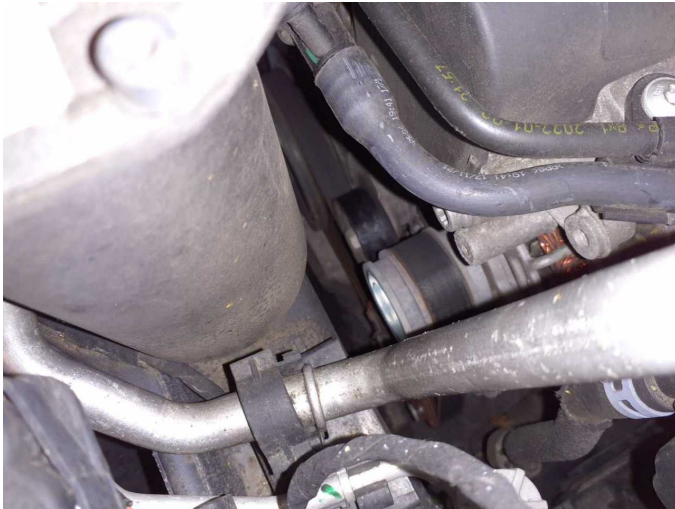
**Damage 8:** Engine: Belt drive (Quischen im Bereich des Riementriebs) - Noise - Perform diagnosis

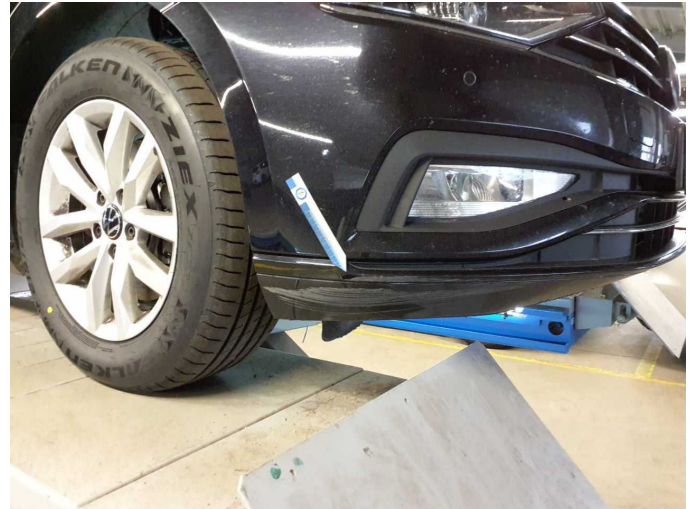
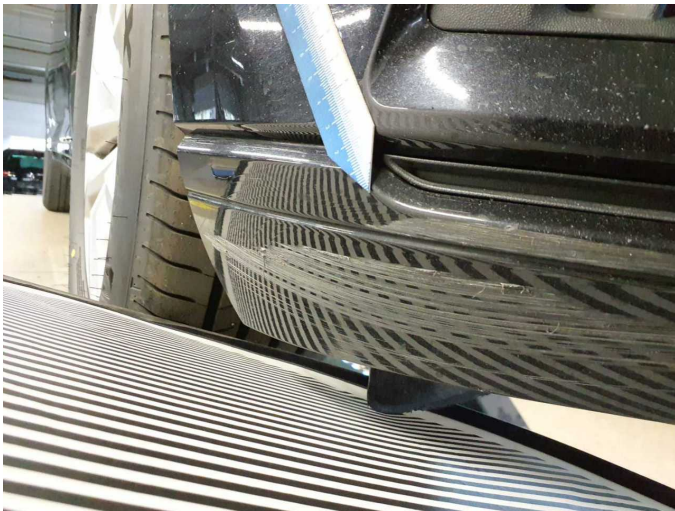
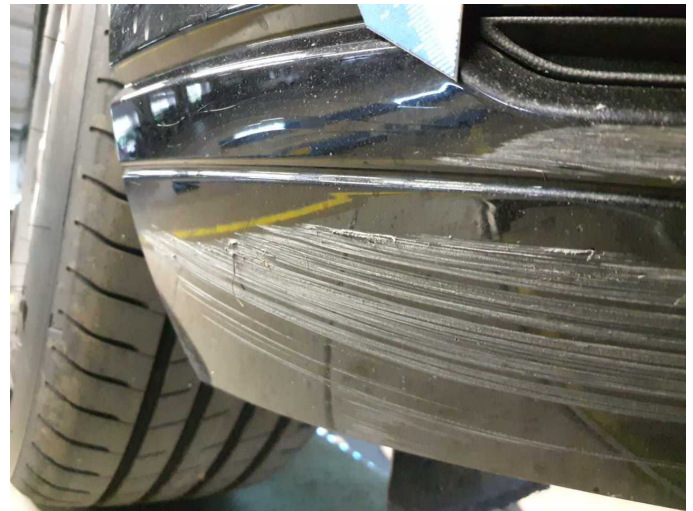
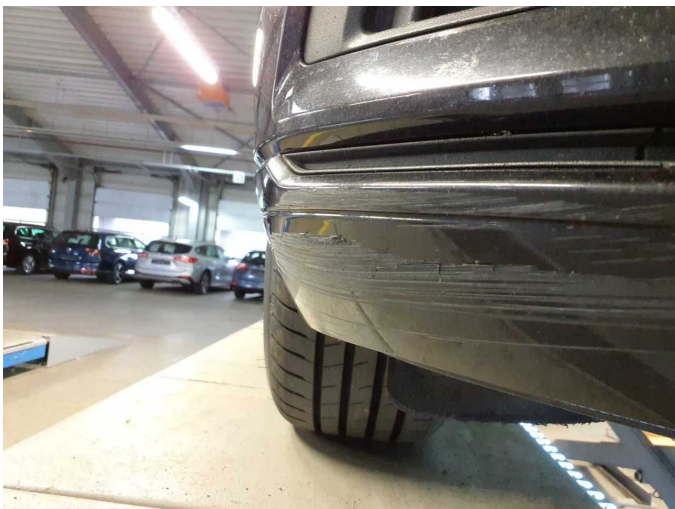
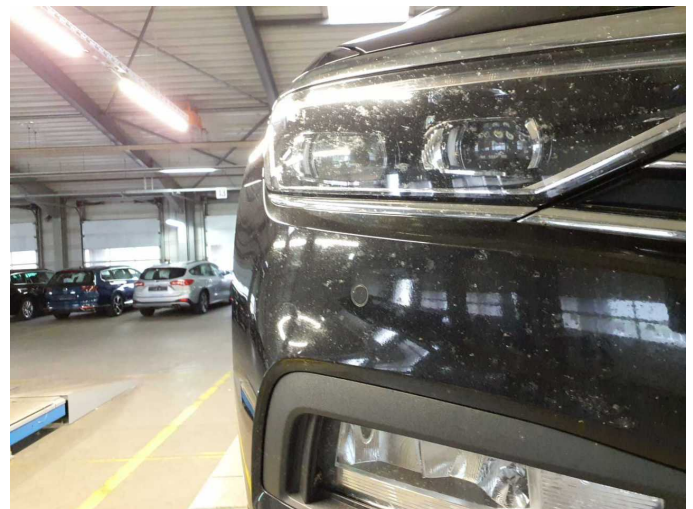
**Damage 9:** Front bumper: Spoiler - Scratched - Paint

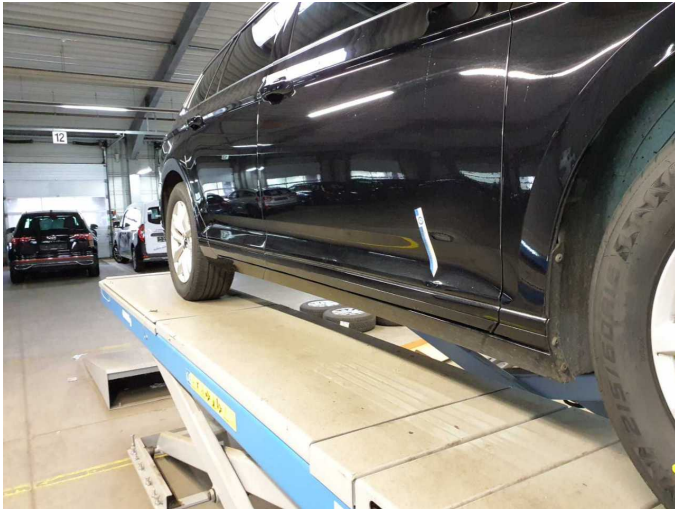
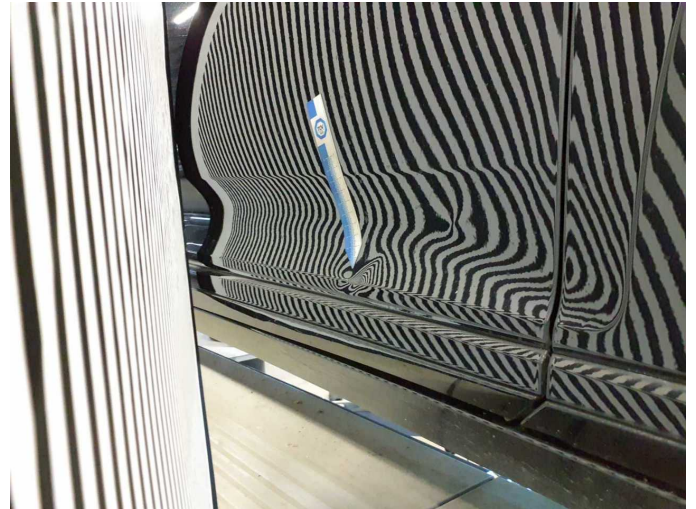
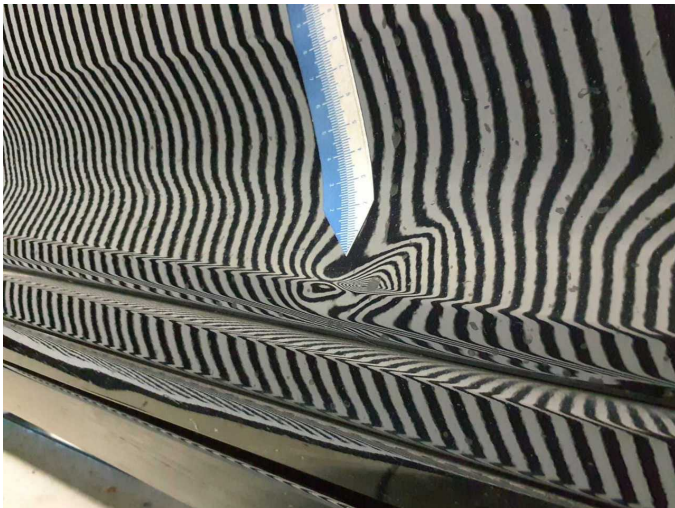
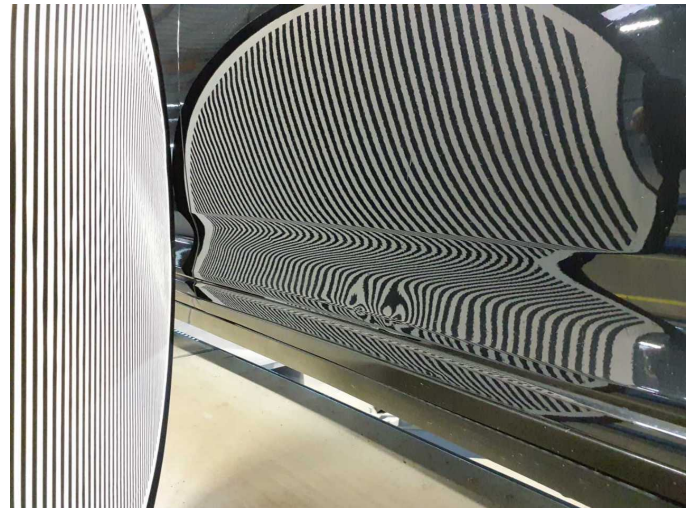
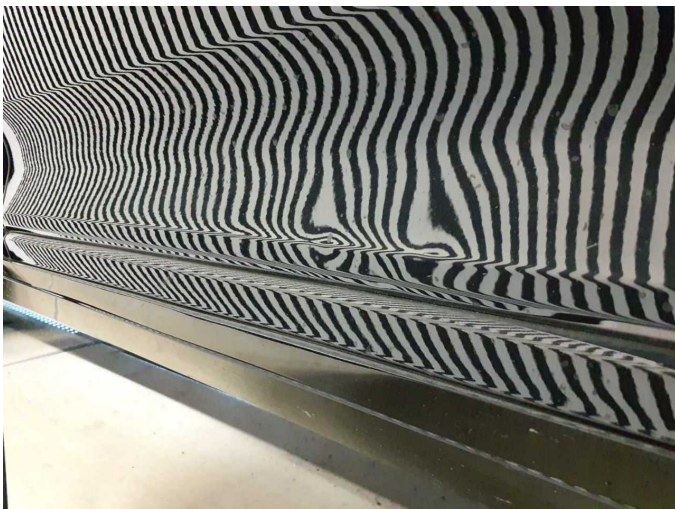
**Damage 10:** Door - front right side: Door - Deformed - Repair and paint

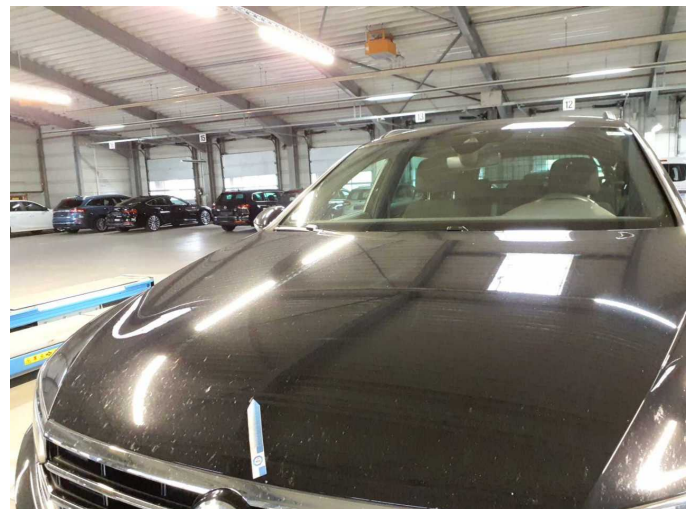
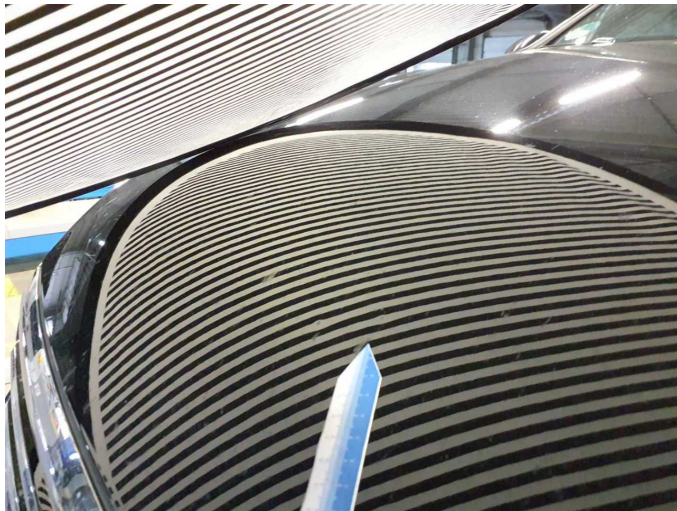
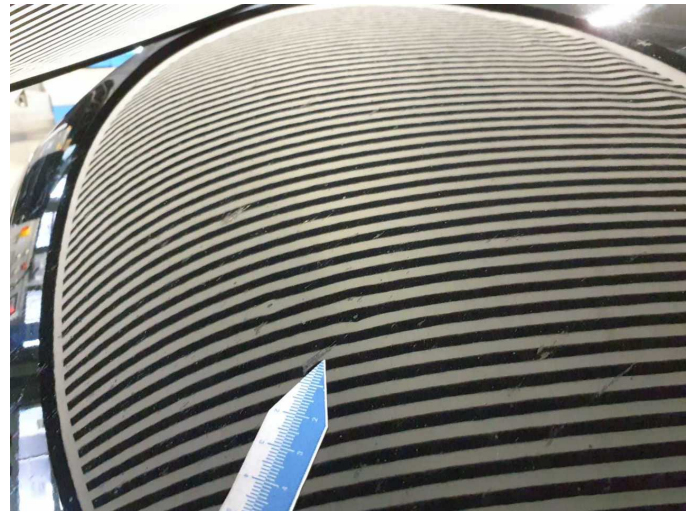
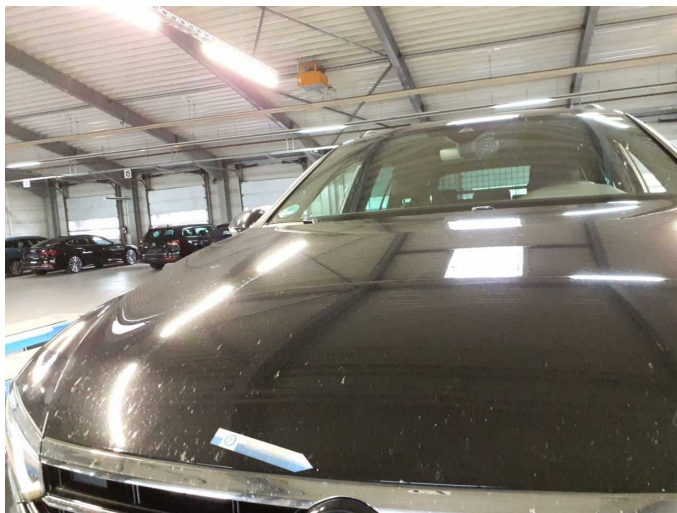
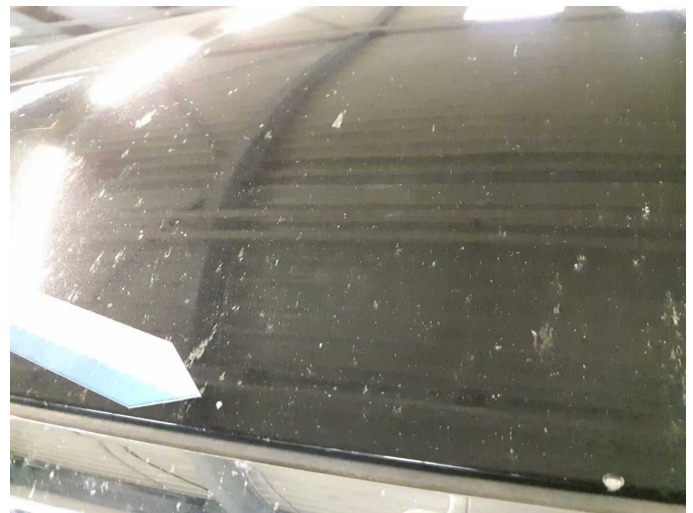
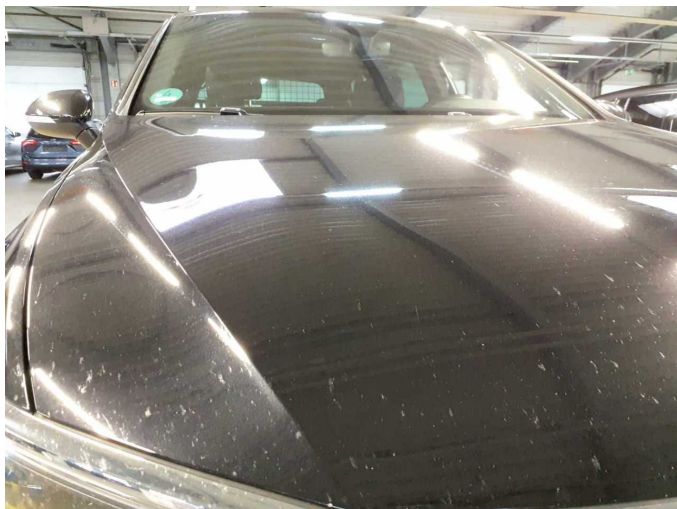
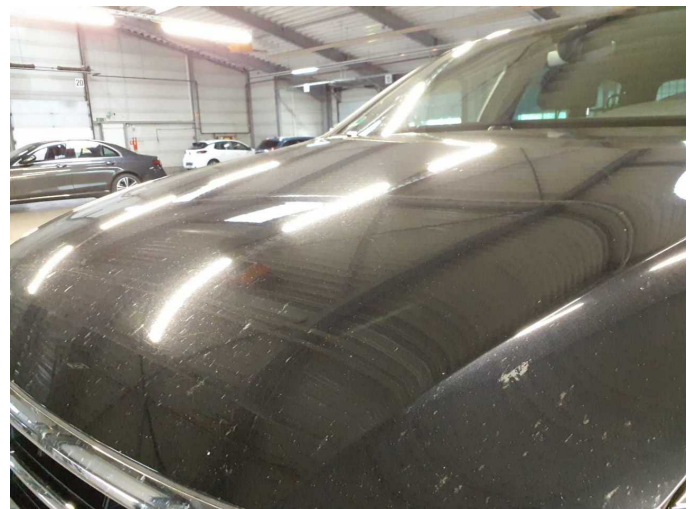
**Damage 11:** Bonnet: Bonnet (Dellen) - Stone chips - Repair and paint

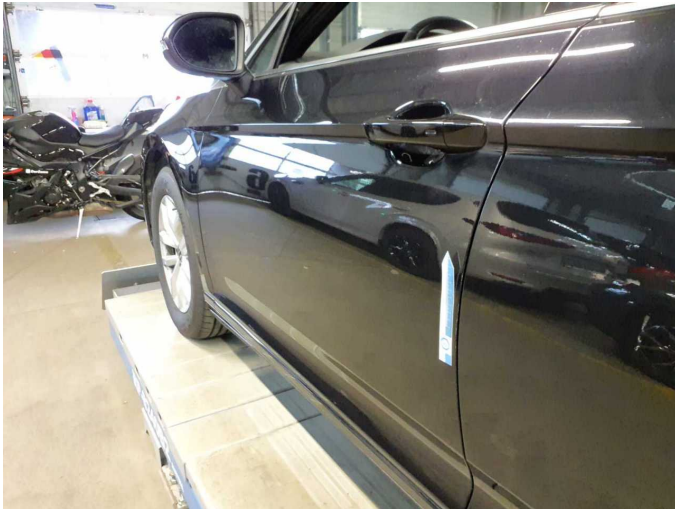
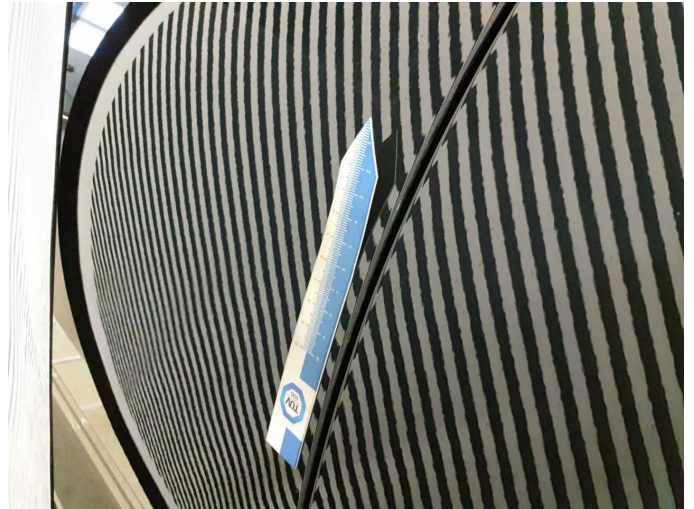
**Wear and tear 4:** Door - front left side: Door edge - Scratched - No deduction

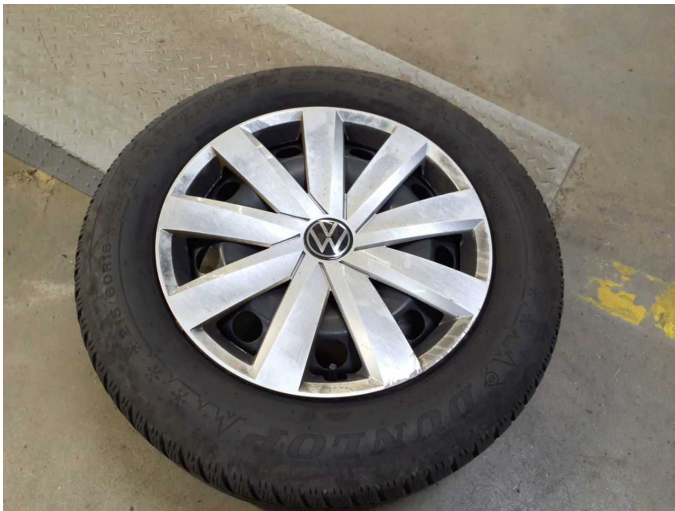
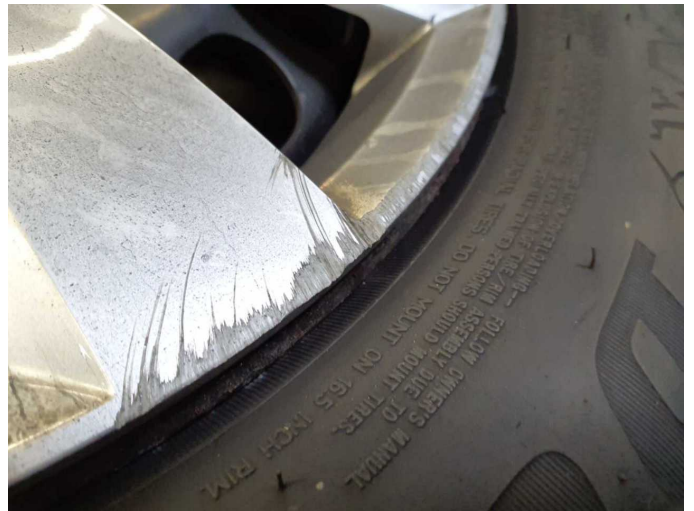
**Wear and tear 10:** 2nd wheel set: 1 wheel cover (nicht zur Ausstattung) - Scratched - No deduction

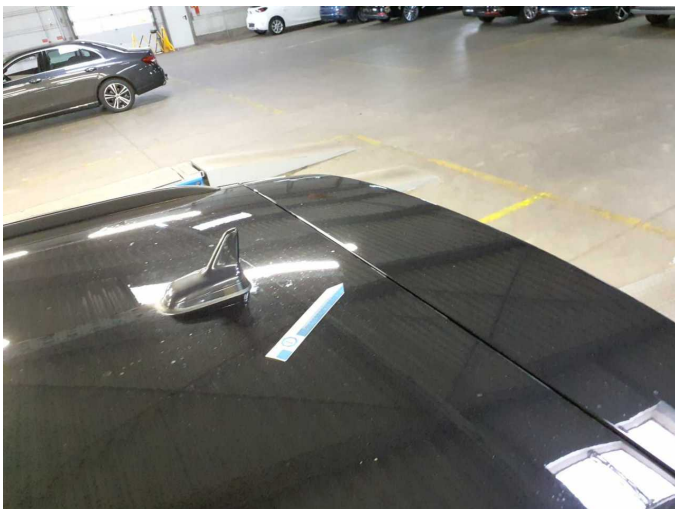
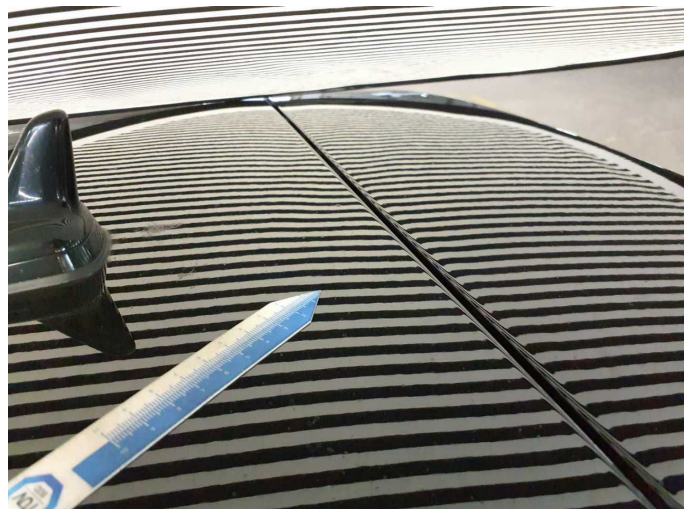
**Wear and tear 11:** Roof: Roof (Kratzer) - dent(s) - Smooth repair work
