Expertise

Protocol number: 41516539
Order No. / Reference: 25210668
Inspection date: 11 Sept 2025

Manufacturer: Volkswagen

Model: Passat Variant 2.0 TDI SCR DSG Business

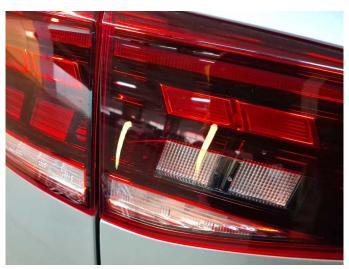
| No. | Component group | Description |
|---|---|---|
| 3 | Tail light | Tail lamp - left side - Broken / torn - Replace |

Damage 3: Tail light: Tail lamp - left side - Broken / torn - Replace

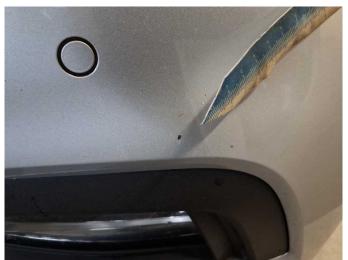
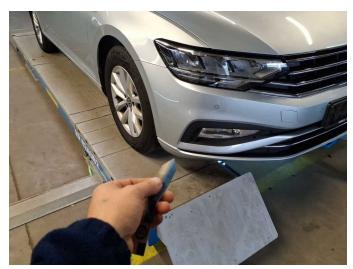
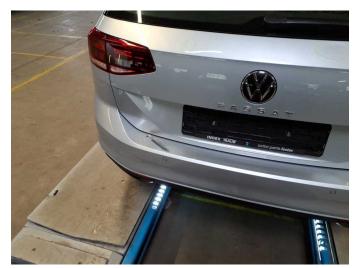
| No. | Component group | Description |
|---|---|---|
| 4 | Front bumper | Front bumper - Scratched - Paint |

Damage 4: Front bumper: Front bumper - Scratched - Paint

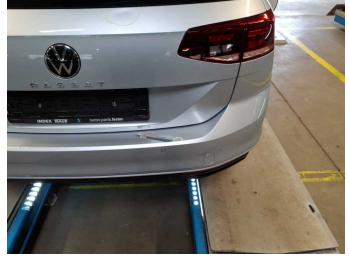
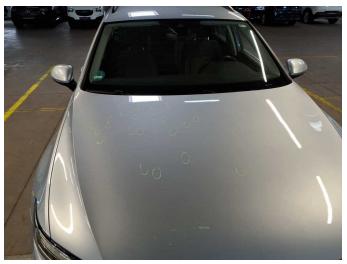
| No. | Component group | Description |
|---|---|---|
| 5 | Rear bumper | Rear bumper - Scratch(es) - Paint |

Damage 5: Rear bumper: Rear bumper - Scratch(es) - Paint

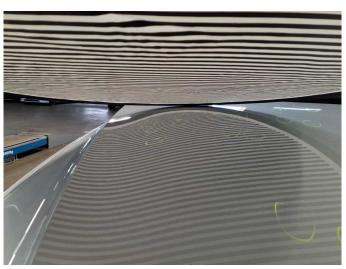
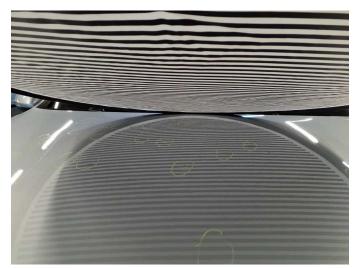
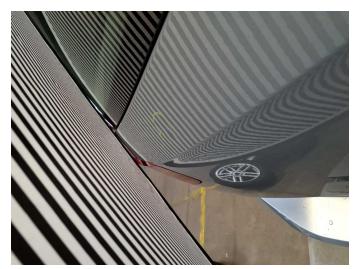
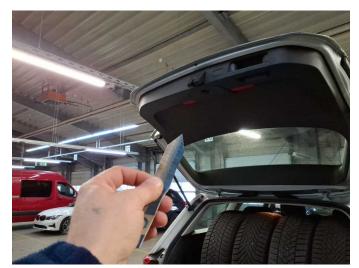
| No. | Component group | Description |
|---|---|---|
| 6 | Body | Body - Damage by hail - repair according to calculation |

Die beigefügte Reparaturkostenkalkulation wurde nach bestem Wissen und Gewissen im demontagefreien Zustand erstellt. Es können Mehrkosten und somit Abweichung der für den Hagelschaden ausgewiesener Reparaturkosten nicht ausgeschlossen werden.

Damage 6: Body: Body - Damage by hail - repair according to calculation Damage 6: Body: Body - Damage by hail - repair according to calculation

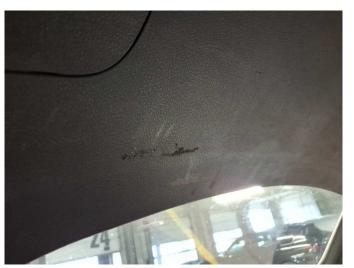
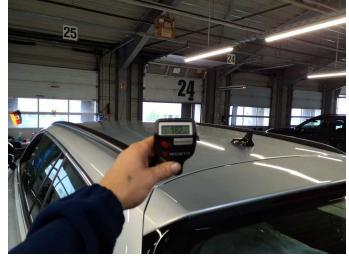
| No. | Component group | Description |
|---|---|---|
| 2 | Trim / covers | Boot lid - interior trim - Scratch(es) - No deduction |

Wear and tear 2: Trim / covers: Boot lid - interior trim - Scratch(es) - No deduction

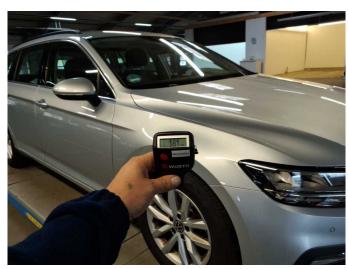
Repainting 3: Mudguard - left side

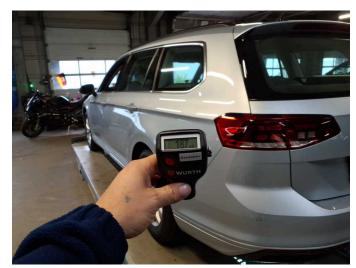
Repainting 4: Mudguard - right side

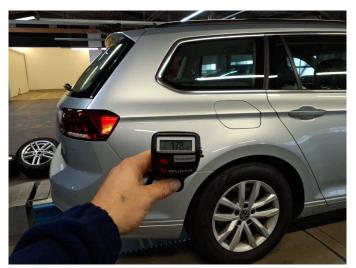
Repainting 5: Side panel - rear left side

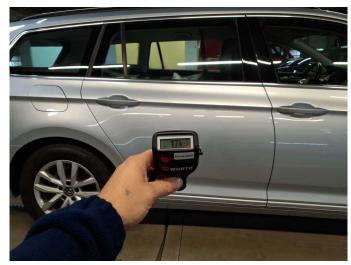
Repainting 7: Door - rear left side

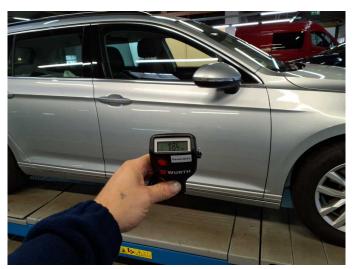
Repainting 9: Door - front left side
