Expertise

Protocol number: 40825539  
Order No. / Reference: 25040354  
Inspection date: 31 Jul 2025

Manufacturer: Volkswagen

Model: Passat Variant 2.0 TDI SCR DSG Business

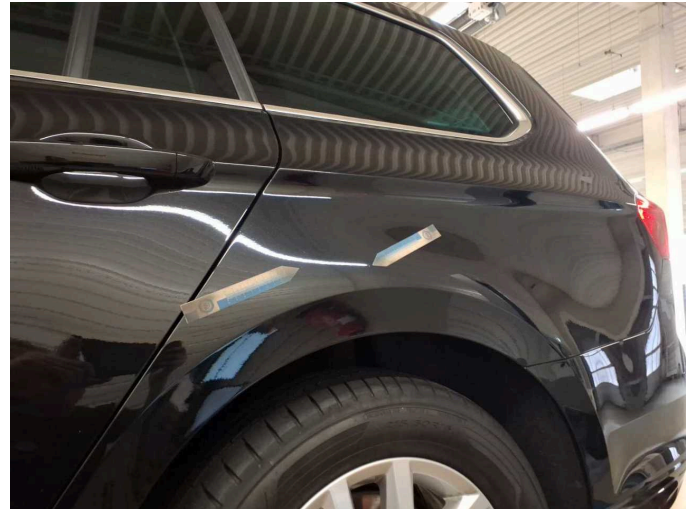
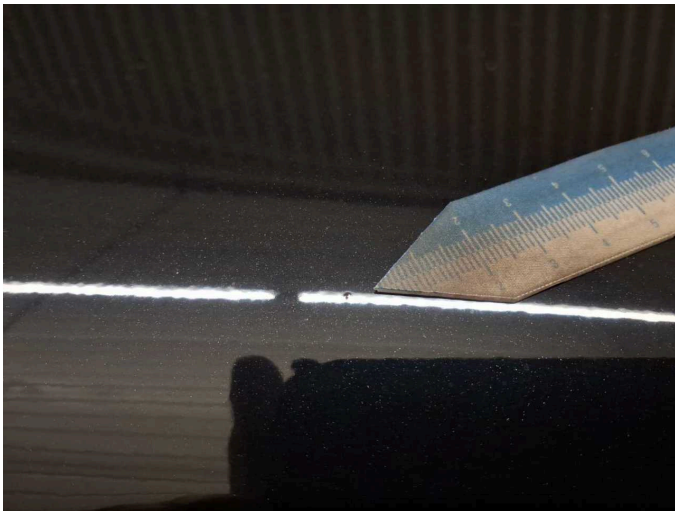
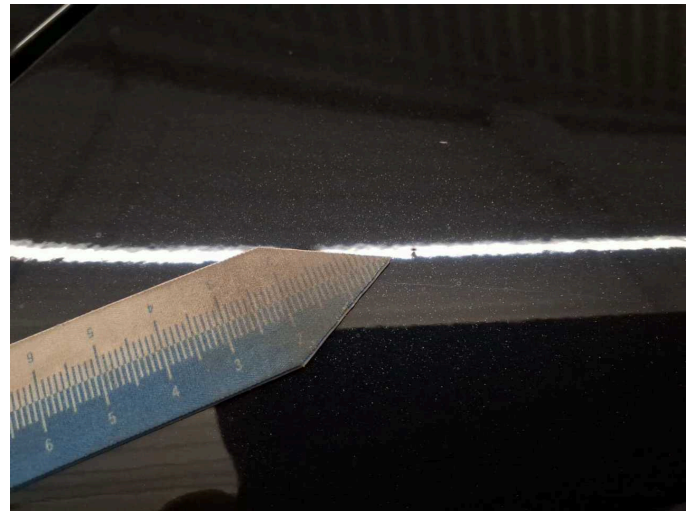
No.	Component group	Description
1	Side panel - rear left side	Side panel (Lackeinschlüsse) - Unprofessionally repaired - Paint
2	Side panel - rear right side	Side panel (Lackmängel + Einschlüsse) - Unprofessionally repaired - Paint
3	Bonnet	Bonnet (+ Steinschläge) - Scratch(es) - Paint
4	Door - front right side	Door (wellig + Lackeinschlüsse) - Unprofessionally repaired - Repair and paint

**Damage 1:** Side panel - rear left side: Side panel (Lackeinschlüsse) - Unprofessionally repaired - Paint

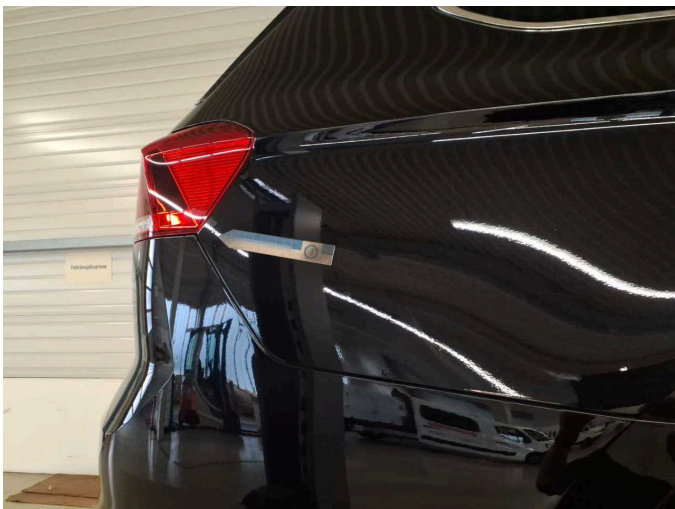
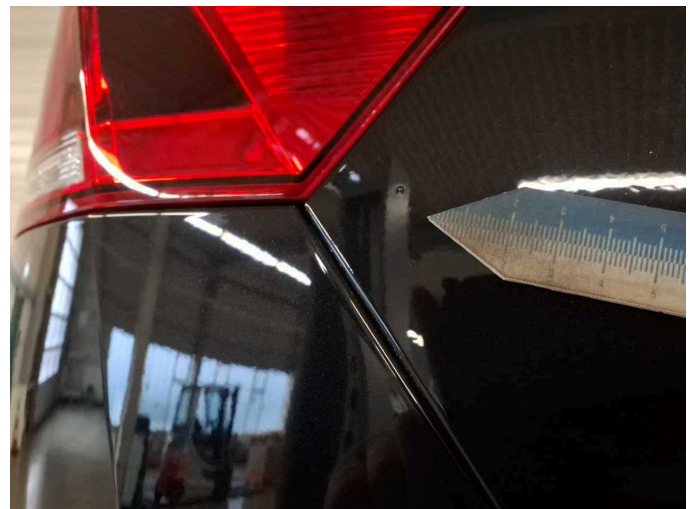
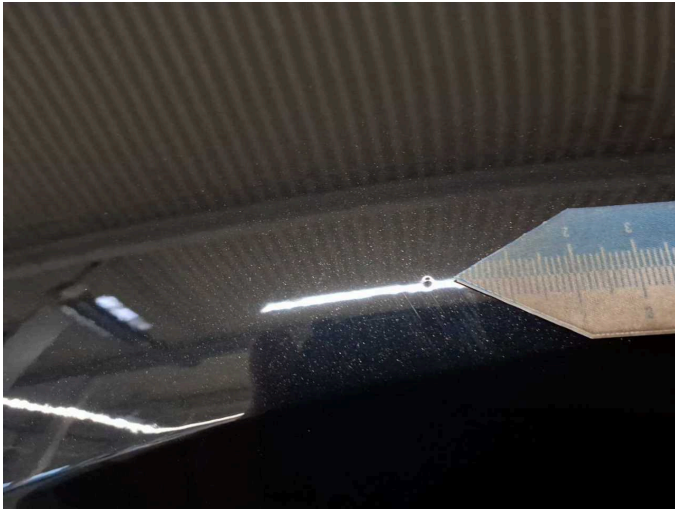
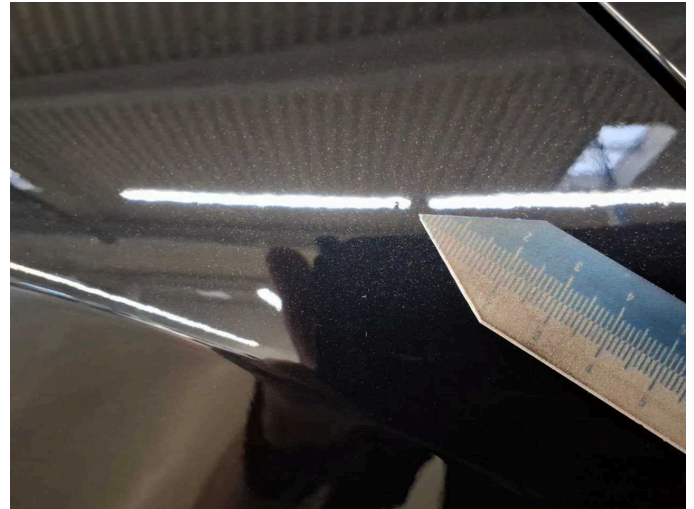
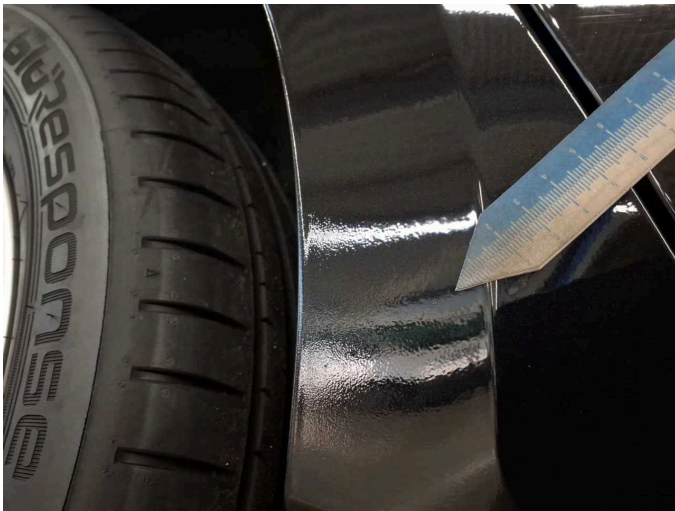
**Damage 2:** Side panel - rear right side: Side panel (Lackmängel + Einschlüsse) - Unprofessionally repaired - Paint

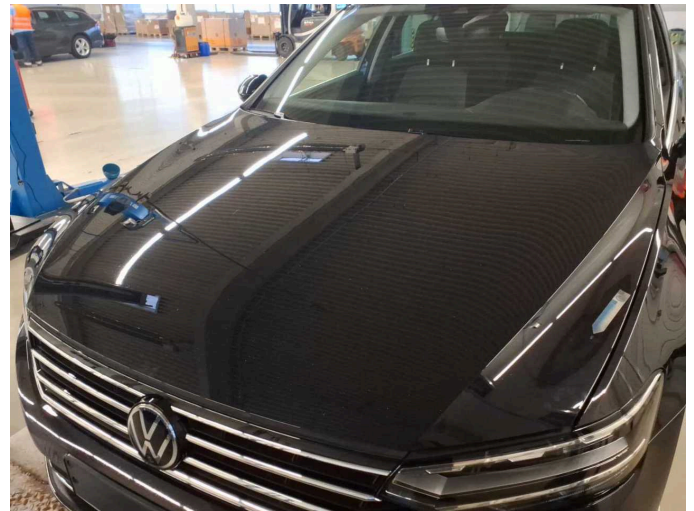
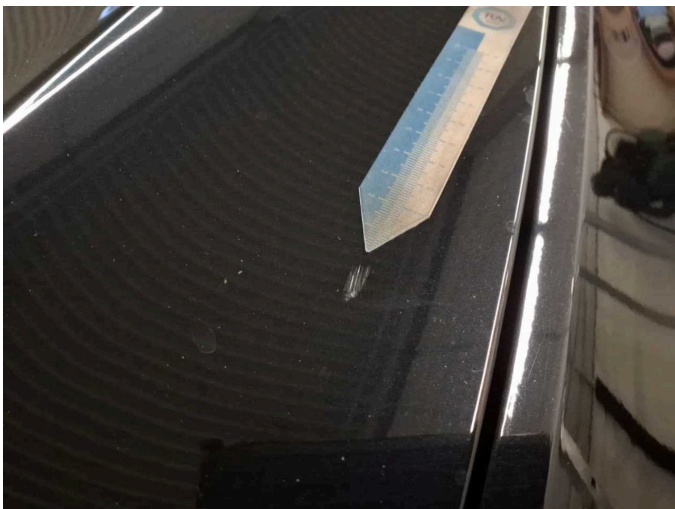
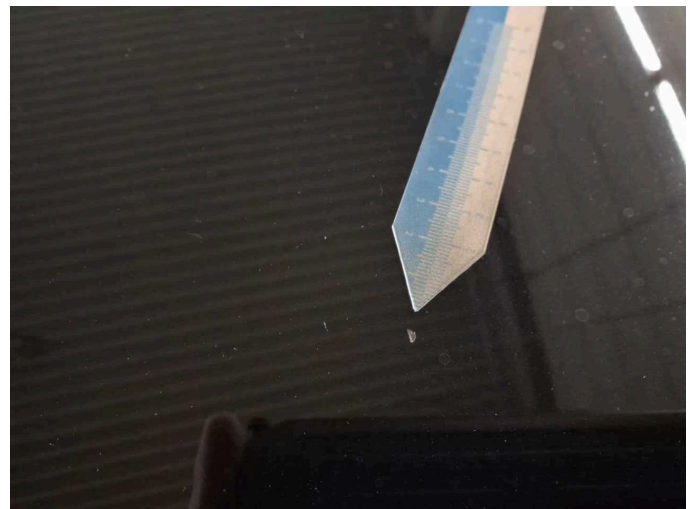
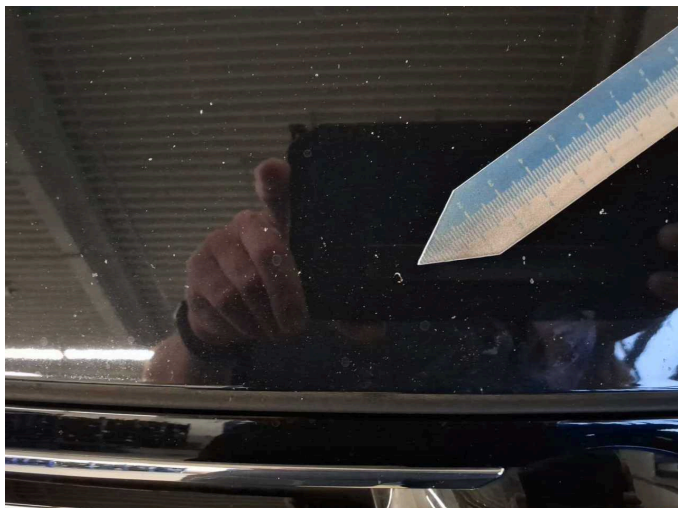
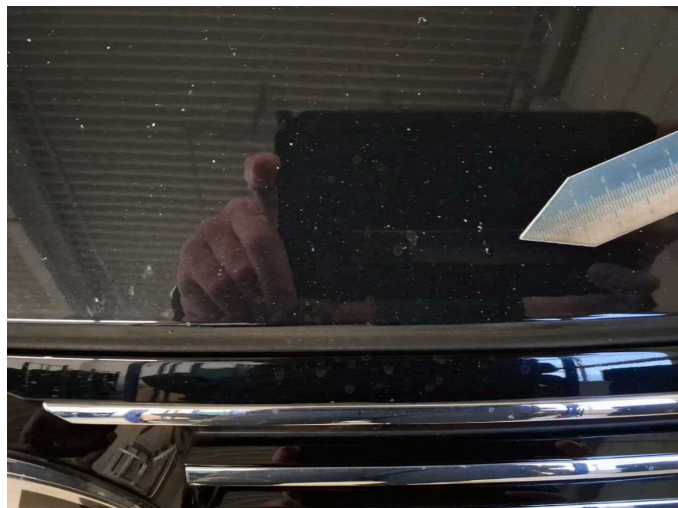
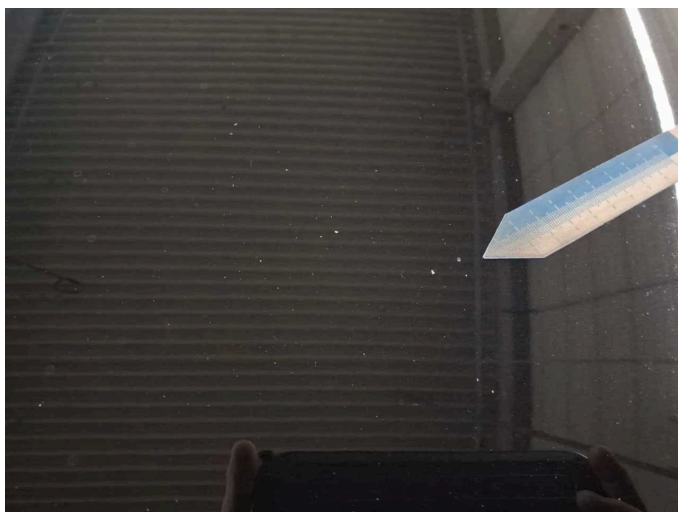
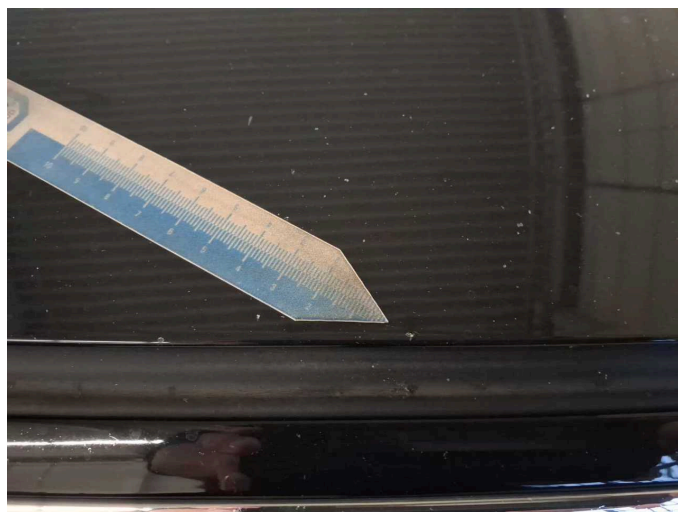
**Damage 3:** Bonnet: Bonnet (+ Steinschläge) - Scratch(es) - Paint

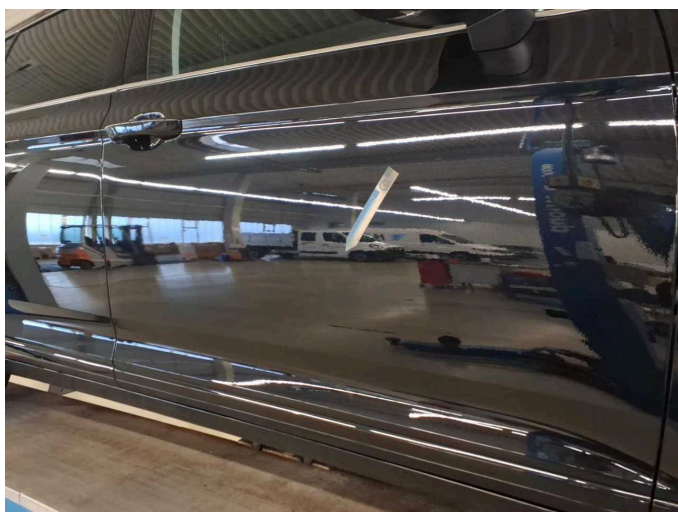
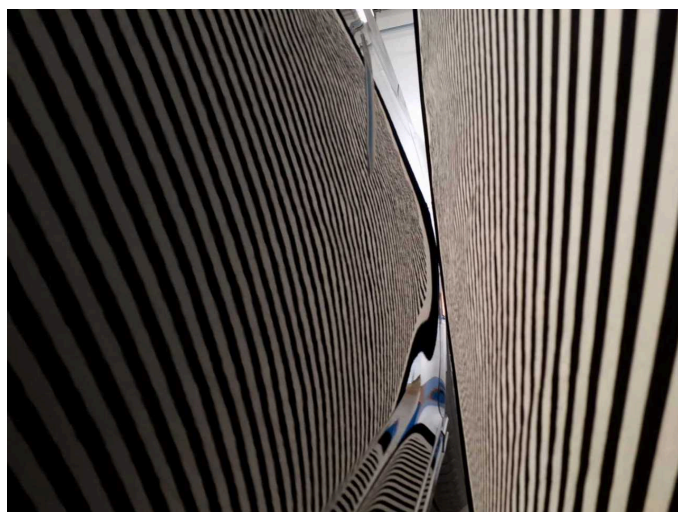
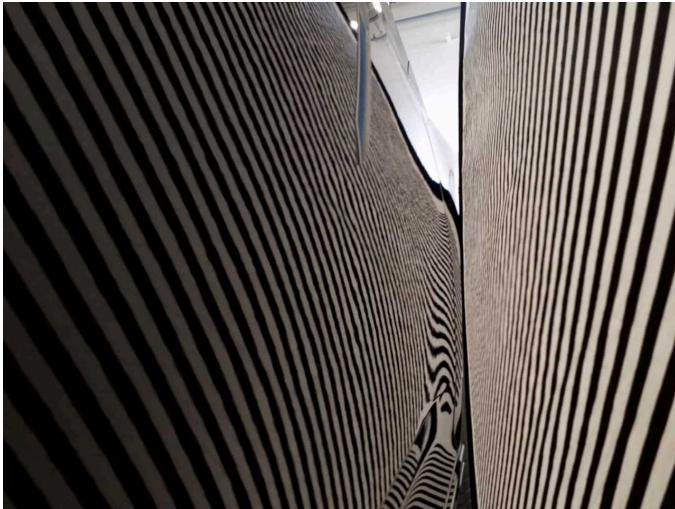
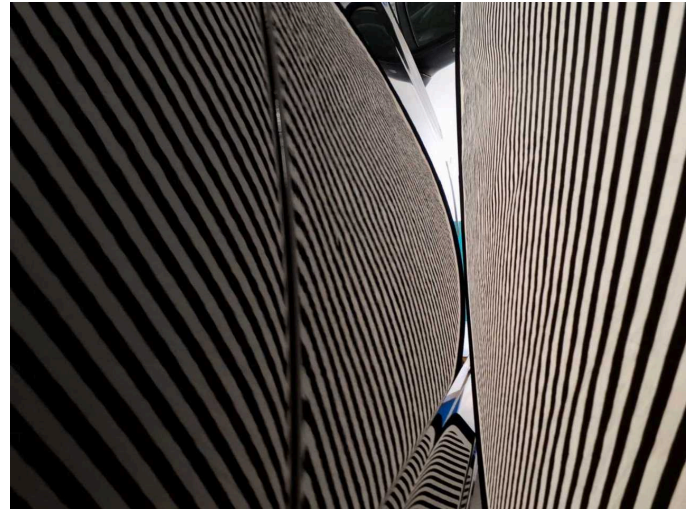
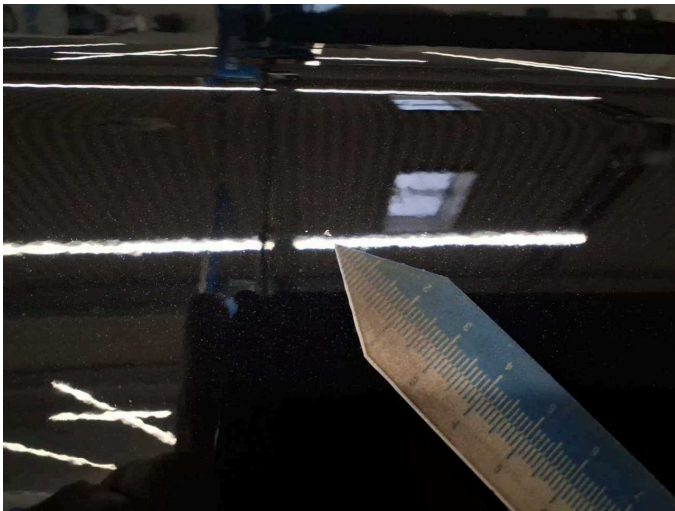
**Damage 4:** Door - front right side: Door (wellig + Lackeinschlüsse) - Unprofessionally repaired - Repair and paint

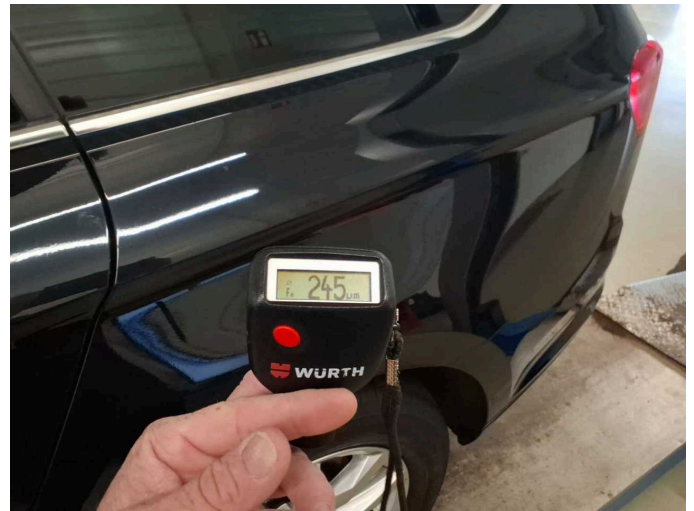
- Side panel - rear left side, Side panel - rear right side, Door - front right side, Unprofessionally carried out

**Side panel - rear left side:** 245 µm

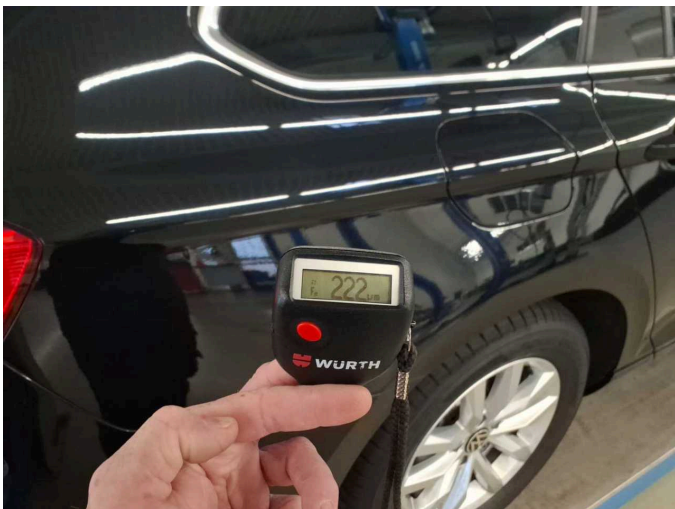
**Side panel - rear right side:** 222 µm

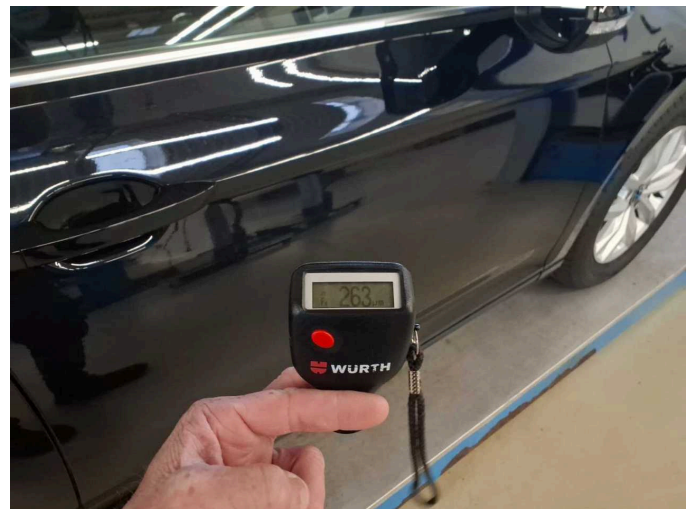
**Door - front right side:** 263 µm
