VOLKSWAGEN Arteon

Arteon Shooting Brake 1.4 eHybrid OPF DSG

Inspection Report Summary

Customer	BCA Online	Report Number	P20250904122217
Inspection Date / Place	2025-09-04 / BCA Neuss	Cosmetic Grade	5

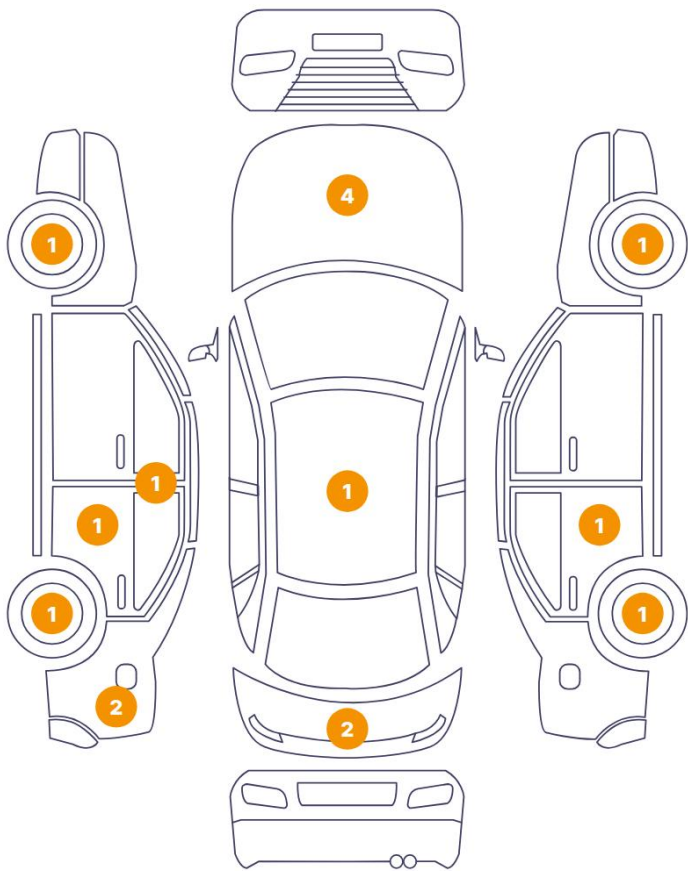
18 Schäden

Component		Damage	Comments
1	B Pillar / Center Left	Bodywork / Dent / Dent	
2	Roof	Paint / Poor Previous Repair	
3	Door / Back Left	Paint / Poor Previous Repair	
4	Fender / Back Left	Paint / Poor Previous Repair	
5	Tailgate	Paint / Poor Previous Repair	
6	Door / Back Right	Paint / Poor Previous Repair	
7	Hood	Bodywork / Dent / Dent	
8	Hood	Bodywork / Dent / Dent	
9	Hood	Bodywork / Dent / Dent	
10	Hood	Bodywork / Dent / Dent	
11	Rim / Front Left	Out of Bodywork / Scratch	
12	Fender / Back Left	Bodywork / Dent / Dent

13	Rim / Back Left	Out of Bodywork / Scratch
14	Tailgate	Bodywork / Dent / Dent
15	Rim / Back Right	Out of Bodywork / Scratch
16	Rim / Front Right	Out of Bodywork / Scratch

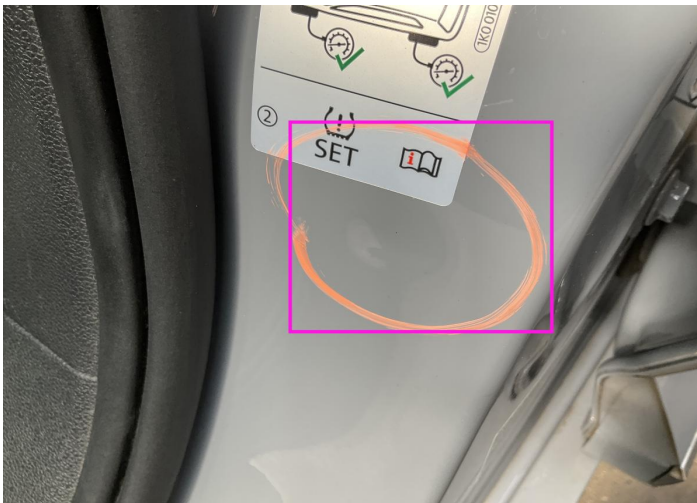
1. B Pillar / Center Left
Bodywork / Dent / Dent -

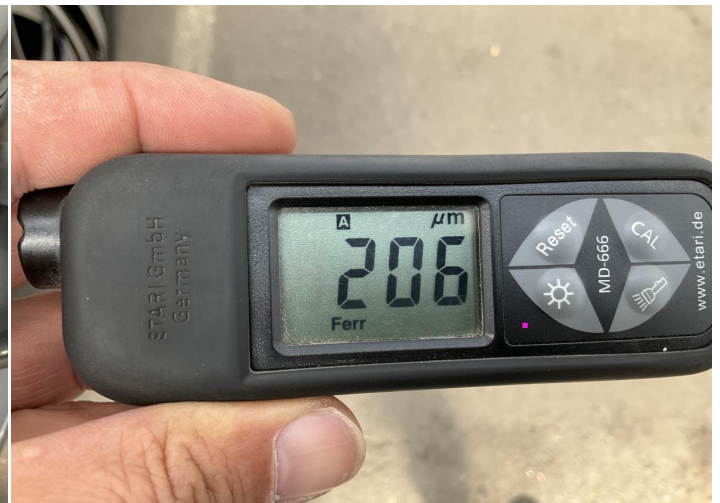
2. Roof
Paint / Poor Previous Repair -

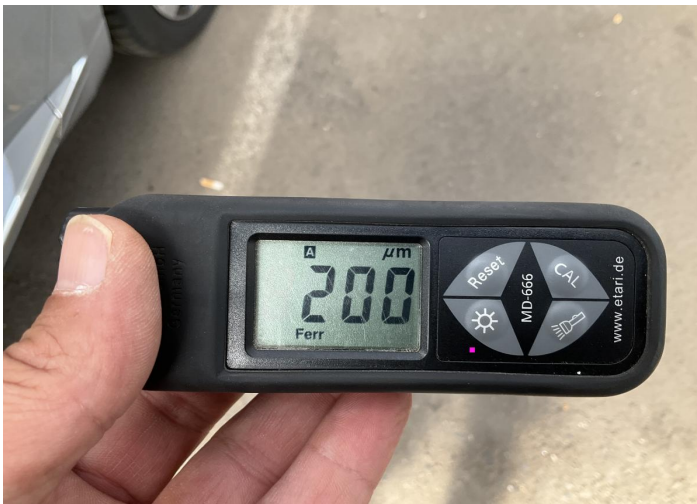
3. Door / Back Left
Paint / Poor Previous Repair -

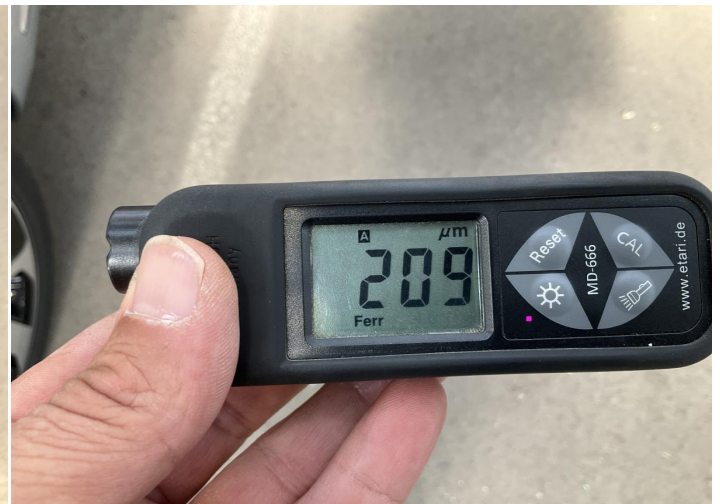
4. Fender / Back Left
Paint / Poor Previous Repair -

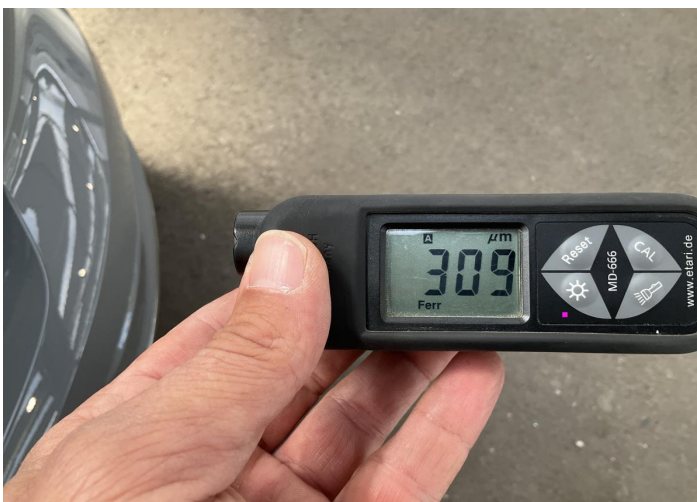
5. Tailgate
Paint / Poor Previous Repair -

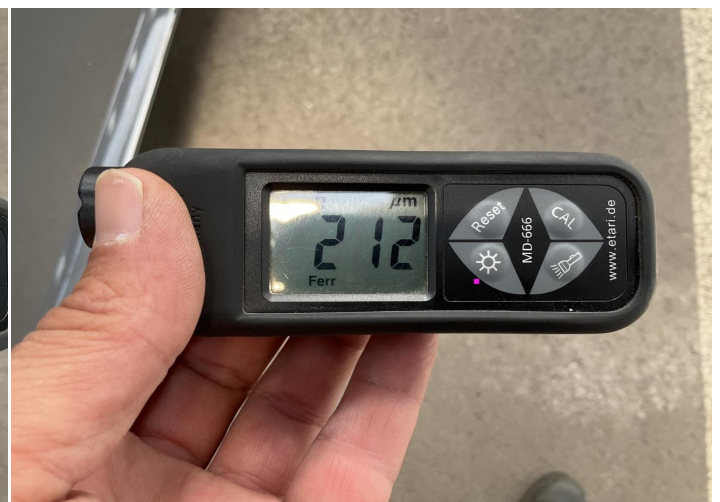
6. Door / Back Right
Paint / Poor Previous Repair -

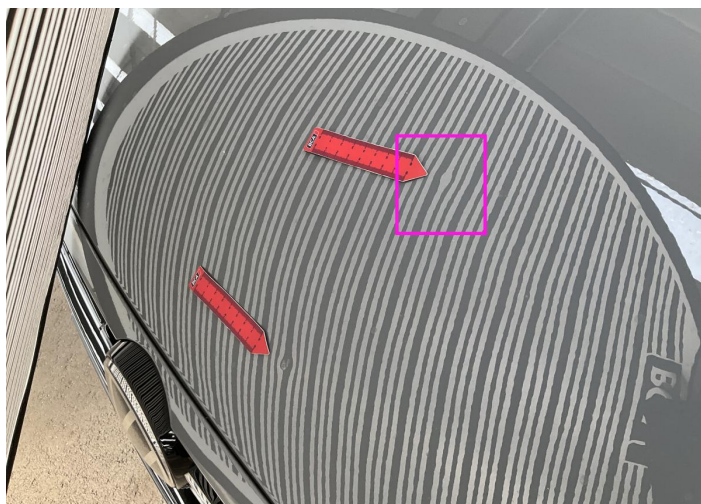
7. Hood
Bodywork / Dent / Dent -

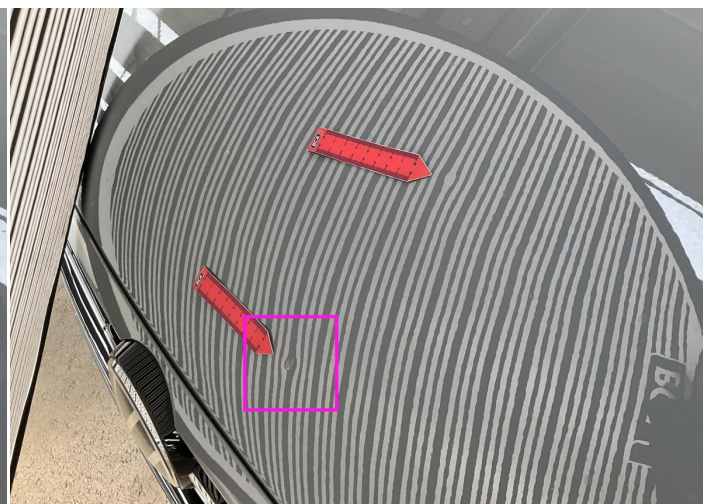
8. Hood
Bodywork / Dent / Dent -

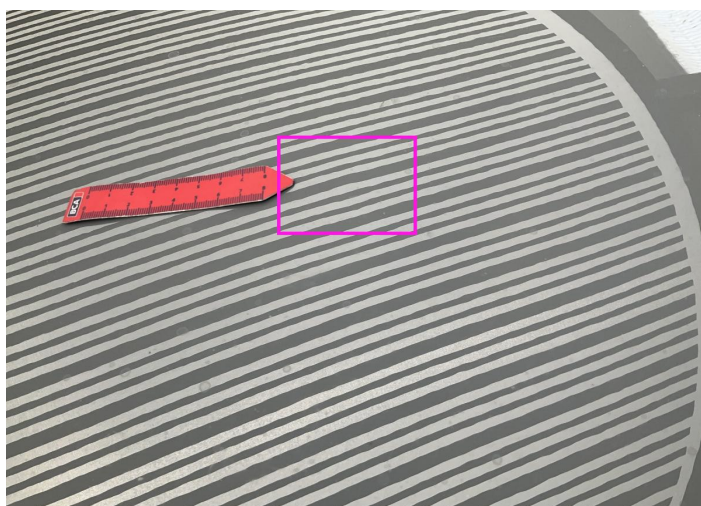
9. Hood
Bodywork / Dent / Dent -

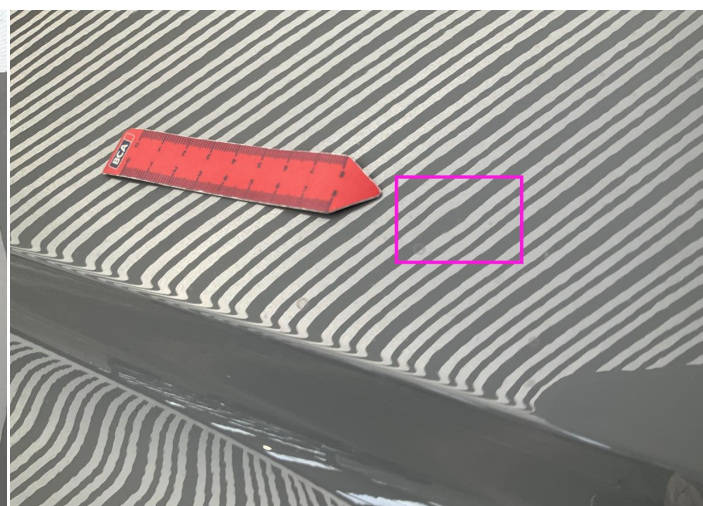
10. Hood
Bodywork / Dent / Dent -

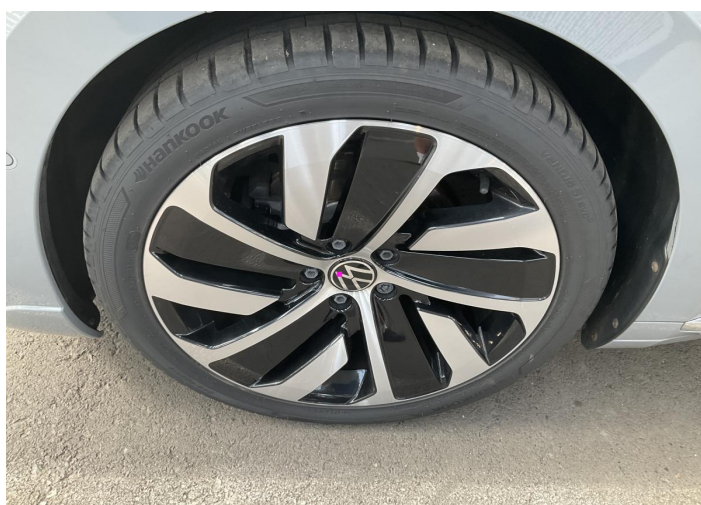
11. Rim / Front Left
Out of Bodywork / Scratch -

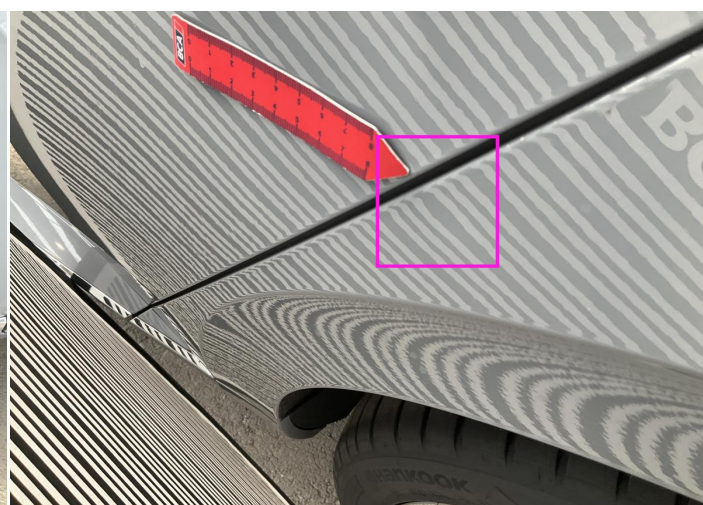
12. Fender / Back Left
Bodywork / Dent / Dent -

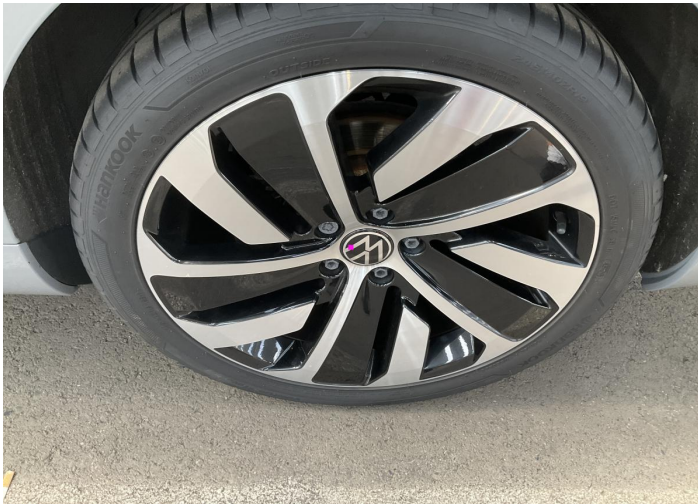
13. Rim / Back Left
Out of Bodywork / Scratch -

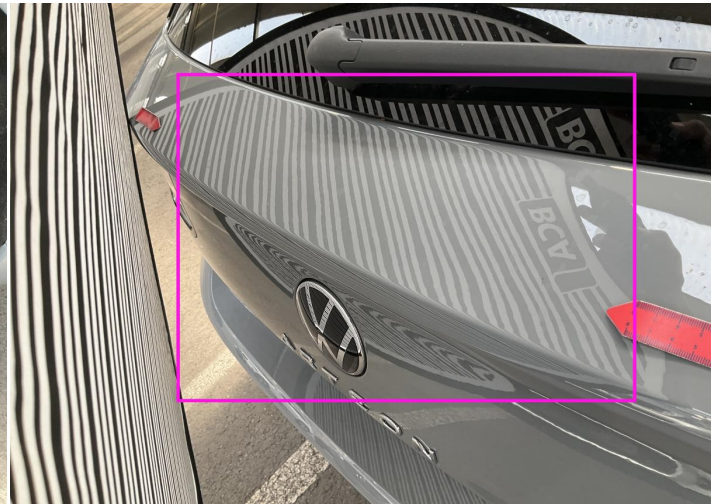
14. Tailgate
Bodywork / Dent / Dent -

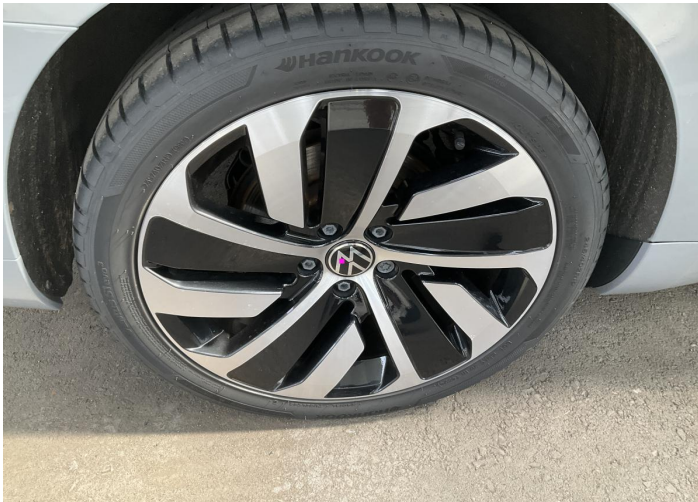
15. Rim / Back Right
Out of Bodywork / Scratch -

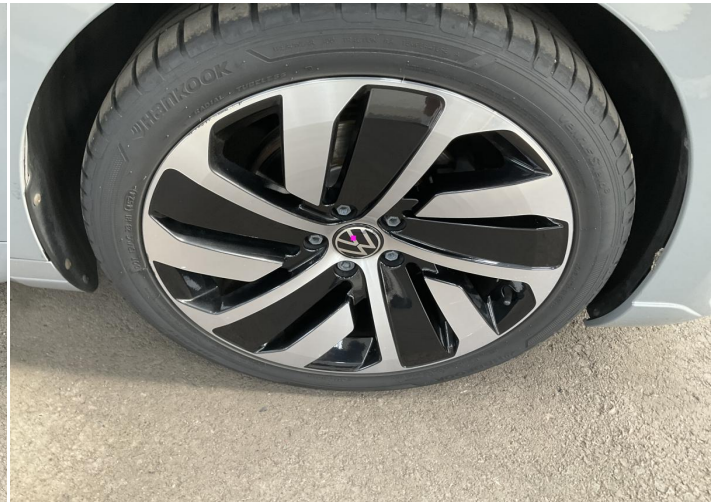
16. Rim / Front Right
Out of Bodywork / Scratch -
