# VOLKSWAGEN Polo 2009 Diesel

## polo 1.2 tdi Trendline 5p

VIN NO WVWZZZ6RZEY038741

### Inspection Report Summary

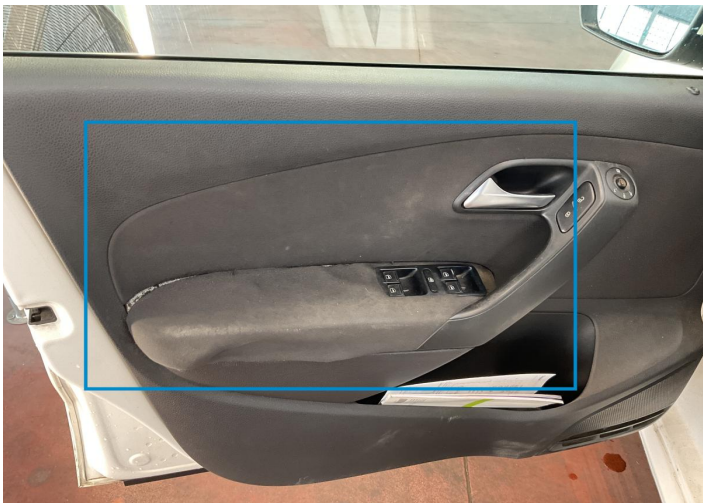
| Component | | Damage | Comments |
|---|---|---|---|
| 1 | Panel Filling / Front Left | Interior / Broken | |

1. Panel Filling / Front Left  
Interior / Broken -

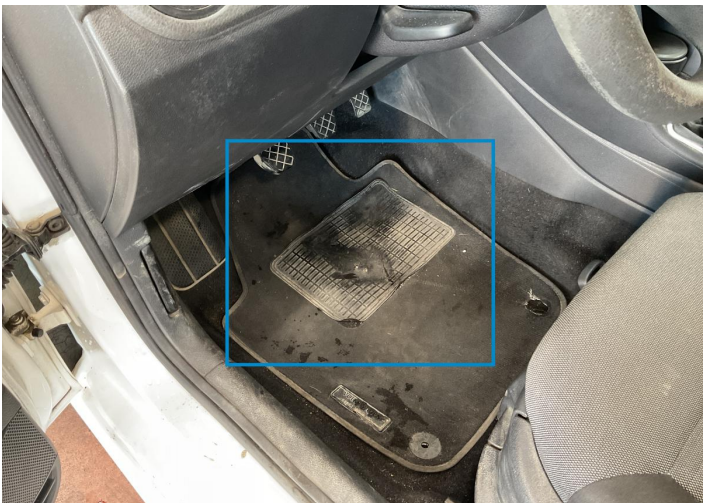
| Component | | Damage | Comments |
|---|---|---|---|
| 2 | Floor Carpet | Interior / Broken | |

2. Floor Carpet  
Interior / Broken -

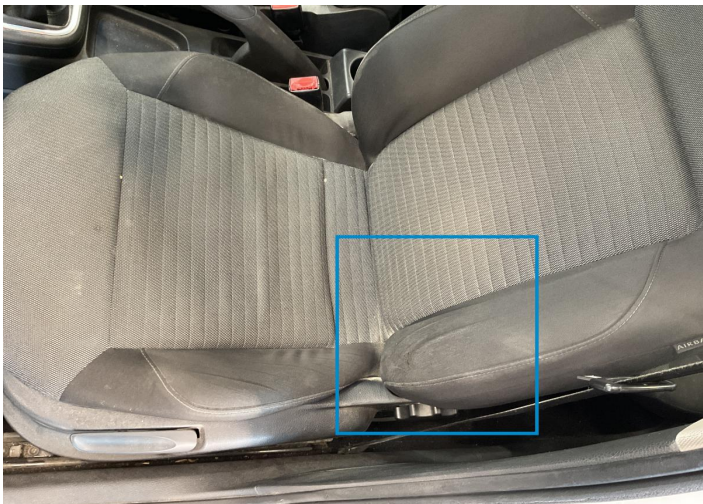
| Component | | Damage | Comments |
|---|---|---|---|
| 3 | Seat / Front Left | Interior / Broken | |

3. Seat / Front Left  
Interior / Broken -

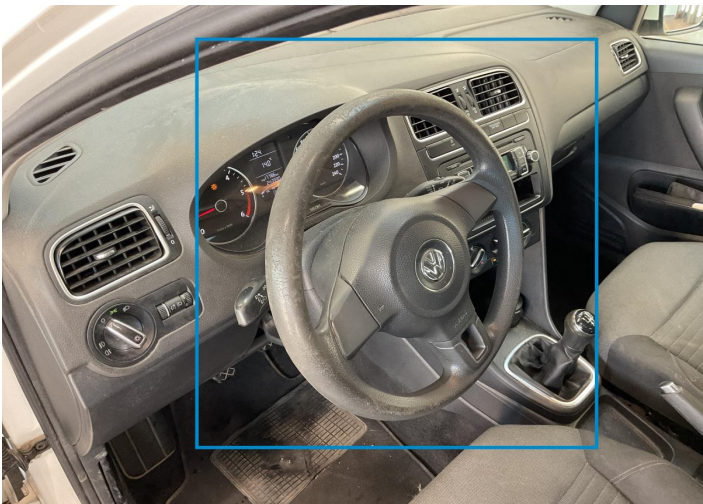
| Component | | Damage | Comments |
|---|---|---|---|
| 4 | Steering Wheel / Front | Interior / Worn - out | |

4. Steering Wheel / Front  
Interior / Worn - out -

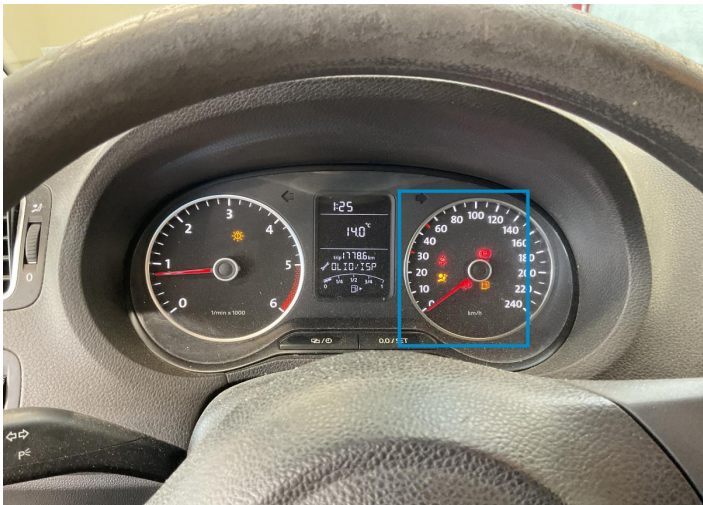
| Component | | Damage | Comments |
|---|---|---|---|
| 5 | Dashboard / Front | Interior / Warning Light ON | |

5. Dashboard / Front  
Interior / Warning Light ON -

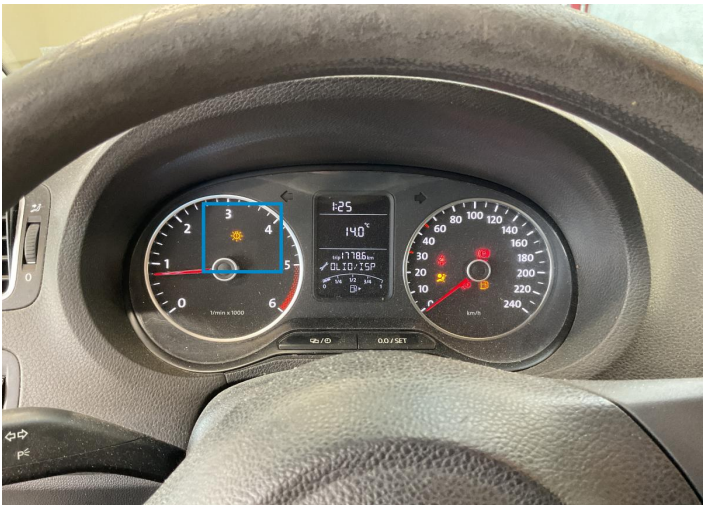
| Component | | Damage | Comments |
|---|---|---|---|
| 6 | Dashboard / Front | Interior / Warning Light ON | |

6. Dashboard / Front  
Interior / Warning Light ON -

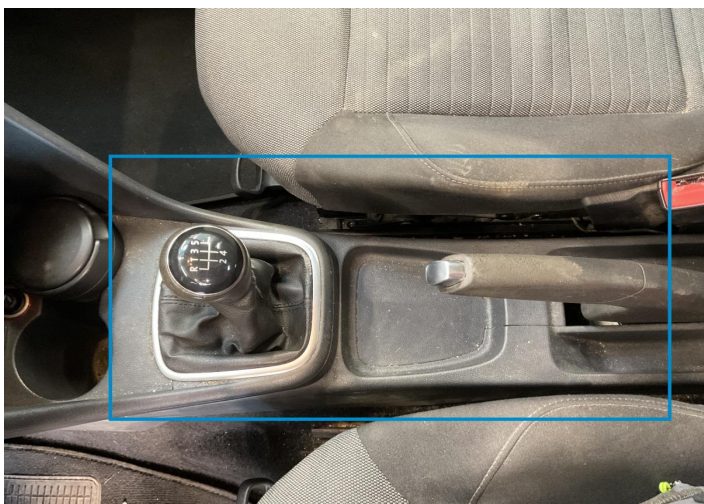
| Component | | Damage | Comments |
|---|---|---|---|
| 7 | Center Console | Interior / Worn - out | |

7. Center Console  
Interior / Worn - out -

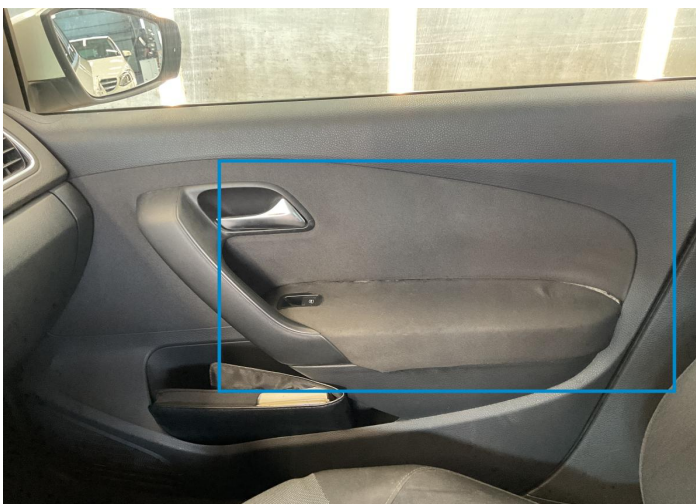
| Component | | Damage | Comments |
|---|---|---|---|
| 8 | Panel Filling / Front Right | Interior / Broken | |

8. Panel Filling / Front Right  
Interior / Broken -

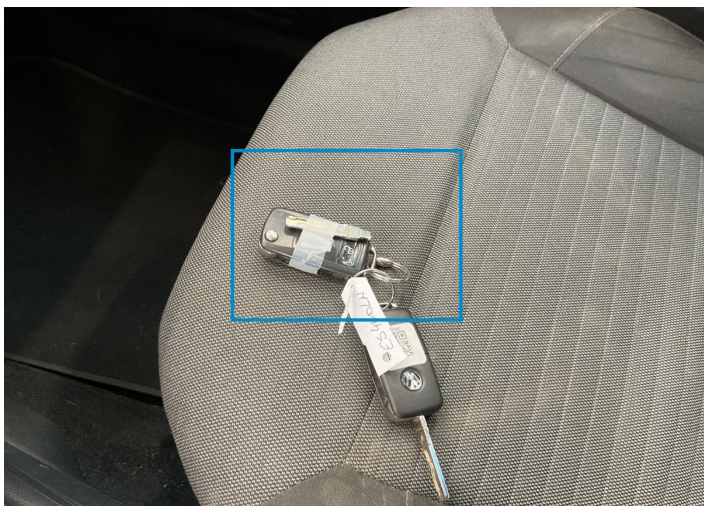
| Component | | Damage | Comments |
|---|---|---|---|
| 9 | Ignition Key | Interior / Broken | |

9. Ignition Key  
Interior / Broken -

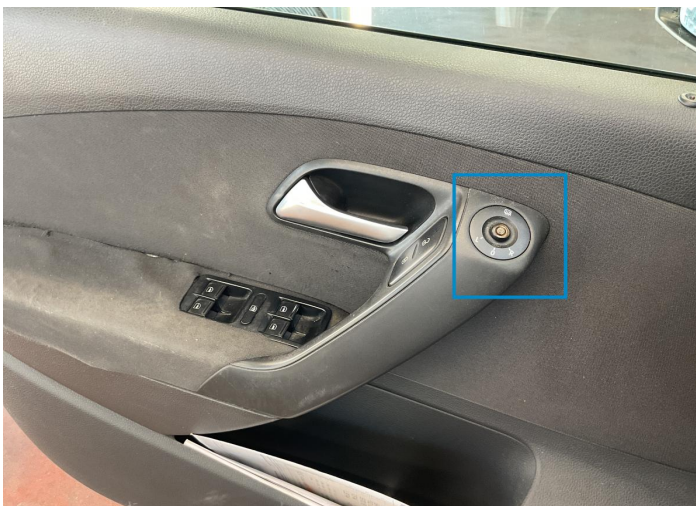
| Component | | Damage | Comments |
|---|---|---|---|
| 10 | Window Switch / Front Left | Interior / Broken | |

10. Window Switch / Front Left  
Interior / Broken -

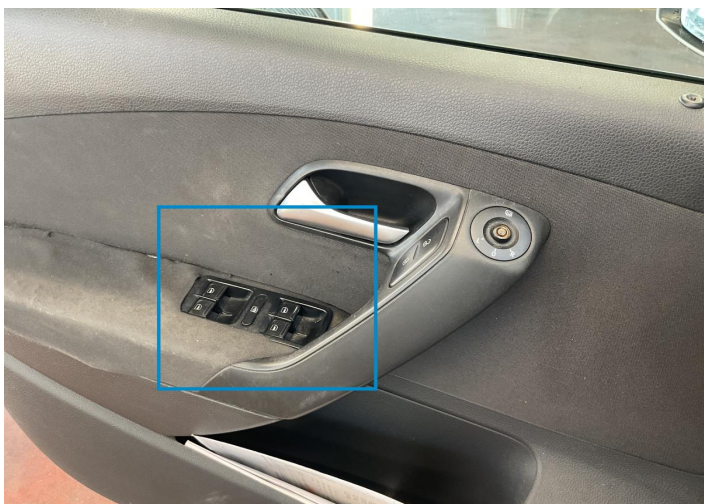
| Component | | Damage | Comments |
|---|---|---|---|
| 11 | Window Switch / Front Left | Interior / Broken | |

11. Window Switch / Front Left  
Interior / Broken -

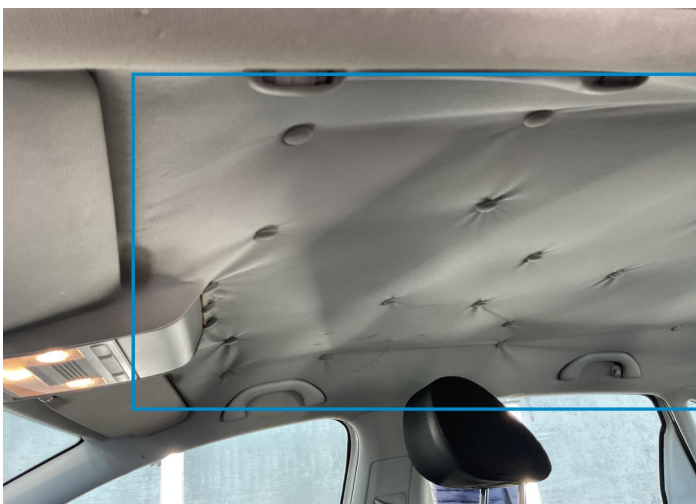
| Component | | Damage | Comments |
|---|---|---|---|
| 12 | Roof Upholstery | Interior / Broken | |

12. Roof Upholstery  
Interior / Broken -

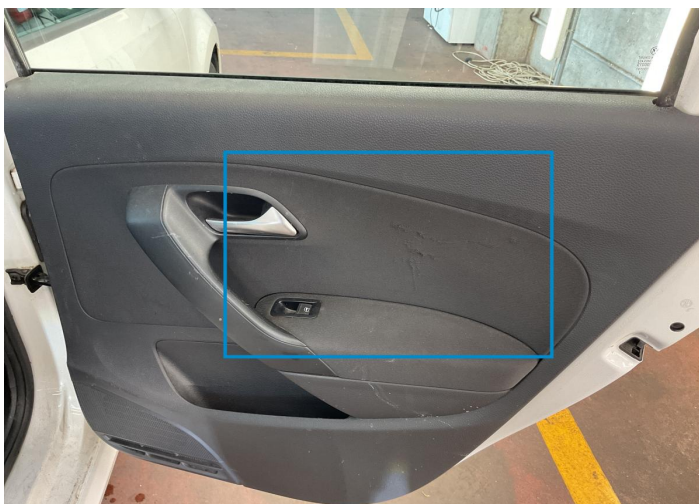
| 13 | Panel Filling / Back Right | Interior / Broken |

13. Panel Filling / Back Right  
Interior / Broken -

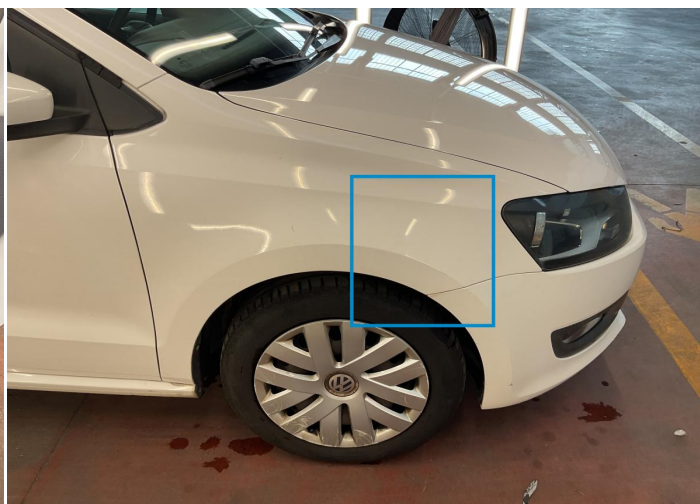
| 14 | Fender / Front Right | Bodywork / Dent |

14. Fender / Front Right  
Bodywork / Dent -

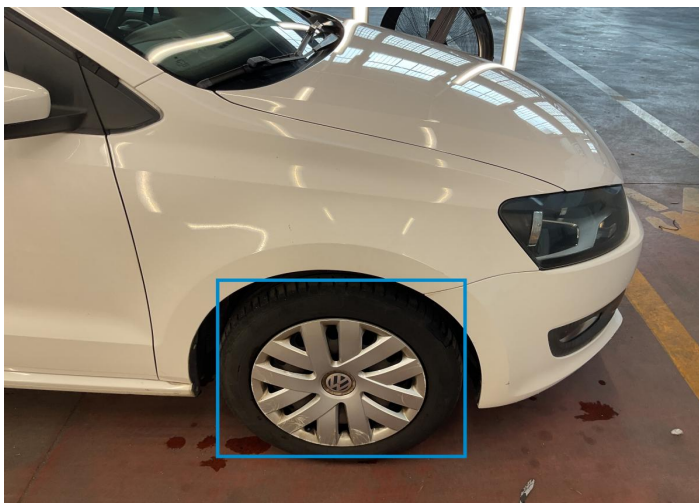
| 15 | Hubcap / Front Right | Out of Bodywork / Scratch |

15. Hubcap / Front Right  
Out of Bodywork / Scratch -

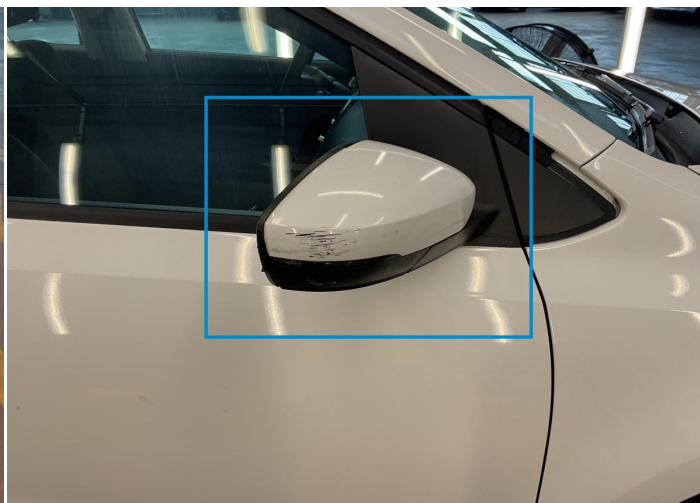
| 16 | Mirror Shell / Front Right | Bodywork / Breakage |

16. Mirror Shell / Front Right  
Bodywork / Breakage -

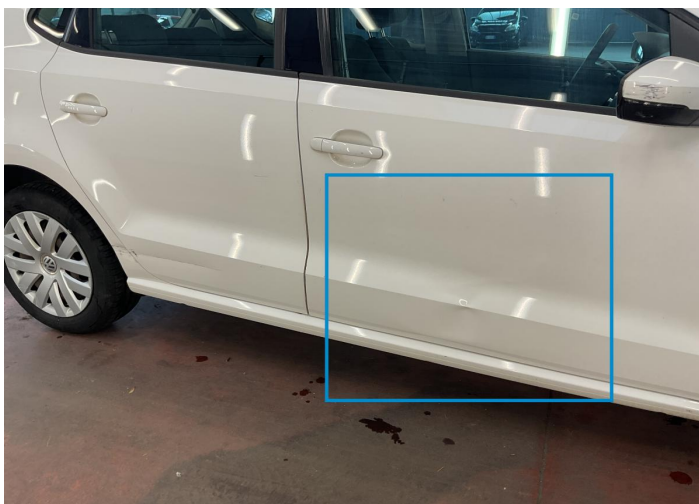
| 17 | Door / Front Right | Bodywork / Dent |

17. Door / Front Right  
Bodywork / Dent -

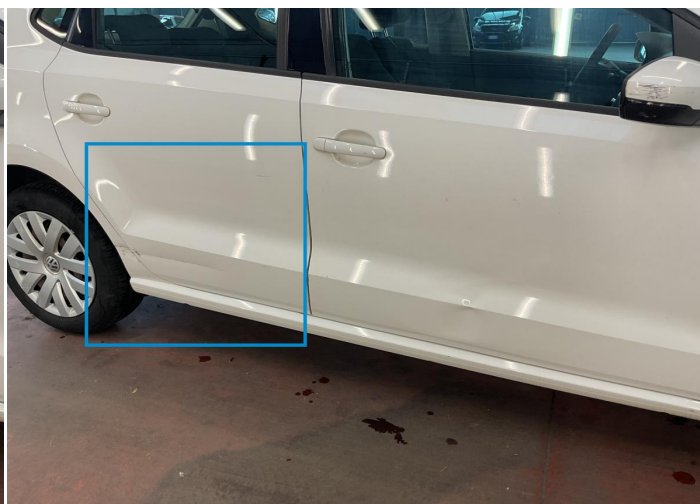
| 18 | Door / Back Right | Bodywork / Dent |

18. Door / Back Right  
Bodywork / Dent -

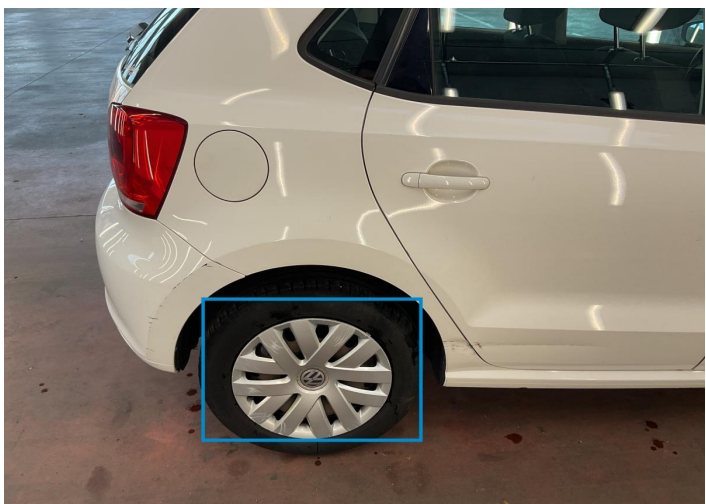
| 19 | Hubcap / Back Right | Out of Bodywork / Scratch |

19. Hubcap / Back Right  
Out of Bodywork / Scratch -

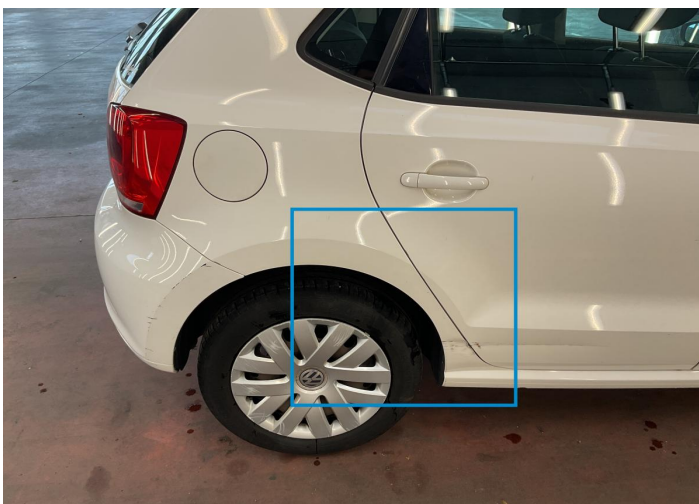
| 20 | Fender / Back Right | Bodywork / Dent |

20. Fender / Back Right  
Bodywork / Dent -

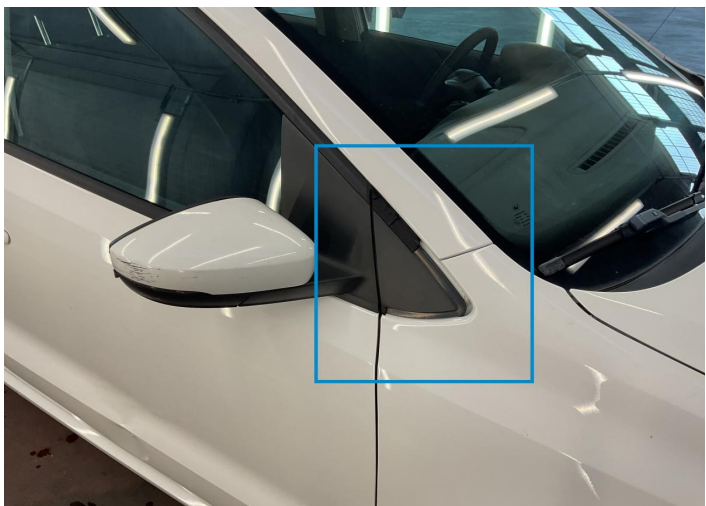
| 21 | Mirror Shell / Front Right | Bodywork / Breakage |

21. Mirror Shell / Front Right  
Bodywork / Breakage -

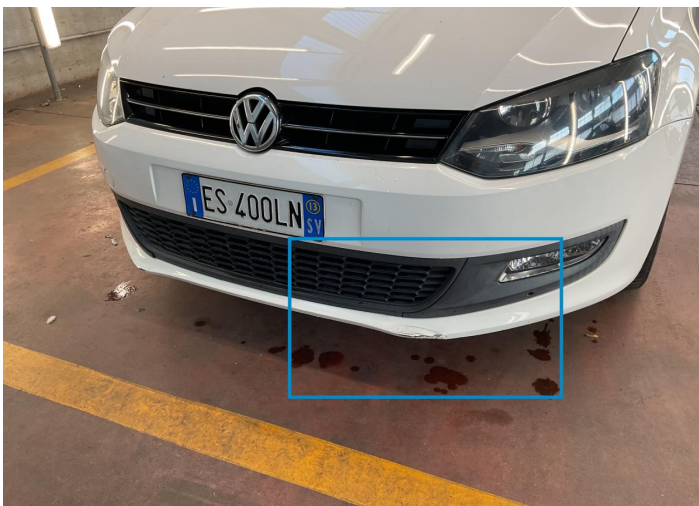
| 22 | Bumper / Front | Bodywork / Breakage |

22. Bumper / Front  
Bodywork / Breakage -

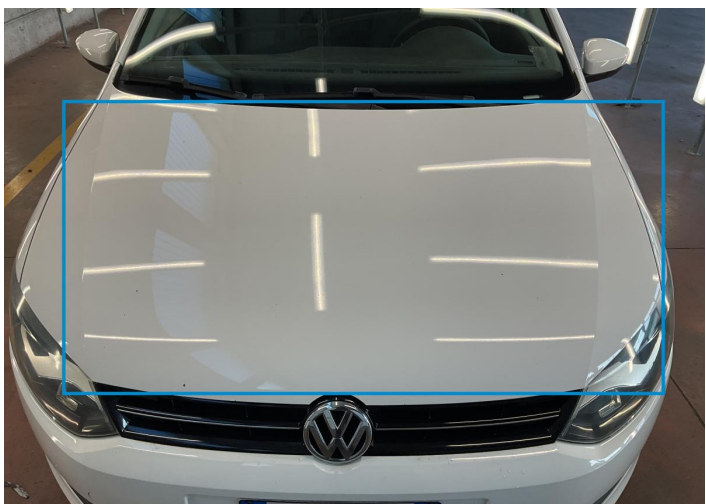
| 23 | Hood | Paint / Chipping |

23. Hood  
Paint / Chipping -

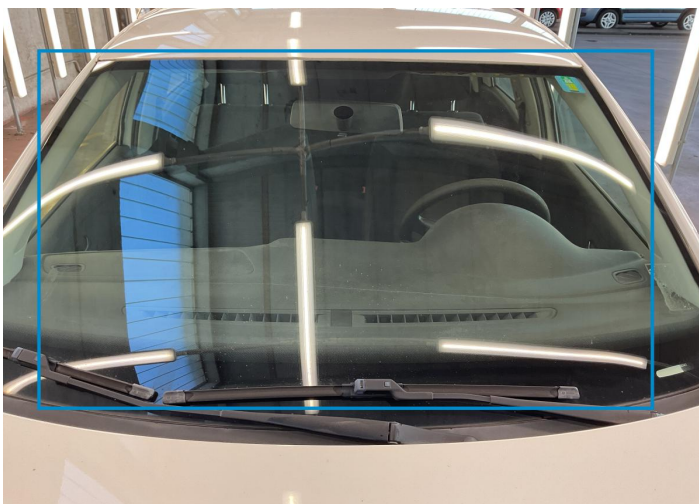
| 24 | Windshield / Front | Glass Break / Impact |

24. Windshield / Front  
Glass Break / Impact -

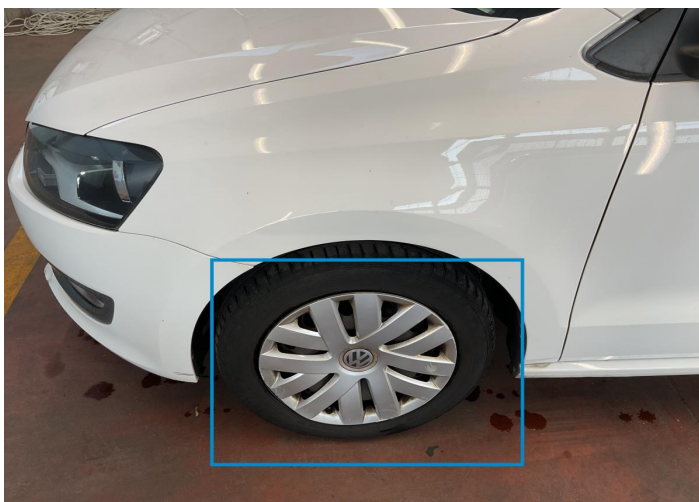
| 25 | Hubcap / Front Left | Out of Bodywork / Deformation |

25. Hubcap / Front Left  
Out of Bodywork / Deformation -

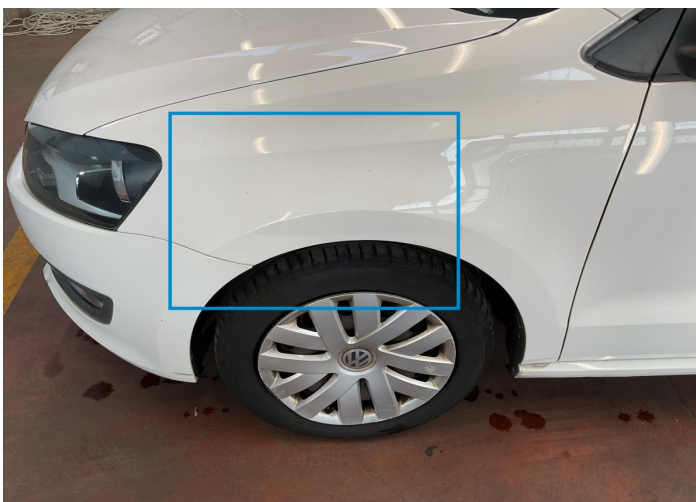
| 26 | Fender / Front Left | Bodywork / Dent |

26. Fender / Front Left  
Bodywork / Dent -

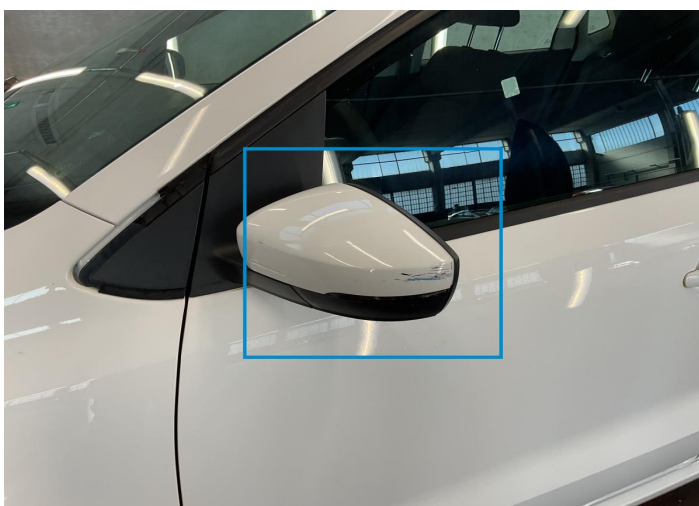
| 27 | Mirror Shell / Front Left | Paint / Scratch / Line |

27. Mirror Shell / Front Left  
Paint / Scratch / Line -

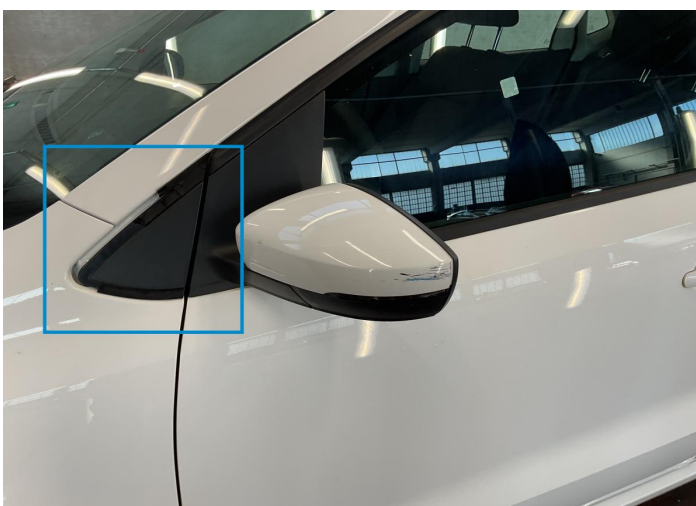
| 28 | Mirror Shell / Front Left | Bodywork / Breakage |

28. Mirror Shell / Front Left  
Bodywork / Breakage -

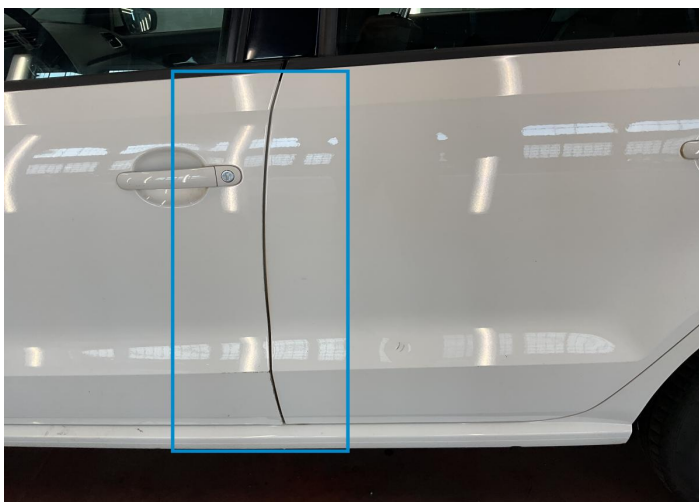
| 29 | Door / Front Left | Paint / Scratch / Line |

29. Door / Front Left  
Paint / Scratch / Line -

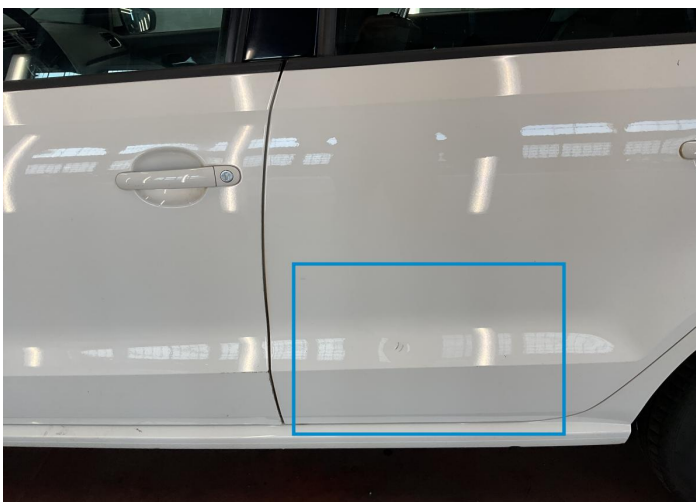
| 30 | Door / Back Left | Bodywork / Dent |

30. Door / Back Left  
Bodywork / Dent -

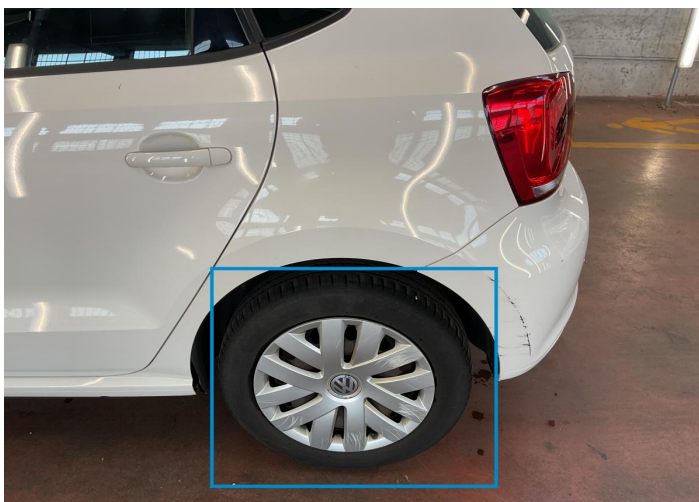
| 31 | Hubcap / Back Left | Out of Bodywork / Scratch |

31. Hubcap / Back Left  
Out of Bodywork / Scratch -

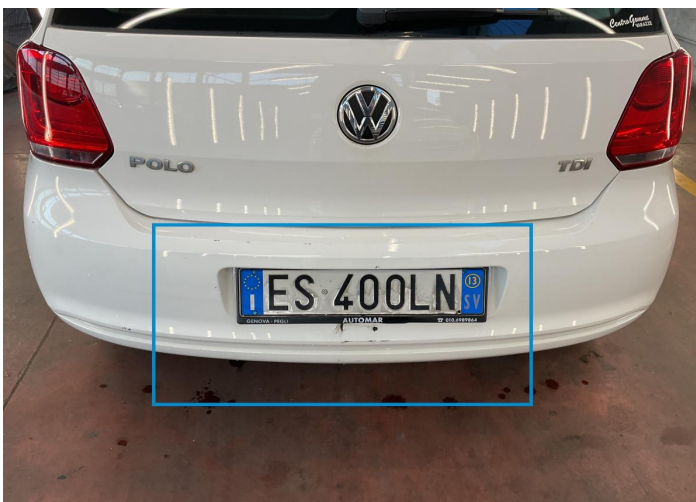
| 32 | Bumper / Back | Bodywork / Breakage |

32. Bumper / Back  
Bodywork / Breakage -

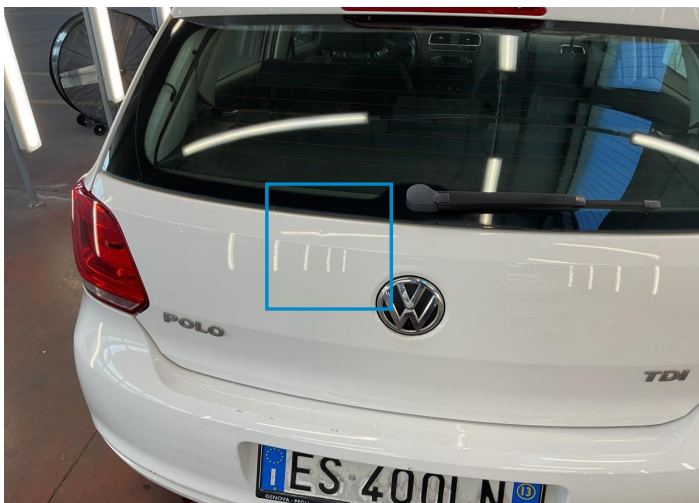
| 33 | Tailgate | Bodywork / Dent |

33. Tailgate  
Bodywork / Dent -

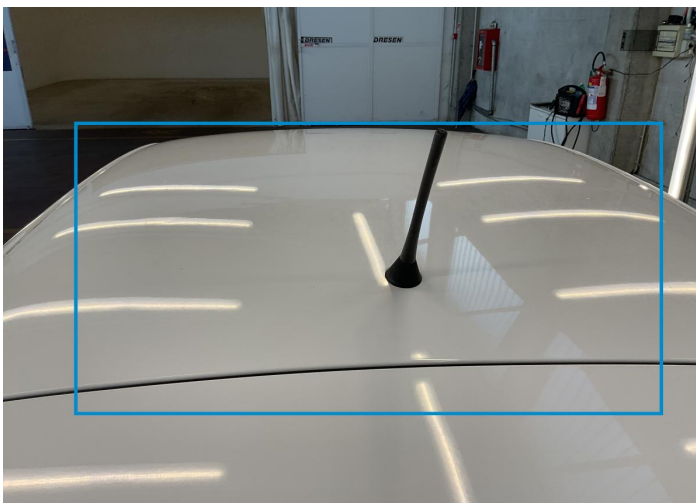
| 34 | Roof | Bodywork / Dent / Hail Area |

34. Roof  
Bodywork / Dent / Hail Area -

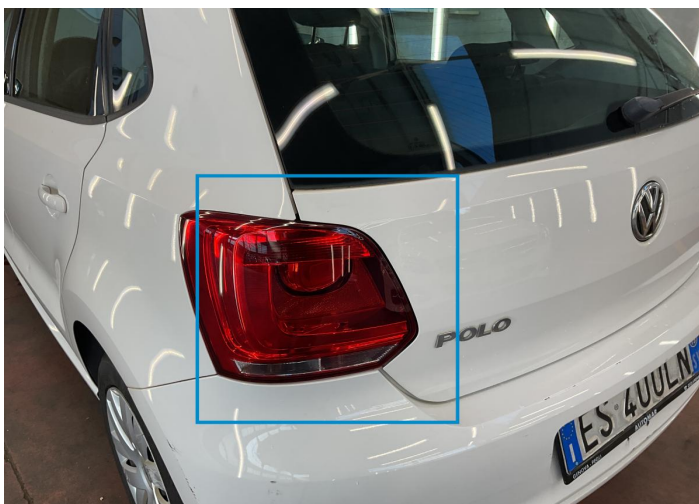
| 35 | Back Light / Left | Glass Break / Scratch |

35. Back Light / Left  
Glass Break / Scratch -
