# VOLKSWAGEN POLO

## Polo TDI 75

VIN NO WVWZZZ9NZ3D030446  
Registration Number 6909XZ30

### Inspection Report Summary

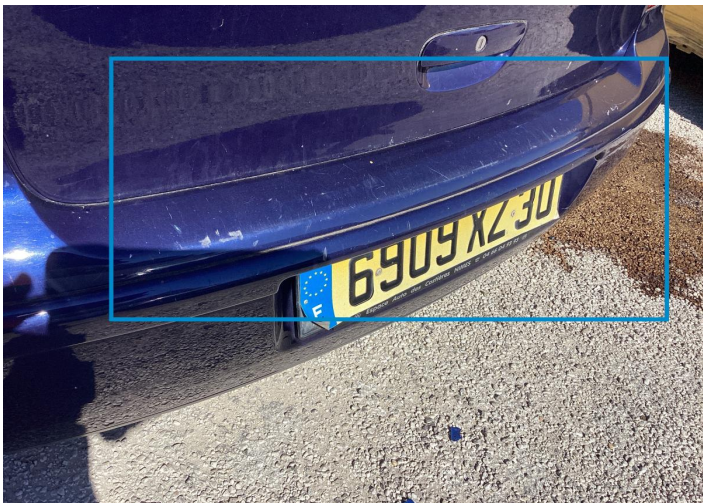
| Component | | Damage | Comments |
|---|---|---|---|
| 1 | Bumper / Back | Paint / Scratch / Line | |

1. Bumper / Back  
Paint / Scratch / Line -

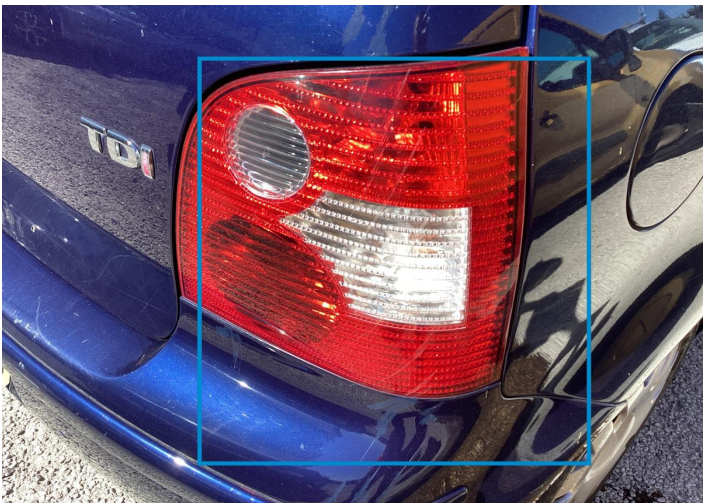
| Component | | Damage | Comments |
|---|---|---|---|
| 3 | Back Light / Right | Glass Break | |

3. Back Light / Right  
Glass Break -

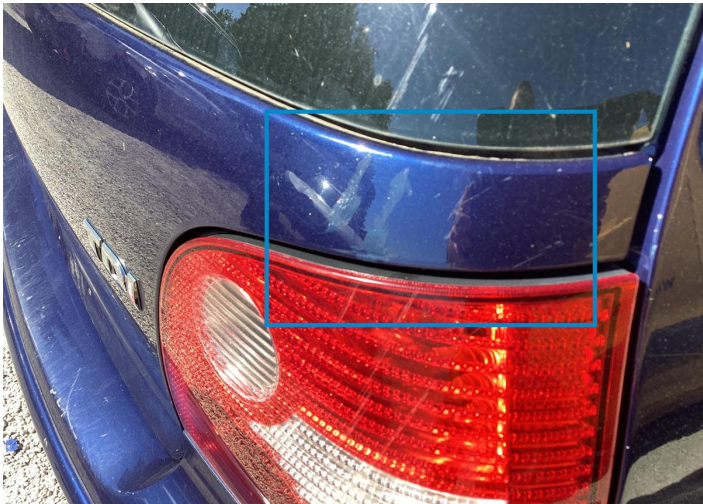
| Component | | Damage | Comments |
|---|---|---|---|
| 4 | Tailgate | Paint / Scratch / Line | |

4. Tailgate  
Paint / Scratch / Line -

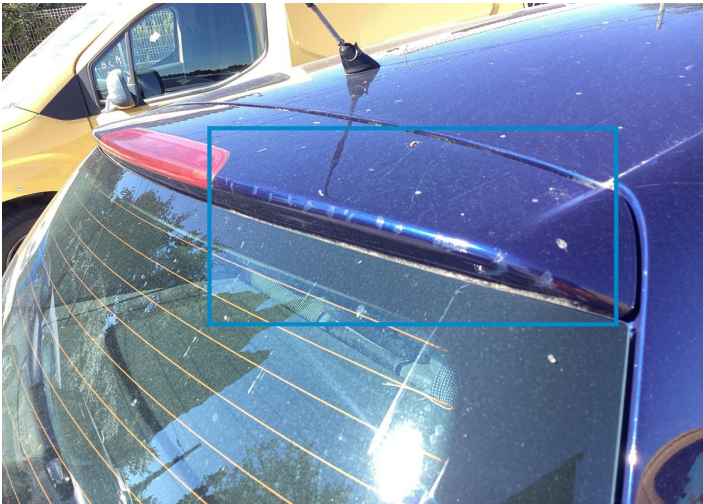
| Component | | Damage | Comments |
|---|---|---|---|
| 5 | Tailgate | Paint / Scratch / Line | |

5. Tailgate  
Paint / Scratch / Line -

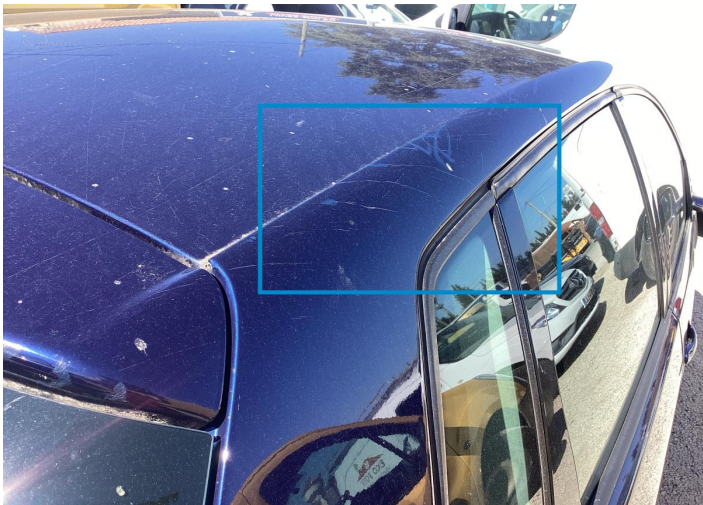
| Component | | Damage | Comments |
|---|---|---|---|
| 6 | Cant Rail / Right | Paint / Scratch / Line | |

6. Cant Rail / Right  
Paint / Scratch / Line -

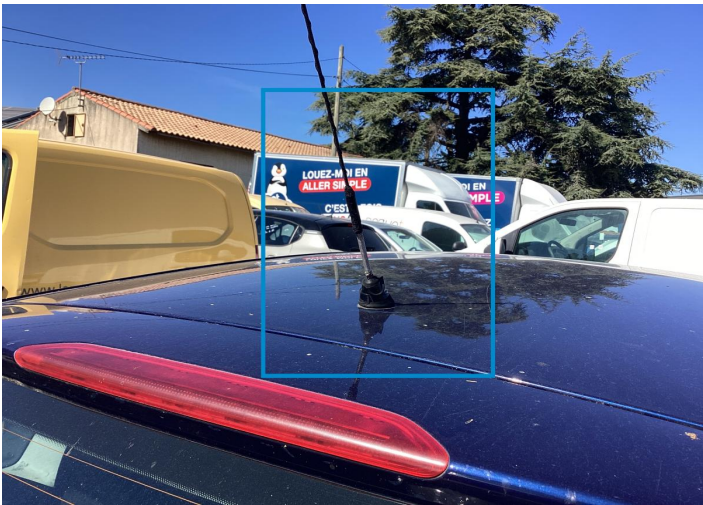
| Component | | Damage | Comments |
|---|---|---|---|
| 7 | Antenna Rod | Out of Bodywork / Breakage | |

7. Antenna Rod  
Out of Bodywork / Breakage -

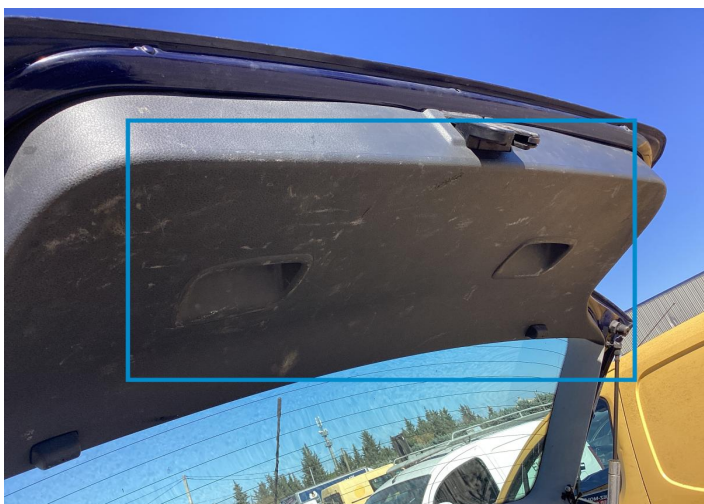
| Component | | Damage | Comments |
|---|---|---|---|
| 8 | Tailgate Upholstery / Back | Interior / Scraped | |

8. Tailgate Upholstery / Back Interior / Scraped -

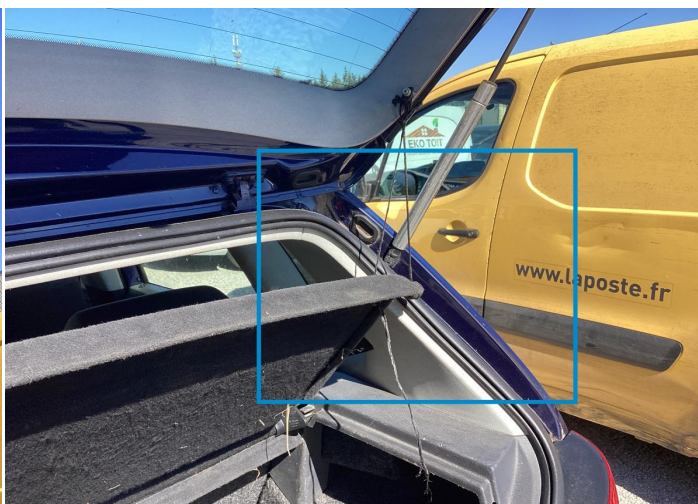
| Component | | Damage | Comments |
|---|---|---|---|
| 9 | Luggage Space Cover / Back | Interior / Broken | |

9. Luggage Space Cover / Back Interior / Broken -

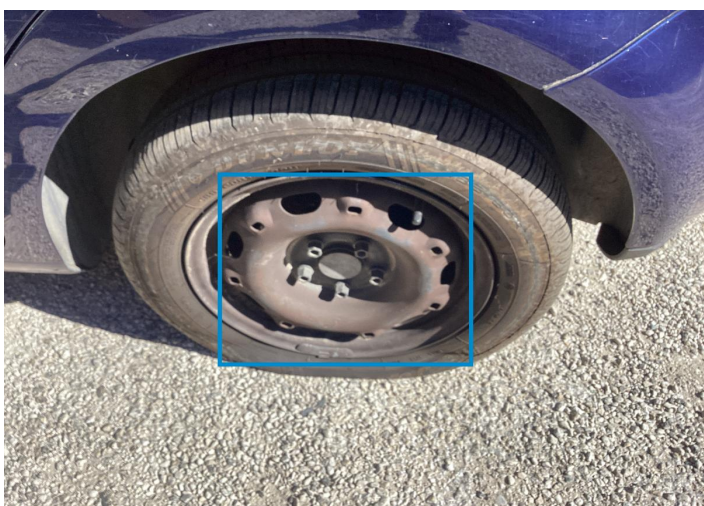
| Component | | Damage | Comments |
|---|---|---|---|
| 10 | Hubcap / Back Left | Missing element hubcap | |

10. Hubcap / Back Left  
Missing element hubcap -

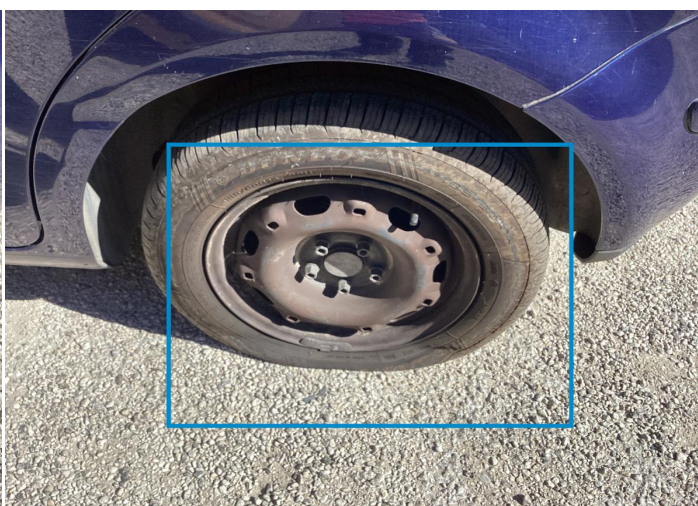
| Component | | Damage | Comments |
|---|---|---|---|
| 11 | Tire / Back Left | Tire | |

11. Tire / Back Left  
Tire -

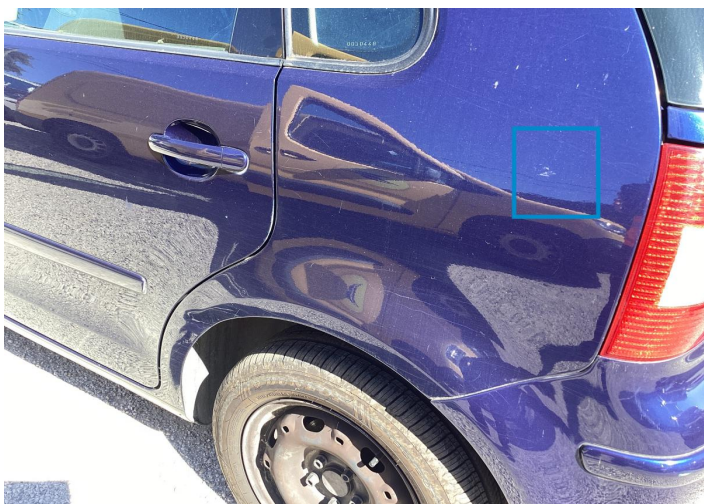
| Component | | Damage | Comments |
|---|---|---|---|
| 12 | Fender / Back Left | Bodywork / Dent / Dent | |

12. Fender / Back Left  
Bodywork / Dent / Dent -

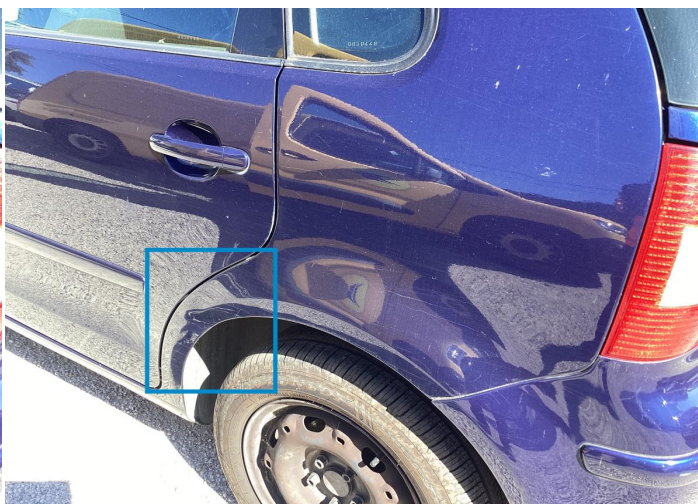
| 13 | Fender / Back Left | Bodywork / Dent / Deformation |

13. Fender / Back Left  
Bodywork / Dent / Deformation -

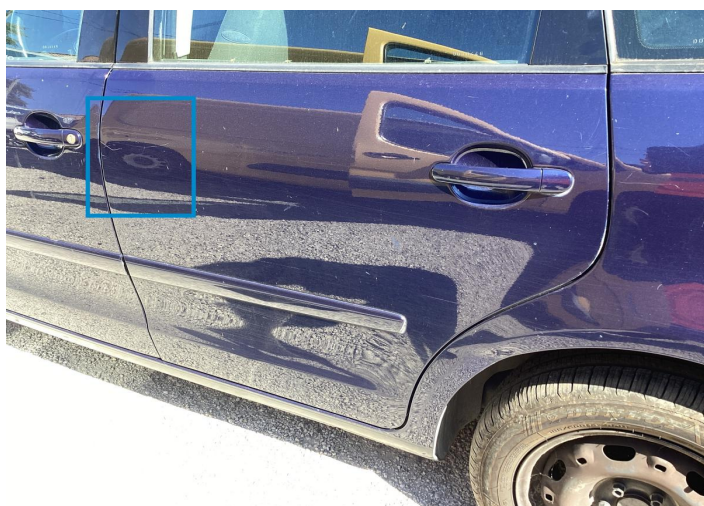
| 14 | Door / Back Left | Paint / Scratch / Line |

14. Door / Back Left  
Paint / Scratch / Line -

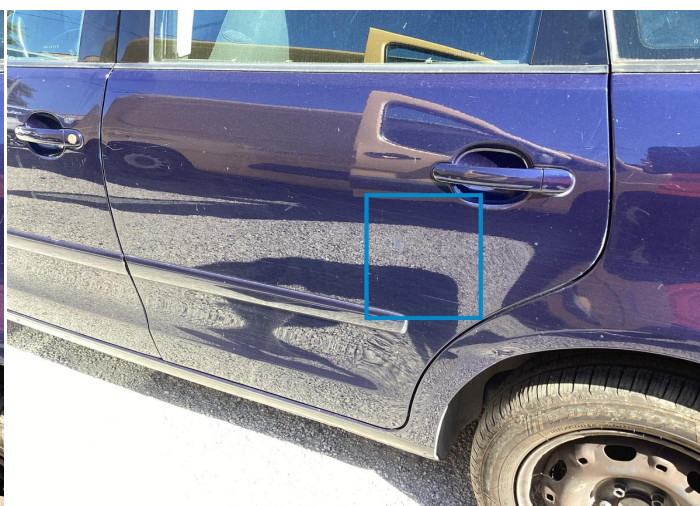
| 15 | Door / Back Left | Paint / Scratch / Line |

15. Door / Back Left  
Paint / Scratch / Line -

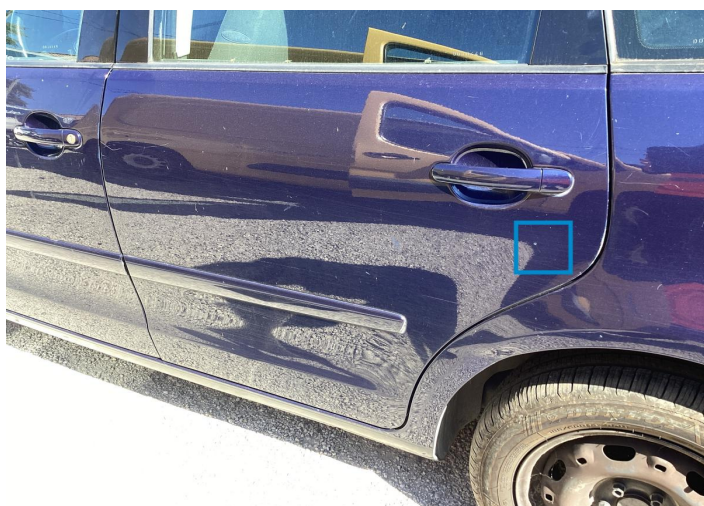
| 16 | Door / Back Left | Paint / Chipping |

16. Door / Back Left  
Paint / Chipping -

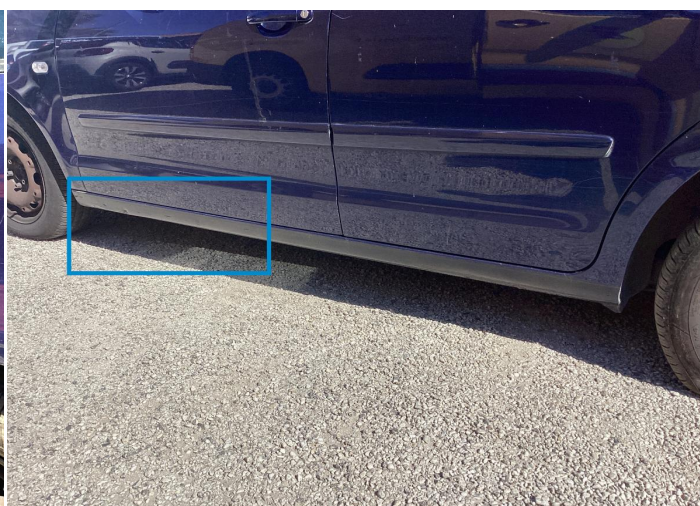
| 17 | Rocker Panel / Center Left | Bodywork / Dent / Deformation |

17. Rocker Panel / Center Left  
Bodywork / Dent / Deformation -

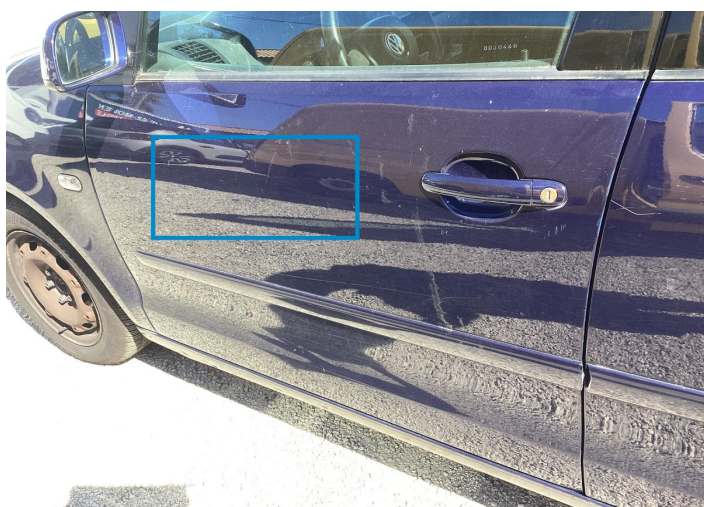
| 18 | Door / Front Left | Bodywork / Dent / Dent |

18. Door / Front Left  
Bodywork / Dent / Dent -

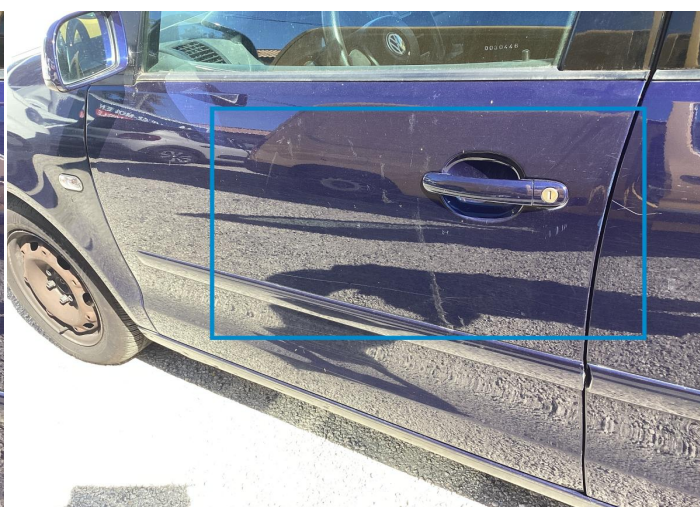
| 19 | Door / Front Left | Paint / Scratch / Line |

19. Door / Front Left  
Paint / Scratch / Line -

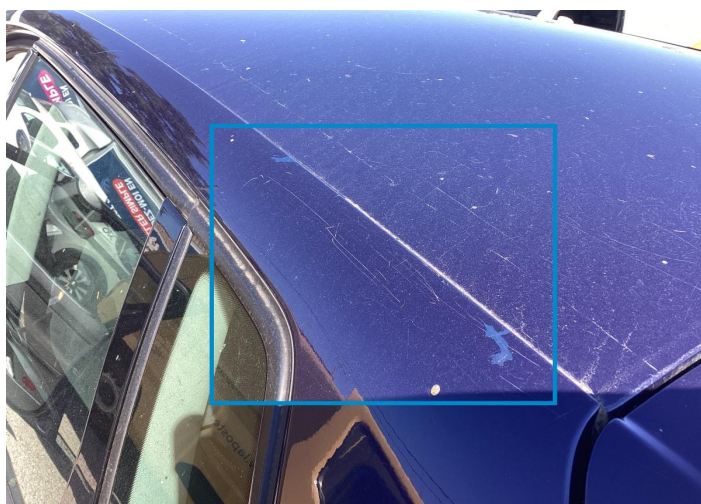
| 20 | Cant Rail / Left | Paint / Scratch / Line |

20. Cant Rail / Left  
Paint / Scratch / Line -

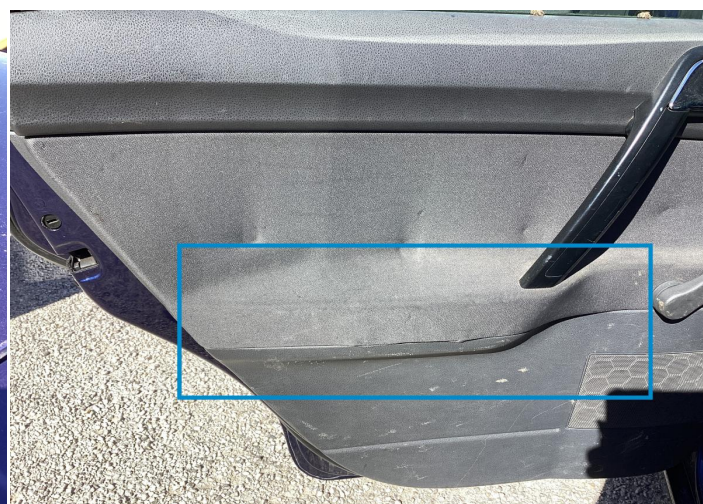
| 21 | Panel Filling / Back Left | Interior / Broken |

21. Panel Filling / Back Left  
Interior / Broken -

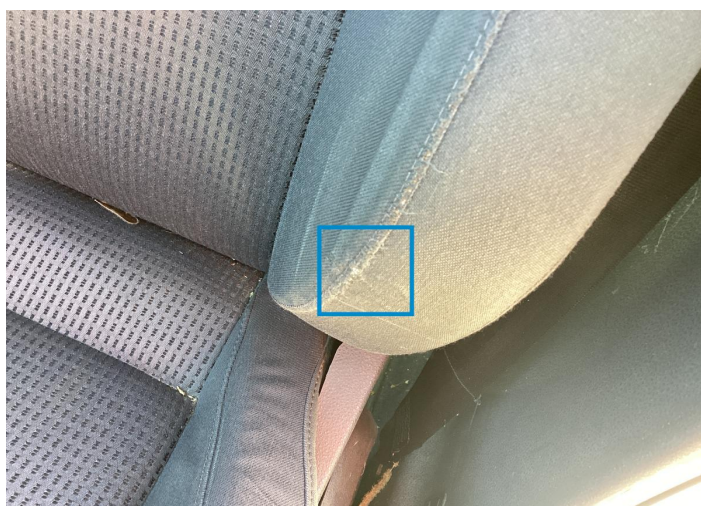
| 22 | Backrest Cover / Front Left | Interior / Ripped |

22. Backrest Cover / Front Left  
Interior / Ripped -

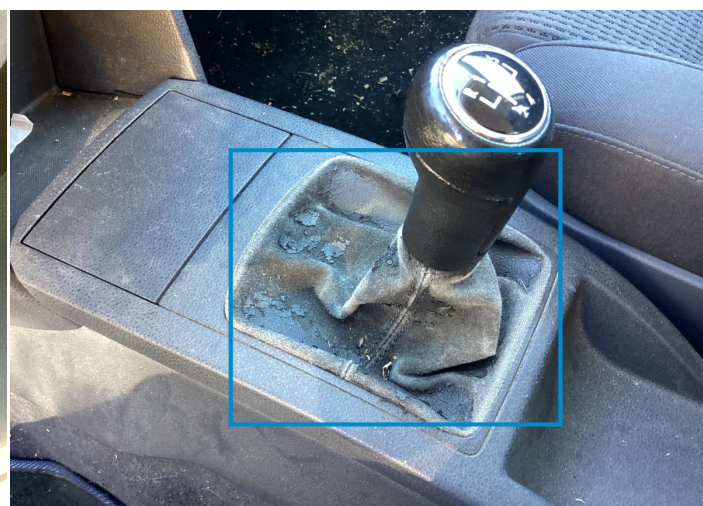
| 23 | Gear Knob | Interior / Scraped |

23. Gear Knob  
Interior / Scraped -

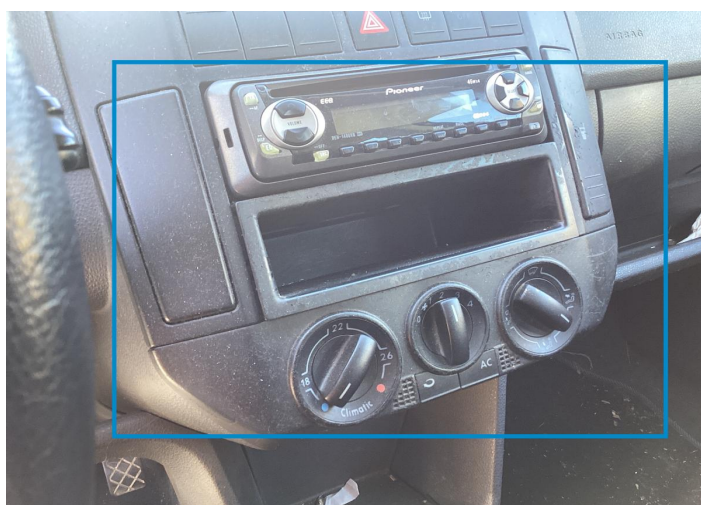
| 24 | Digital Combined Instrument Panel | Interior / Scraped |

24. Digital Combined Instrument Panel  
Interior / Scraped -

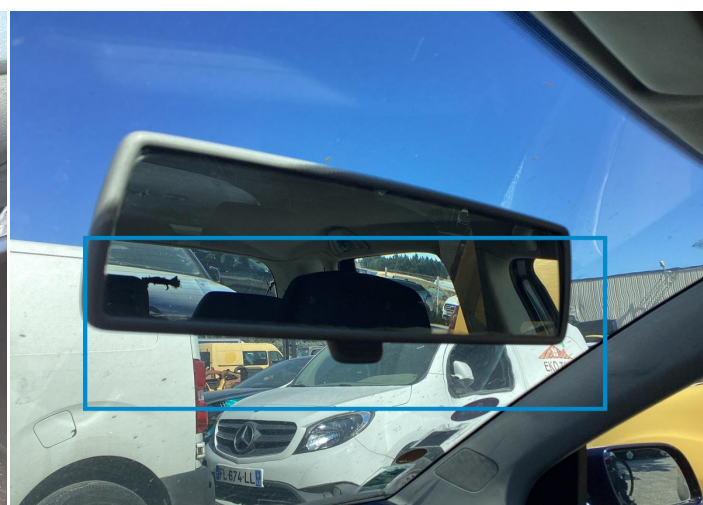
| 25 | Rearview Mirror / Front Center | Interior / Worn - out |

25. Rearview Mirror / Front Center  
Interior / Worn - out -

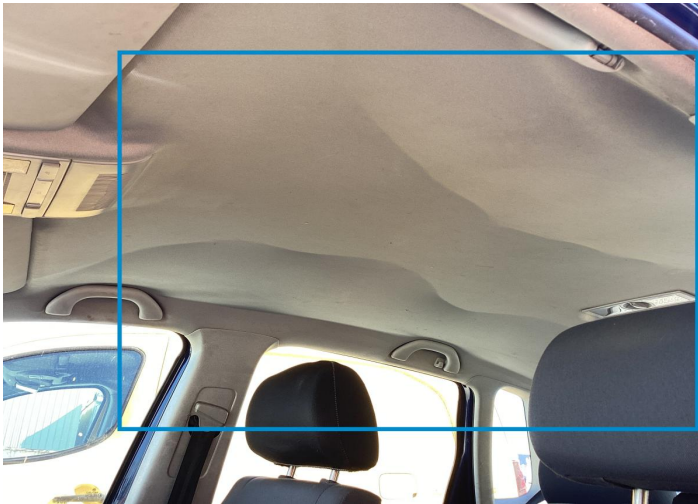
| 26 | Roof Upholstery | Interior / Loose |

26. Roof Upholstery  
Interior / Loose -

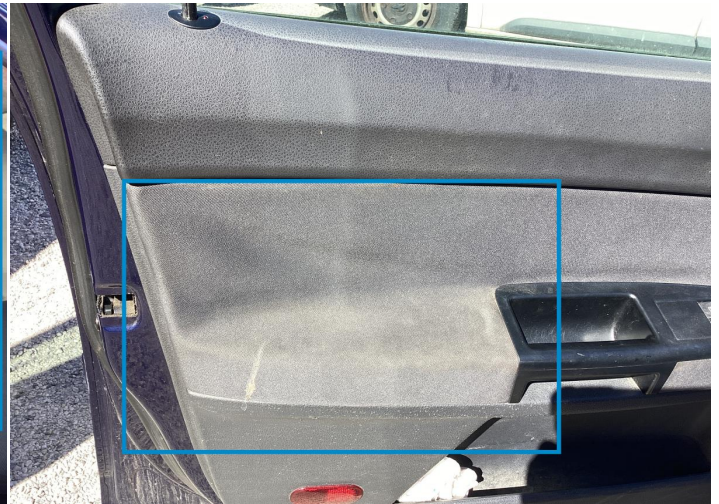
| 27 | Panel Filling / Front Left | Interior / Loose |

27. Panel Filling / Front Left  
Interior / Loose -

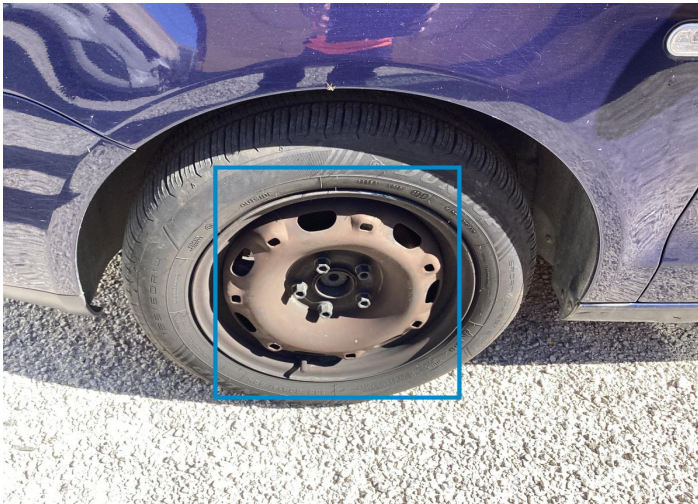
| 28 | Hubcap / Front Left | Missing element hubcap |

28. Hubcap / Front Left  
Missing element hubcap -

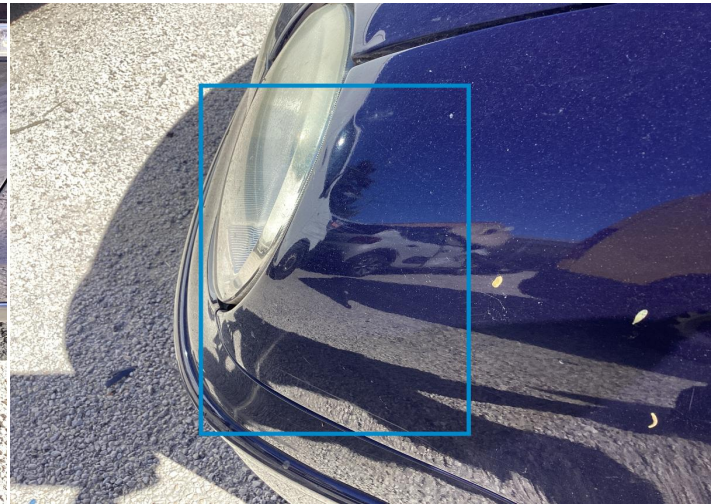
| 29 | Fender / Front Left | Bodywork / Dent / Dent |

29. Fender / Front Left  
Bodywork / Dent / Dent -

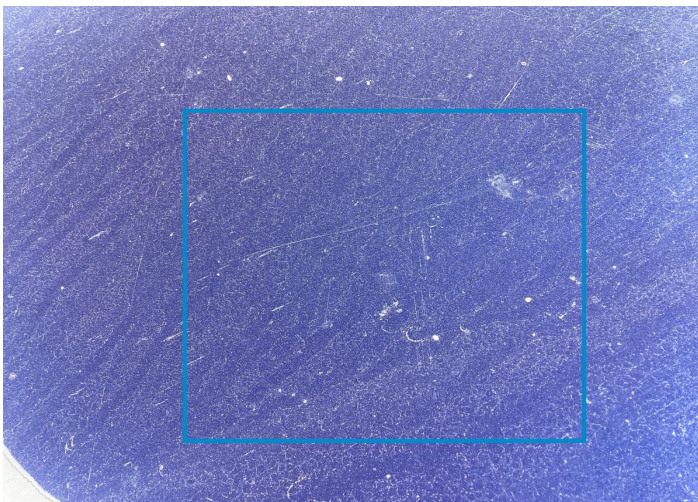
| 30 | Hood | Paint / Scratch / Line |

30. Hood  
Paint / Scratch / Line -

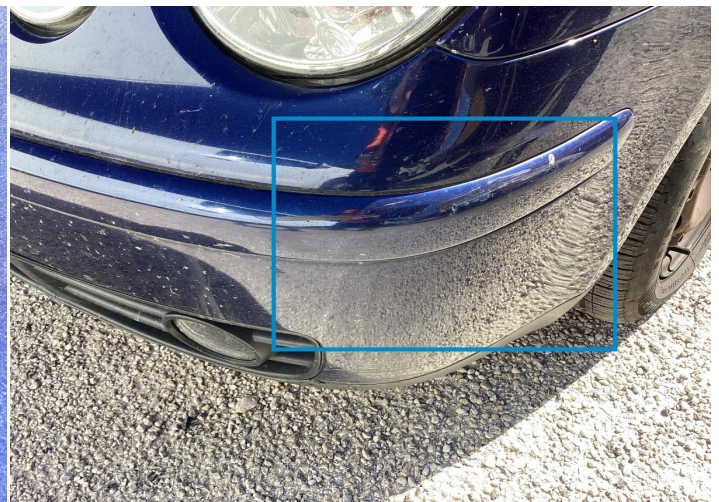
| 31 | Bumper / Front | Paint / Scratch / Line |

31. Bumper / Front  
Paint / Scratch / Line -

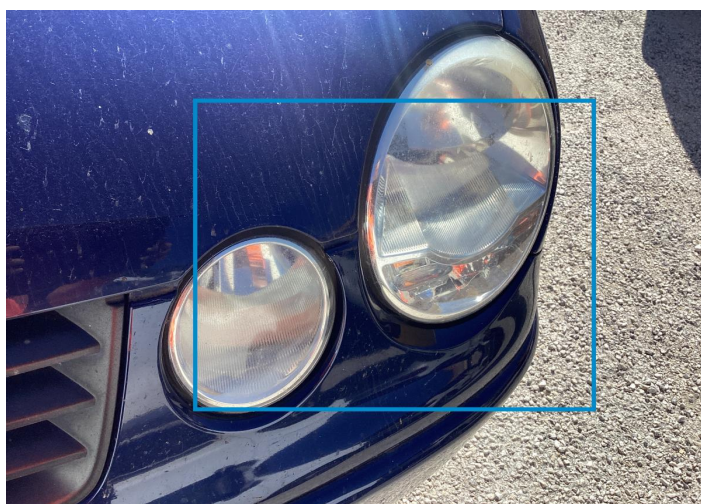
| 32 | Front Light / Front Left | Glass Break |

32. Front Light / Front Left  
Glass Break -

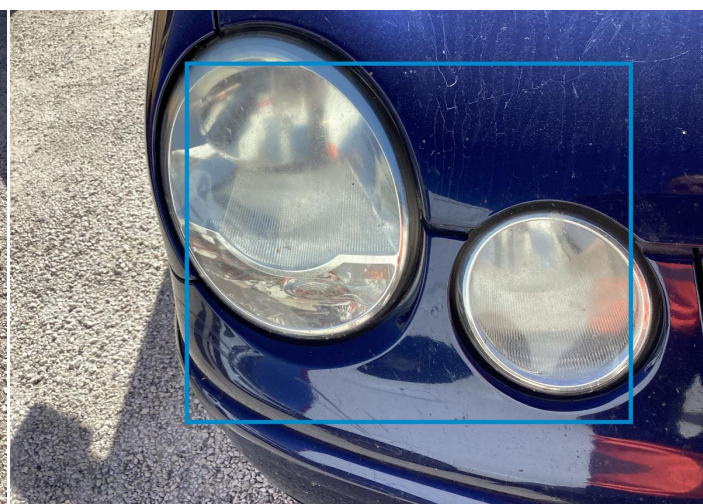
| 33 | Front Light / Front Right | Glass Break |

33. Front Light / Front Right  
Glass Break -

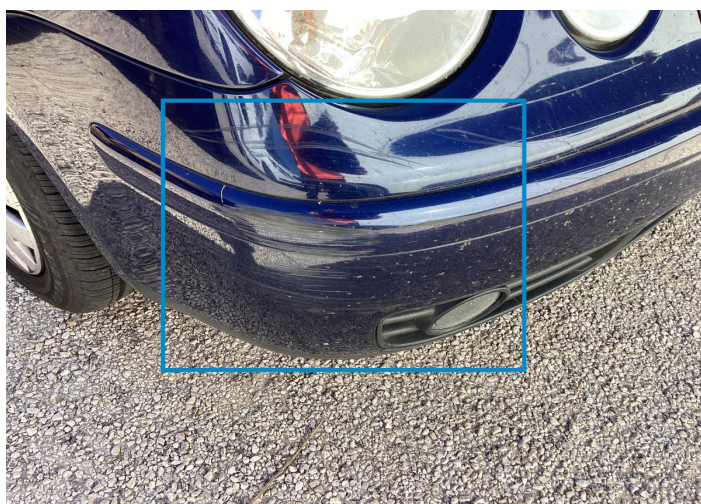
| 34 | Bumper / Front | Paint / Scratch / Line |

34. Bumper / Front  
Paint / Scratch / Line -

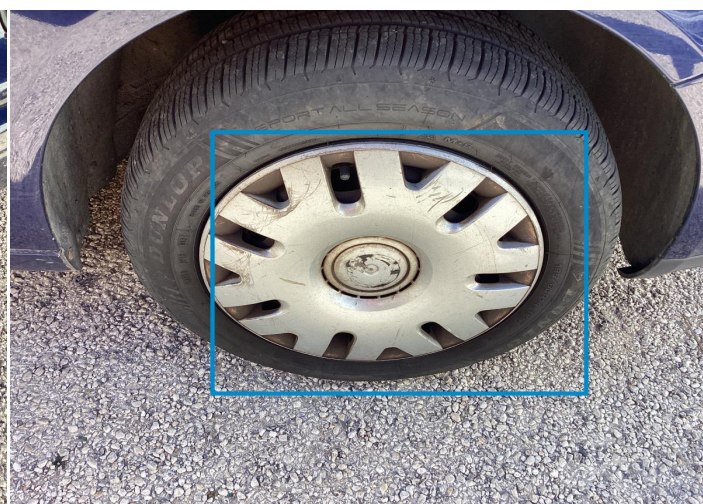
| 35 | Hubcap / Front Right | Out of Bodywork / Scratch |

35. Hubcap / Front Right  
Out of Bodywork / Scratch -

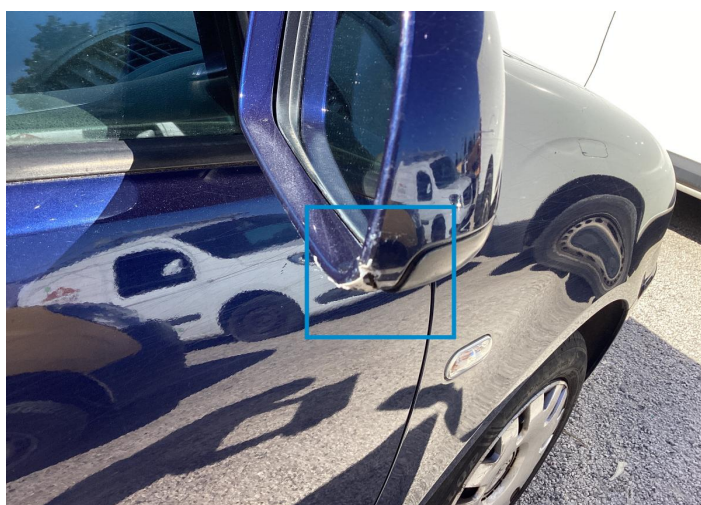
| 36 | Mirror / Front Right | Bodywork / Breakage |

36. Mirror / Front Right  
Bodywork / Breakage -

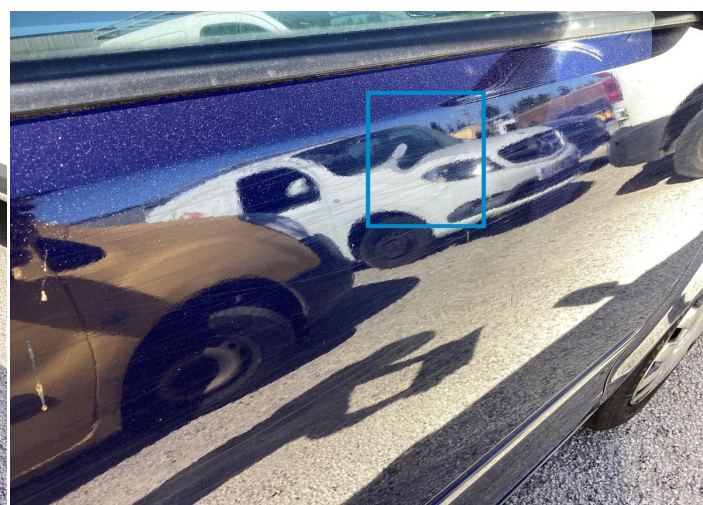
| 37 | Door / Front Right | Bodywork / Dent / Dent |

37. Door / Front Right  
Bodywork / Dent / Dent -

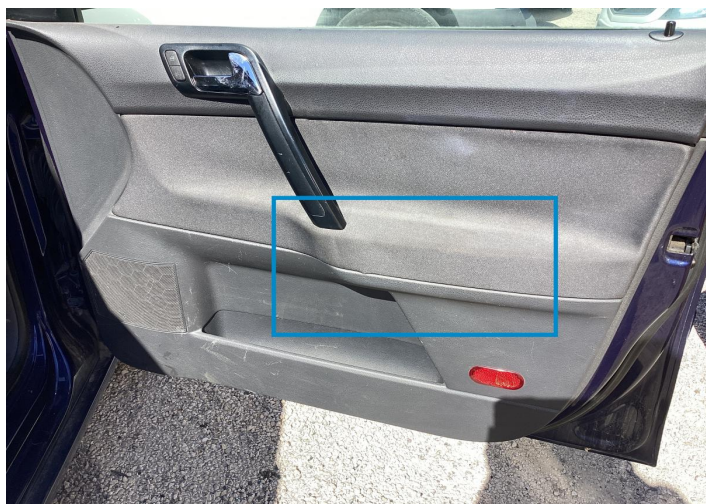
| 38 | Panel Filling / Front Right | Interior / Broken |

38. Panel Filling / Front Right  
Interior / Broken -

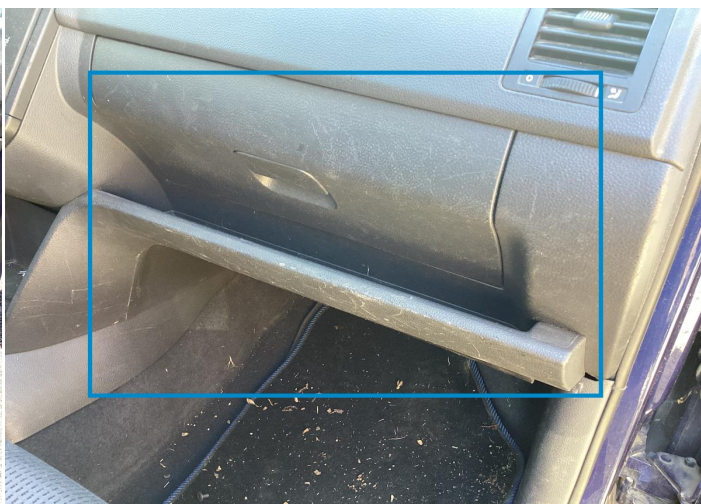
| 39 | Glovebox | Interior / Scraped |

39. Glovebox  
Interior / Scraped -

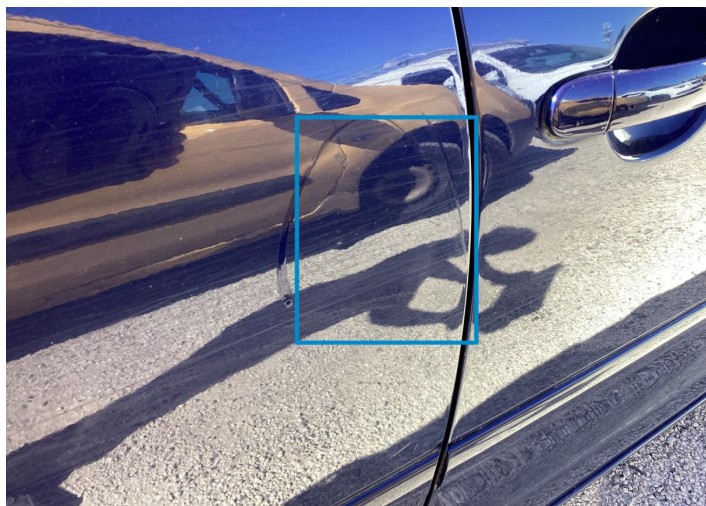
| 40 | Door / Back Right | Bodywork / Dent / Deformation |

40. Door / Back Right  
Bodywork / Dent / Deformation -

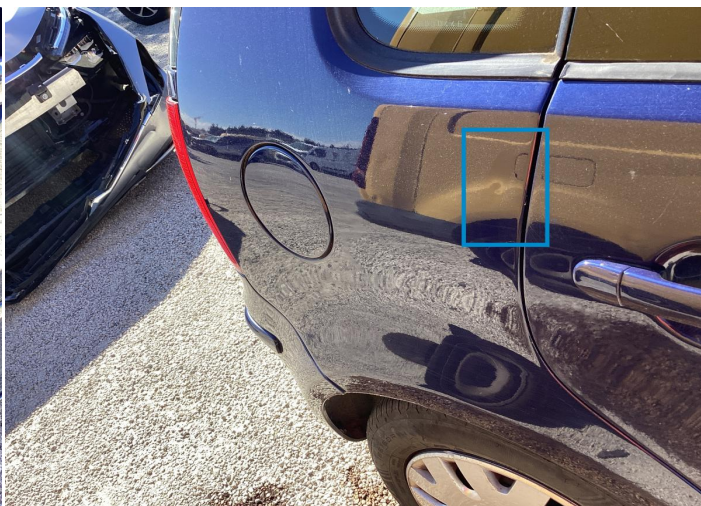
| 41 | Fender / Back Right | Bodywork / Dent / Dent |

41. Fender / Back Right  
Bodywork / Dent / Dent -

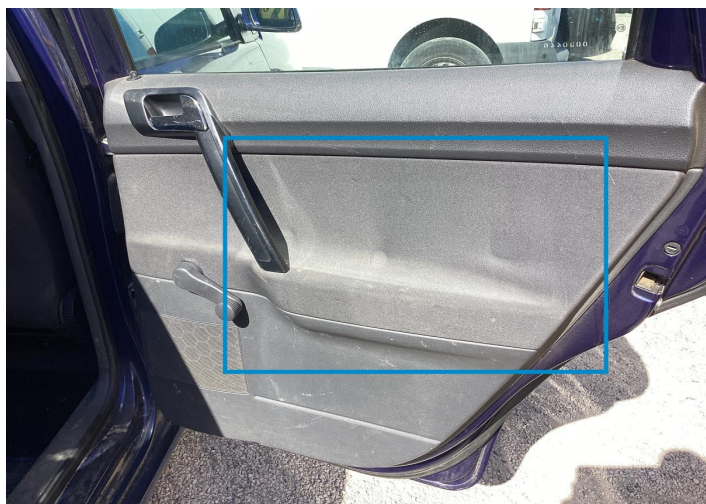
| 42 | Panel Filling / Back Right | Interior / Loose |

42. Panel Filling / Back Right  
Interior / Loose -

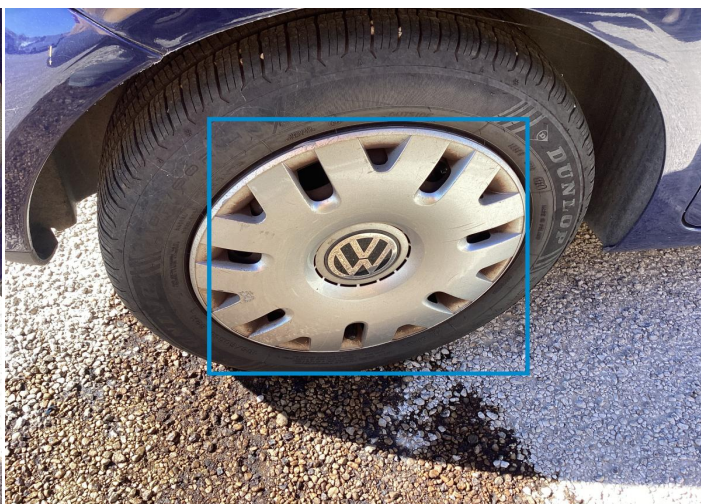
| 43 | Hubcap / Back Right | Out of Bodywork / Scratch |

43. Hubcap / Back Right  
Out of Bodywork / Scratch -

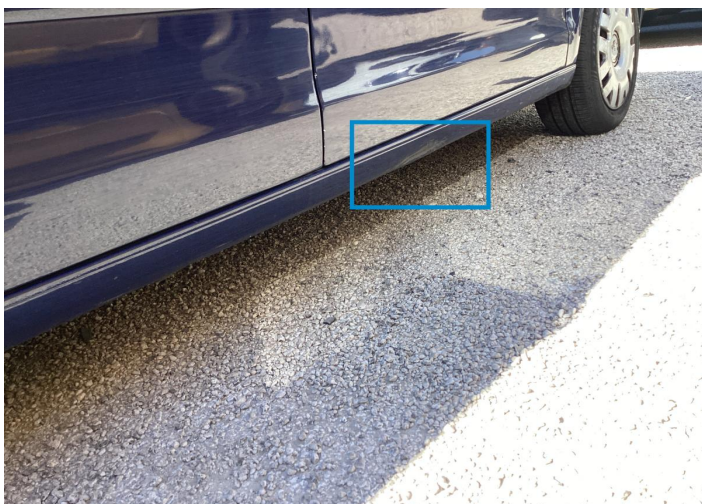
| 44 | Rocker Panel / Center Right | Bodywork / Dent / Deformation |

44. Rocker Panel / Center Right  
Bodywork / Dent / Deformation -

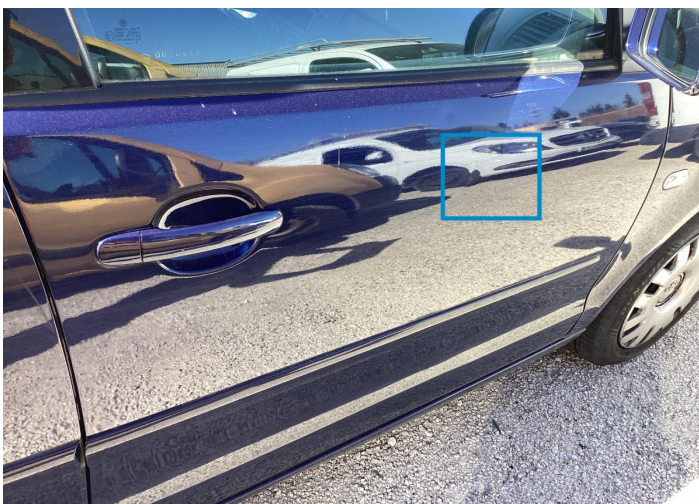
| 45 | Door / Front Right | Bodywork / Dent / Deformation |

45. Door / Front Right  
Bodywork / Dent / Deformation -

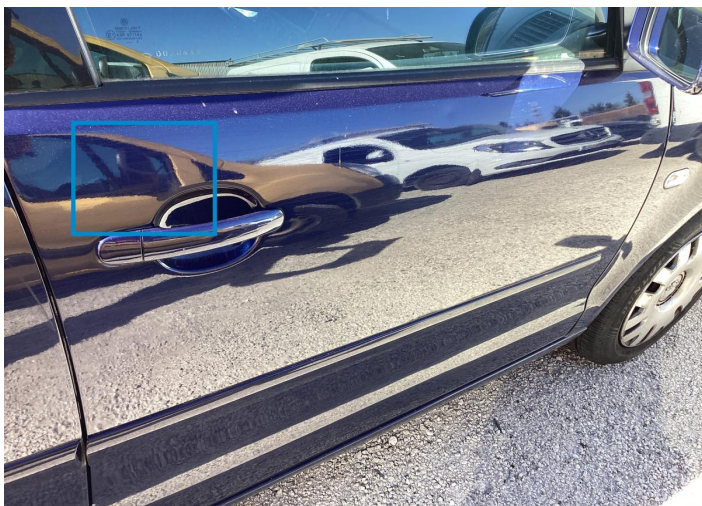
| 46 | Door / Front Right | Bodywork / Dent / Dent |

46. Door / Front Right  
Bodywork / Dent / Dent -

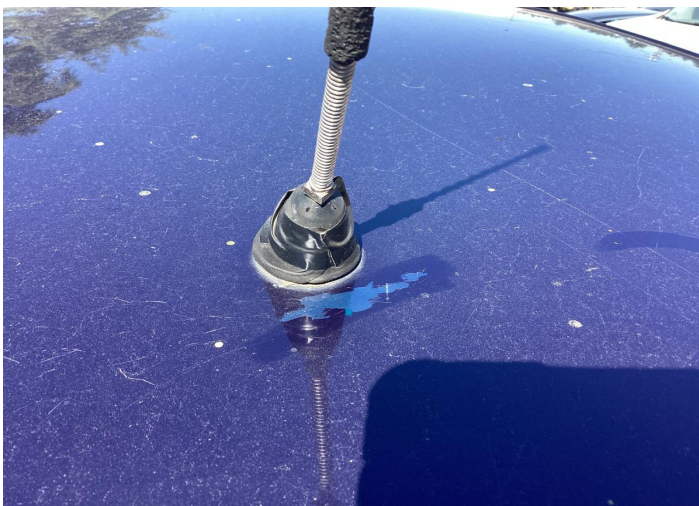
| 47 | Roof | Paint / Poor Previous Repair |

47. Roof  
Paint / Poor Previous Repair -

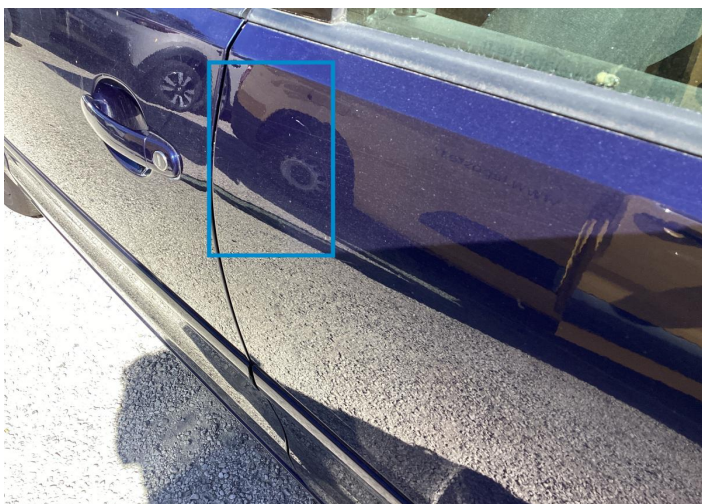
| 48 | Door / Back Left | Bodywork / Dent / Dent |

48. Door / Back Left  
Bodywork / Dent / Dent -
