VOLKSWAGEN Polo IV

Polo 1.2

VIN NO WVVZZZ9NZ6D054004

Inspection Report Summary

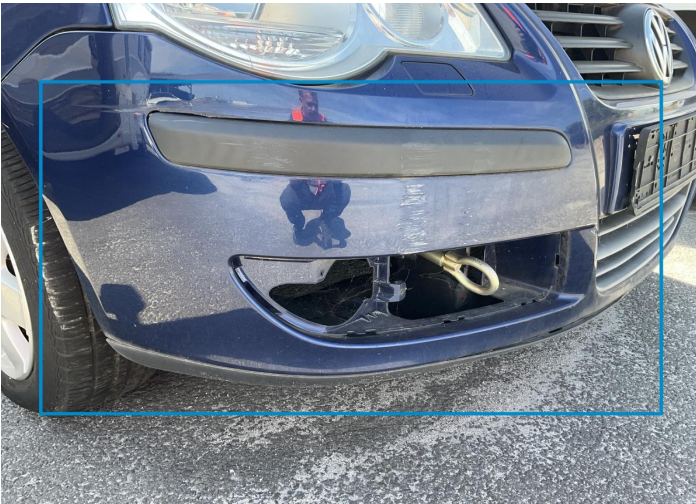
1. Bumper / Front
Missing Part -

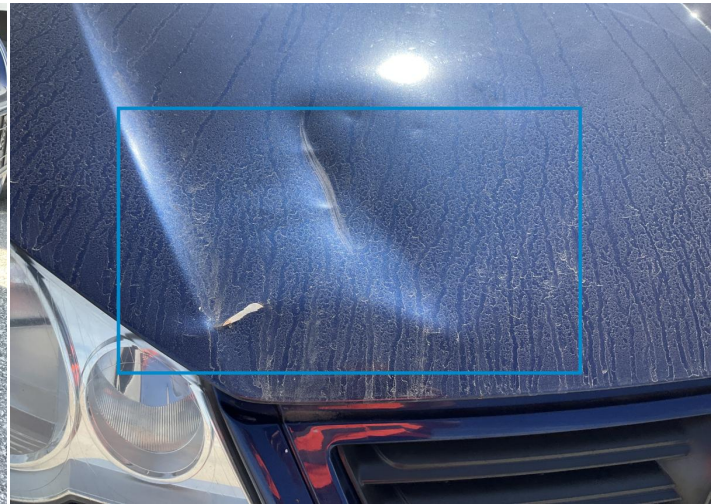
2. Hood
Bodywork / Dent / Dent -

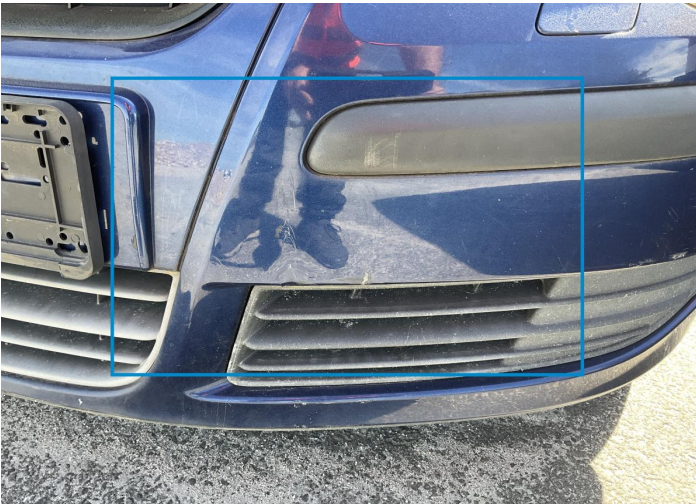
3. Bumper / Front
Paint / Scratch / Scuff -

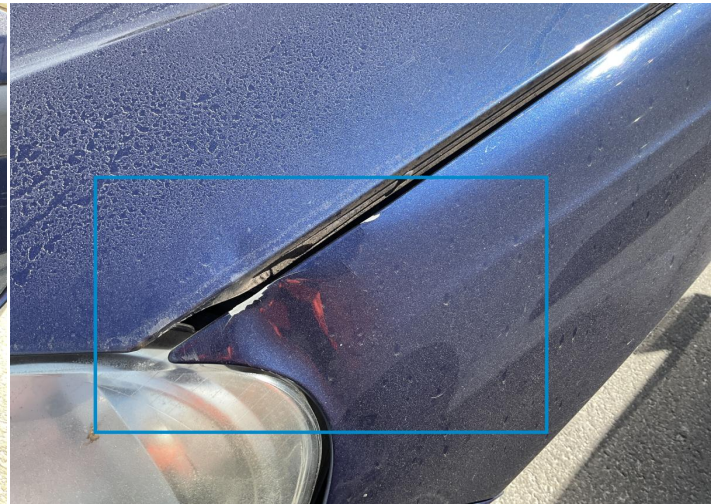
4. Fender / Front Left
Bodywork / Dent / Dent -

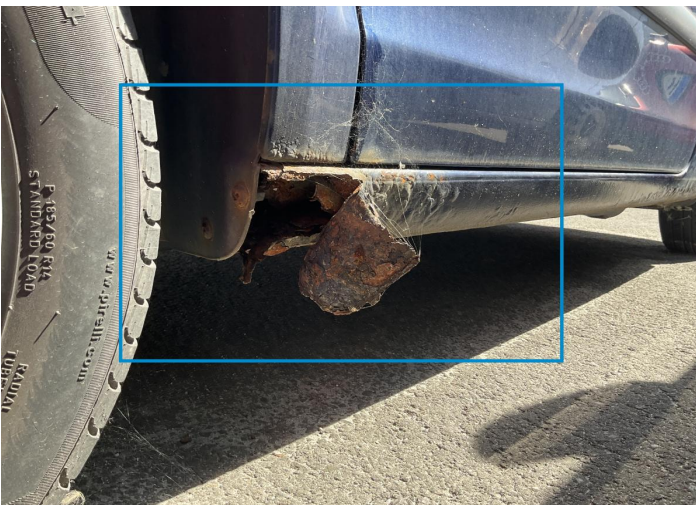
5. Rocker Panel / Center Left
Paint / Corrosion -

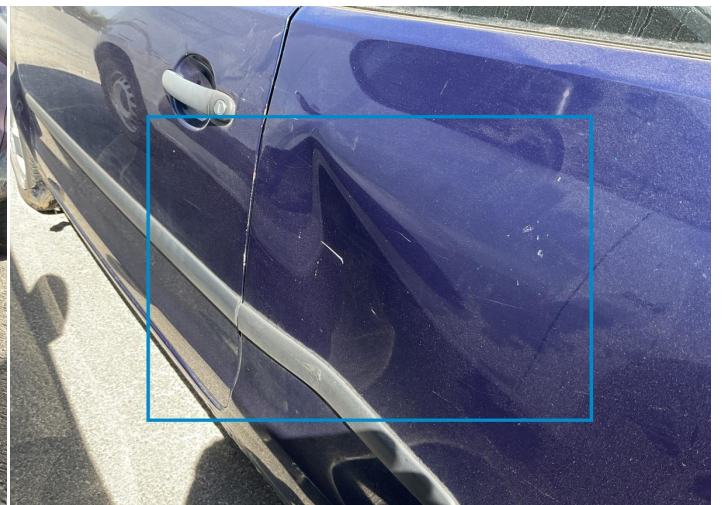
6. Side Panel / Back Left
Bodywork / Dent / Dent -

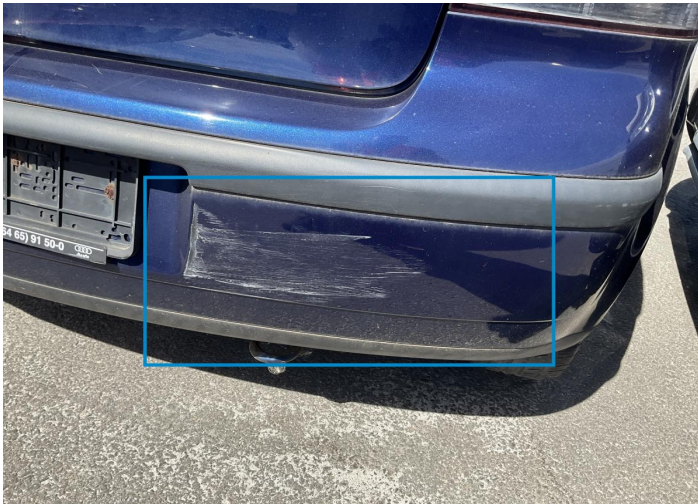
7. Bumper / Back
Paint / Scratch / Scuff -

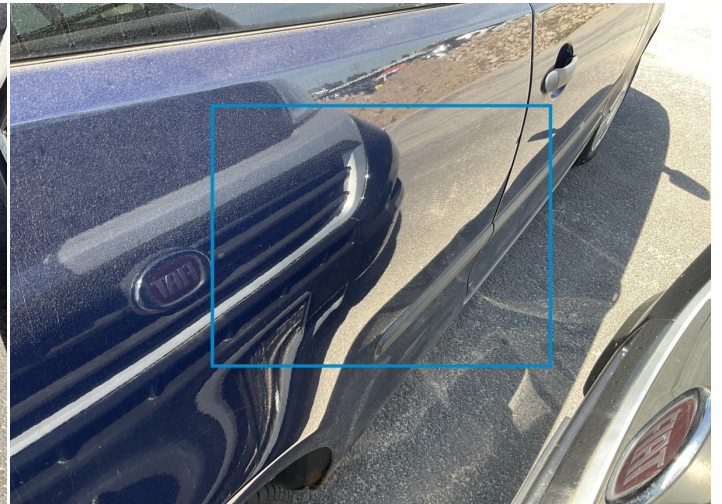
8. Side Panel / Back Right
Bodywork / Dent / Dent -

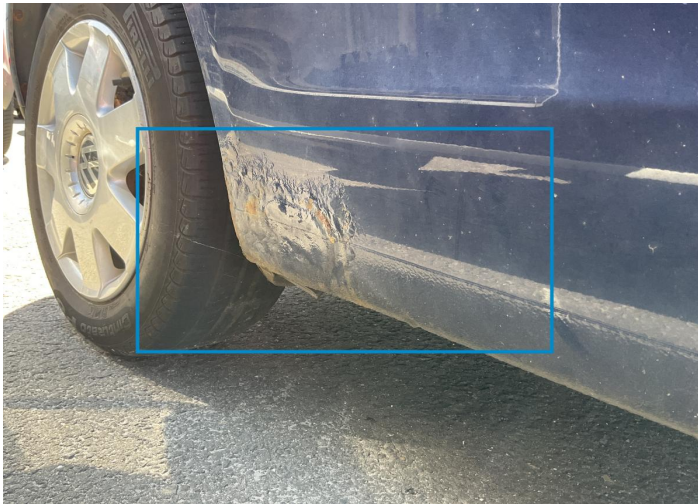
9. Rocker Panel / Center Right
Paint / Corrosion -

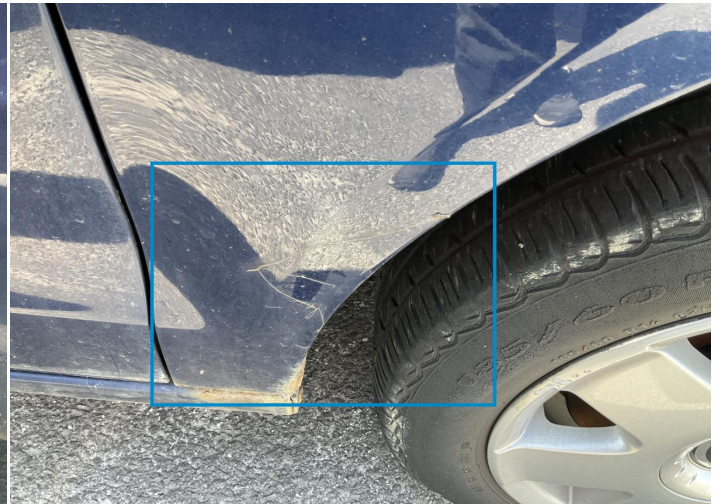
10. Fender / Front Right
Paint / Scratch / Scuff -

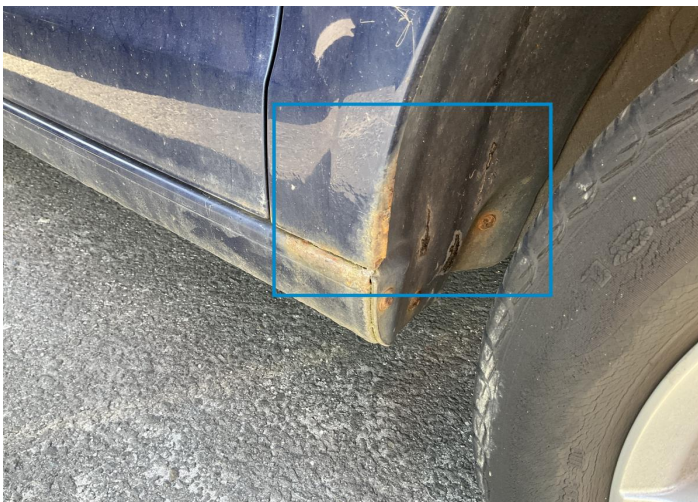
11. Fender / Front Right
Paint / Corrosion -
