VOLKSWAGEN Up up! BlueMotion Technology

VIN NO WVWZZZAAZED017825
Registration Number AZED017825

Inspection Report Summary

Customer	BCA Online	Report Number	P20250903130752
Inspection Date / Place	2025-09-03 / BCA Oberndorf	Cosmetic Grade	4

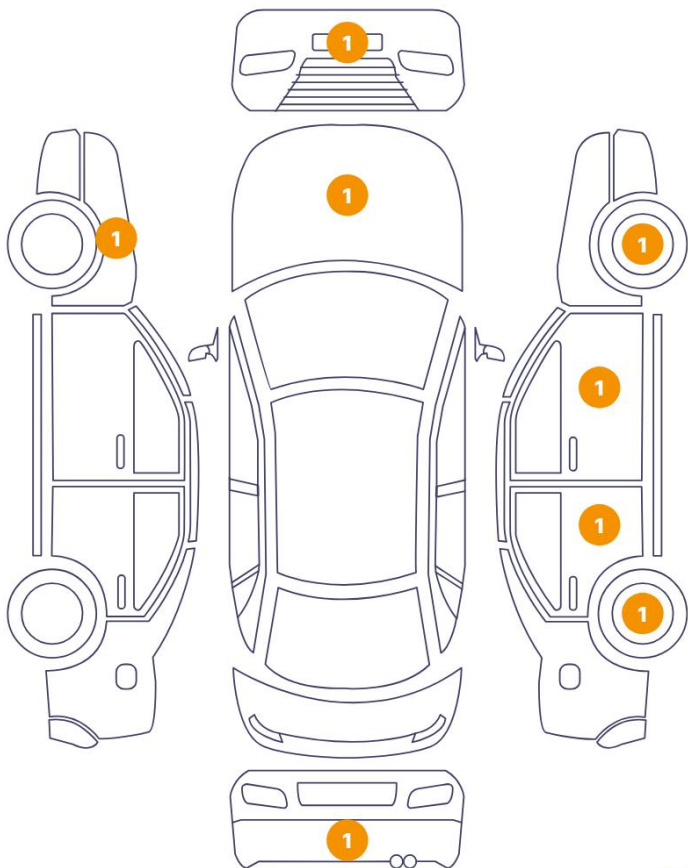
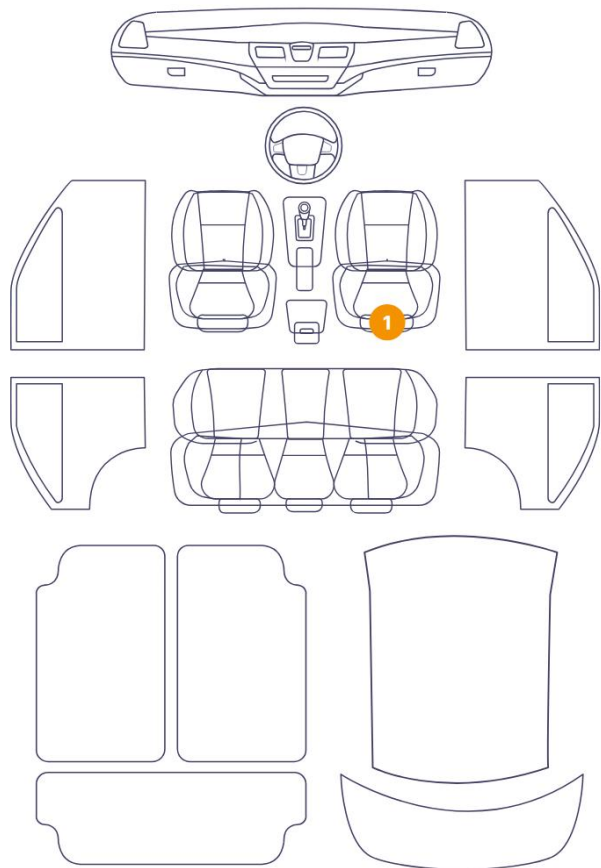
Component		Damage	Comments
1	Other	Anomalyon Element	
2	Hood	Bodywork / Dent / Dent	
3	Bumper / Front	Bodywork / Breakage / Crack	
4	Fender / Front Left	Bodywork / Dent / Dent	
5	Seat / Front Right	Interior / Dirty	
6	Bumper / Back	Paint / Scratch / Scuff	
7	Rim / Back Right	Paint / Stone Chip	
8	Door / Back Right	Bodywork / Dent / Dent	
9	Mirror / Front Right	Paint / Scratch / Line	
10	Rim / Front Right	Paint / Stone Chip

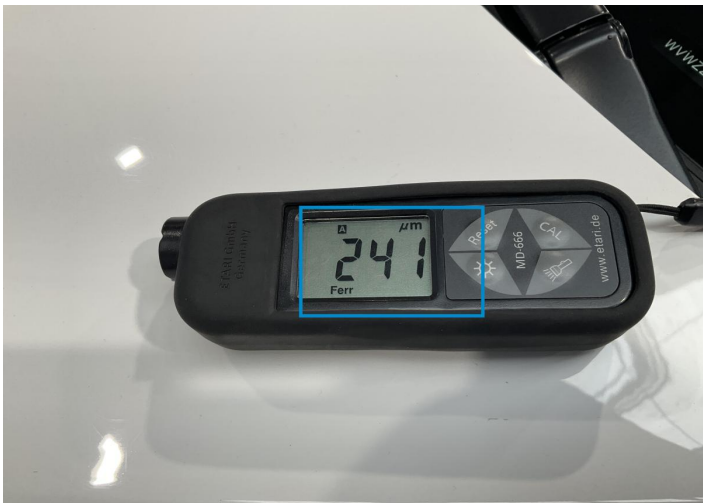
1. Anomalyon Element -

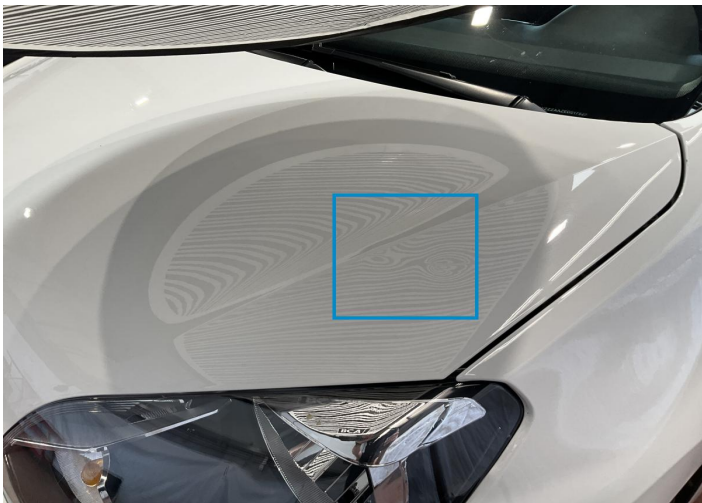
2. Hood Bodywork / Dent / Dent -

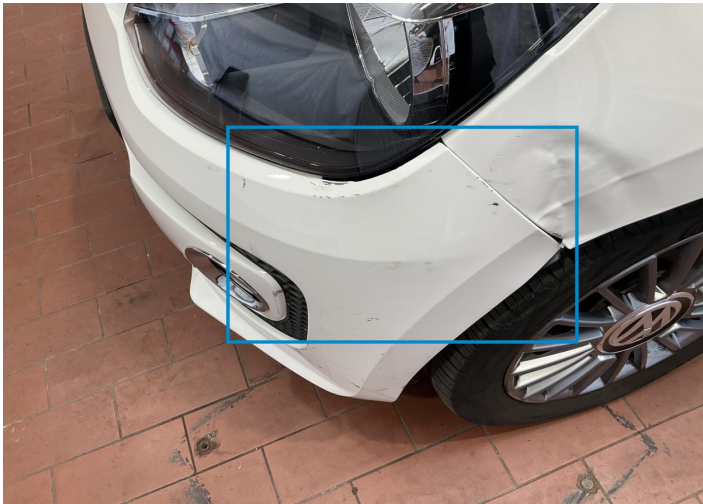
3. Bumper / Front Bodywork / Breakage / Crack -

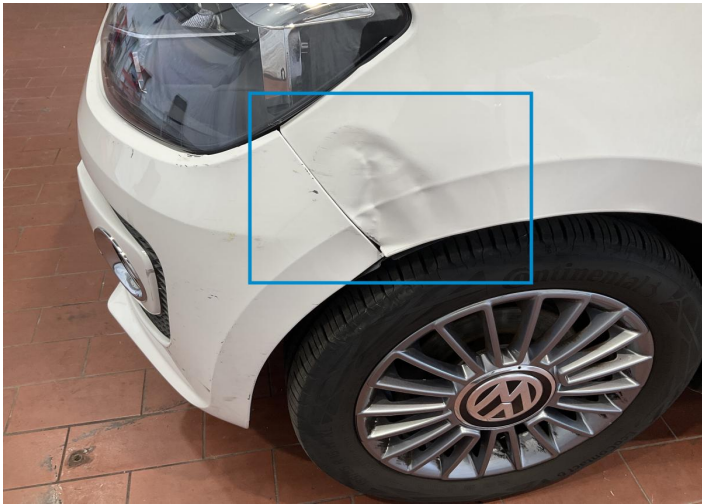
4. Fender / Front Left Bodywork / Dent / Dent -

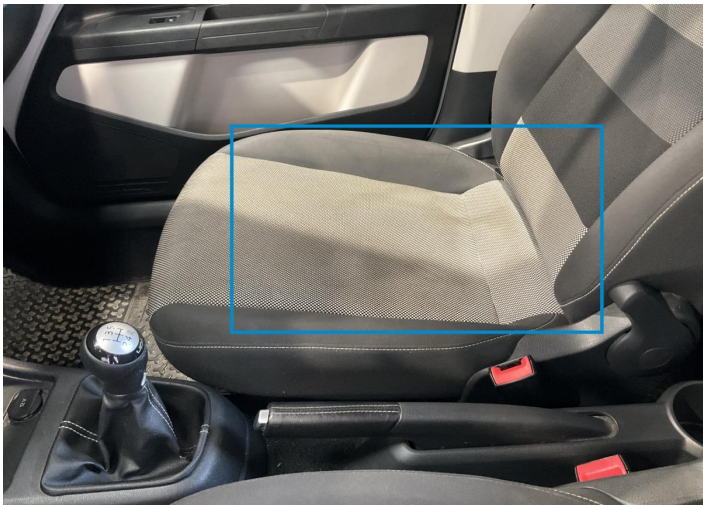
5. Seat / Front Right Interior / Dirty -

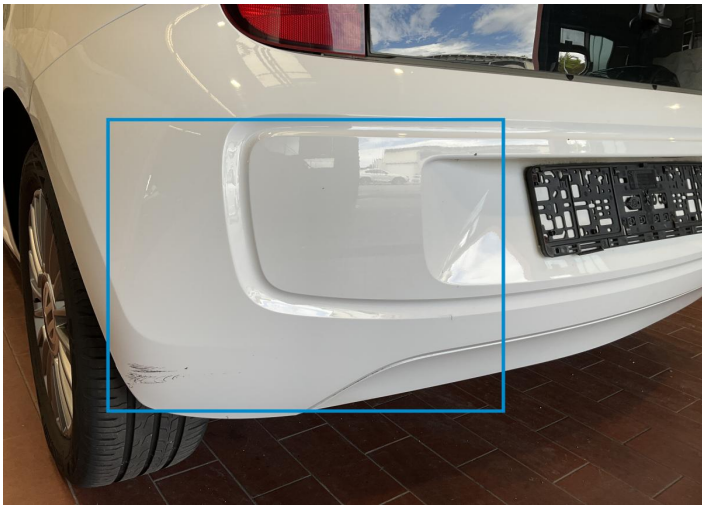
6. Bumper / Back Paint / Scratch / Scuff -

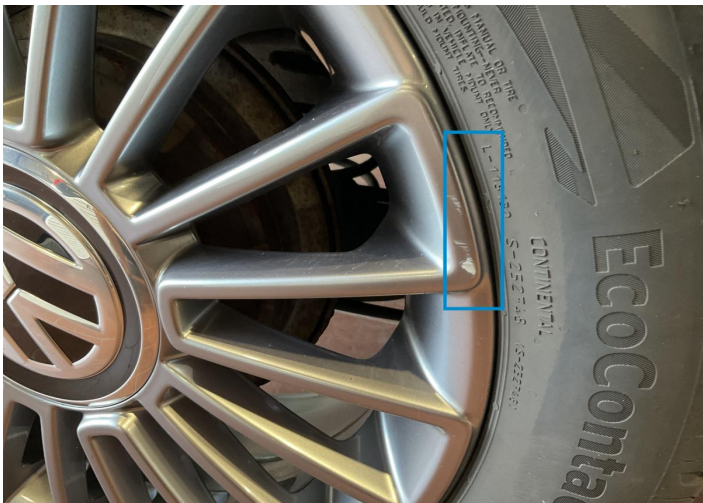
7. Rim / Back Right
Paint / Stone Chip -

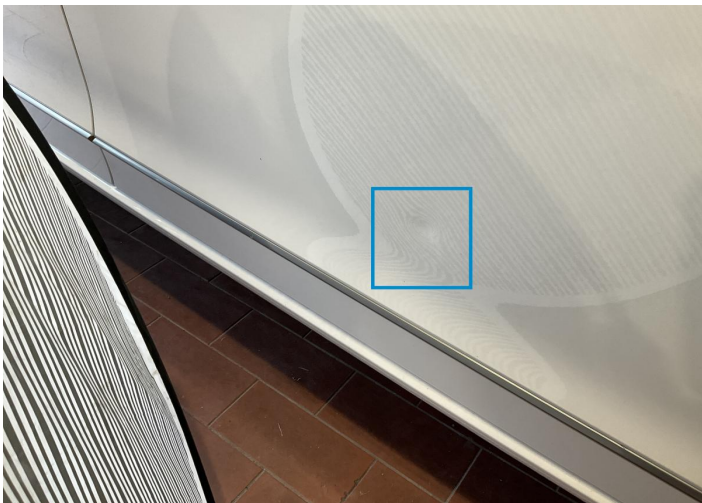
8. Door / Back Right
Bodywork / Dent / Dent -

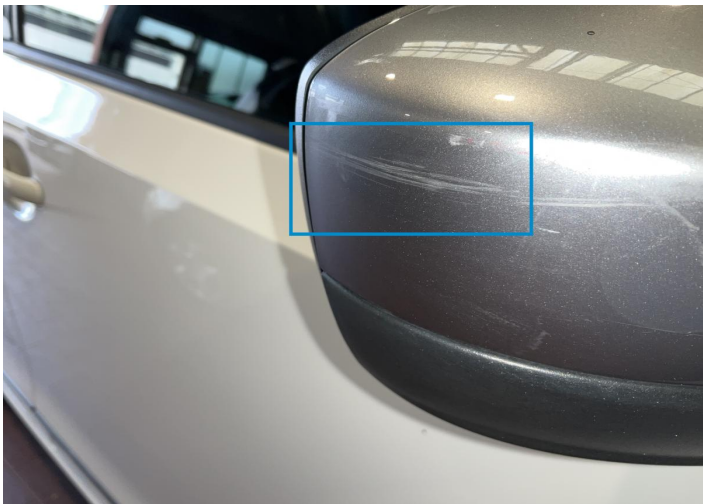
9. Mirror / Front Right
Paint / Scratch / Line -

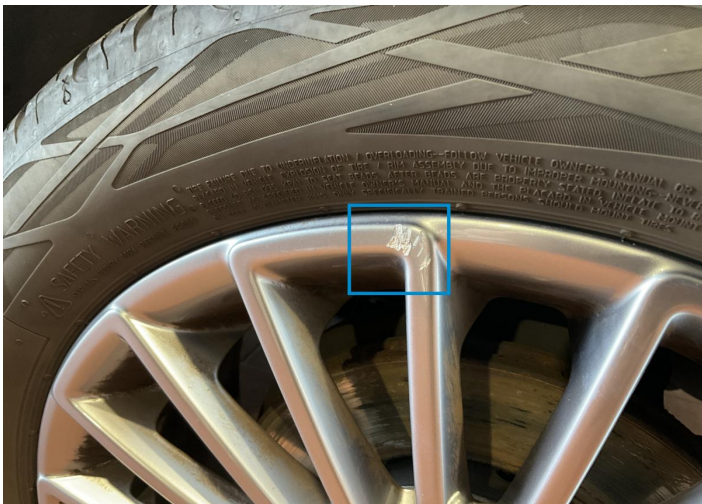
10. Rim / Front Right
Paint / Stone Chip -
