## status report

**customer:** Bank 11, Neuss  
**contract number:** 922079830  
**reference:**

#### Volkswagen up! move up!

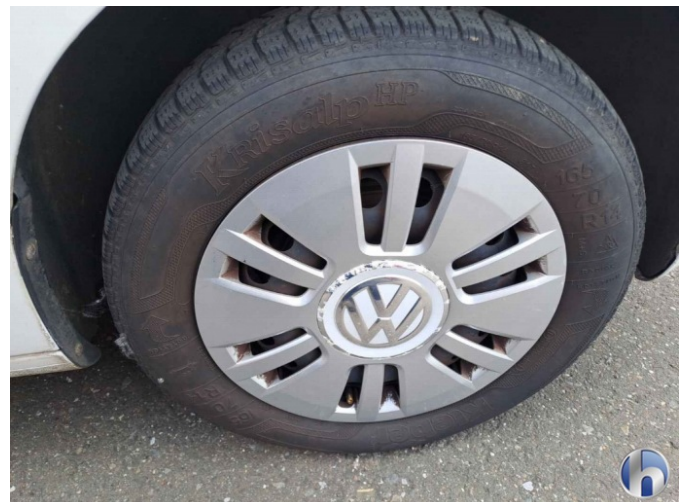
| component | Damage | Rep kind |
|---|---|---|
| 1. tire front - right | Worn | Replace |

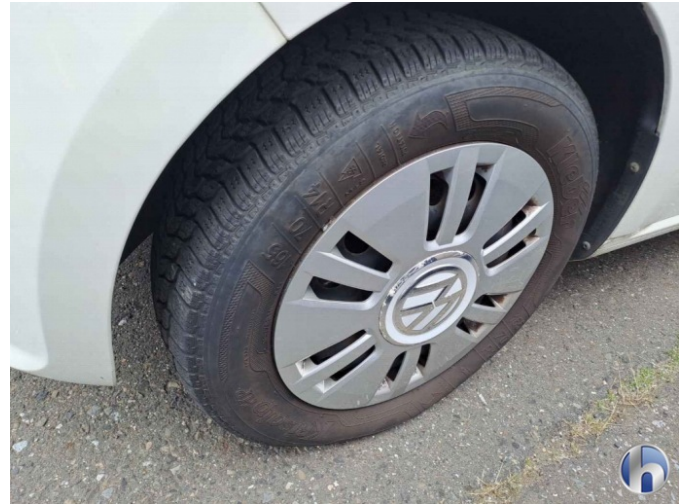
| component | Damage | Rep kind |
|---|---|---|
| 2. tire front - left | Worn | Replace |

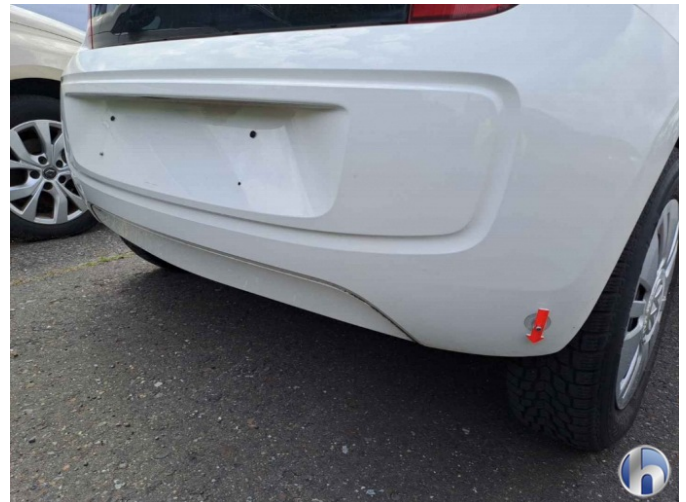
| component | Damage | Rep kind |
|---|---|---|
| 5. Rear bumper | Scratch(es) | Paint |

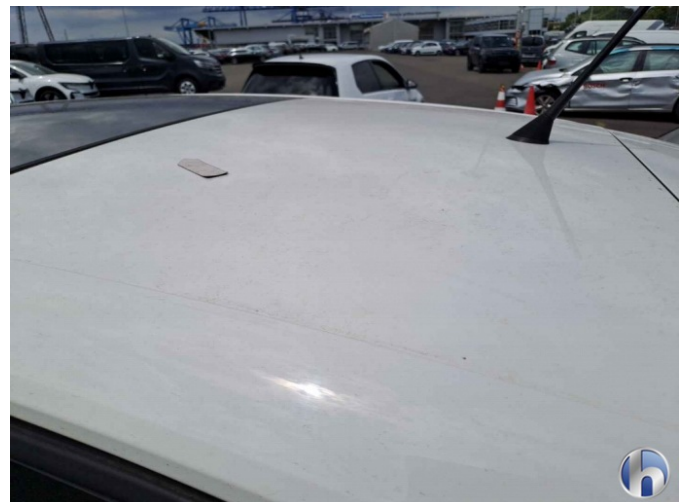
| component | Damage | Rep kind |
|---|---|---|
| 6. roof | Deformed | Refurbish and paint |

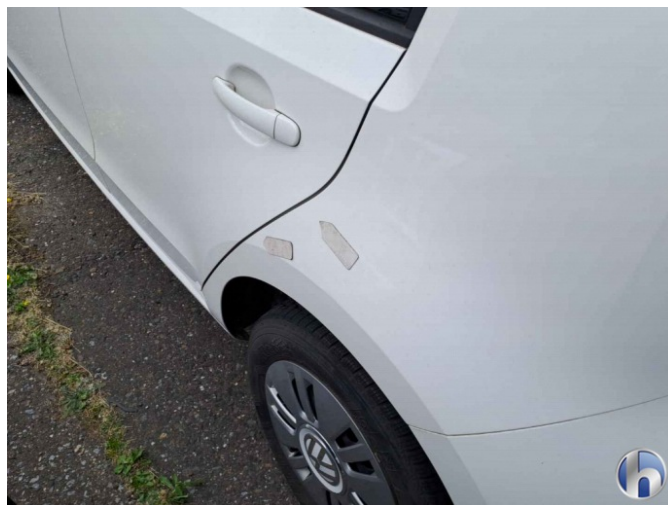
| component | Damage | Rep kind |
|---|---|---|
| 7. Sidewall - Rear - Left | Damaged | Refurbish and paint |

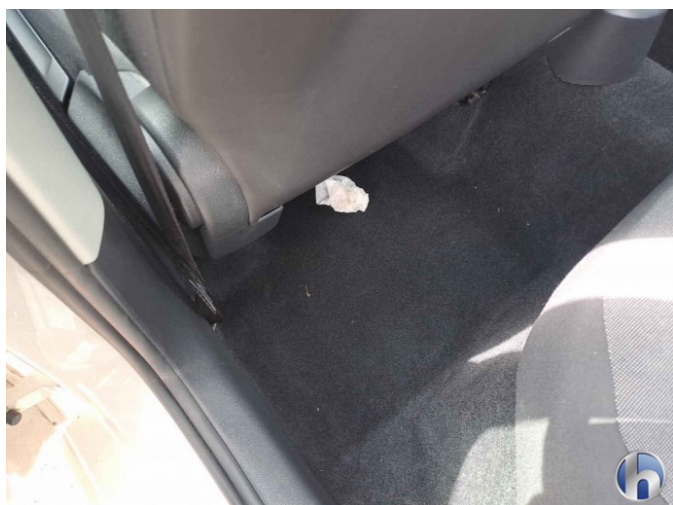
| component | Damage | Rep kind |
|---|---|---|
| 8. | Missing | Replace |

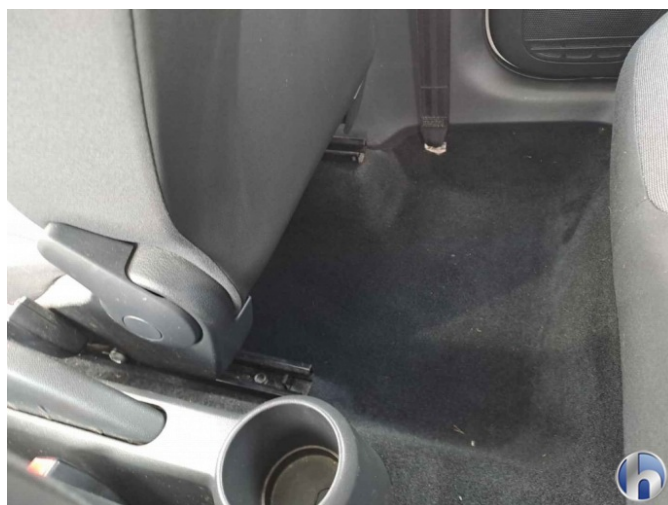
| component | Damage | Rep kind |
|---|---|---|
| 9. | Missing | Replace |

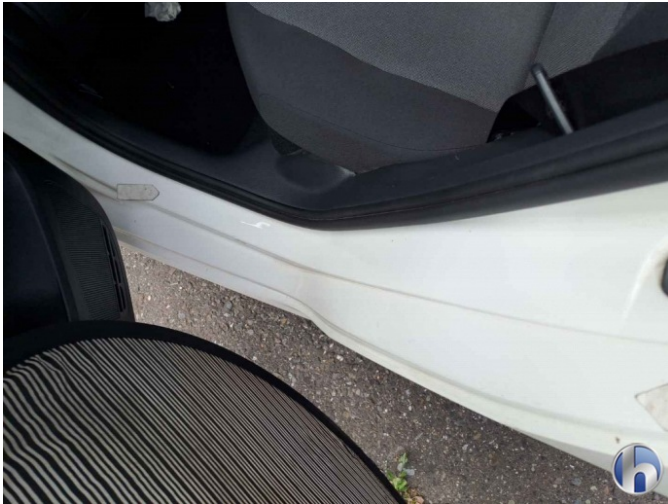
| component | Damage | Rep kind |
|---|---|---|
| 10. Türeinstieg Hinten - Links | Damaged | Refurbish and paint |

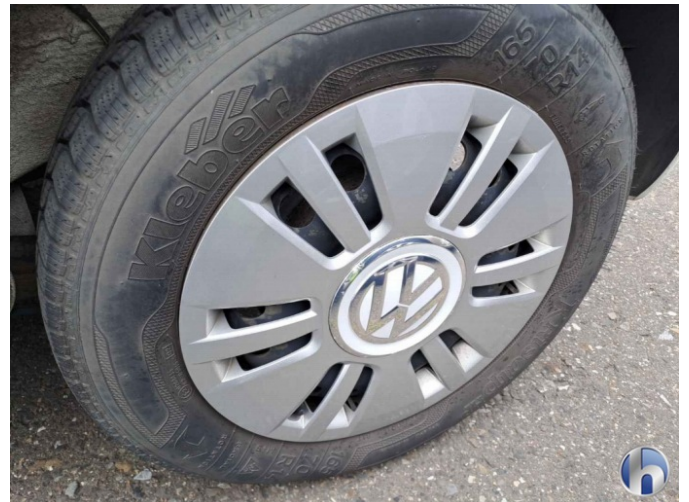
| component | Damage | Rep kind |
|---|---|---|
| 11. Hubcap - Rear - Left | Wear and tear | acceptable |

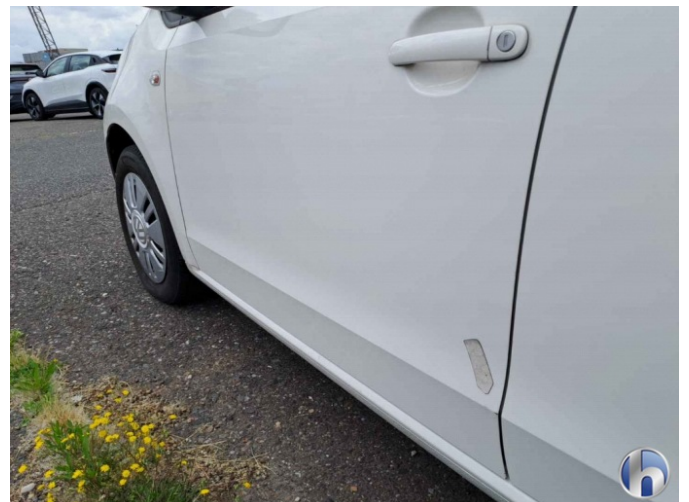
| component | Damage | Rep kind |
|---|---|---|
| 12. Front door - left | Damaged | Refurbish and paint |

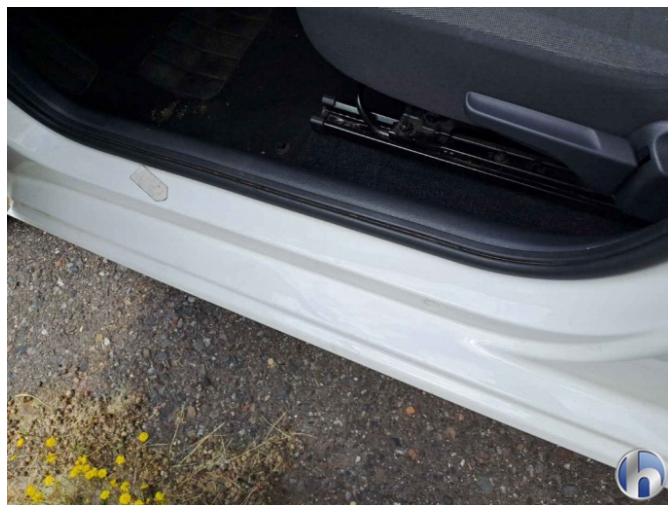
| component | Damage | Rep kind |
|---|---|---|
| 13. Türeinstieg Hinten - Rechts | Damaged | Paint |

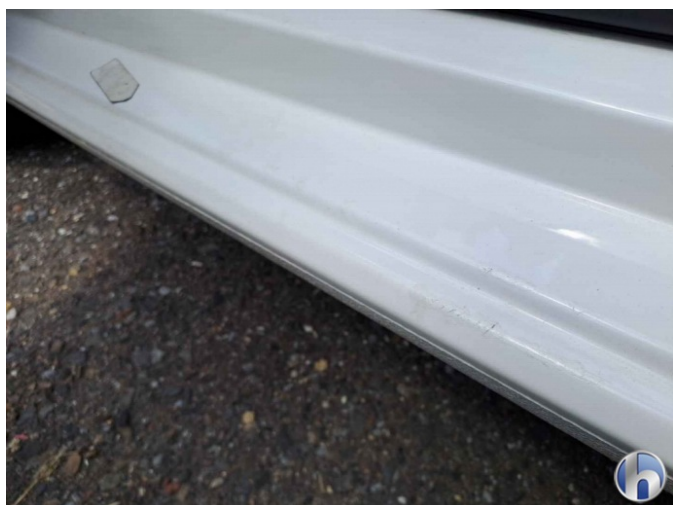
| component | Damage | Rep kind |
|---|---|---|
| 14. side skirt - left | Damaged | Refurbish and paint |

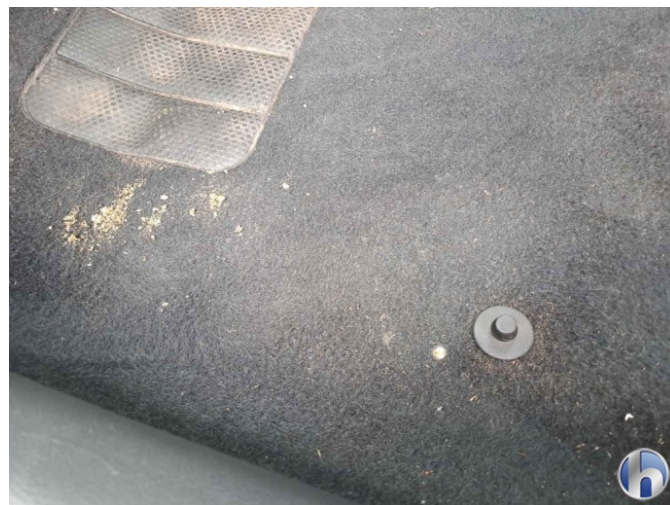
| component | Damage | Rep kind |
|---|---|---|
| 17. flooring | Burn hole | Replace |

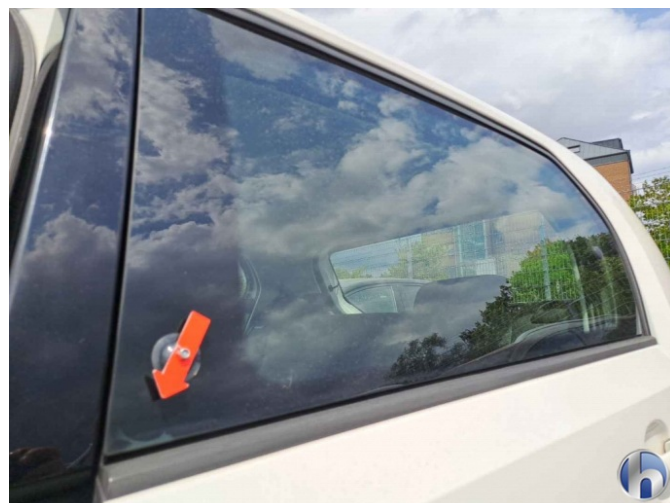
| component | Damage | Rep kind |
|---|---|---|
| 18. Side window - Rear - Left | Damaged | Replace |

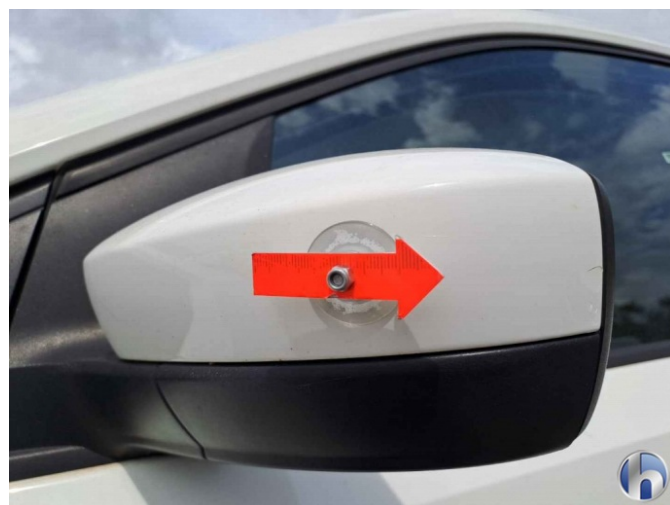
| component | Damage | Rep kind |
|---|---|---|
| 19. Outside mirror - left | Scratch(es) | Replace |

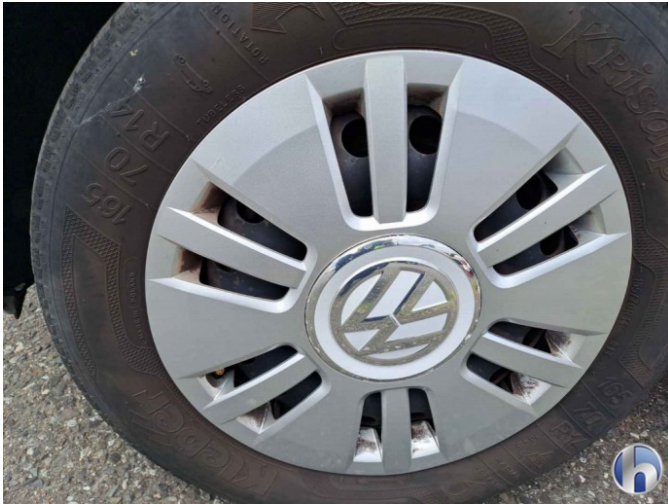
| component | Damage | Rep kind |
|---|---|---|
| 20. Radkappe - Vorne - Links | Damaged | Replace |

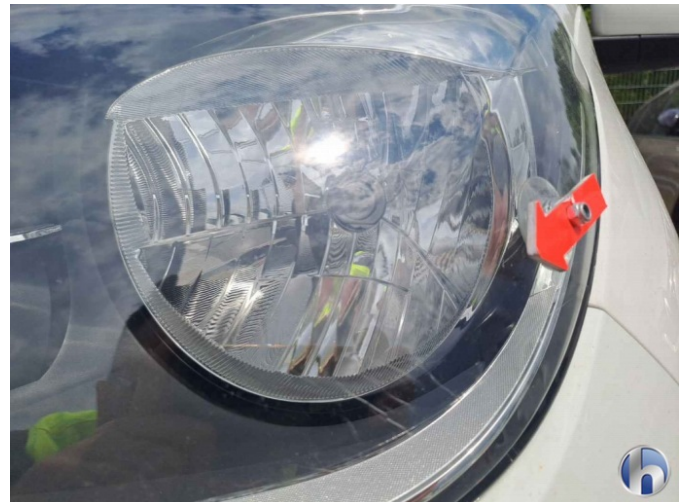
| component | Damage | Rep kind |
|---|---|---|
| 21. Halogen headlights - left | Scratch(es) | Replace |

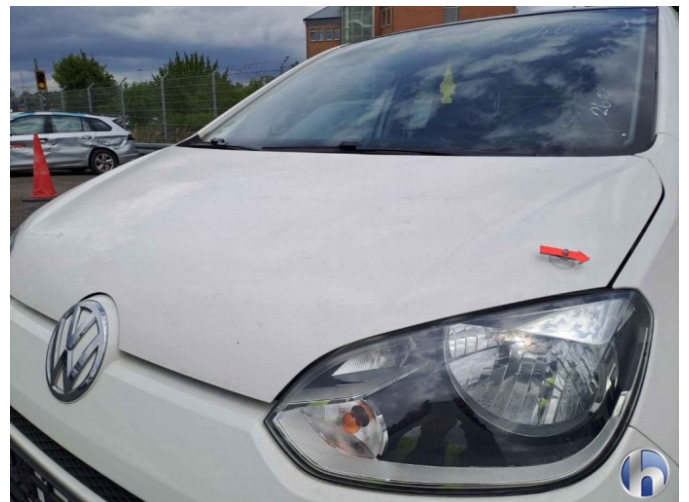
| component | Damage | Rep kind |
|---|---|---|
| 22. hood | Scratch(es) | Paint |

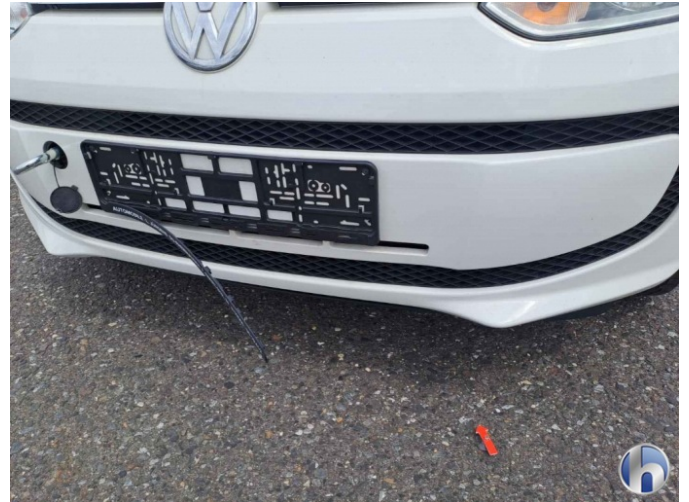
| component | Damage | Rep kind |
|---|---|---|
| 23. Front bumper | Scratch(es) | Paint |

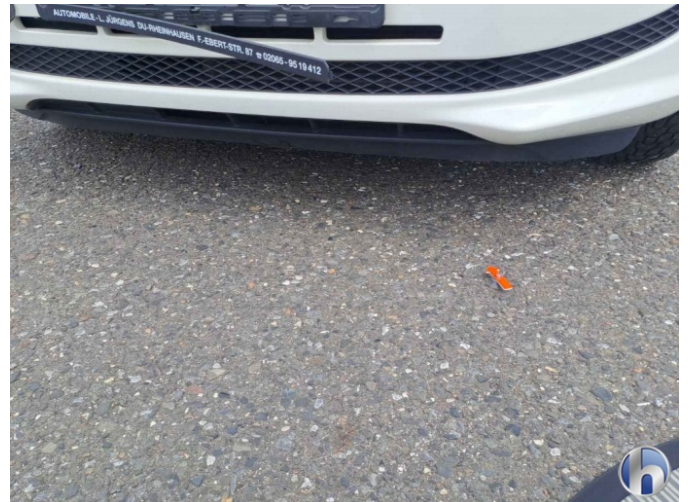
| component | Damage | Rep kind |
|---|---|---|
| 24. spoiler | Scrape | Replace |

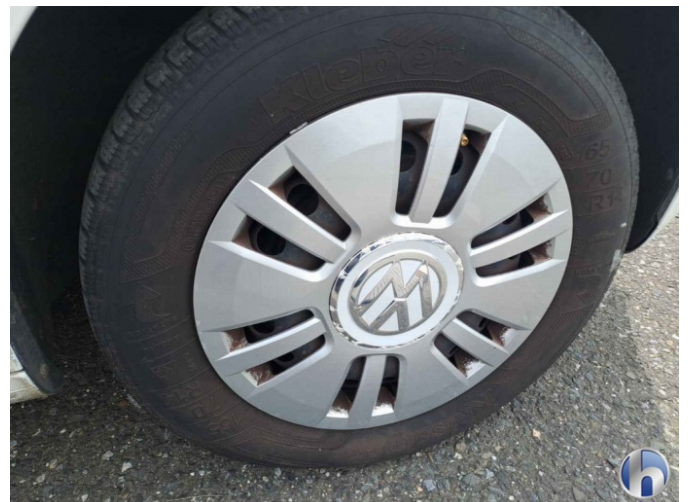
| component | Damage | Rep kind |
|---|---|---|
| 25. Radkappe - Vorne - Rechts | Damaged | Replace |

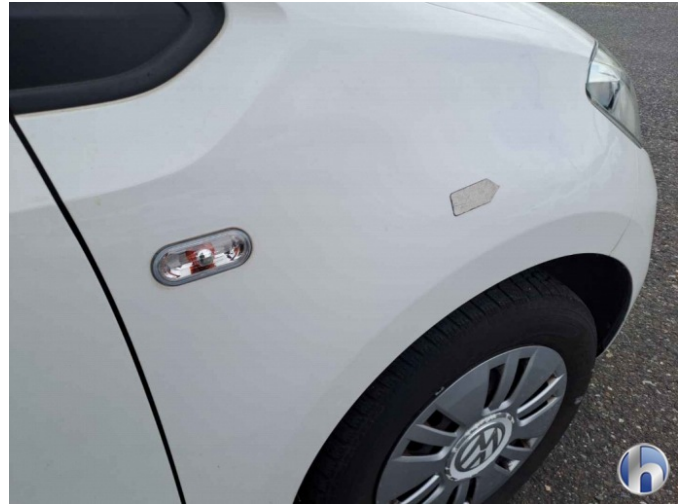
| component | Damage | Rep kind |
|---|---|---|
| 26. Front fender - right | Scratch(es) | Paint |

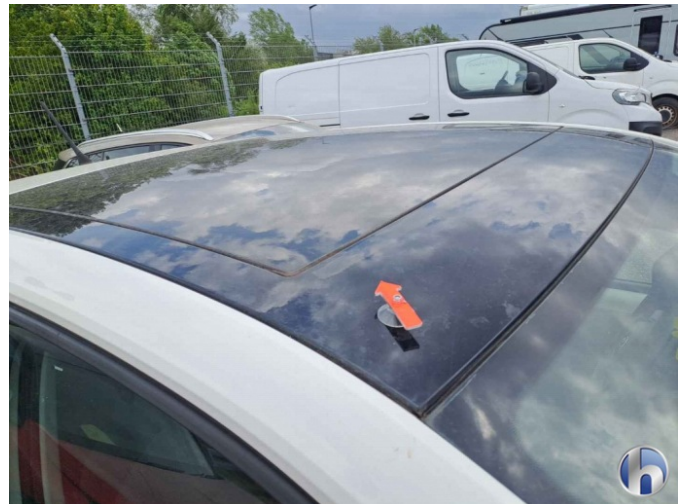
| component | Damage | Rep kind |
|---|---|---|
| 27. Dach Vorne | Damaged | Refurbish and paint |

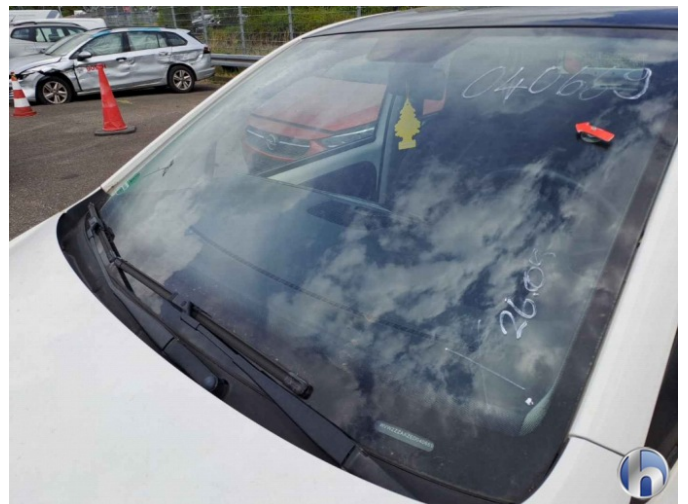
| component | Damage | Rep kind |
|---|---|---|
| 28. Windshield | Damaged | Replace |

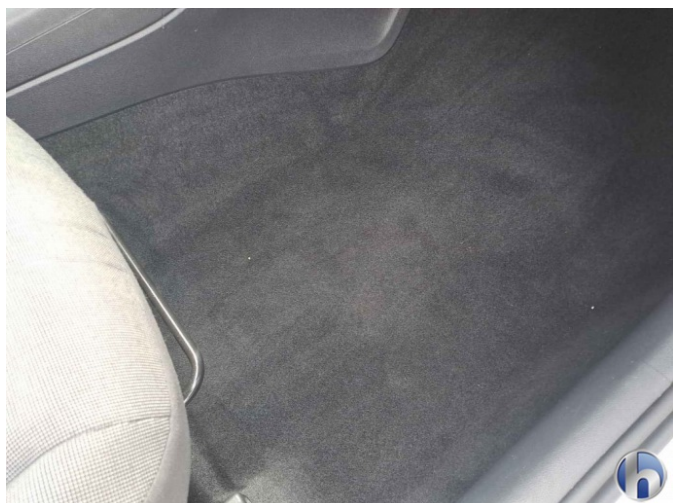
| component | Damage | Rep kind |
|---|---|---|
| 29. | Missing | Replace |

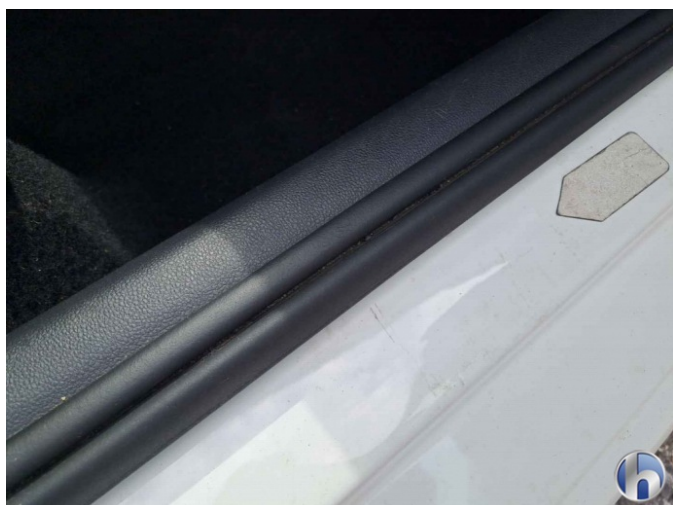
| component | Damage | Rep kind |
|---|---|---|
| 30. Türeinstieg Vorne - Rechts | Scratch(es) | Paint |

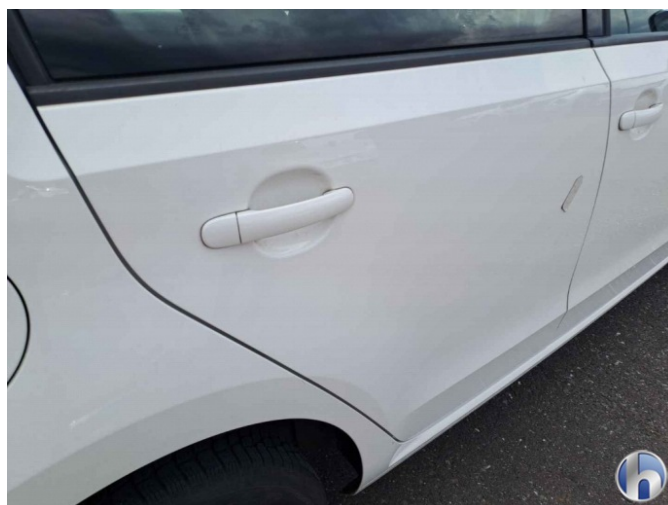
| component | Damage | Rep kind |
|---|---|---|
| 31. Door Rear - right | Scratch(es) | Paint |

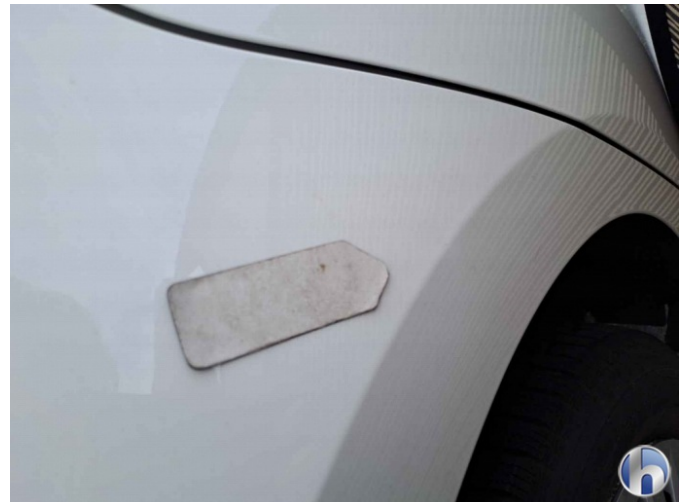
| component | Damage | Rep kind |
|---|---|---|
| 32. Sidewall - Rear - right | Damaged | Refurbish and paint |

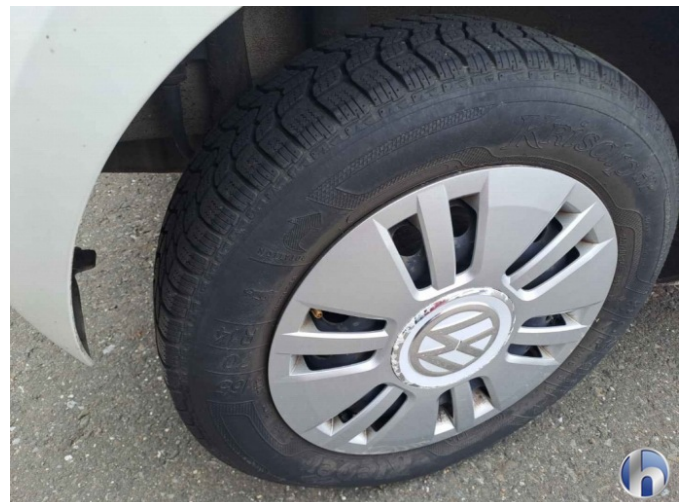
| component | Damage | Rep kind |
|---|---|---|
| 33. Radkappe - Hinten - Rechts | Damaged | Replace |

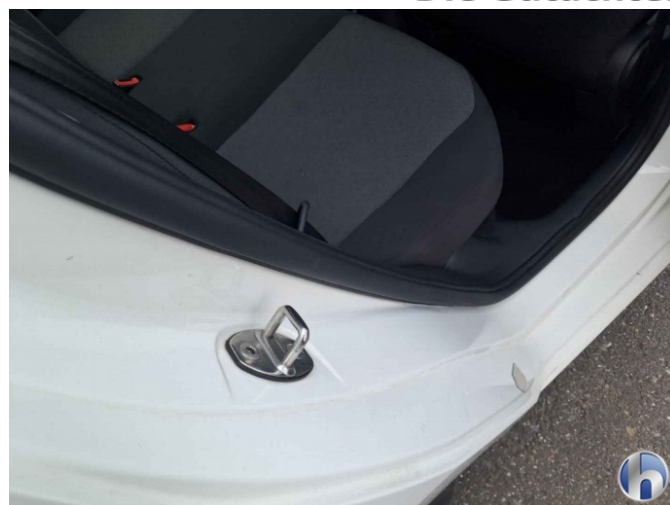
| component | Damage | Rep kind |
|---|---|---|
| 34. Türeinstieg Hinten - Rechts | Damaged | Refurbish and paint |

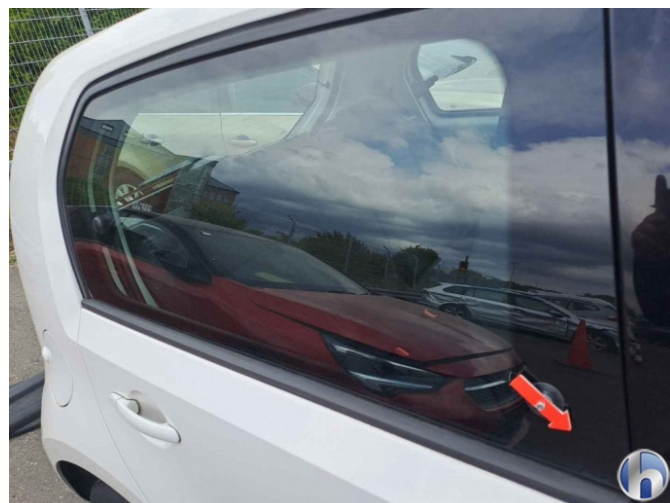
| component | Damage | Rep kind |
|---|---|---|
| 35. Side window - Rear - right | Damaged | Replace |

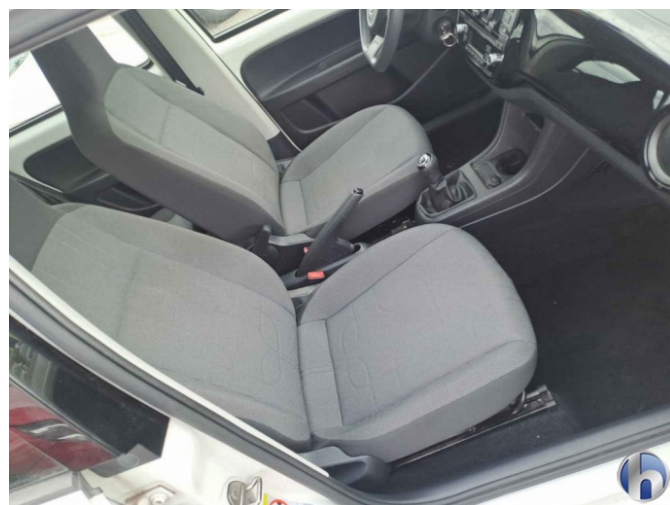
| component | Damage | Rep kind |
|---|---|---|
| 36. | Dirty | |

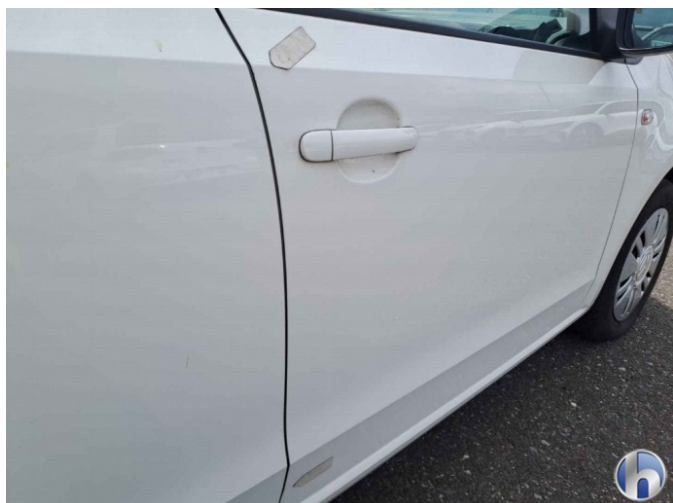
| component | Damage | Rep kind |
|---|---|---|
| 37. Front door - right | Damaged | Refurbish and paint |
