VOLKSWAGEN Up

VIN NO WVWZZZAAZFD046338 Registration Number AZFD046338

Inspection Report Summary

Customer	BCA Online	Report Number	P20250924082112
Inspection Date / Place	2025-09-24 / ARS Altmann AG Wolnzach	Cosmetic Grade	4

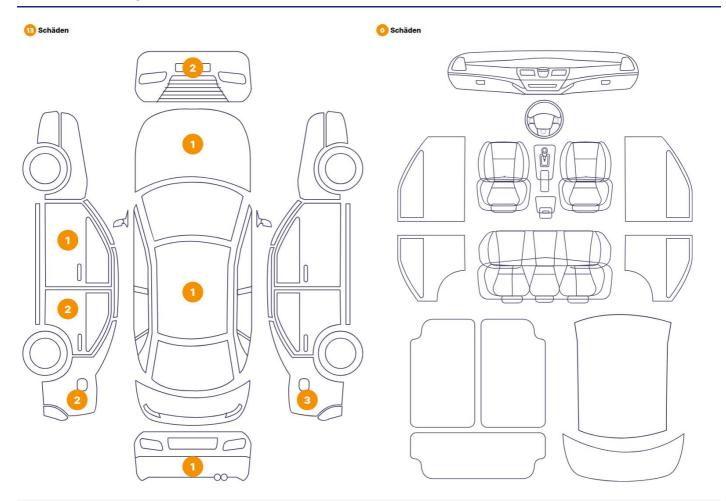
Cosmetic Damage

Component	Damage	Comments
1	Hood	Bodywork / Dent / Dent	
2	Side Panel / Back Left	Bodywork / Dent / Dent	
3	Side Panel / Back Right	Bodywork / Dent / Dent	
4	Bumper / Front	Paint / Scratch / Scuff	
5	Door / Front Left	Paint / Scratch / Scuff	
6	Pillar / Back Left	Bodywork / Dent / Dent	
7	Pillar / Back Left	Paint / Scratch / Scuff	
8	Side Panel / Back Left	Paint / Scratch / Scuff	
9	Bumper / Back	Paint / Scratch / Scuff	
10	Side Panel / Back Right	Paint / Corrosion	
11	Side Panel / Back Right	Bodywork / Dent / Dent	
12	Antenna Rod	Out of Bodywork / Breakage

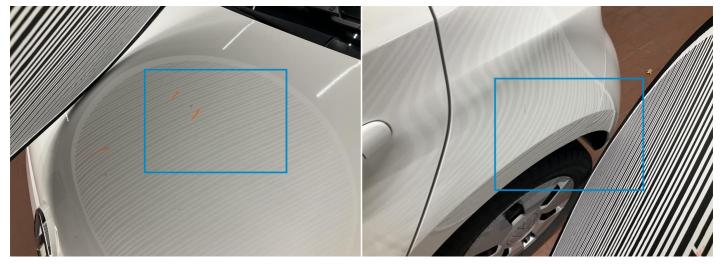
1. Hood Bodywork / Dent / Dent -

2. Side Panel / Back Left Bodywork / Dent / Dent -

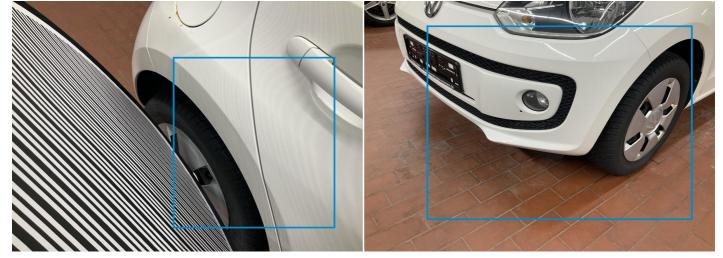
3. Side Panel / Back Right Bodywork / Dent / Dent -

4. Bumper / Front Paint / Scratch / Scuff -

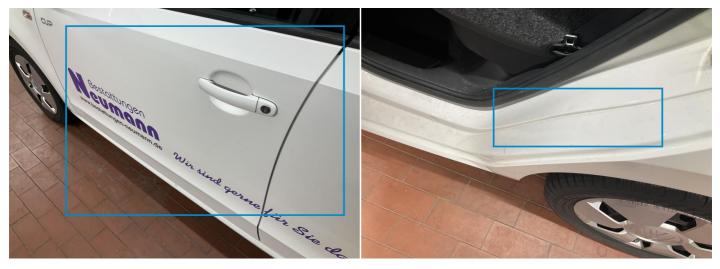
5. Door / Front Left Paint / Scratch / Scuff -

6. Pillar / Back Left Bodywork / Dent / Dent -

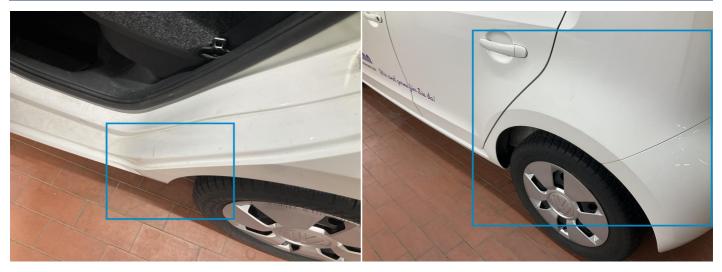
7. Pillar / Back Left Paint / Scratch / Scuff -

8. Side Panel / Back Left Paint / Scratch / Scuff -

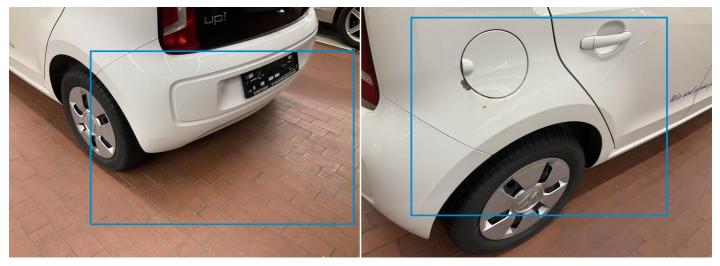
9. Bumper / Back Paint / Scratch / Scuff -

10. Side Panel / Back Right Paint / Corrosion -

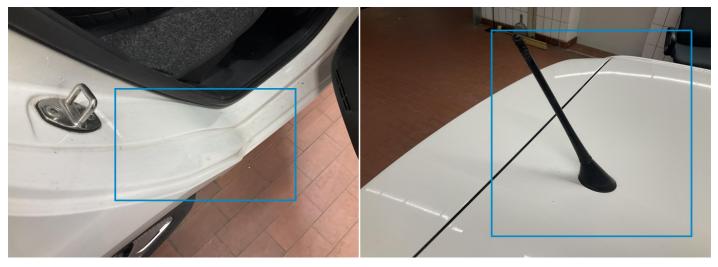
11. Side Panel / Back Right Bodywork / Dent / Dent -

12. Antenna Rod Out of Bodywork / Breakage -

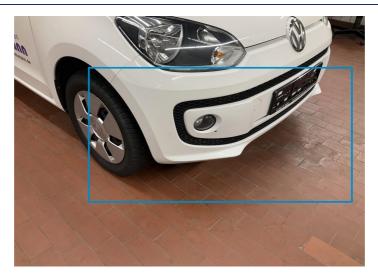
13. Bumper / Front Paint / Scratch / Scuff -
