VOLKSWAGEN Golf VII

Golf 1.2 TSI BlueMotion Technology

Inspection Report Summary

Customer	BCA Online	Report Number	P20251006105107
Inspection Date / Place	2025-10-06 / BCA Oberndorf	Cosmetic Grade	4

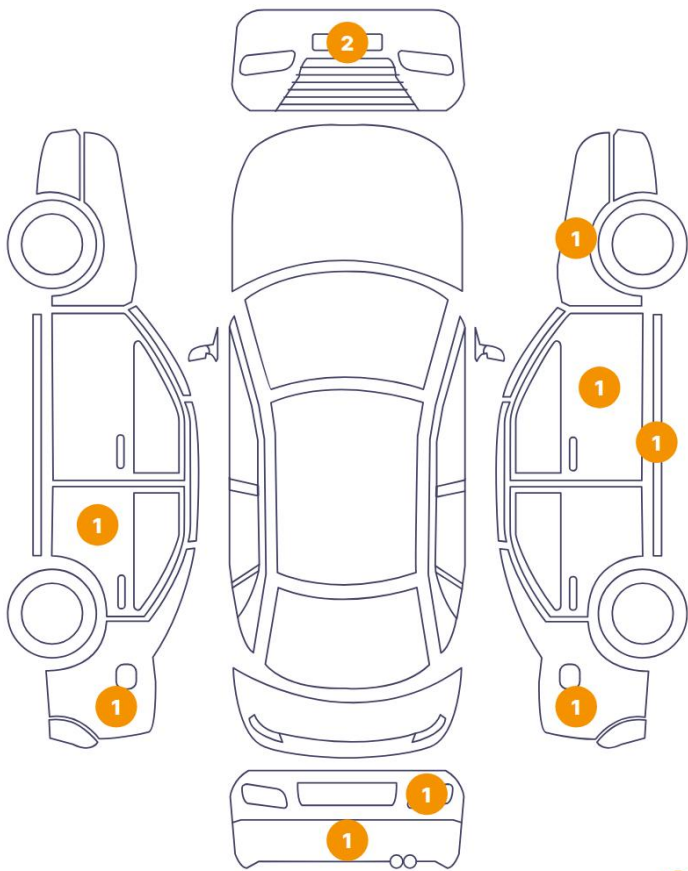
11 Schäden

Component		Damage	Comments
1	Other	Paint / Other	
2	Bumper / Front	Paint / Stone Chip	
3	Bumper / Front	Paint / Scratch / Scuff	
4	Seat / Front Left	Interior / Ripped	
5	Door / Back Left	Paint / Scratch / Scuff	
6	Fender / Back Left	Bodywork / Dent / Dent	
7	Bumper / Back	Bodywork / Dent / Dent	
8	Back Light / Right	Glass Break / Impact	
9	Fender / Back Right	Bodywork / Dent / Dent	
10	Rocker Panel / Center Right	Paint / Scratch / Scuff	
11	Door / Front Right	Paint / Stone Chip	
12	Fender / Front Right	Bodywork / Dent / Dent

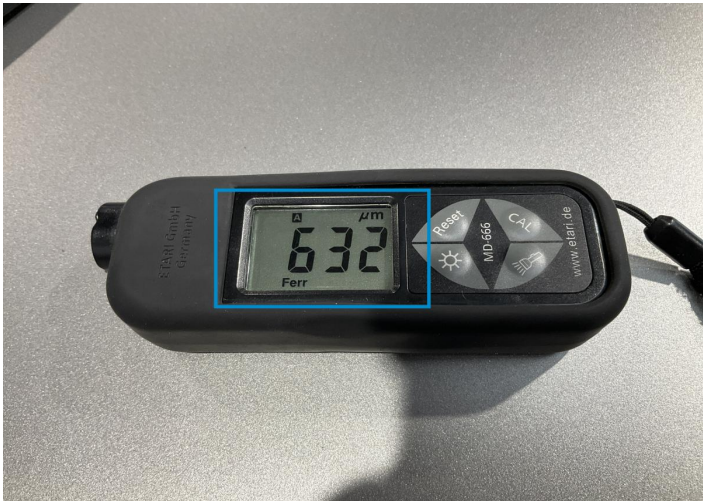
1.
Paint / Other -

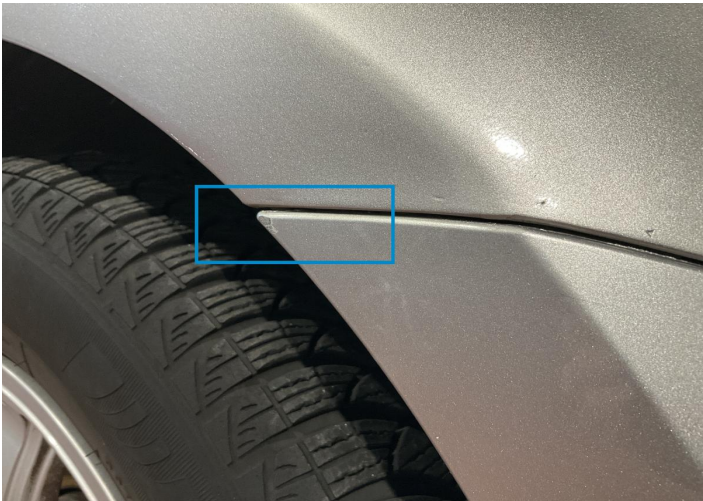
2. Bumper / Front
Paint / Stone Chip -

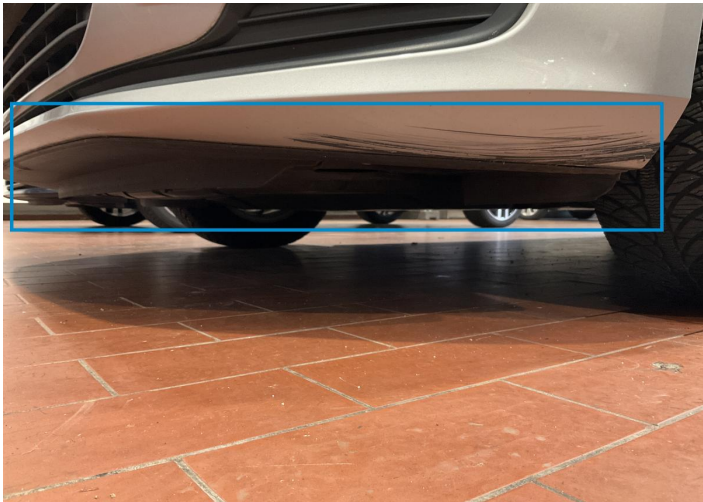
3. Bumper / Front
Paint / Scratch / Scuff -

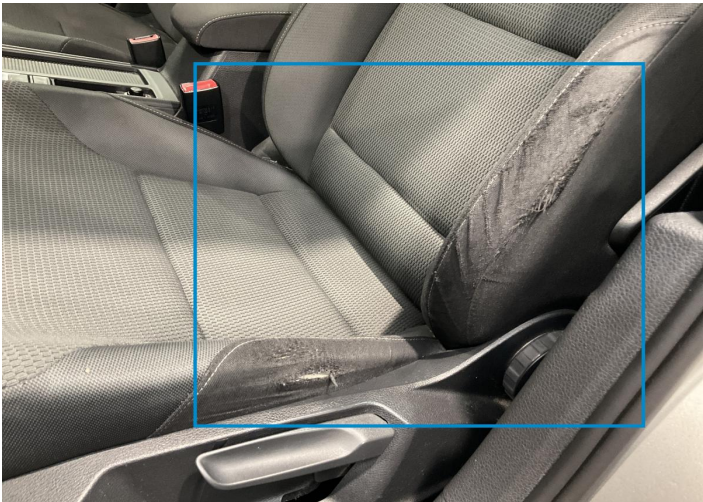
4. Seat / Front Left
Interior / Ripped -

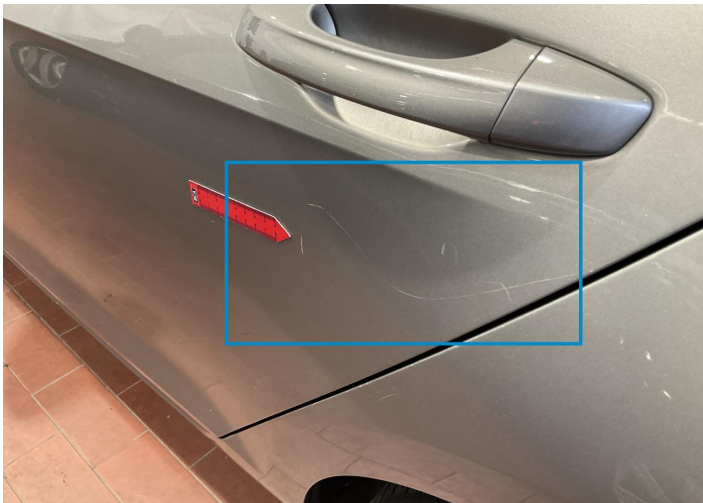
5. Door / Back Left
Paint / Scratch / Scuff -

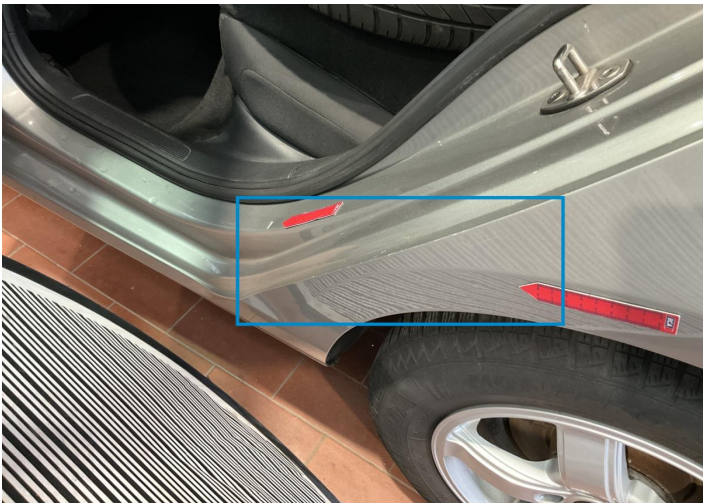
6. Fender / Back Left
Bodywork / Dent / Dent -

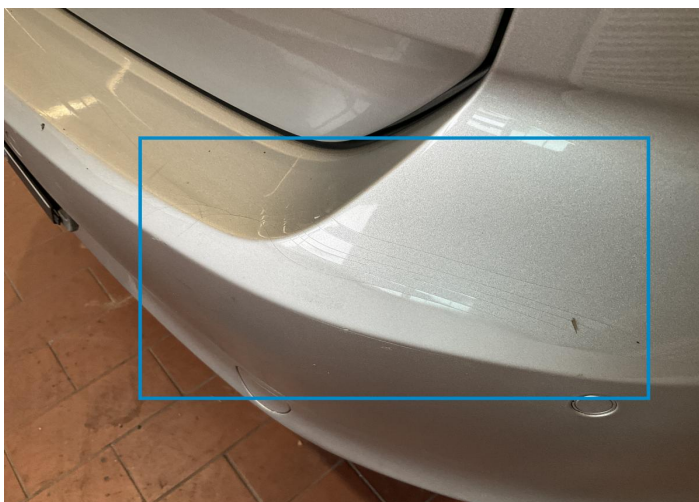
7. Bumper / Back
Bodywork / Dent / Dent -

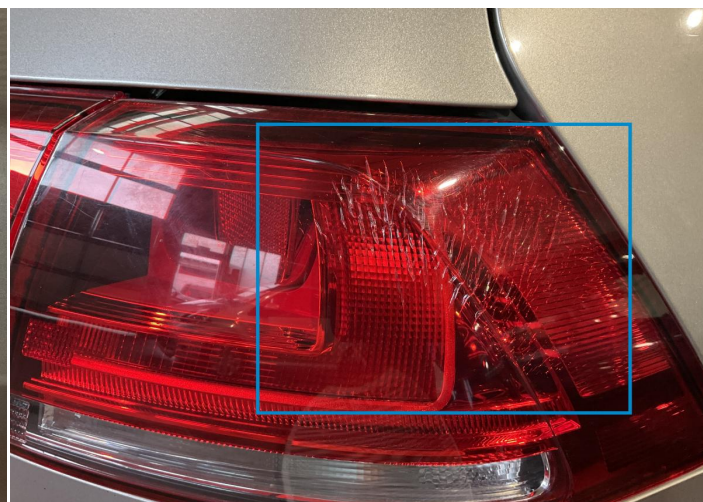
8. Back Light / Right
Glass Break / Impact -

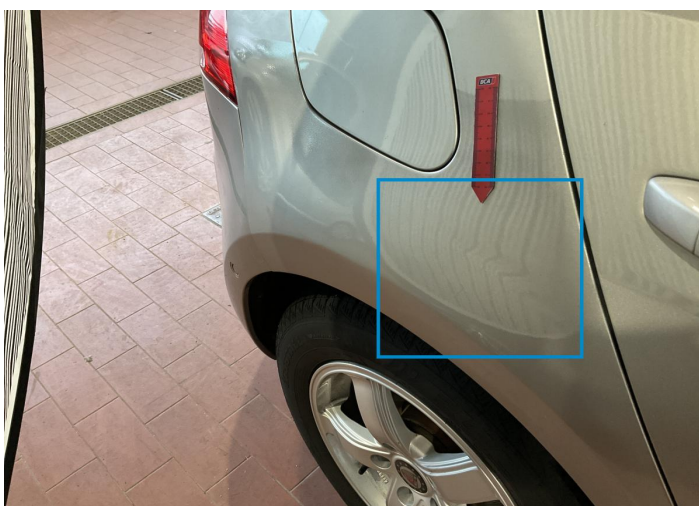
9. Fender / Back Right
Bodywork / Dent / Dent -

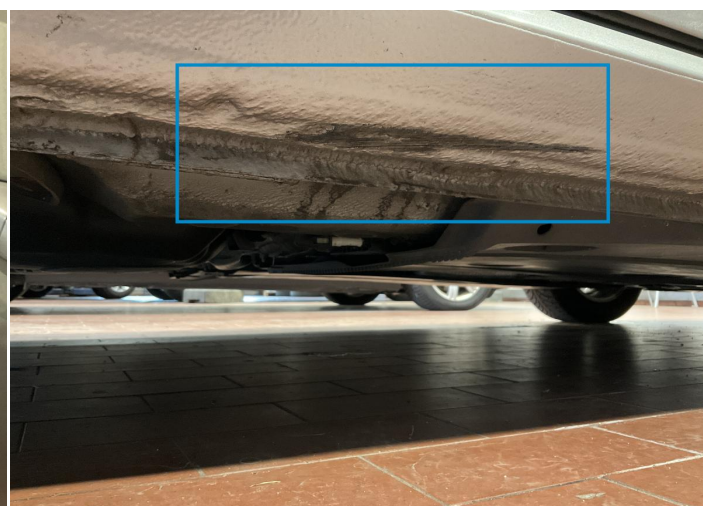
10. Rocker Panel / Center Right
Paint / Scratch / Scuff -

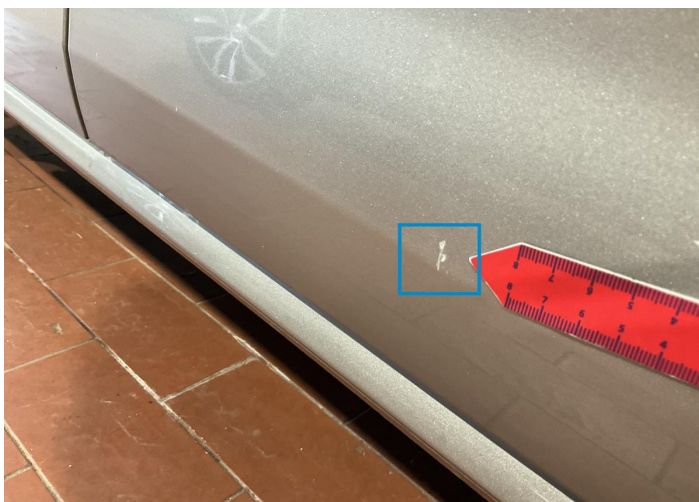
11. Door / Front Right
Paint / Stone Chip -

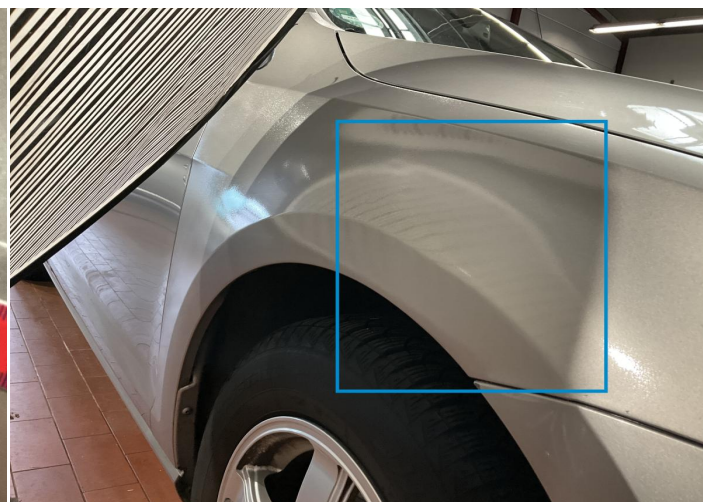
12. Fender / Front Right
Bodywork / Dent / Dent -
