VOLKSWAGEN Golf VII Golf Sportsvan 1.4 TSI (BlueMotion Technology) DSG

VIN NO WVWZZZAUZGW528952 Registration Number UZGW528952

Inspection Report Summary

Customer	BCA Online	Report Number	P20251009100910
Inspection Date / Place	2025-10-09 / BCA Oberndorf	Cosmetic Grade	4

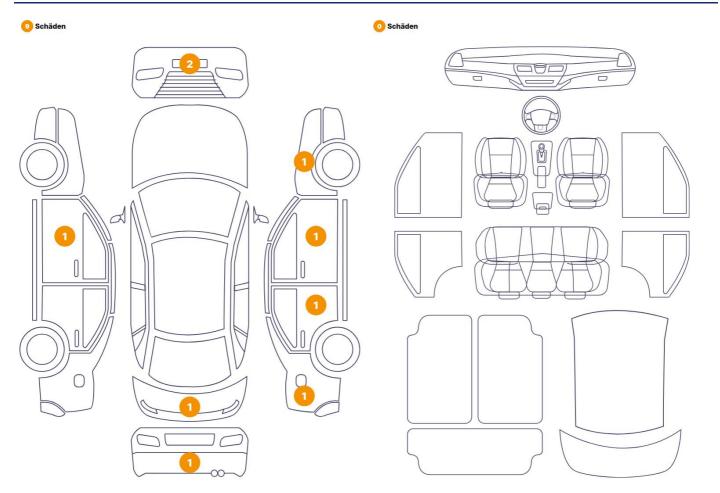
Component	Damage	Comments
1	Bumper / Front	Paint / Scratch / Scuff	
2	Corner Bumper / Front Left	Paint / Scratch / Scuff	
3	Fender / Back Right	Bodywork / Dent / Dent	
4	Bumper / Back	Paint / Scratch / Scuff	
5	Mirror / Front Right	Bodywork / Breakage / Crack	
6	Door / Back Right	Paint / Scratch / Scuff	
7	Tailgate	Paint / Scratch / Scuff	
8	Fender / Front Right	Paint / Scratch / Scuff	
9	Mirror / Front Left	Bodywork / Breakage / Crack

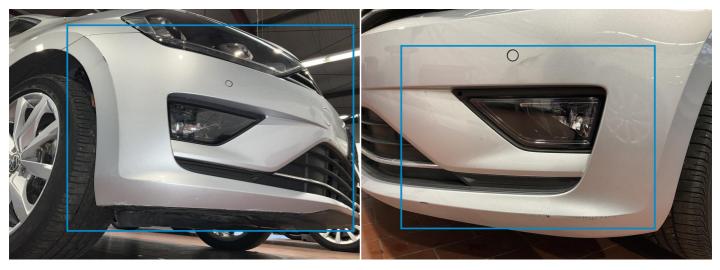
1. Bumper / Front Paint / Scratch / Scuff -

2. Corner Bumper / Front Left Paint / Scratch / Scuff -

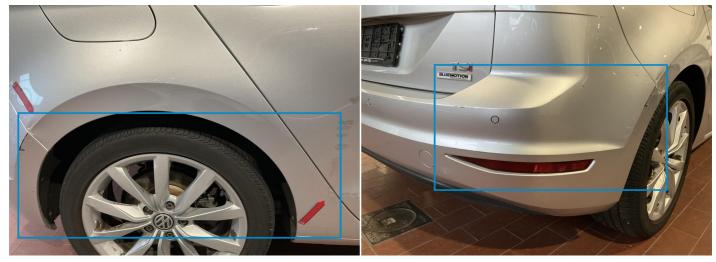
3. Fender / Back Right Bodywork / Dent -

4. Bumper / Back Paint / Scratch / Scuff -

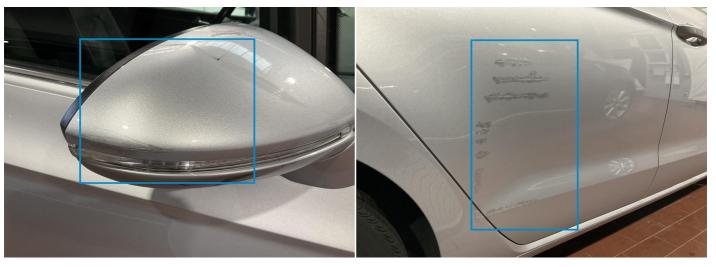
5. Mirror / Front Right Bodywork / Breakage / Crack -

6. Door / Back Right Paint / Scratch / Scuff -

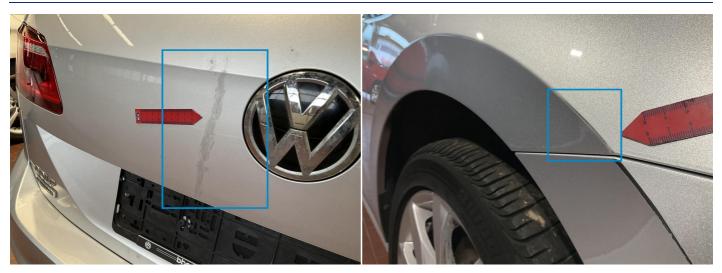
7. Tailgate Paint / Scratch / Scuff -

8. Fender / Front Right Paint / Scratch / Scuff -

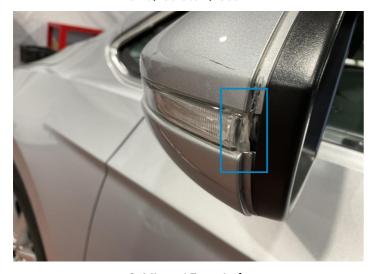
9. Mirror / Front Left Bodywork / Breakage / Crack -
