# VOLKSWAGEN Golf VII

## Golf Sportsvan 1.4 TSI BlueMotion Technology DSG

### Inspection Report Summary

Customer	BCA Online	Report Number	P20250926091033
Inspection Date / Place	2025-09-26 / Extern	Cosmetic Grade	3

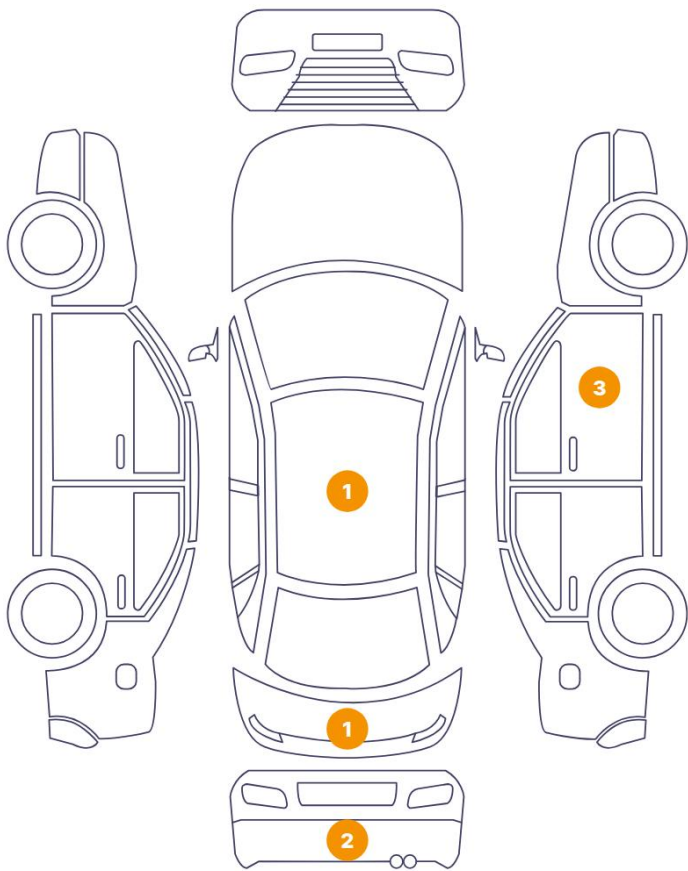
7 Schäden

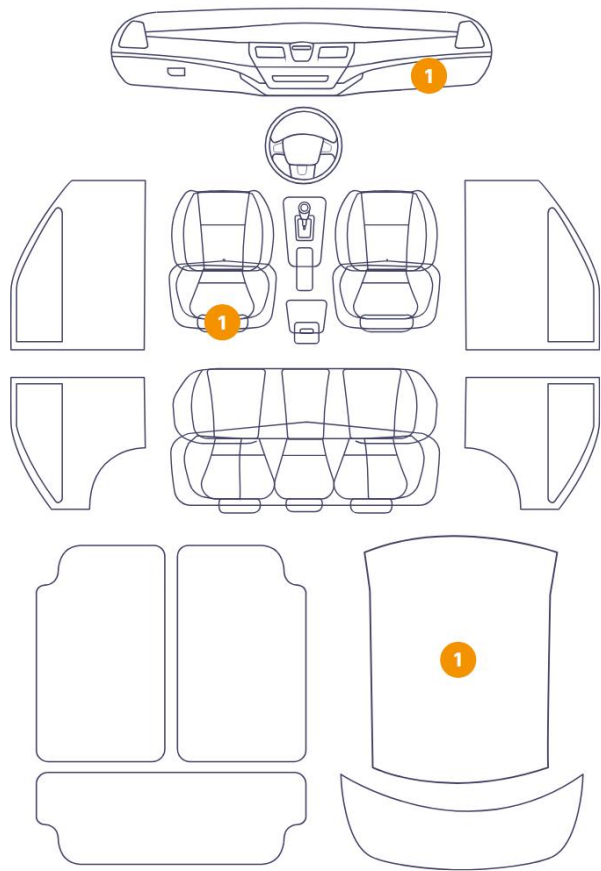
3 Schäden

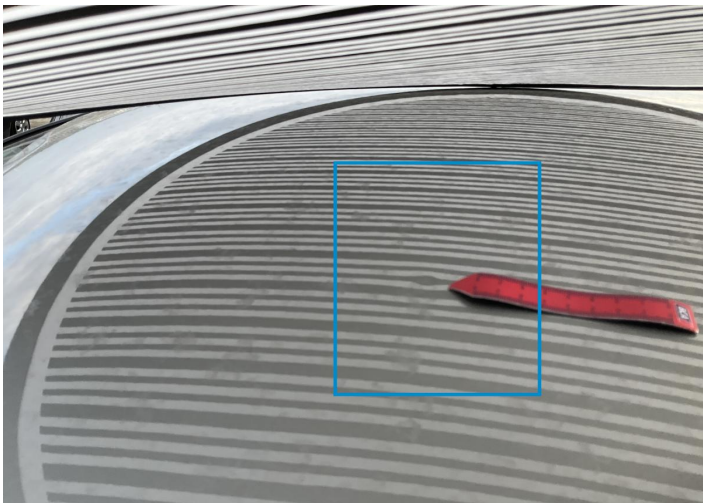
1. Roof  
Bodywork / Dent / Deformation -

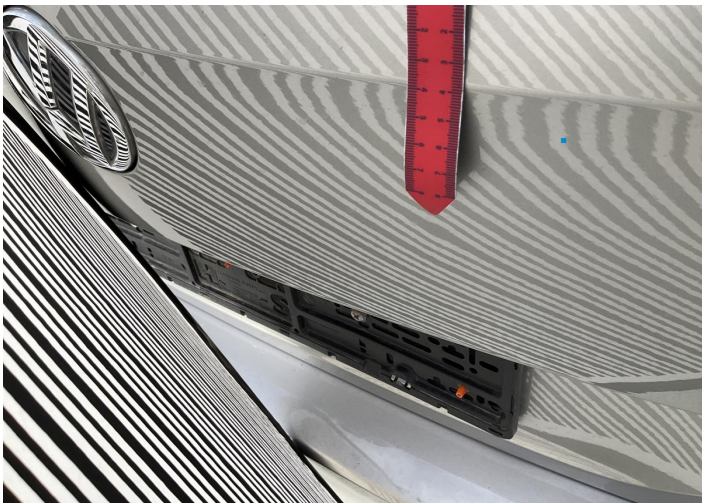
2. Tailgate  
Bodywork / Dent / Deformation -

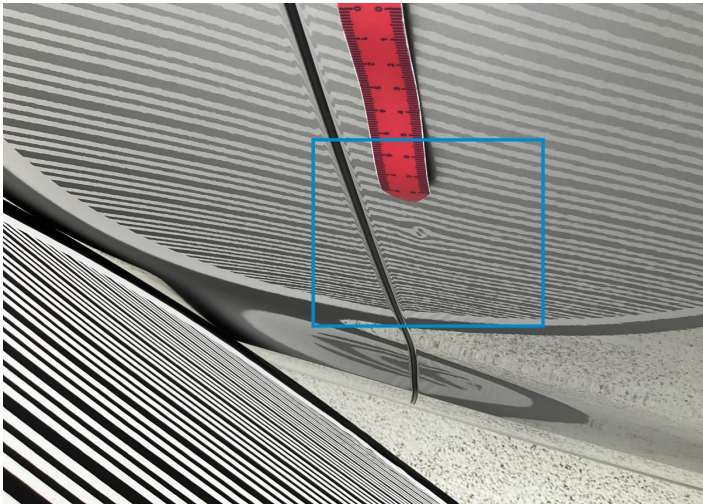
3. Door / Front Right  
Bodywork / Dent / Deformation -

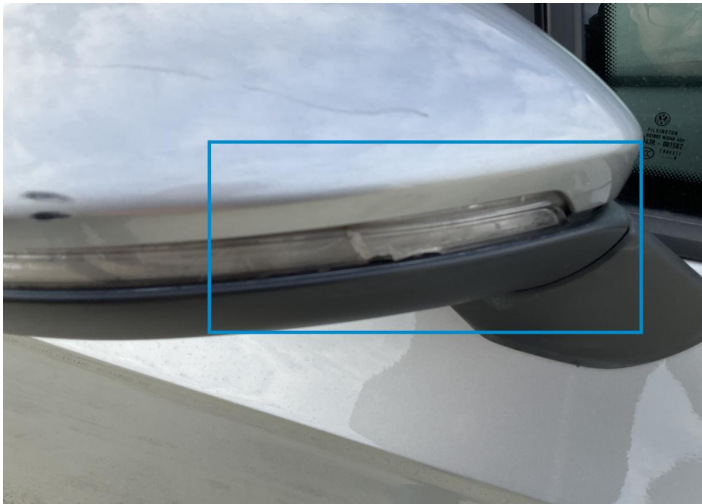
4. Mirror Repeater / Right  
Bodywork / Breakage -

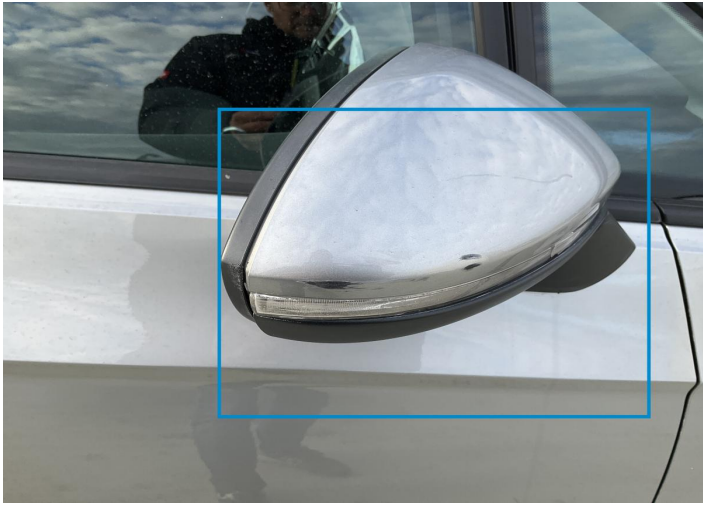
5. Mirror / Front Right  
Paint / Scratch / Scuff -

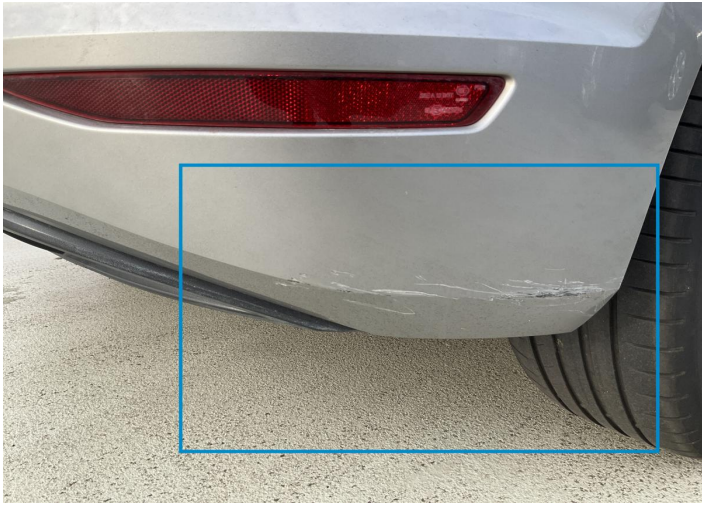
6. Bumper / Back  
Paint / Scratch / Scuff -

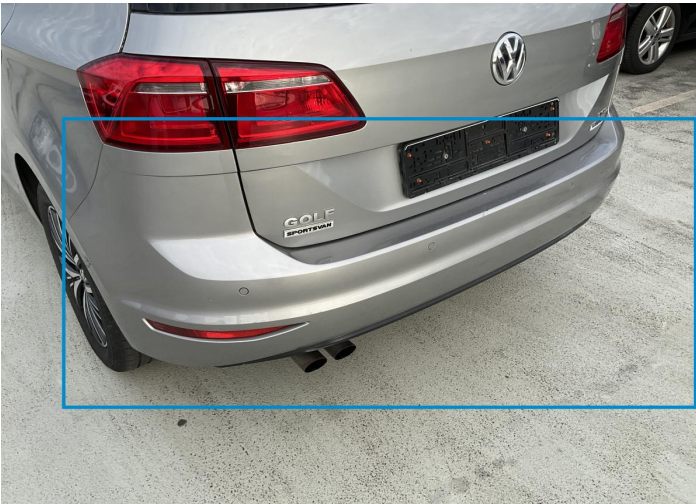
7. Bumper / Back  
Paint / Scratch / Scuff -

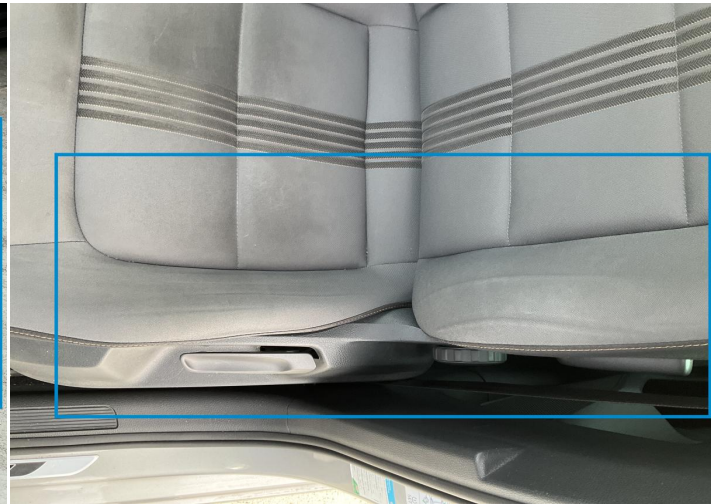
8. Seat / Front Left  
Interior / Worn - out -

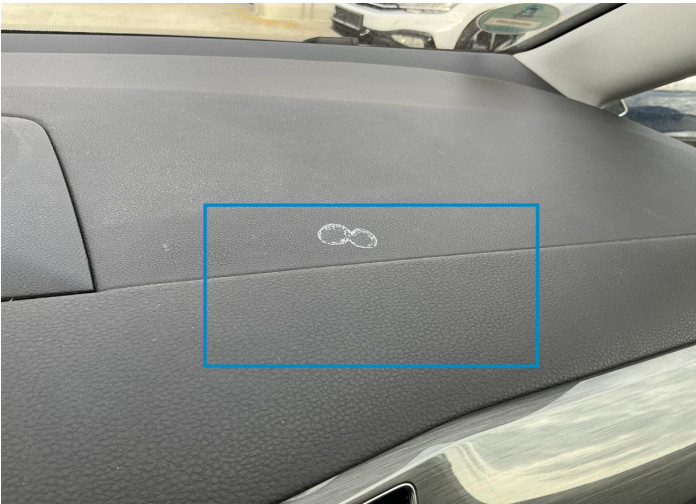
9. Dashboard / Front  
Interior / Dirty -

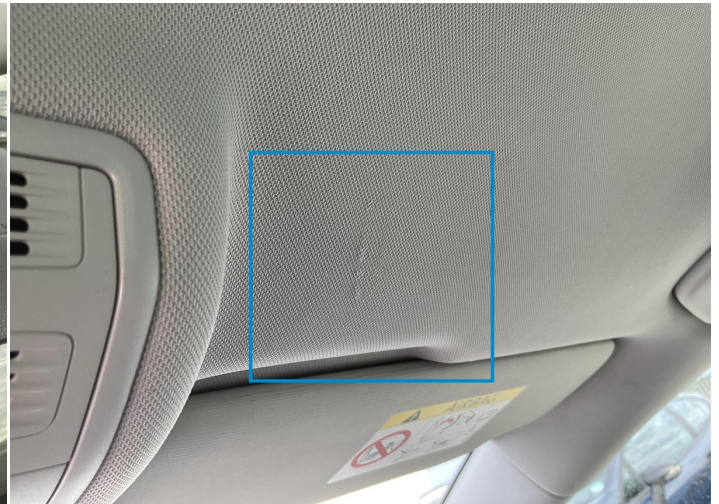
10. Roof Upholstery  
Interior / Scratched -
