## status report

| vehicle data | | | |
|---|---|---|---|
| <b>Volkswagen Golf VII Variant Highline BMT/Start-Stopp</b> | | | |
| Vehicle identification number | WVWZZZAUZJP599499 | mileage read: | 242632 km |
| First Registration / construction year: | 23.05.2018 / 2018 | Visit Date / place of birth: | 04.09.2025 Hoppegarten |

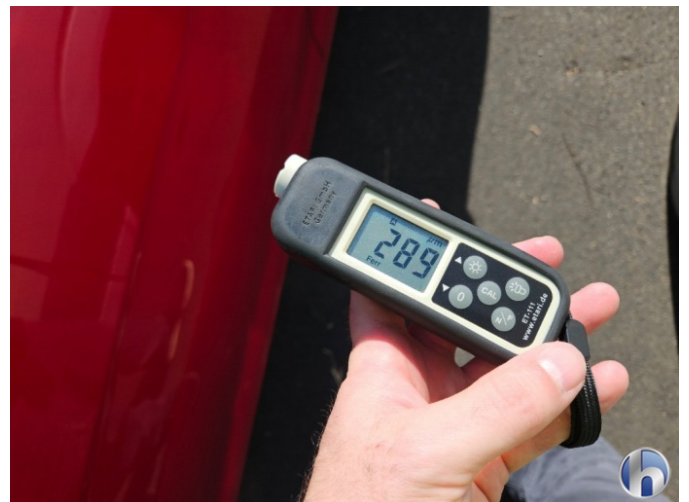
| component | Damage | Rep kind |
|---|---|---|
| 1. Front door - left | Subsequently painted | acceptable |

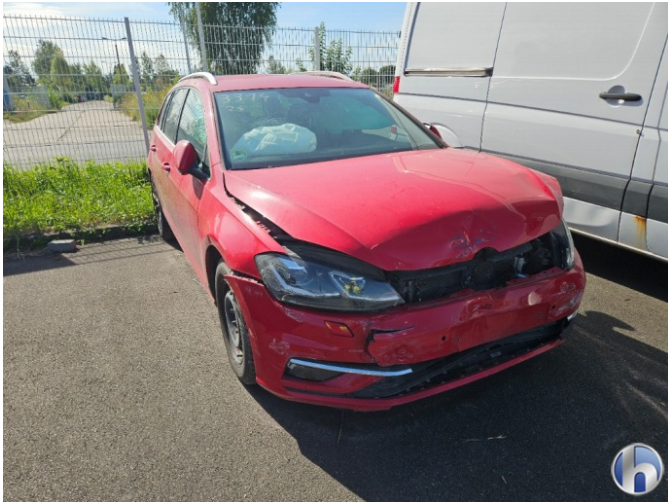
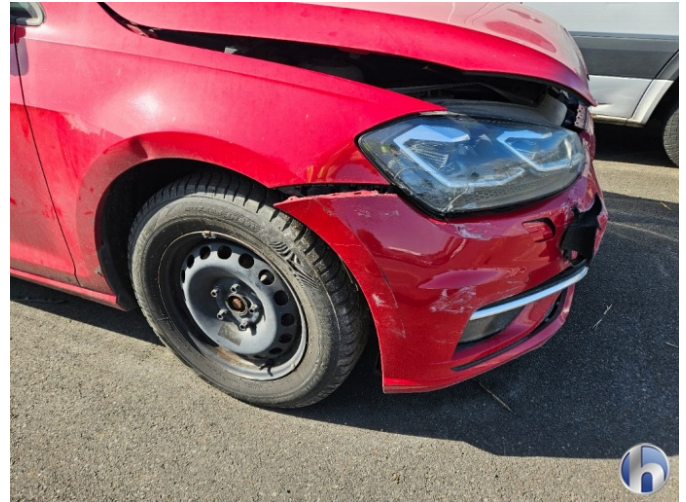
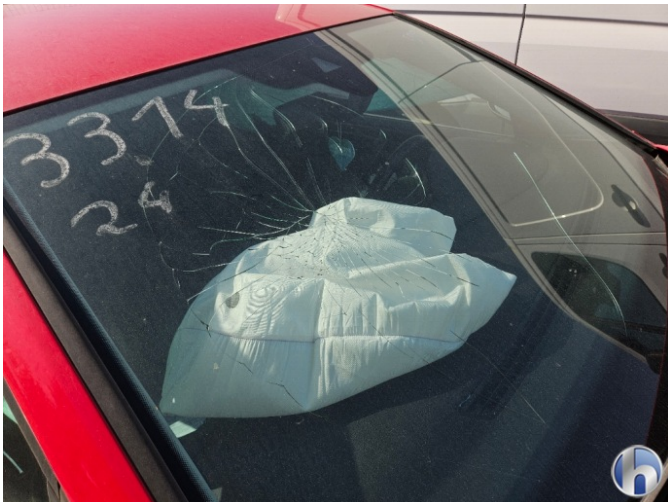
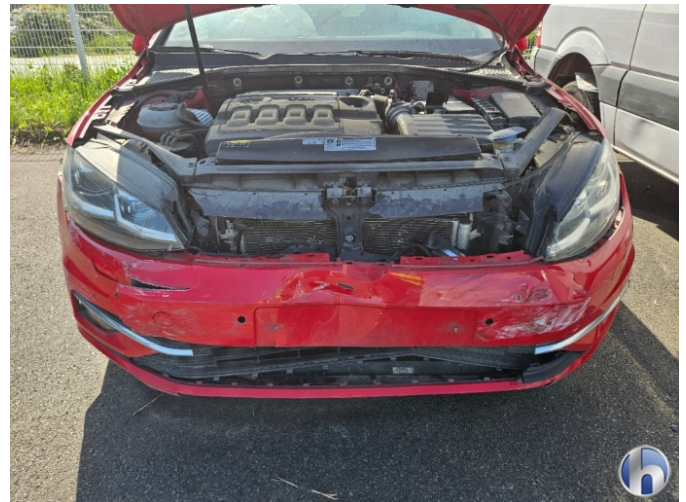
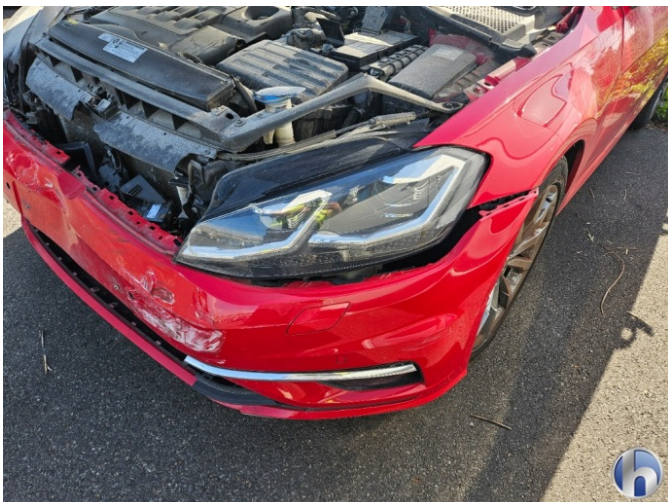
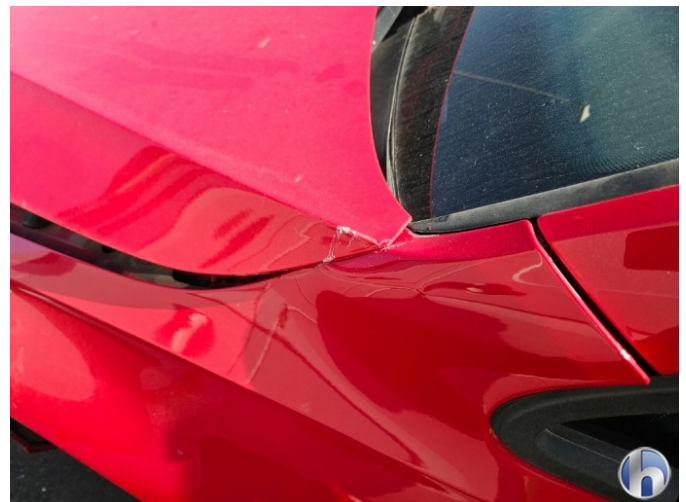
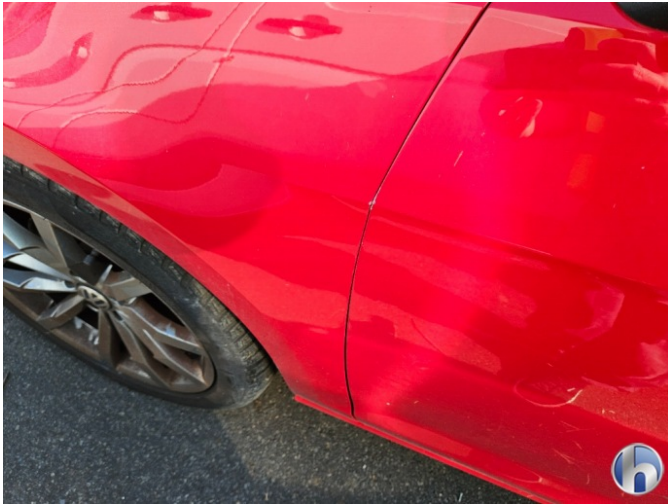
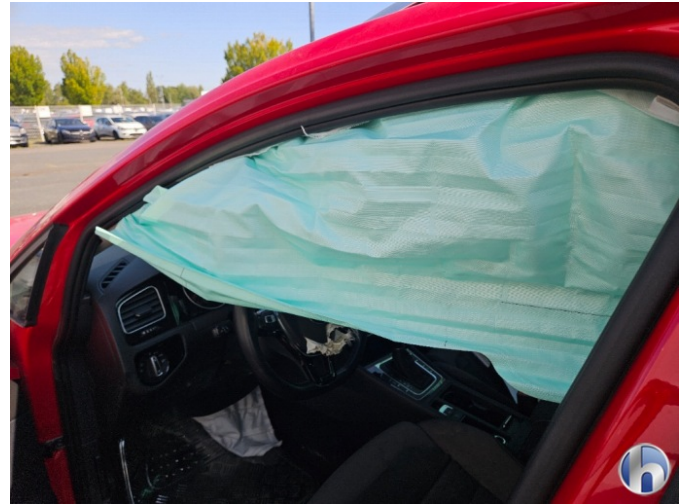
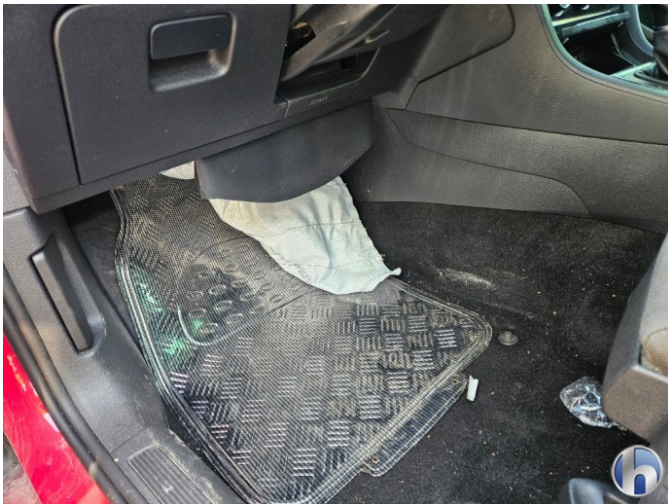
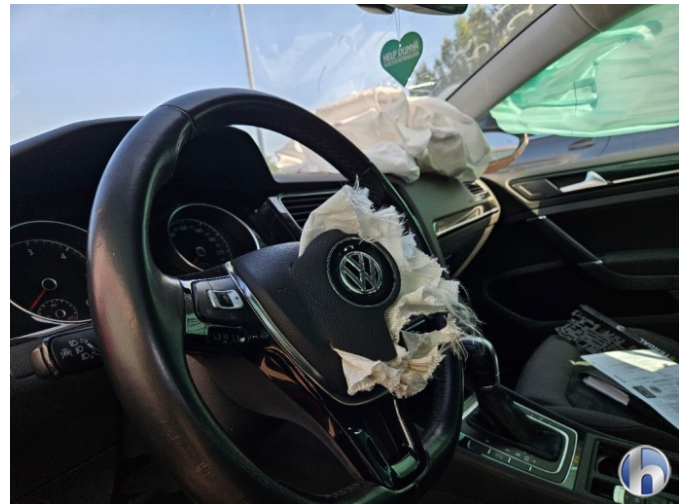
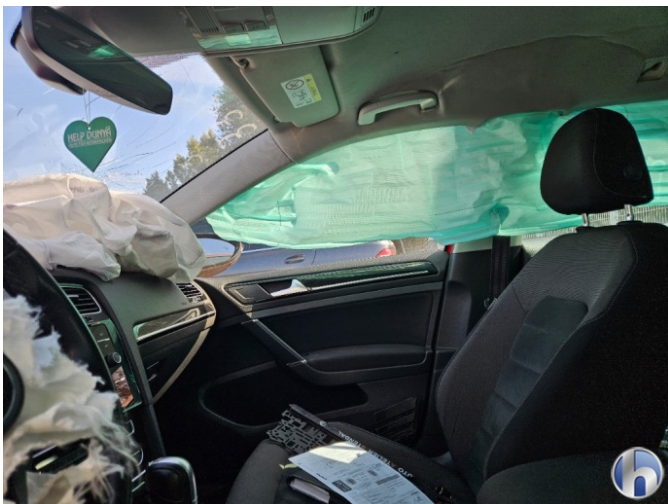
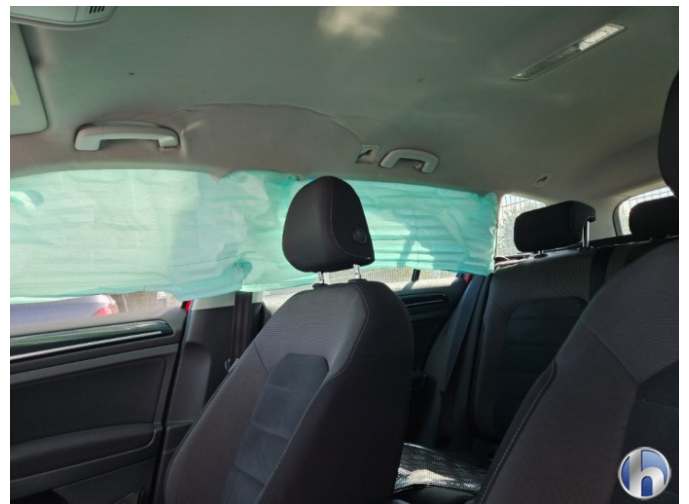
| <b>Existing collision damage:</b> | <b>found</b><br>At the unrepaired vehicle accident damage were observed on visual examination on the body skin . |
| <b>reference:</b> | Front, nicht sichtbare Schäden möglich |

| component | Damage | Rep kind |
|---|---|---|
| 4. exterior body | Accident damage | Refer to calculation |

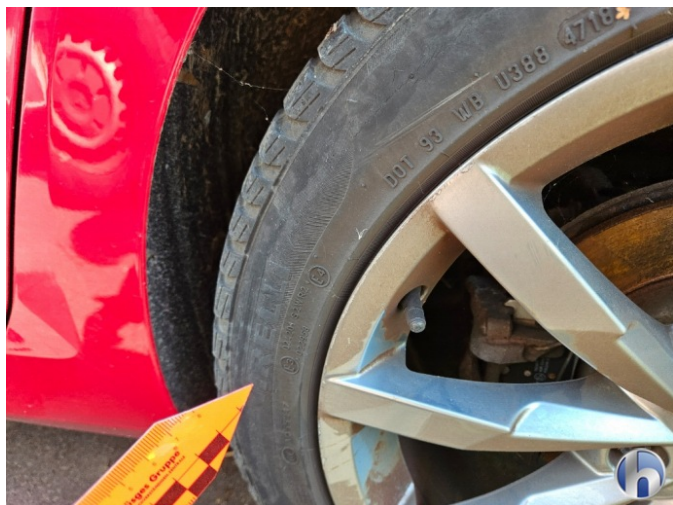
| component | Damage | Rep kind |
|---|---|---|
| 5. | Scratch(es) | Paint |

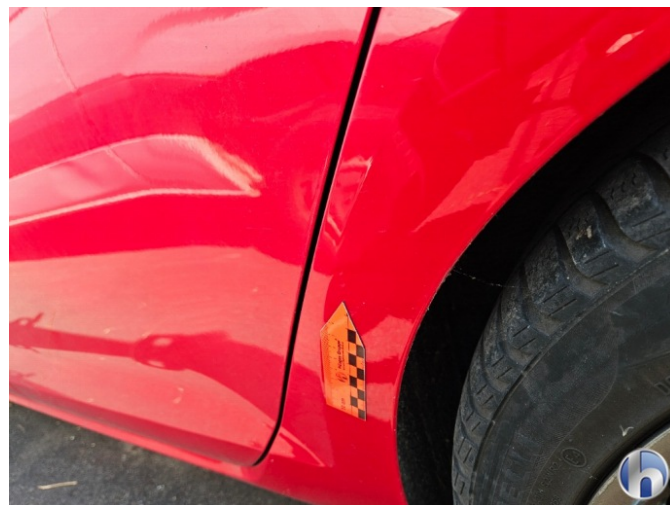
| component | Damage | Rep kind |
|---|---|---|
| 6. Sidewall - Rear - Left | Wear and tear | acceptable |

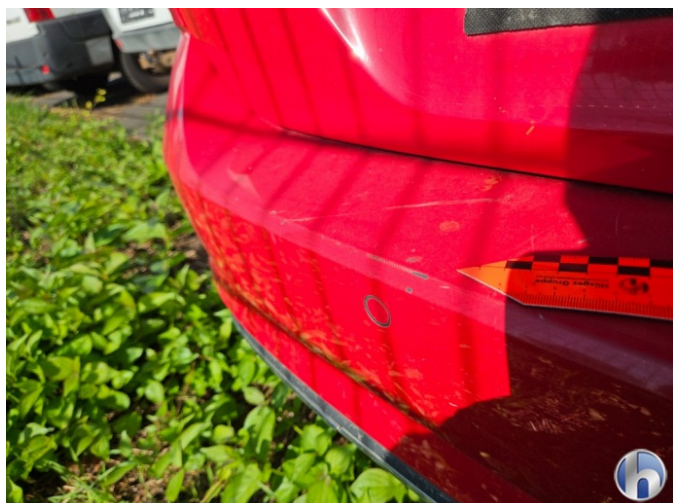
| component | Damage | Rep kind |
|---|---|---|
| 7. Rear bumper | Scratch(es) | Paint |

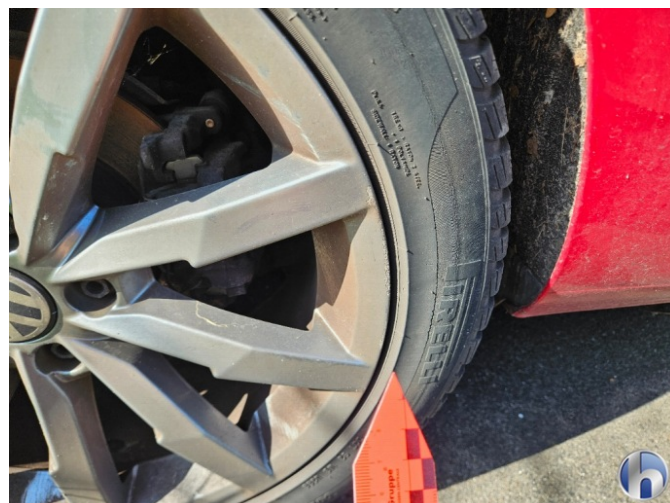
| component | Damage | Rep kind |
|---|---|---|
| 8. | Scratch(es) | Paint |

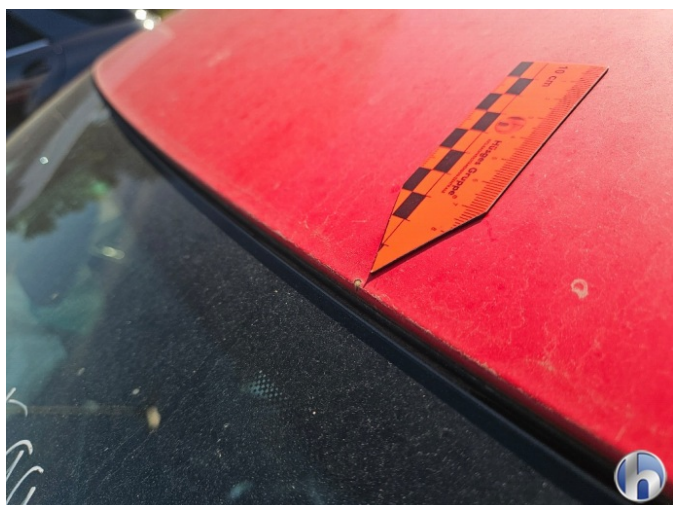
| component | Damage | Rep kind |
|---|---|---|
| 10. roof | Corroded | Paint |
