## status report

#### Volkswagen Golf VII Lim. GTI TCR Start-Stopp

| Vehicle identification number | <b>VWZZZAUZKW213637</b> | mileage read: | <b>152915 km</b> |

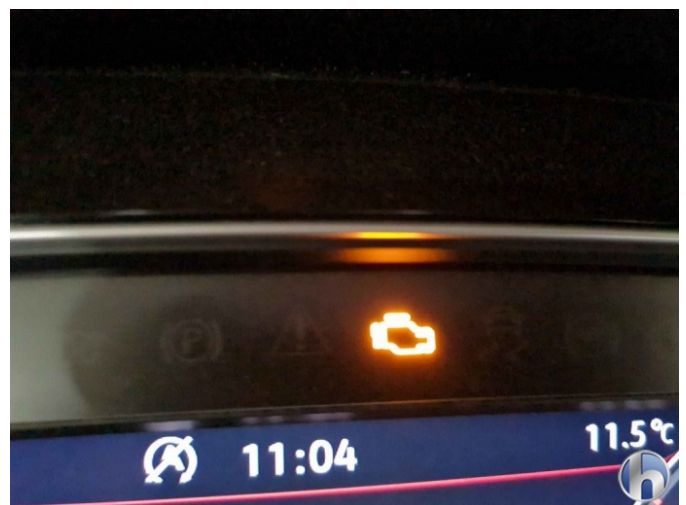
| component | Damage | Rep kind |
|---|---|---|
| 2. motor | Error message | Carry out a fault diagnosis |

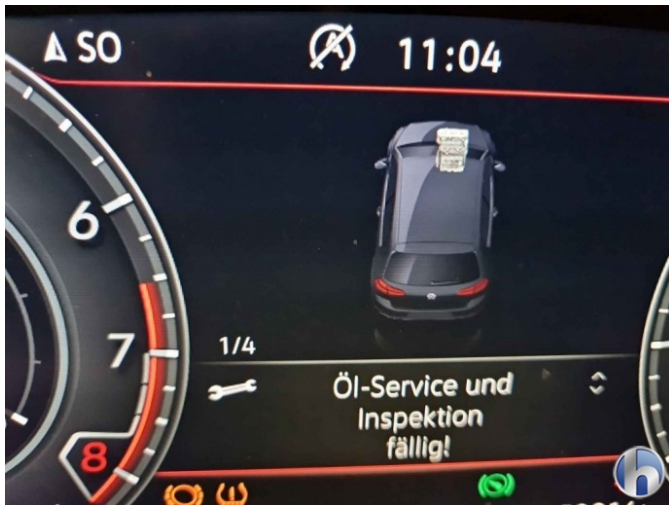
| component | Damage | Rep kind |
|---|---|---|
| 3. Wartung | Error message | Replace |

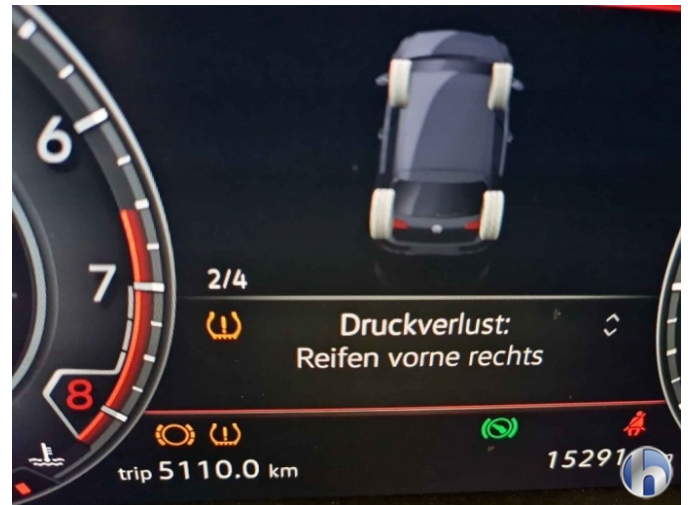
| component | Damage | Rep kind |
|---|---|---|
| 4. Reifendruckkontrolle | Error message | Carry out a fault diagnosis |

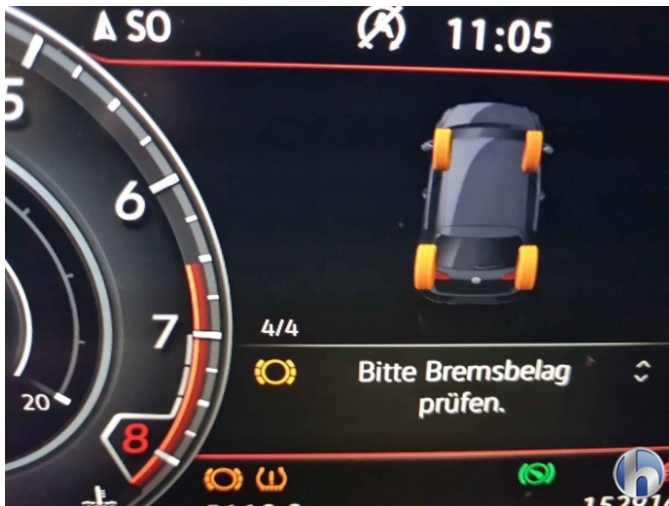
| component | Damage | Rep kind |
|---|---|---|
| 5. brake system | Error message | Carry out a fault diagnosis |

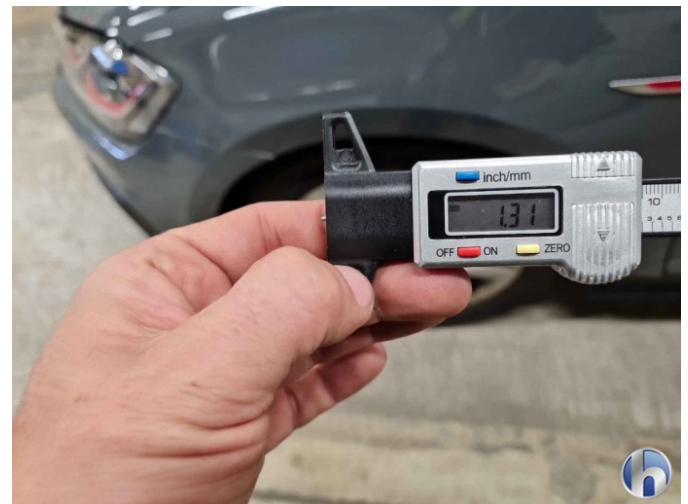
| 1st axis - Left / states . | <b>Michelin</b> | <b>205/50/R17/93H 1.3 mm</b> |

| component | Damage | Rep kind |
|---|---|---|
| 6. tire front - left | Worn | Replace |

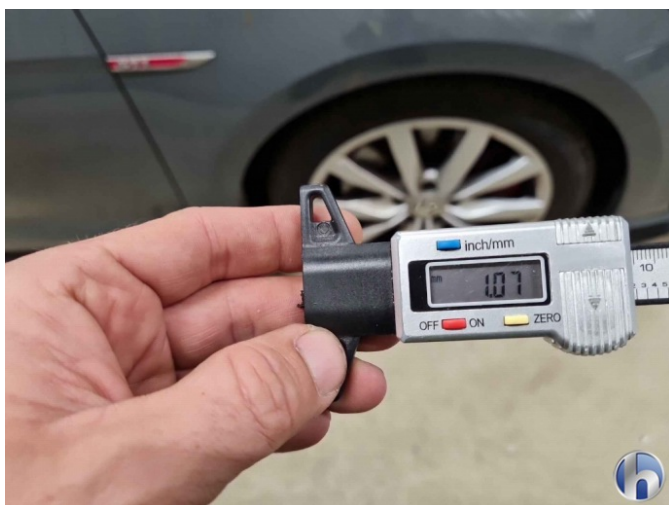
| 1st axis - right / states . | <b>Michelin</b> | <b>205/50/R17/93H 1 mm</b> |

| component | Damage | Rep kind |
|---|---|---|
| 7. tire front - right | Worn | Replace |

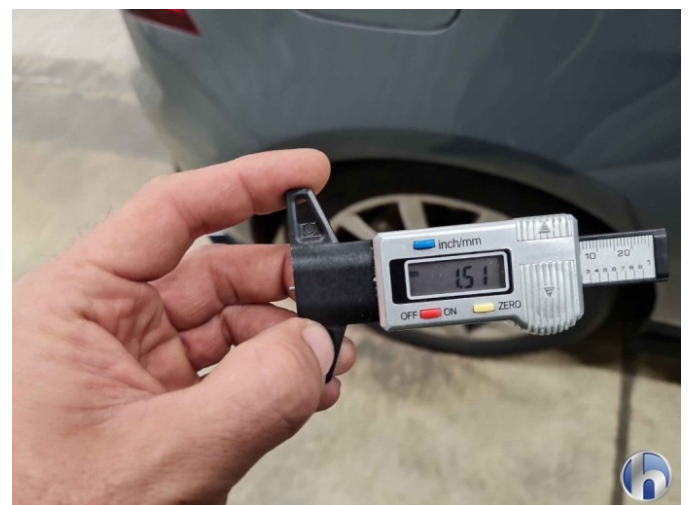
| 2nd axis - right / states . | <b>Michelin</b> | <b>205/50/R17/93H 1.5 mm</b> |

| component | Damage | Rep kind |
|---|---|---|
| 8. tire rear - right | Worn | Replace |

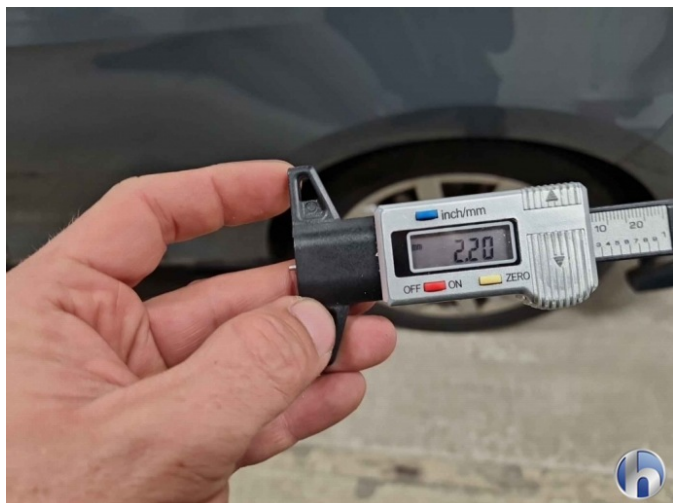
| 2nd axis - Left / states . | <b>Michelin</b> | <b>205/50/R17/93H 2 mm</b> |

| component | Damage | Rep kind |
|---|---|---|
| 9. tire rear - left | Worn | Replace |

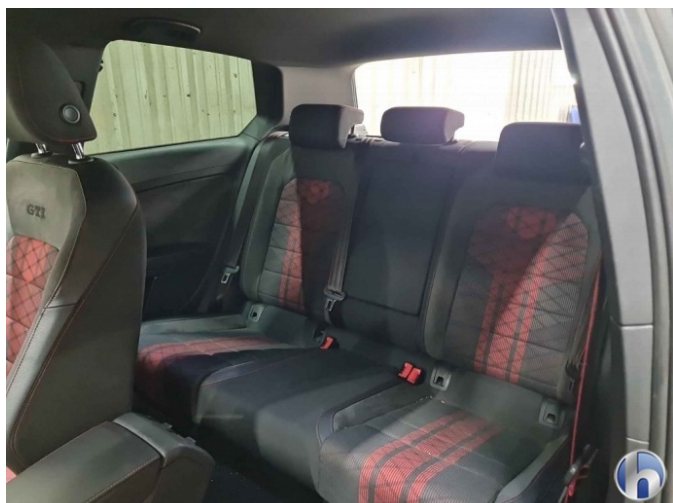
| component | Damage | Rep kind |
|---|---|---|
| 10. Kofferraum und Innenraum | Wear and tear | acceptable |

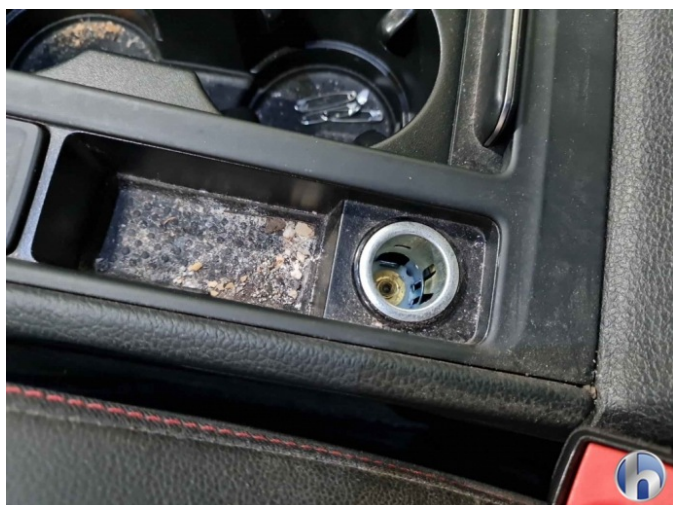
11. Zigarettenanzünder vorn: Verschlusskappe

| component | Damage | Rep kind |
|---|---|---|
| 11. Zigarettenanzünder vorn:<br>Verschlusskappe | Missing | Replace |

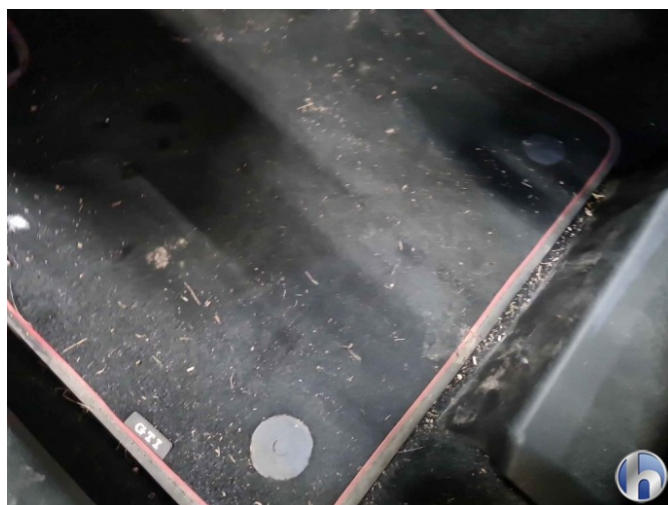
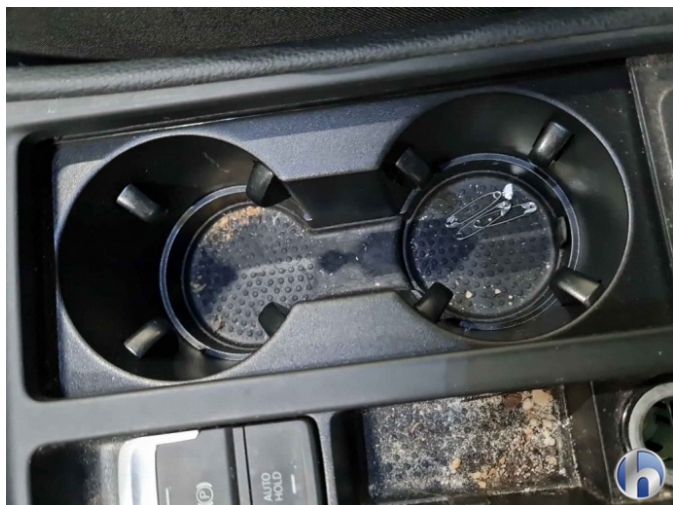
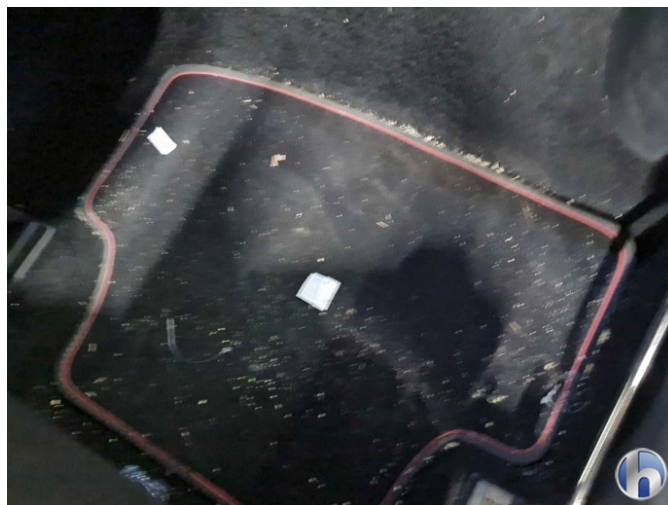
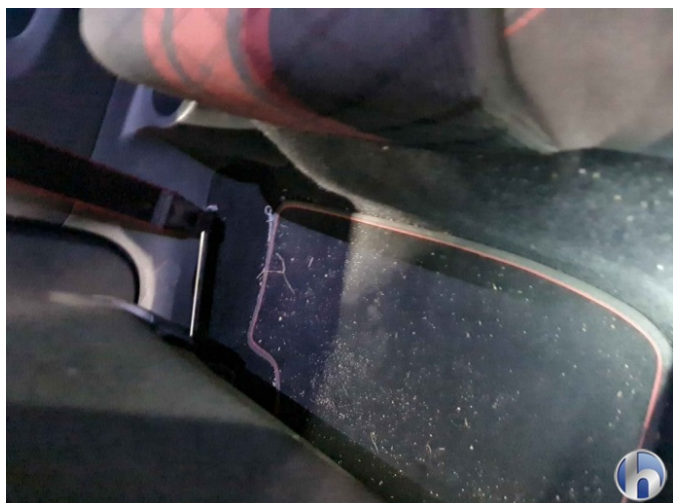
| component | Damage | Rep kind |
|---|---|---|
| 12. | Dirty | |

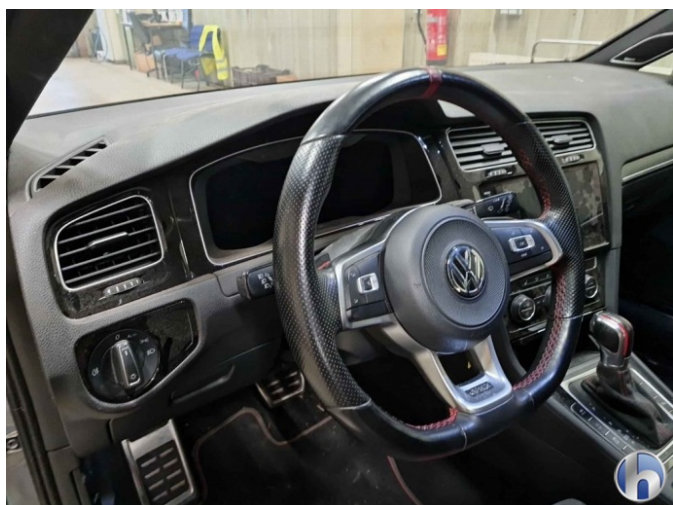
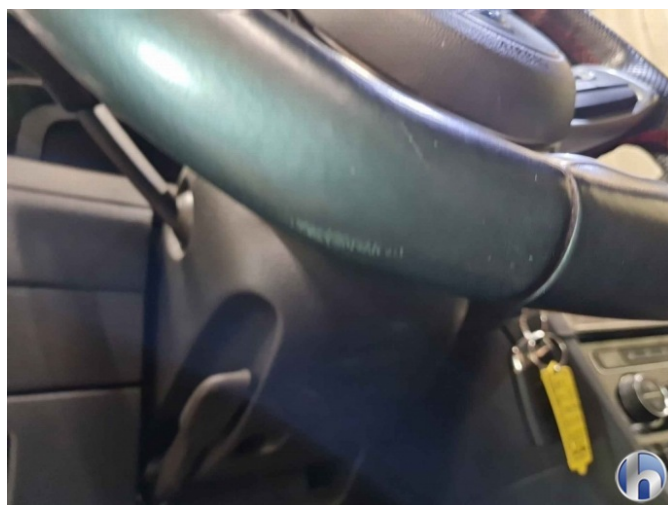
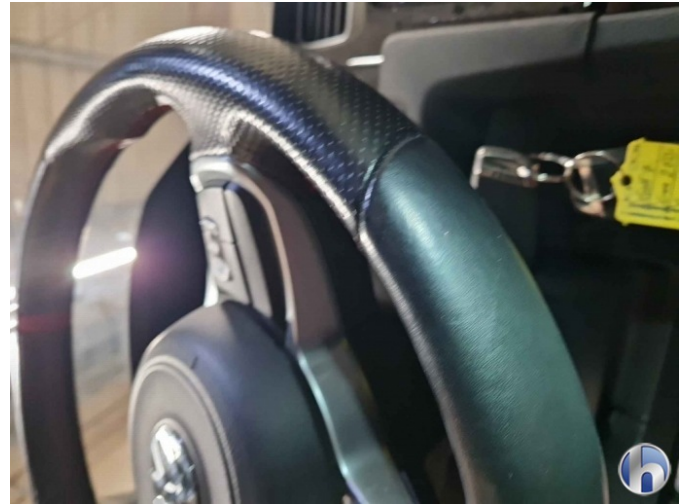
| component | Damage | Rep kind |
|---|---|---|
| 13. steering wheel | Scrape | Replace |

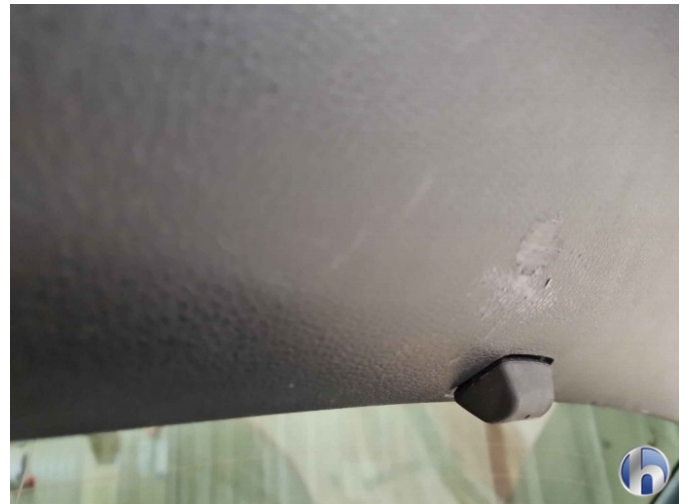
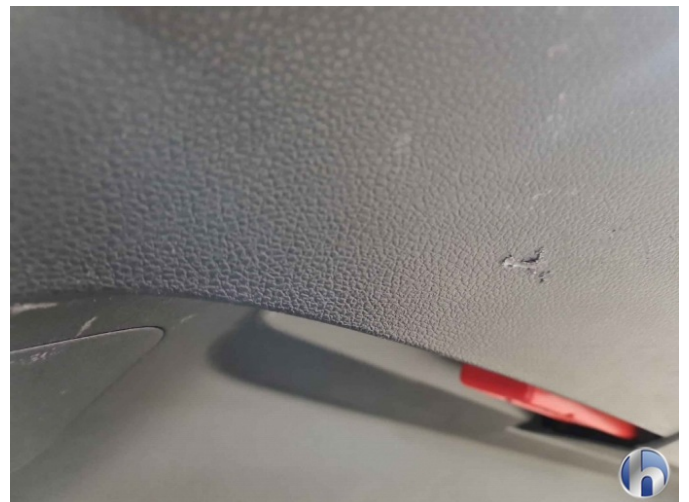
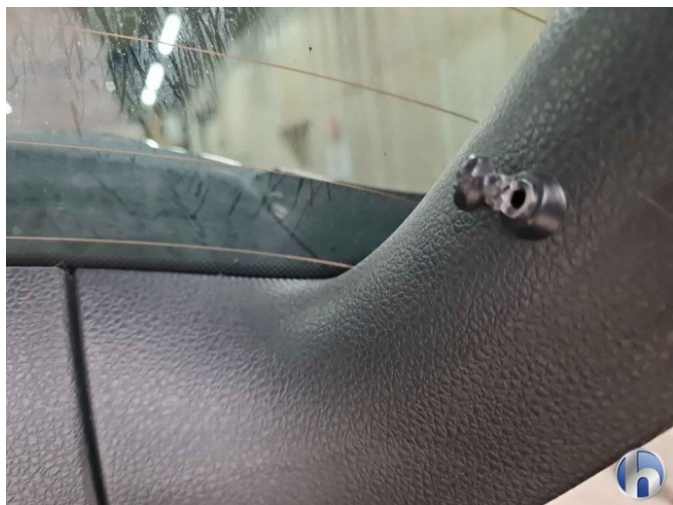
| component | Damage | Rep kind |
|---|---|---|
| 14. tailgate trim | Damaged | Replace |

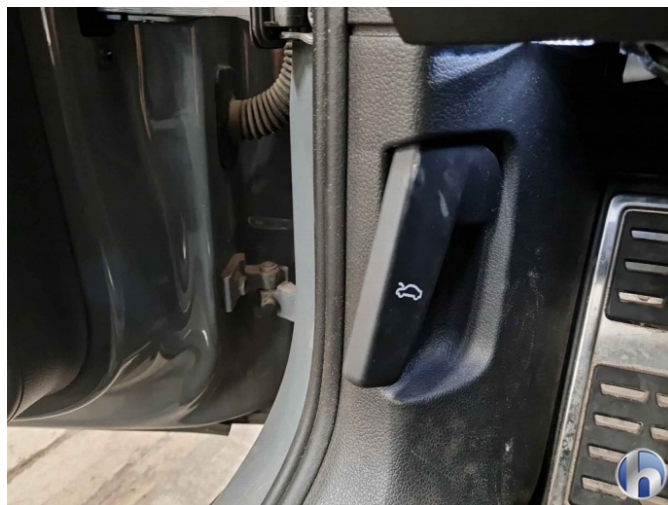
| component | Damage | Rep kind |
|---|---|---|
| 15. Motorhaubenentriegelung | Not okay | Replace |

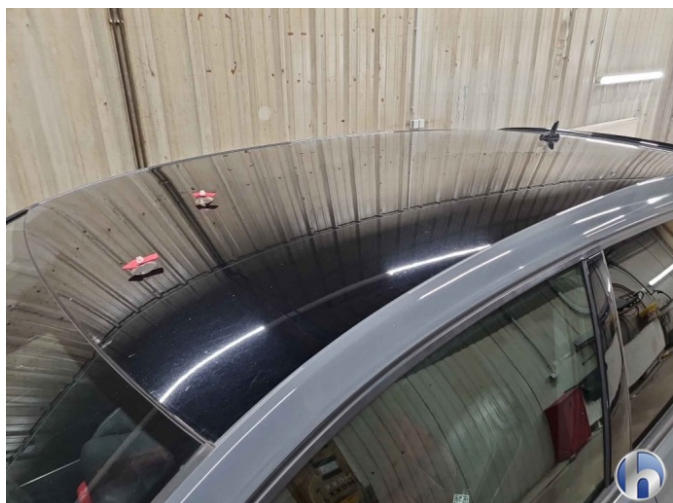
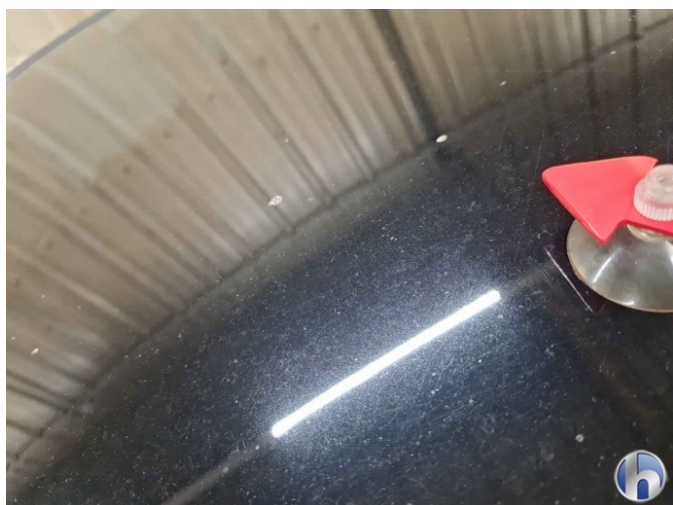
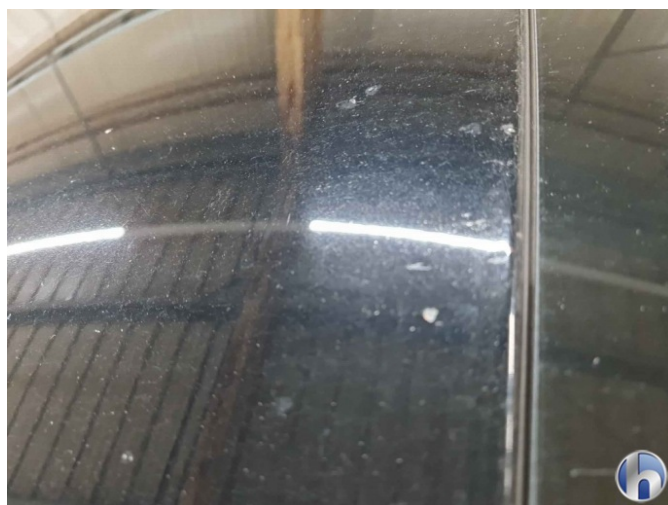
| component | Damage | Rep kind |
|---|---|---|
| 17. roof | chipped paint | Paint |

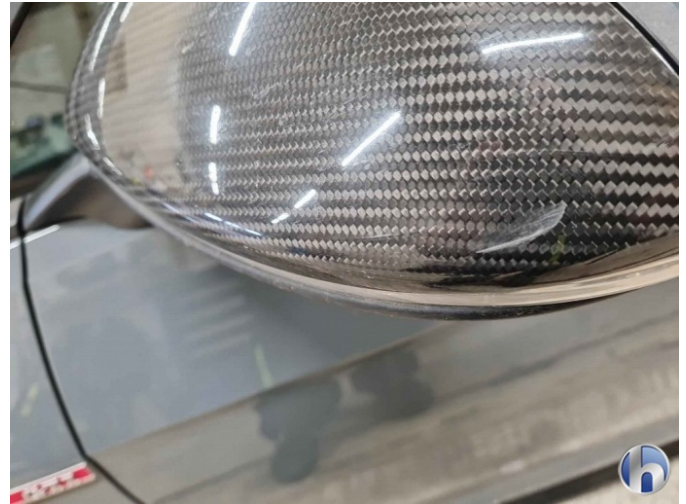
| component | Damage | Rep kind |
|---|---|---|
| 18. | Scrape | Replace |

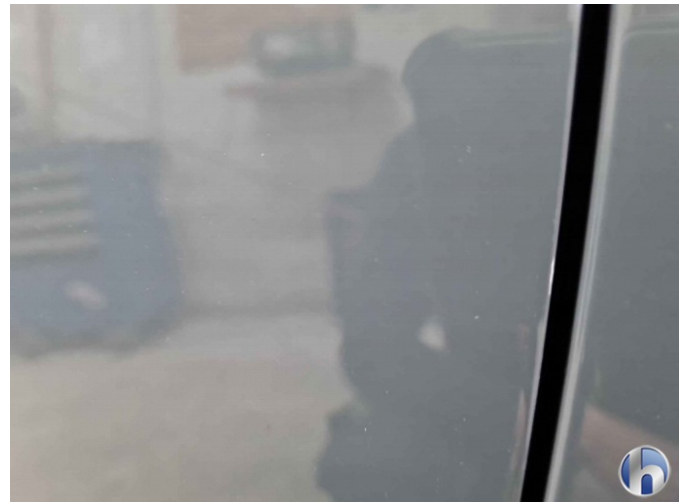
| component | Damage | Rep kind |
|---|---|---|
| 19. Front door - left | Wear and tear | acceptable |

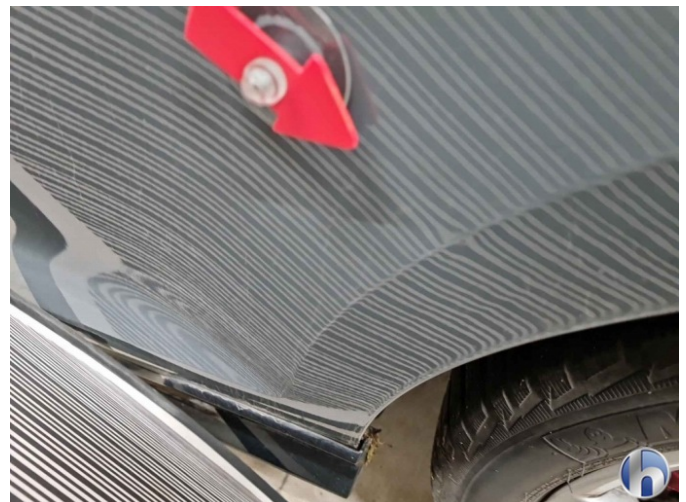
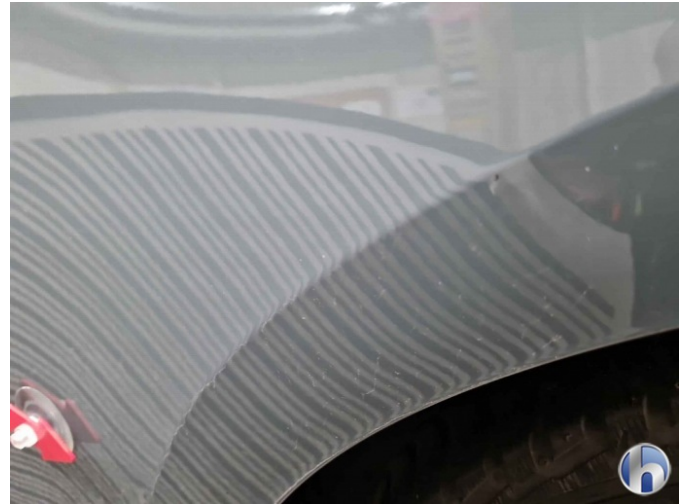
| component | Damage | Rep kind |
|---|---|---|
| 20. Sidewall - Rear - Left | Damaged | Refurbish and paint |

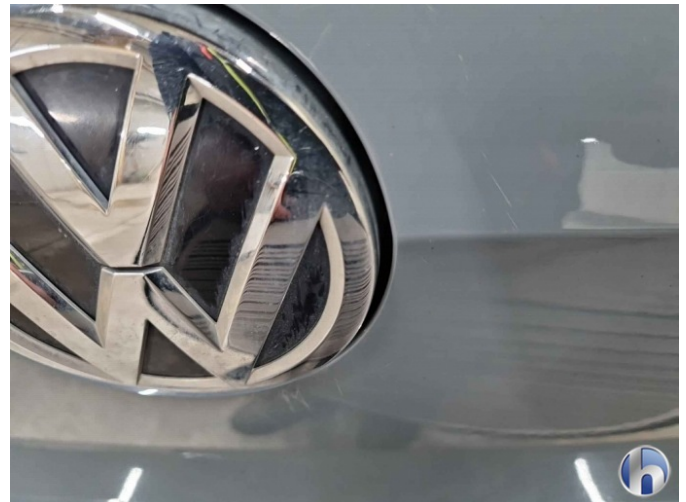
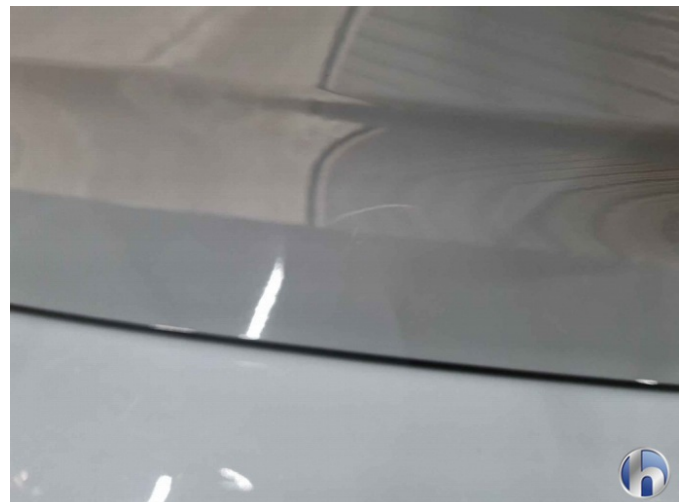
| component | Damage | Rep kind |
|---|---|---|
| 21. tailgate | Scratch(es) | Paint |

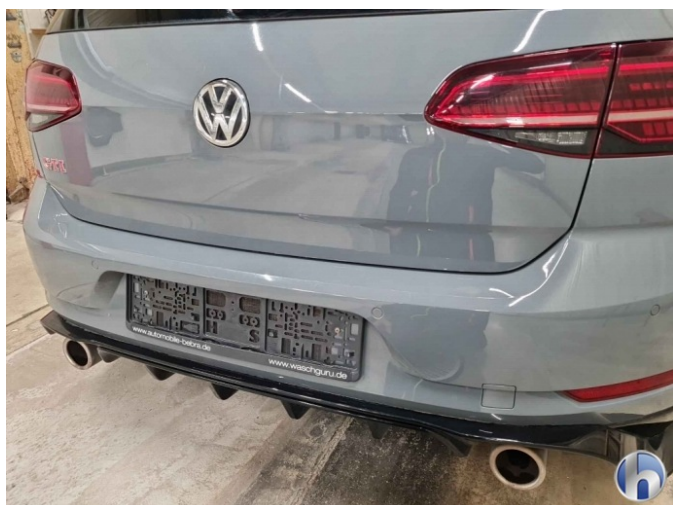
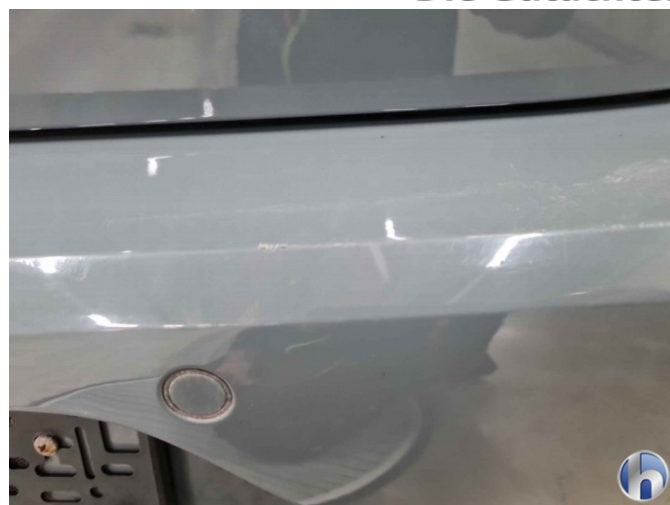
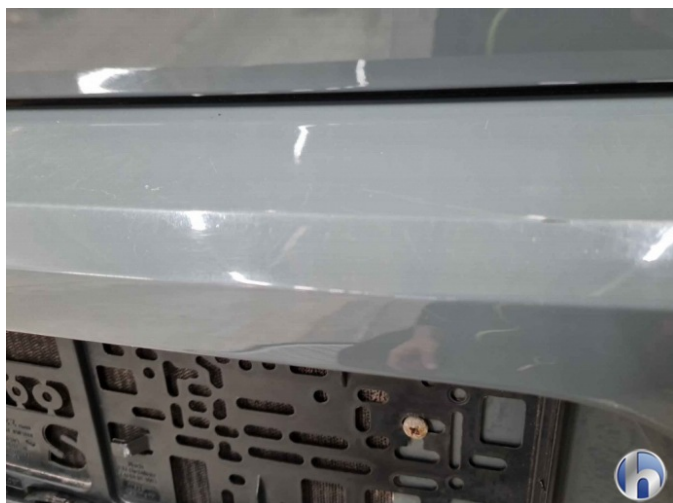
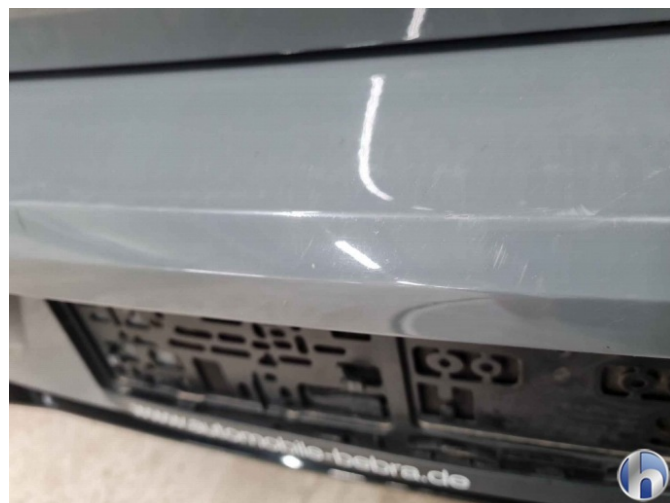
| component | Damage | Rep kind |
|---|---|---|
| 22. Rear bumper | Scrape | Paint |

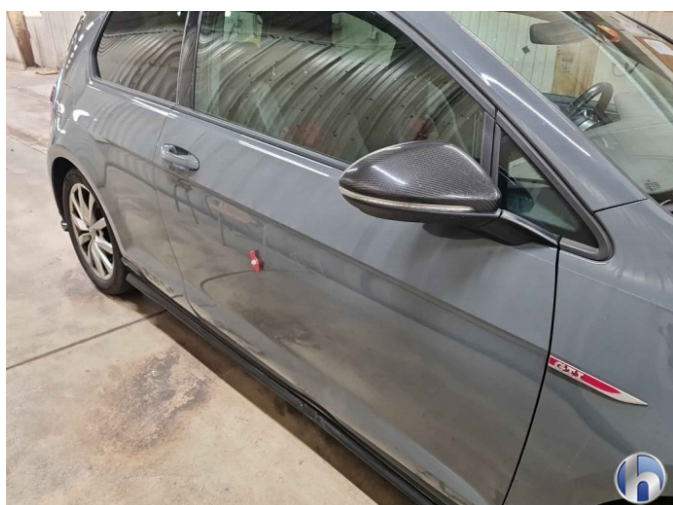
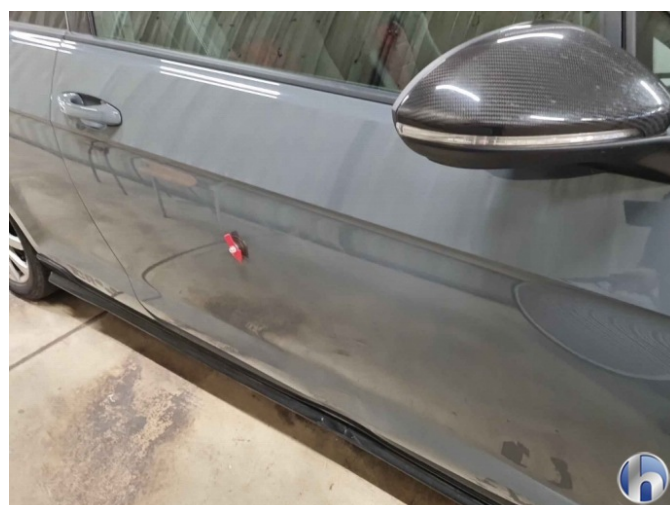
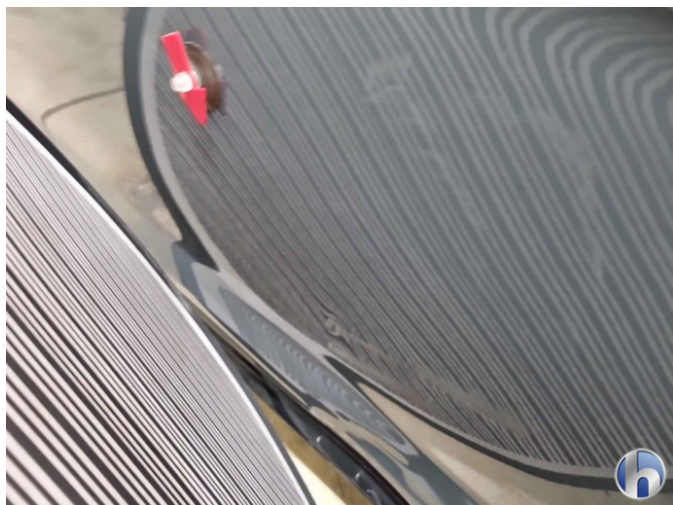
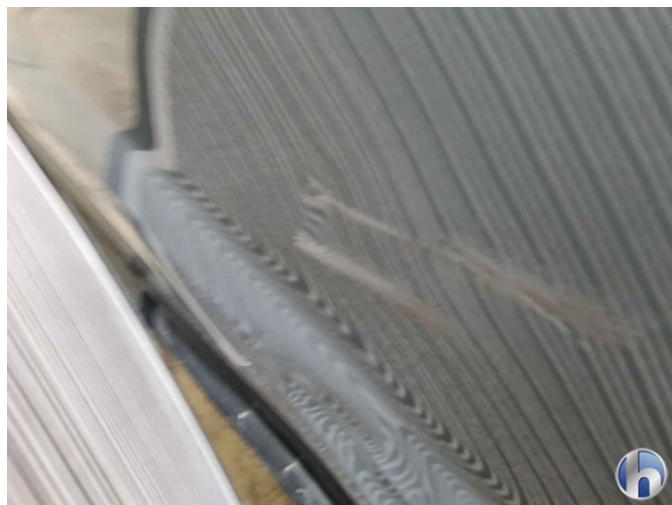
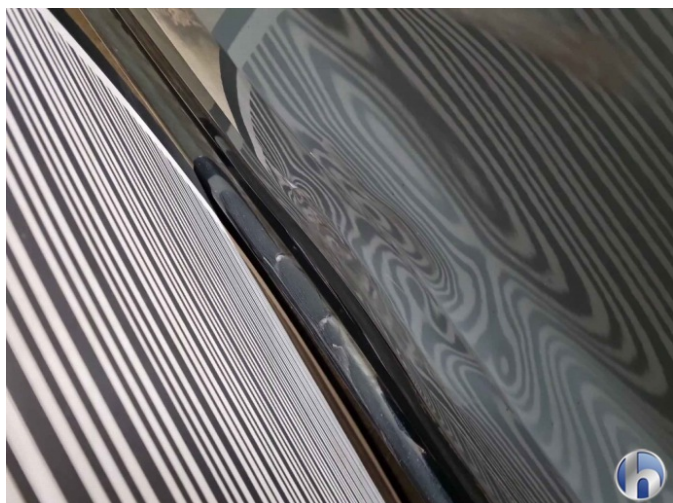
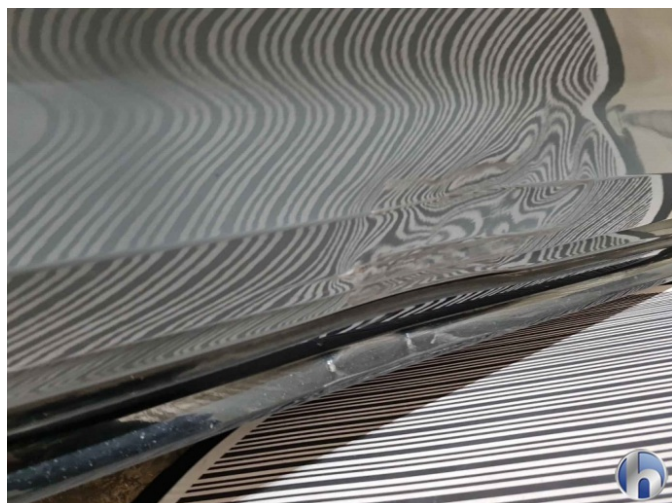
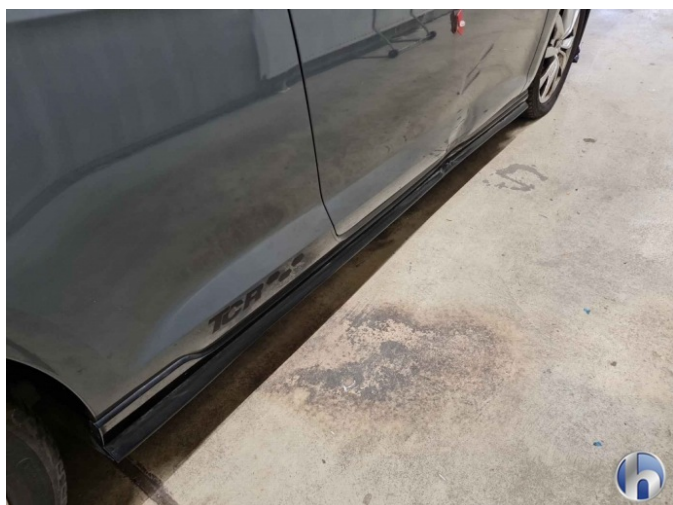
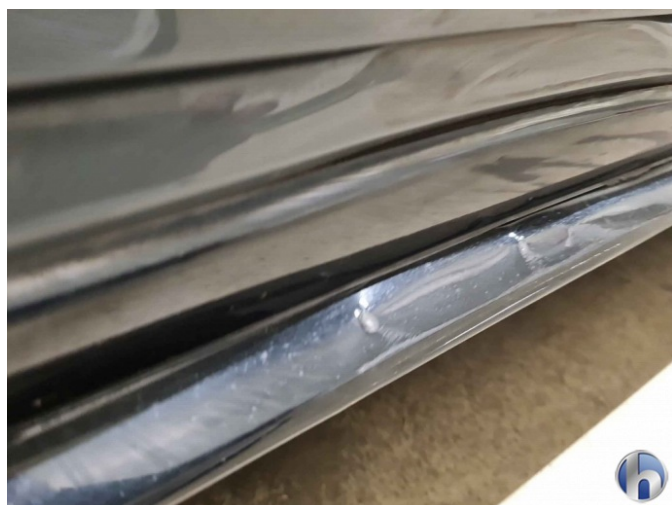
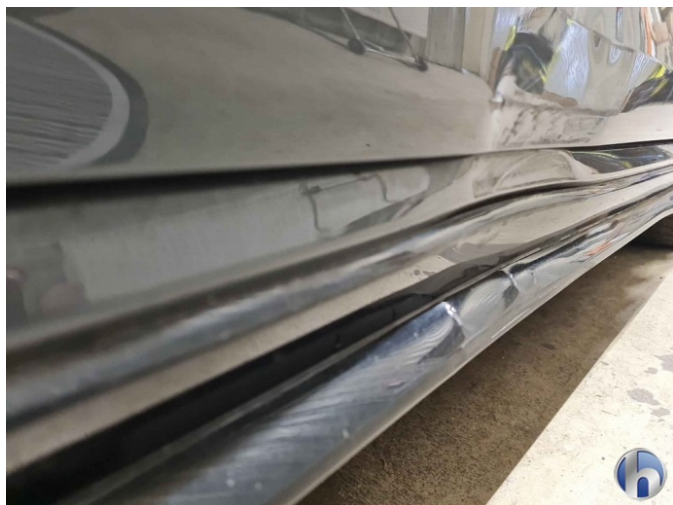
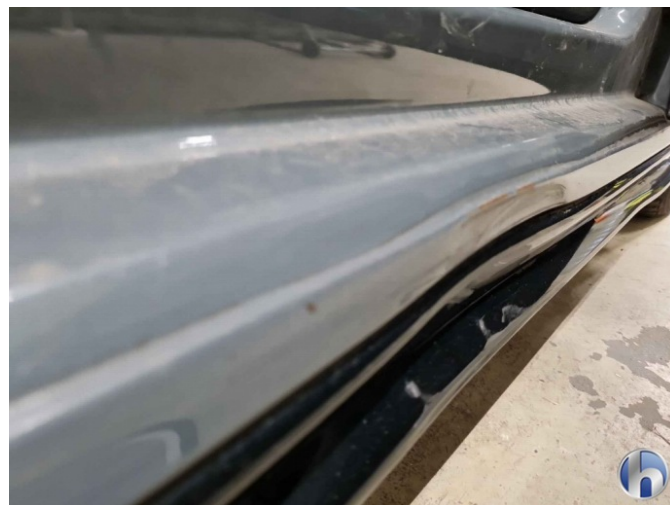
| <b>Existing collision damage:</b> | <b>found</b><br>At the unrepaired vehicle accident damage were observed on visual examination on the body skin . |
| <b>reference:</b> | Fahrzeug mit bestehenden Unfallschaden, zur Schadensermittlung wurden keine Demontearbeiten durchgeführt, verborgen gebliebene Schäden können nicht ausgeschlossen werden. Unfallschaden Kosten wurden überschlägig Kalkuliert, Kostenerweiterung möglich. |

| component | Damage | Rep kind |
|---|---|---|
| 23. Fahrzeug rechts | Accident damage | Replace |

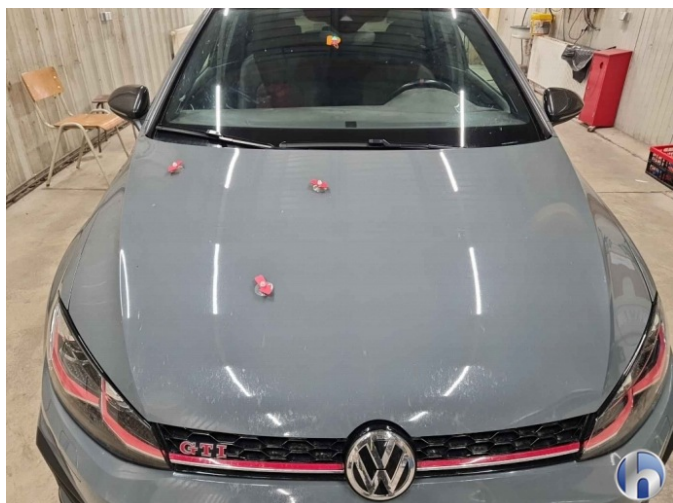
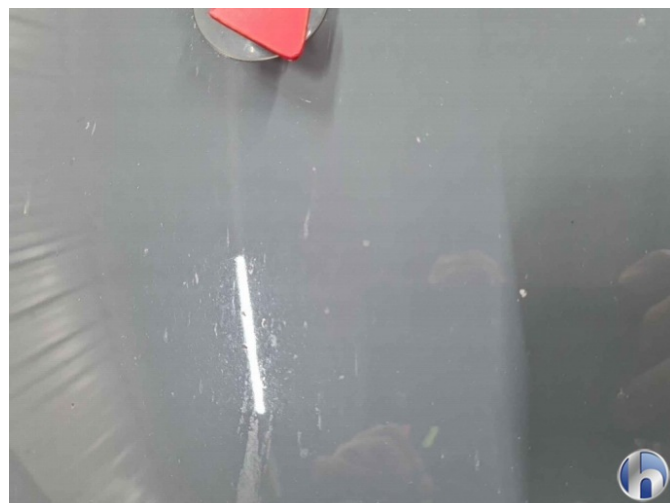
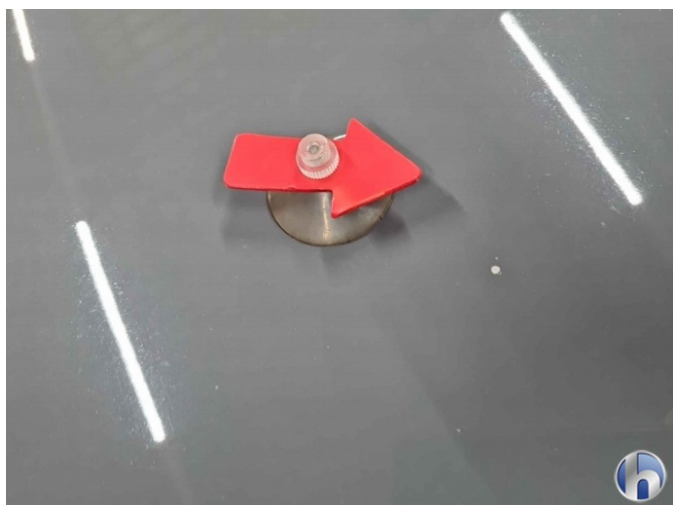
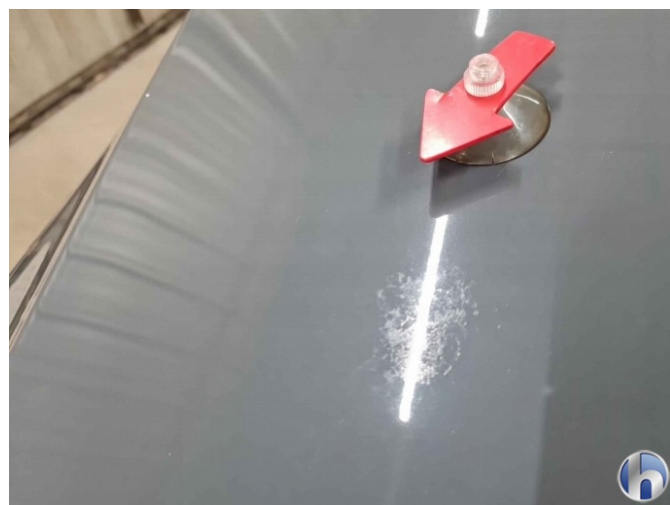
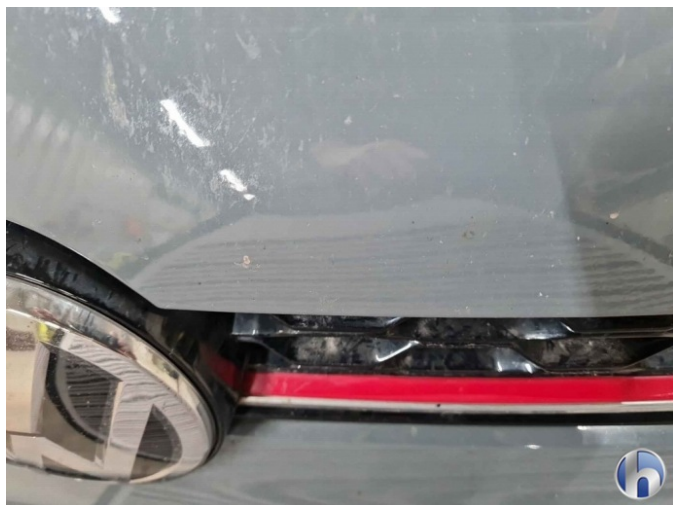
| component | Damage | Rep kind |
|---|---|---|
| 24. hood | chipped paint | Paint |

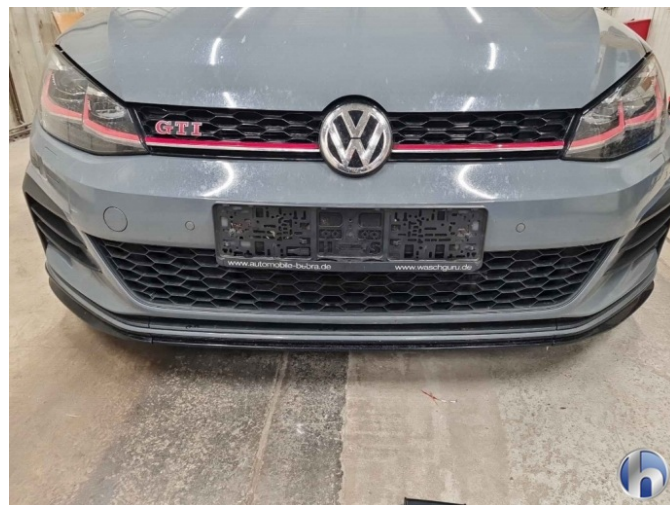
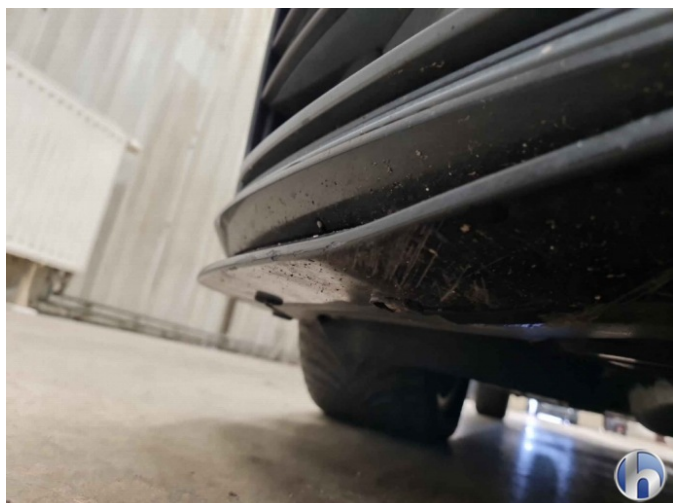
| component | Damage | Rep kind |
|---|---|---|
| 25. spoiler | Scrape | Replace |

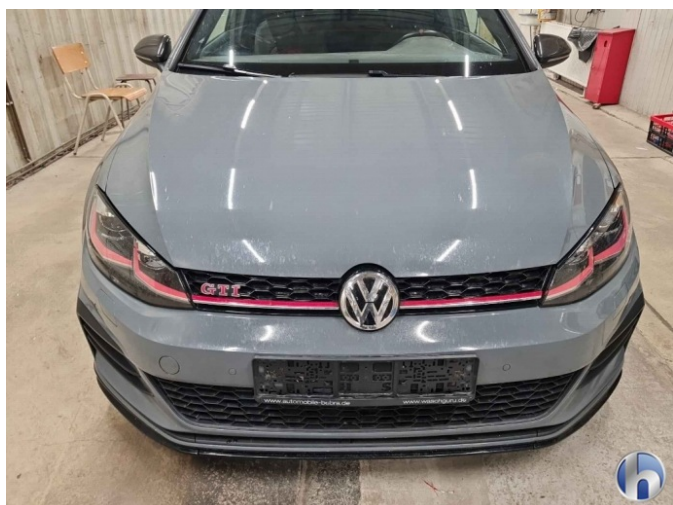
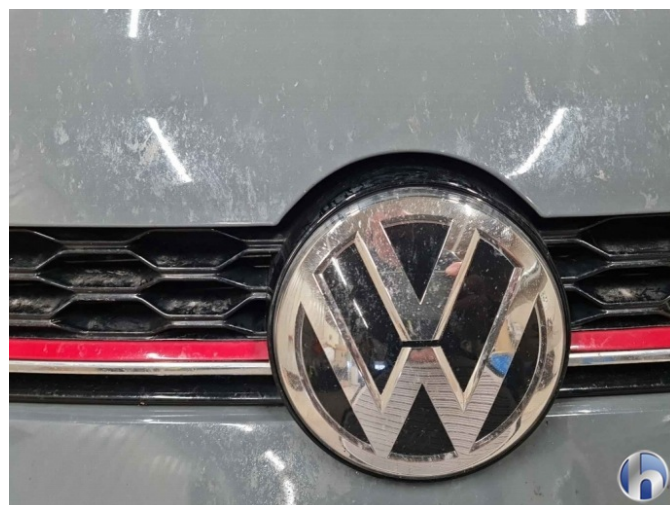
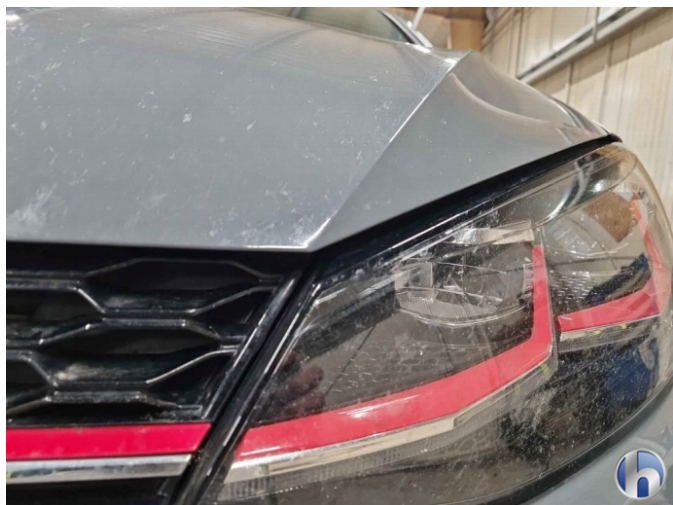
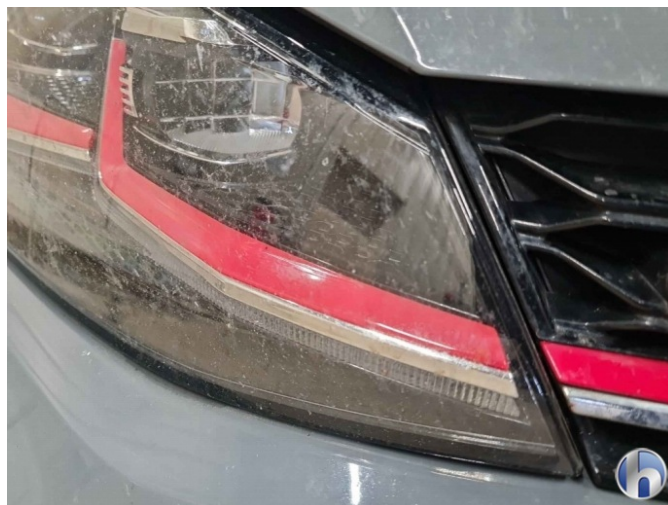
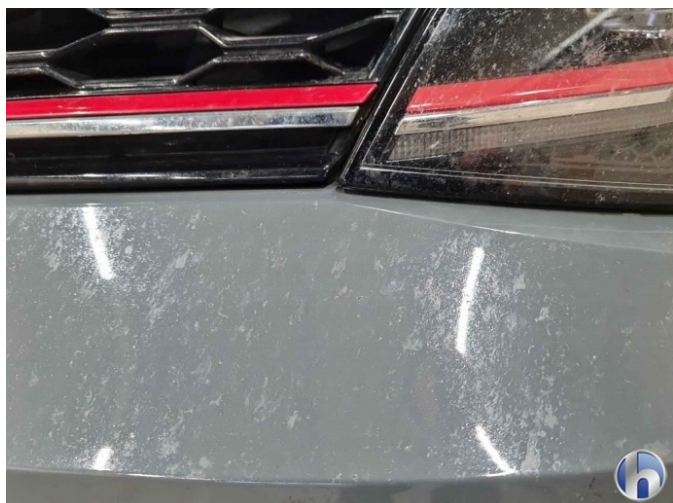
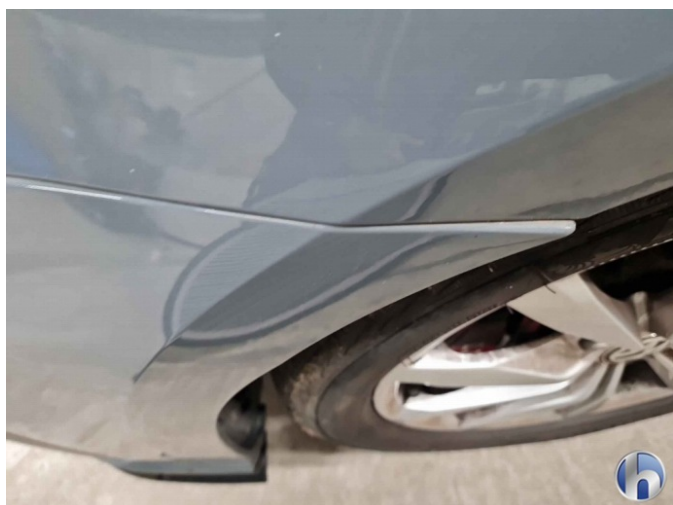
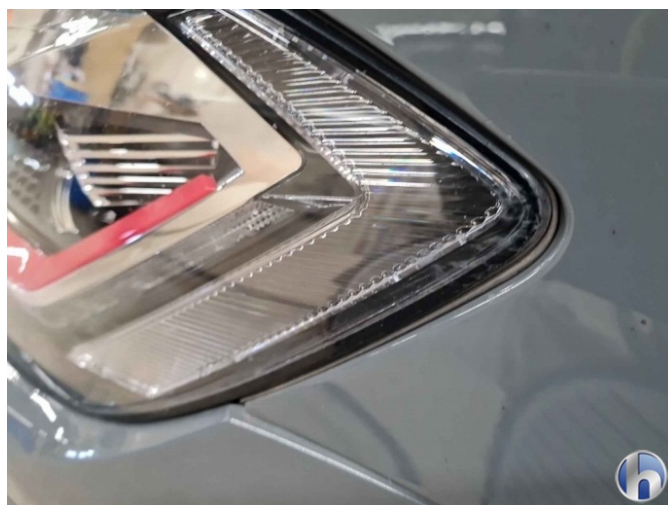
| component | Damage | Rep kind |
|---|---|---|
| 26. Fahrzeug vorn | Clearance not exact | Uninstall/install |

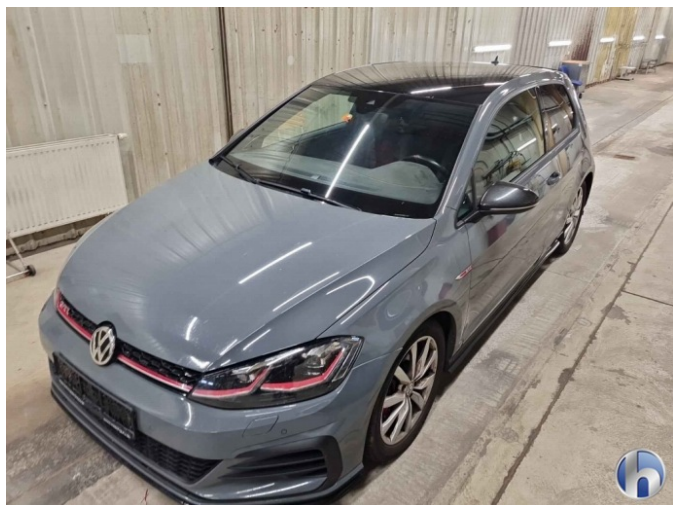
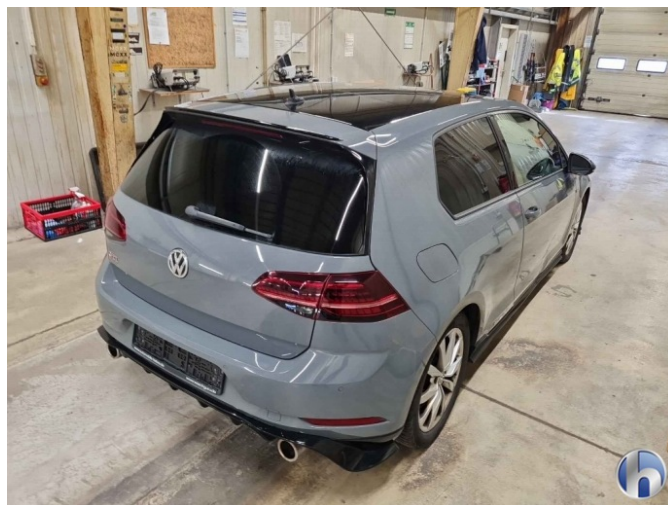
28. Fahrzeug (Kratzer, Harz-/Säureeinwirkung)

| component | Damage | Rep kind |
|---|---|---|
| 28. Fahrzeug (Kratzer,<br>Harz-/Säureeinwirkung) | Not looked after | |
