## status report

#### Volkswagen Golf VII Lim. GTI Performance BMT/Start-Stopp

| Vehicle identification number | <b>WVWZZZAUZLW024379</b> | mileage read: | <b>47395 km</b> |

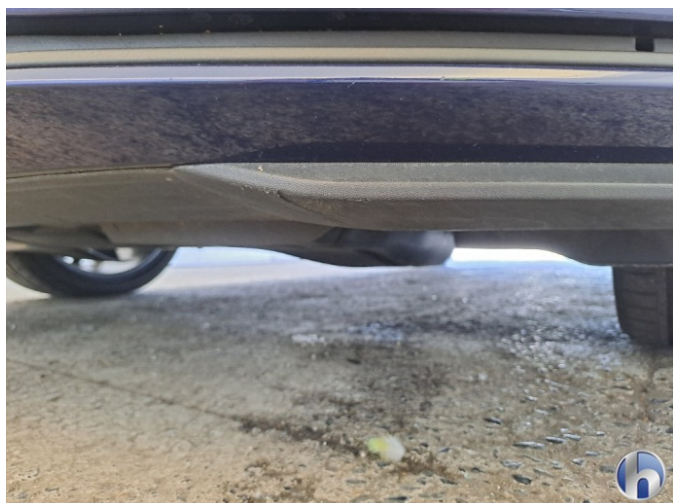
| component | Damage | Rep kind |
|---|---|---|
| 4. spoiler | Scrape | Replace |

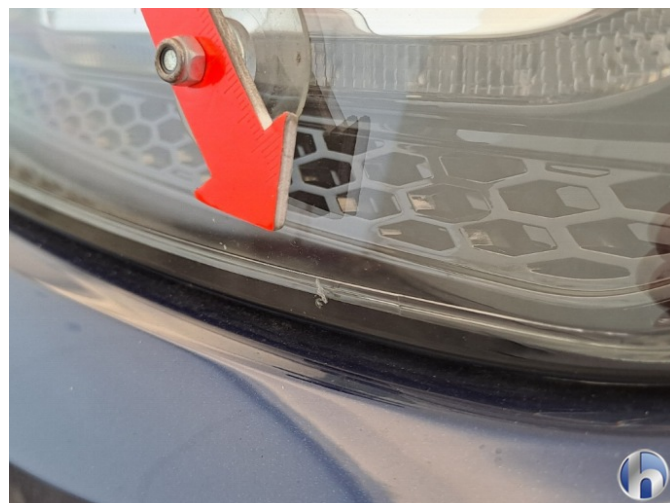
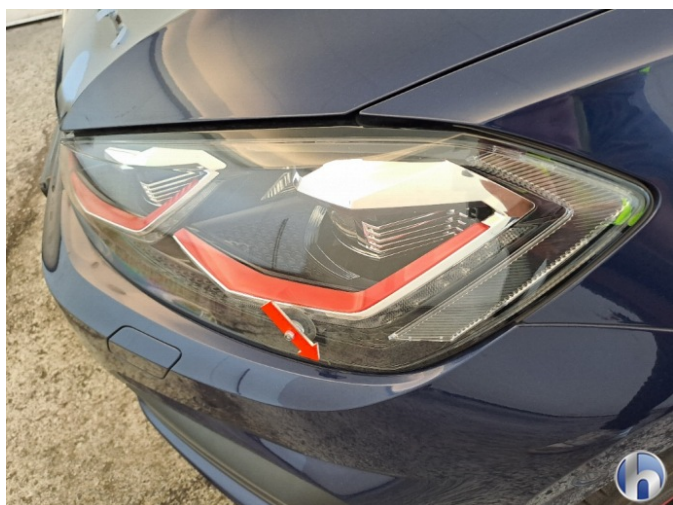
| component | Damage | Rep kind |
|---|---|---|
| 5. Halogen headlights - left | Chipping from stones | Replace |

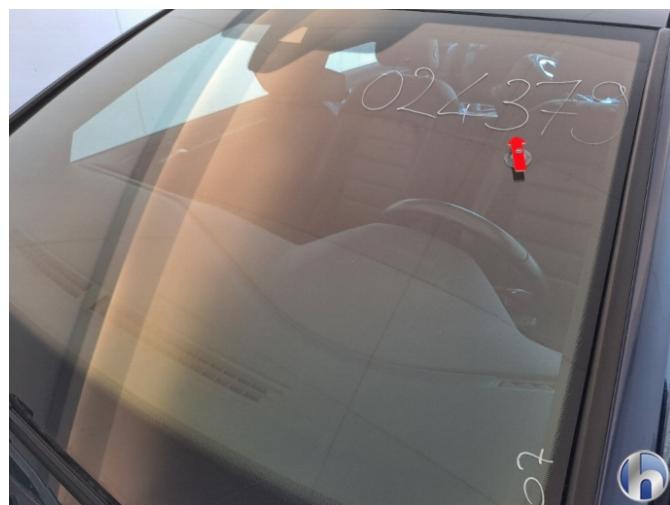
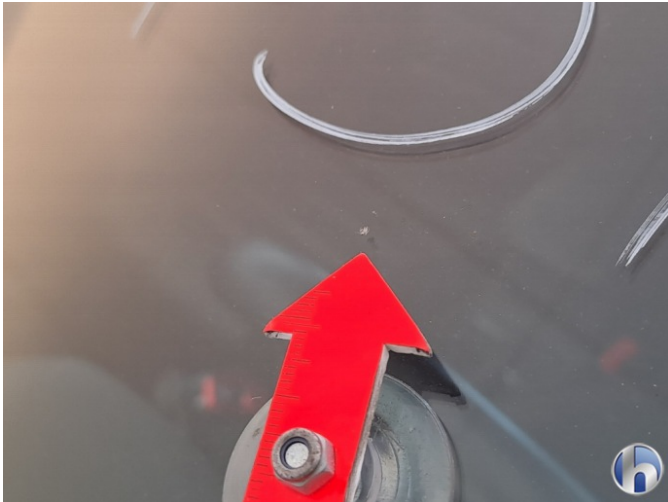
| component | Damage | Rep kind |
|---|---|---|
| 6. Windshield | Chipping from stones in field of view | Replace |

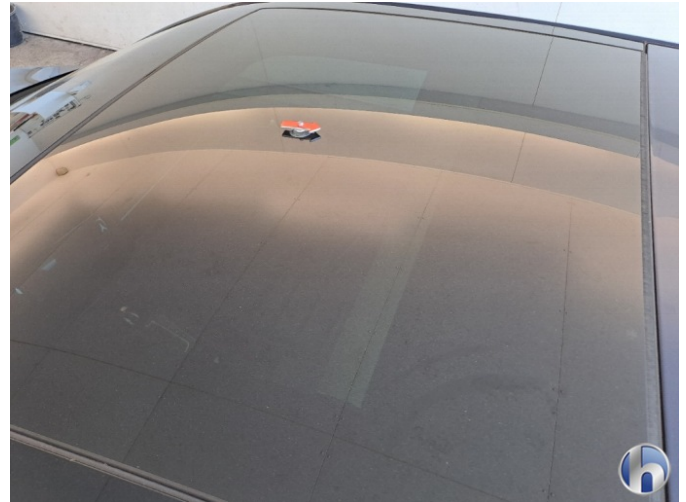
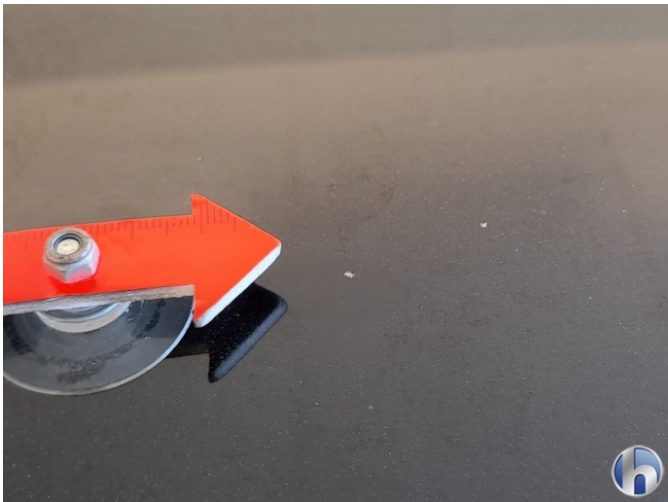
| component | Damage | Rep kind |
|---|---|---|
| 7. Sunroof | Chipping from stones | Replace |

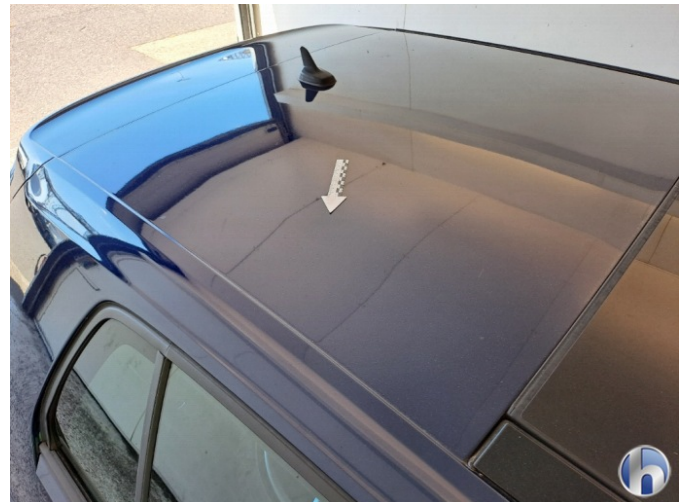
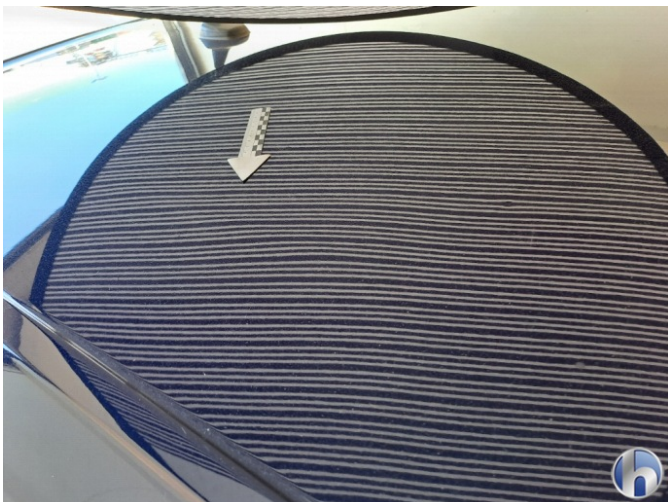
| component | Damage | Rep kind |
|---|---|---|
| 8. roof | Deformed | Smart repair |

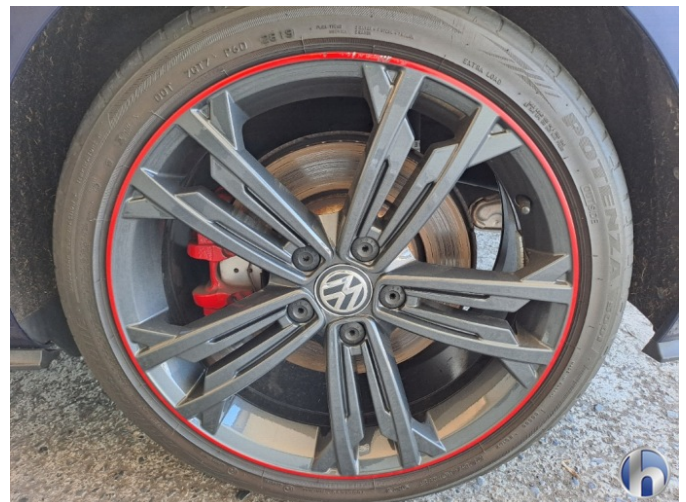
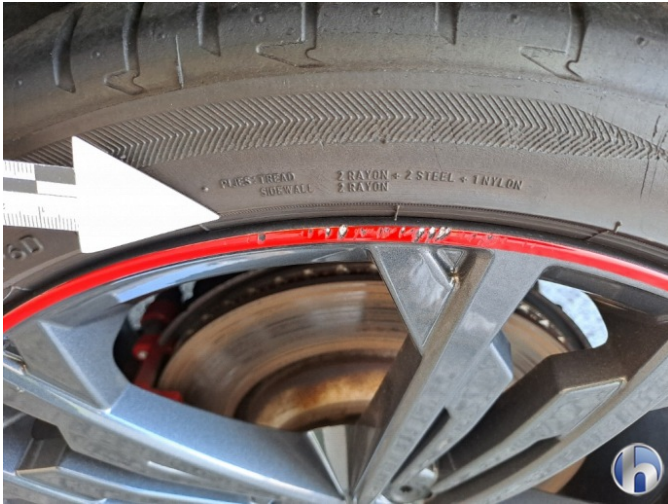
| component | Damage | Rep kind |
|---|---|---|
| 9. | Scrape | Paint |

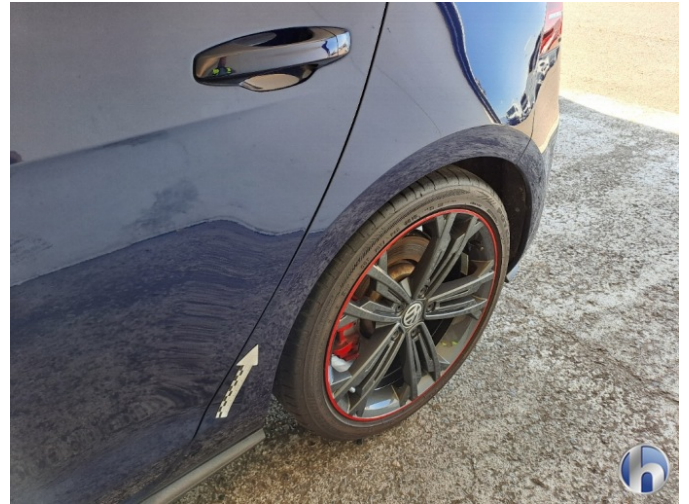
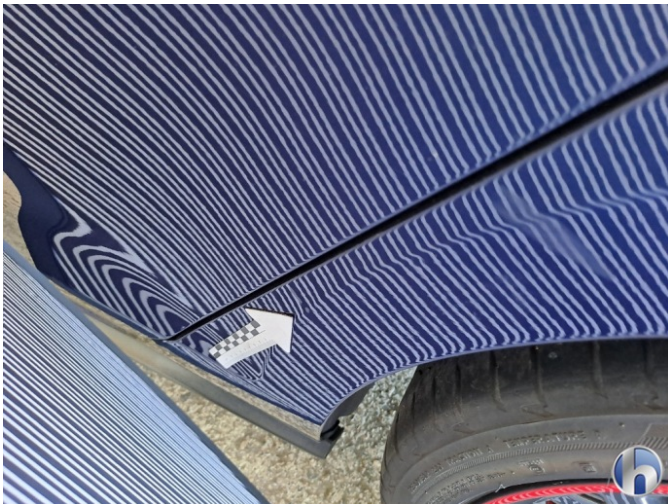
| component | Damage | Rep kind |
|---|---|---|
| 10. Sidewall - Rear - Left | | Refurbish and paint |

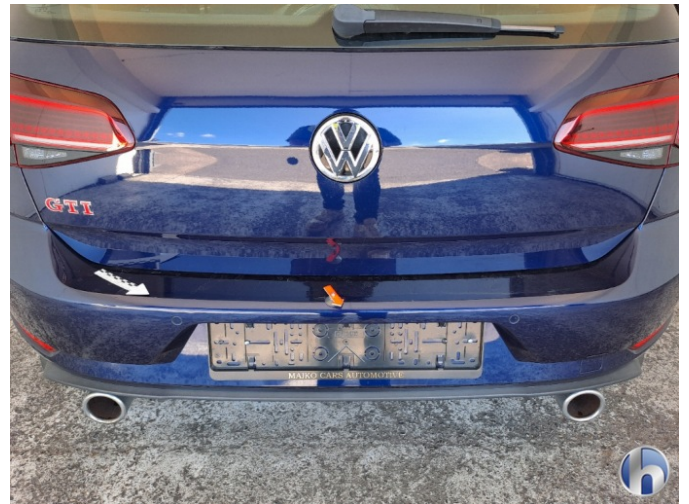
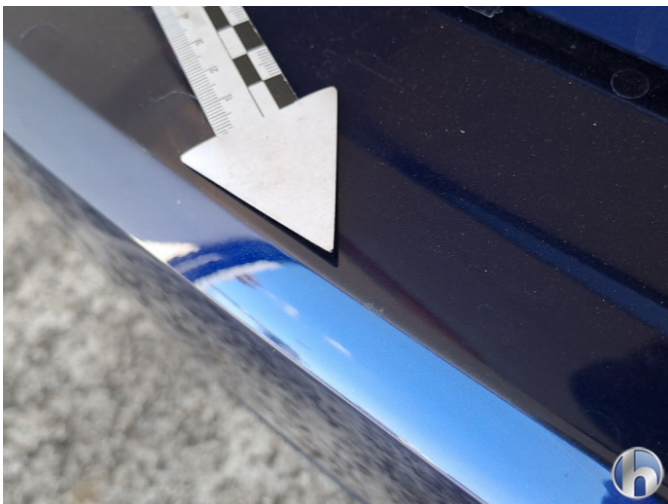
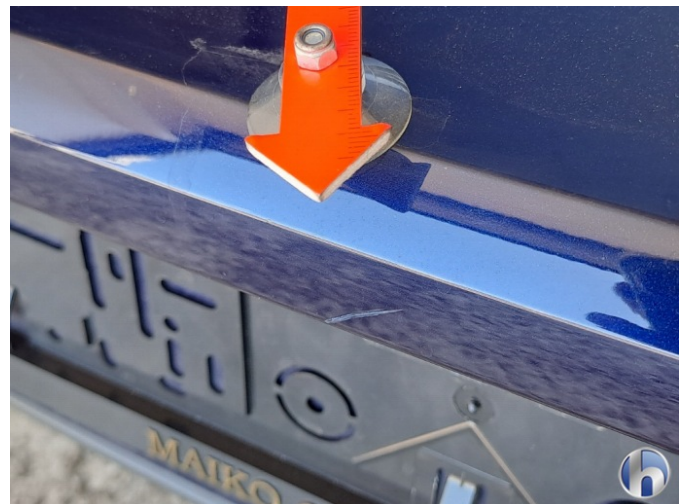
| component | Damage | Rep kind |
|---|---|---|
| 11. Rear bumper | Scratch(es) | Paint |

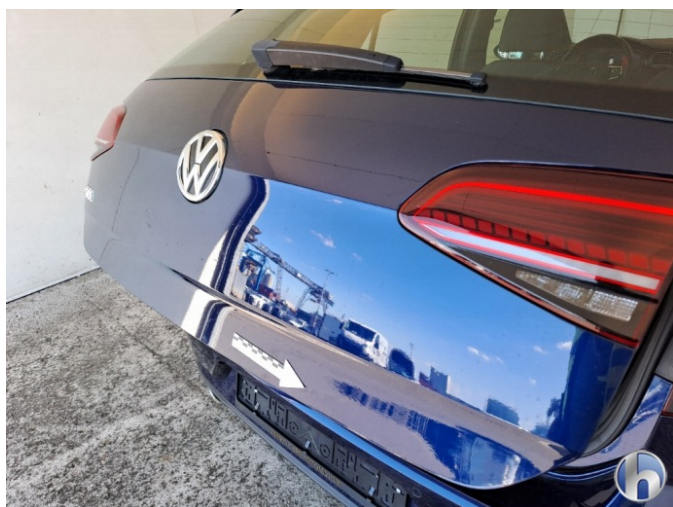
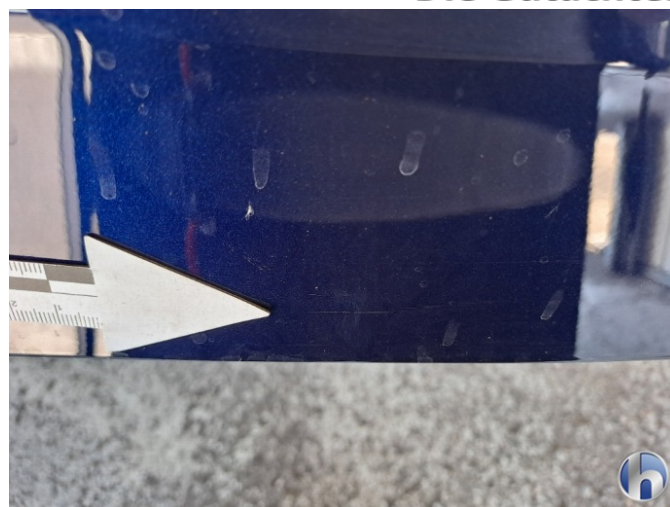
| component | Damage | Rep kind |
|---|---|---|
| 12. tailgate | Wear and tear | acceptable |

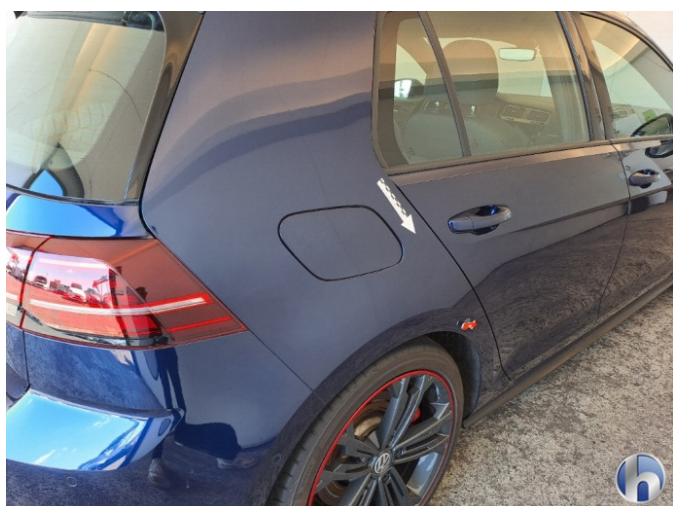
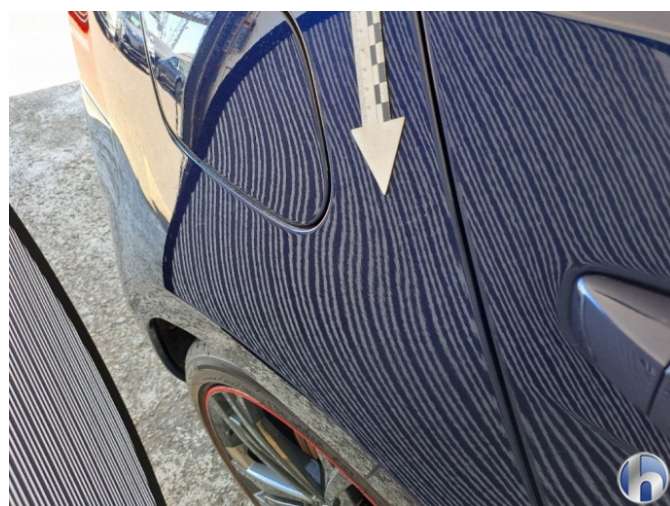
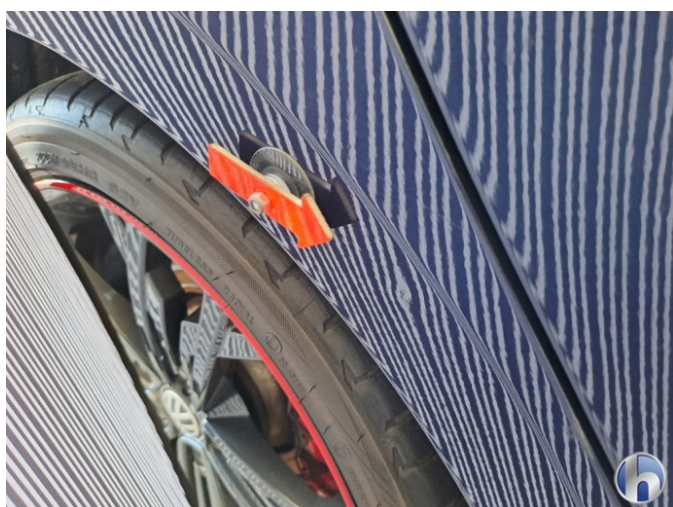
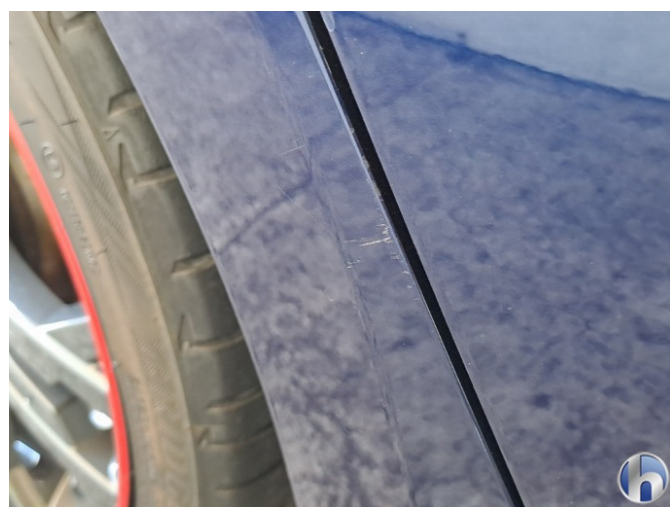
| component | Damage | Rep kind |
|---|---|---|
| 13. Sidewall - Rear - right | Damaged | Refurbish and paint |

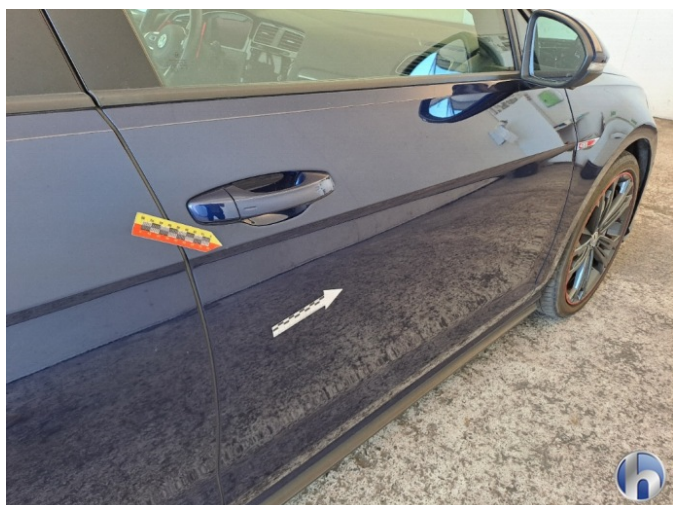
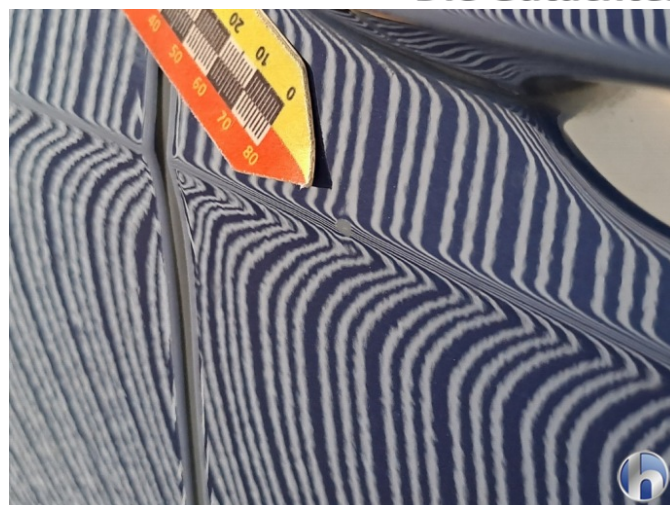
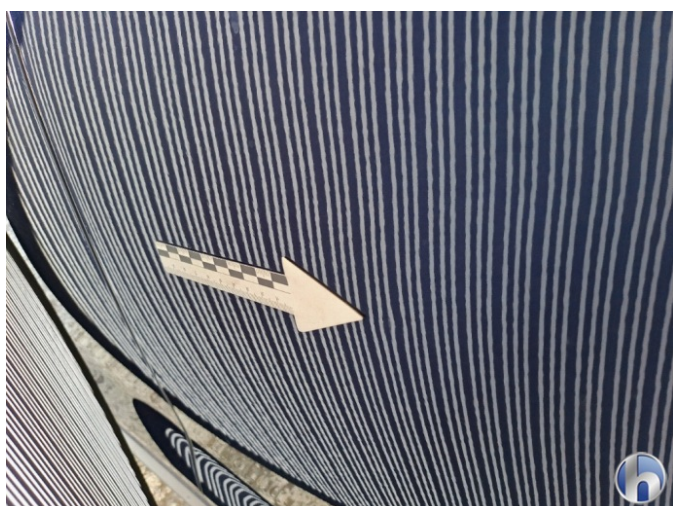
| component | Damage | Rep kind |
|---|---|---|
| 14. Front door - right | | Refurbish and paint |

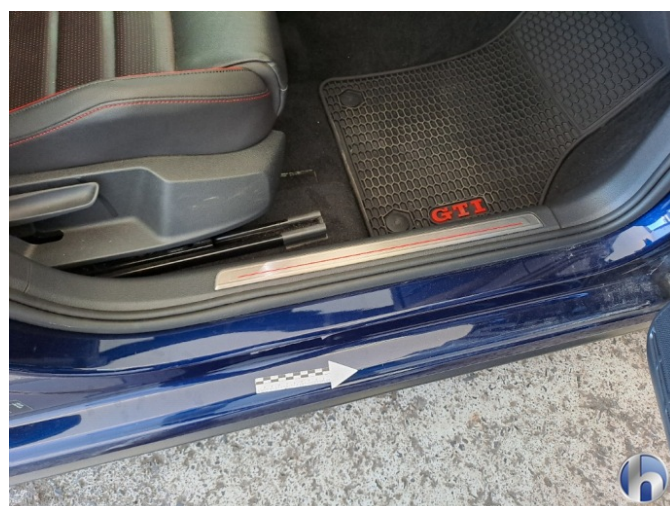
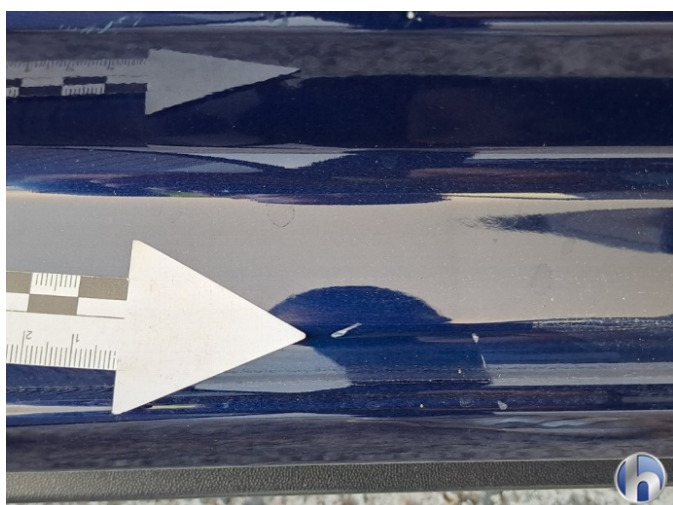
| component | Damage | Rep kind |
|---|---|---|
| 15. Türeinstieg Vorne - Rechts | Scratch(es) | Paint |

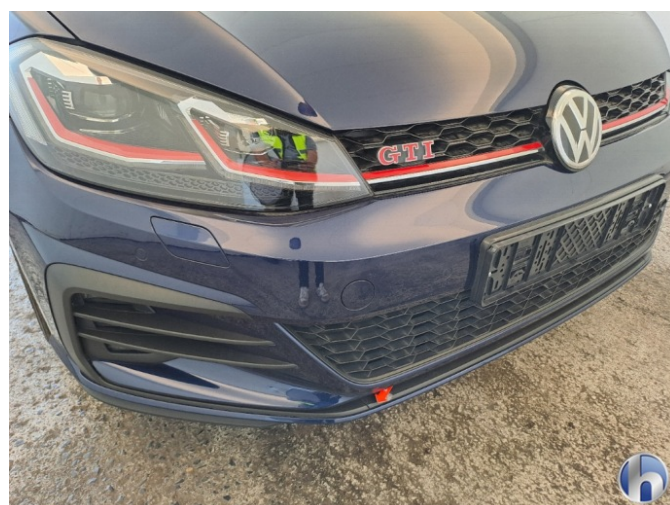
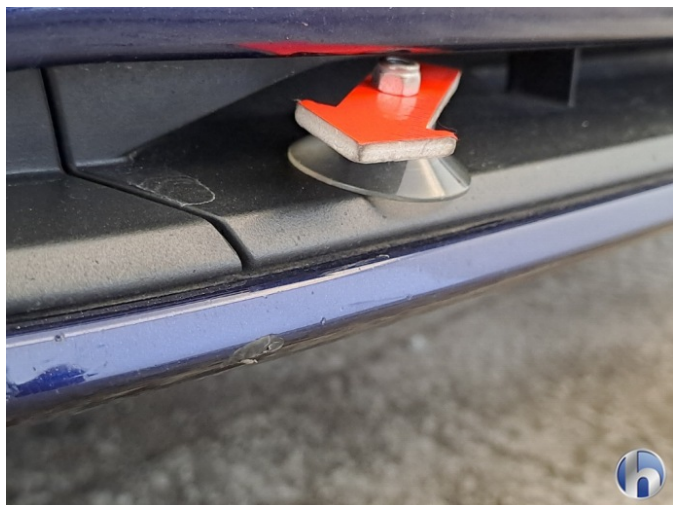
| component | Damage | Rep kind |
|---|---|---|
| 16. Front bumper | Scrape | Refurbish and paint |

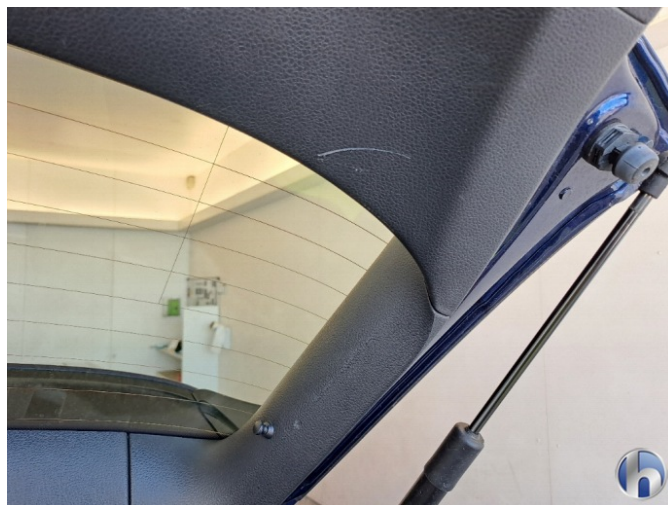
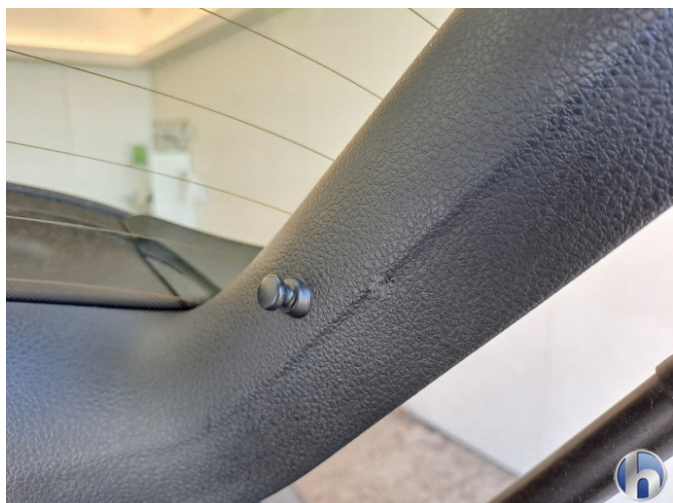
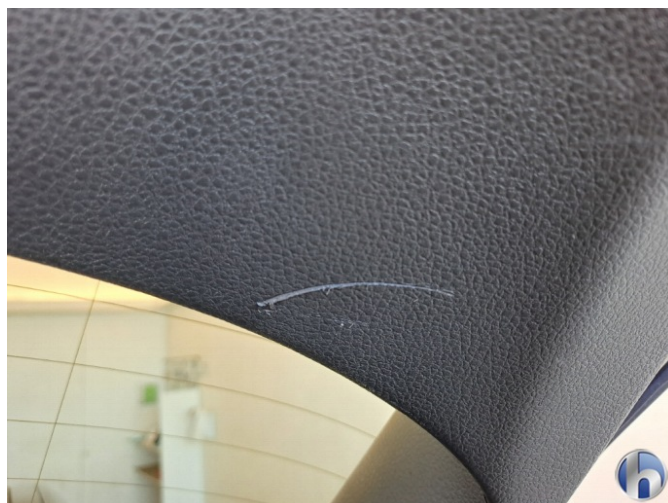
| component | Damage | Rep kind |
|---|---|---|
| 17. tailgate trim | Scrape | Replace |

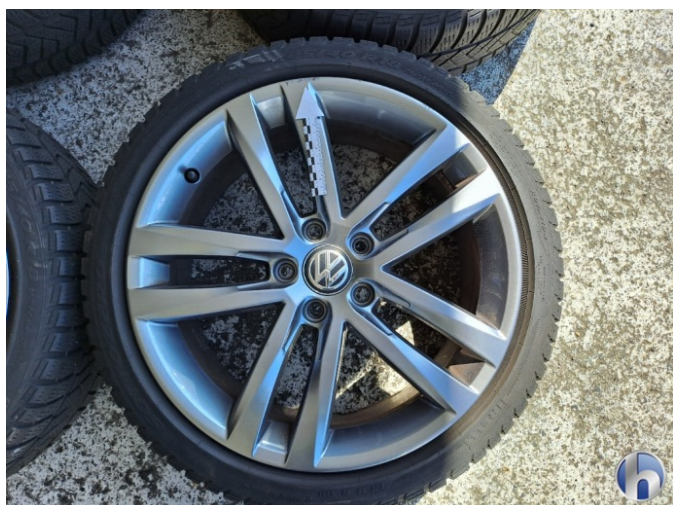
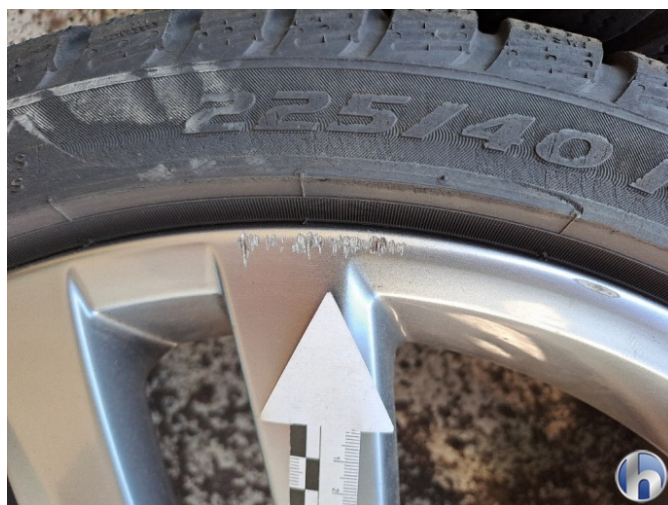
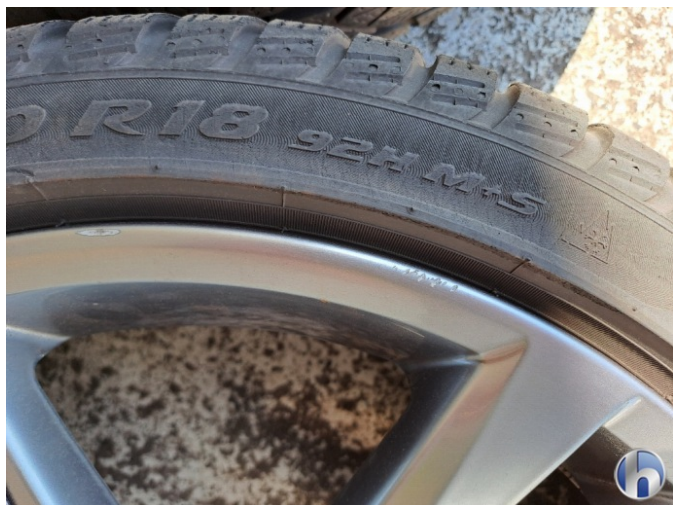
| component | Damage | Rep kind |
|---|---|---|
| 18. | Scrape | Paint |

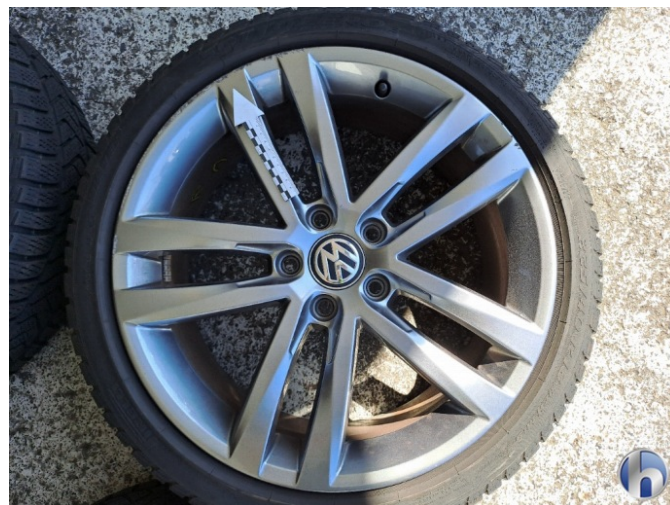
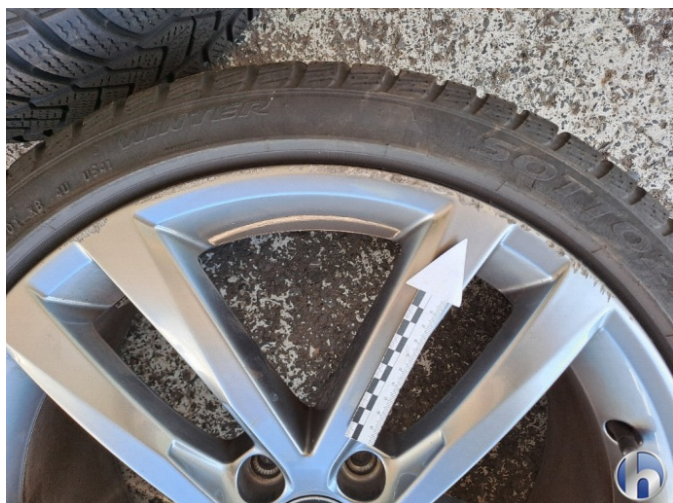
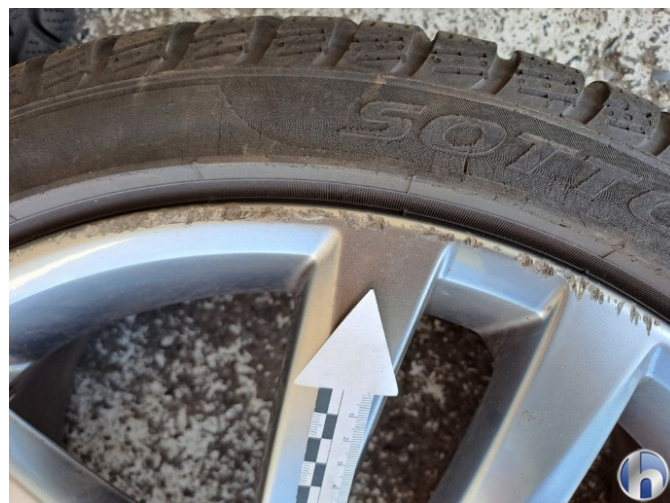
| component | Damage | Rep kind |
|---|---|---|
| 19. | Damaged | Replace |

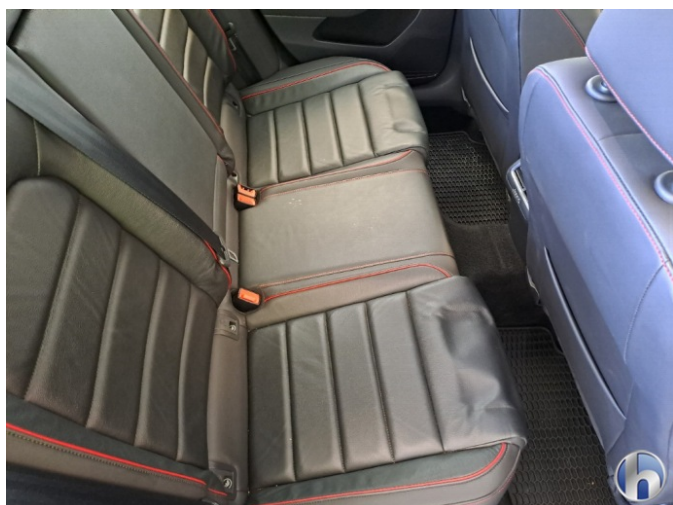
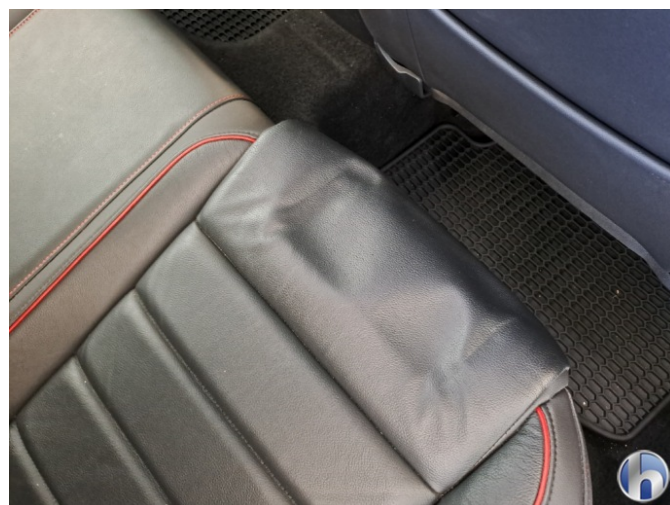
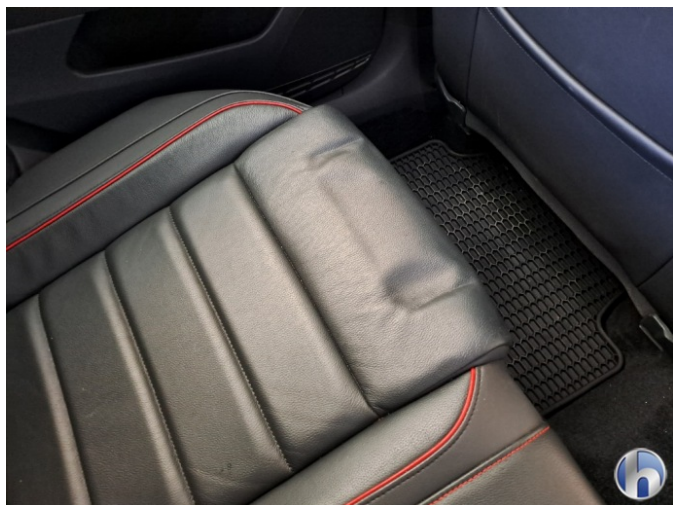
| component | Damage | Rep kind |
|---|---|---|
| 20. | Deformed | Replace |

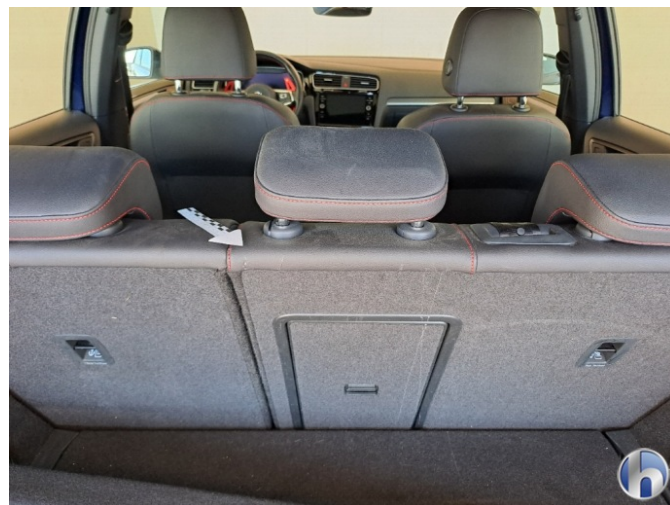
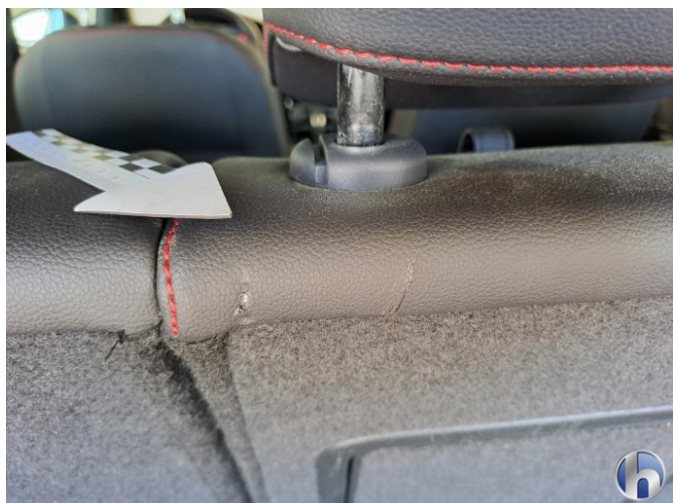
| component | Damage | Rep kind |
|---|---|---|
| 21. Sitz - Hinten - Mitte: Lehne Rückseite (Leder) | Damaged | Smart repair |

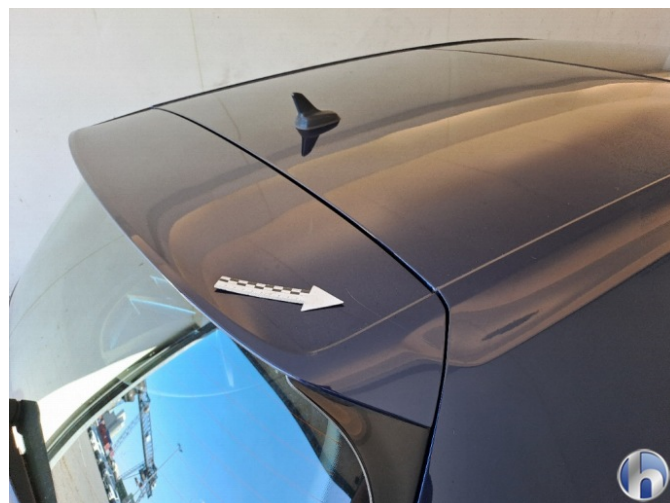
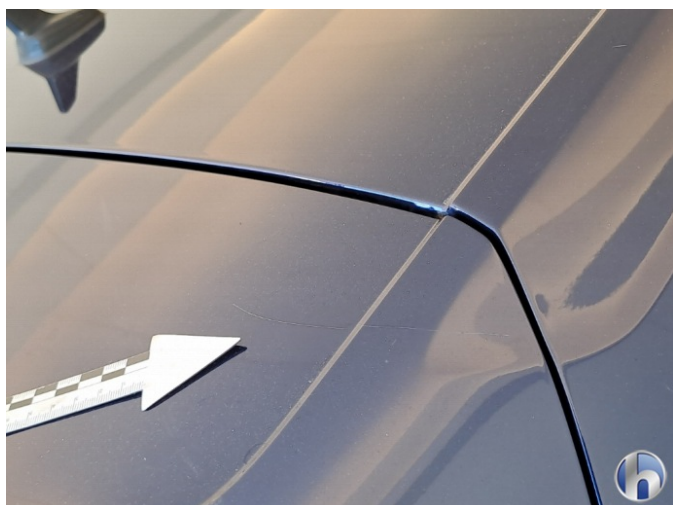
| component | Damage | Rep kind |
|---|---|---|
| 22. Spoiler Heckklappe | Scratch(es) | Paint |
