# **Expertise**

Protocol number: 41731149
Order number / reference: 25232862
Inspection date: 25 Sept 2025

Manufacturer: Volkswagen Model: Golf 2.0 TDI SCR Life

VIN: WVWZZZCDZMW118697

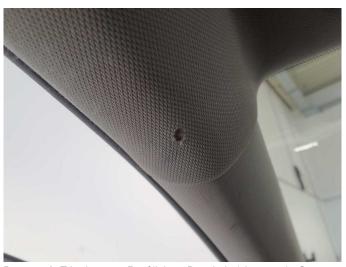
**Damage 2:** Trim / covers: Roof lining - Burn hole (cigarettes) - Smart repair

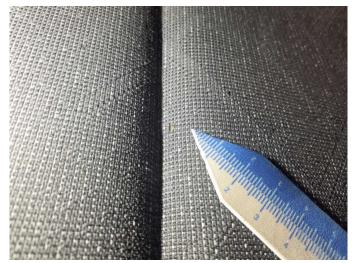
**Damage 4:** Seat - front: Seat cover - left side - Burn hole (cigarettes) - Smart repair

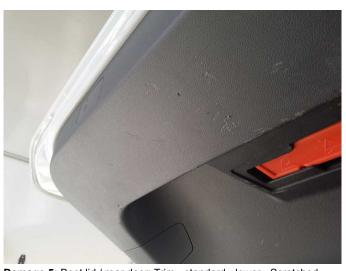
Damage 5: Boot lid / rear door: Trim - standard - lower - Scratched -Replace

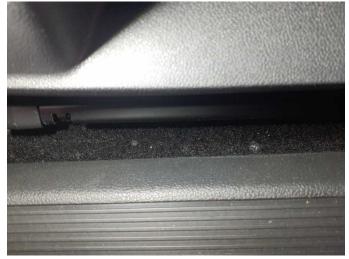
Damage 6: Trim / covers: Carpet - front left side - Burn hole (cigarettes) -Smart repair

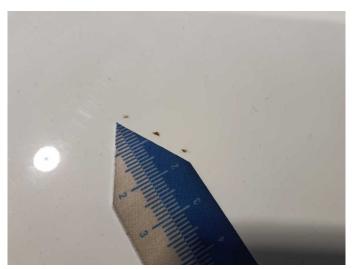
Damage 8: Roof: Roof - Corrosion - Repair and paint

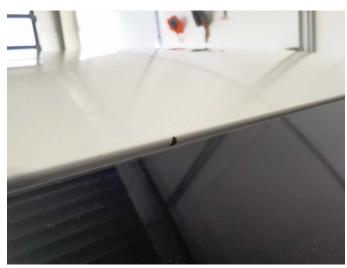
Damage 8: Roof: Roof - Corrosion - Repair and paint

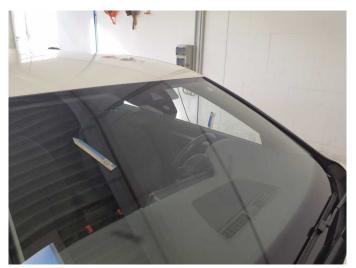
Damage 8: Roof: Roof - Corrosion - Repair and paint

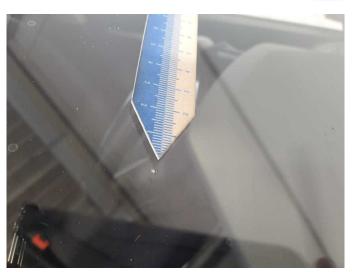
Wear and tear 1: Vehicle glazing: Windscreen with lane departure assistant (ohne Rissbildung) - Stone chips - No deduction
