TOYOTA PROACE VERSO: 1YGA615

Limited Technical Inspection

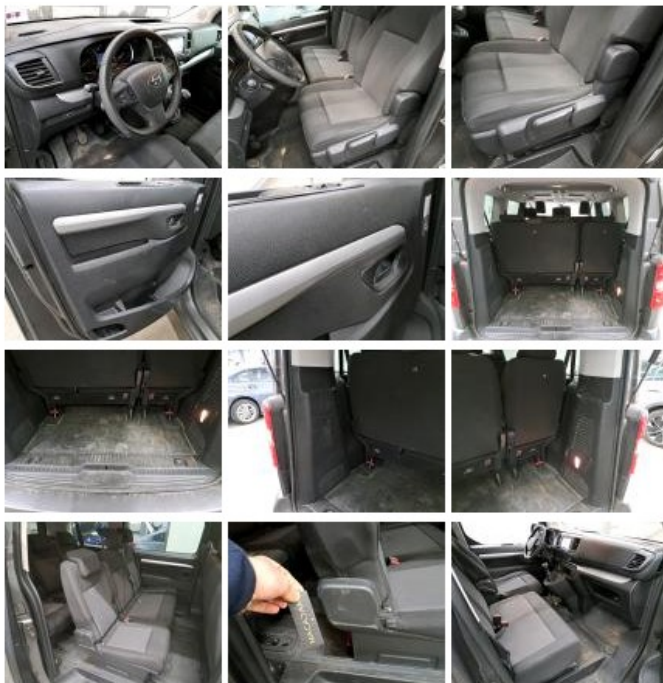
| Interior, Damaged, Acceptable: | 0,00 |

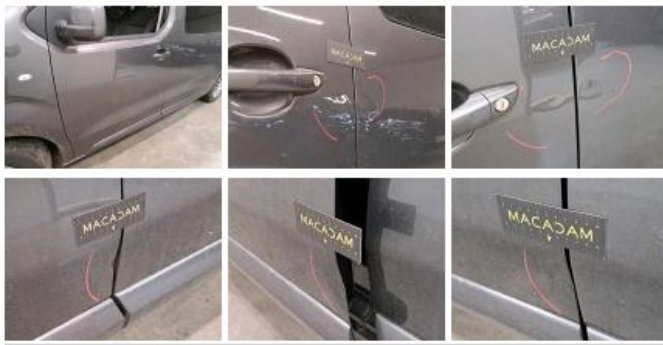
DOOR RL, Dent(s) and scratch(es), repair and paint (complete)

43,00
