Expertise

Protocol number: 41228948
Order No. / Reference: 25124708
Inspection date: 25 Aug 2025

Manufacturer: Volvo

Model: XC90 B5 D AWD Geartronic Momentum Pro

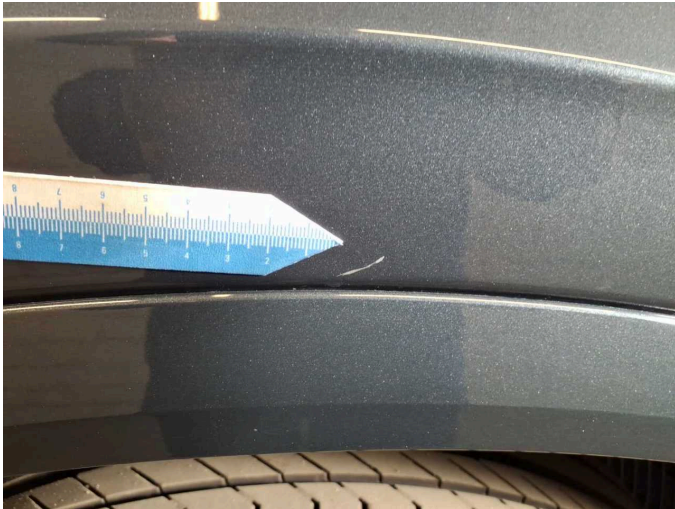
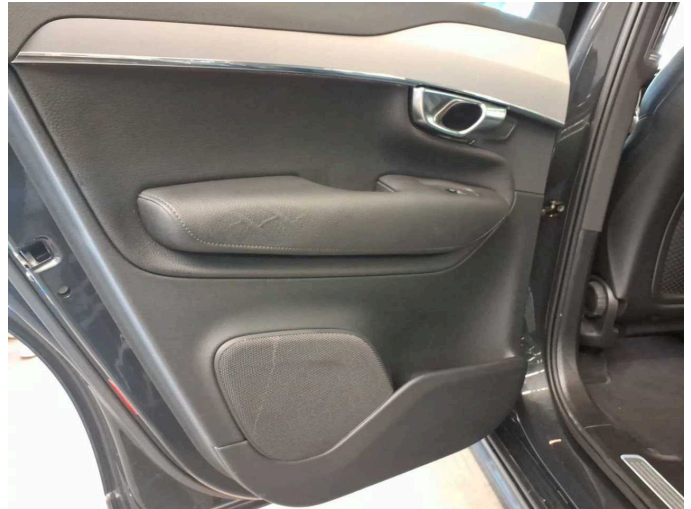
Damage 1: Mudguard - right side: Mudguard - right side - Scratch(es) - Smart repair

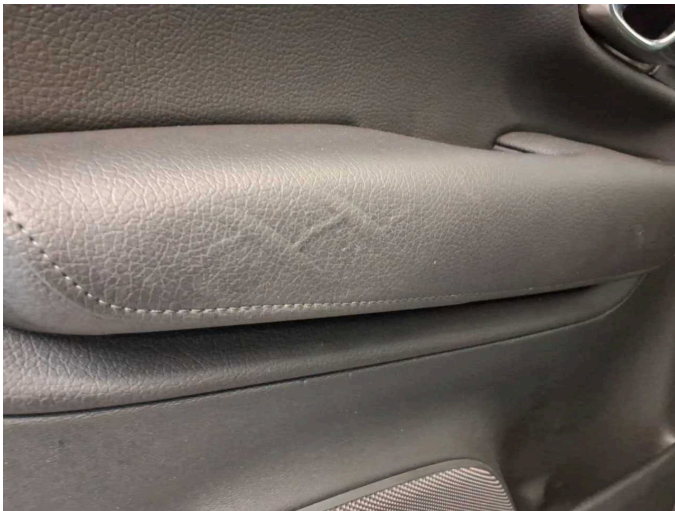
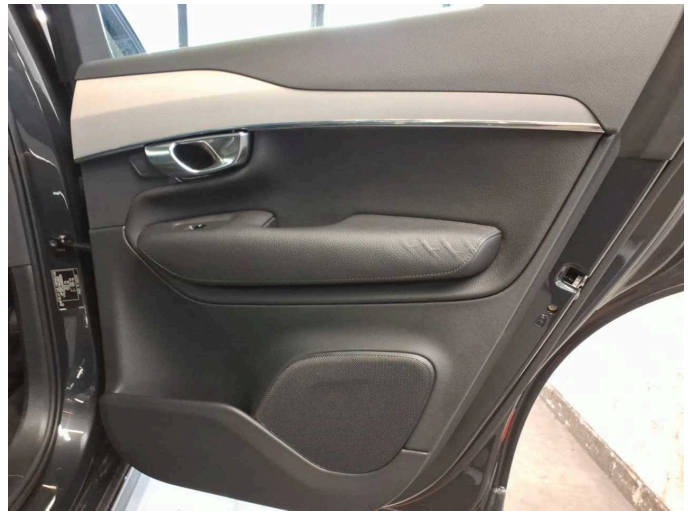
Damage 2: Trim / covers: Door trim - rear left side - Deformed - Smart repair

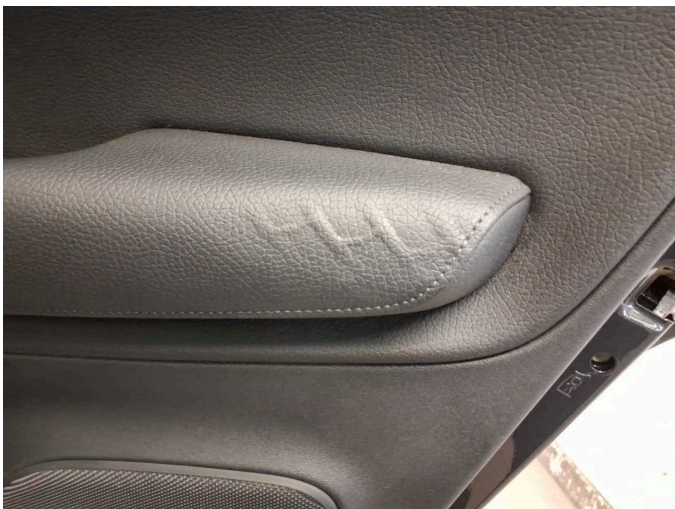
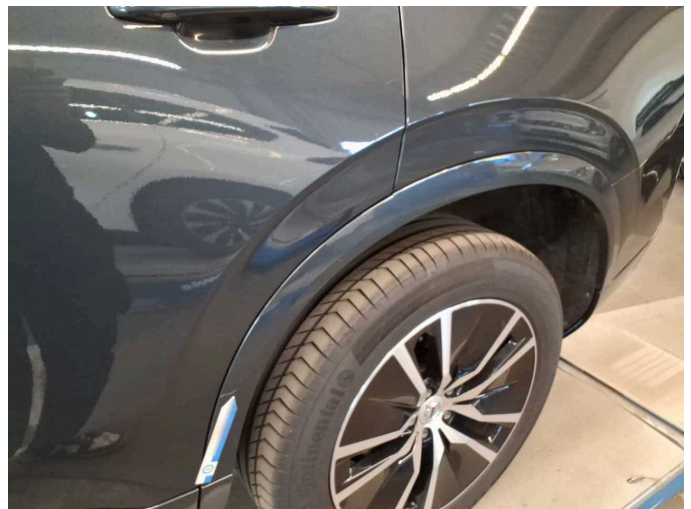
Damage 3: Trim / covers: Door trim - rear right side - Deformed - Smart repair

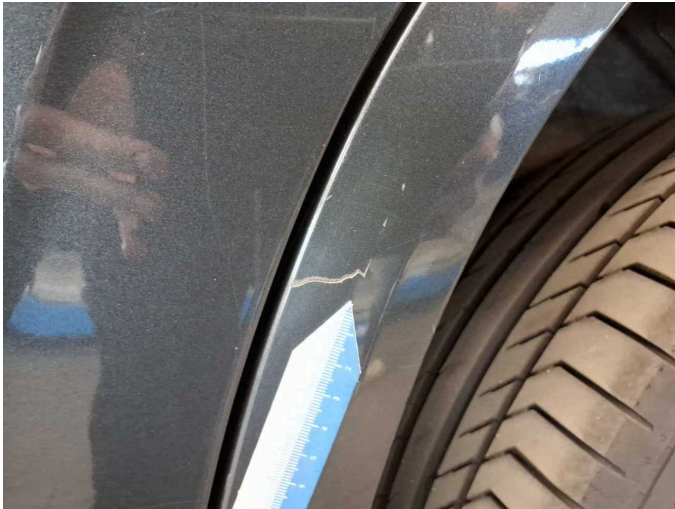
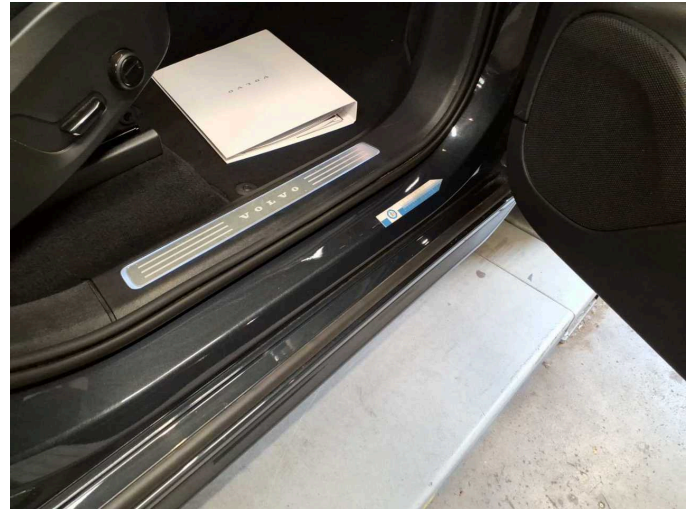
Damage 4: Side panel - rear left side: Wheel well extension - Scratch(es) - Smart repair

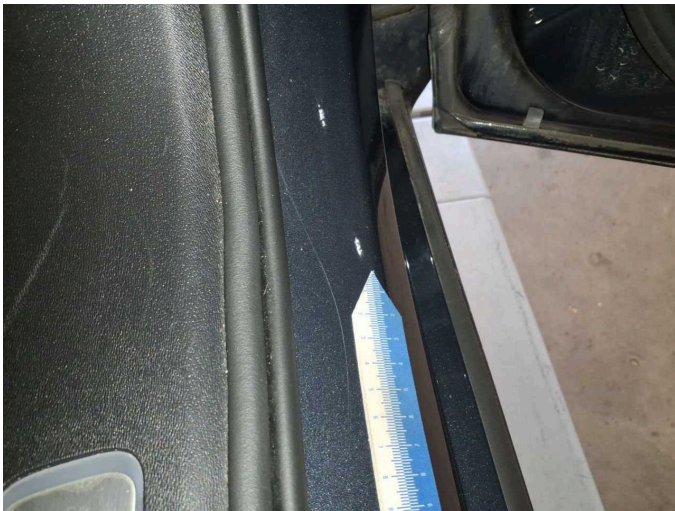
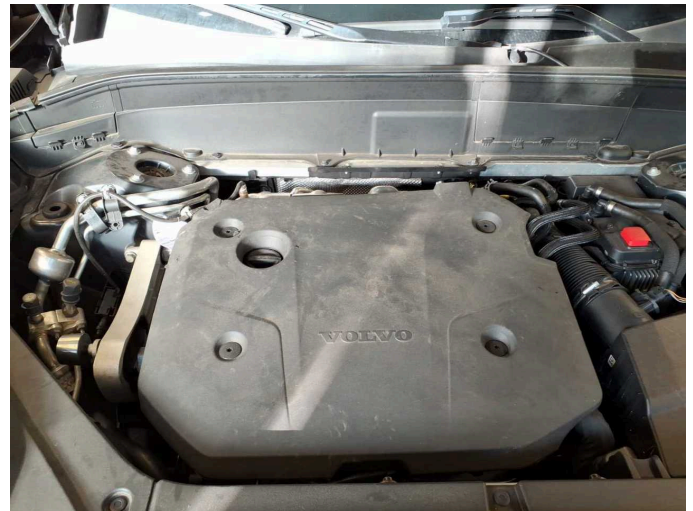
Damage 5: Sill - right side: Sill - Scratch(es) - Smart repair

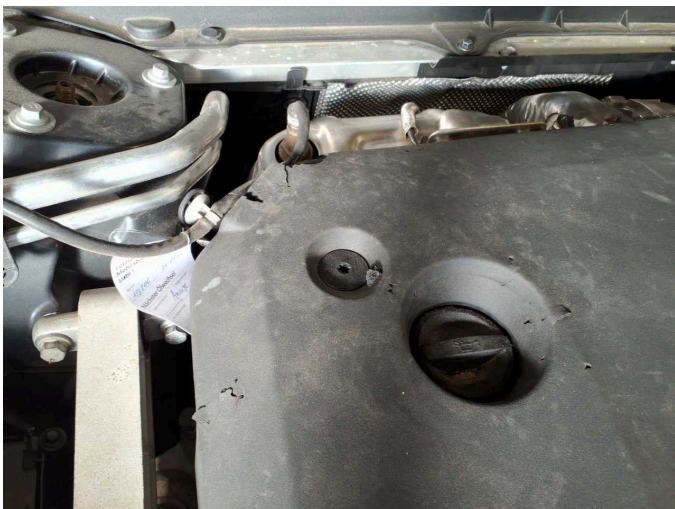
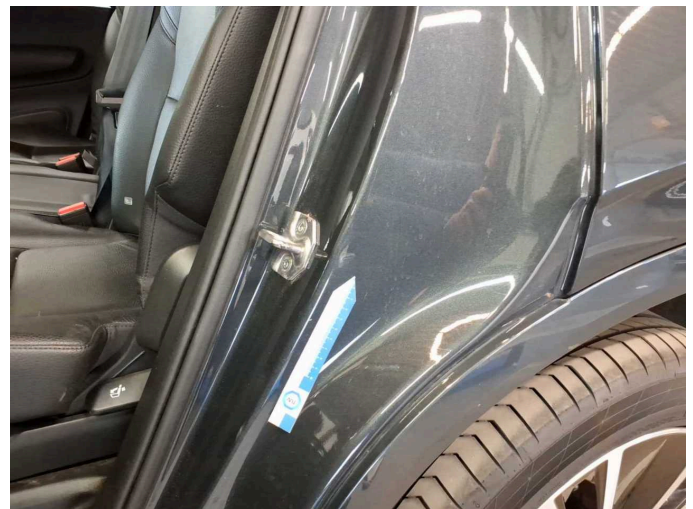
Damage 6: Engine: Engine cover - top / cover - Damage caused by marten / rodent - Replace

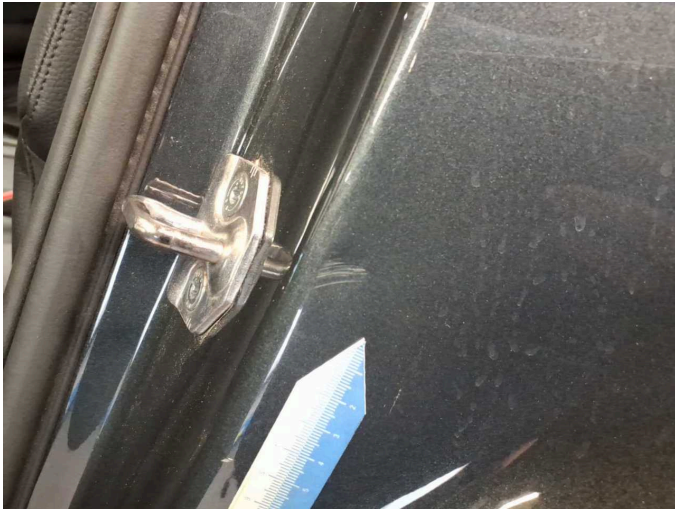
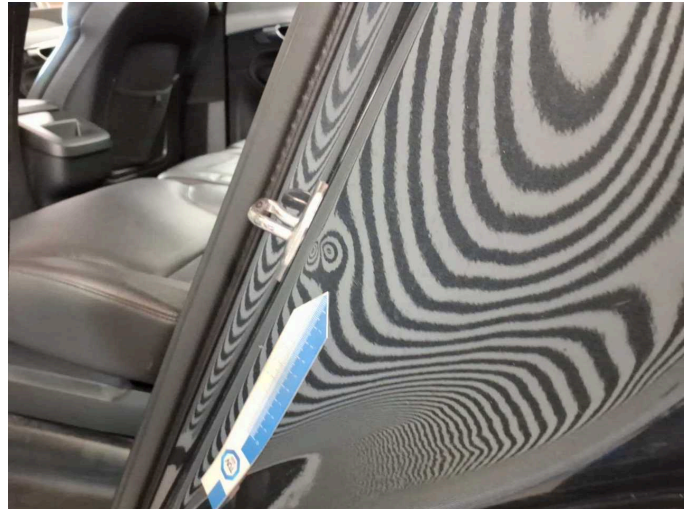
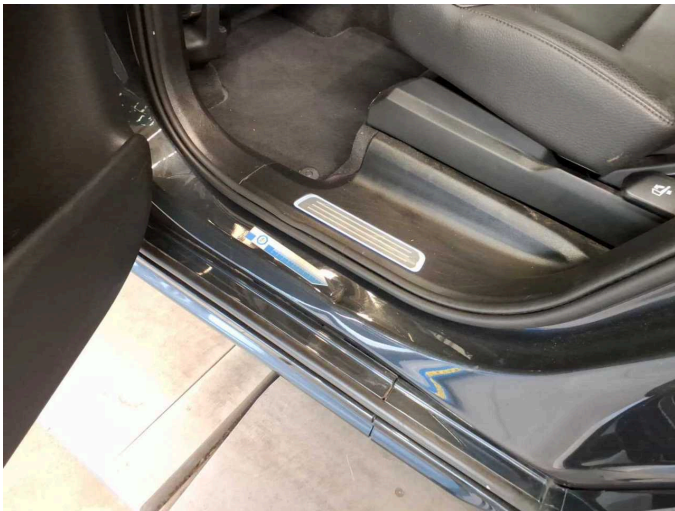
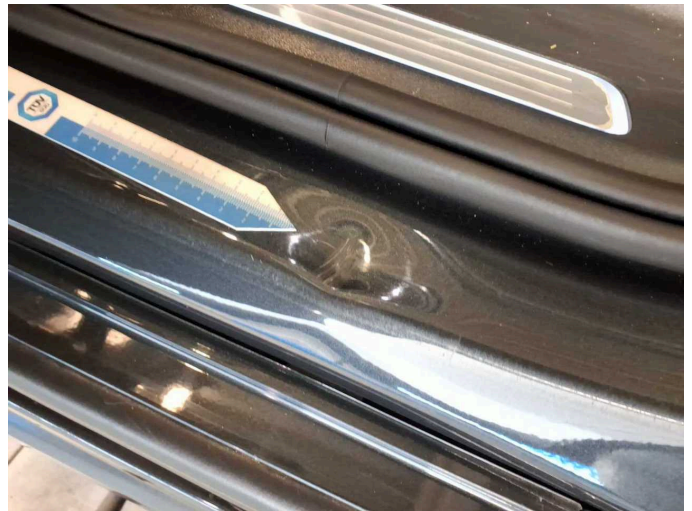
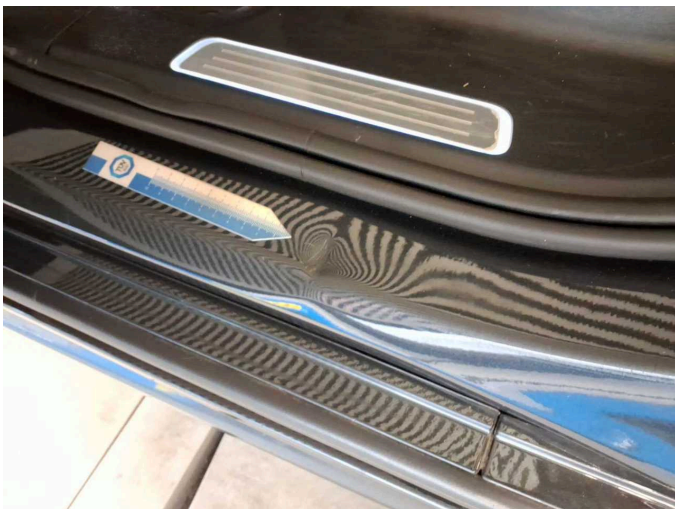
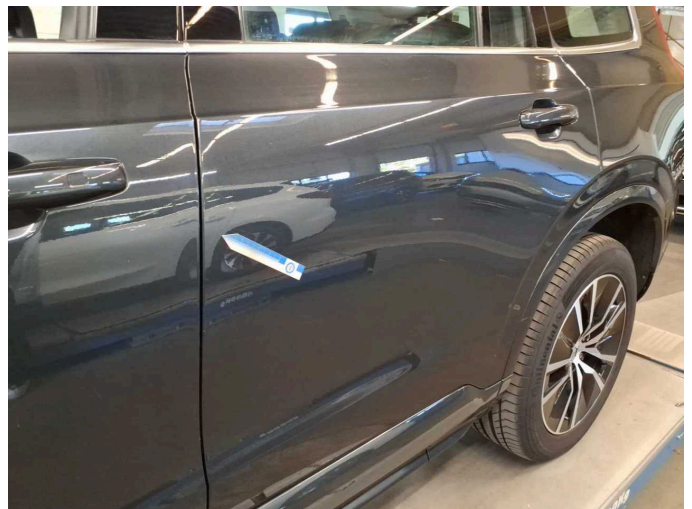
Damage 7: Side panel - rear left side: Sill - Dent / paintcoat damage - Smart repair

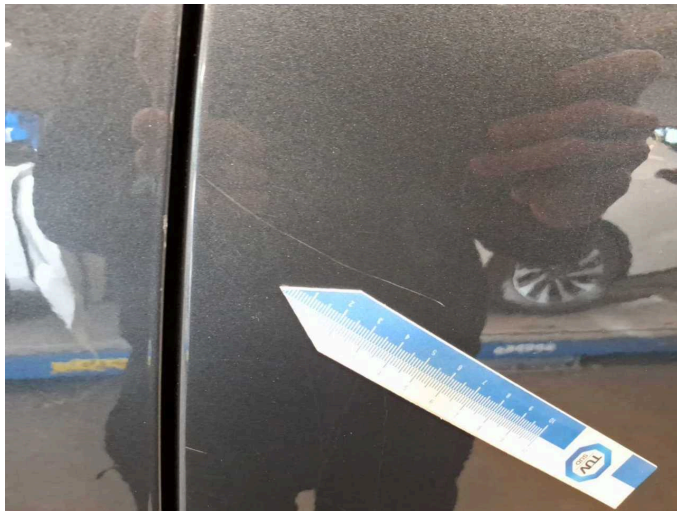
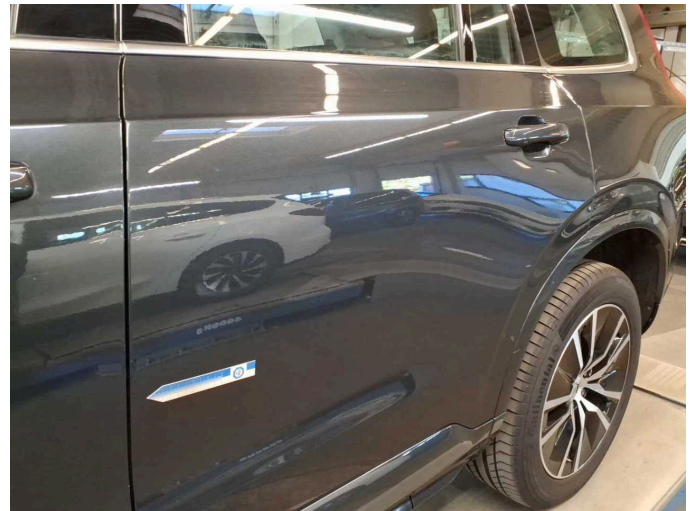
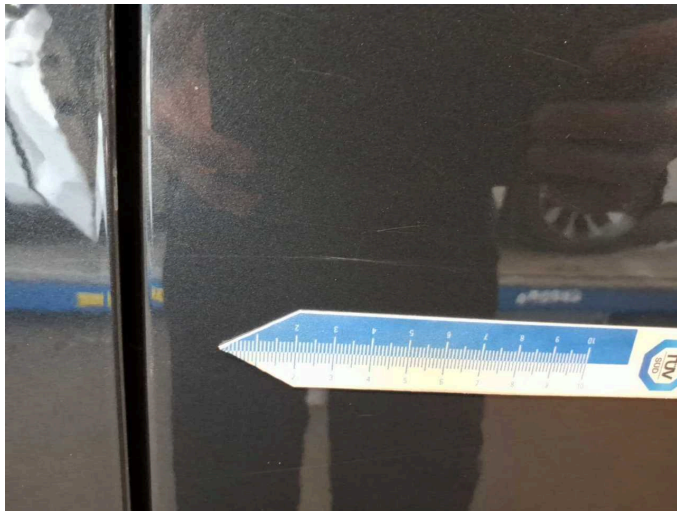
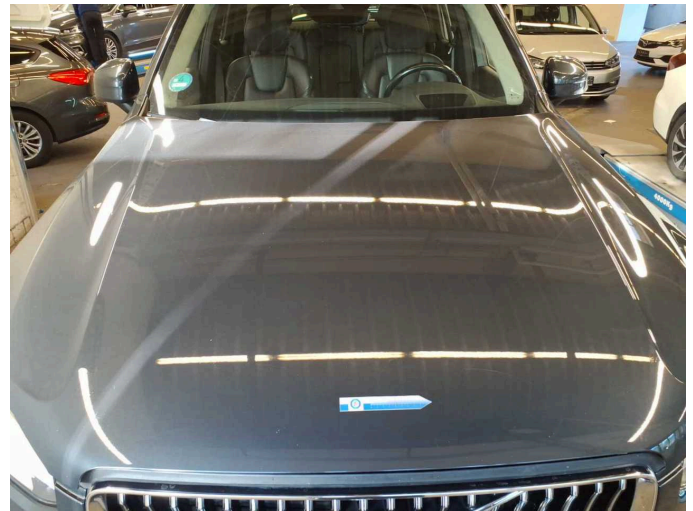
Damage 8: Door - rear left side: Door - Scratch(es) - Paint

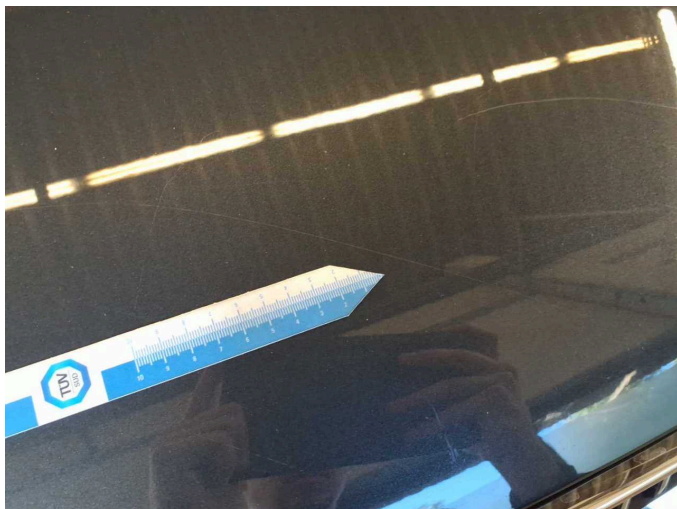
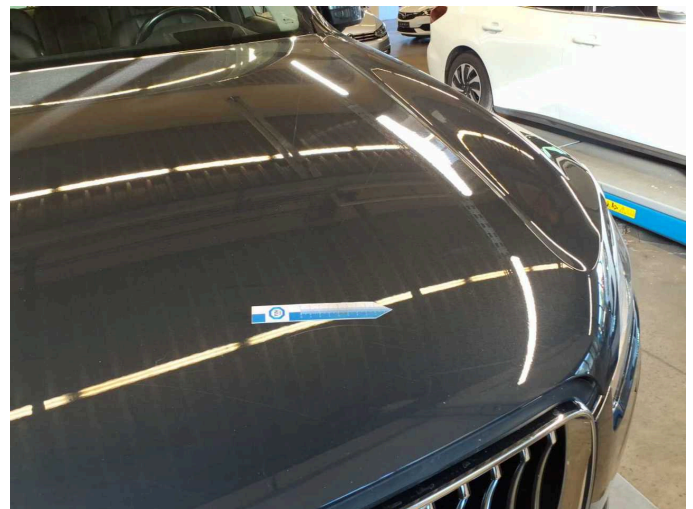
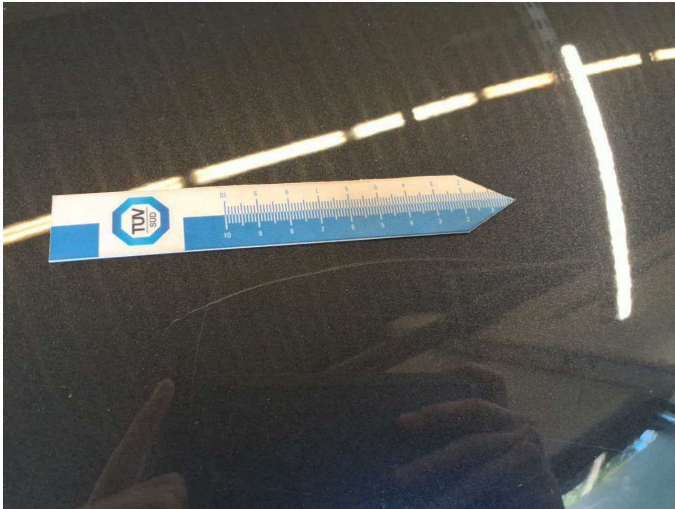
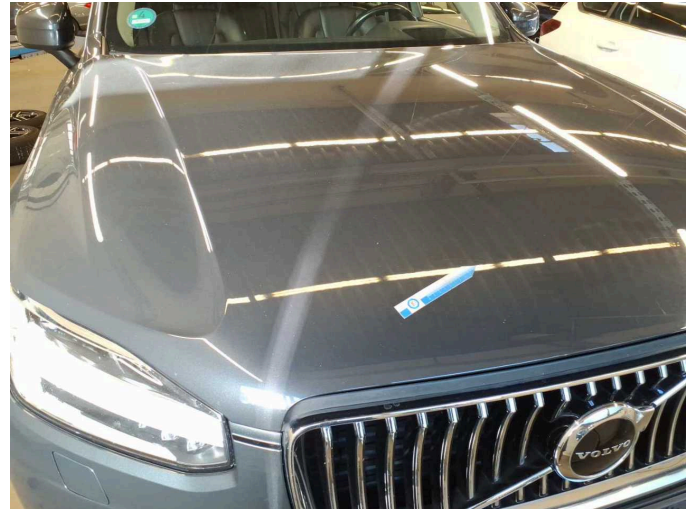
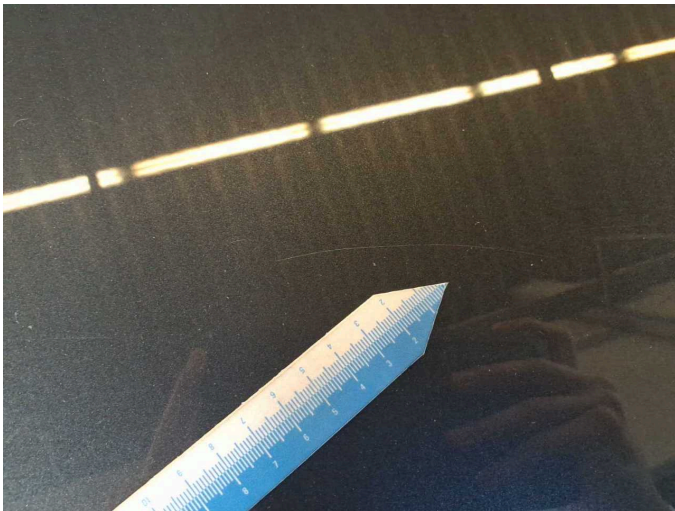
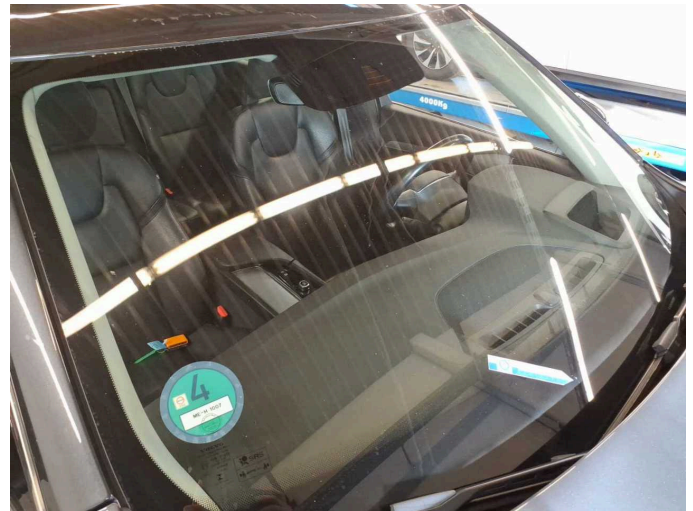
Damage 9: Bonnet: Bonnet - Scratch(es) - Paint

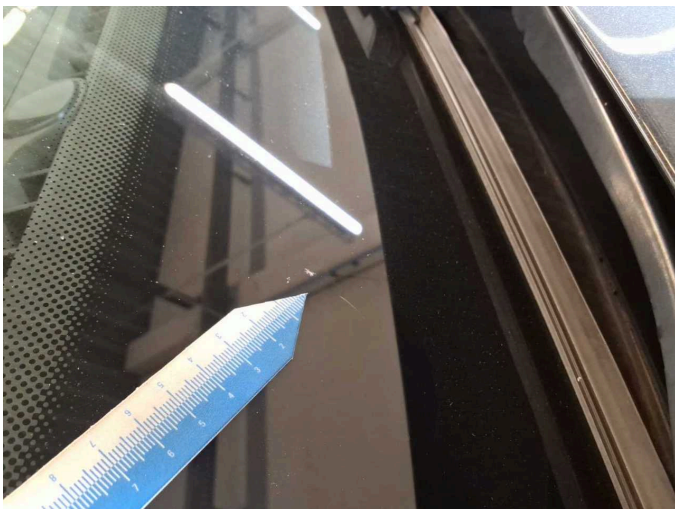
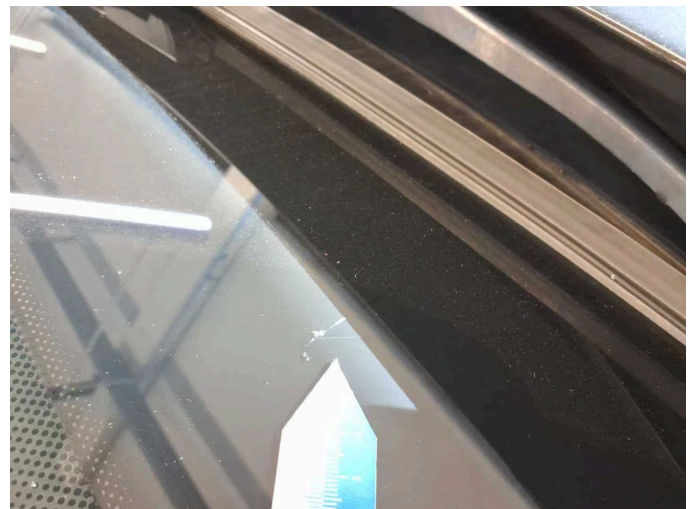
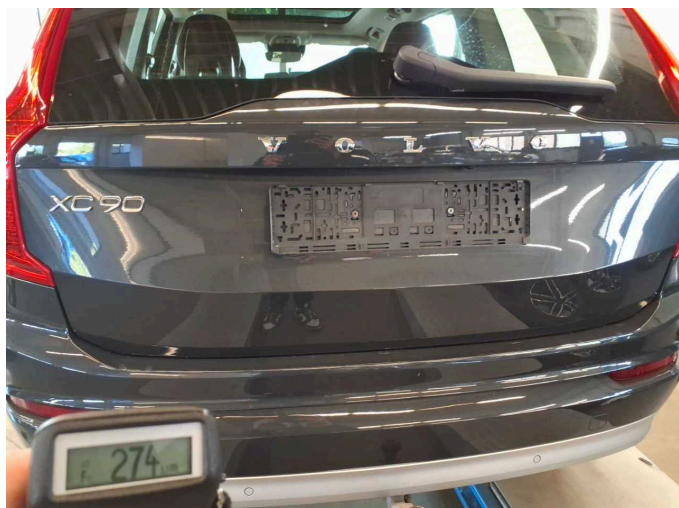
Damage 10: Vehicle glazing: Windscreen (Riß) - Broken / torn - repair according to calculation

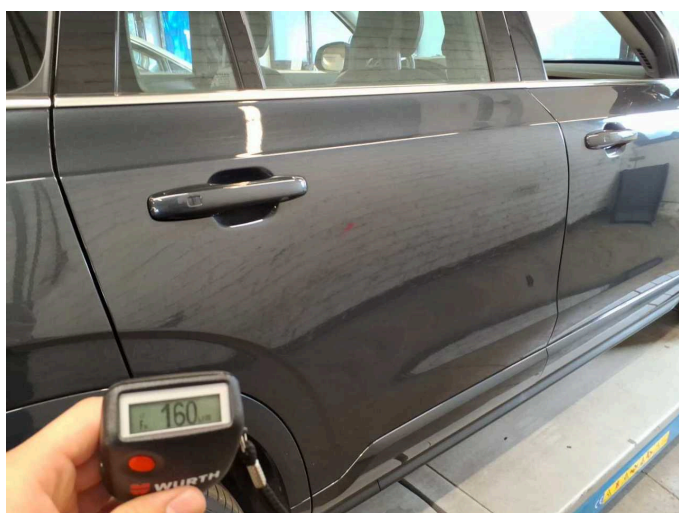
Repainting 1: Boot lid / rear door

- Boot lid / rear door, Professionally carried out, Invoice of repair done Non-existent
- Door - rear right side, Professionally carried out, Invoice of repair done Non-existent

Boot lid / rear door	274 µm	Door - rear right side	160 µm
----------------------	--------	------------------------	--------
