VOLVO XC90
XC90 T8 Twin Engine 320+87 ch Geartronic
7pl Inscription Luxe

VIN NO YV1LFBABDH1146117
Registration Number EG338SB

Inspection Report Summary

Customer	BCAuto Encheres	Report Number	P20250925130427
Inspection Date / Place	2025-09-25 / BCA MITRY	Cosmetic Grade	3

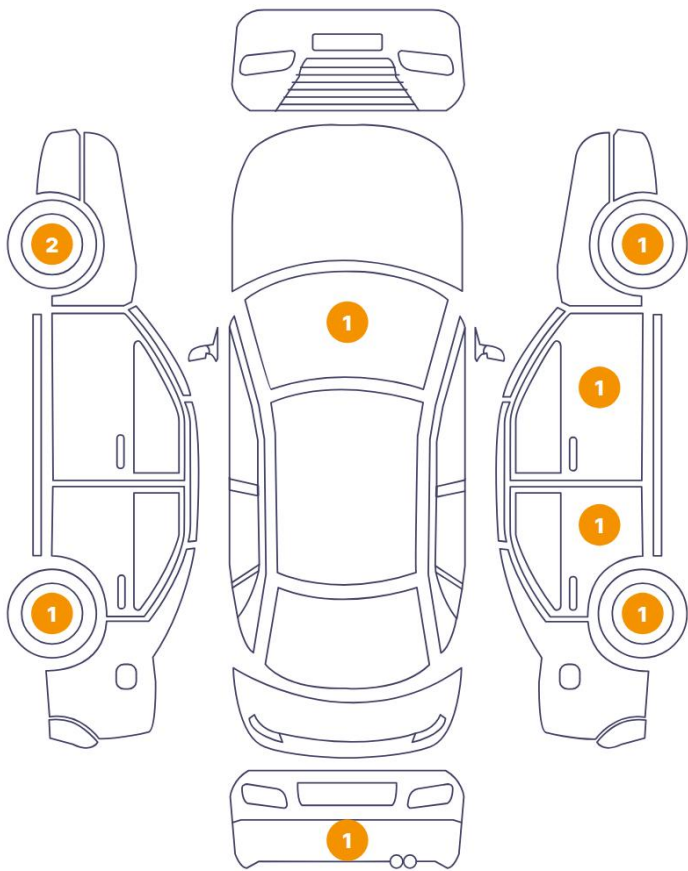
9 Dommages

Component		Damage	Comments
1	Bumper / Back	Paint / Scratch / Line	
2	Rim	Out of Bodywork / Scratch	
3	Rim	Out of Bodywork / Scratch	
4	Tire / Front Left	Tire	
5	Windshield / Front	Glass Break	
6	Rim	Out of Bodywork / Scratch	
7	Door / Front Right	Bodywork / Dent / Deformation	
8	Door / Back Right	Bodywork / Dent / Hail Area	
9	Rim Brake pads	Out of Bodywork / Scratch

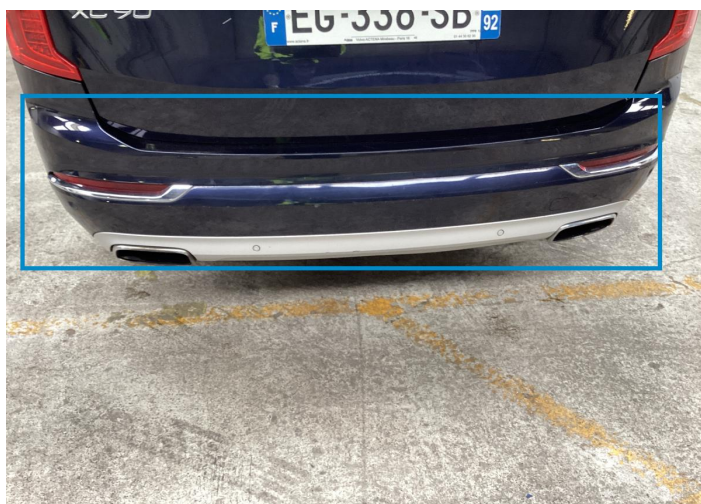
1. Bumper / Back
Paint / Scratch / Line -

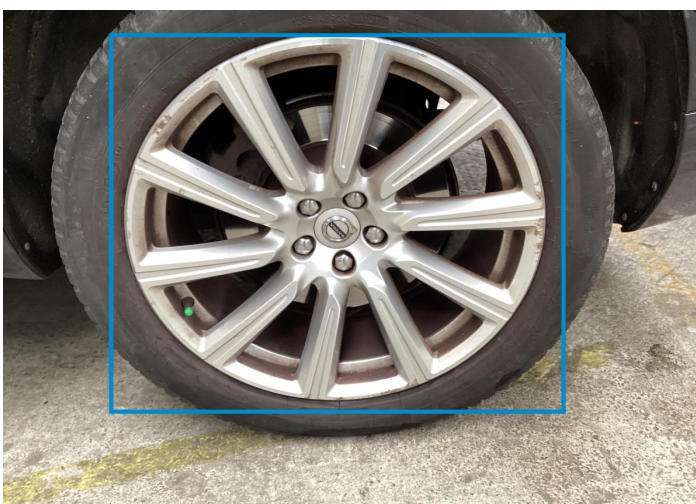
2. Rim
Out of Bodywork / Scratch -

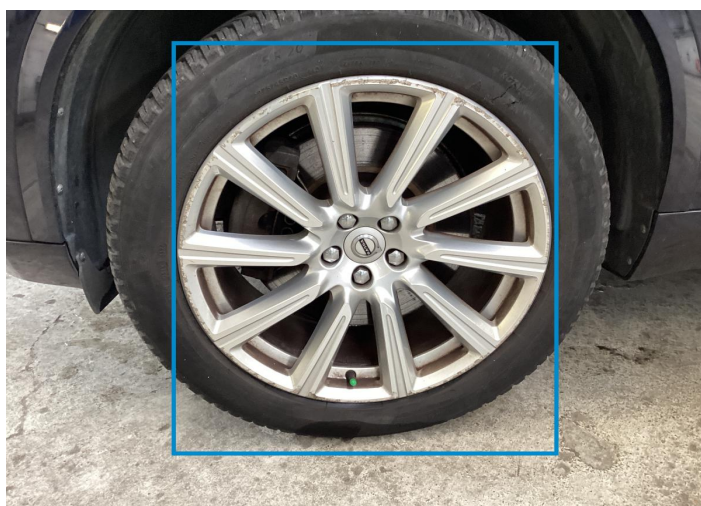
3. Rim
Out of Bodywork / Scratch -

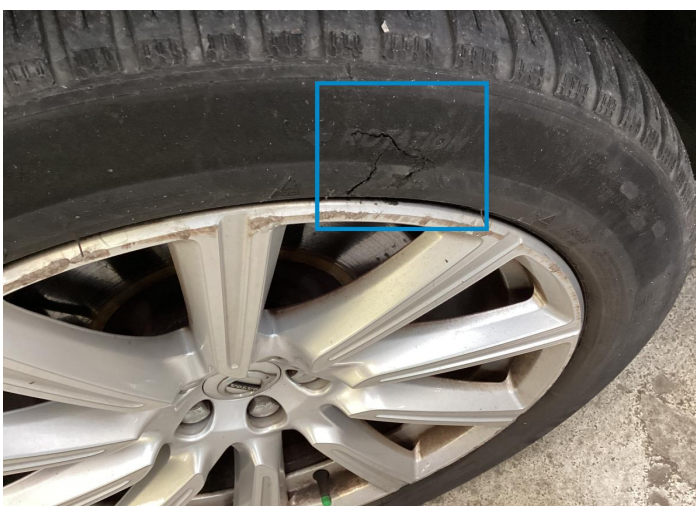
4. Tire / Front Left
Tire -

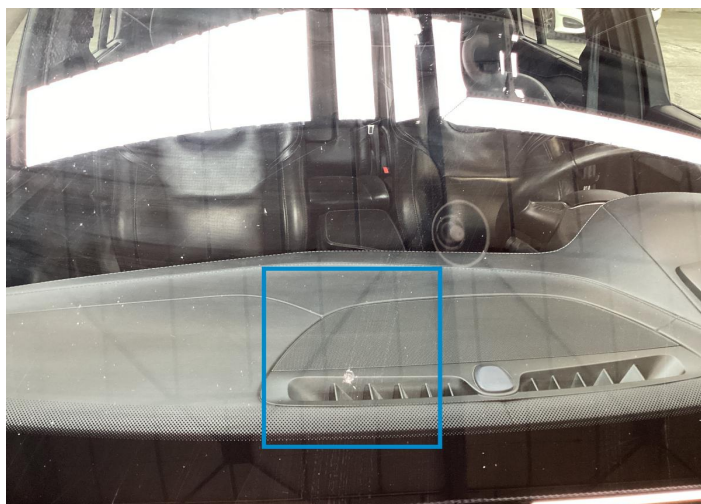
5. Windshield / Front
Glass Break -

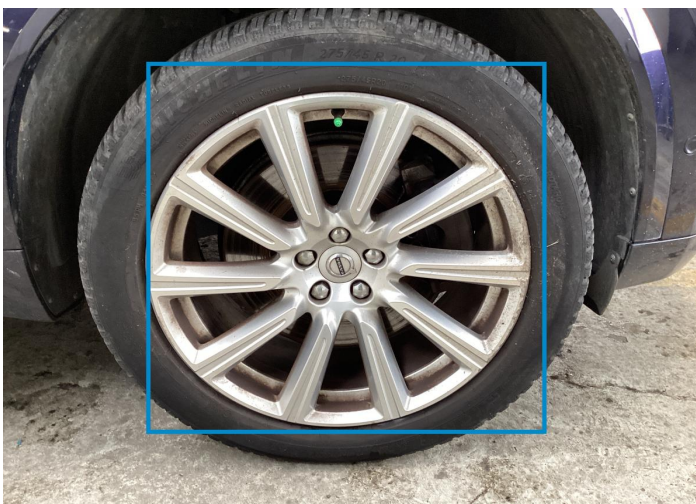
6. Rim
Out of Bodywork / Scratch -

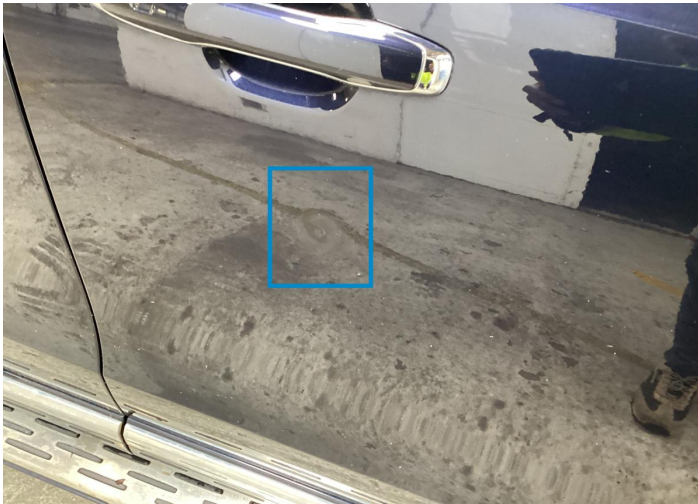
7. Door / Front Right
Bodywork / Dent / Deformation -

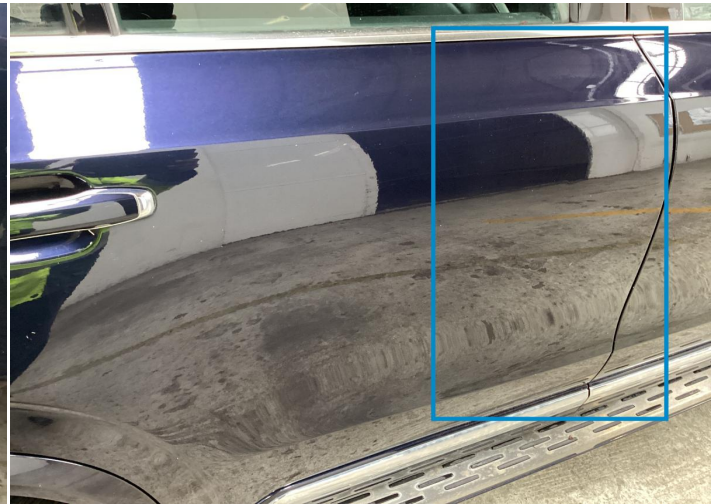
8. Door / Back Right
Bodywork / Dent / Hail Area -

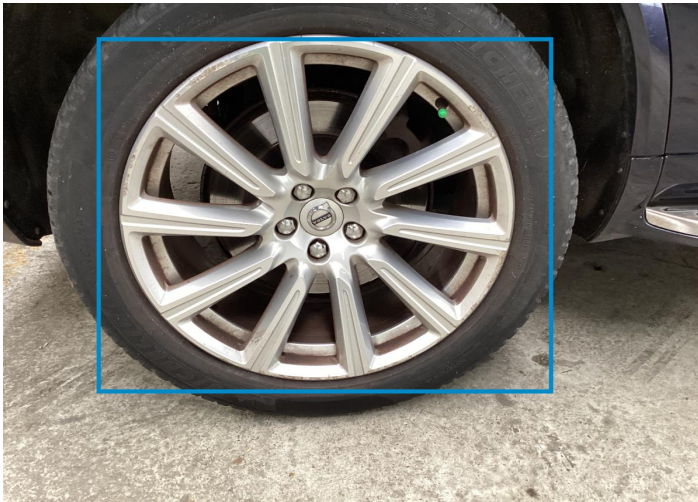
9. Rim Brake pads
Out of Bodywork / Scratch -
