Expertise

Protocol number: 41337532
Order No. / Reference: 25147311
Inspection date: 28 Aug 2025

Manufacturer: Volvo	Model: XC90 T8 AWD Recharge Ultimate Dark
VIN: YV1LFH5V1P1981548

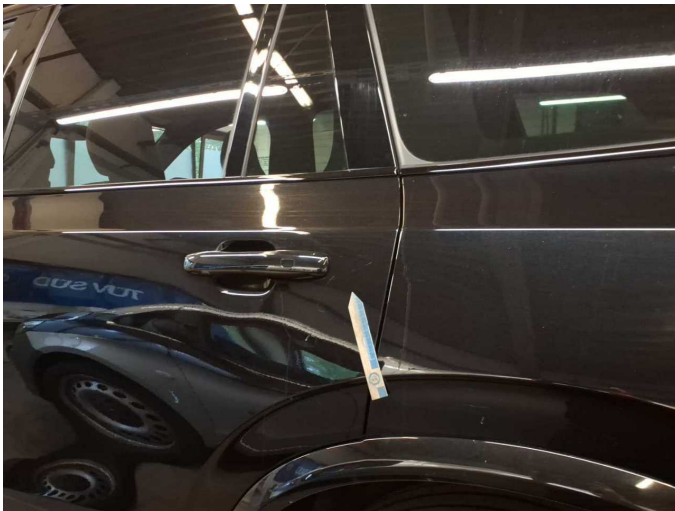
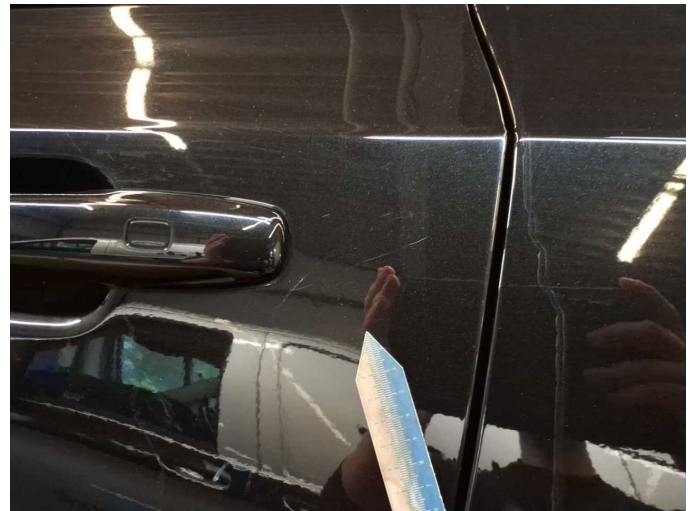
Damage 1: Door - rear left side: Door - Scratch(es) - Smart repair

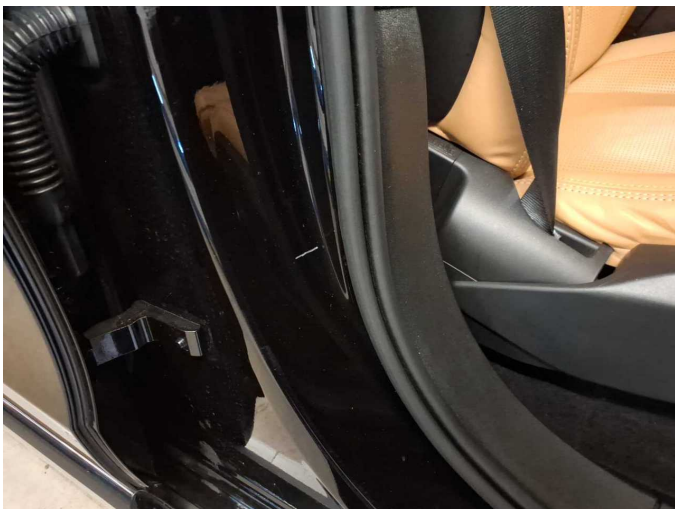
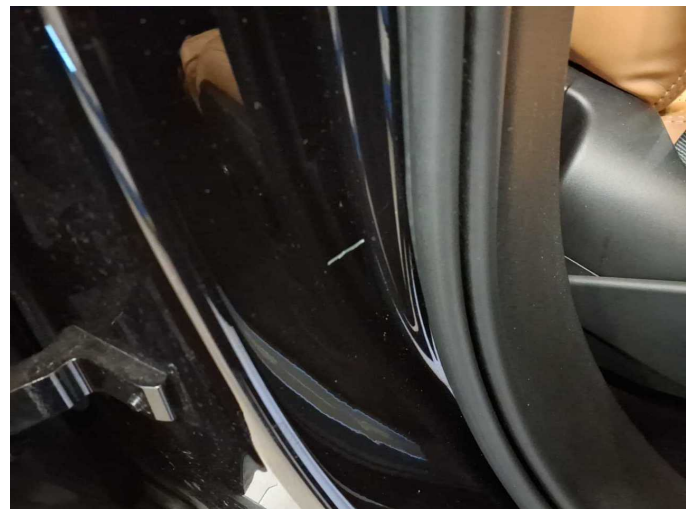
Damage 2: Body: B-pillar - right side - Scratch(es) - Smart repair

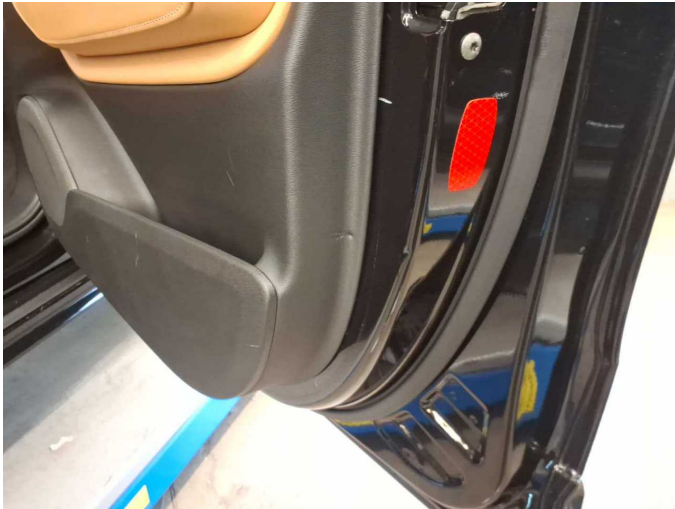
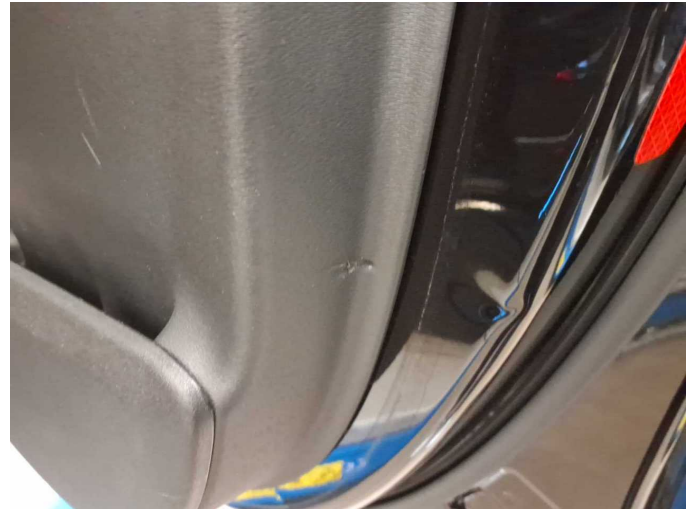
Damage 4: Trim / covers: Door trim - front right side - Scratch(es) - Smart repair

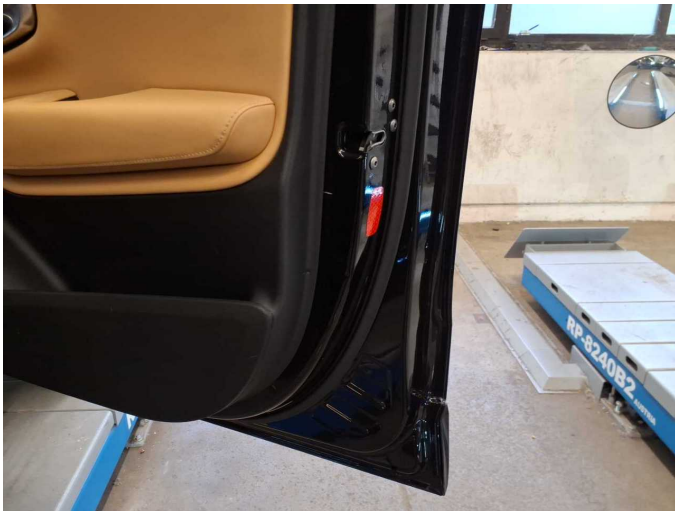
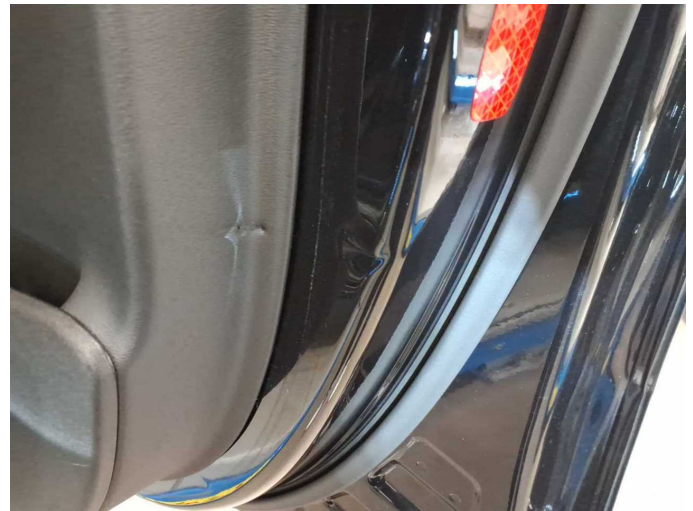
Damage 5: Door - front right side: Door (Innen) - dent(s) - Smooth repair work

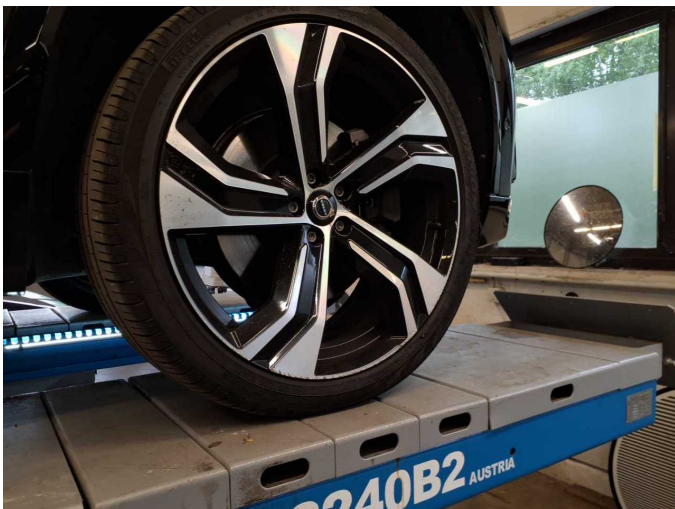
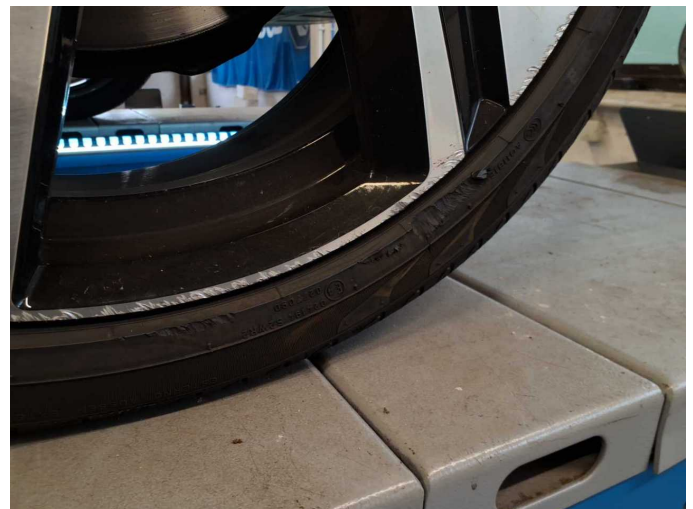
Damage 6: Wheel / tyres: Tyre - front right side (nicht fahrbereit) - Damaged - Replace

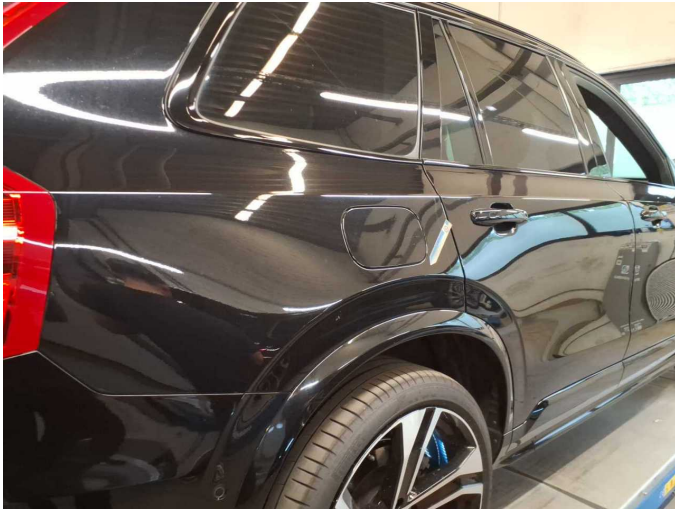
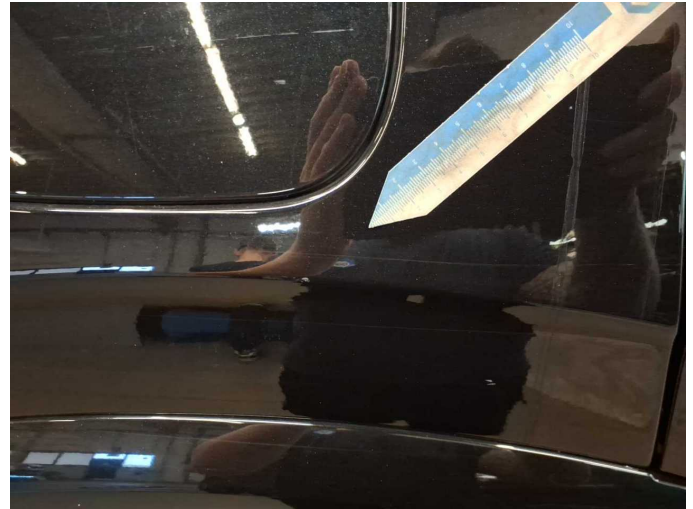
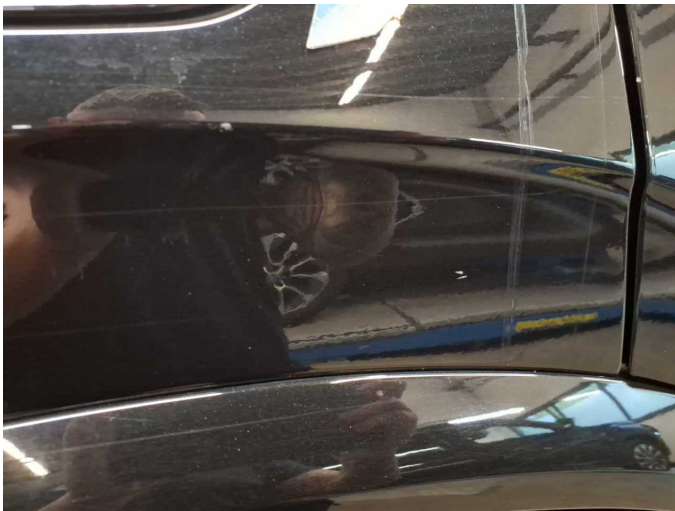
Damage 7: Side panel - rear right side: Side panel - Scratch(es) - Paint

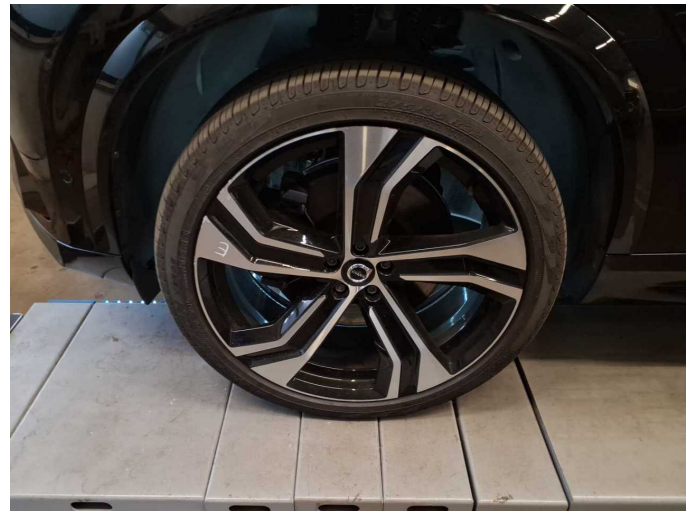
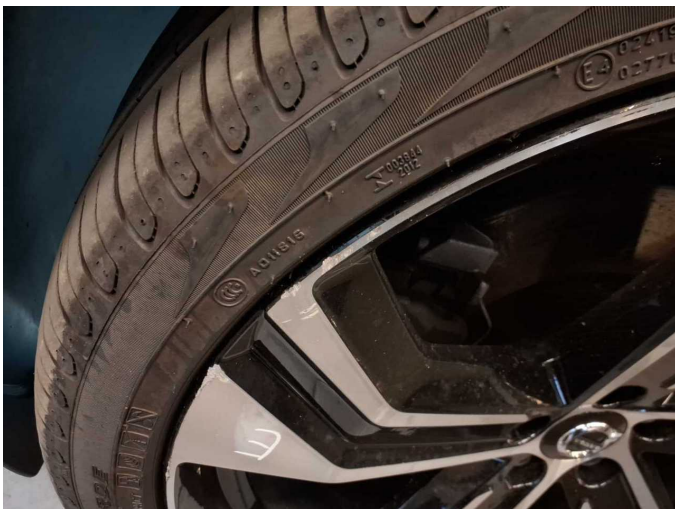
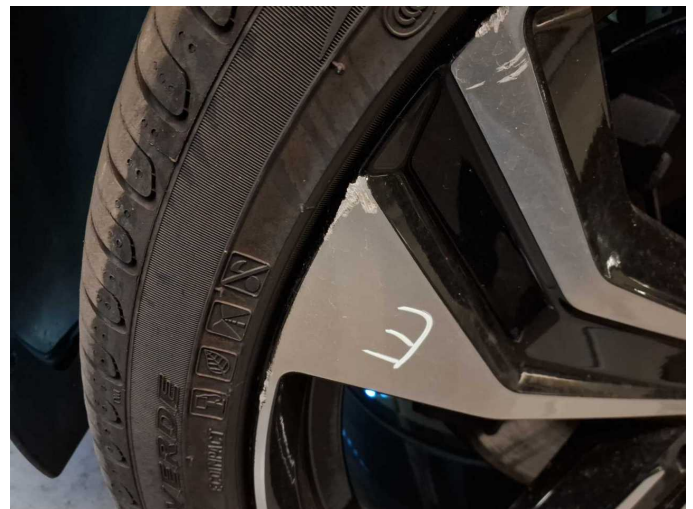
Damage 8: Wheel / tyres: Alloy rim - front left side - Scratched - Loss in value

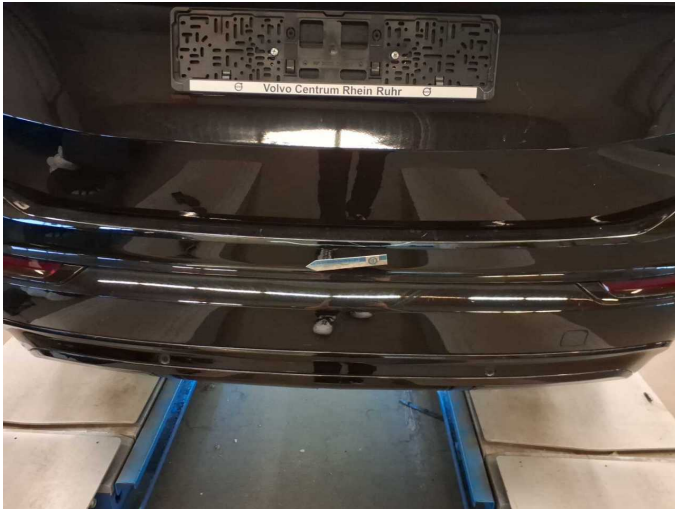
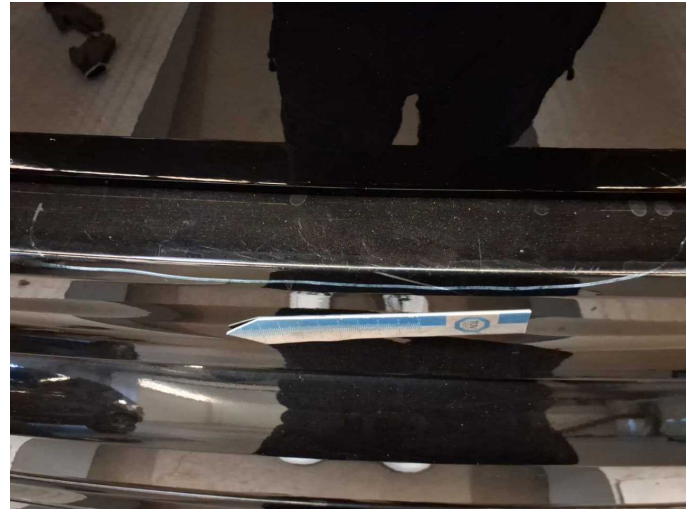
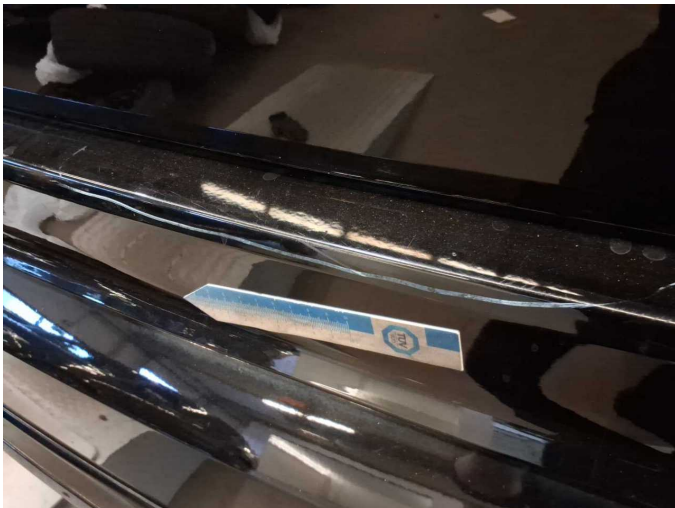
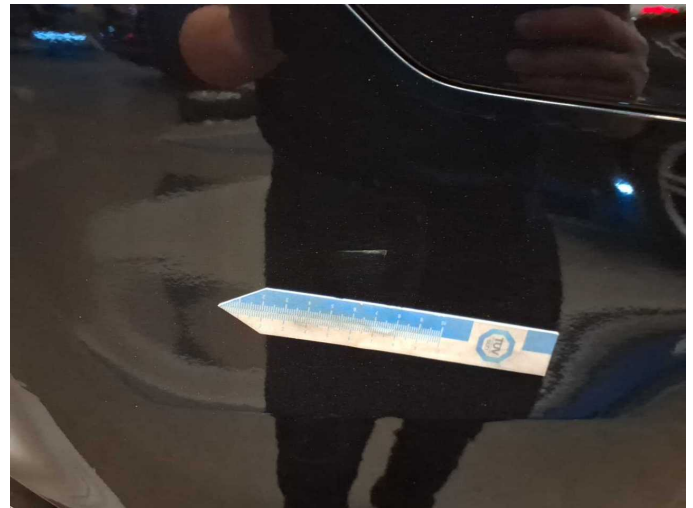
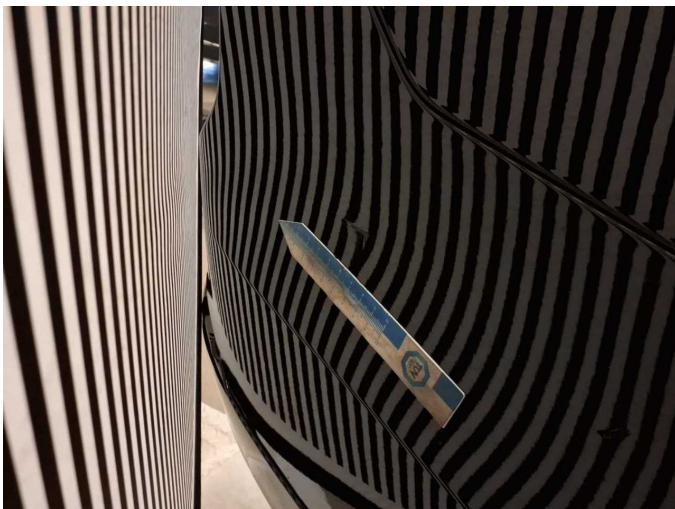
Damage 9: Rear bumper: Rear bumper - Dent / paintcoat damage - Repair and paint

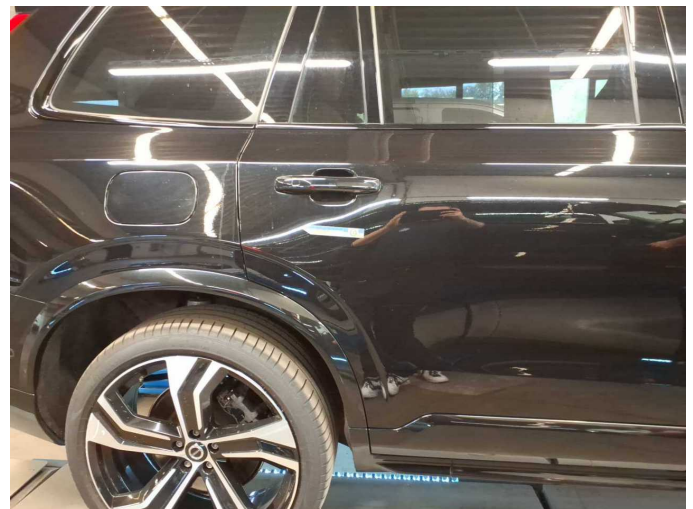
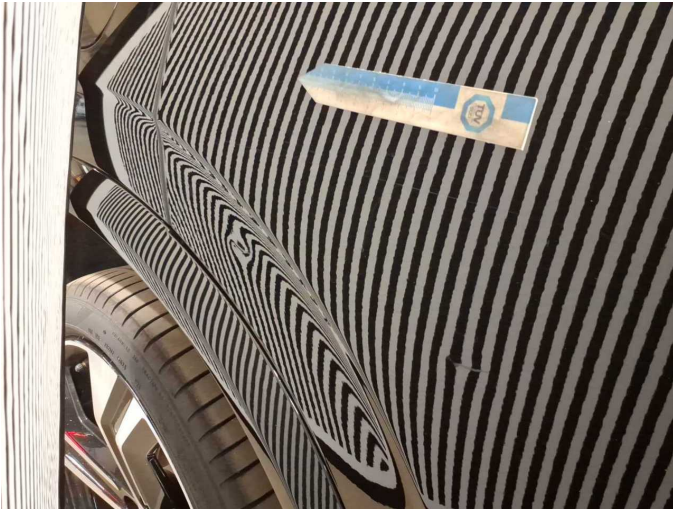
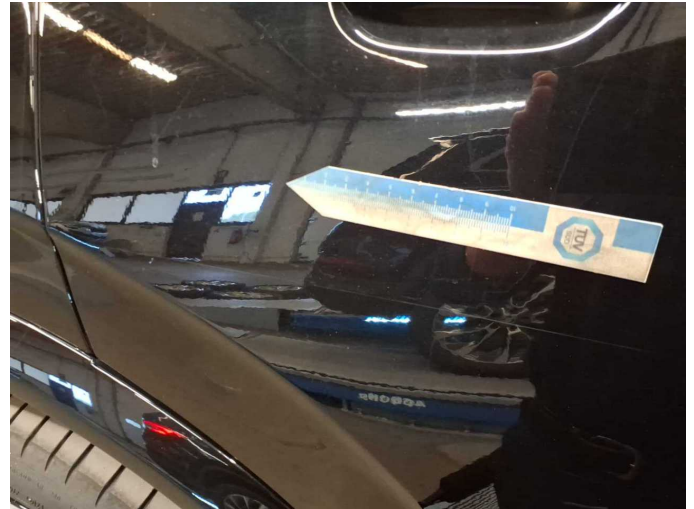
Damage 10: Door - rear right side: Door - Dent / paintcoat damage - Repair and paint

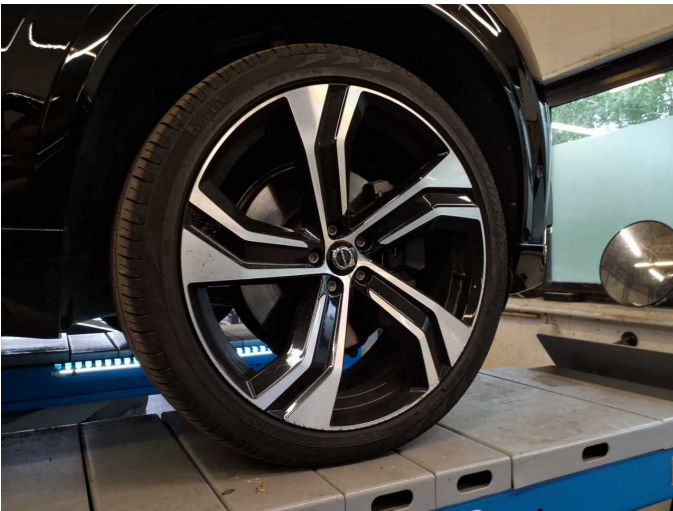
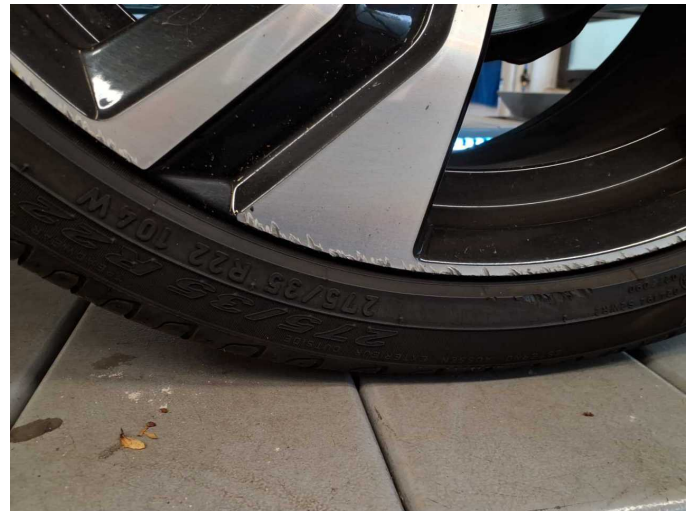
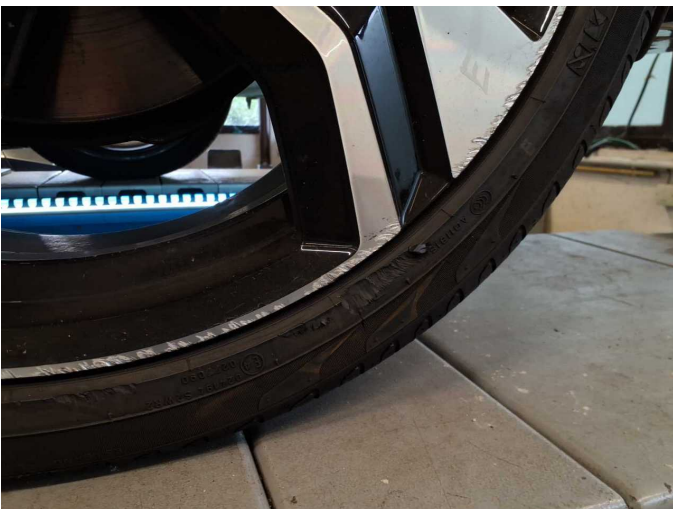
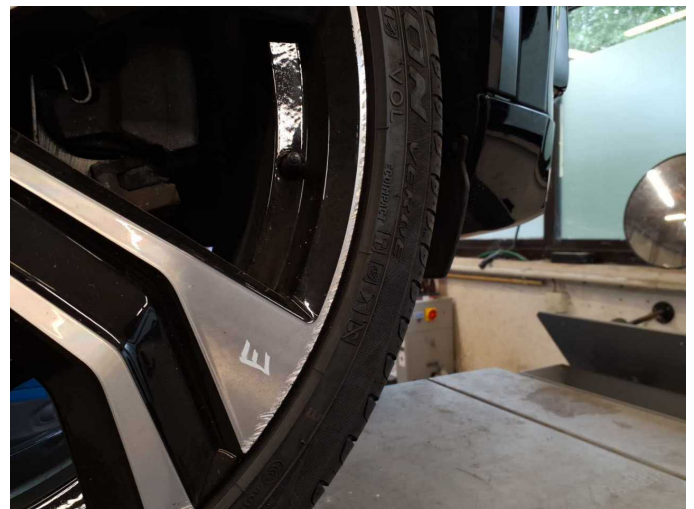
Damage 11: Wheel / tyres: Alloy rim - front right side - Scratched - Loss in value

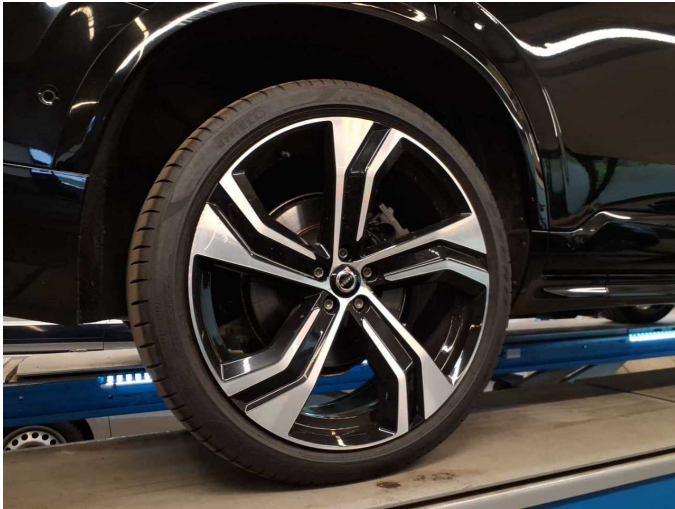
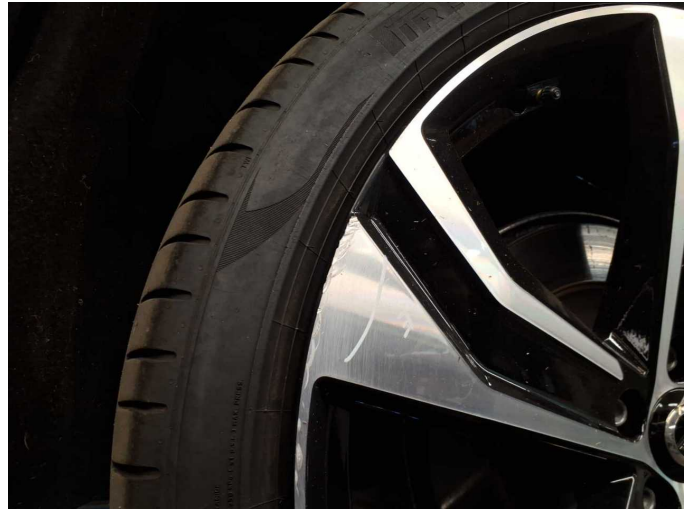
Damage 12: Wheel / tyres: Alloy rim - rear right side (Materialabtrag) - Scratched - Loss in value

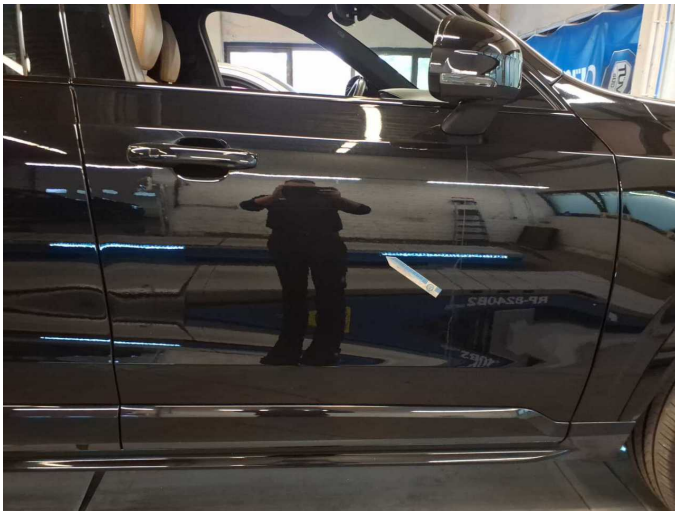
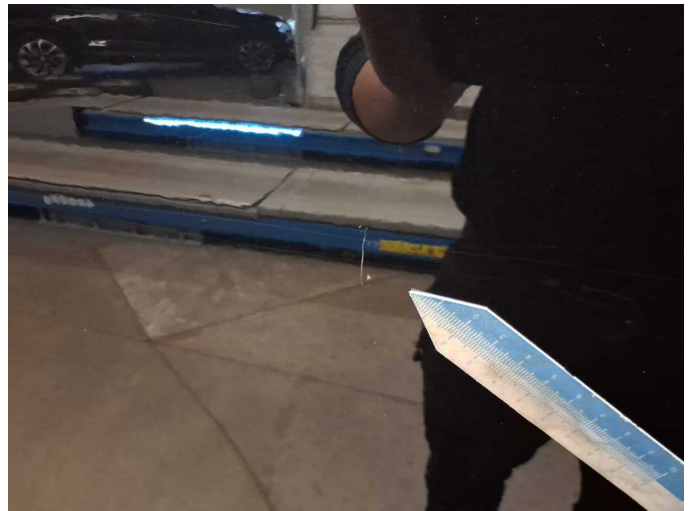
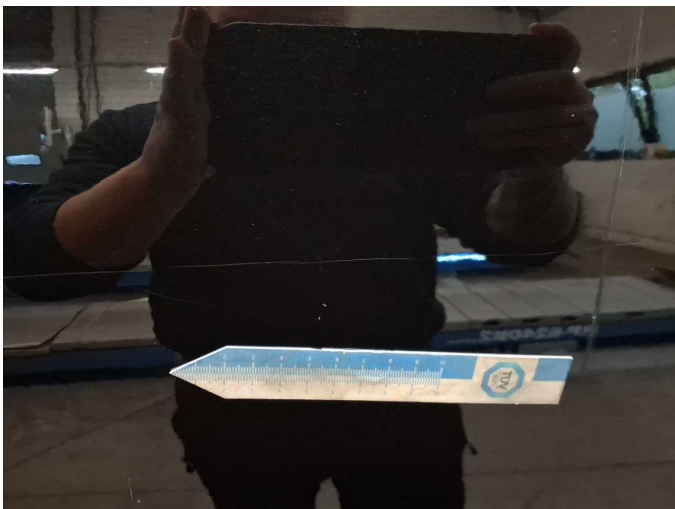
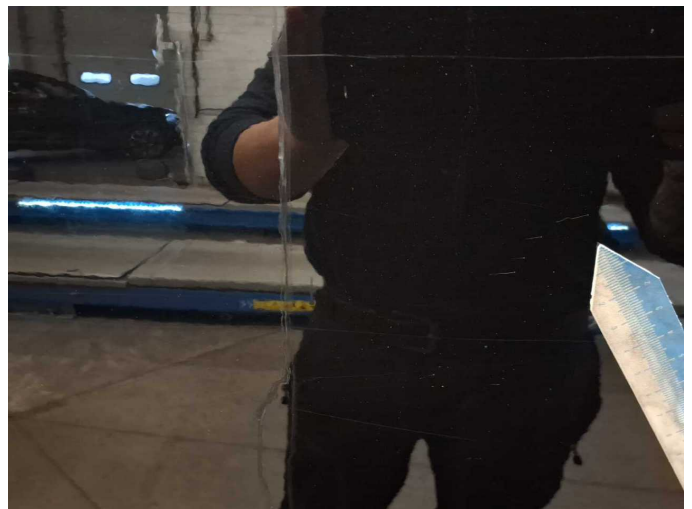
Damage 13: Door - front right side: Door - Scratch(es) - Paint

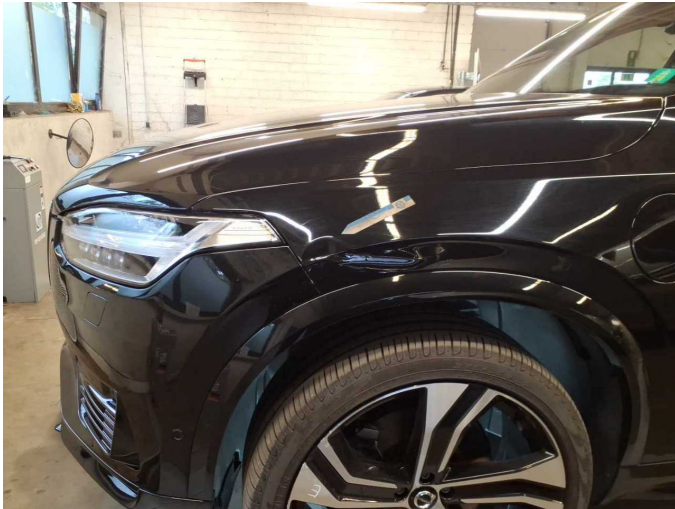
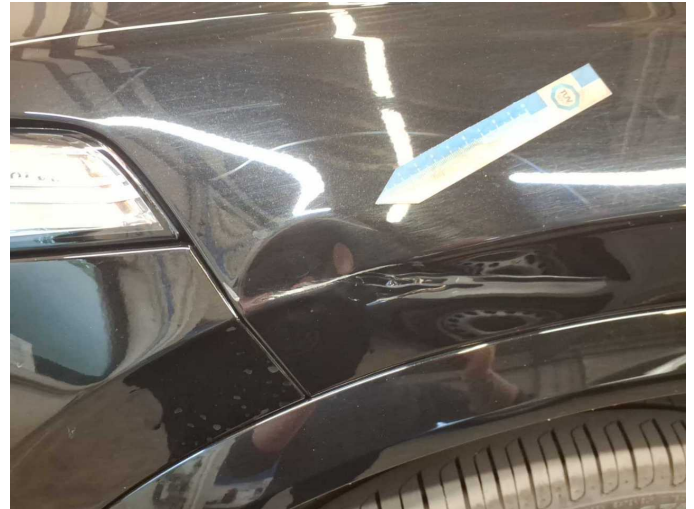
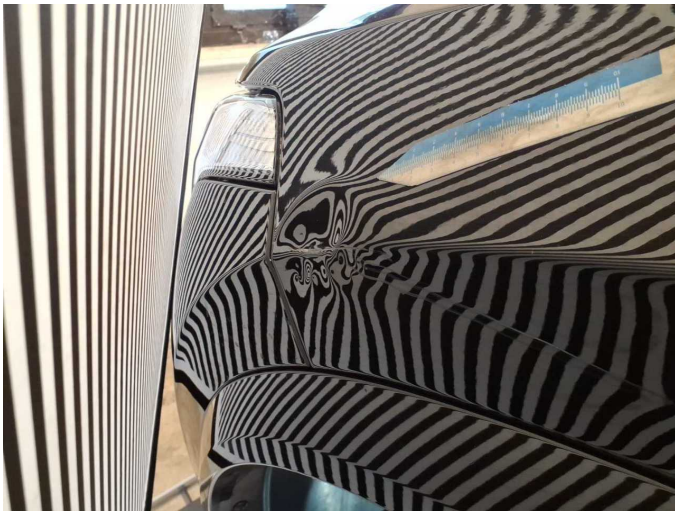
Damage 14: Mudguard - left side: Mudguard - left side - Dent / paintcoat damage - Replace

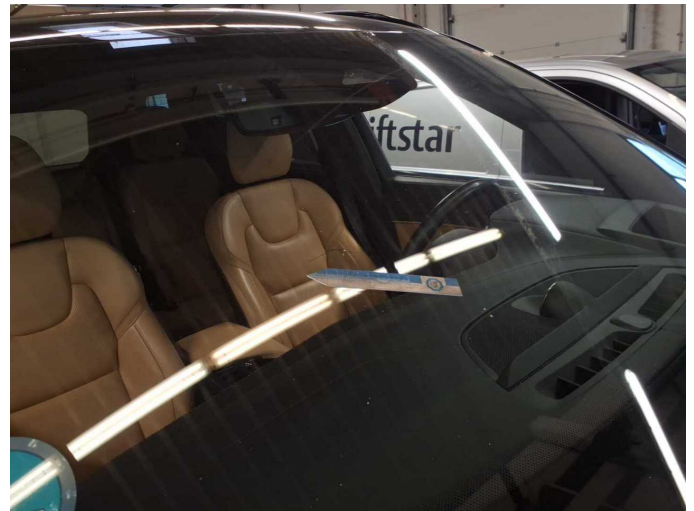
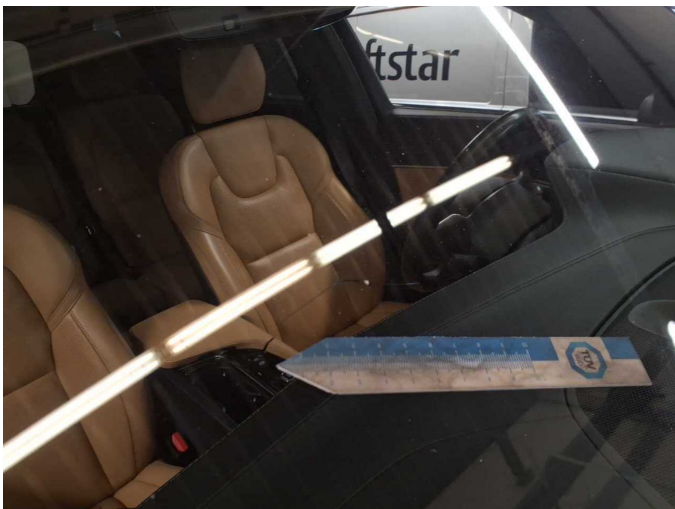
Damage 15: Vehicle glazing: Windscreen - Broken / torn - repair according to calculation

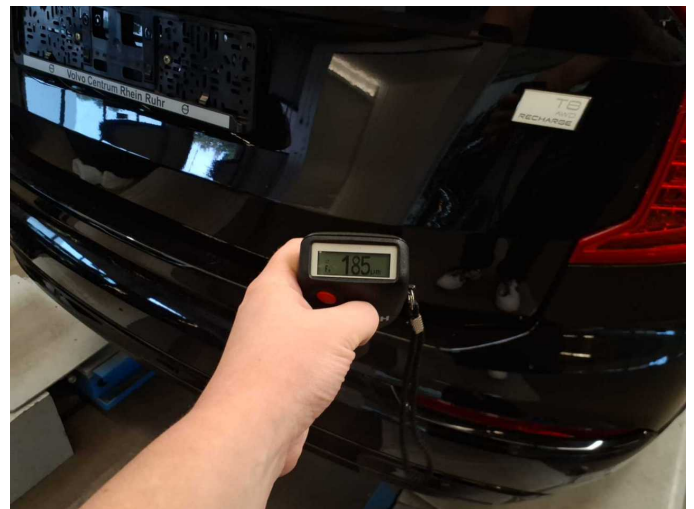
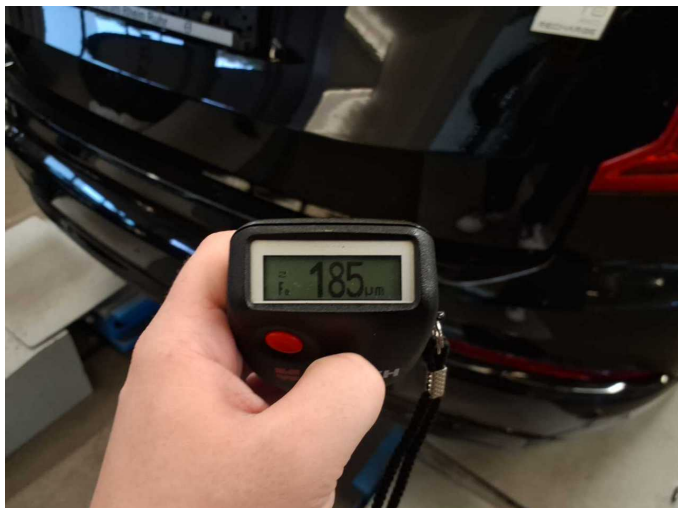
No.	Repainting
1	Boot lid / rear door, Professionally carried out, Invoice of repair done Non-existent

Boot lid / rear door	185 µm
----------------------	--------

Repainting 1: Boot lid / rear door
