## status report

| <b>report Number:</b> | <b>0000001256008-EN18</b> |

| vehicle data | | | |
|---|---|---|---|
| <b>Volvo XC90 (09.2014-&gt;) Plus Dark AWD</b> | | | |
| Vehicle identification number | <b>YV1LFK2V6P1952130</b> | mileage read: | <b>40431 km</b> |

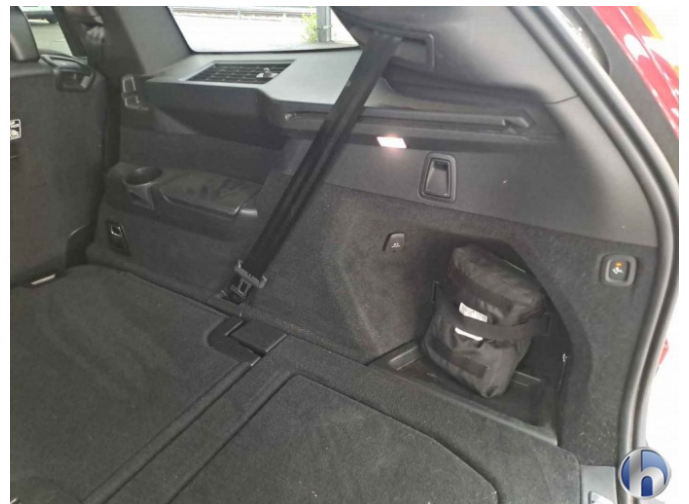
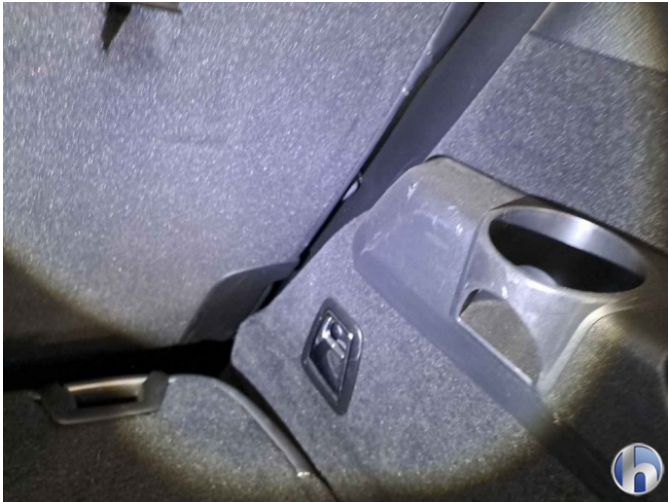
2. Trunk lining law

| | component | Damage | Rep kind |
|---|---|---|---|
| 2. | Trunk lining law | Scrape | |

Scrape

**Scrape**

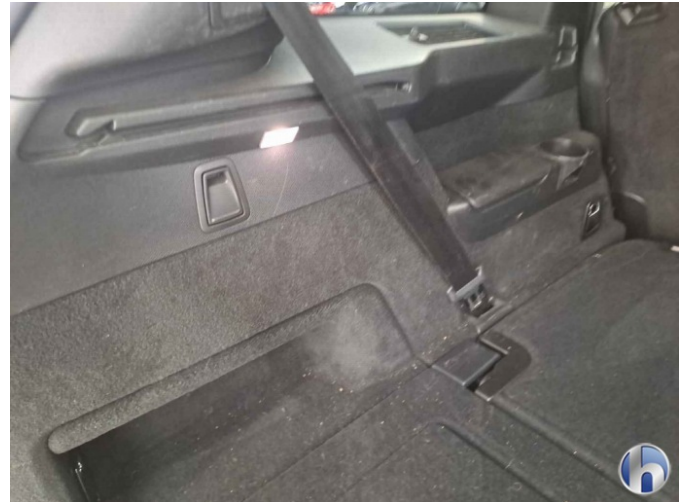
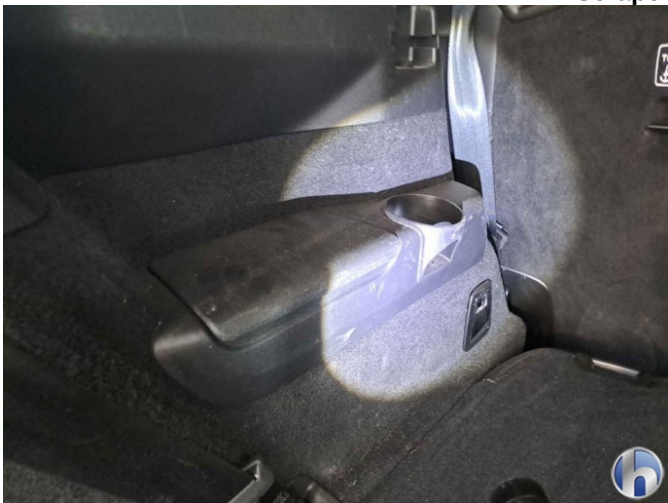
3. Trunk lining left

| | component | Damage | Rep kind |
|---|---|---|---|
| 3. | Trunk lining left | Scrape | |

**Scrape**

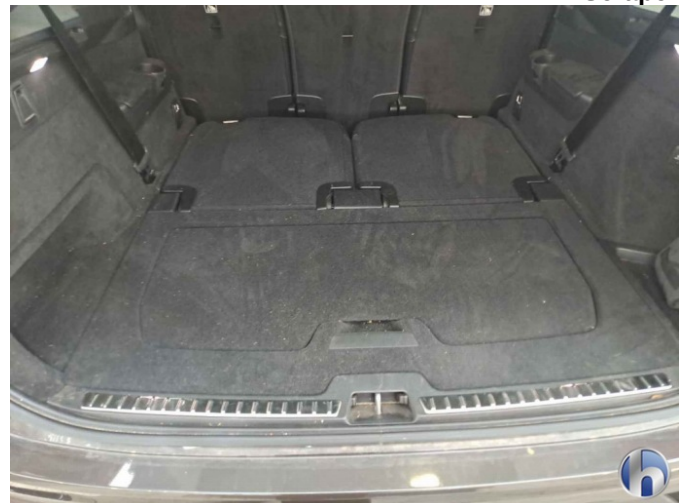
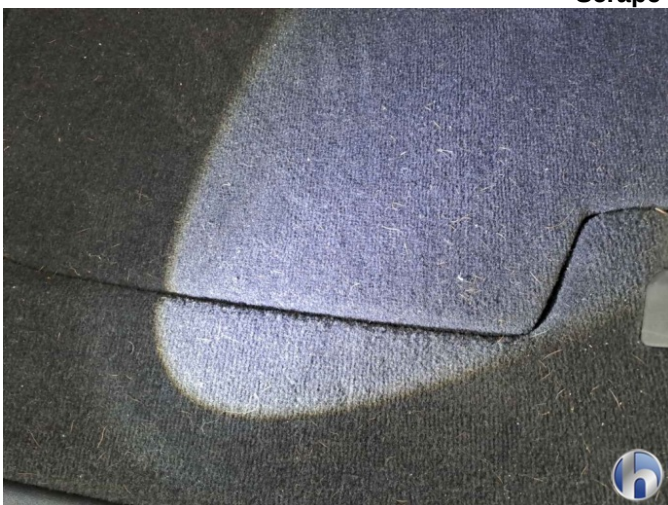
| | component | Damage | Rep kind |
|---|---|---|---|
| 4. | | Dirty (animal hair) | |

**Dirty (animal hair)**

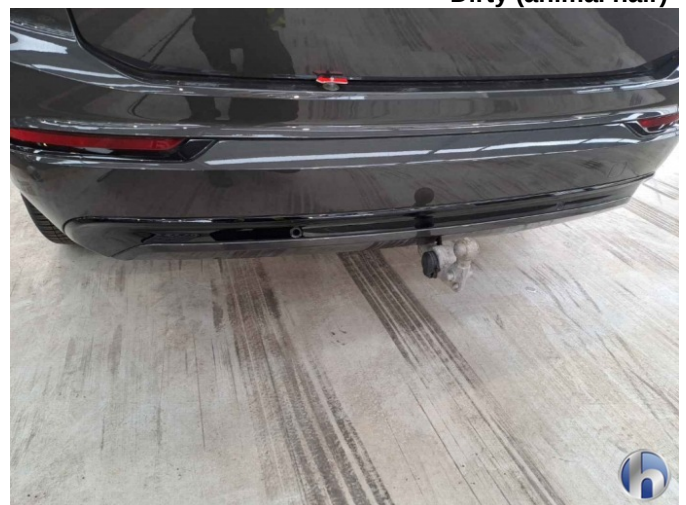
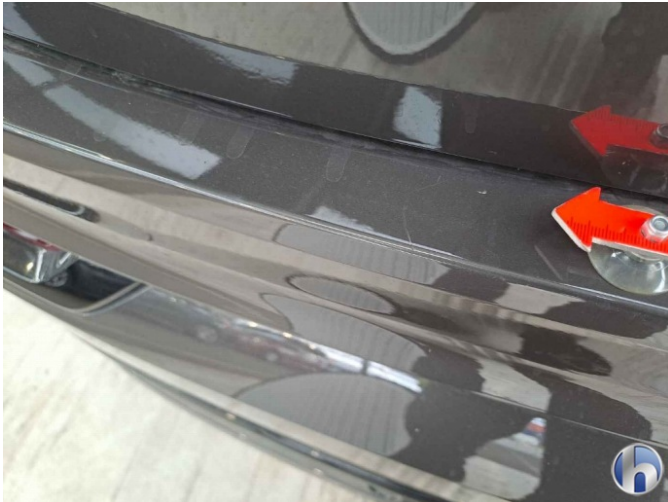
5. Rear bumper

| | component | Damage | Rep kind |
|---|---|---|---|
| 5. | Rear bumper | Scratch(es) | |

**Scratch(es)**

Scratch(es)

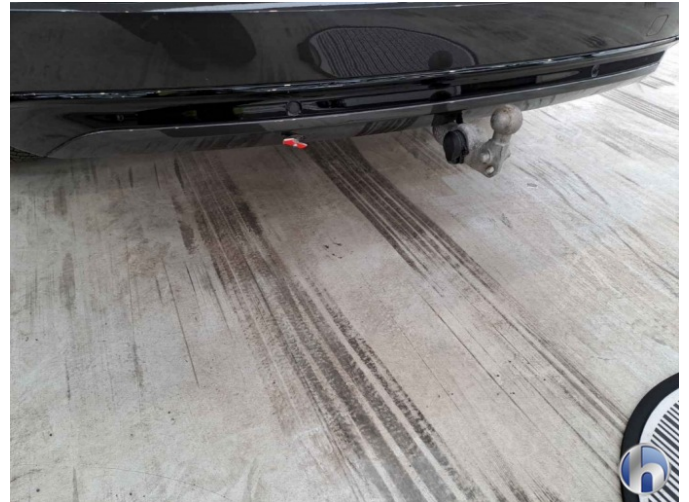
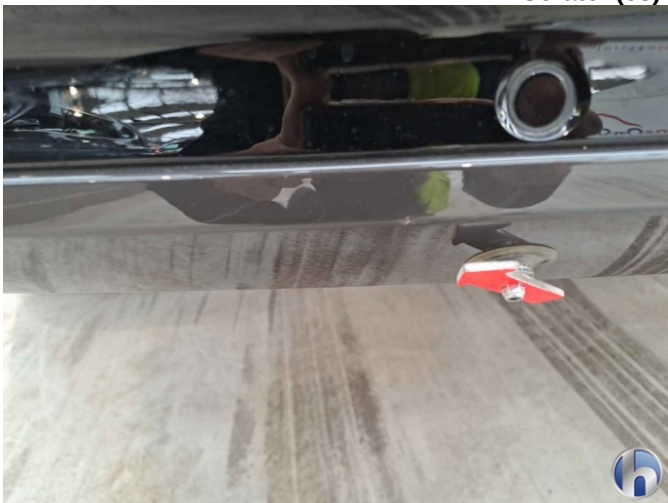
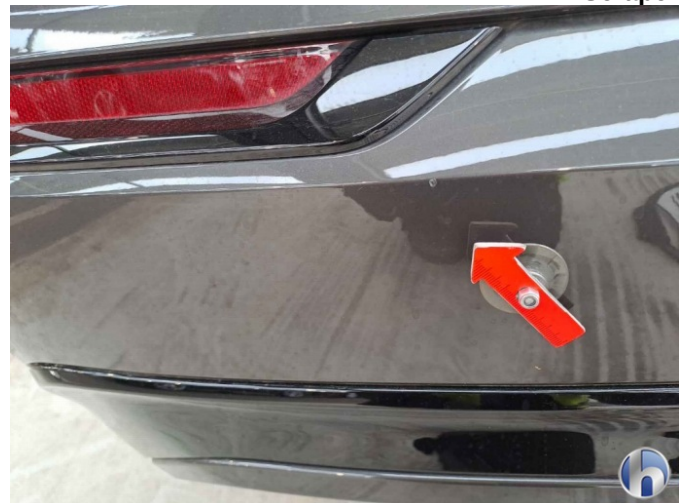
6. Diffusor

| | component | Damage | Rep kind |
|---|---|---|---|
| 6. | Diffusor | Scrape | |

Scrape

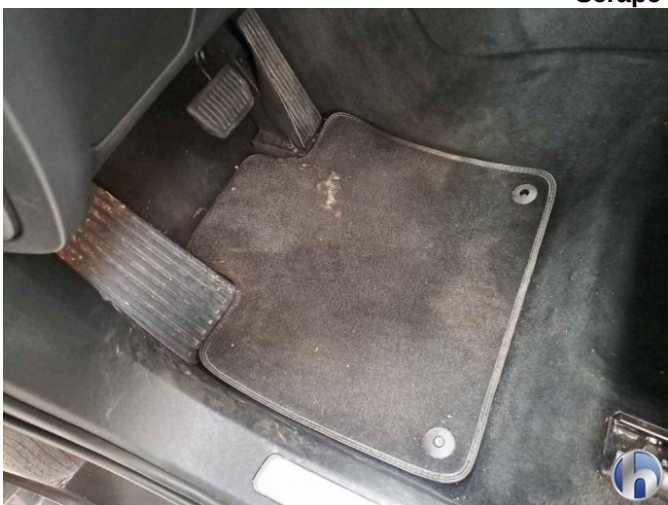
| | component | Damage | Rep kind |
|---|---|---|---|
| 7. | | Damaged | |

Damaged

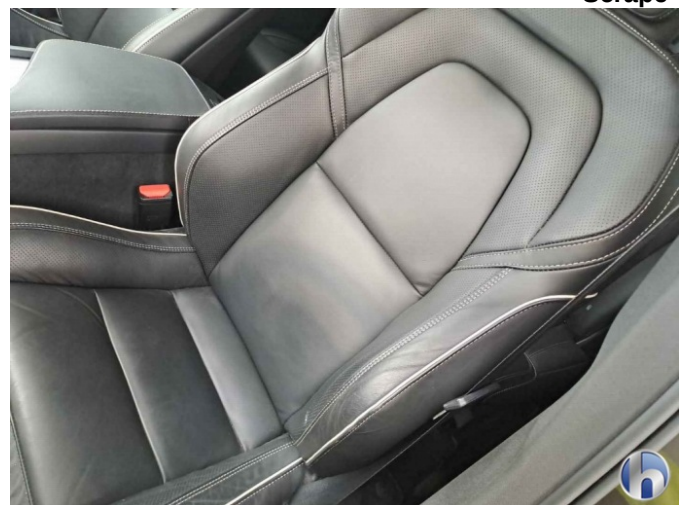
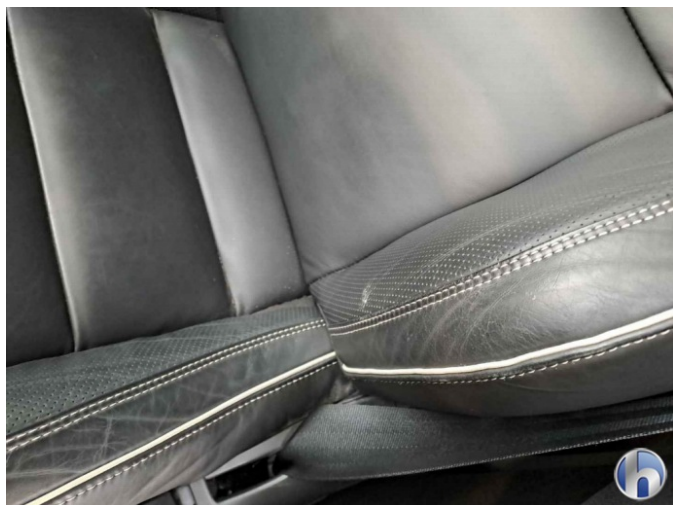
| | component | Damage | Rep kind |
|---|---|---|---|
| 9. | | Damaged | |

Damaged

**Damaged**

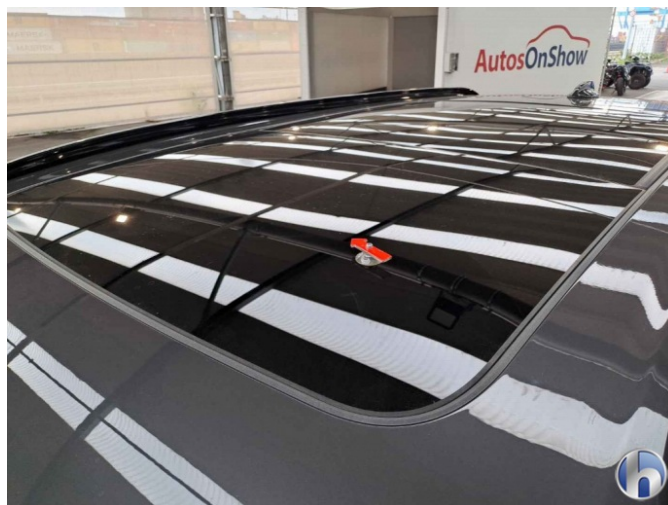
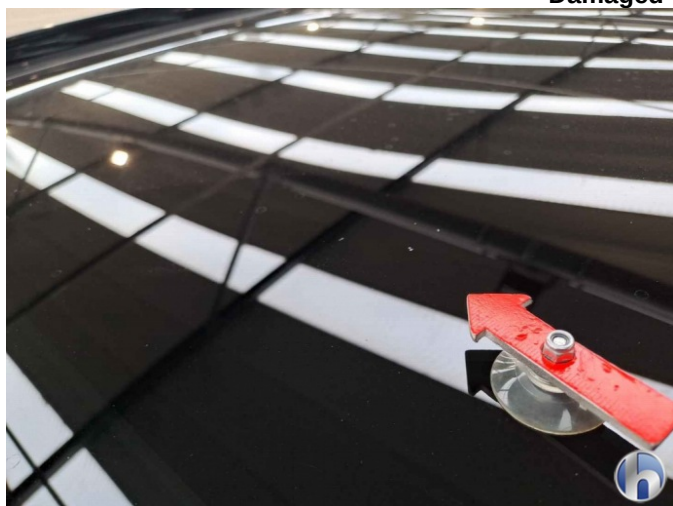
10. Sunroof

| | component | Damage | Rep kind |
|---|---|---|---|
| 10. | Sunroof | Chipping from stones | |

**Chipping from stones**

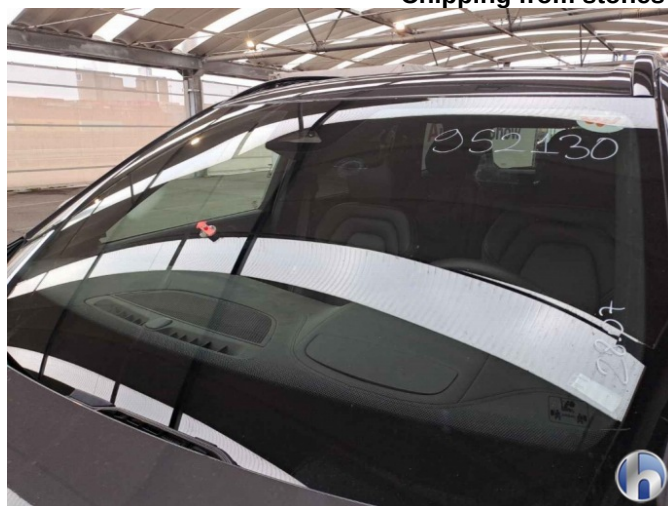
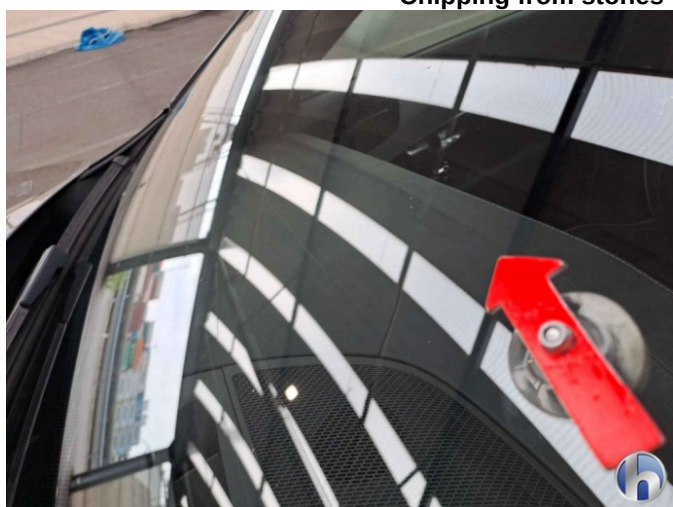
11. Windshield

| | component | Damage | Rep kind |
|---|---|---|---|
| 11. | Windshield | Chipping from stones in field of view | |

**Chipping from stones in field of view**

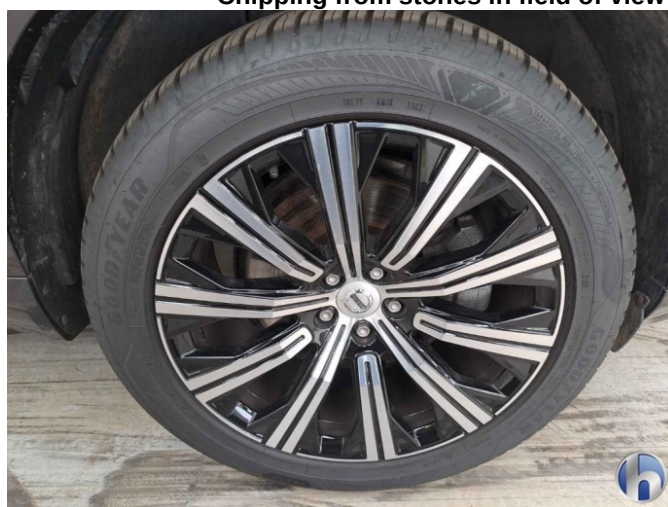
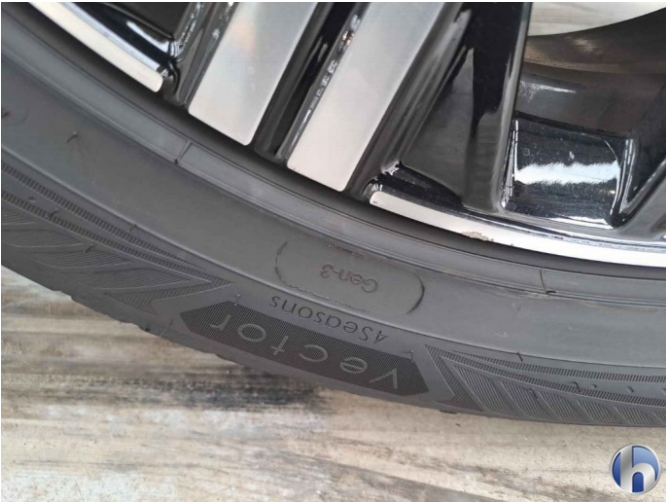
| | component | Damage | Rep kind |
|---|---|---|---|
| 12. | | Scrape | |

**Scrape**

12. **Scrape**

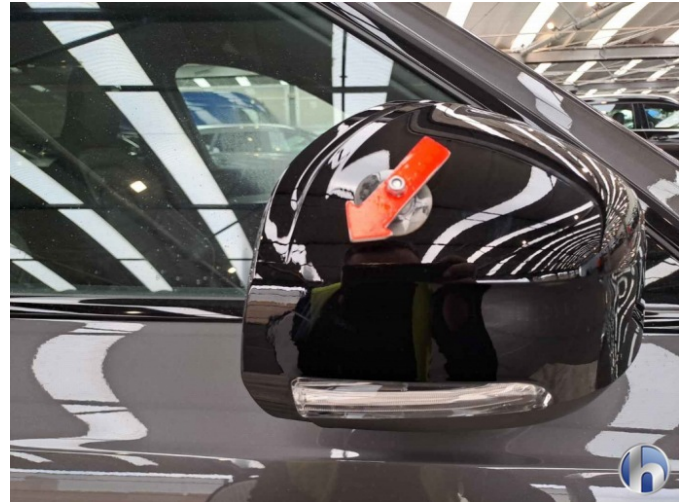
| | component | Damage | Rep kind |
|---|---|---|---|
| 13. | Outside mirror - right | Scratch(es) | |

13. Outside mirror - right **Scratch(es)**

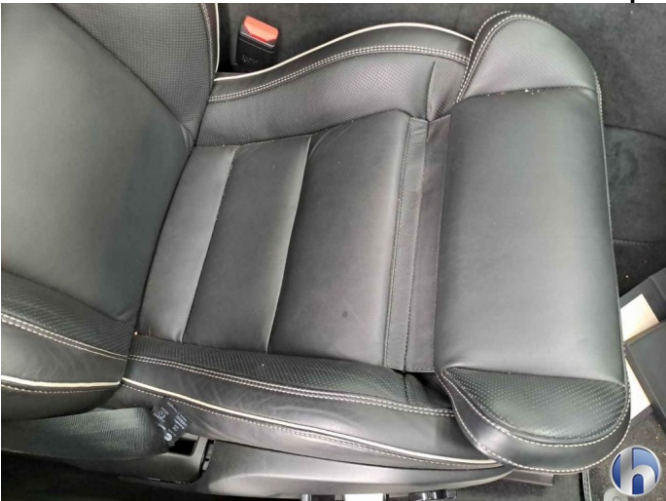
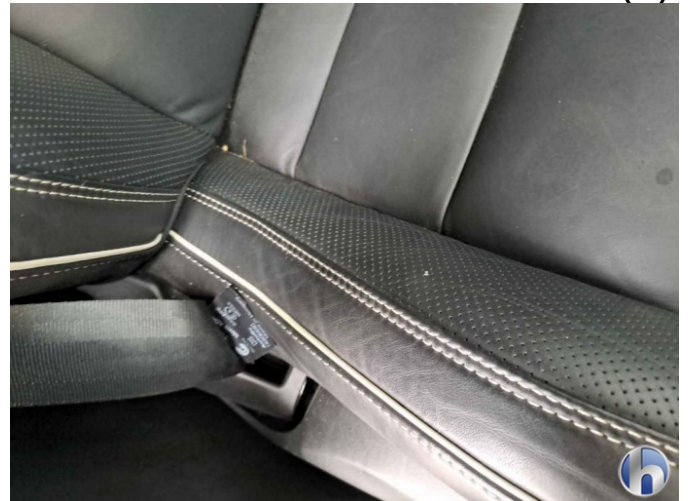
| | component | Damage | Rep kind |
|---|---|---|---|
| 14. | Sitz - Vorne - Rechts: Kissen | Damaged | |

14. Sitz - Vorne - Rechts: Kissen **Damaged**

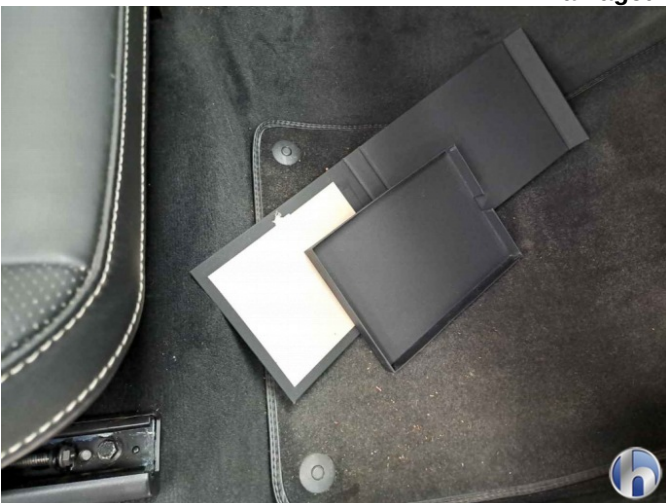
| | component | Damage | Rep kind |
|---|---|---|---|
| 15. | | Damaged | |

15. **Damaged**

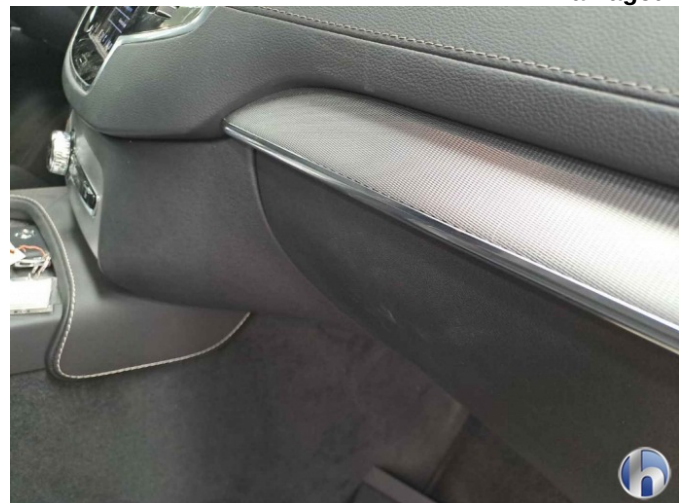
| | component | Damage | Rep kind |
|---|---|---|---|
| 16. | Zierleiste Vorne - Mitte | Scratch(es) | |

16. Zierleiste Vorne - Mitte **Scratch(es)**

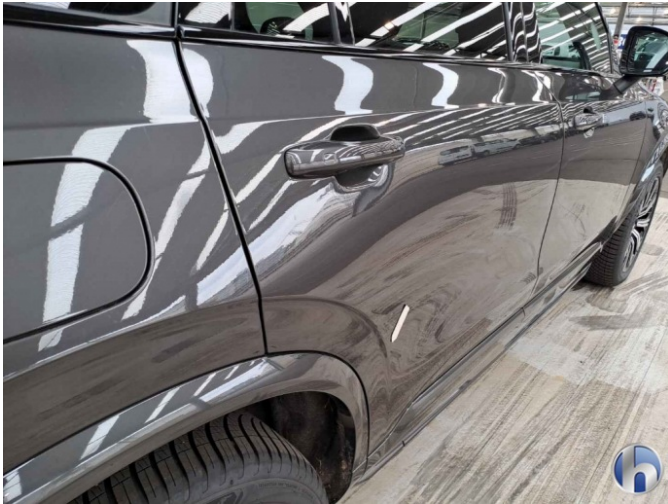
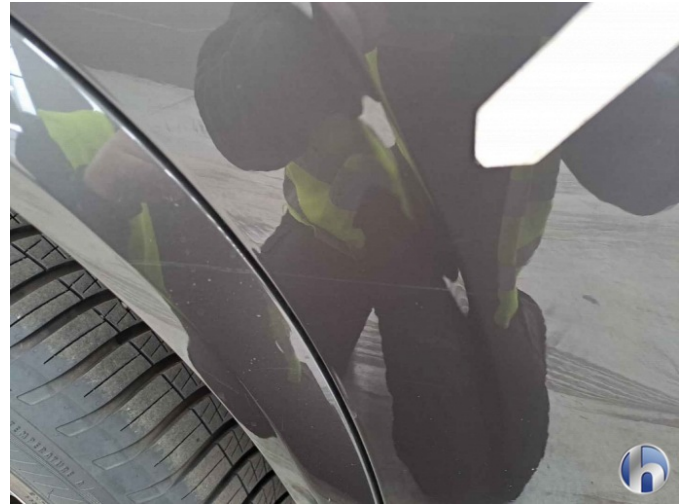
17. Door Rear - right

| | component | Damage | Rep kind |
|---|---|---|---|
| 17. | Door Rear - right | Scratch(es) | |

Scratch(es)

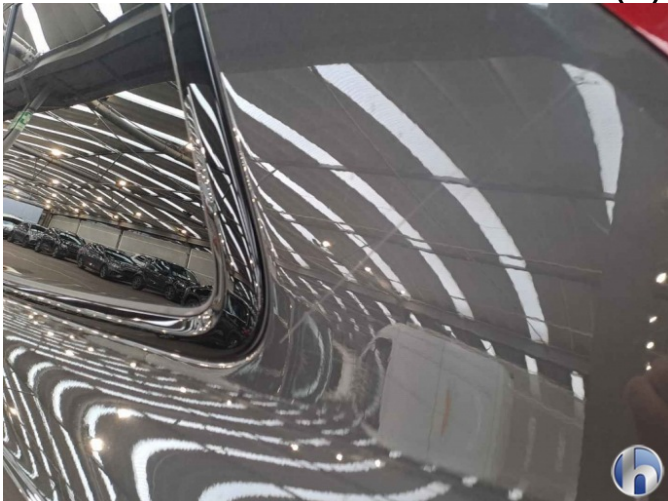
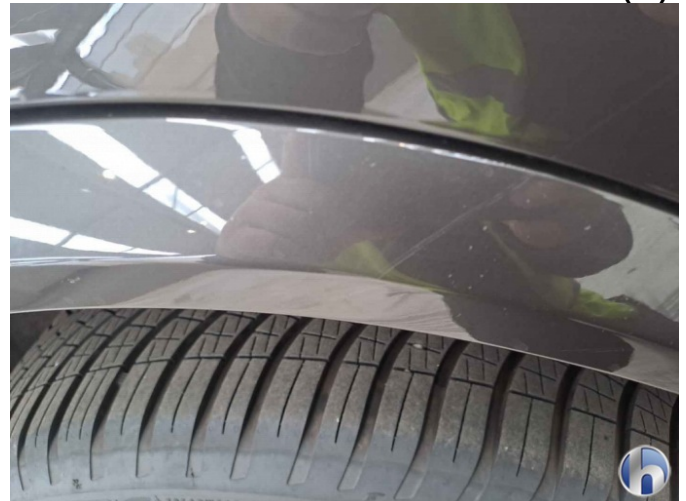
18. exterior body

| | component | Damage | Rep kind |
|---|---|---|---|
| 18. | exterior body | Surface scratch(es) | |

Surface scratch(es)

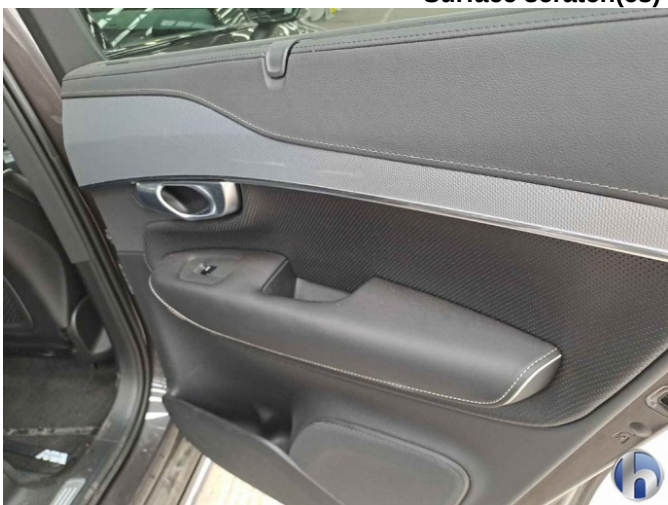
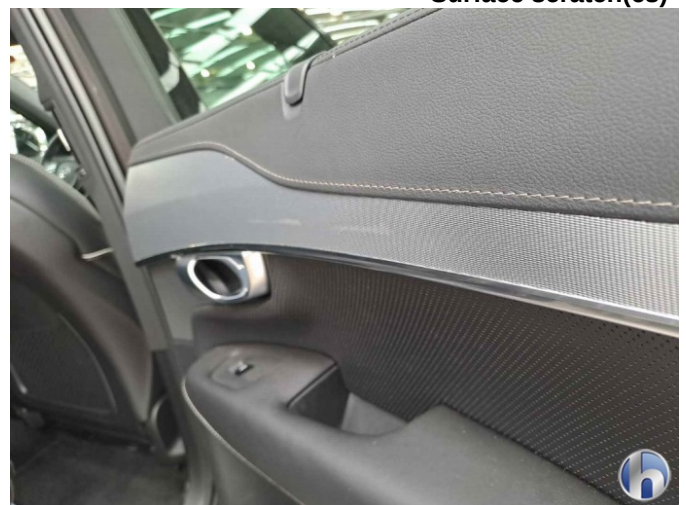
19. Moulding Rear - right

| | component | Damage | Rep kind |
|---|---|---|---|
| 19. | Moulding Rear - right | Damaged | |

Damaged

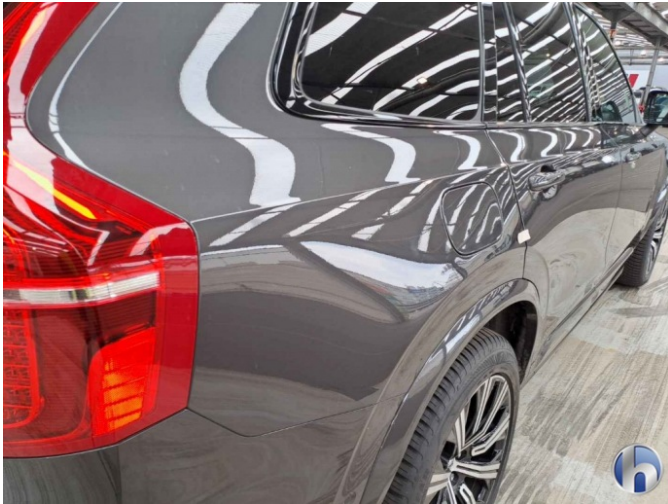
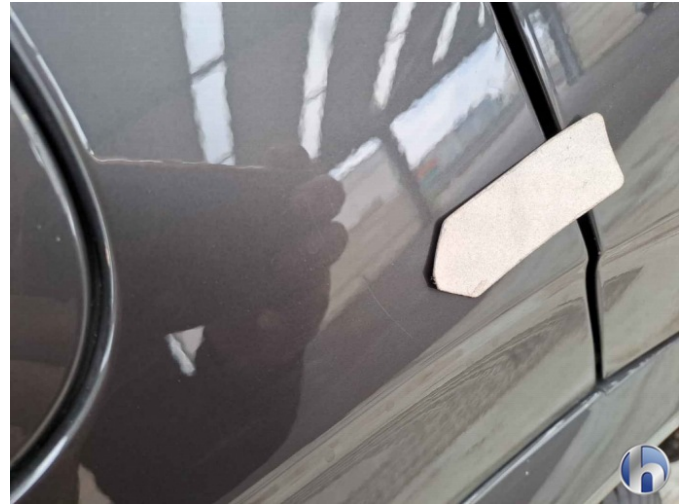
20. Sidewall - Rear - right

| | component | Damage | Rep kind |
|---|---|---|---|
| 20. | Sidewall - Rear - right | Scratch(es) | |

**Scratch(es)**

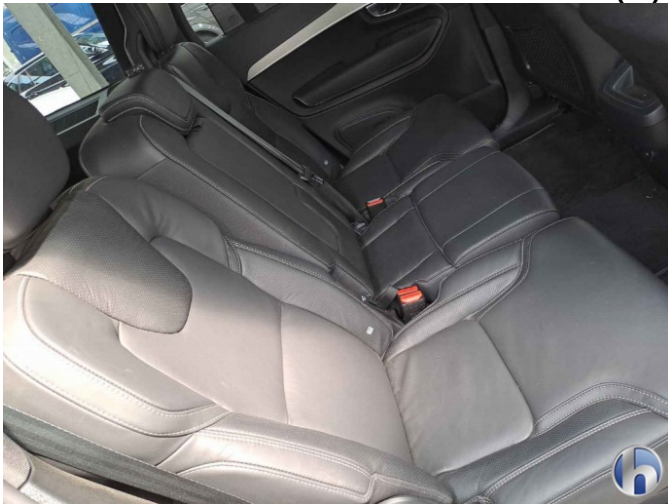
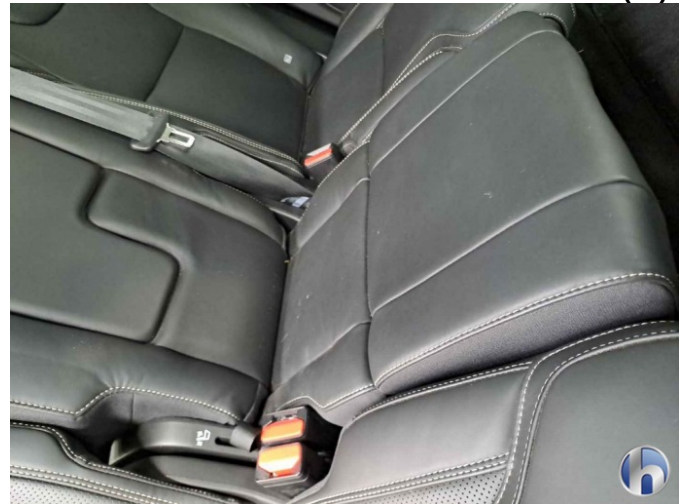
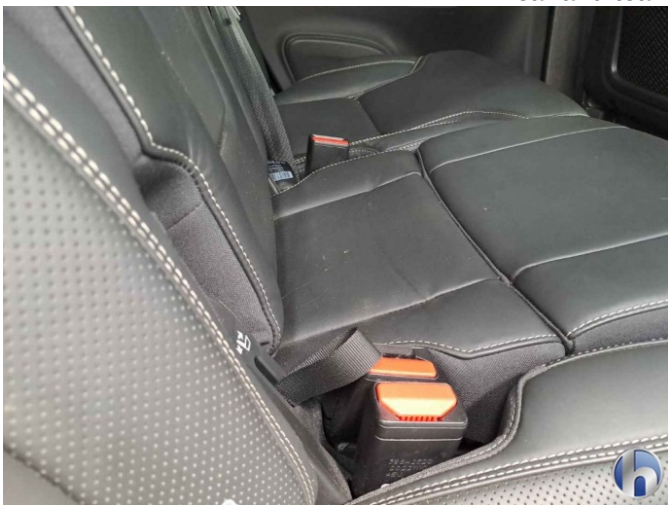
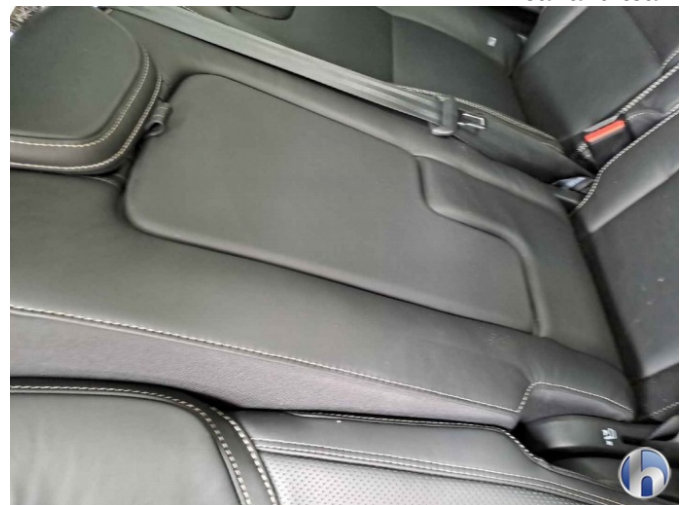
| | component | Damage | Rep kind |
|---|---|---|---|
| 21. | | Wear and tear | |

**Wear and tear**

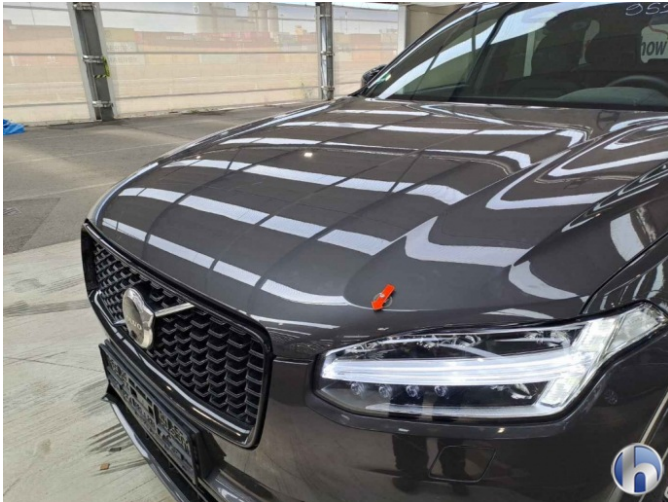
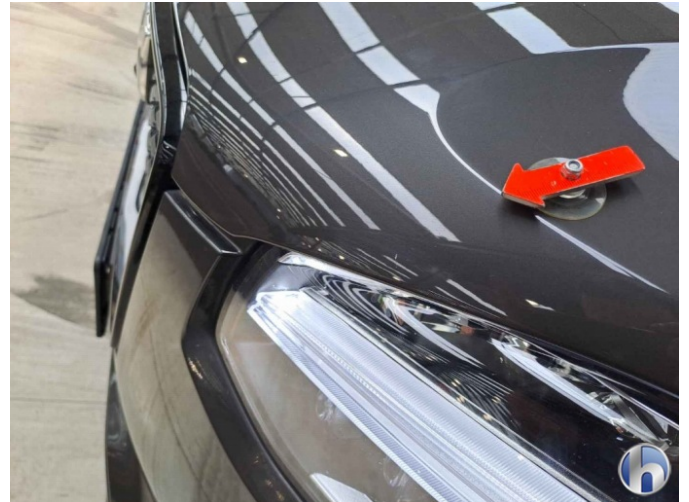
22. hood

| | component | Damage | Rep kind |
|---|---|---|---|
| 22. | hood | Wear and tear | |

**Wear and tear**

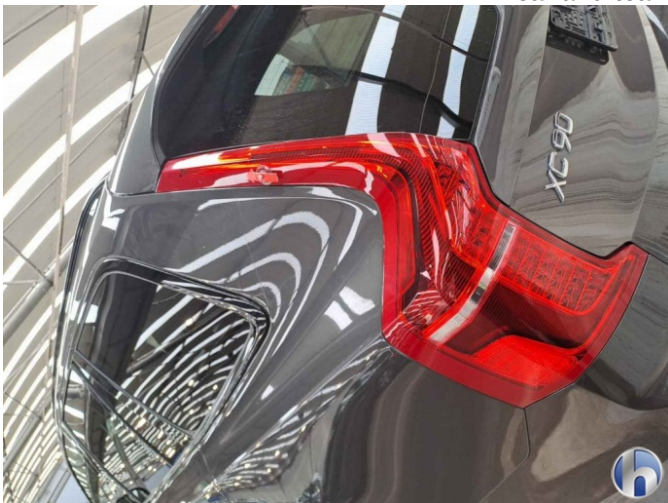
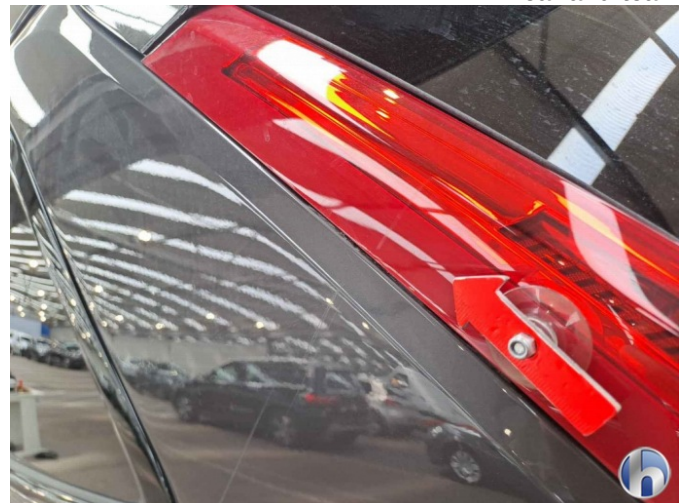
23. Taillight left

| | component | Damage | Rep kind |
|---|---|---|---|
| 23. | Taillight left | Scratch(es) | |

**Scratch(es)**

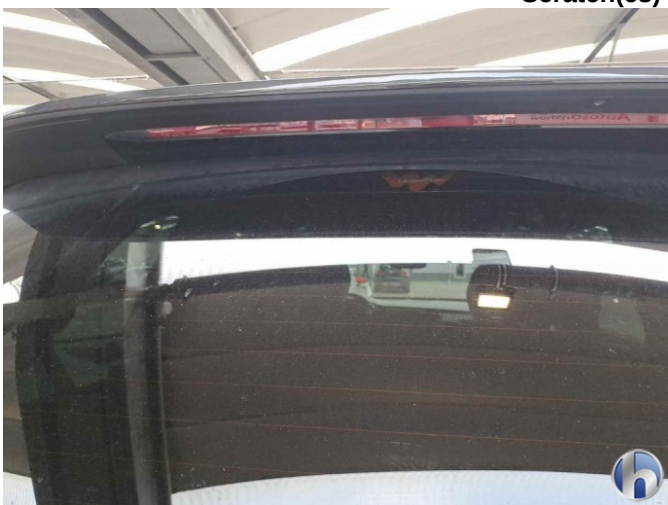
24. rear window

| | component | Damage | Rep kind |
|---|---|---|---|
| 24. | rear window | Sticker | |

**Sticker**
