Expertise

Protocol number: 41133448  
Order No. / Reference: 25015474  
Inspection date: 11 Aug 2025

Manufacturer: Volvo	Model: XC60 B4 D Core
VIN: YV1UZZK5V6P1265544

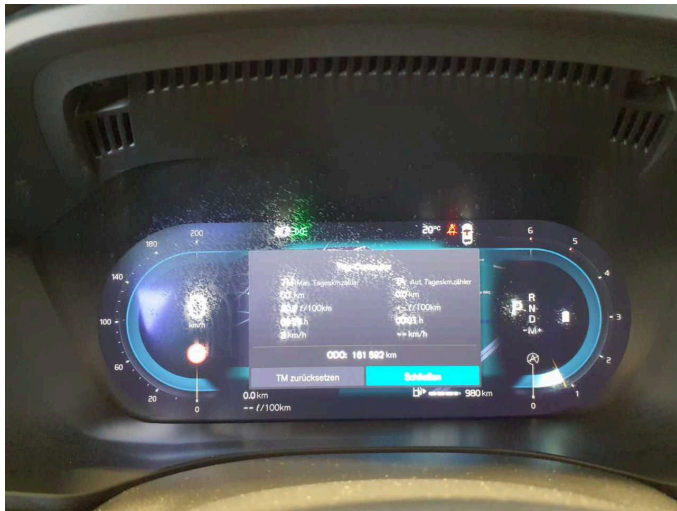
Damage 1: Instrument panel: Instrument cluster - Soiled - Clean

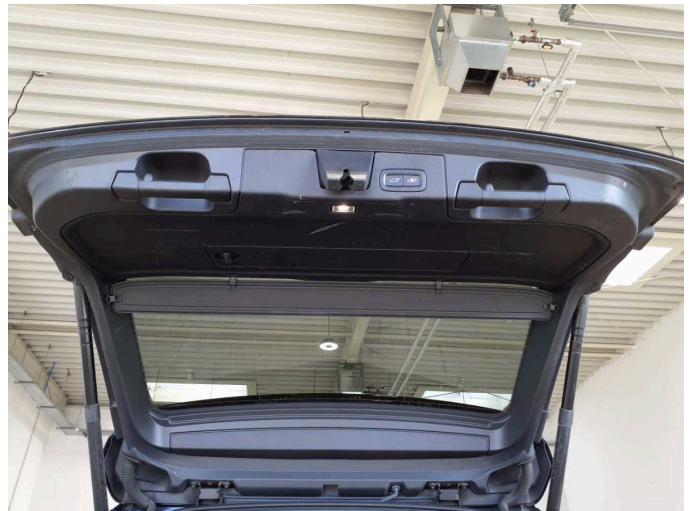
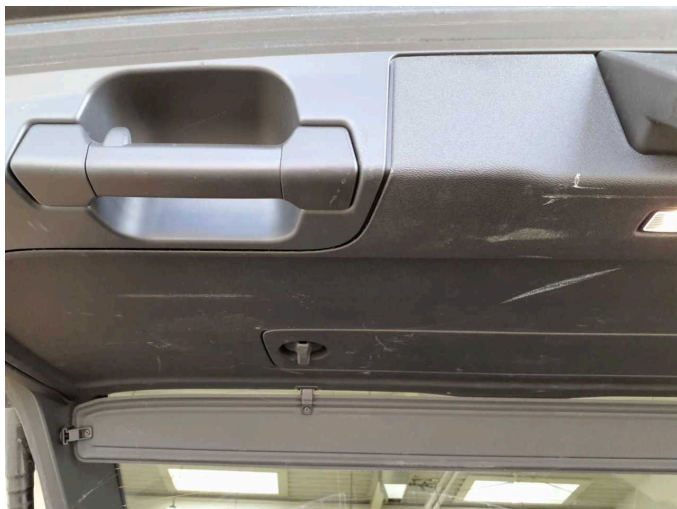
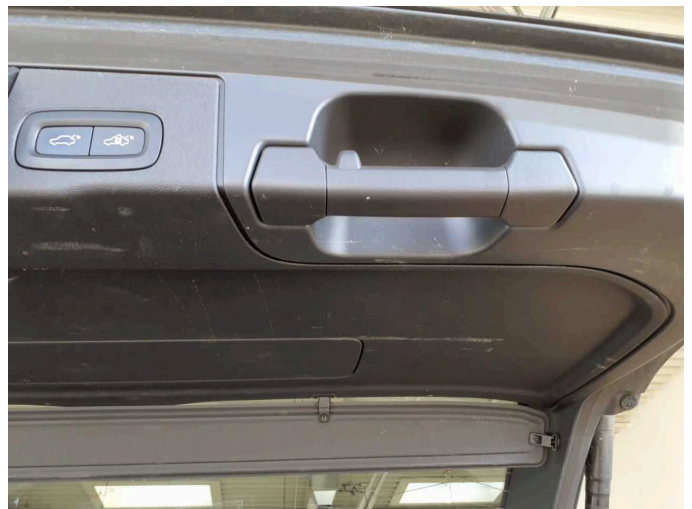
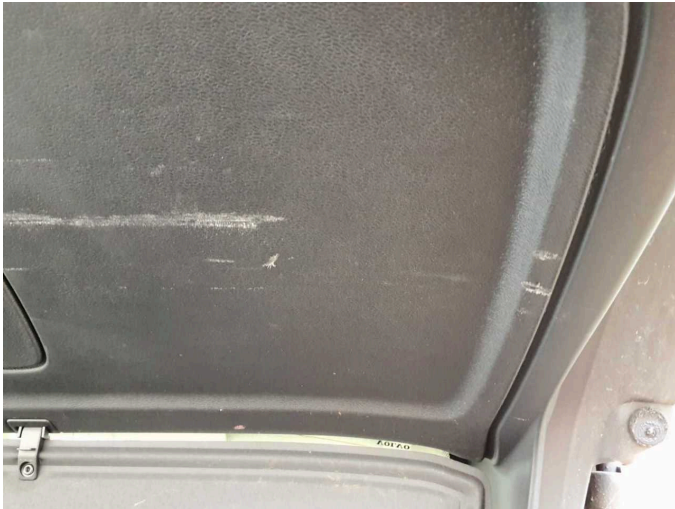
Damage 2: Trim / covers: Boot lid - interior trim - Scratch(es) - Loss in value

**Damage 2:** Trim / covers: Boot lid - interior trim - Scratch(es) - Loss in value

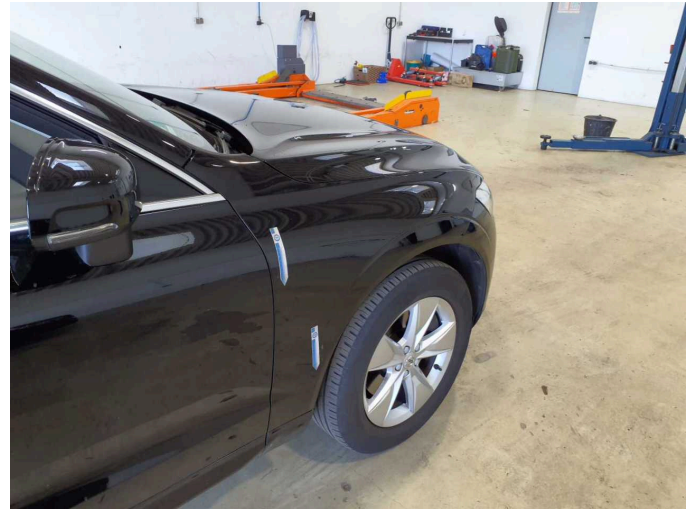
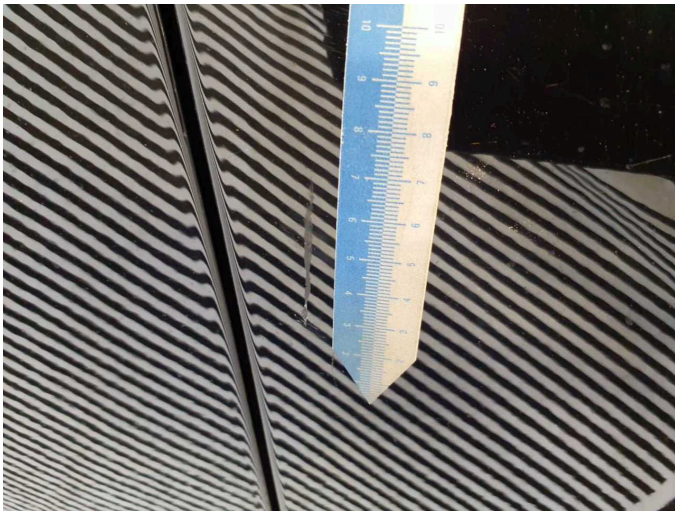
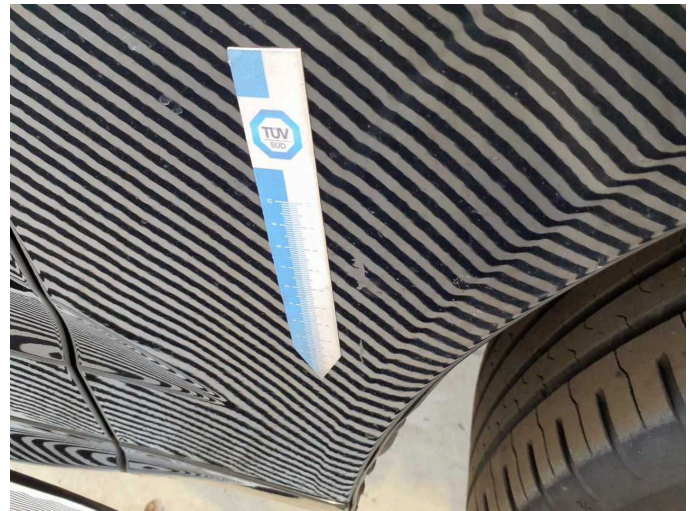
**Damage 3:** Mudguard - right side: Mudguard - right side (Fremdfarbe) - Soiled - Conditioning

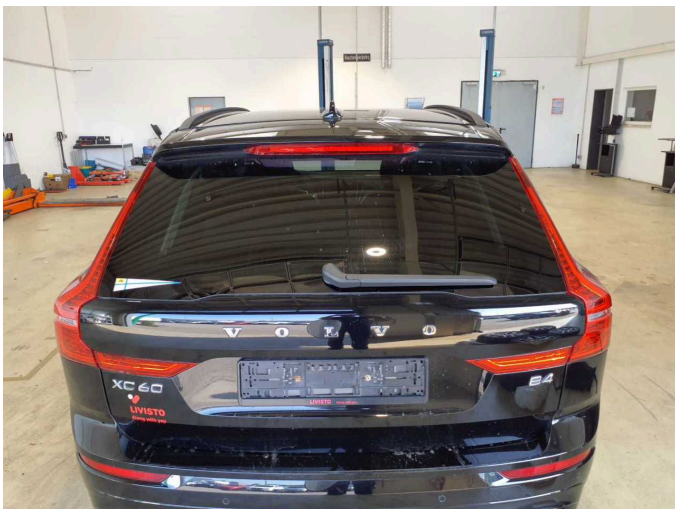
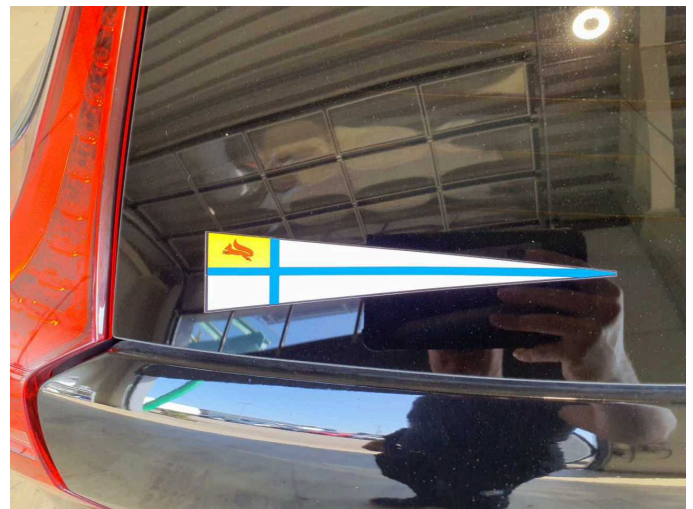
**Damage 4:** Vehicle glazing: Rear window - Glued / labelled - De-glue / neutralise

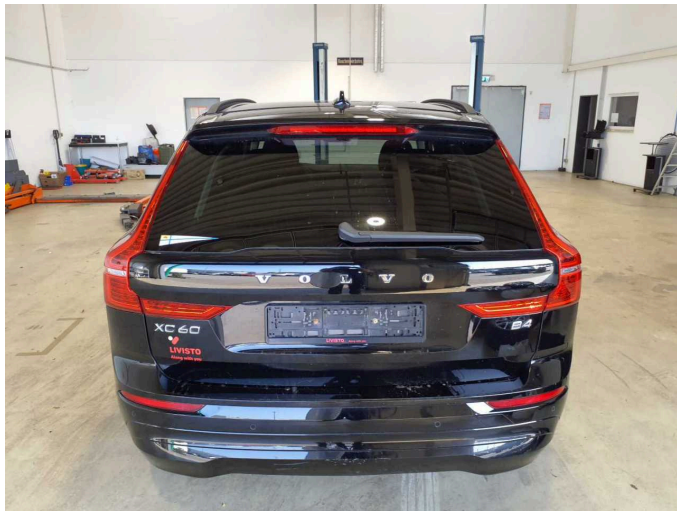
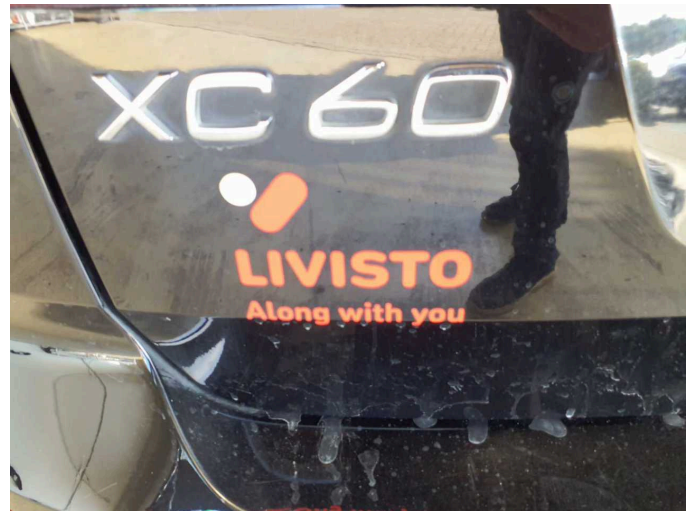
**Damage 5:** Boot lid / rear door: Boot lid - Glued / labelled - De-glue / neutralise

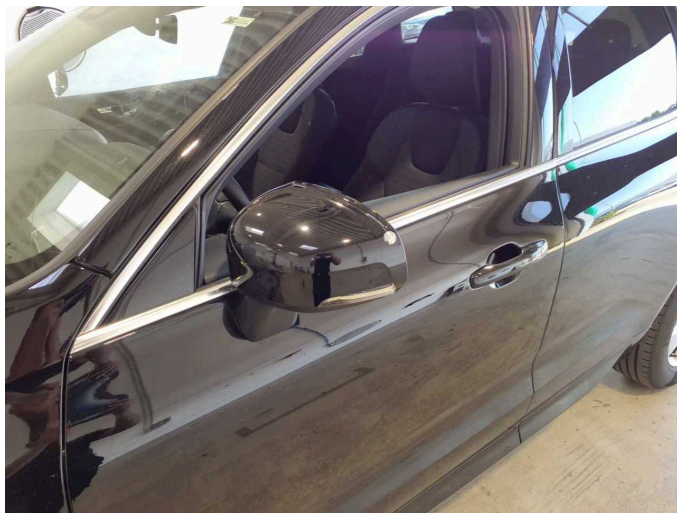
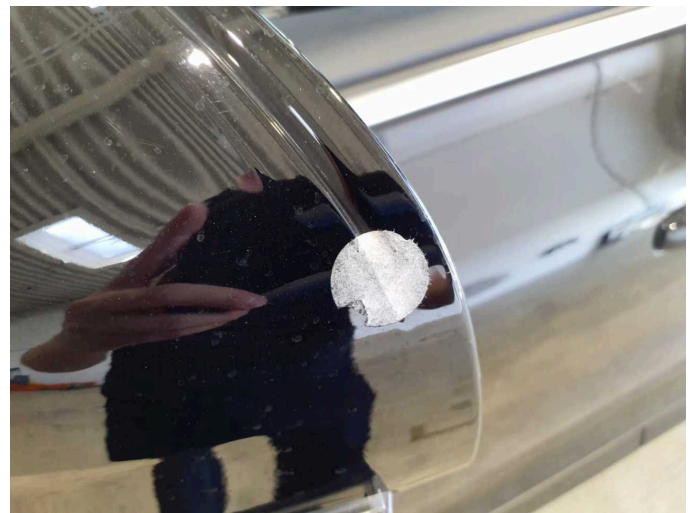
**Damage 6:** Wing mirror - left side: Cap - Glued / labelled - De-glue / neutralise

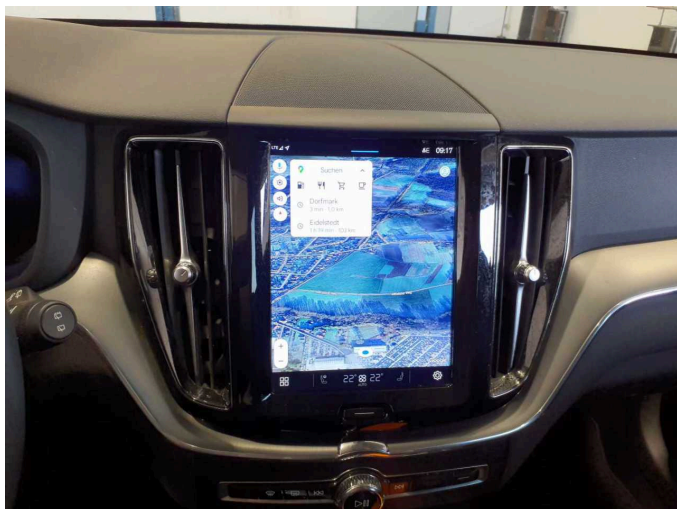
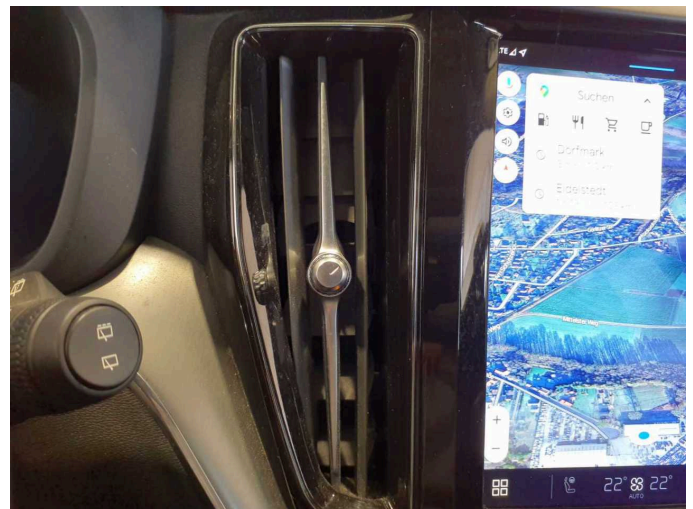
**Damage 7:** Instrument panel: Air nozzle - centre - Damaged - Replace

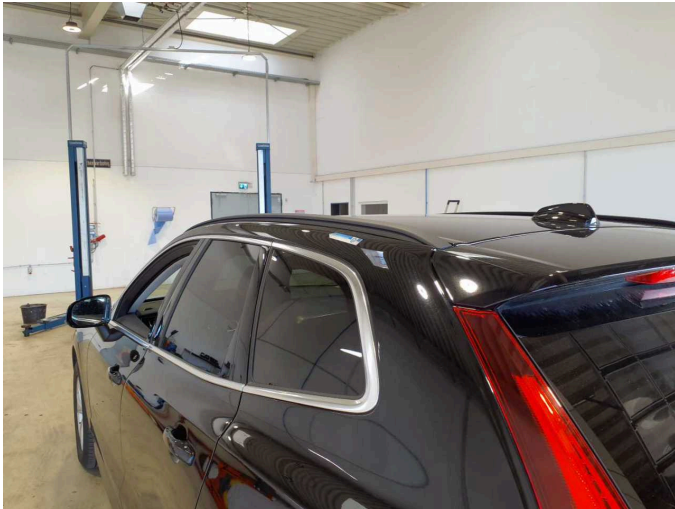
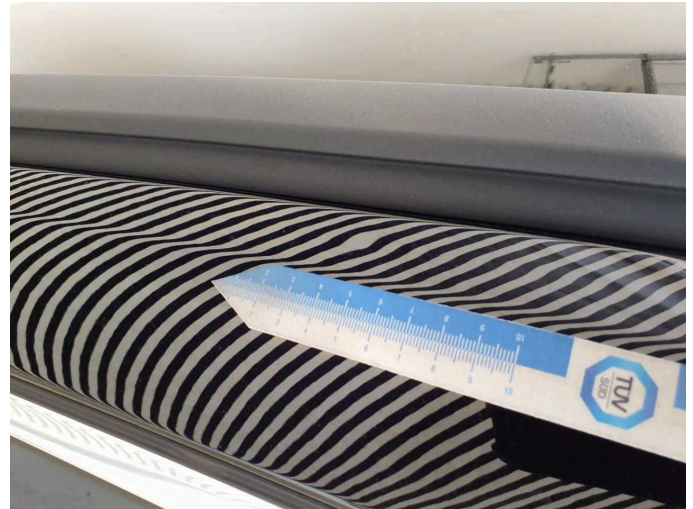
**Damage 8:** Roof: Roof rail - left side - dent(s) - Smooth repair work

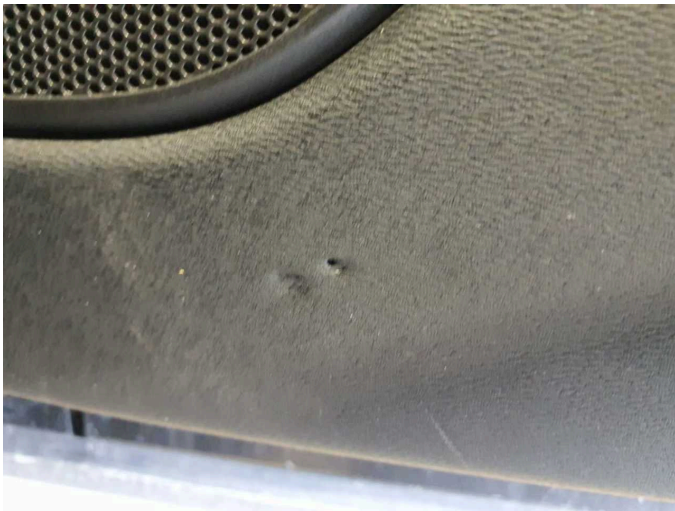
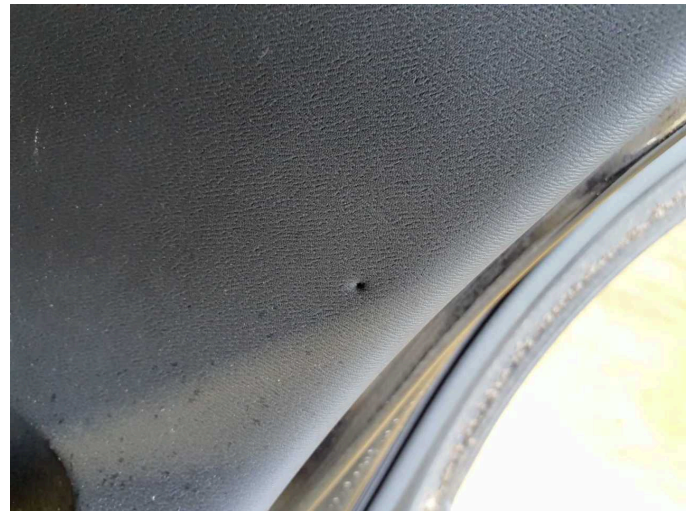
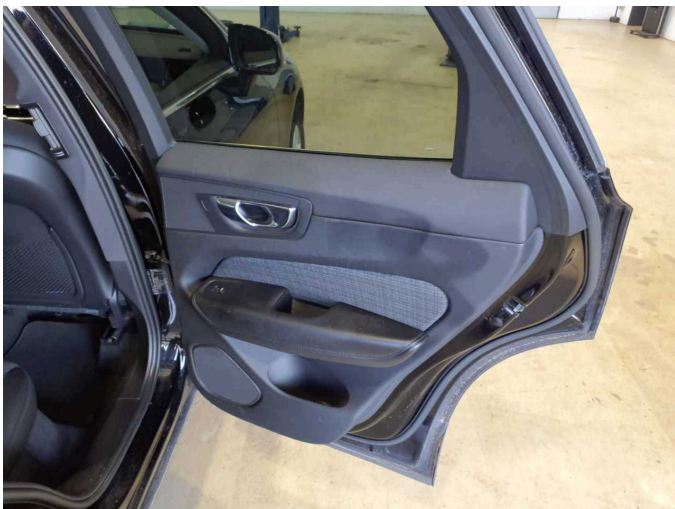
**Damage 9:** Trim / covers: Door trim - rear right side - dent(s) - Loss in value

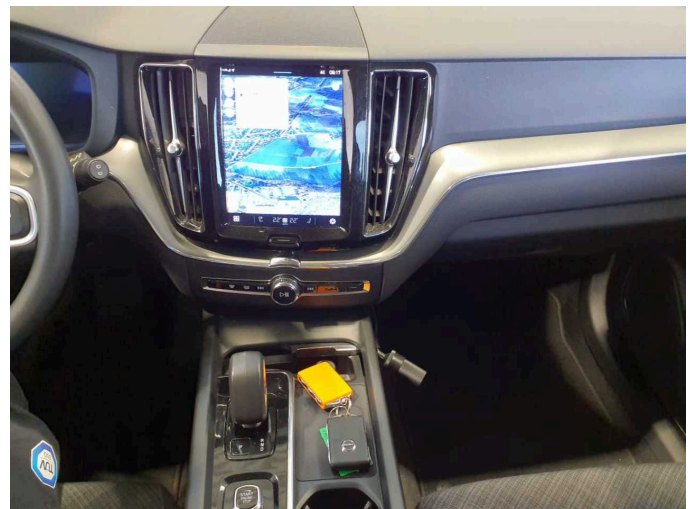
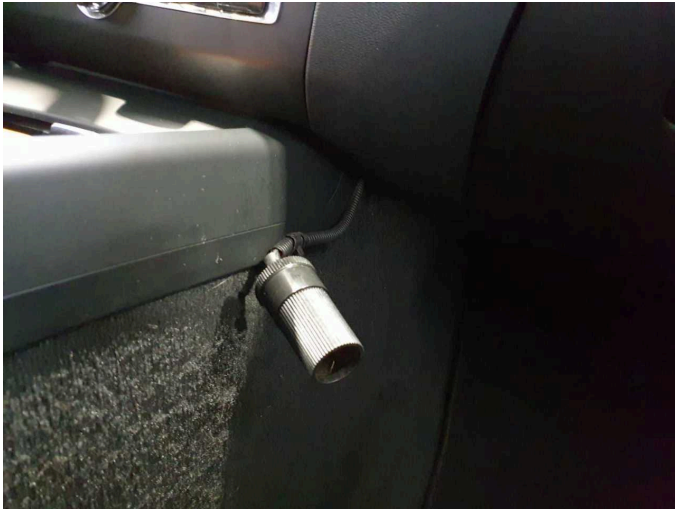
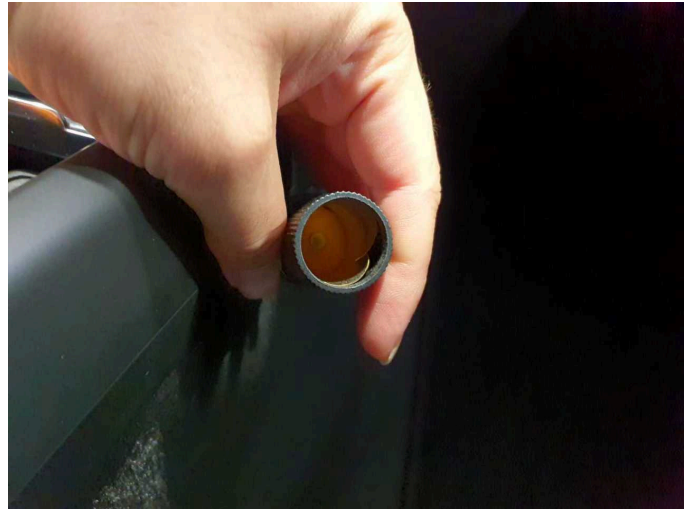
**Damage 10:** Instrument panel: Centre console - front (Kabelverlegung) - Differs from the original configuration - Un- / install

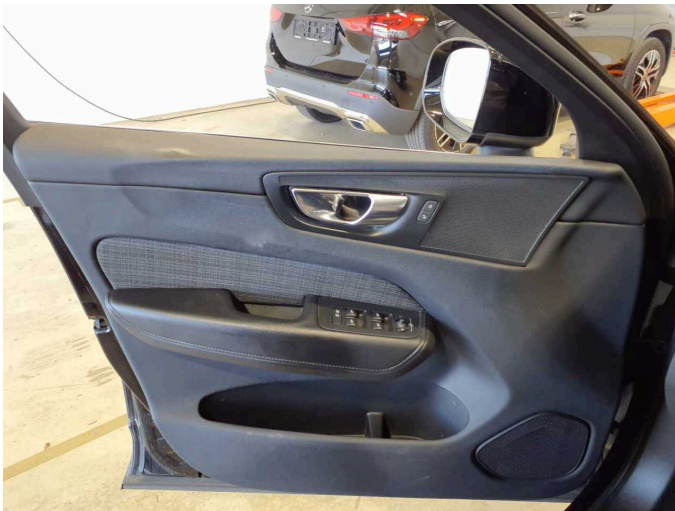
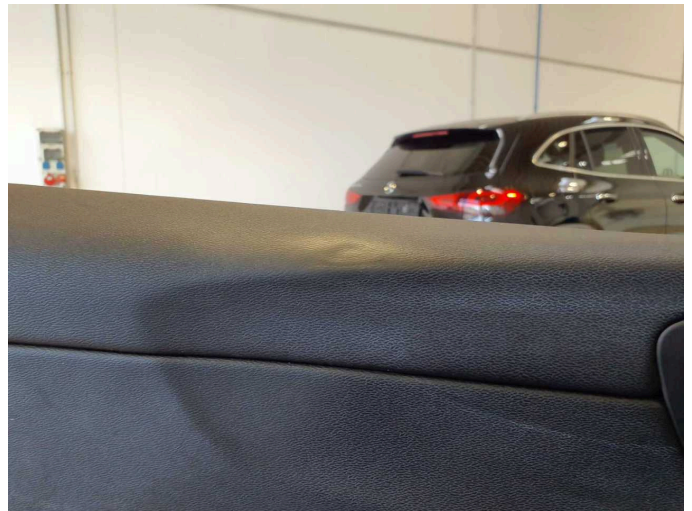
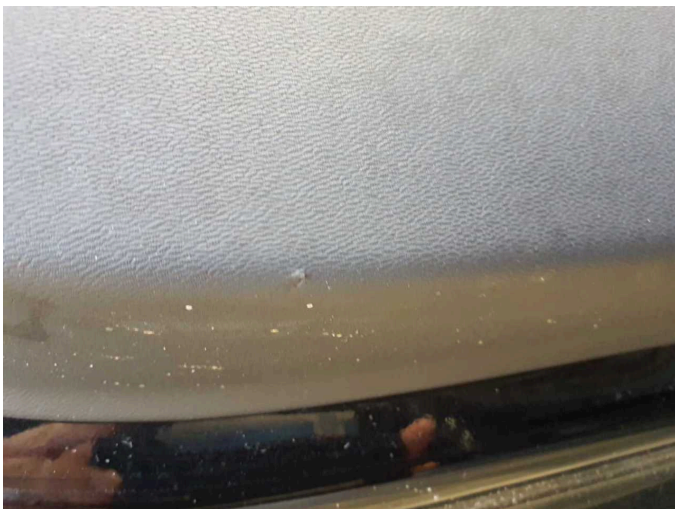
**Damage 11:** Trim / covers: Door trim - front left side - dent(s) - Loss in value

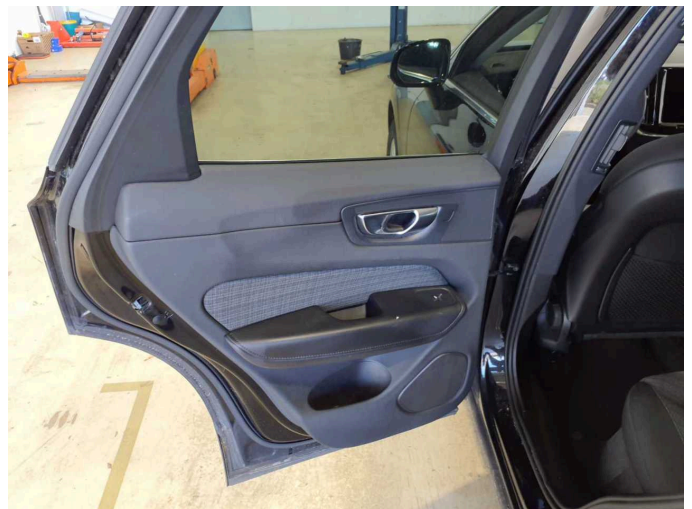
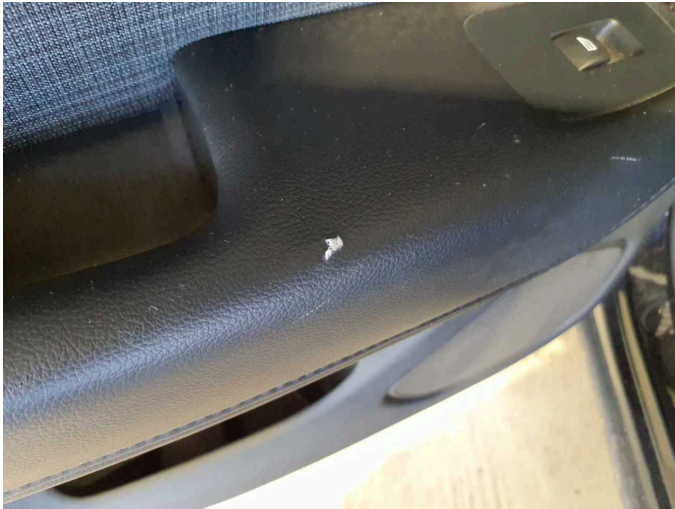
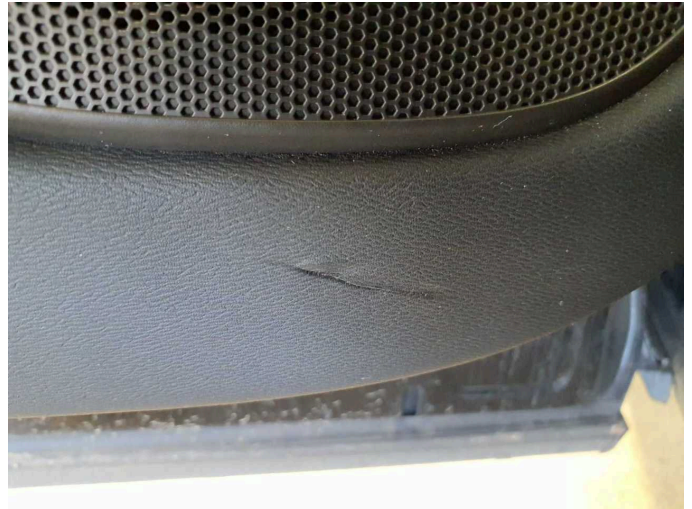
**Damage 12:** Trim / covers: Door trim - rear left side - Damaged - Loss in value

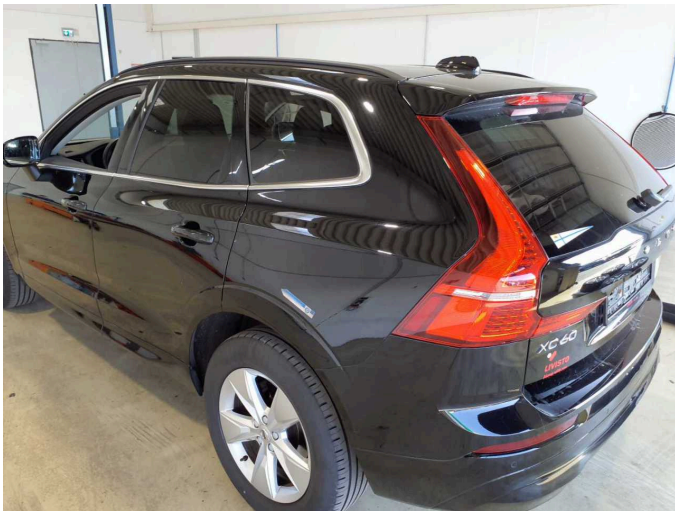
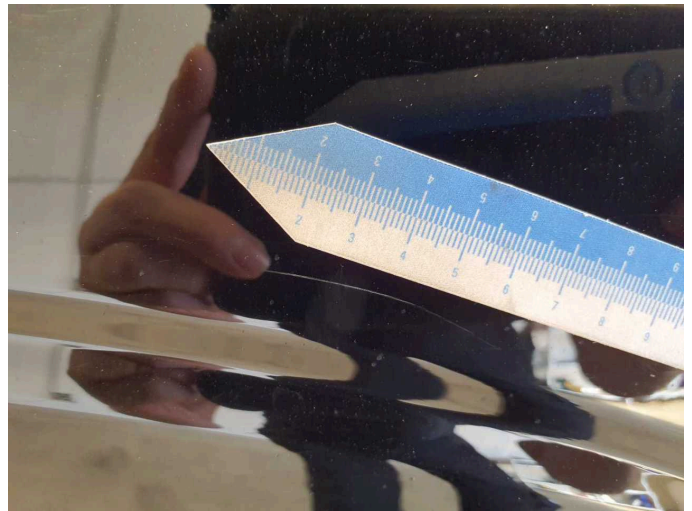
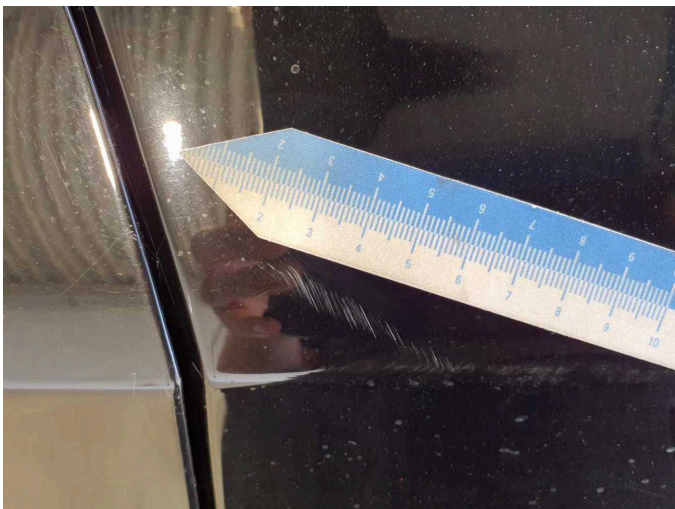
**Damage 13:** Side panel - rear left side: Side panel - Scratch(es) - Paint

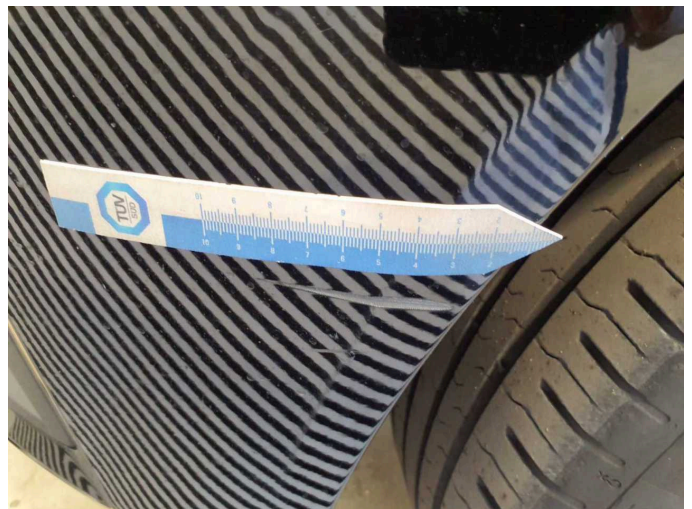
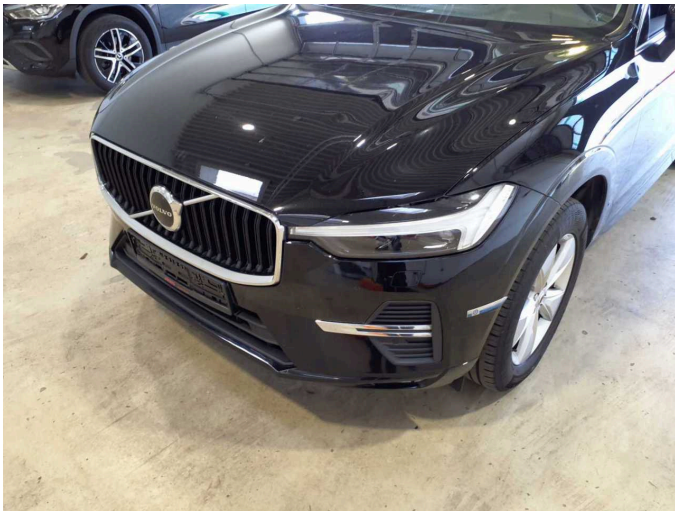
**Damage 14:** Front bumper: Front bumper - Scratch(es) - Paint

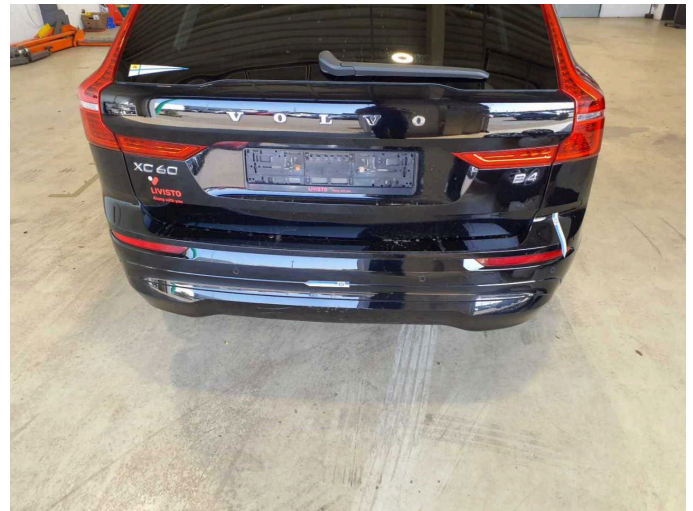
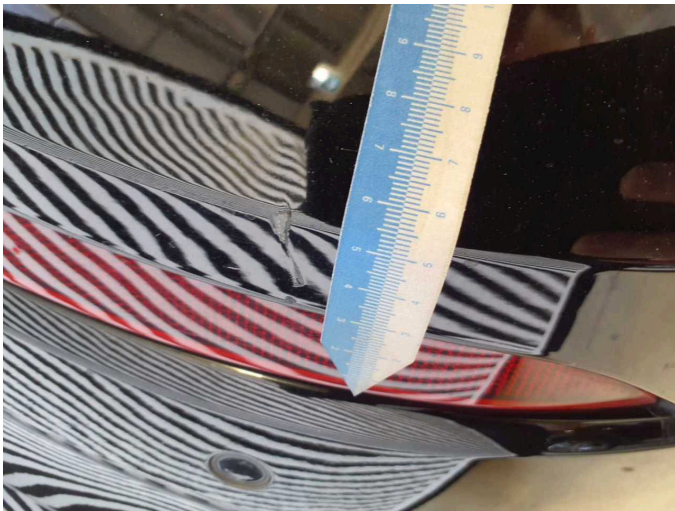
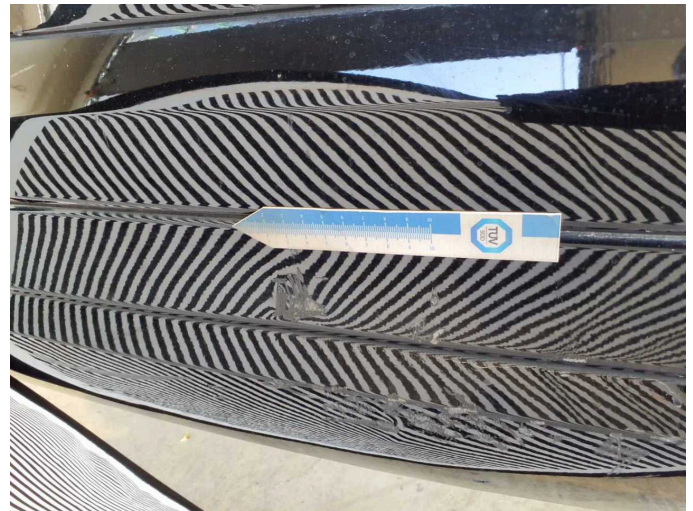
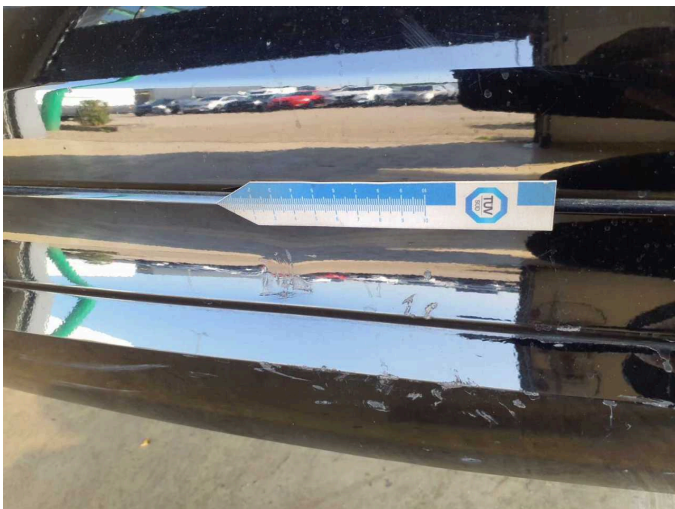
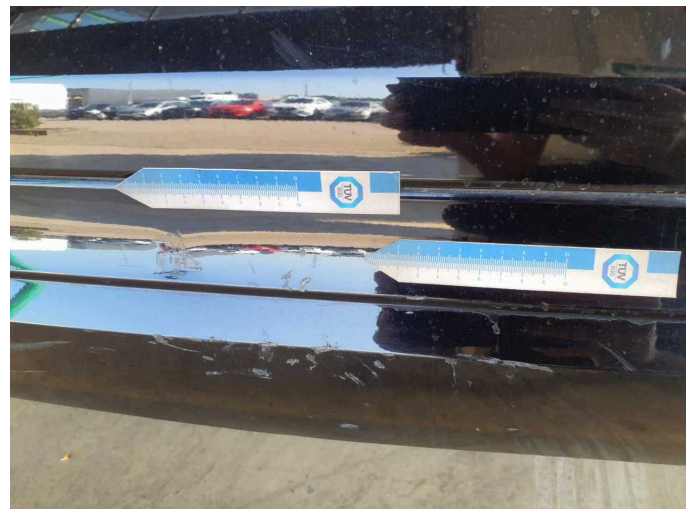
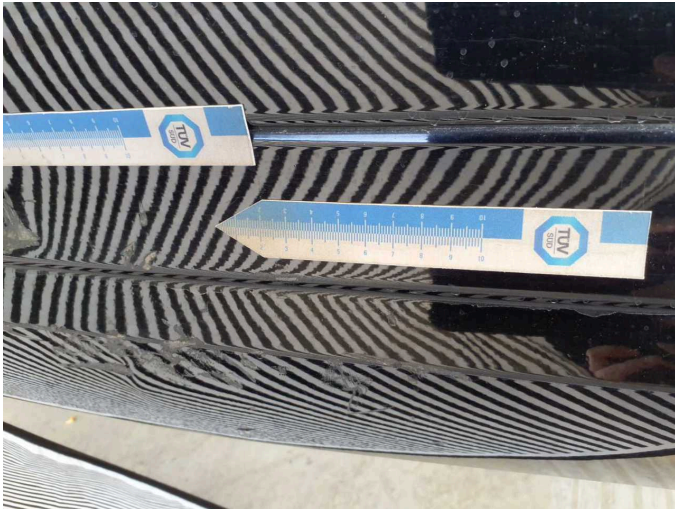
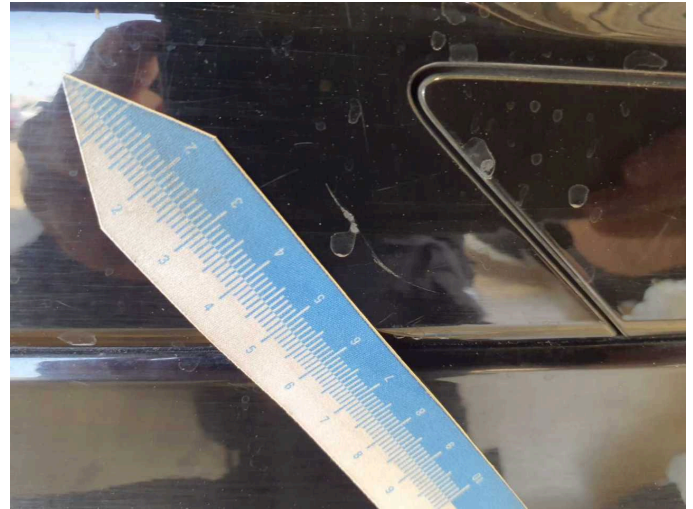
**Damage 15:** Rear bumper: Rear bumper - Dent / paintcoat damage - Repair and paint

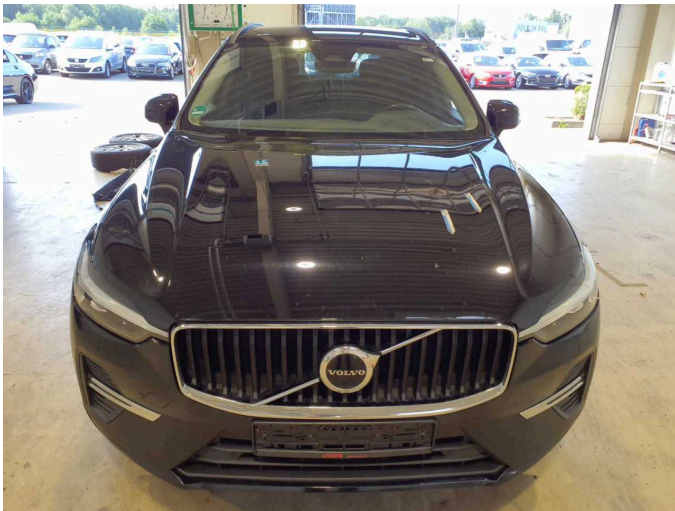
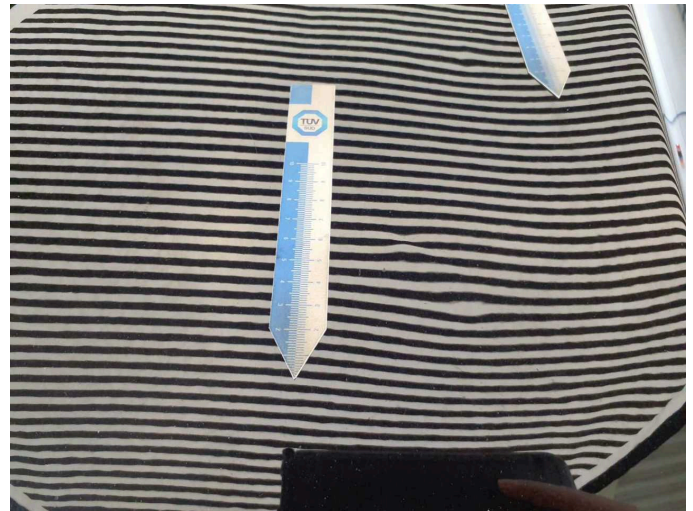
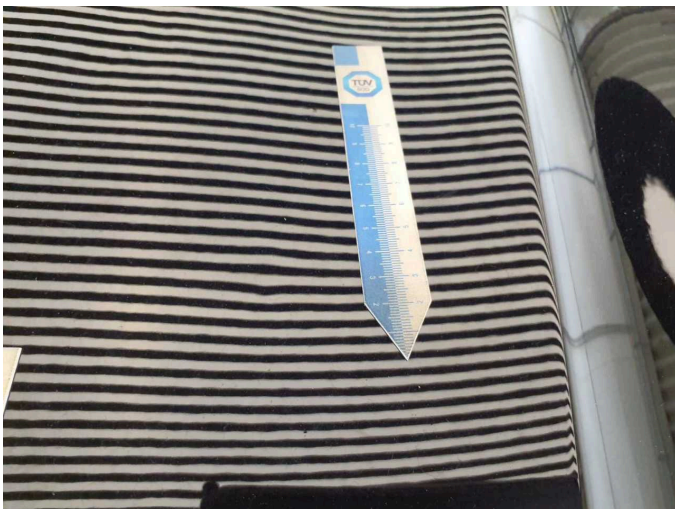
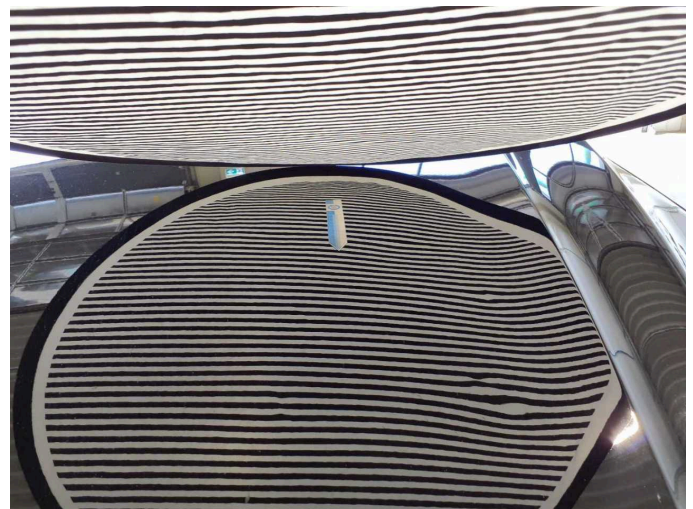
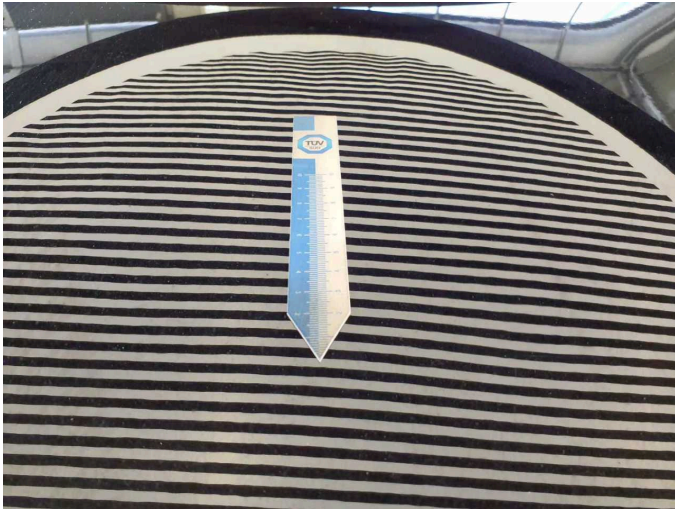
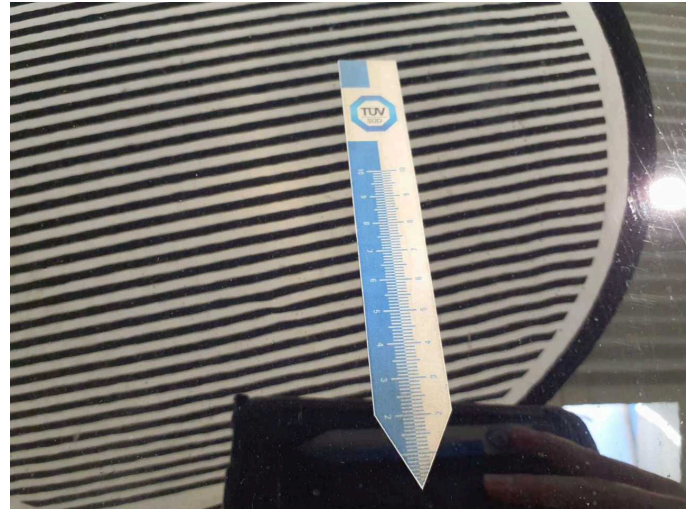
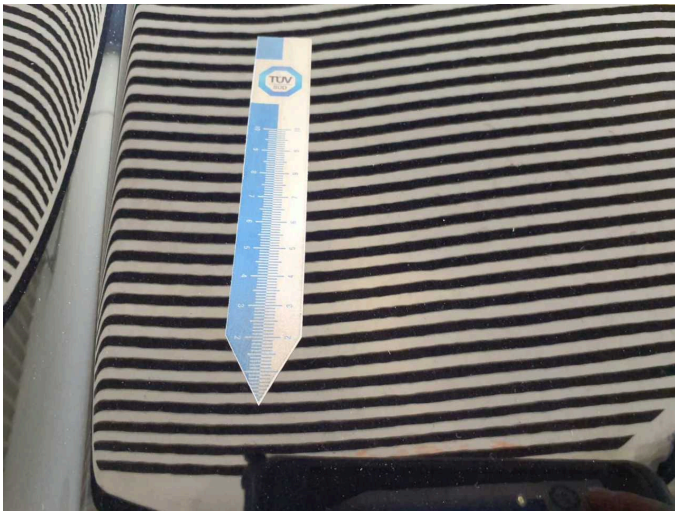
**Damage 16:** Bonnet: Bonnet - Deformed - Repair and paint

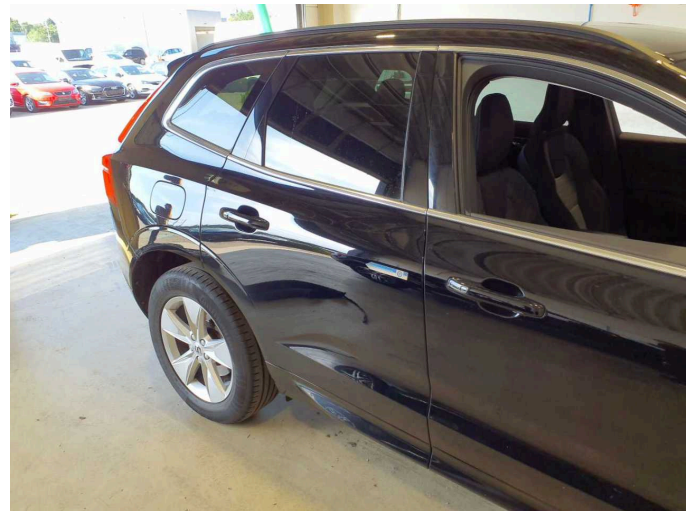
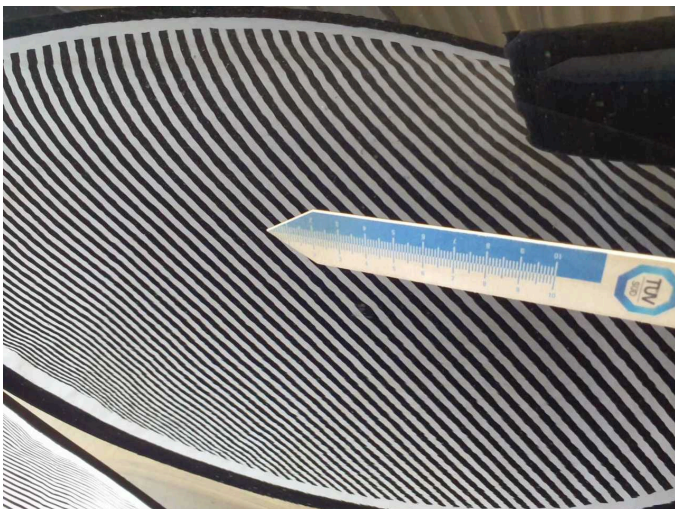
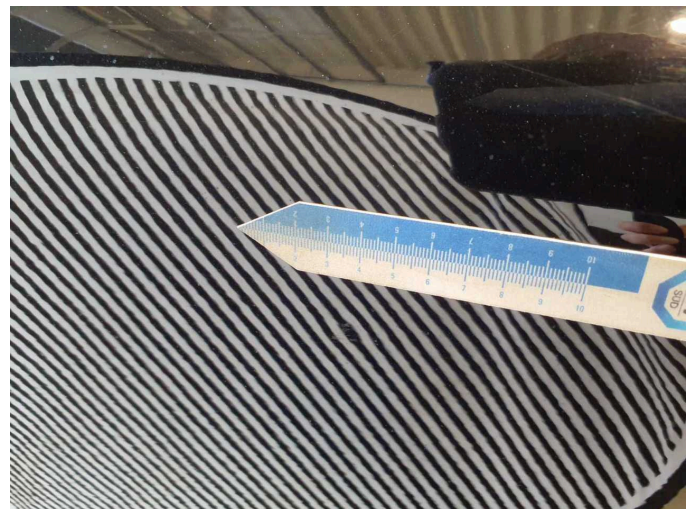
**Wear and tear 4:** Door - rear right side: Door - dent(s) - Smooth repair work
