Expertise

Protocol number: 41153596
Order No. / Reference: 25096669
Inspection date: 18 Aug 2025

Manufacturer: Volvo	Model: XC60 B4 D AWD Geartronic Inscription
VIN: YV1UZZK5VCM1855235

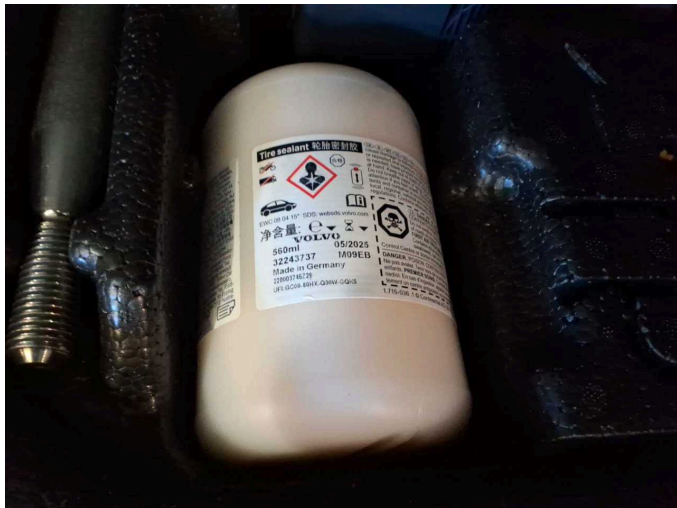
Damage 1: Equipment: Tirefit filler - Expired - Replace

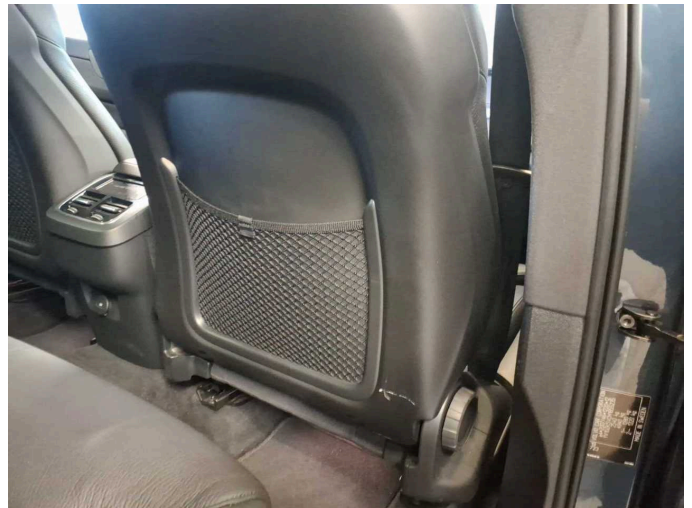
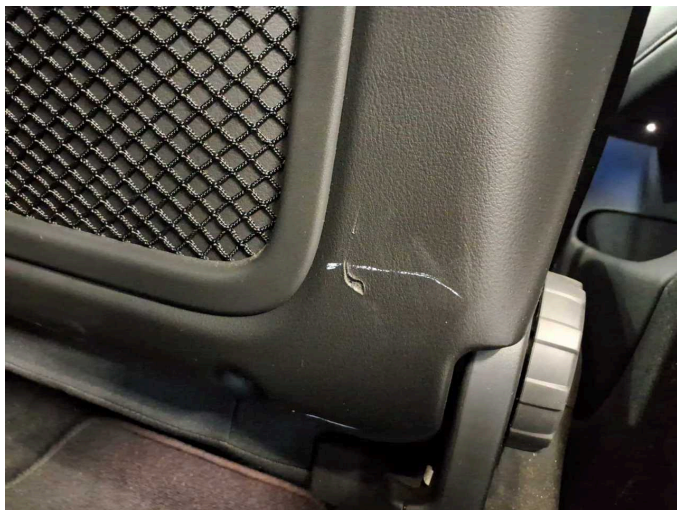
Damage 2: Seat - front: Cover - Scratch(es) - Loss in value

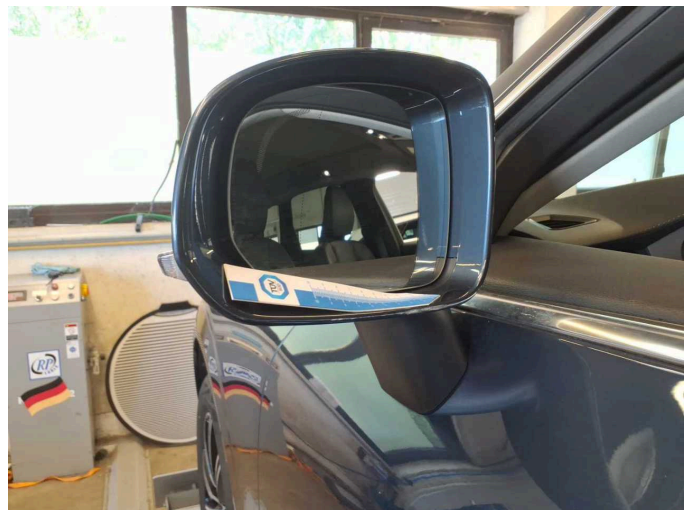
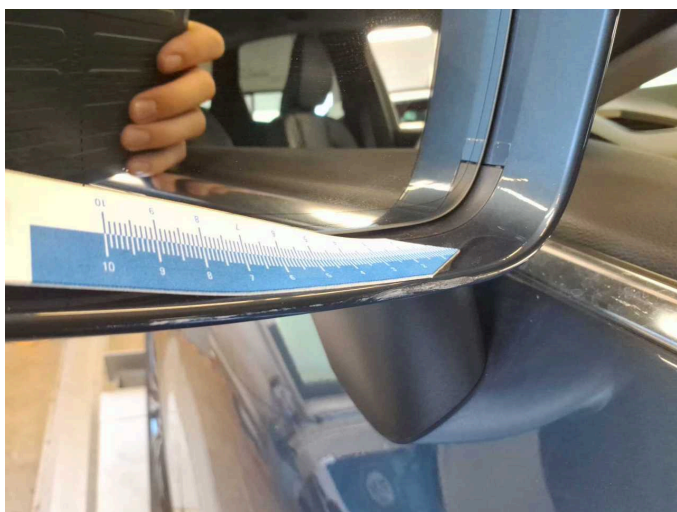
Damage 3: Wing mirror - left side: Cap - Scratch(es) - Smart repair

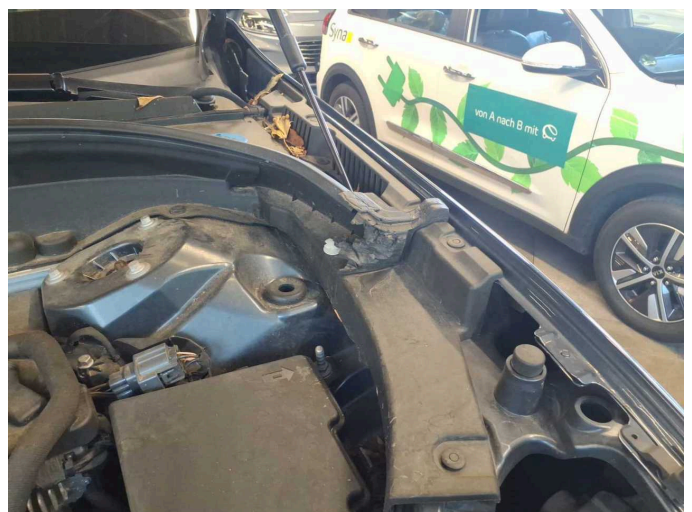
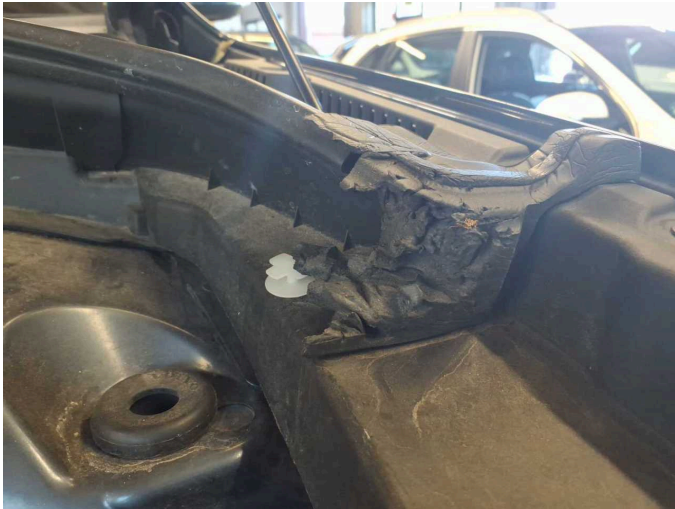
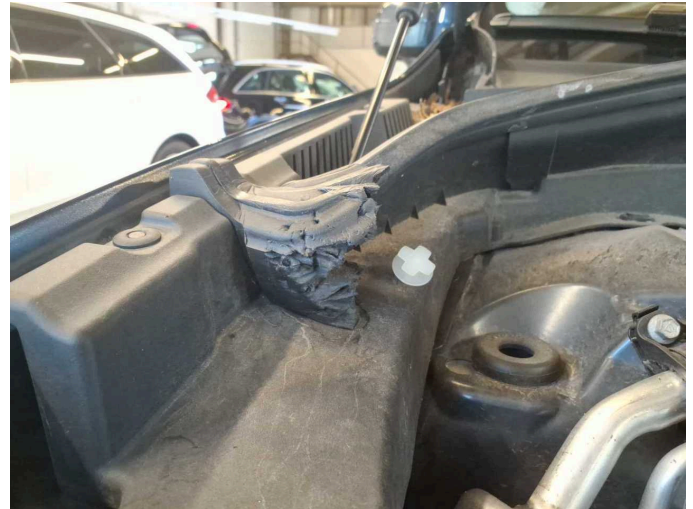
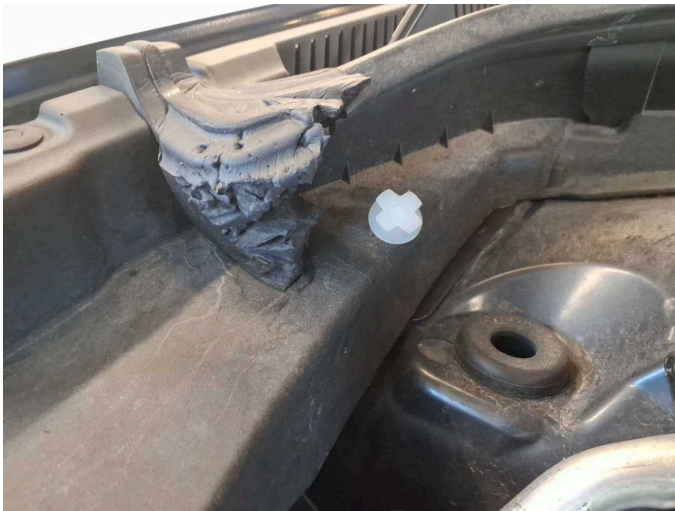
Damage 4: Trim / covers: Trim / covers - Damage caused by marten / rodent - Replace

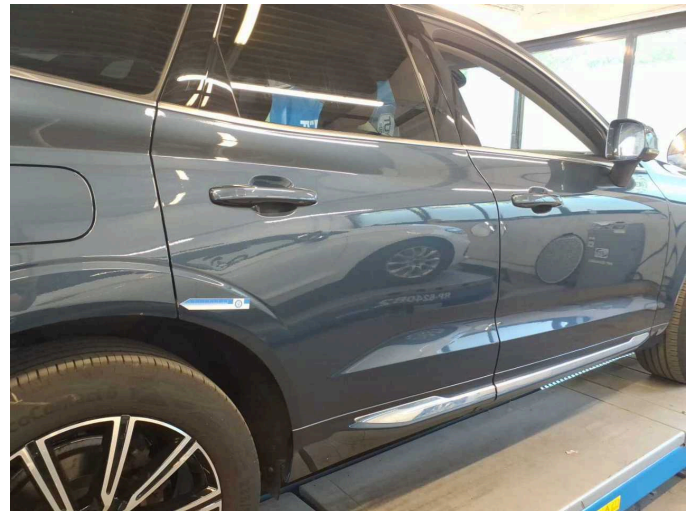
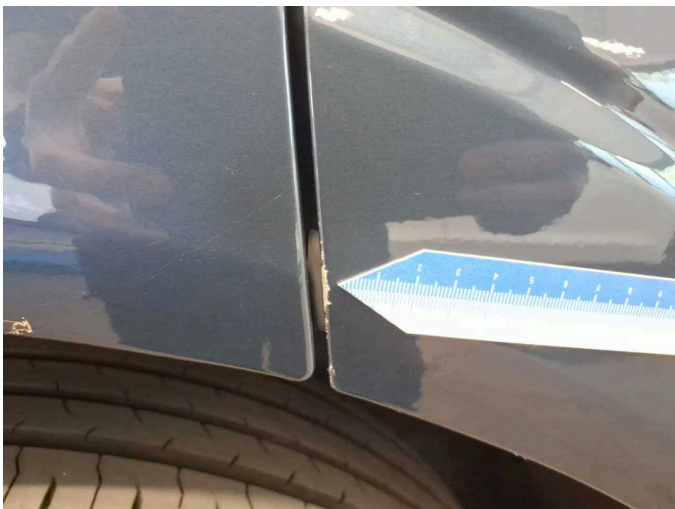
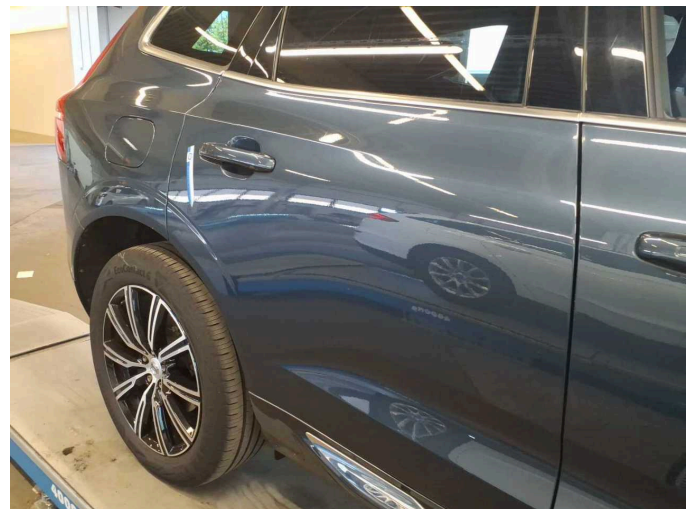
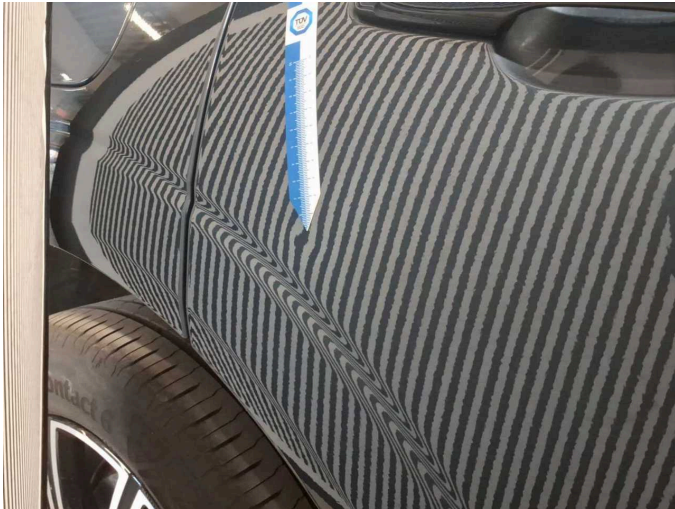
Damage 5: Door - rear right side: Door - Dent / paintcoat damage - Smart repair

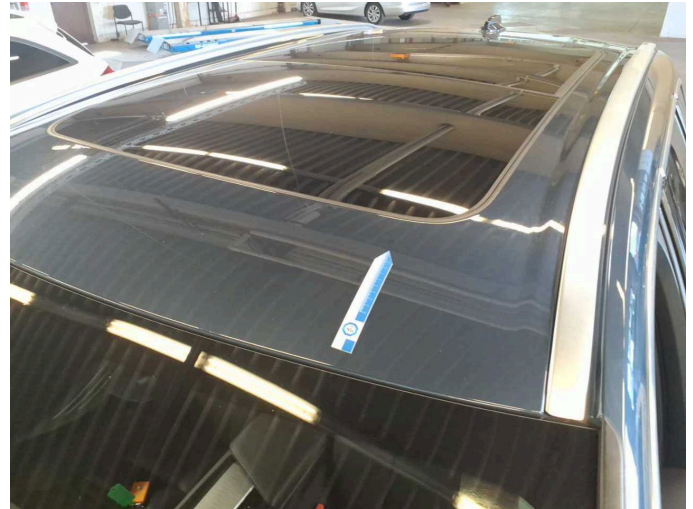
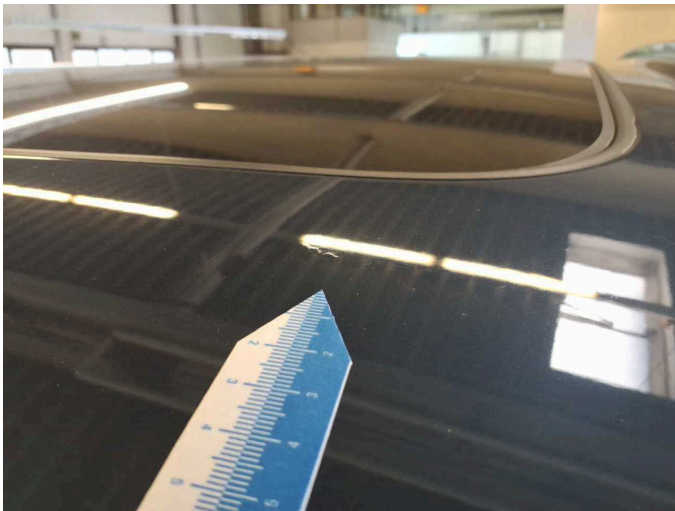
Sollte beim aufbereiten des Daches die Anätzung nicht entfernt werden, können Mehrkosten entstehen.

Damage 6: Roof: Roof (Vogelkotanätzung) - Paint defect - Conditioning

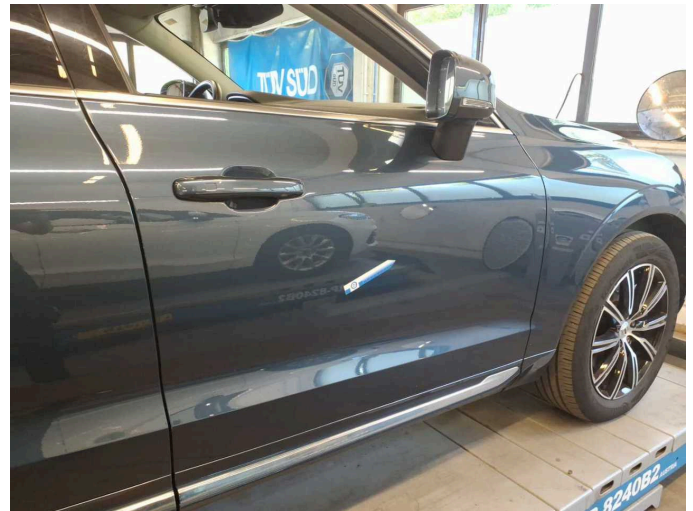
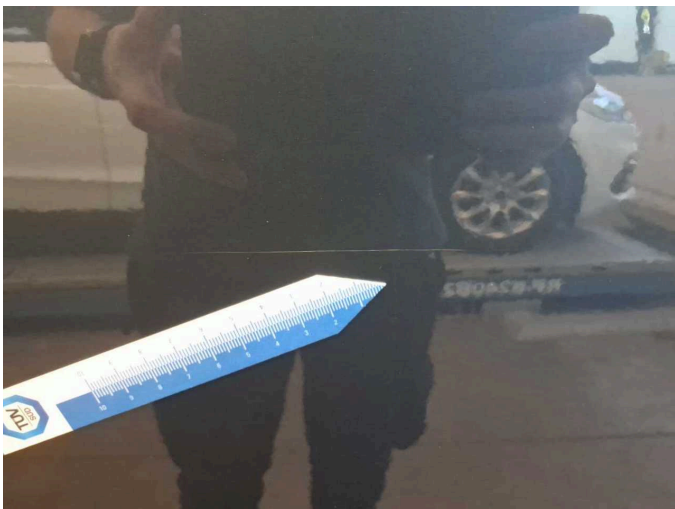
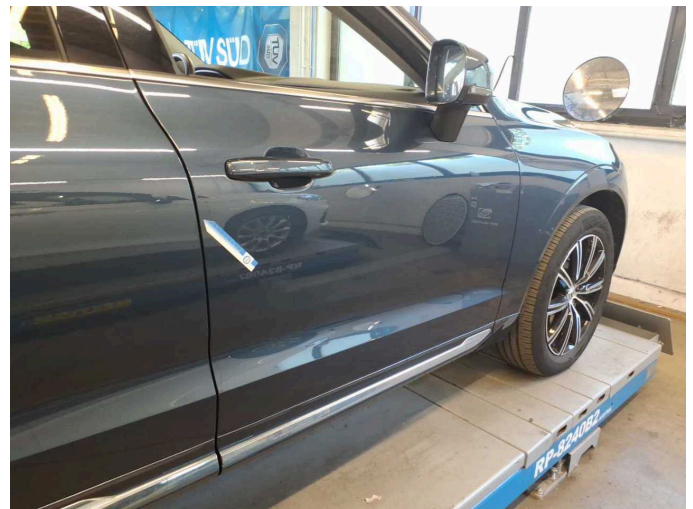
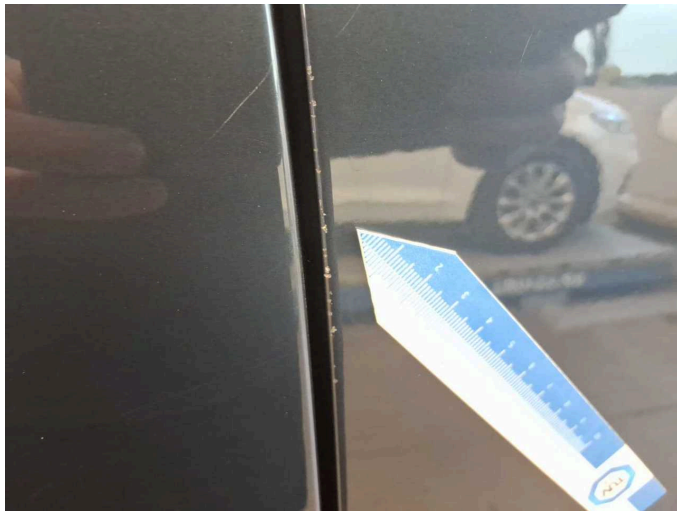
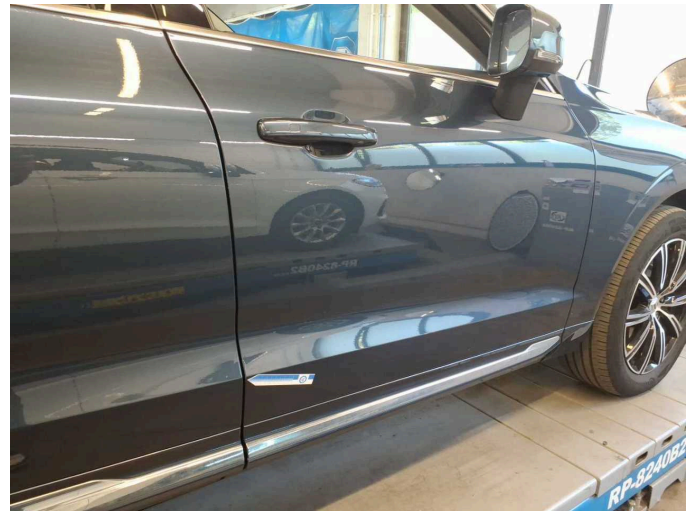
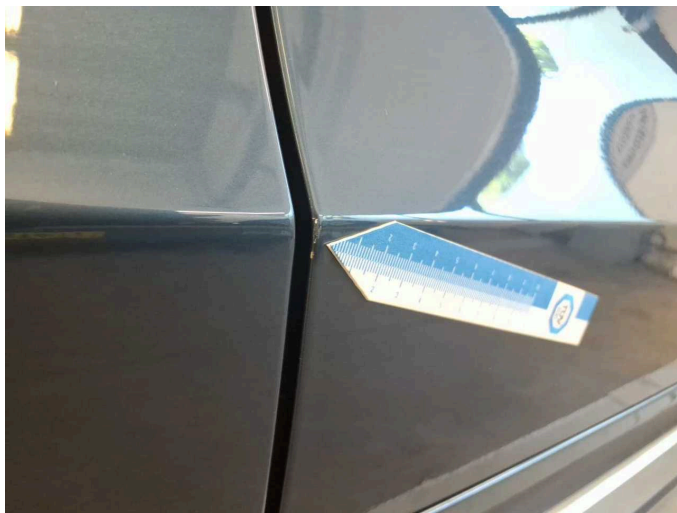
Damage 7: Door - front right side: Door - Scratch(es) - Paint

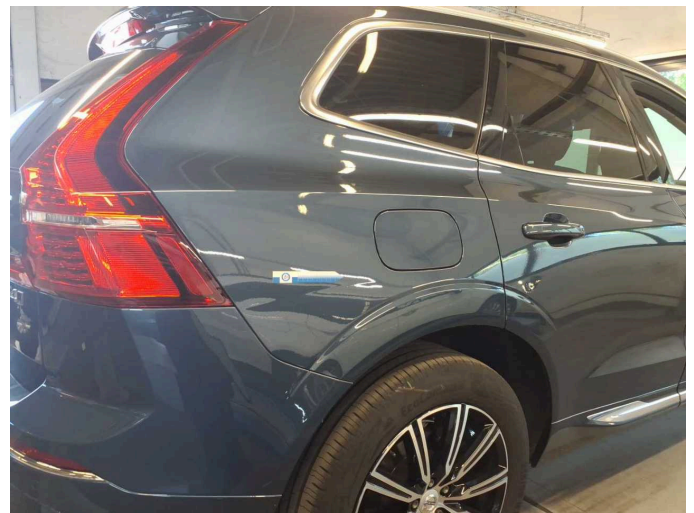
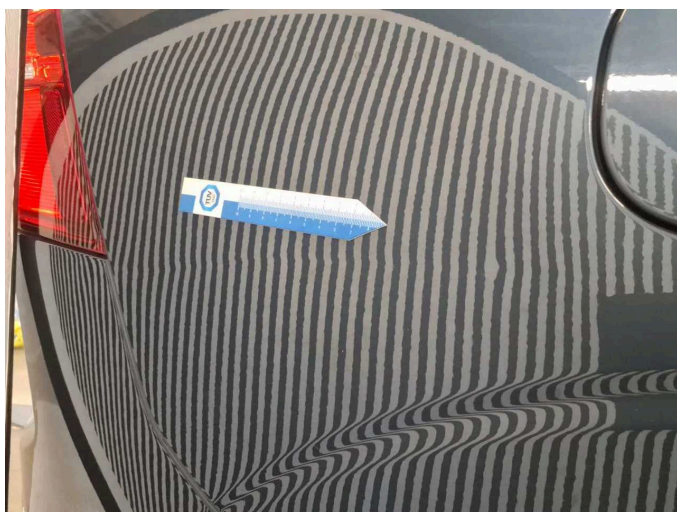
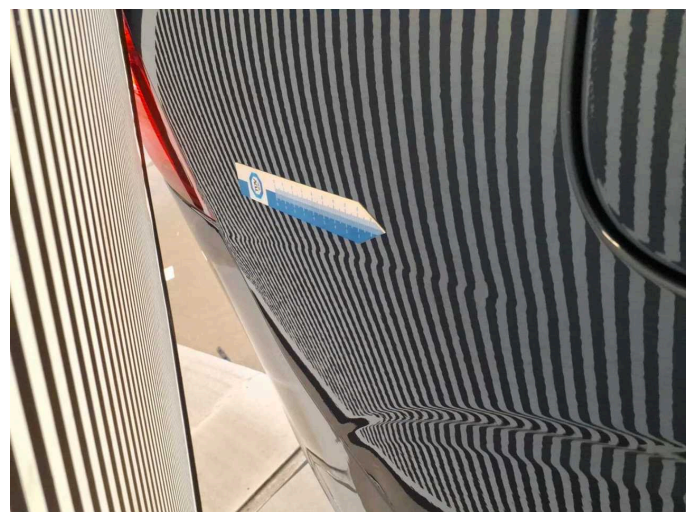
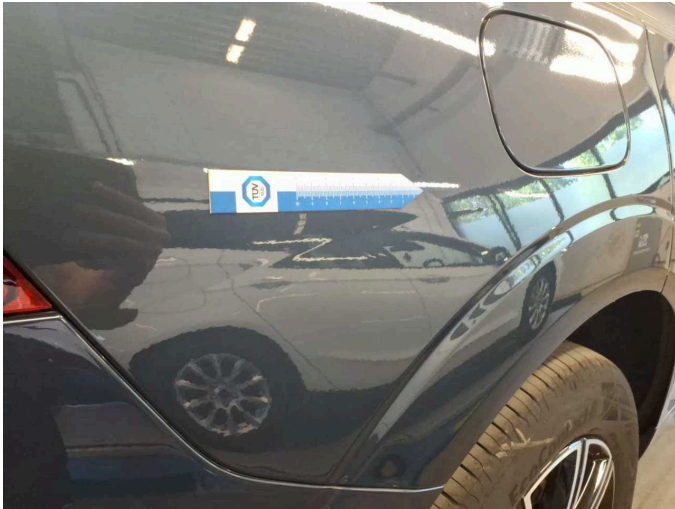
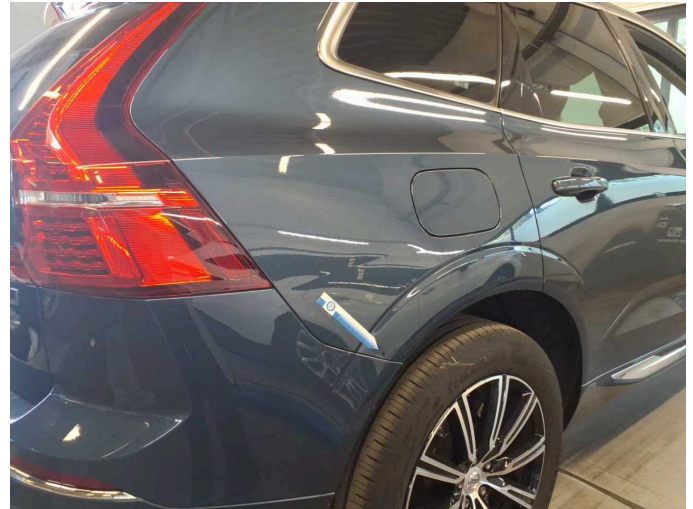
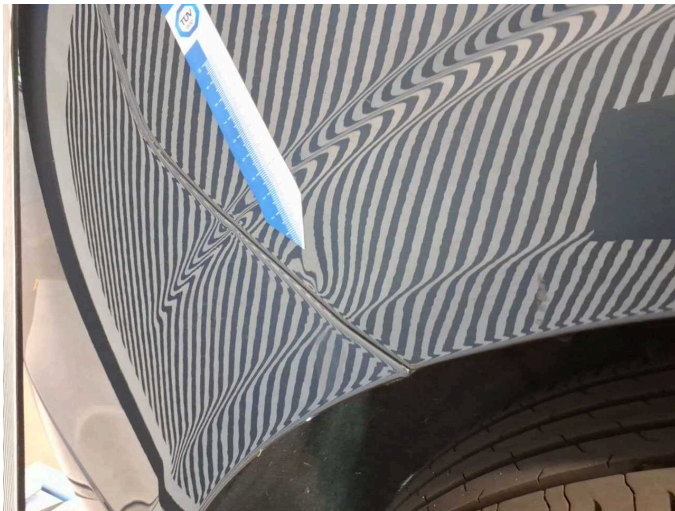
Damage 8: Side panel - rear right side: Side panel - Deformed - Repair and paint

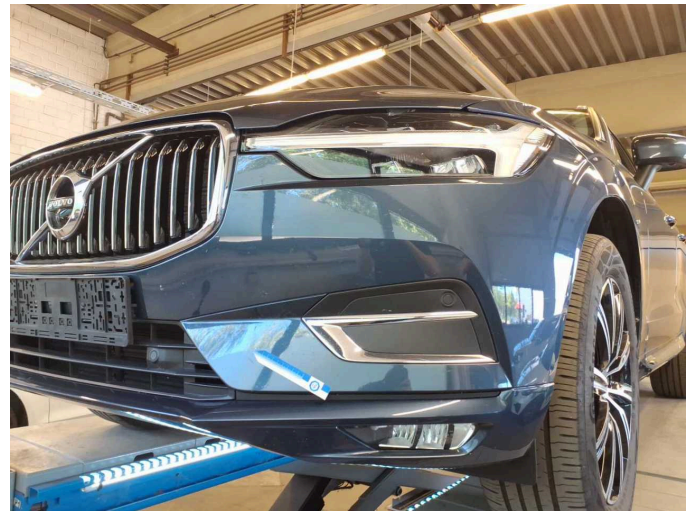
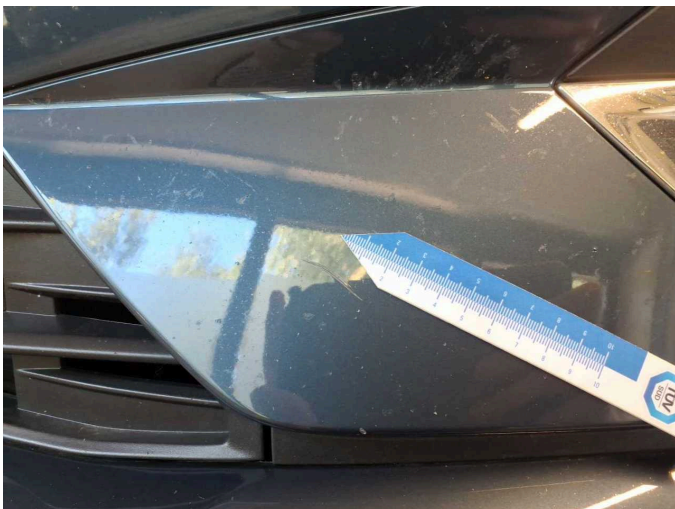
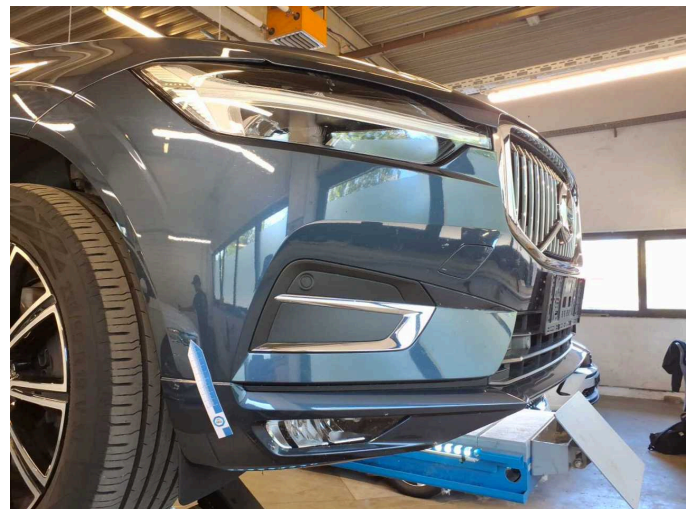
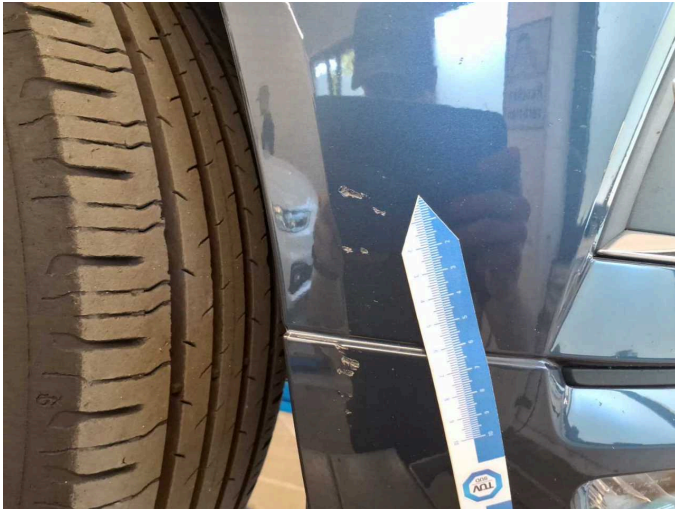
Damage 9: Front bumper: Front bumper (Mit Spoiler) - Scratch(es) - Paint

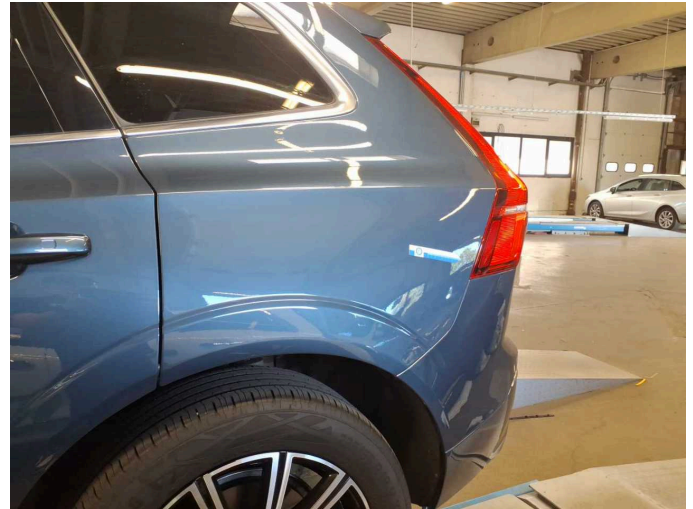
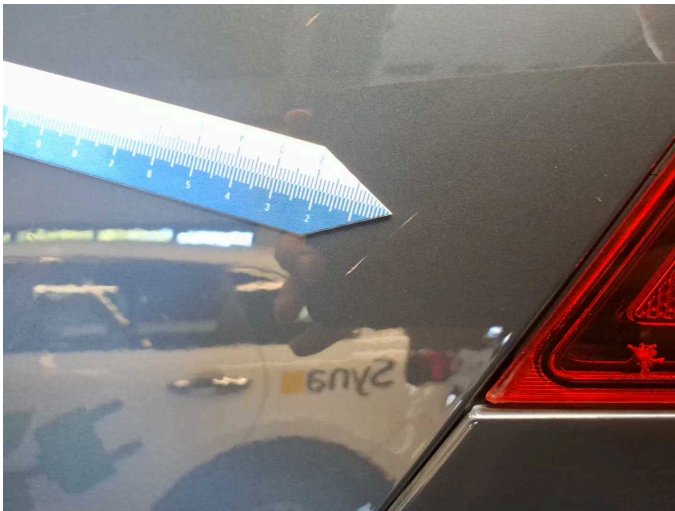
Wear and tear 9: Side panel - rear left side: Side panel - Scratch(es) - Cover / polish

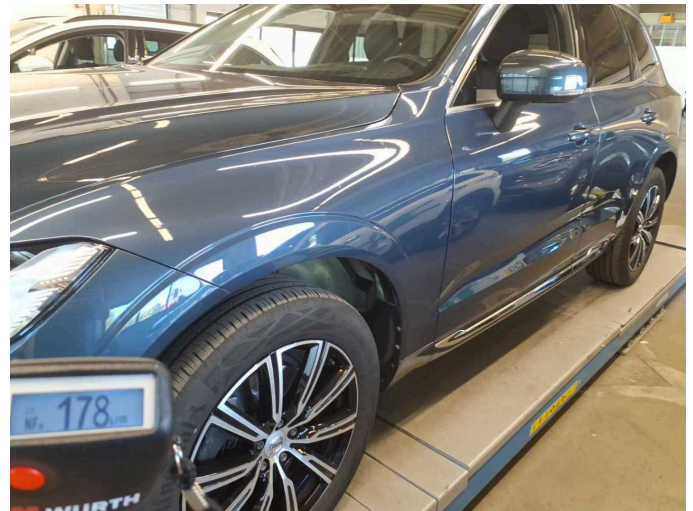
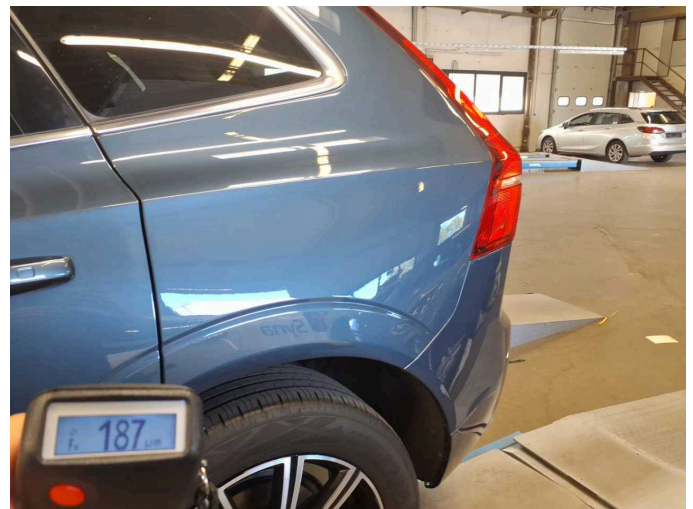
Repainting 1: Mudguard - left side

Repainting 2: Side panel - rear left side

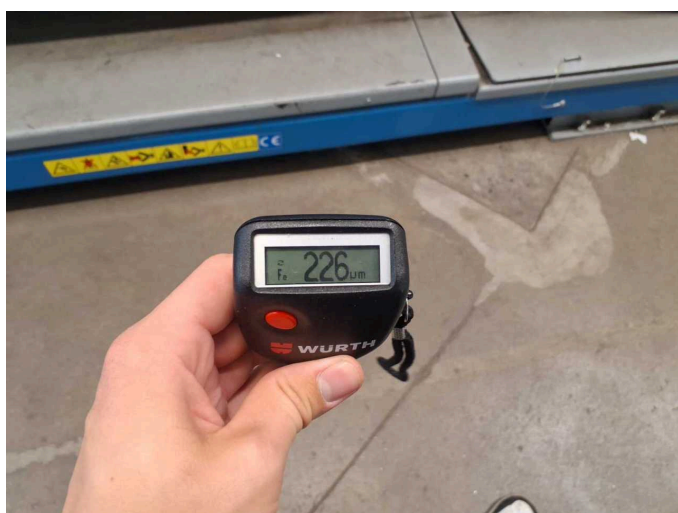
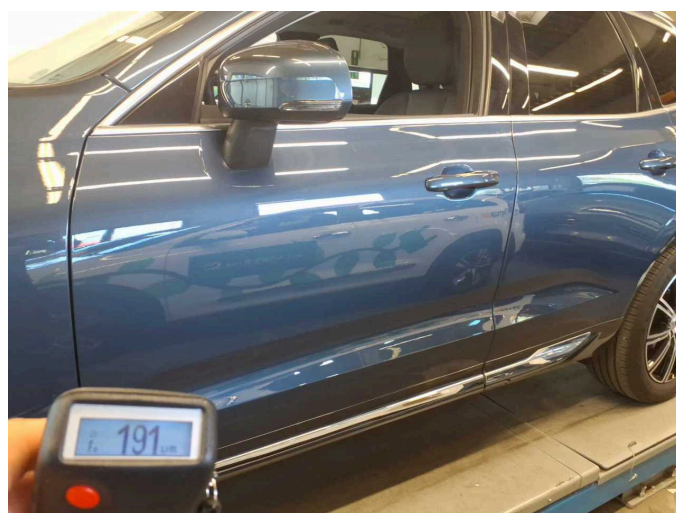
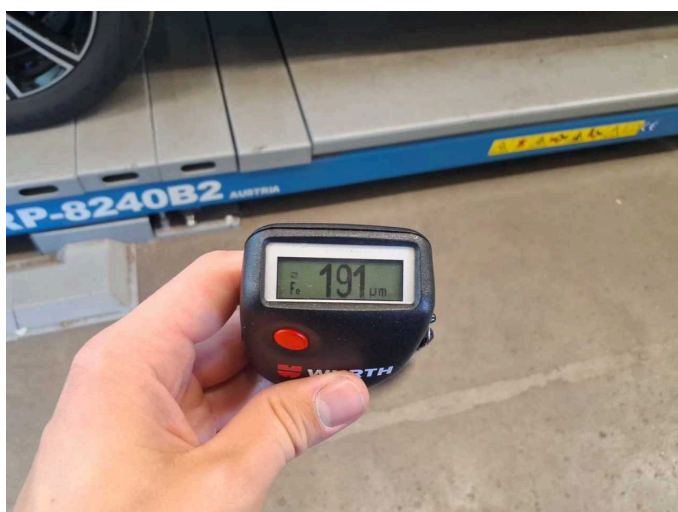
Repainting 3: Door - rear left side

Repainting 4: Door - front left side
