Expertise

Protocol number: 41218855
Order No. / Reference: 25056480
Inspection date: 24 Aug 2025

Manufacturer: Volvo	Model: XC60 B4 D AWD Geartronic Momentum Pro
VIN: YV1UZZK5VCN1051043

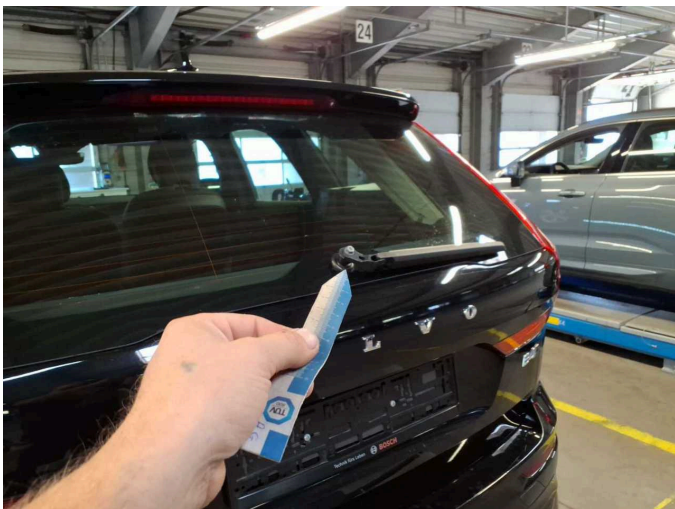
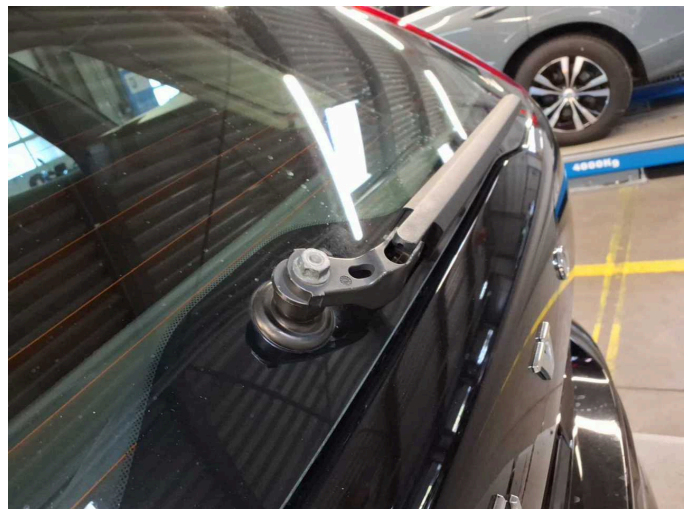
Damage 2: Screen cleaning: Wiper arm - rear (Abdeckung) - Missing - Replace

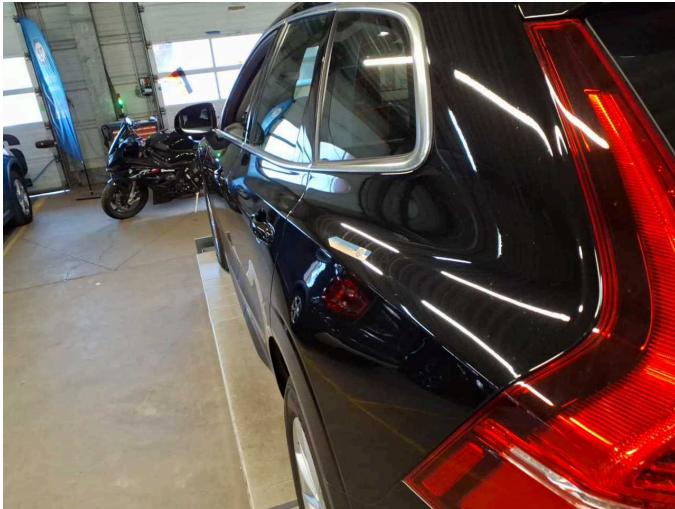
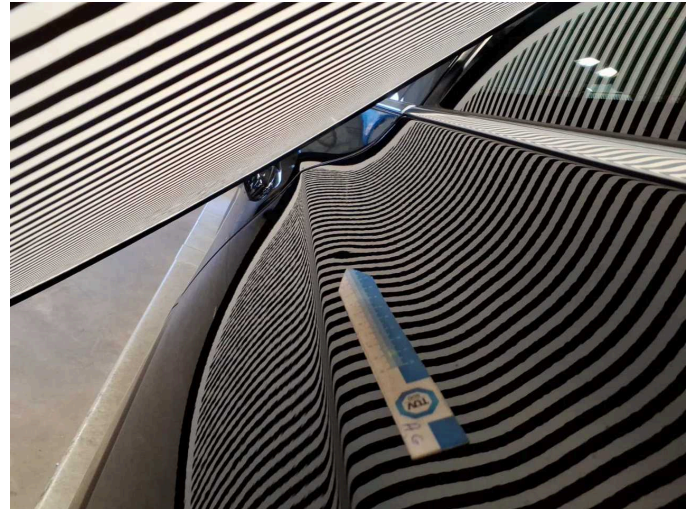
Damage 3: Side panel - rear left side: Side panel - dent(s) - Smooth repair work

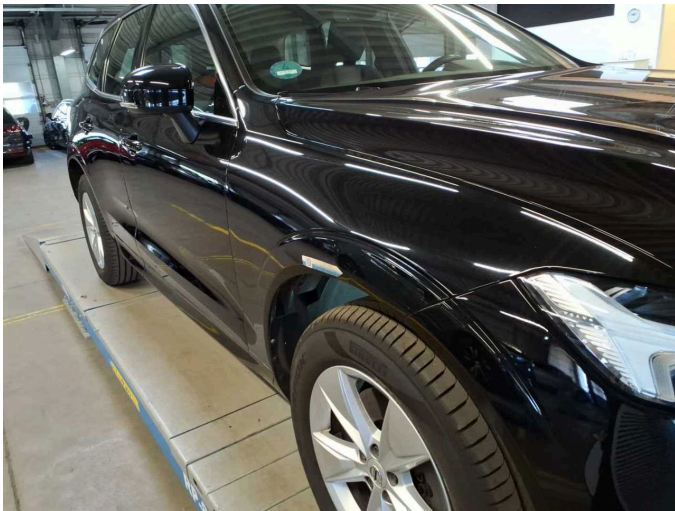
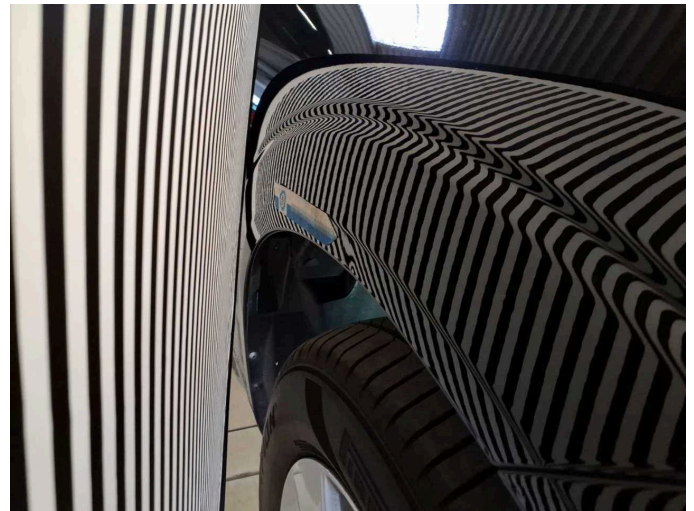
Damage 4: Mudguard - right side: Mudguard - right side - dent(s) - Smooth repair work

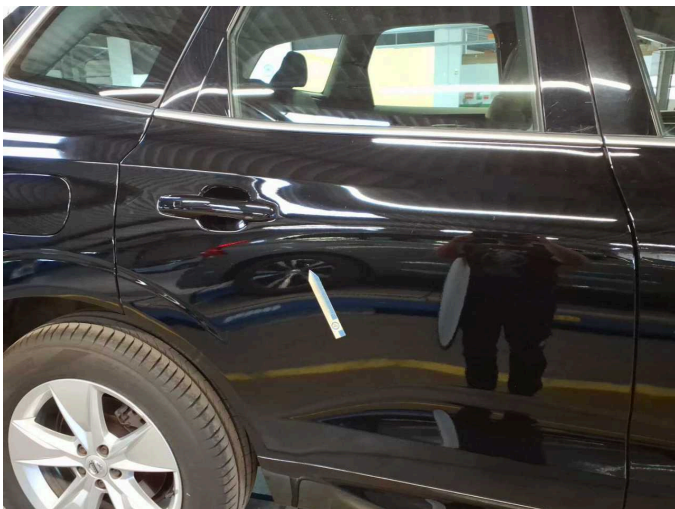
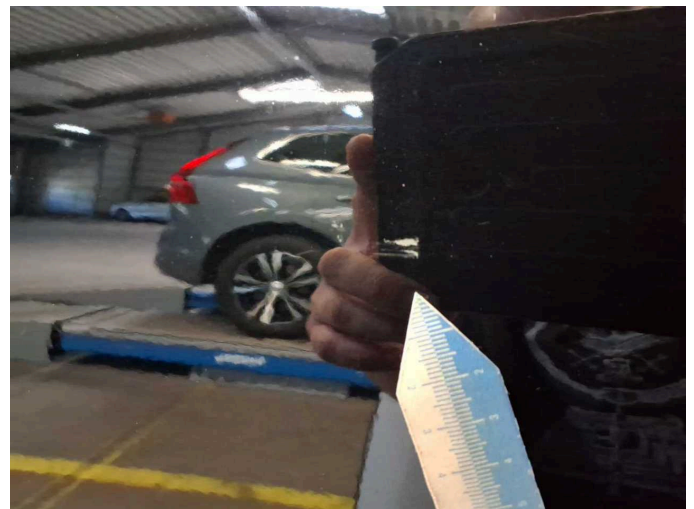
Damage 5: Door - rear right side: Door - Scratch(es) - Smart repair

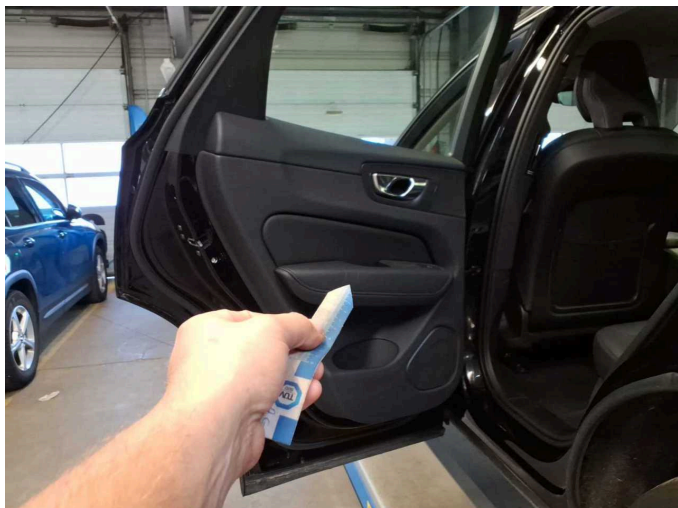
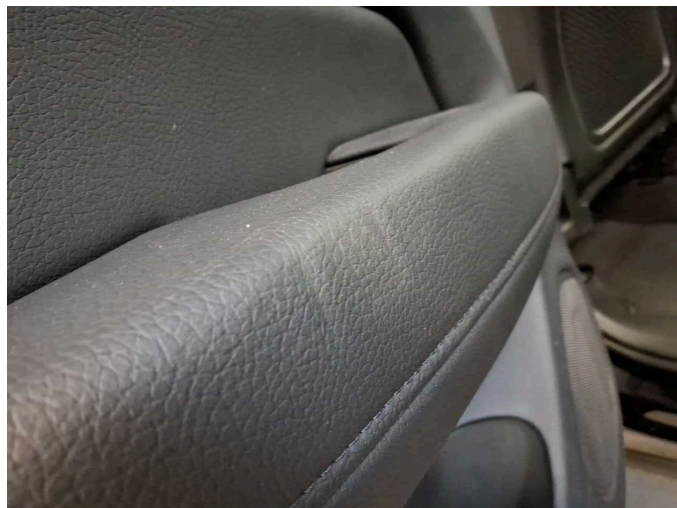
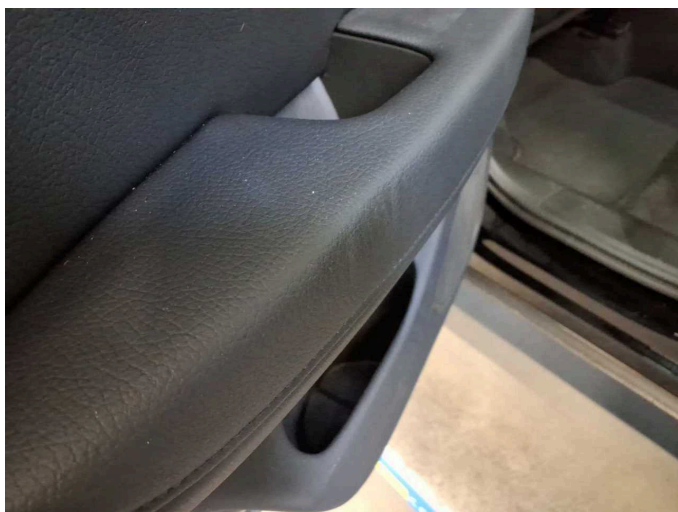
Damage 6: Trim / covers: Door trim - rear left side (Grif) - Deformed - Replace

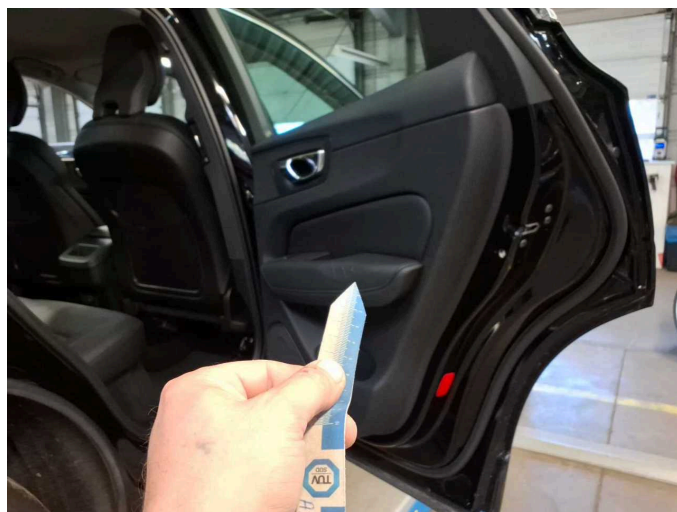
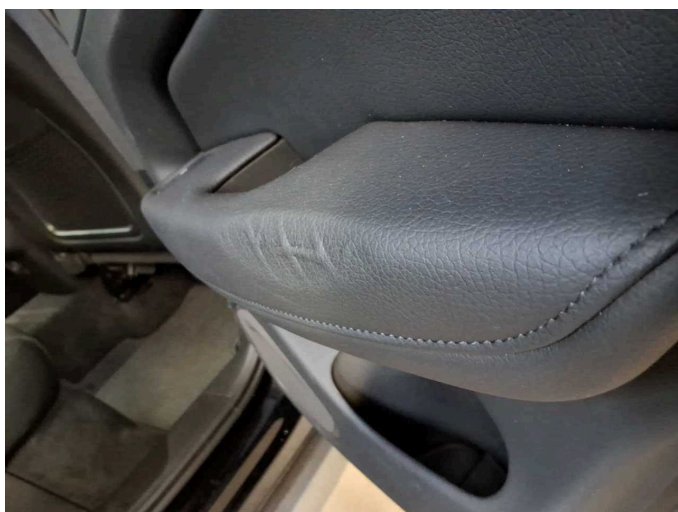
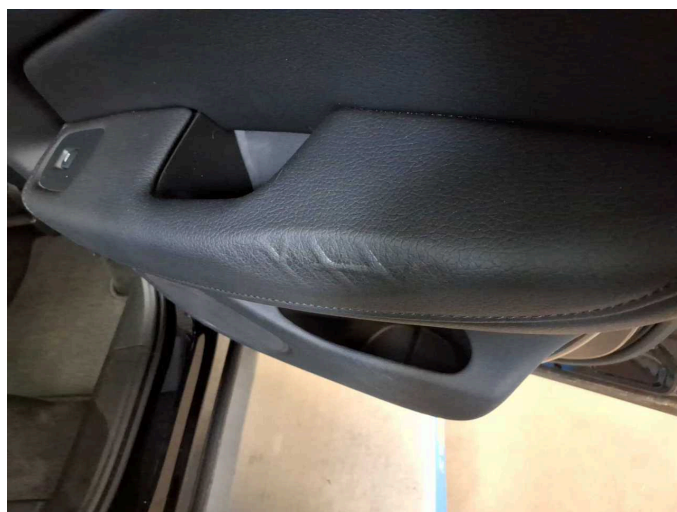
Damage 7: Trim / covers: Door trim - rear right side (Griff) - Deformed - Replace

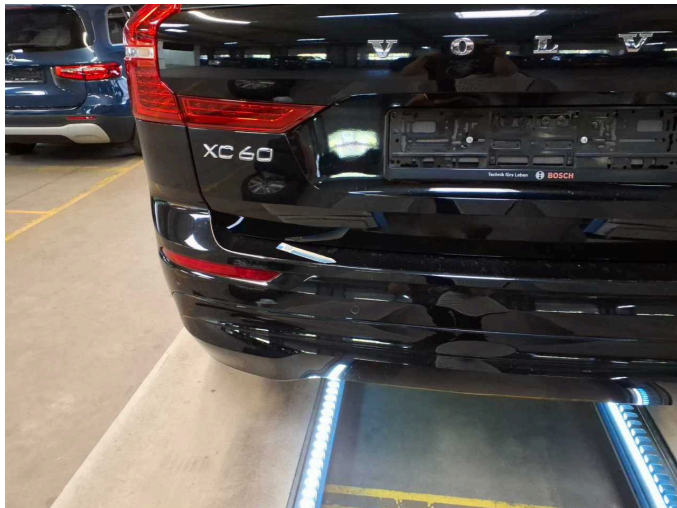
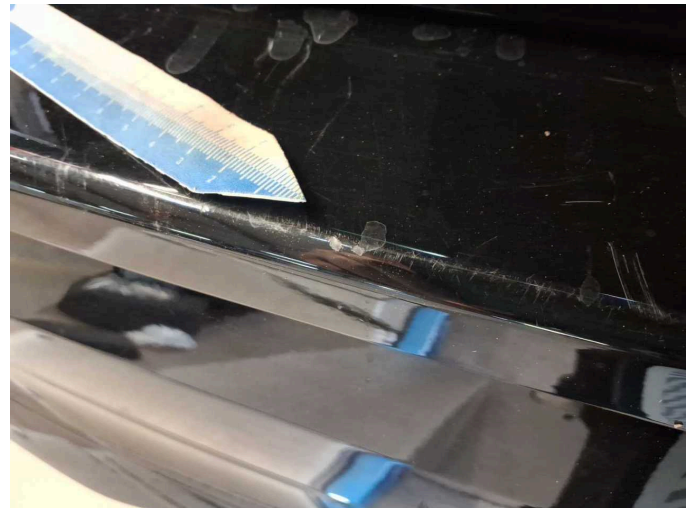
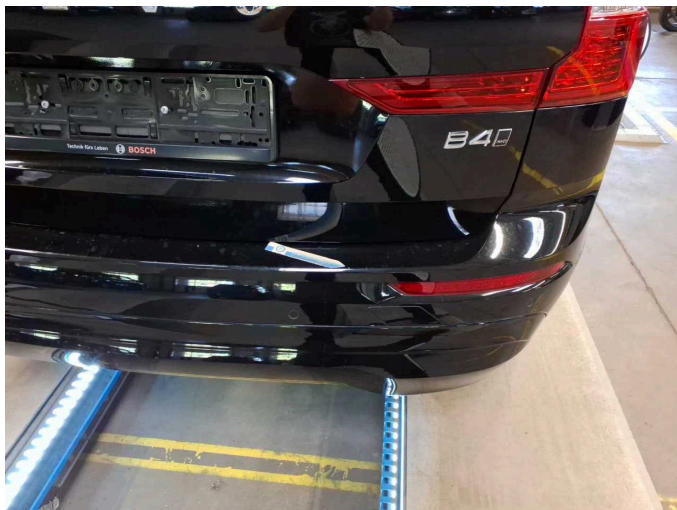
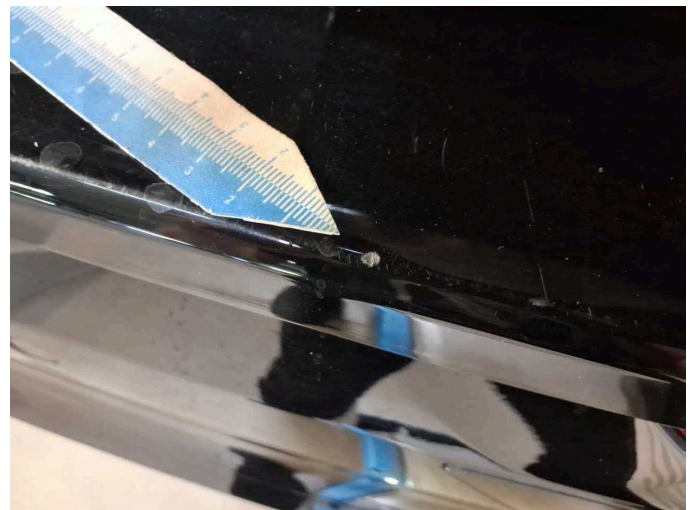
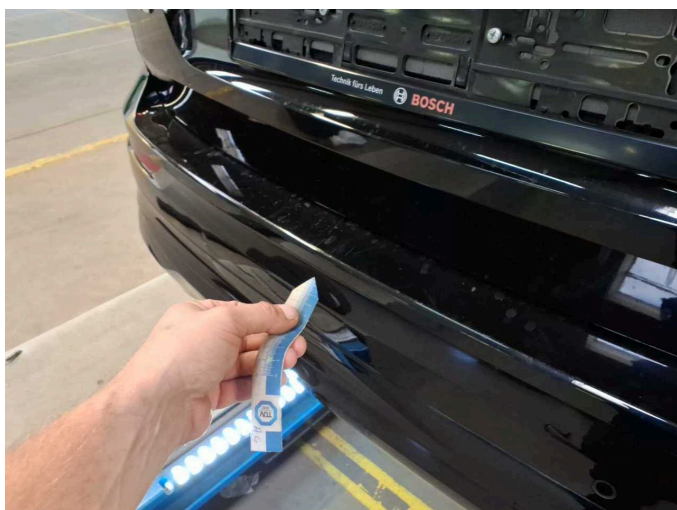
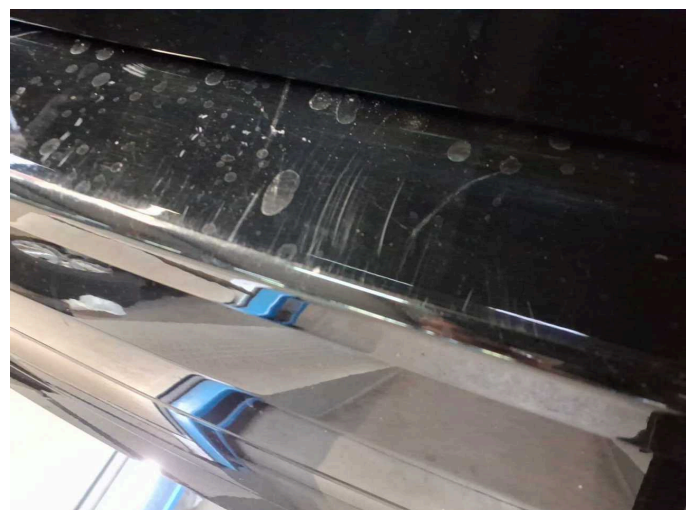
Damage 8: Rear bumper: Rear bumper - Scratch(es) - Paint

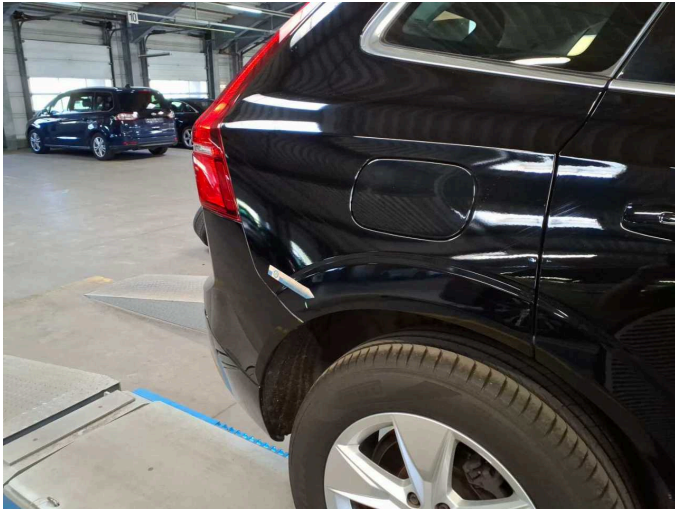
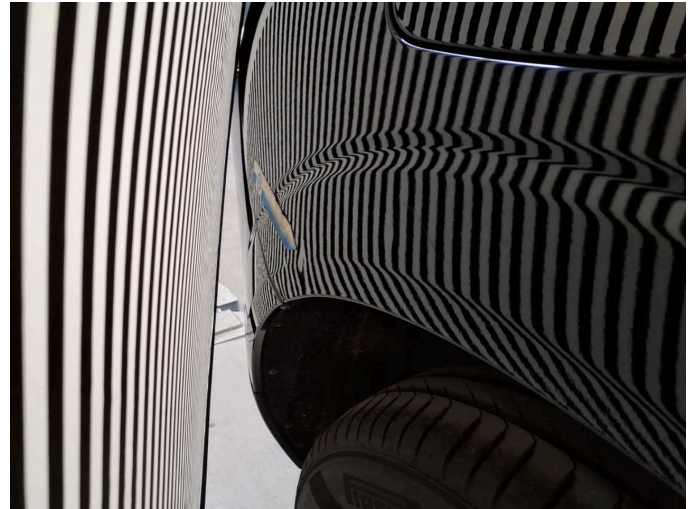
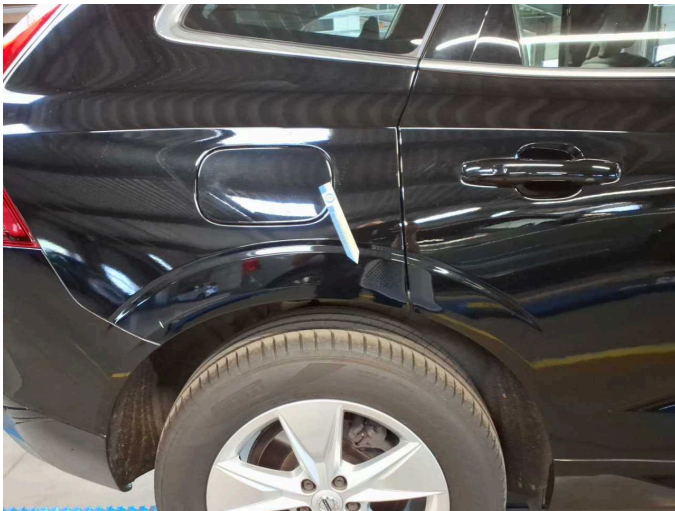
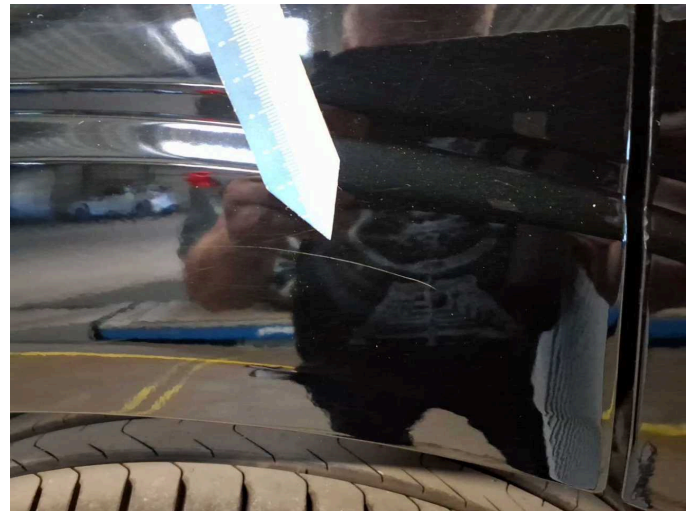
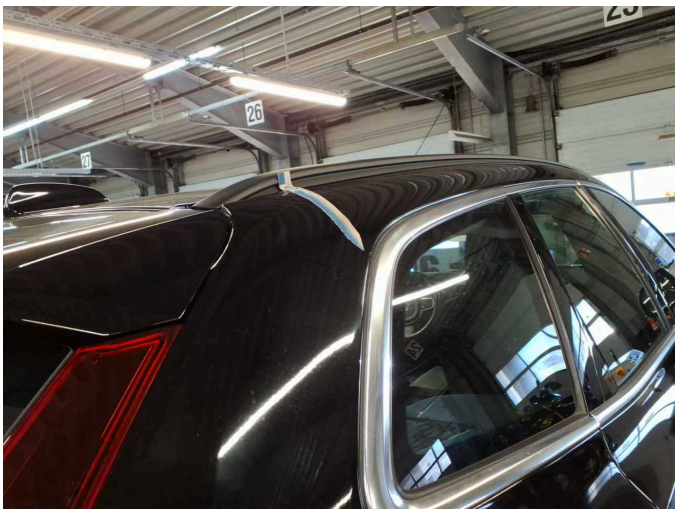
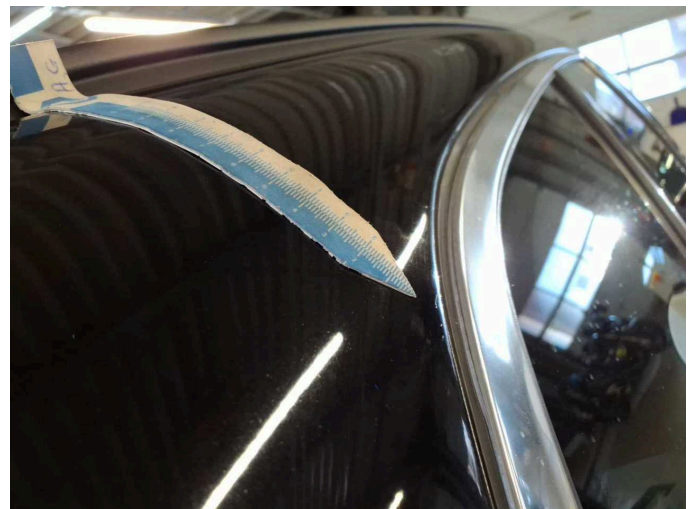
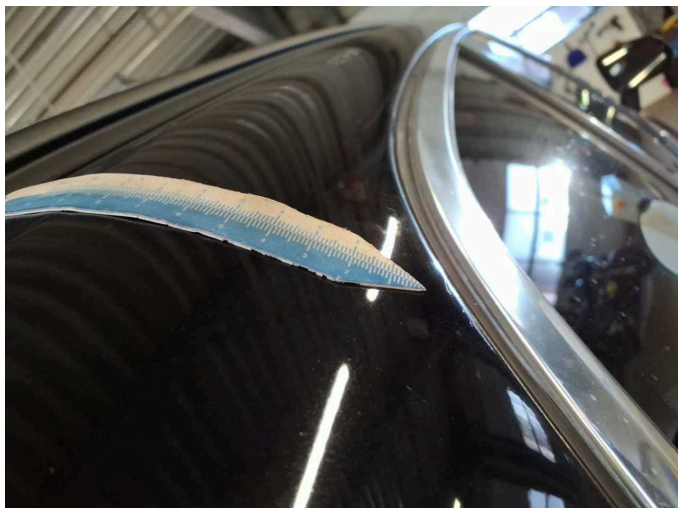
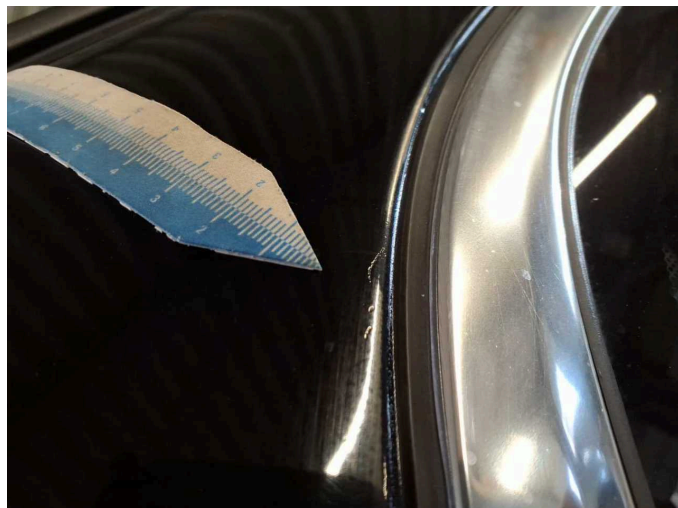
Damage 9: Side panel - rear right side: Side panel (Dellen, Kratzer. Übergang stumpf, schlecht vorbereitet) - Unprofessionally repaired - Repair and paint

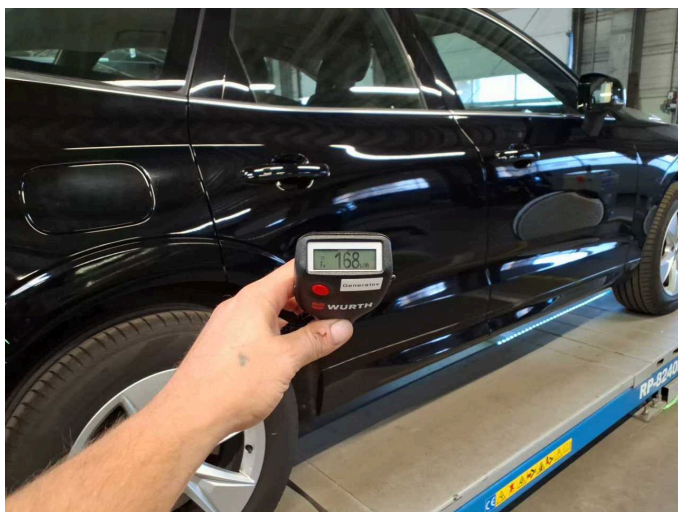
Repainting 1: Door - rear right side

No.	Repainting
1	Door - rear right side, Professionally carried out, Invoice of repair done Non-existent
2	Door - front right side, Professionally carried out, Invoice of repair done Non-existent
3	Side panel - rear right side, Unprofessionally carried out, Invoice of repair done Non-existent

Side panel - rear right side	186 µm	Door - rear right side	168 µm
Door - front right side	174 µm
