## status report

**customer:** Santander Consumer Leasing GmbH

#### Volvo XC60 R Design 2WD

| Vehicle identification number | YV1UZK5VDN1071332 | mileage read: | 127119 km |

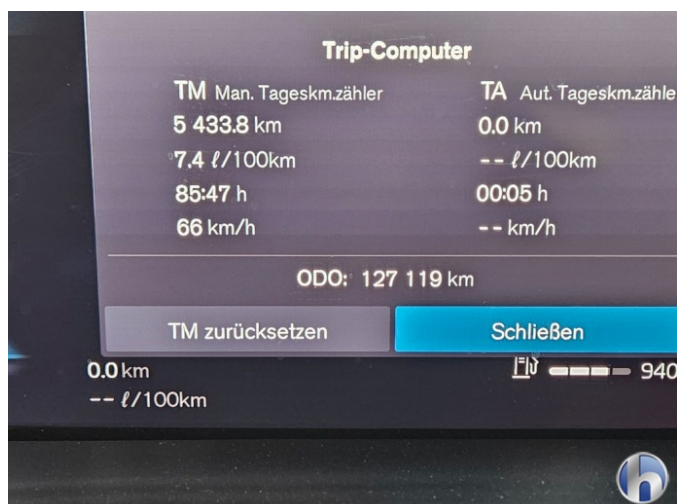
mileage

| General examination | |
|---|---|
| <b>Mileage plausible:</b> | <b>yes</b><br>yes |

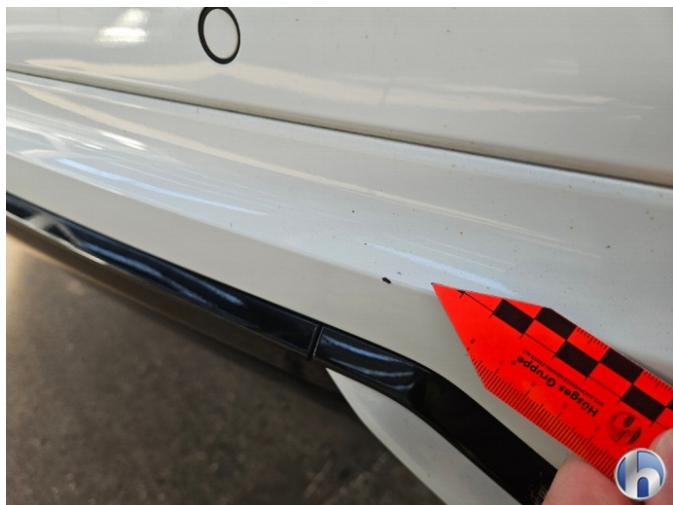
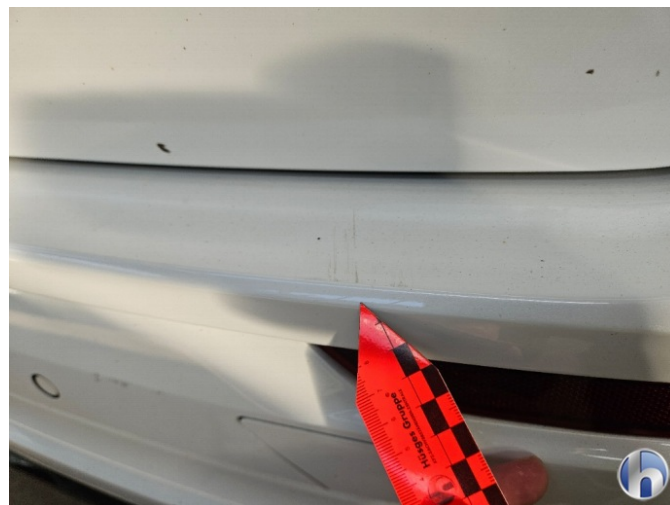
2. Rear bumper

| | component | Damage | Rep kind |
|---|---|---|---|
| 2. | Rear bumper | Wear and tear | acceptable |

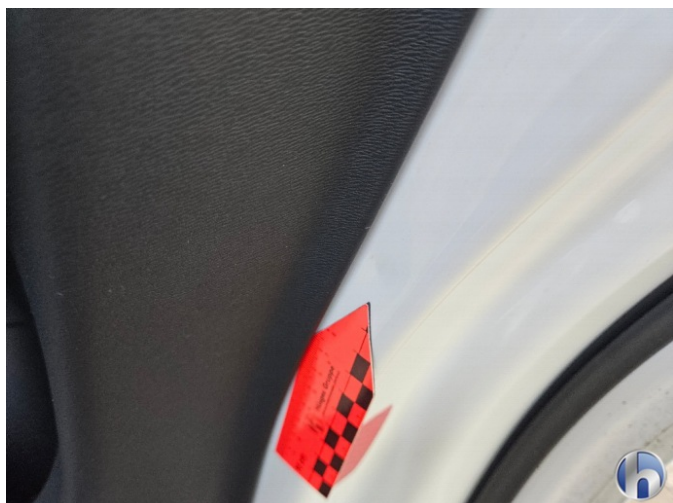
3. Door Rear - right

| | component | Damage | Rep kind |
|---|---|---|---|
| 3. | Door Rear - right | Wear and tear | acceptable |

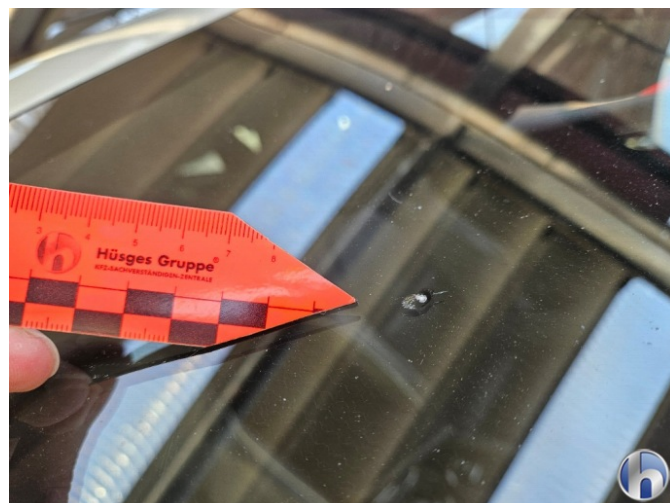
4. Windshield

| | component | Damage | Rep kind |
|---|---|---|---|
| 4. | Windshield | Chipping from stones | Replace |

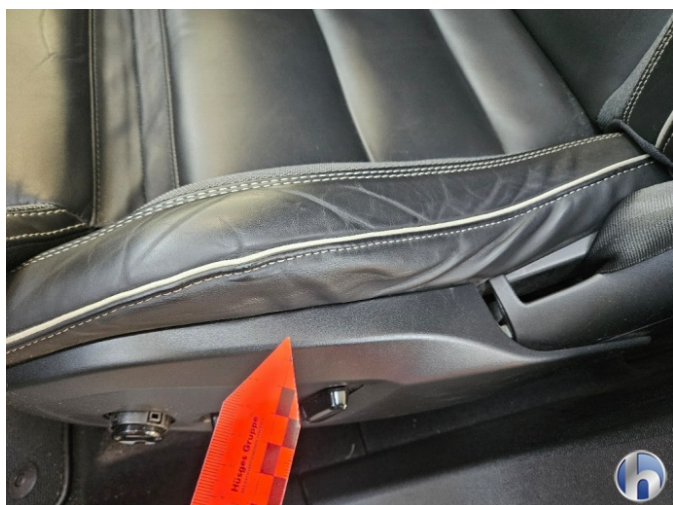
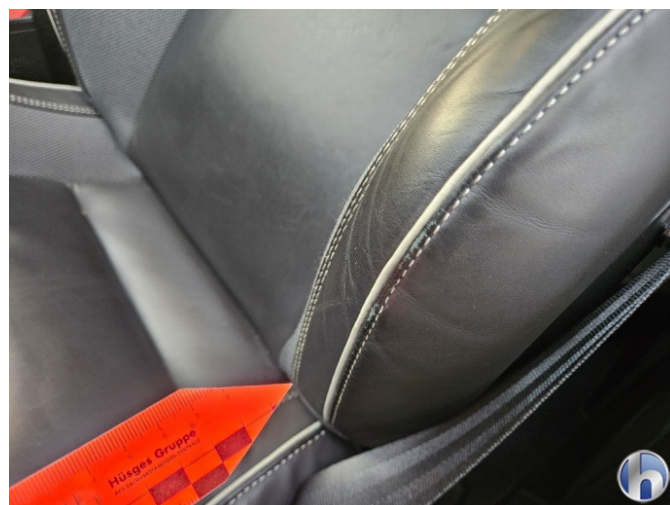
5. Fahrersitz

| | component | Damage | Rep kind |
|---|---|---|---|
| 5. | Fahrersitz | Wear and tear | acceptable |

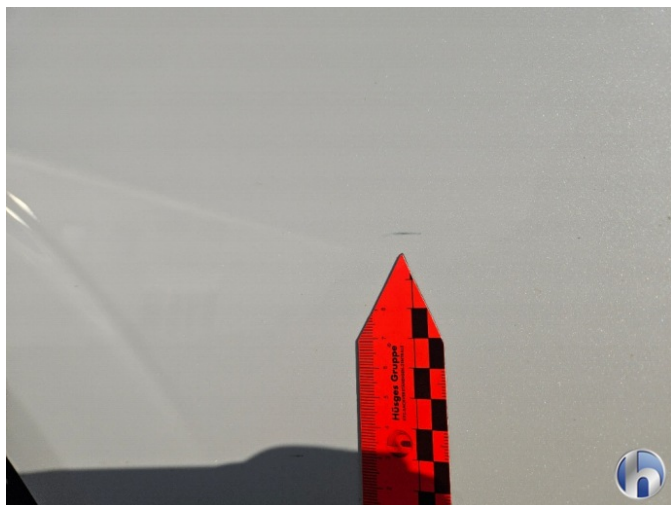
6. Door Rear - right

| | component | Damage | Rep kind |
|---|---|---|---|
| 6. | Door Rear - right | Scratch(es) | |
